**COAL ASH IMPOUNDMENT
SITE ASSESSMENT FINAL REPORT**

**6th Street Power Generating Station
Interstate Power and Light Company
Cedar Rapids, Iowa**

KLEINFELDER PROJECT NUMBER 118953-4

February 28, 2013

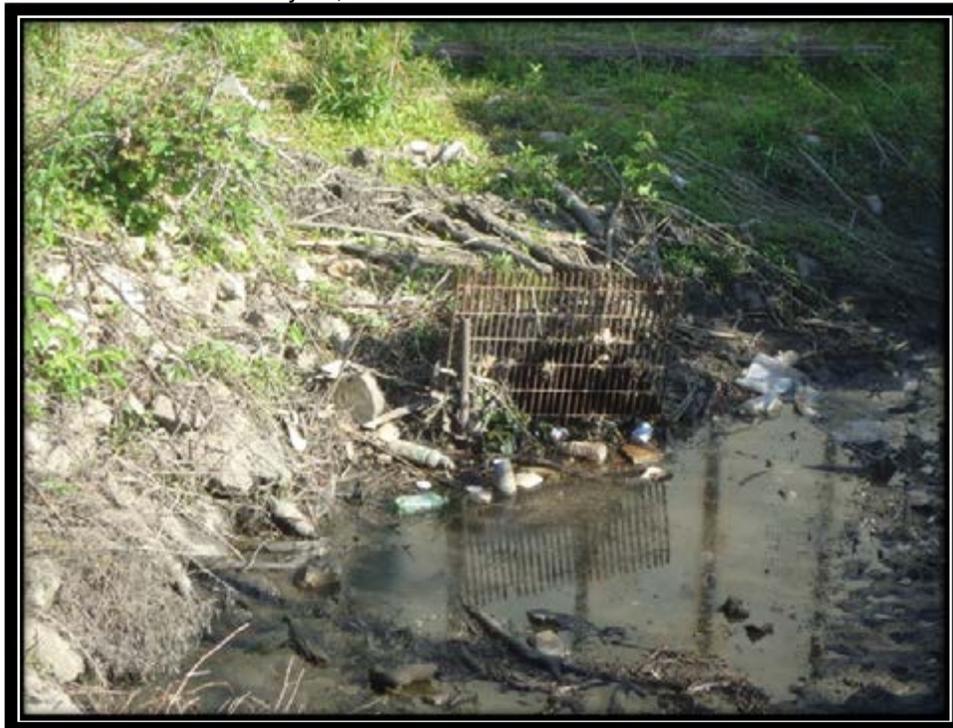
Photo 2 – Corrugated Metal Pipe (CMP) Discharge under Railroad Tracks into Cedar Lake
May 24, 2011 NPDES# IOWA-5715109

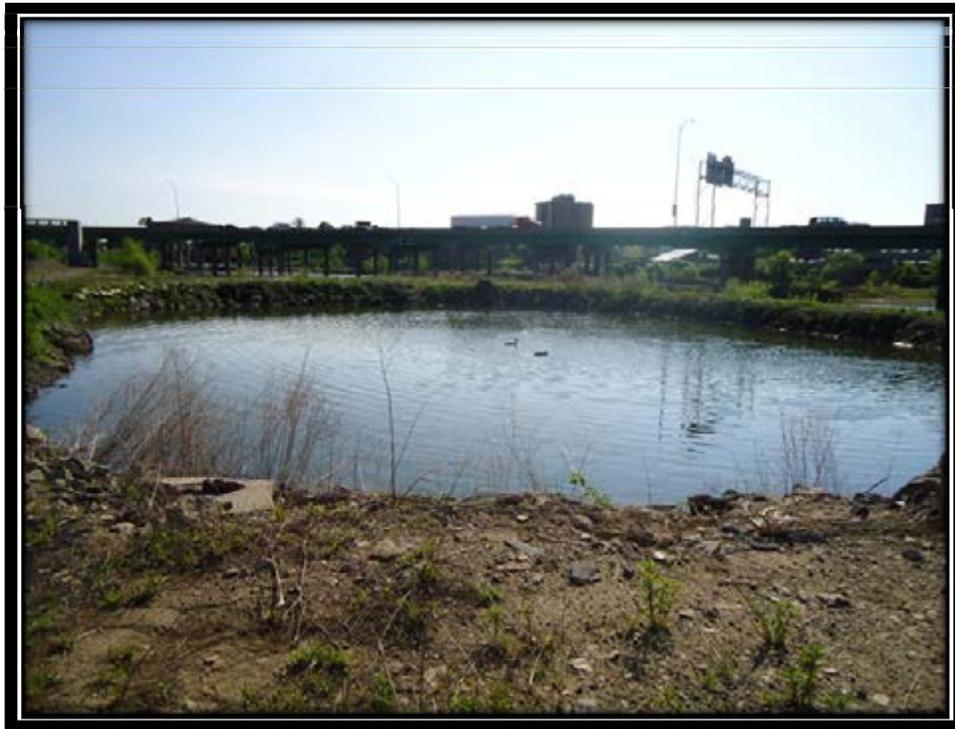
Overall, the upstream slope of the impoundment was in fair condition. Photos 5 through 8 at the end of this section show the conditions of the upstream slope. Specific observations include:

Photo 5 – General Conditions Photograph Ash Pond 2
May 24, 2011 NPDES# IOWA-5715109

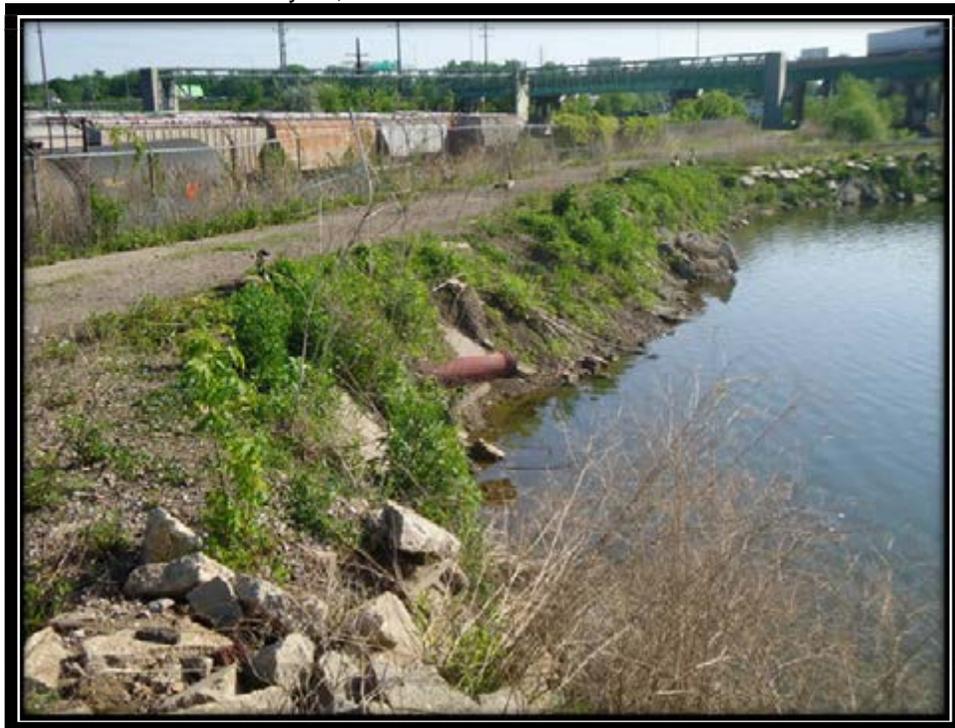
Overall, the crest of the impoundment was in fair condition. Photos 6 and 7 show the condition of the crest. Specific observations include:

Photo 6 – Inlet Pipe into Ash Pond 2
May 24, 2011 NPDES# IOWA-5715109

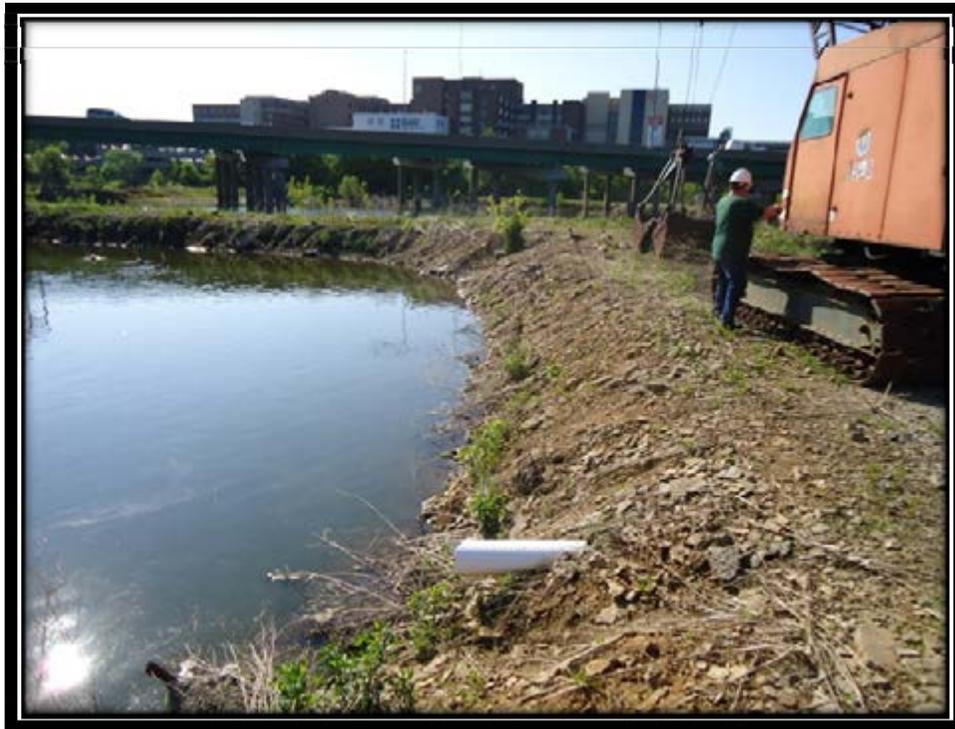
Photo 7 – 12 Inch PVC Pipe Hydraulically Connecting Ash Ponds 1 and 2
May 24, 2011 NPDES# IOWA-5715109

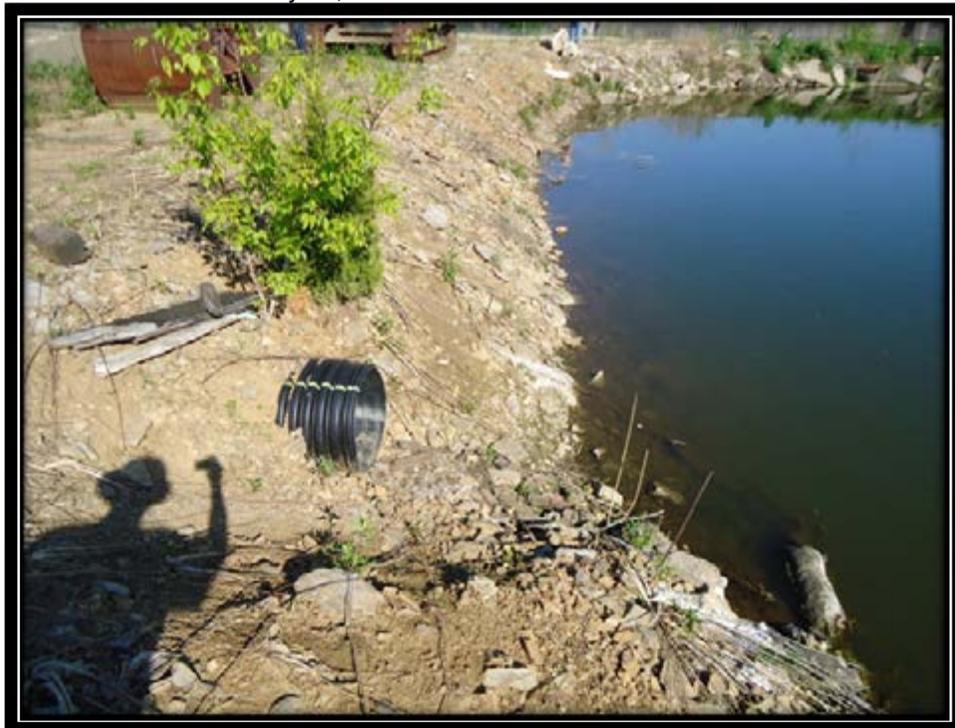
Photo 8 – 30 inch Corrugated Plastic Pipe Hydraulically Connecting Ash Ponds 1 and 2
May 24, 2011 NPDES# IOWA-5715109

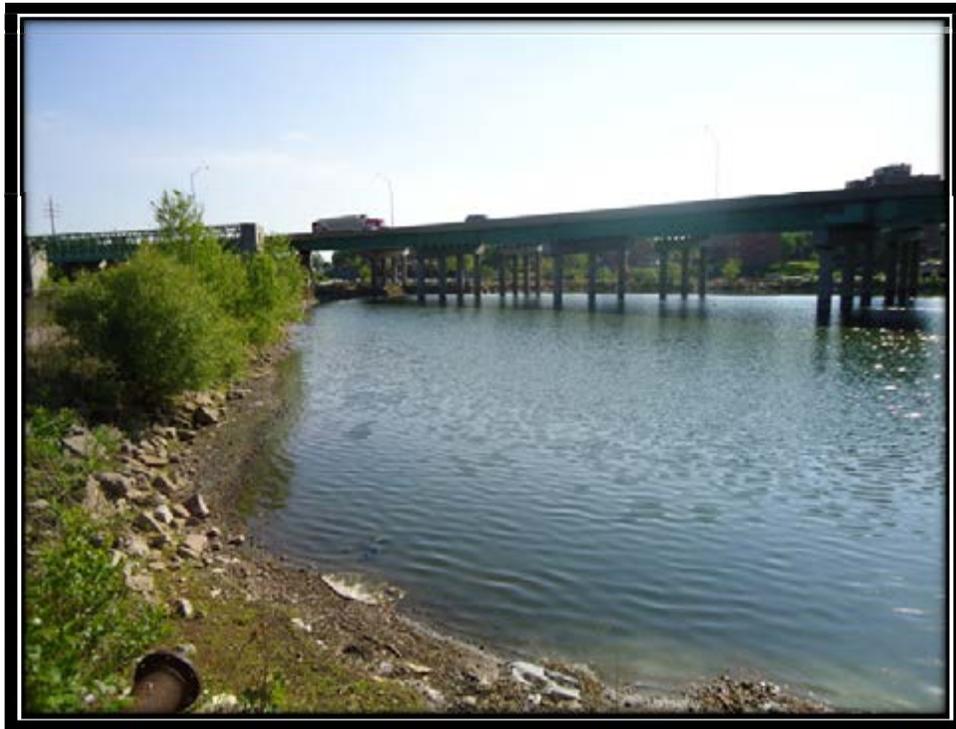
Overall, the upstream slope of the impoundment was in fair condition. Photos 9, 10, 13, 17, and 21 at the end of this section show the conditions of the upstream slope. Specific observations include:

Photo 9 – General Conditions Photograph Ash Pond 3
May 24, 2011 NPDES# IOWA-5715109

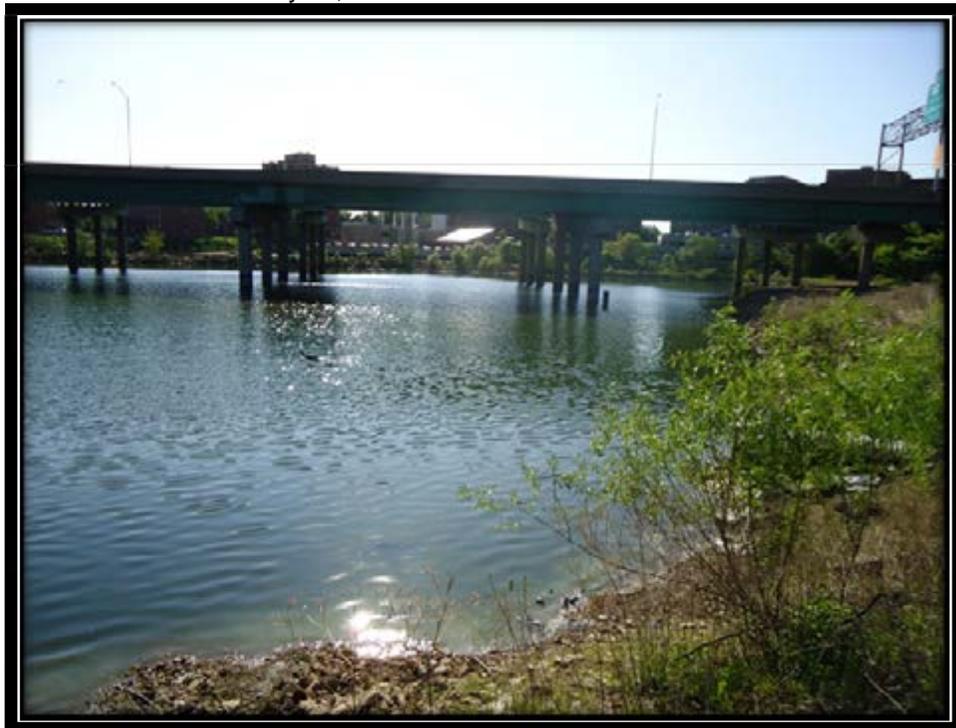
Inflow into Ash Pond 3 is via the discharge conduit from Ash Pond 2 as well as rainfall runoff that flows naturally into the impoundment and stormwater runoff that is transferred from the I-380 downspouts into the pond. The inlet pipe can be seen in photo 10 at the end of this section. In addition, downspouts from I-

Photo 10 – General Conditions Photograph Ash Pond 3
May 24, 2011 NPDES# IOWA-5715109

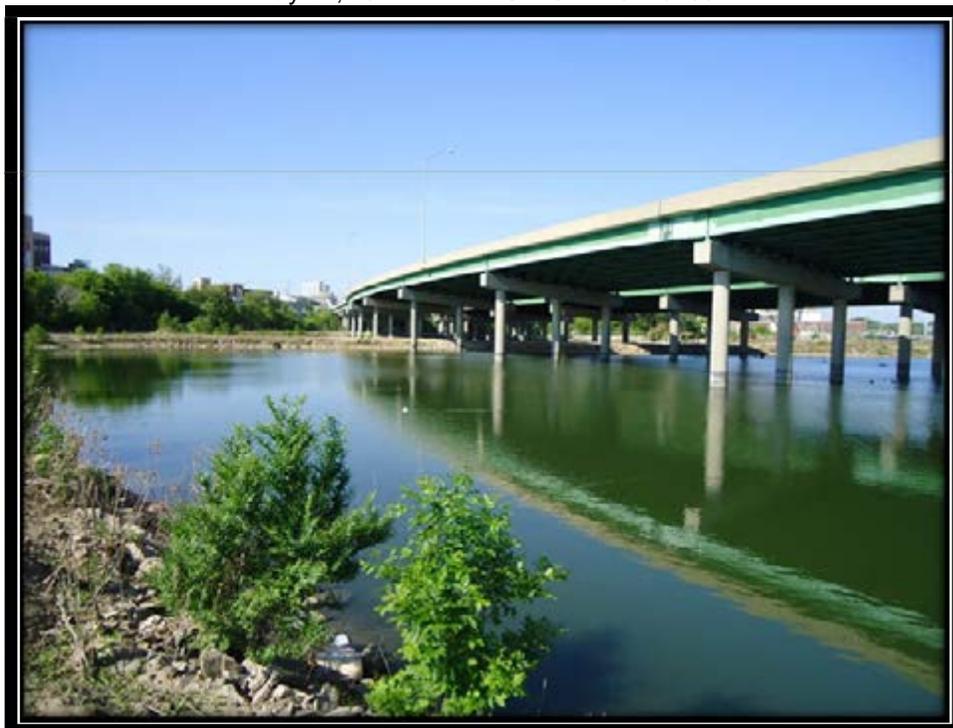
Photo 18 – General Conditions Photograph Ash Pond 3
May 24, 2011 NPDES# IOWA-5715109

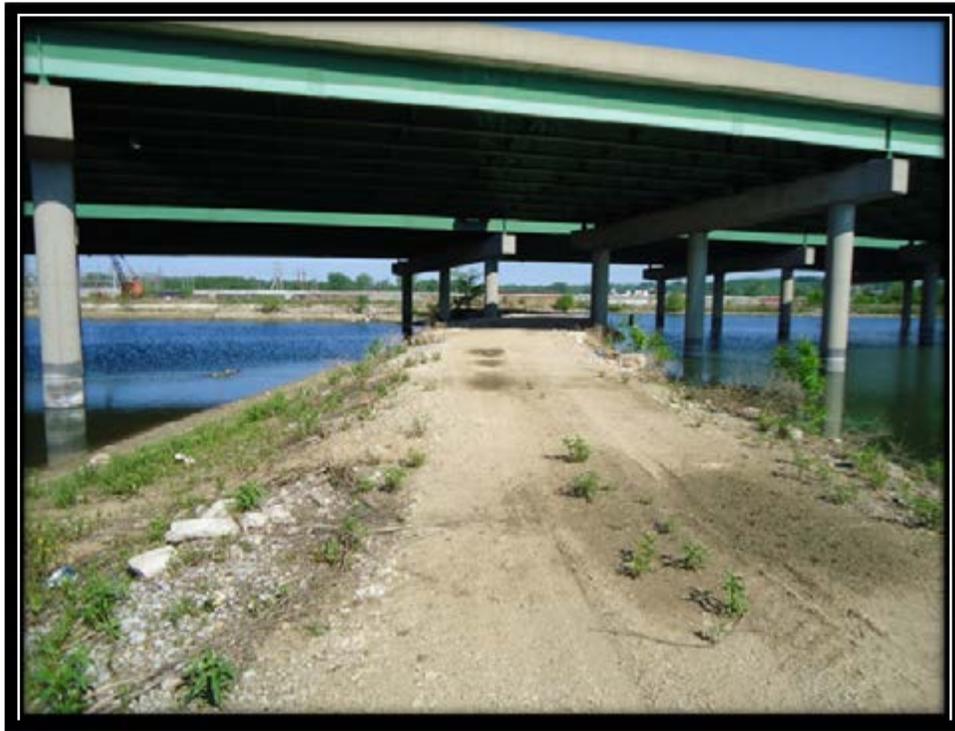
Overall, the upstream slope of the impoundment was in fair condition. Photos 23, 24, and 28 at the end of this section show the conditions of the upstream slope. Specific observations include:

Photo 23 – Embankment between Ash Ponds 3 and 4
May 24, 2011 NPDES# IOWA-5715109

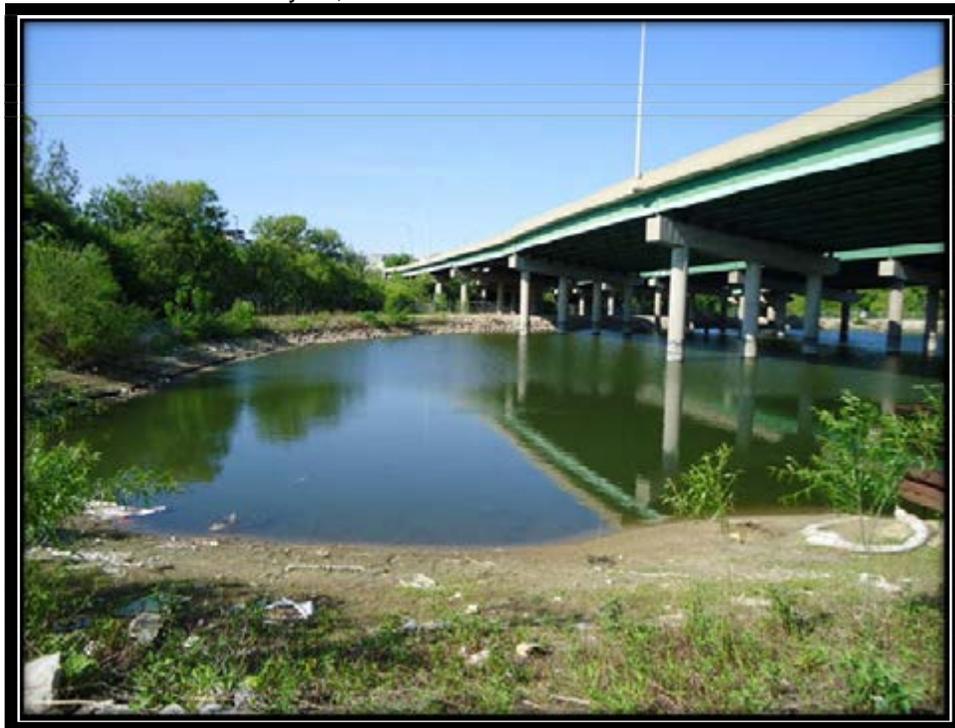
Photo 24 – General Conditions Photograph Ash Pond 4
May 24, 2011 NPDES# IOWA-5715109

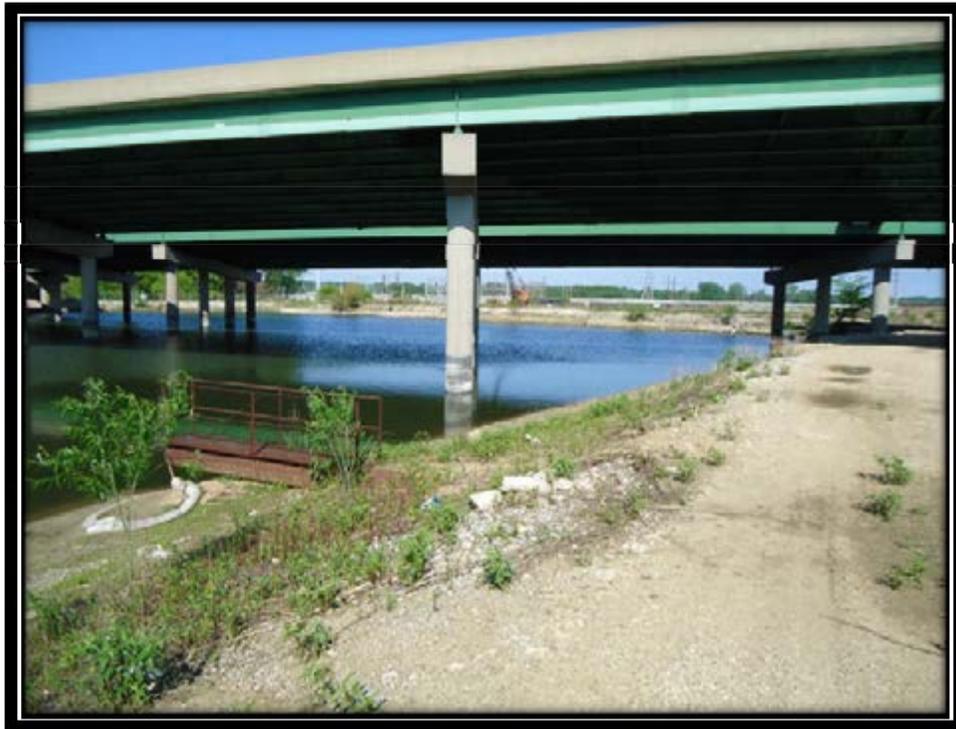
Overall, the crest of the impoundment was in fair condition. Photos 25, 28 and 30 show the condition of the crest. Specific observations include:

Inflow into Ash Pond 4 is via the discharge pipes from Ash Ponds 1 and 3 as well as any rainfall runoff that naturally flows into the impoundment or that is discharged from the I-380 downspouts that terminate in the pond. The inlet pipes can be seen in photos 25 and 31 at the end of this section. The inlet pipes from both Ash Pond 1 and Ash Pond 3 appeared to be in fair to poor condition.

Photo 25 – General Conditions Photograph Ash Pond 4
May 24, 2011 NPDES# IOWA-5715109

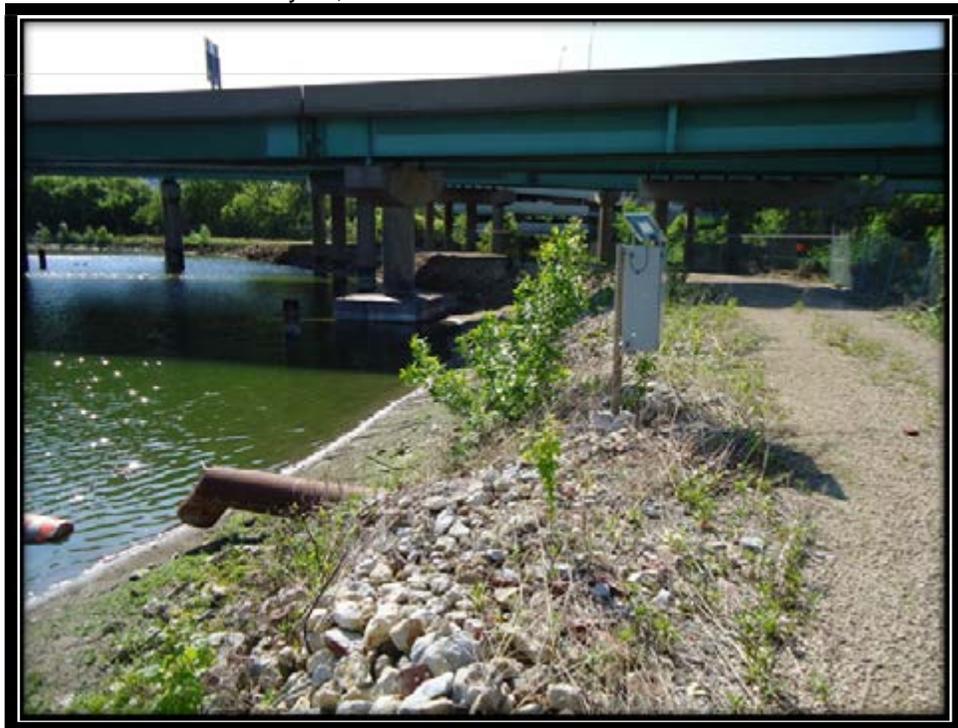
- We understand that video monitoring of the 16-inch metal pipe has not been performed.
- The 16-inch metal outlet pipe has significant corrosion as can be seen in photo 28.
- Overall, the outlet works system appeared that it could function as intended at the time of assessment.

Photo 28 – Ash Pond 4 Outlet Pipe
May 24, 2011 NPDES# IOWA-5715109

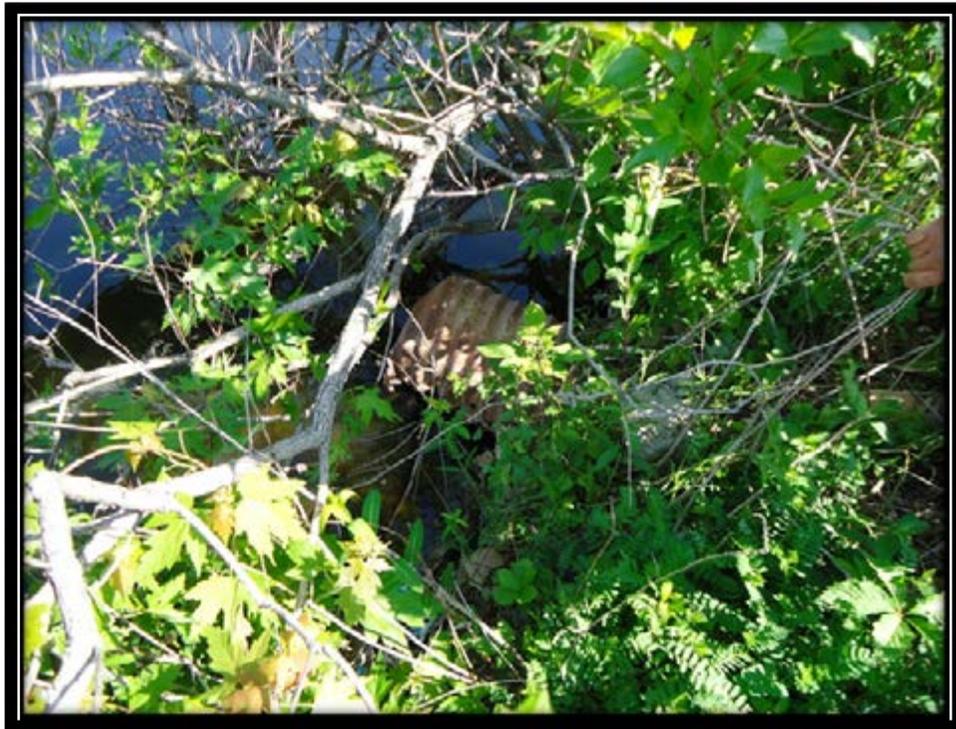
Photo 35 – Corrugated Metal Pipe Outlet from Ash Ponds to Cedar Lake
May 24, 2011 NPDES# IOWA-5715109

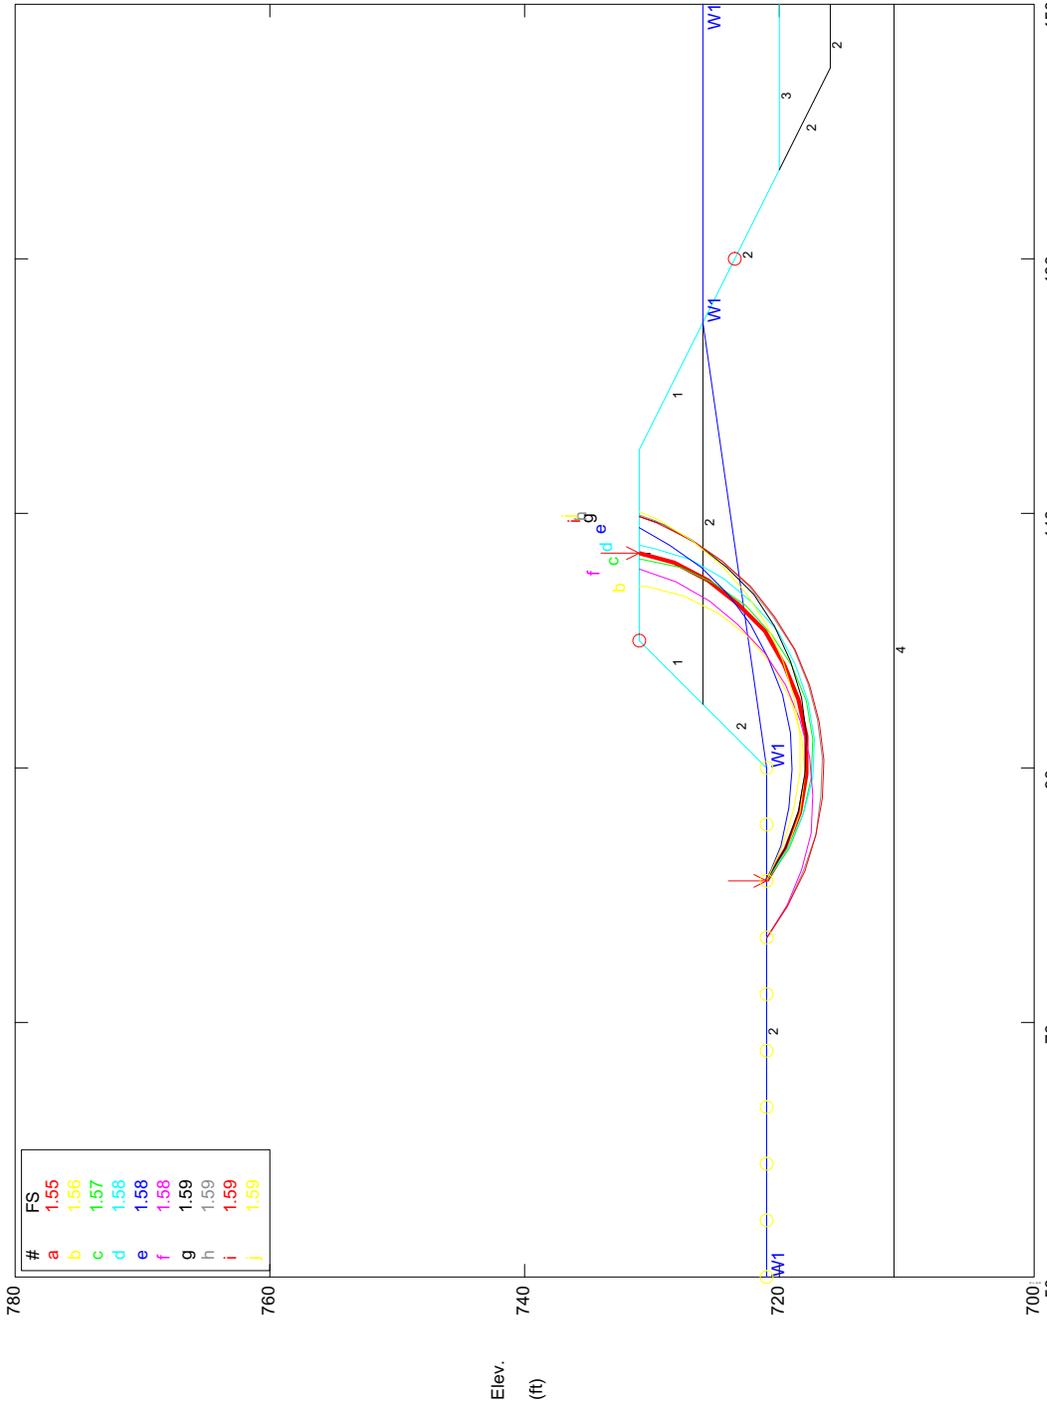
Alliant 6th St. Cedar Rapids Pond #4 Static Case
 Ten Most Critical. C:6THST11C.PLT By: TCW 08-02-11 11:34am

#	FS
a	1.55
b	1.56
c	1.57
d	1.58
e	1.58
f	1.58
g	1.59
h	1.59
i	1.59
j	1.59

PCSTABL5M/SI F_{Smin}=1.55 X-Axis (ft)

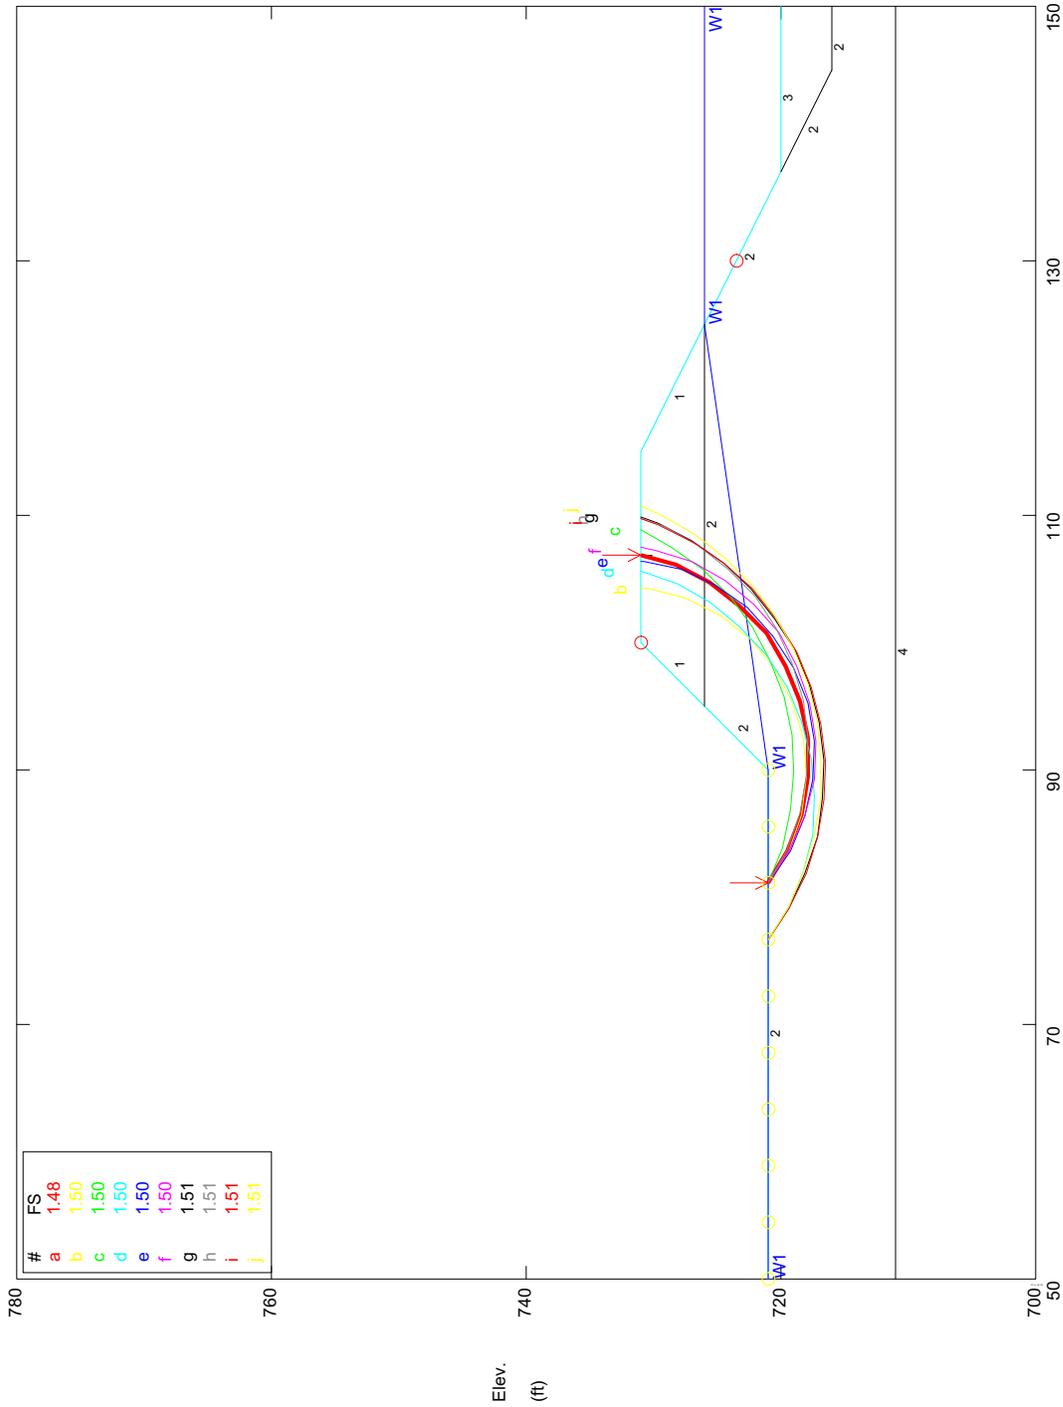
Alliant 6th St. Cedar Rapids Pond #4 Earthquake Case (0.024 & 0.016)
 Ten Most Critical. C:6THST21C.PLT By: TCW 08-02-11 11:10am

#	FS
a	1.48
b	1.50
c	1.50
d	1.50
e	1.50
f	1.50
g	1.51
h	1.51
i	1.51
j	1.51

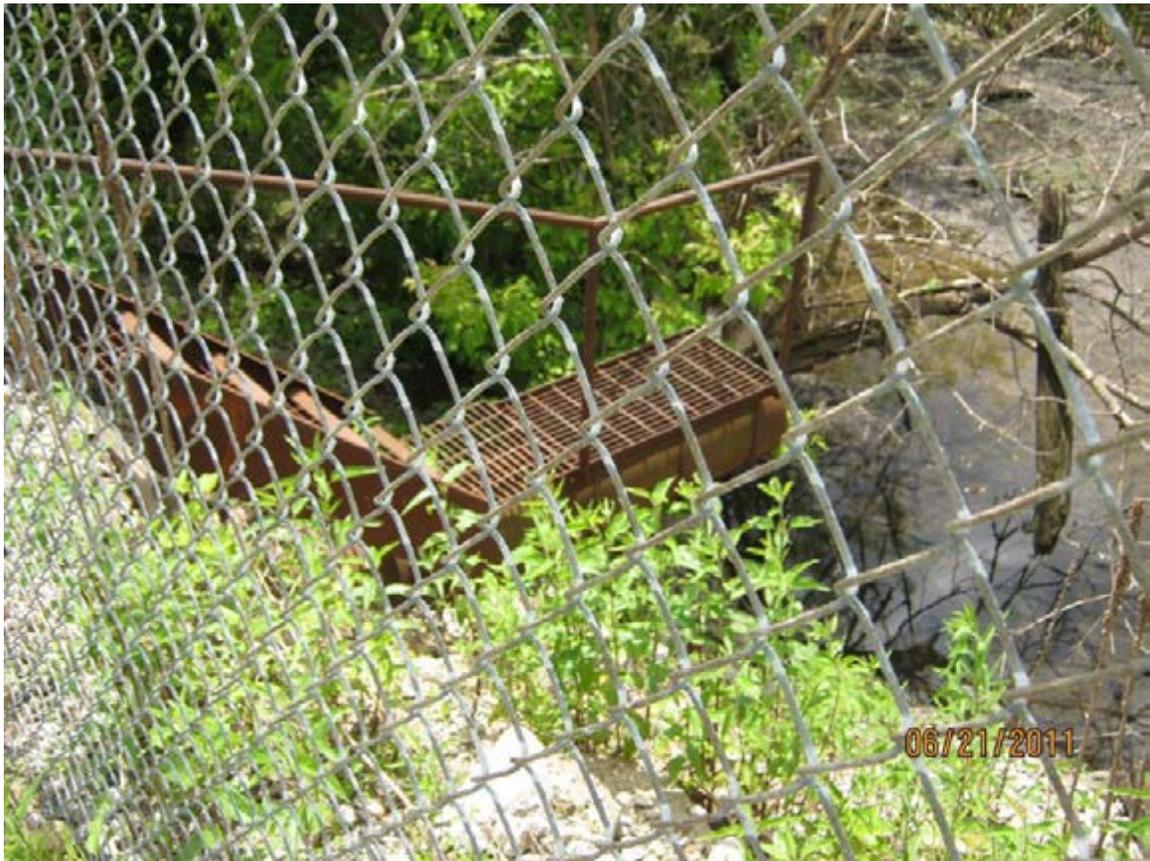
Photograph 2 Outboard Slope at Stability Analysis Cross-Section at SB-3

the crest widths in the higher sections of the embankment range from 15 to 30-foot. The inboard and outboard slopes are as steep as 1H to 1V on some slopes (The steep slopes are covered with rip rap, Photograph 2). From these variations, Aether chose to analyze the highest embankment near the outlet of Pond 4 where the crest was at the minimum width of 15-feet and the toe of the slope is at the water surface of Cedar Lake at elevation 721.

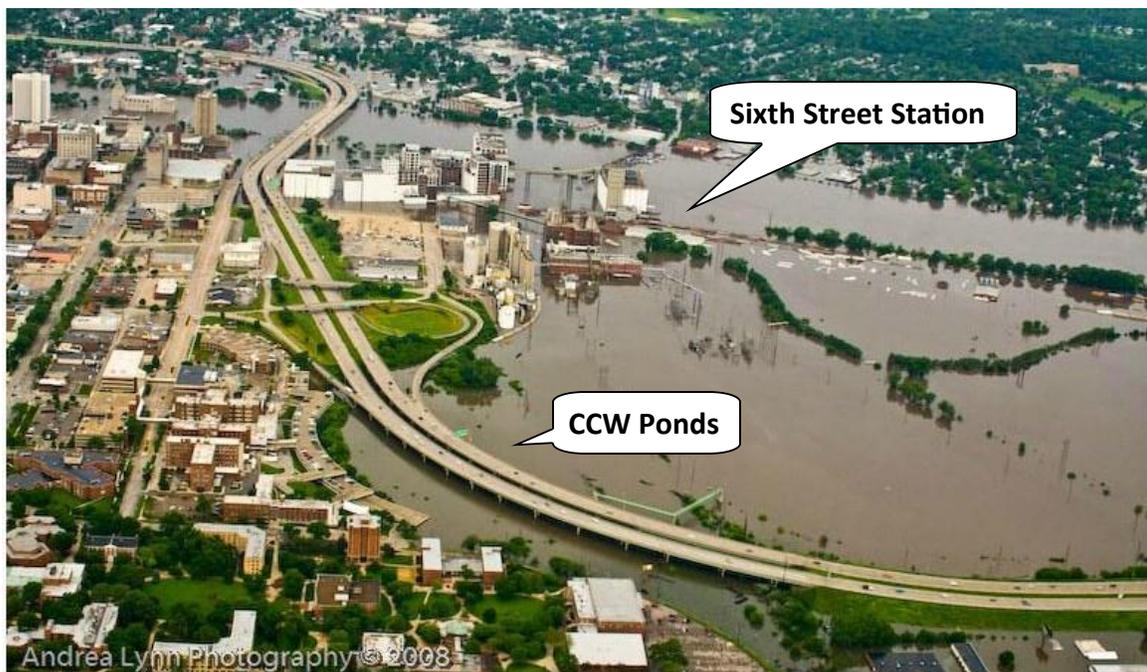
Photograph 3 Water at Flood Peak, June 13, 2008

In June of 2008, the watershed of the Cedar River experienced a storm that caused flow through Cedar Rapids exceeding the 500-year return period event. During the flood the 6th street generating station recorded 6-feet of water on the floor of the station. At the same time the coal combustion waste ponds were fully inundated by the flood flow, Photograph 3. When the flood waters receded, the embankments of the coal combustion waste ponds were subjected to rapid drawdown of the phreatic water surface by sequential lowering of the water elevation on both sides of the embankments. After the flood wave ebbed, Alliant Energy completed an inspection of the coal combustion waste pond embankments that showed no damage from erosion or gully wash outs. No embankment repairs have been conducted by Alliant Energy. The only observed damage was the toppling over of the flow meter, which was unrelated to embankment stability.
