**FINAL REPORT  
ROUND 10 DAM ASSESSMENT  
AMEREN ENERGY GENERATING COMPANY – HUTSONVILLE POWER  
STATION  
POND A, POND B, POND D  
HUTSONVILLE, ILLINOIS**

October 16, 2012  
GZA File No. 170142.30

RE: Assessment of Dam Safety of Coal Combustion Surface Impoundments at the  
Hutsonville Power Station

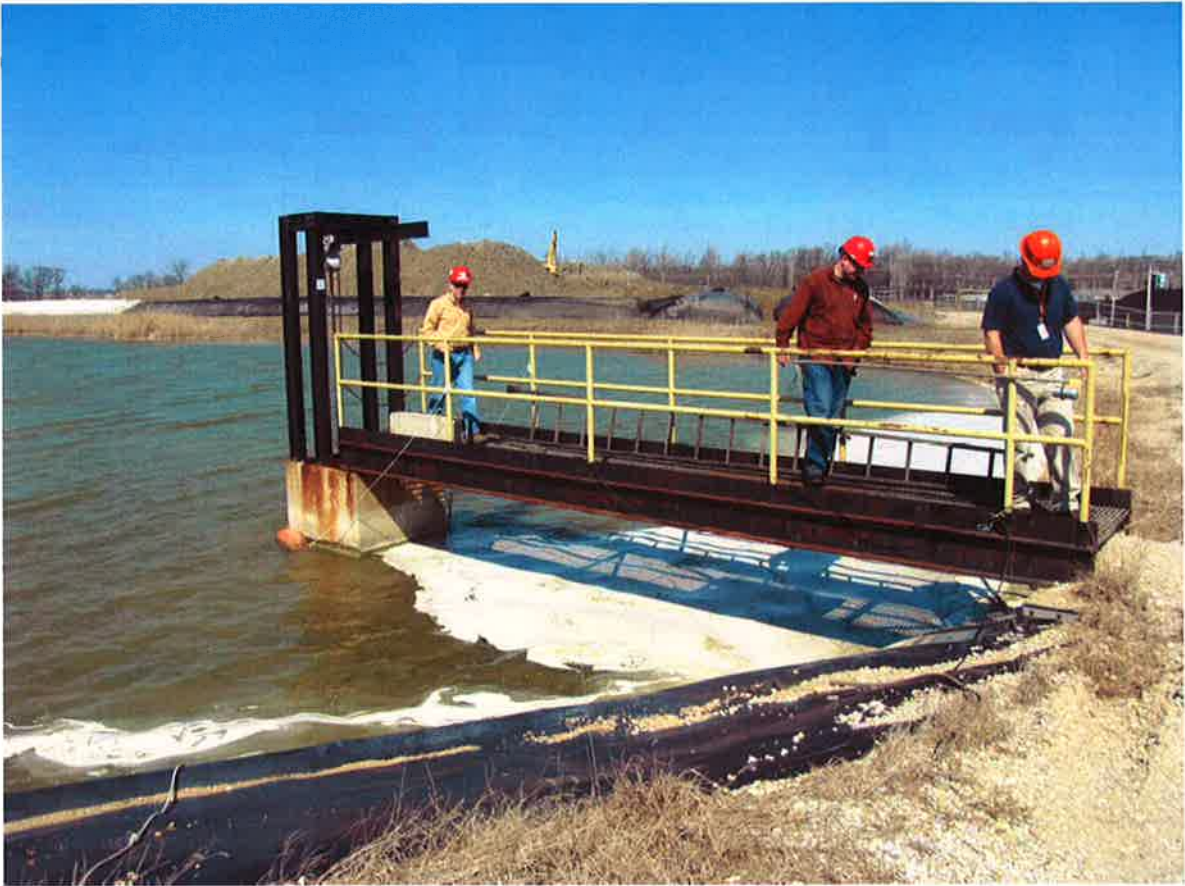
| Item | Condition Code * | Deficiencies | Recommended Remedial Measures and Implementation Schedule |
|---|---|---|---|
| | Outfall Structure Condition | GC | Outlet structure is in good condition (see photo #6). |

Photo #6 – Ash Pond B – Outlet structure
