# **Dam Safety Assessment of CCW Impoundments**

**Joppa Plant**

**United States Environmental Protection Agency  
Washington, DC**

May 27, 2010

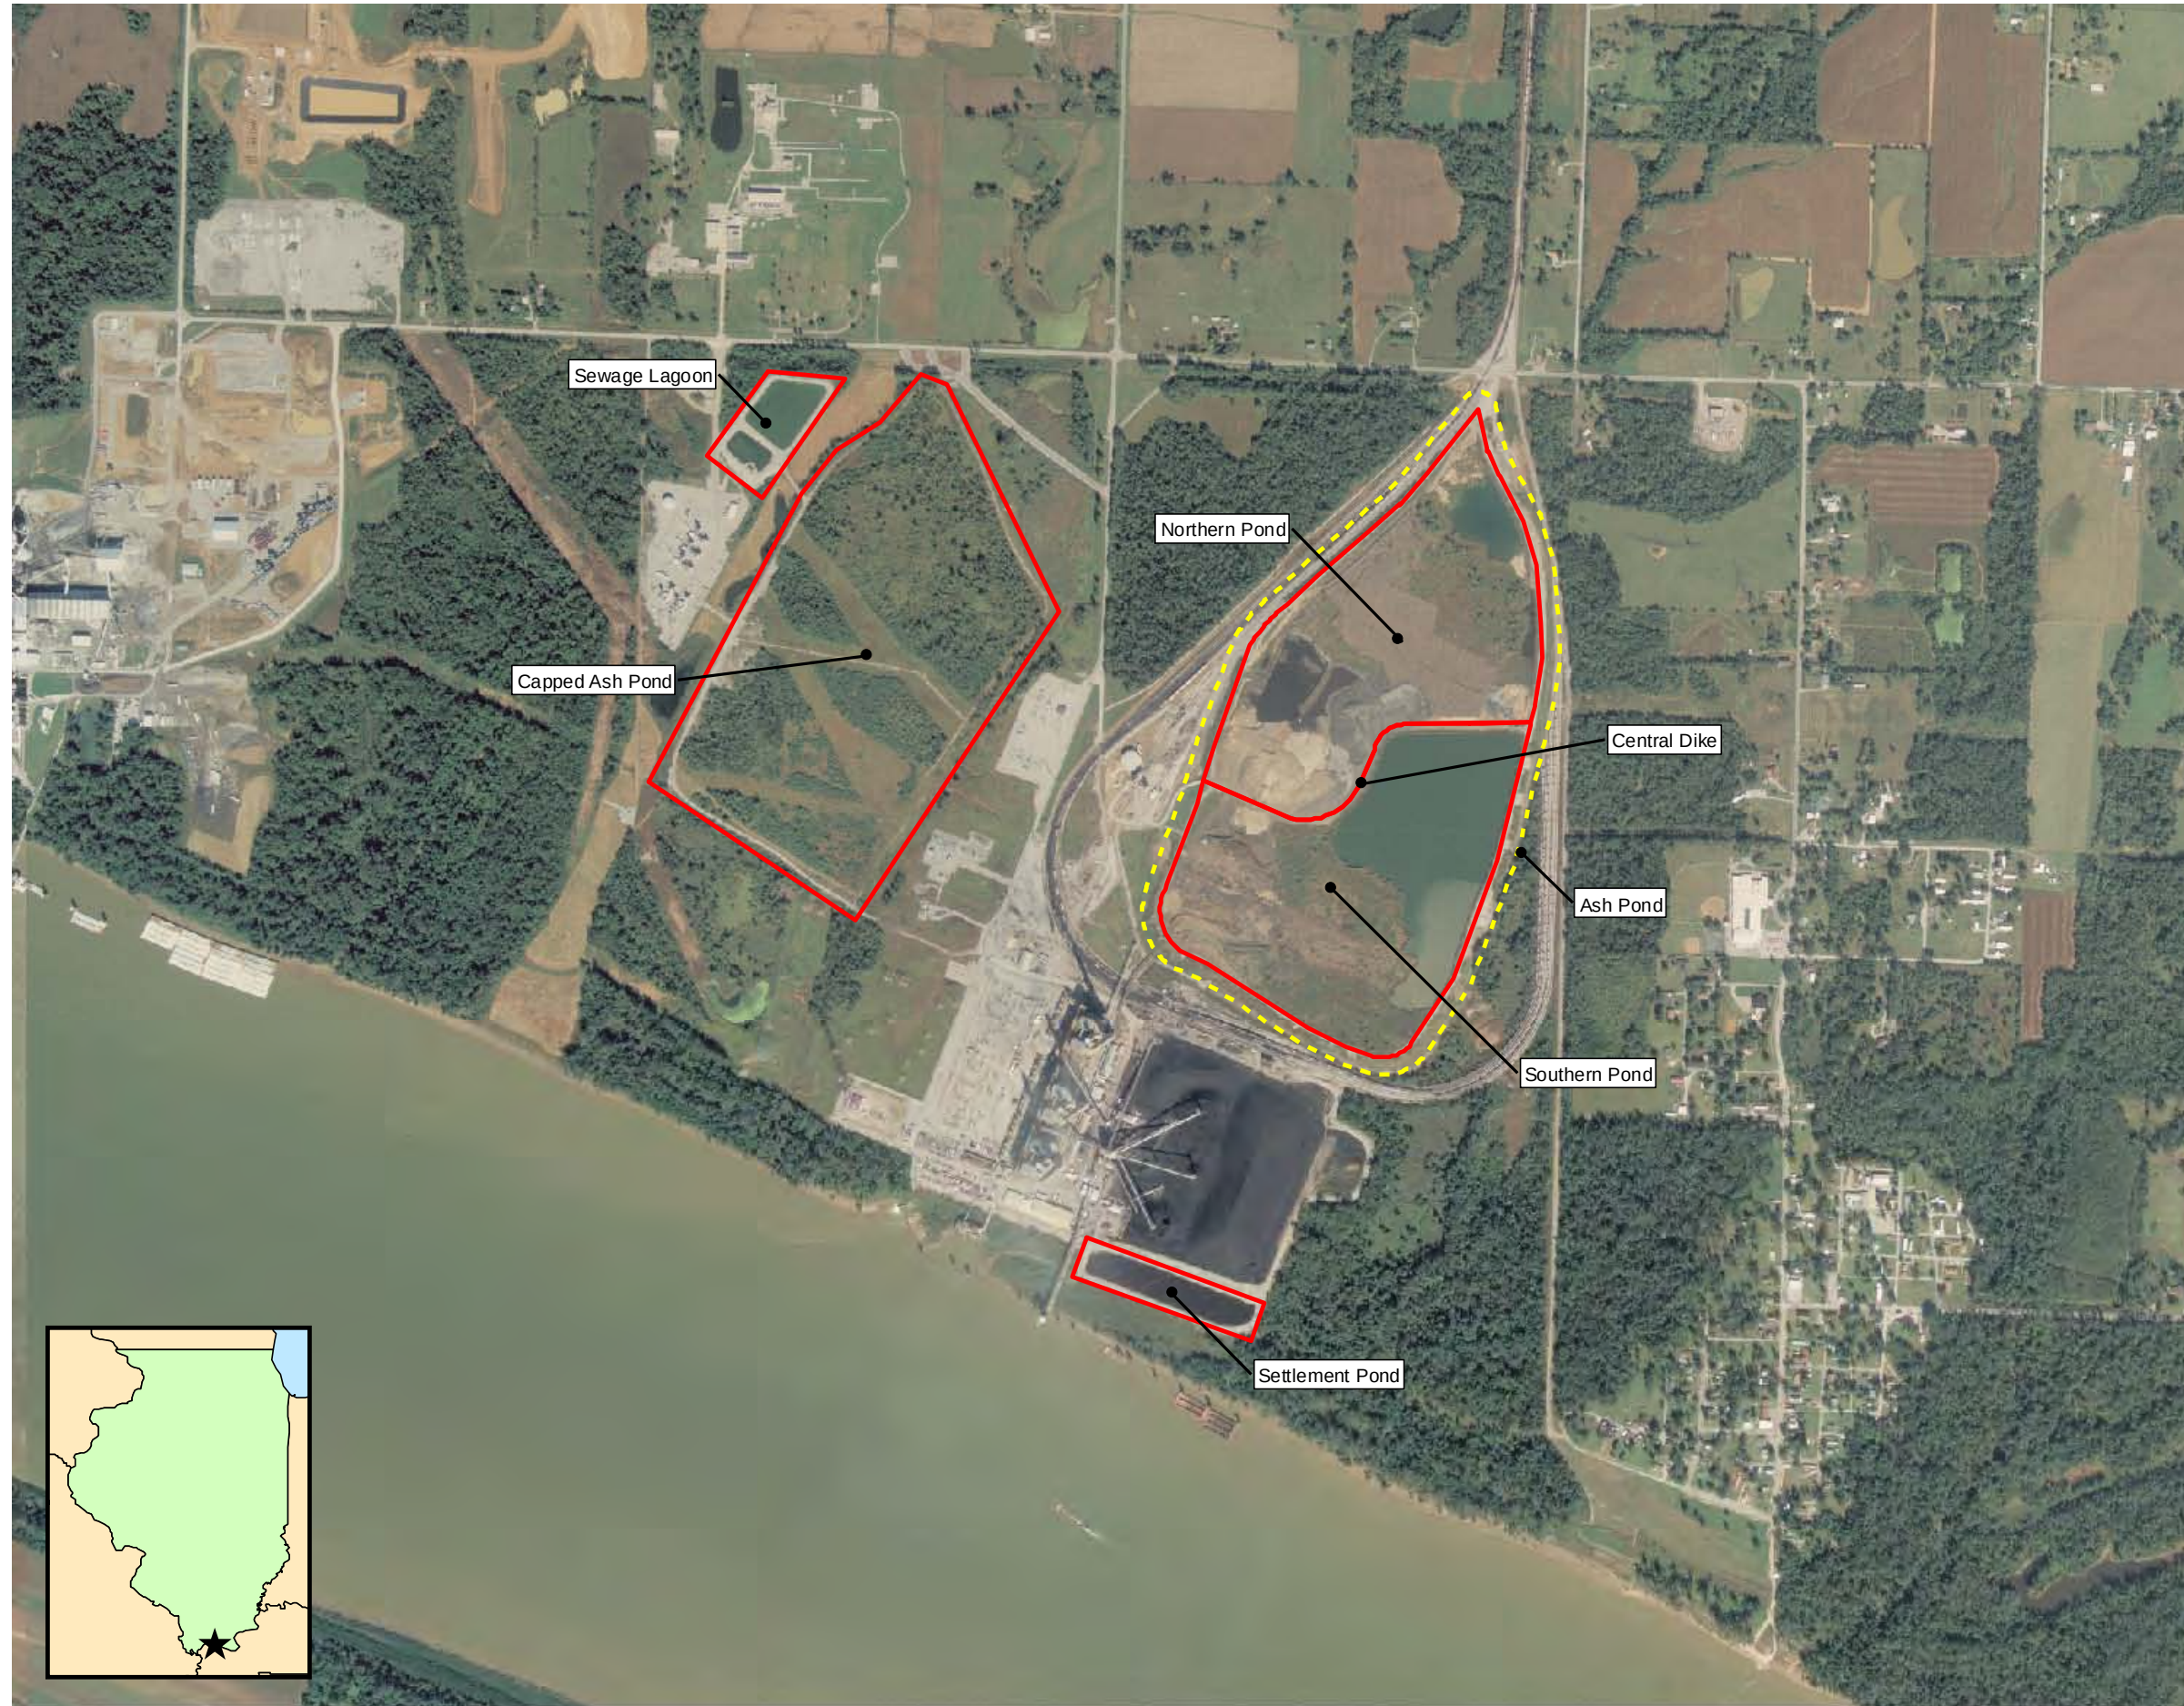
DRAFT FIGURE 2

The Facility Layout Map provided as Figure 2 shows the location of the various impoundments on the site. There are three additional impoundments at the Joppa Station, identified as follows:

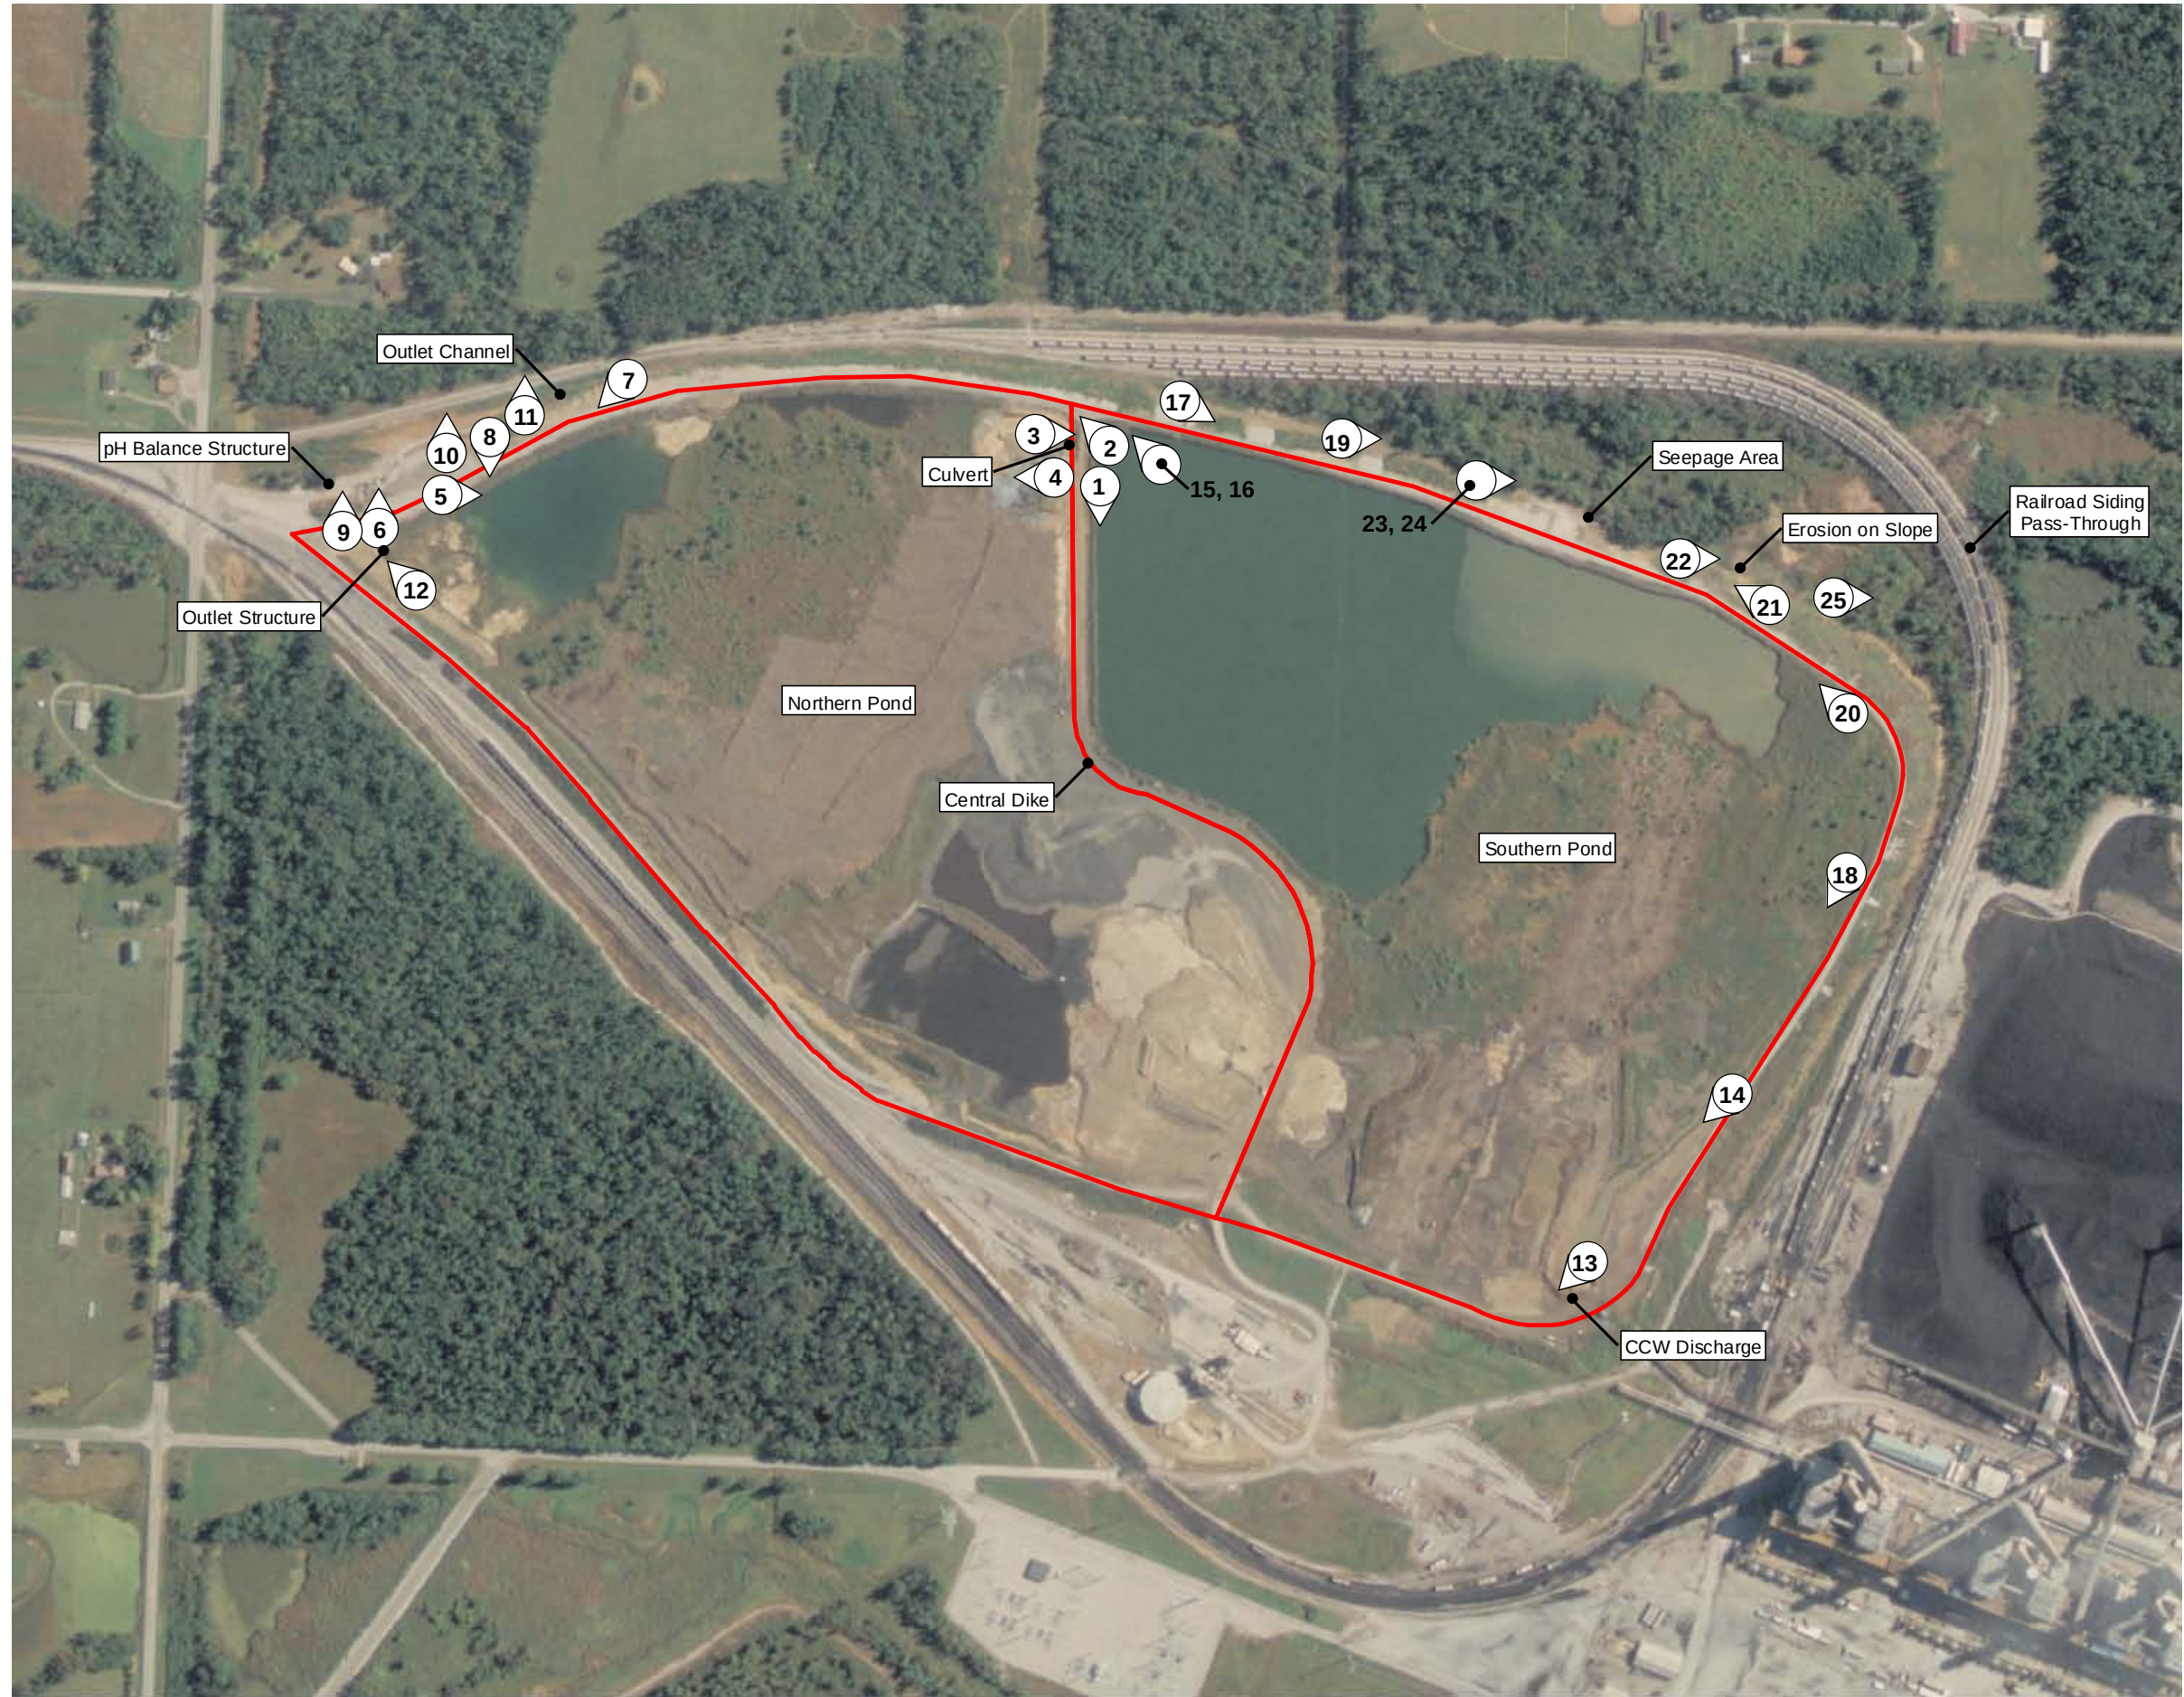
DRAFT FIGURE 3

Photos of relevant features and conditions observed during the inspection were taken by O'Brien & Gere and are provided in Appendix B. A Site Plan of the Northern and Southern Ponds is presented as Figure 3, which also provides photograph locations and directions.

- CCW has accumulated above the normal pool level over an estimated 90 percent of the pond area. Water in the pond is isolated to primarily the northeastern corner (Figures 2 & 3, Photos 4 & 5).

- CCW has accumulated above the normal pool level over an estimated 50 percent of the pond area. Water in the pond is isolated to primarily the eastern half of the pond (Figures 2 & 3, Photo 17).

- Seepage was observed in multiple locations along the outboard toe of the embankment. The most significant area of seepage is located approximately 500 feet north of the power lines (Photos 23 & 24). Other areas where seepage was observed include an area approximately 200 feet south of the power lines and along the southern embankment of the Southern Pond. The approximate locations of seepage are identified on Figure 3.
