Dam Safety Assessment of CCW Impoundments

Joppa Plant

United States Environmental Protection Agency
Washington, DC

September 24, 2010

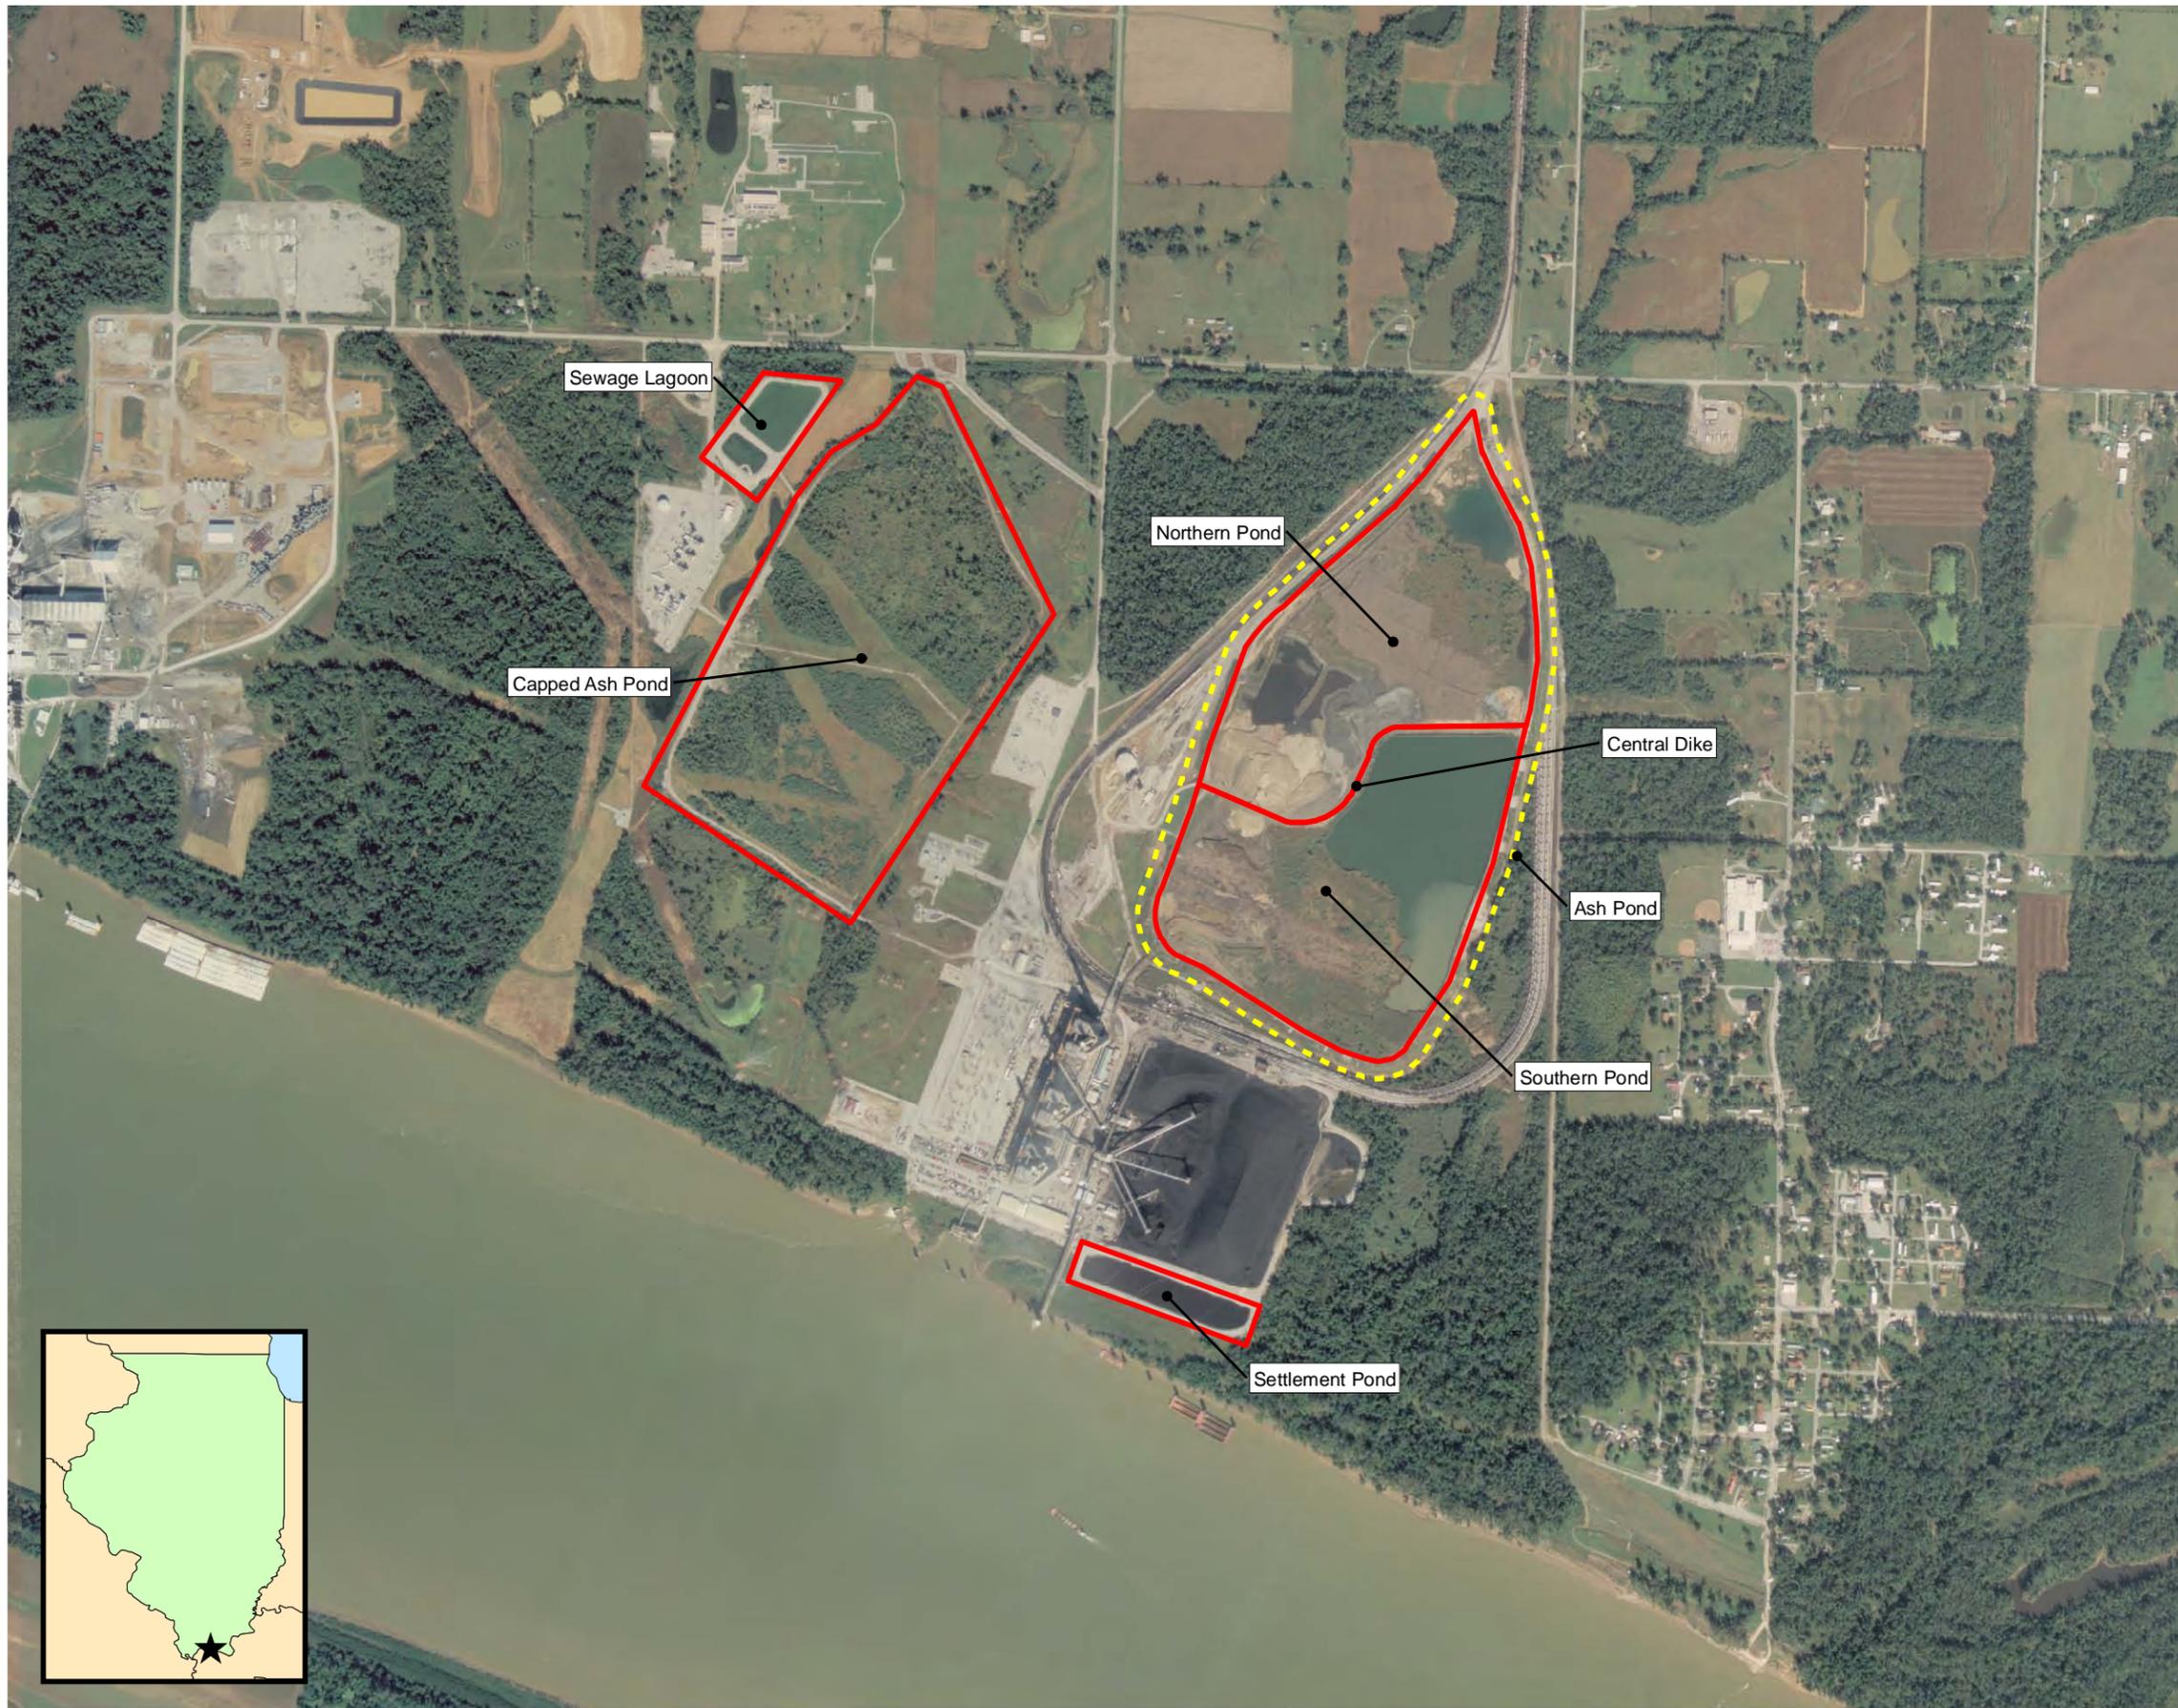
FIGURE 2

The Facility Layout Map provided as Figure 2 shows the location of the various impoundments on the site. There are three additional impoundments at the Joppa Station, identified as follows:

- CCW has accumulated above the normal pool level over an estimated 90 percent of the pond area. Water in the pond is isolated to primarily the northeastern corner (Figures 2 & 3, Photos 4 & 5).

- CCW has accumulated above the normal pool level over an estimated 50 percent of the pond area. Water in the pond is isolated to primarily the eastern half of the pond (Figures 2 & 3, Photo 17).

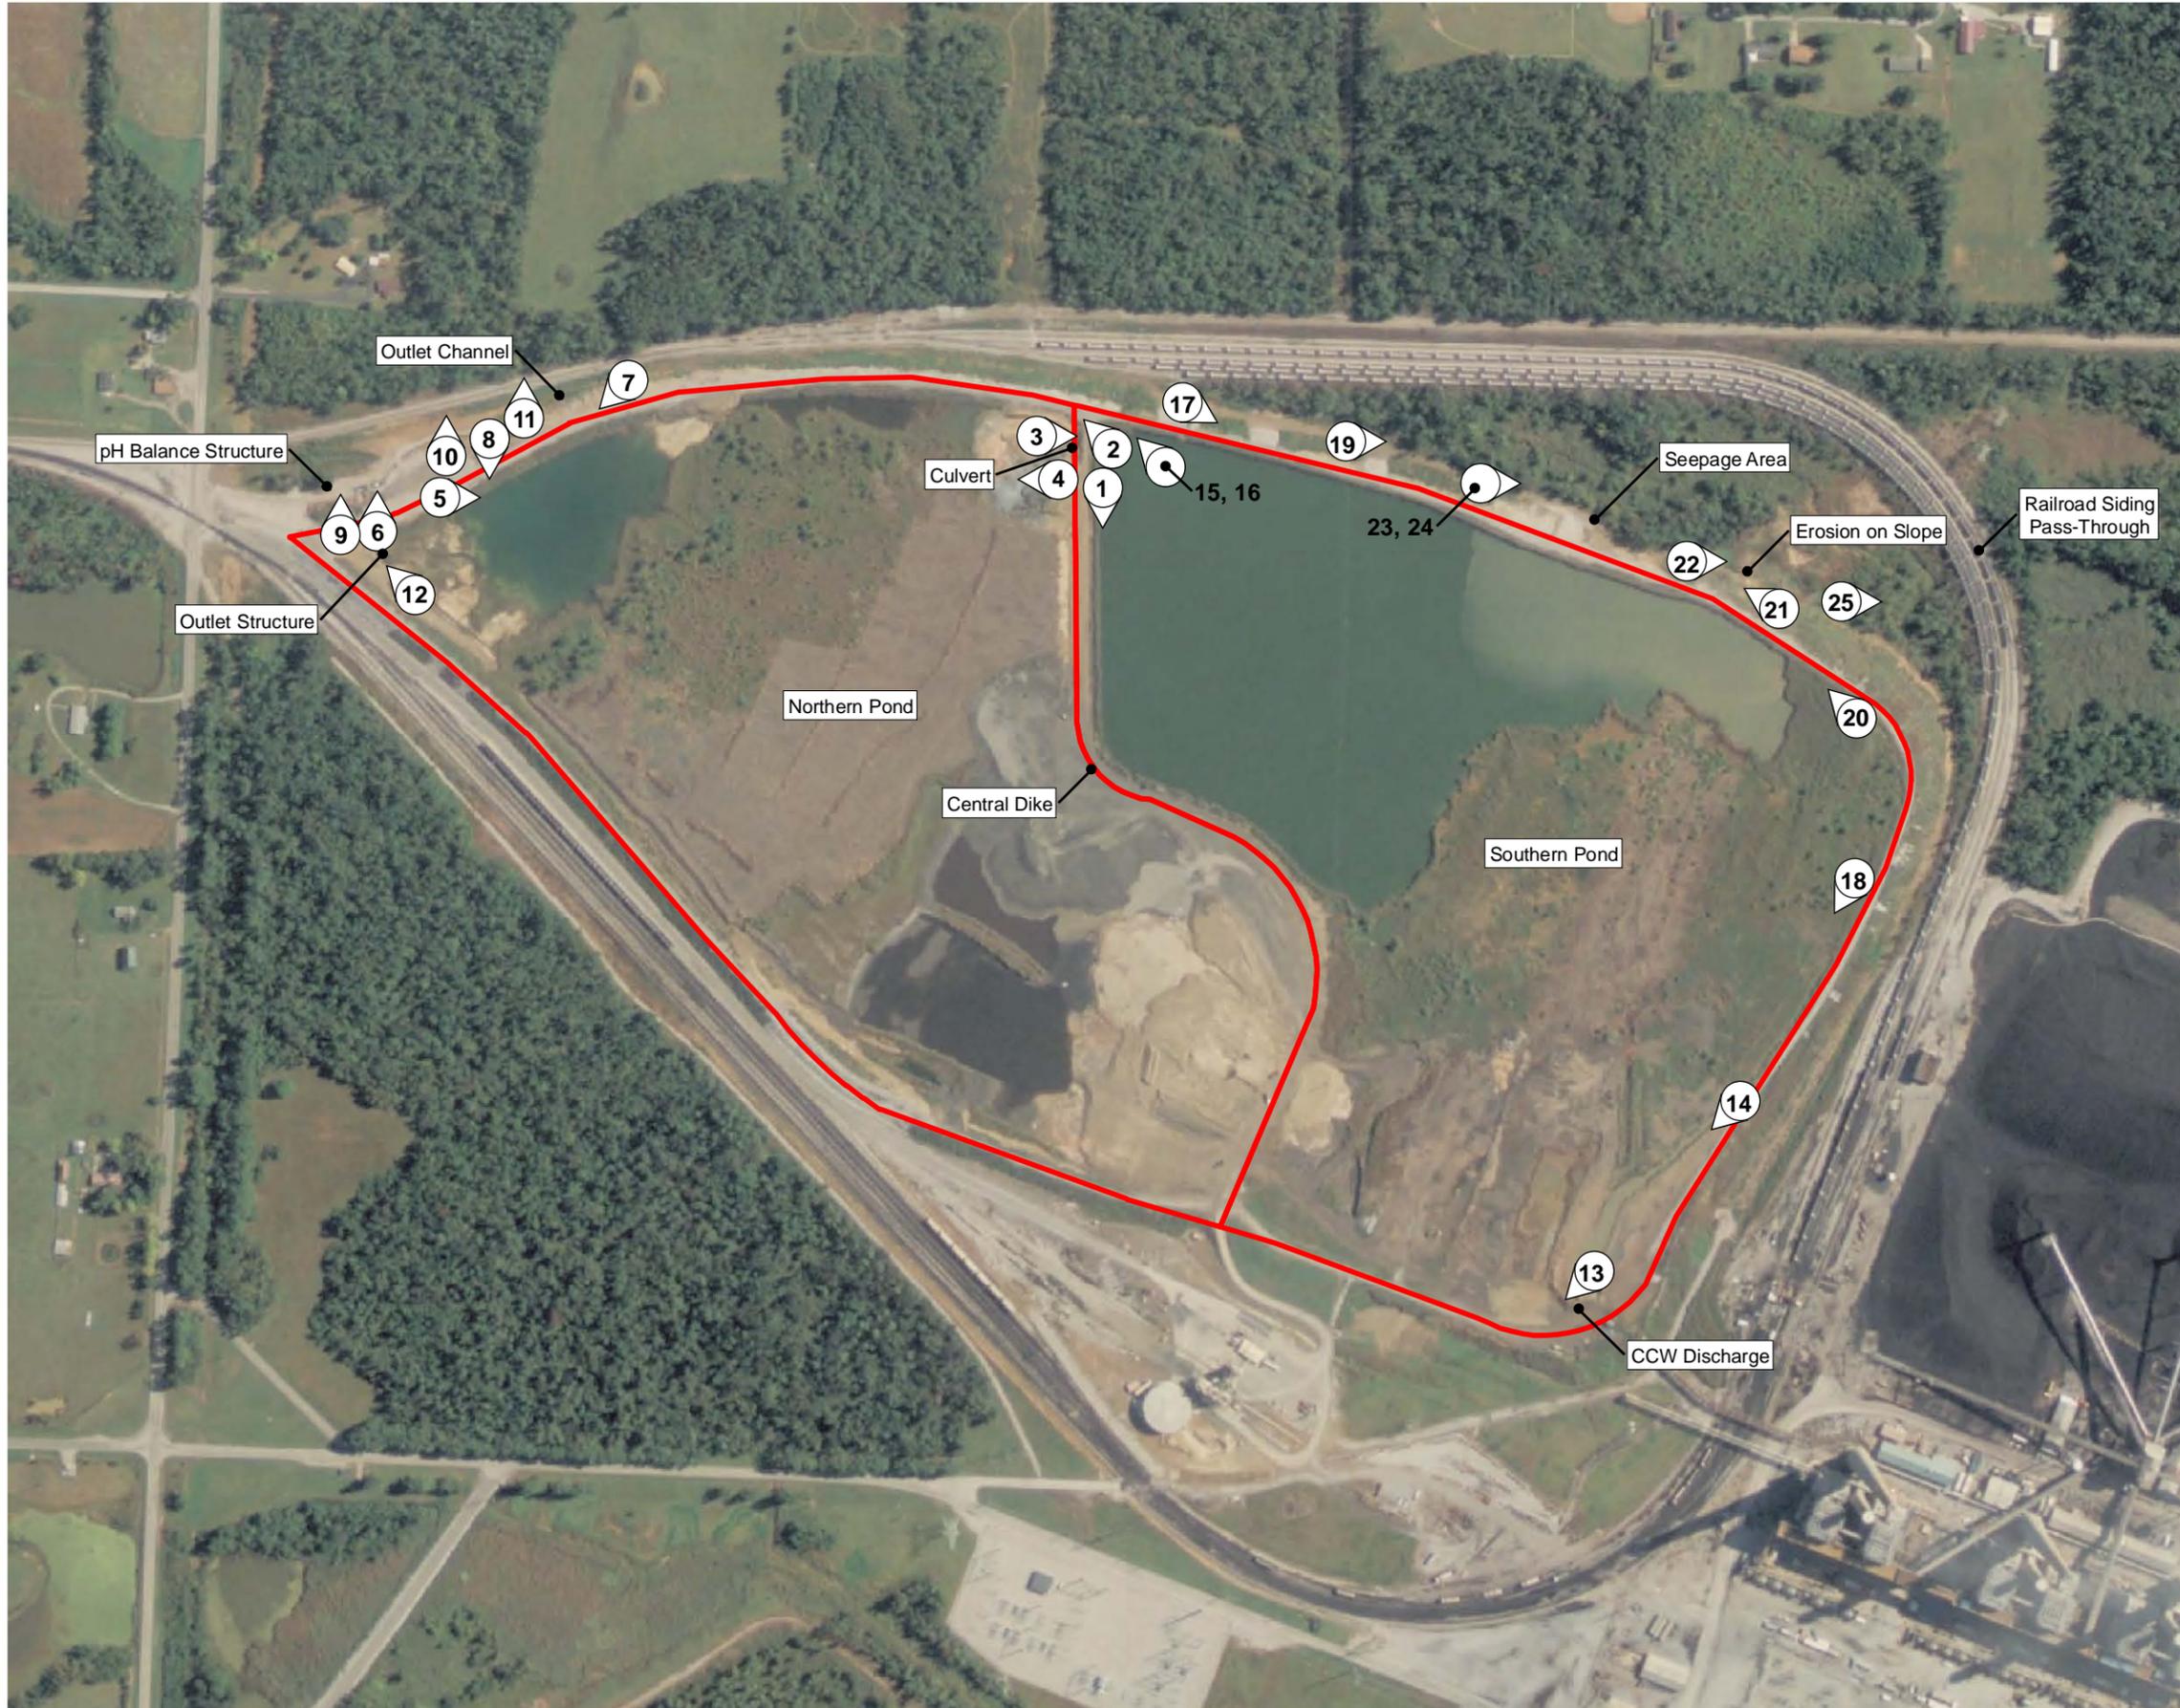
FIGURE 3

Photos of relevant features and conditions observed during the inspection were taken by O'Brien & Gere and are provided in Appendix B. A Site Plan of the Northern and Southern Ponds is presented as Figure 3, which also provides photograph locations and directions.

- Seepage was observed in multiple locations along the outboard toe of the embankment. The most significant area of seepage is located approximately 500 feet north of the power lines (Photos 23 & 24). Other areas where seepage was observed include an area approximately 200 feet south of the power lines and along the southern embankment of the Southern Pond. The approximate locations of seepage are identified on Figure 3.
