DRAFT REPORT

Dam Safety Assessment of CCW Impoundments

Labadie Power Station

January 2011

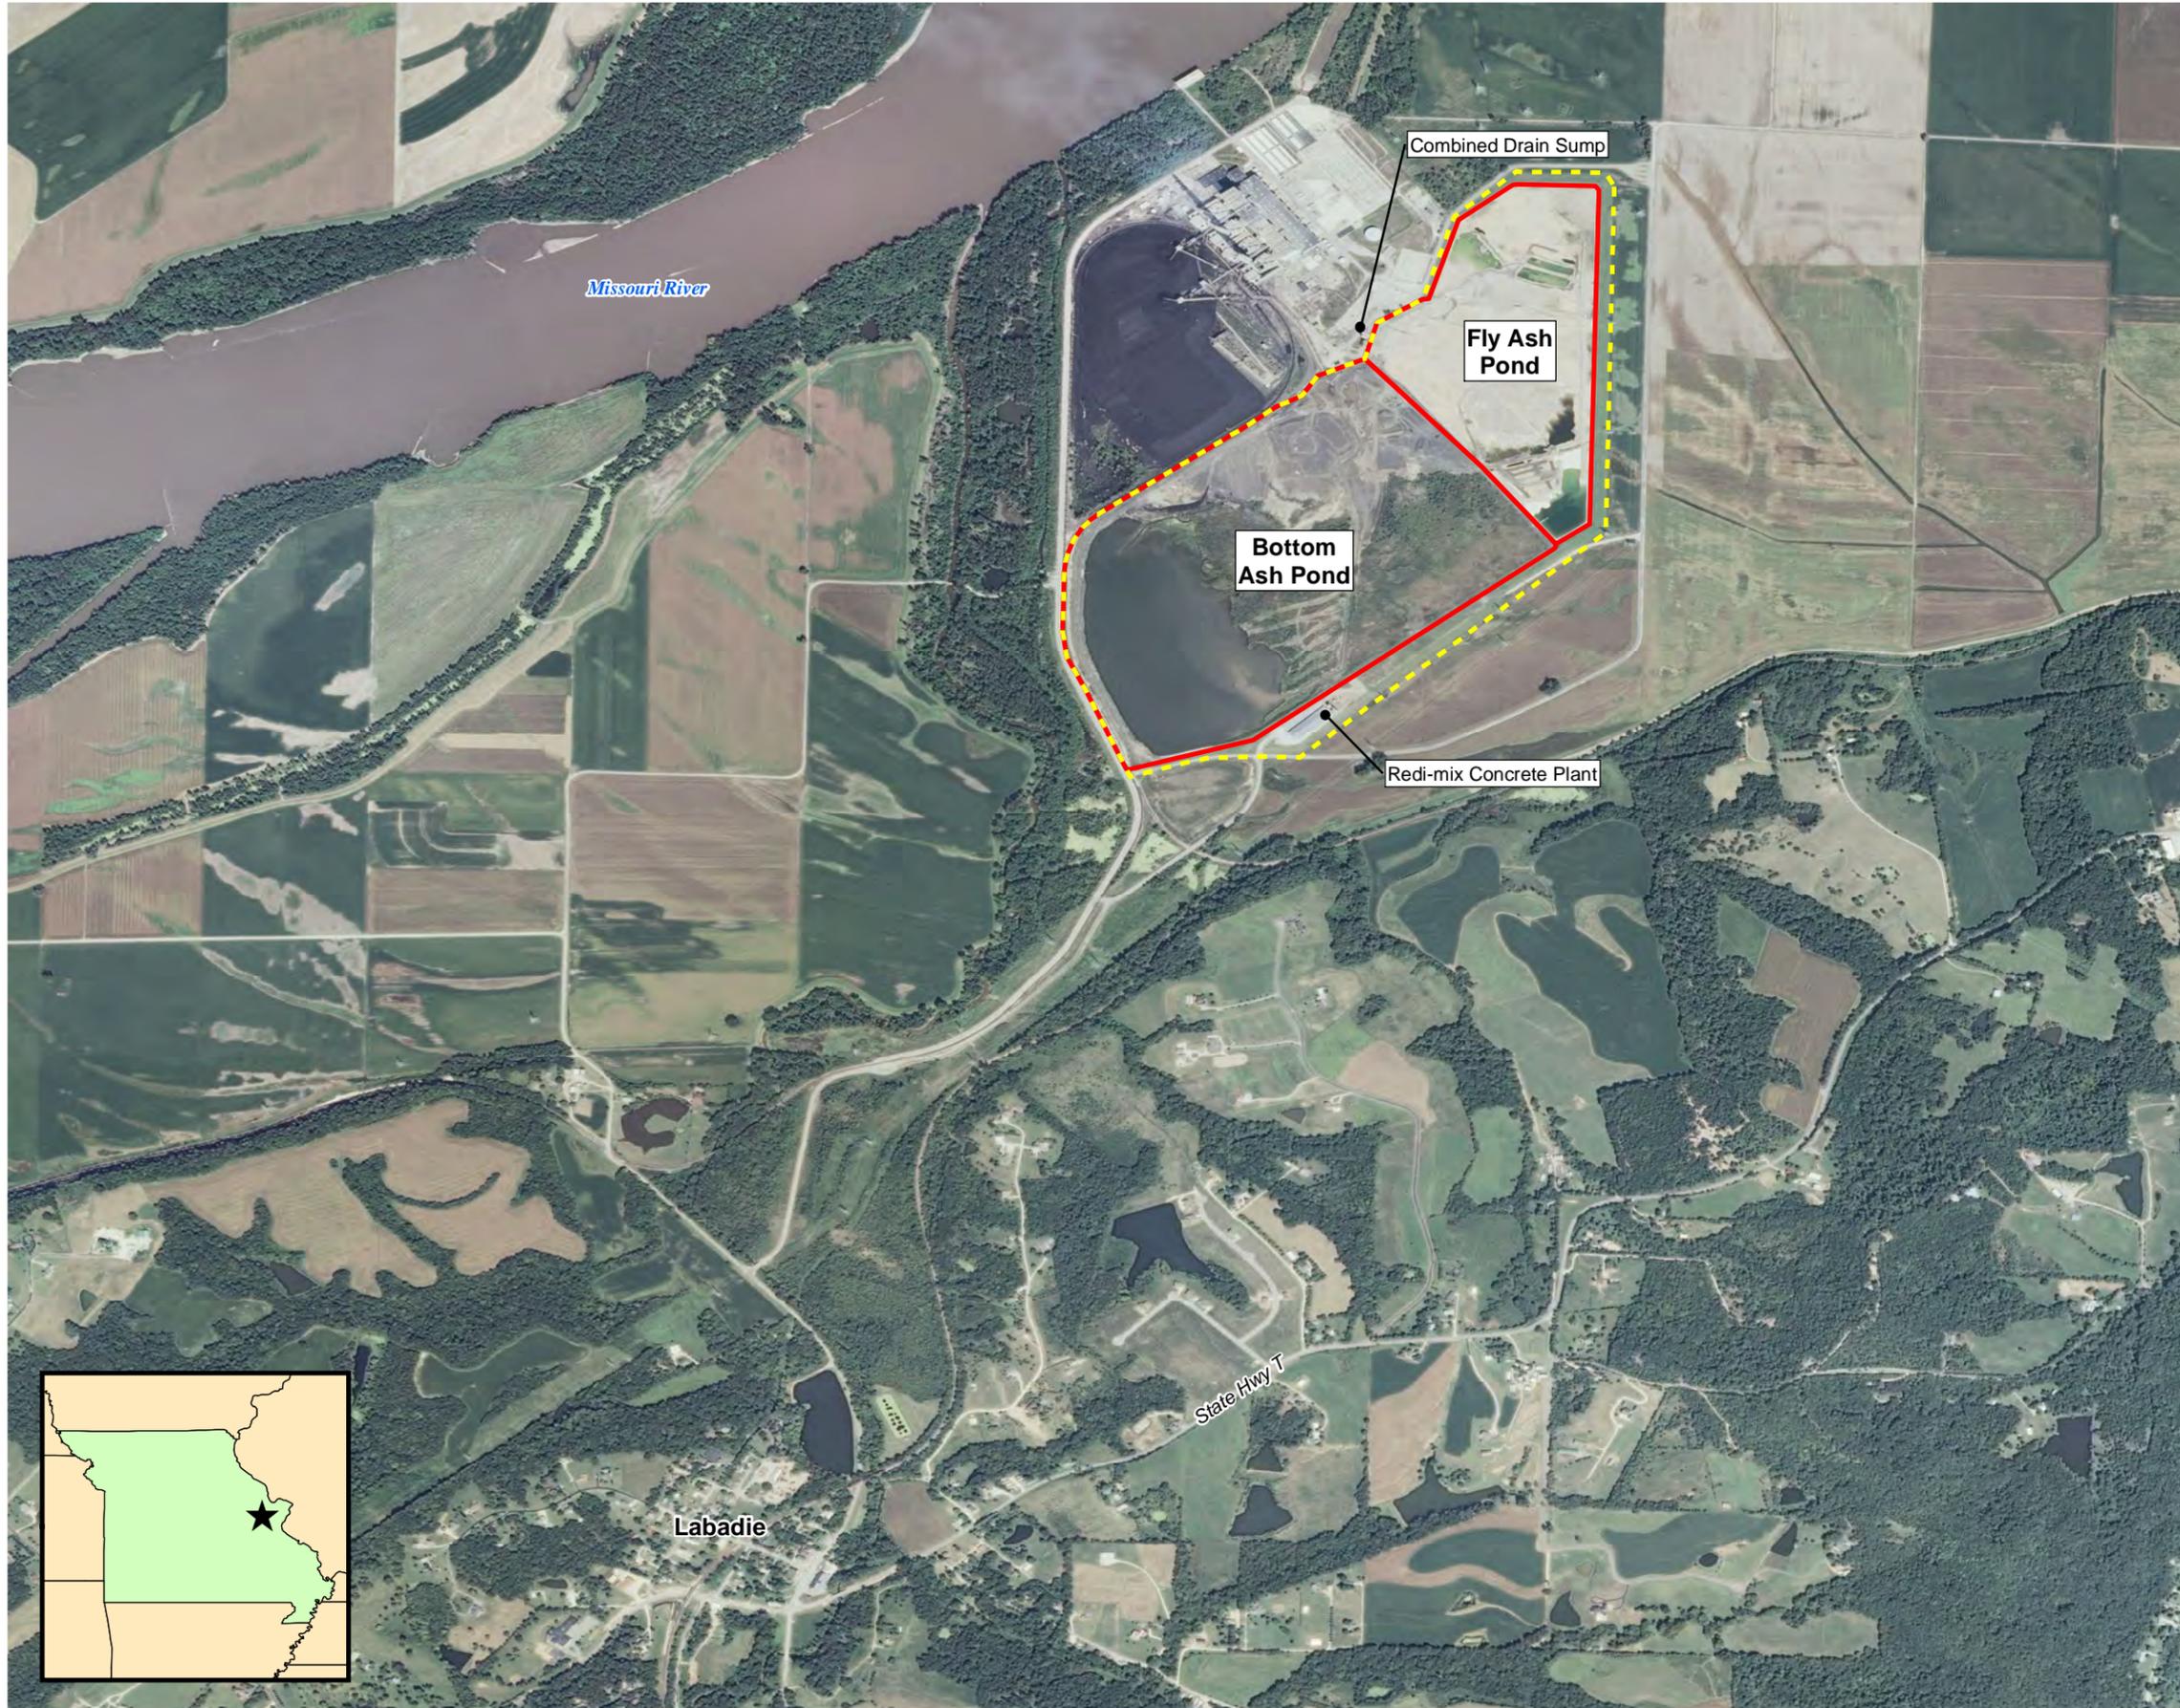
DRAFT FIGURE 2

The two CCW impoundments inspected during this safety assessment are identified on Figure 2 – Facility Layout Plan. Neither impoundment meets the height requirement (35 feet) for regulation as a dam by the Missouri Department of Natural Resources (MoDNR).

A Facility Layout Map is provided as Figure 2, which shows the location of the various impoundments on the site. There is one additional impoundment on the north side of the plan known as the Combined Drain Sump. The Combined Drain Sump is a reinforced concrete pit. It receives the stormwater runoff from the Labadie Power Plant site as well as treated sewage from the facility. Waste water is pumped from the Combined Drain Sump into the Bottom Ash Pond.

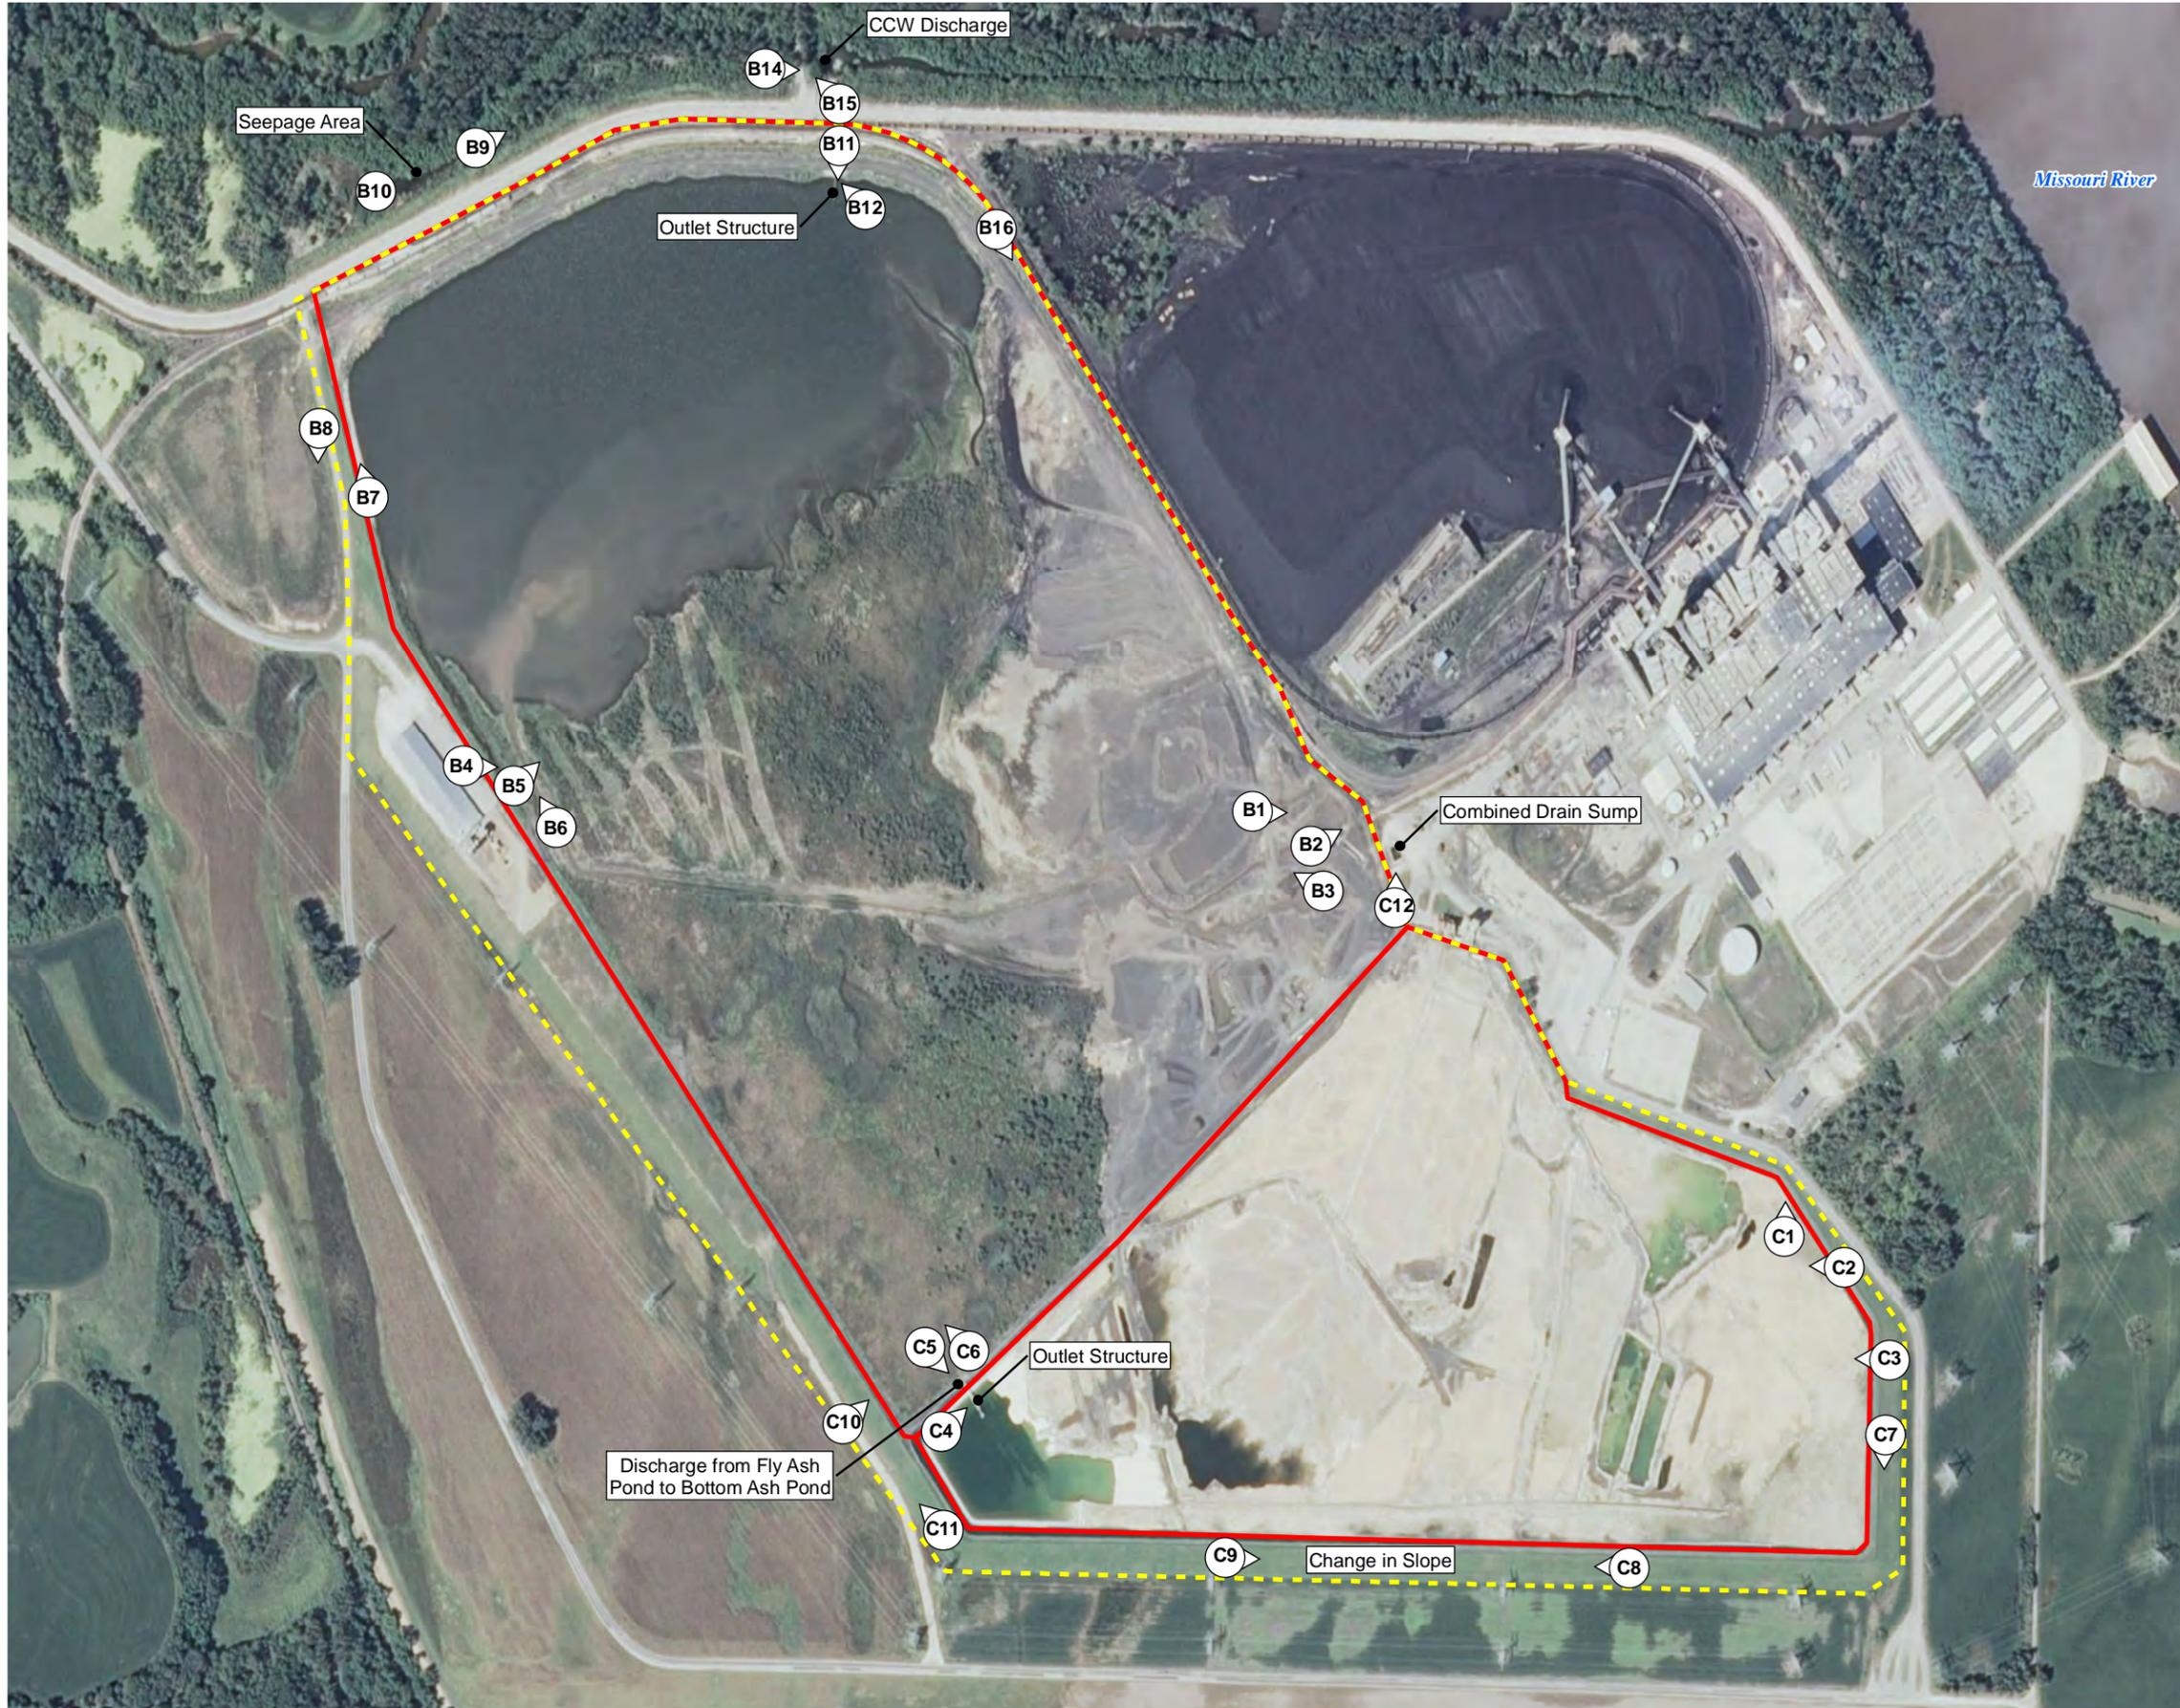
DRAFT FIGURE 3

- The CCW has accumulated above the normal pool level over an estimated 60 percent of the pond area (Photos B4, B5 & B16). Water in the pond is isolated to the western third of the pond (Figures 2 & 3).

- The CCW has accumulated above the normal pool level over an estimated 90 percent of the pond area. Water in the pond is isolated to primarily the southern corner of the pond (Figures 2 & 3, Photos C1 - C4).
