# **Dam Safety Assessment of CCW Impoundments**

## **Labadie Power Station**

# Dam Safety Assessment of CCW Impoundments

Labadie Power Station

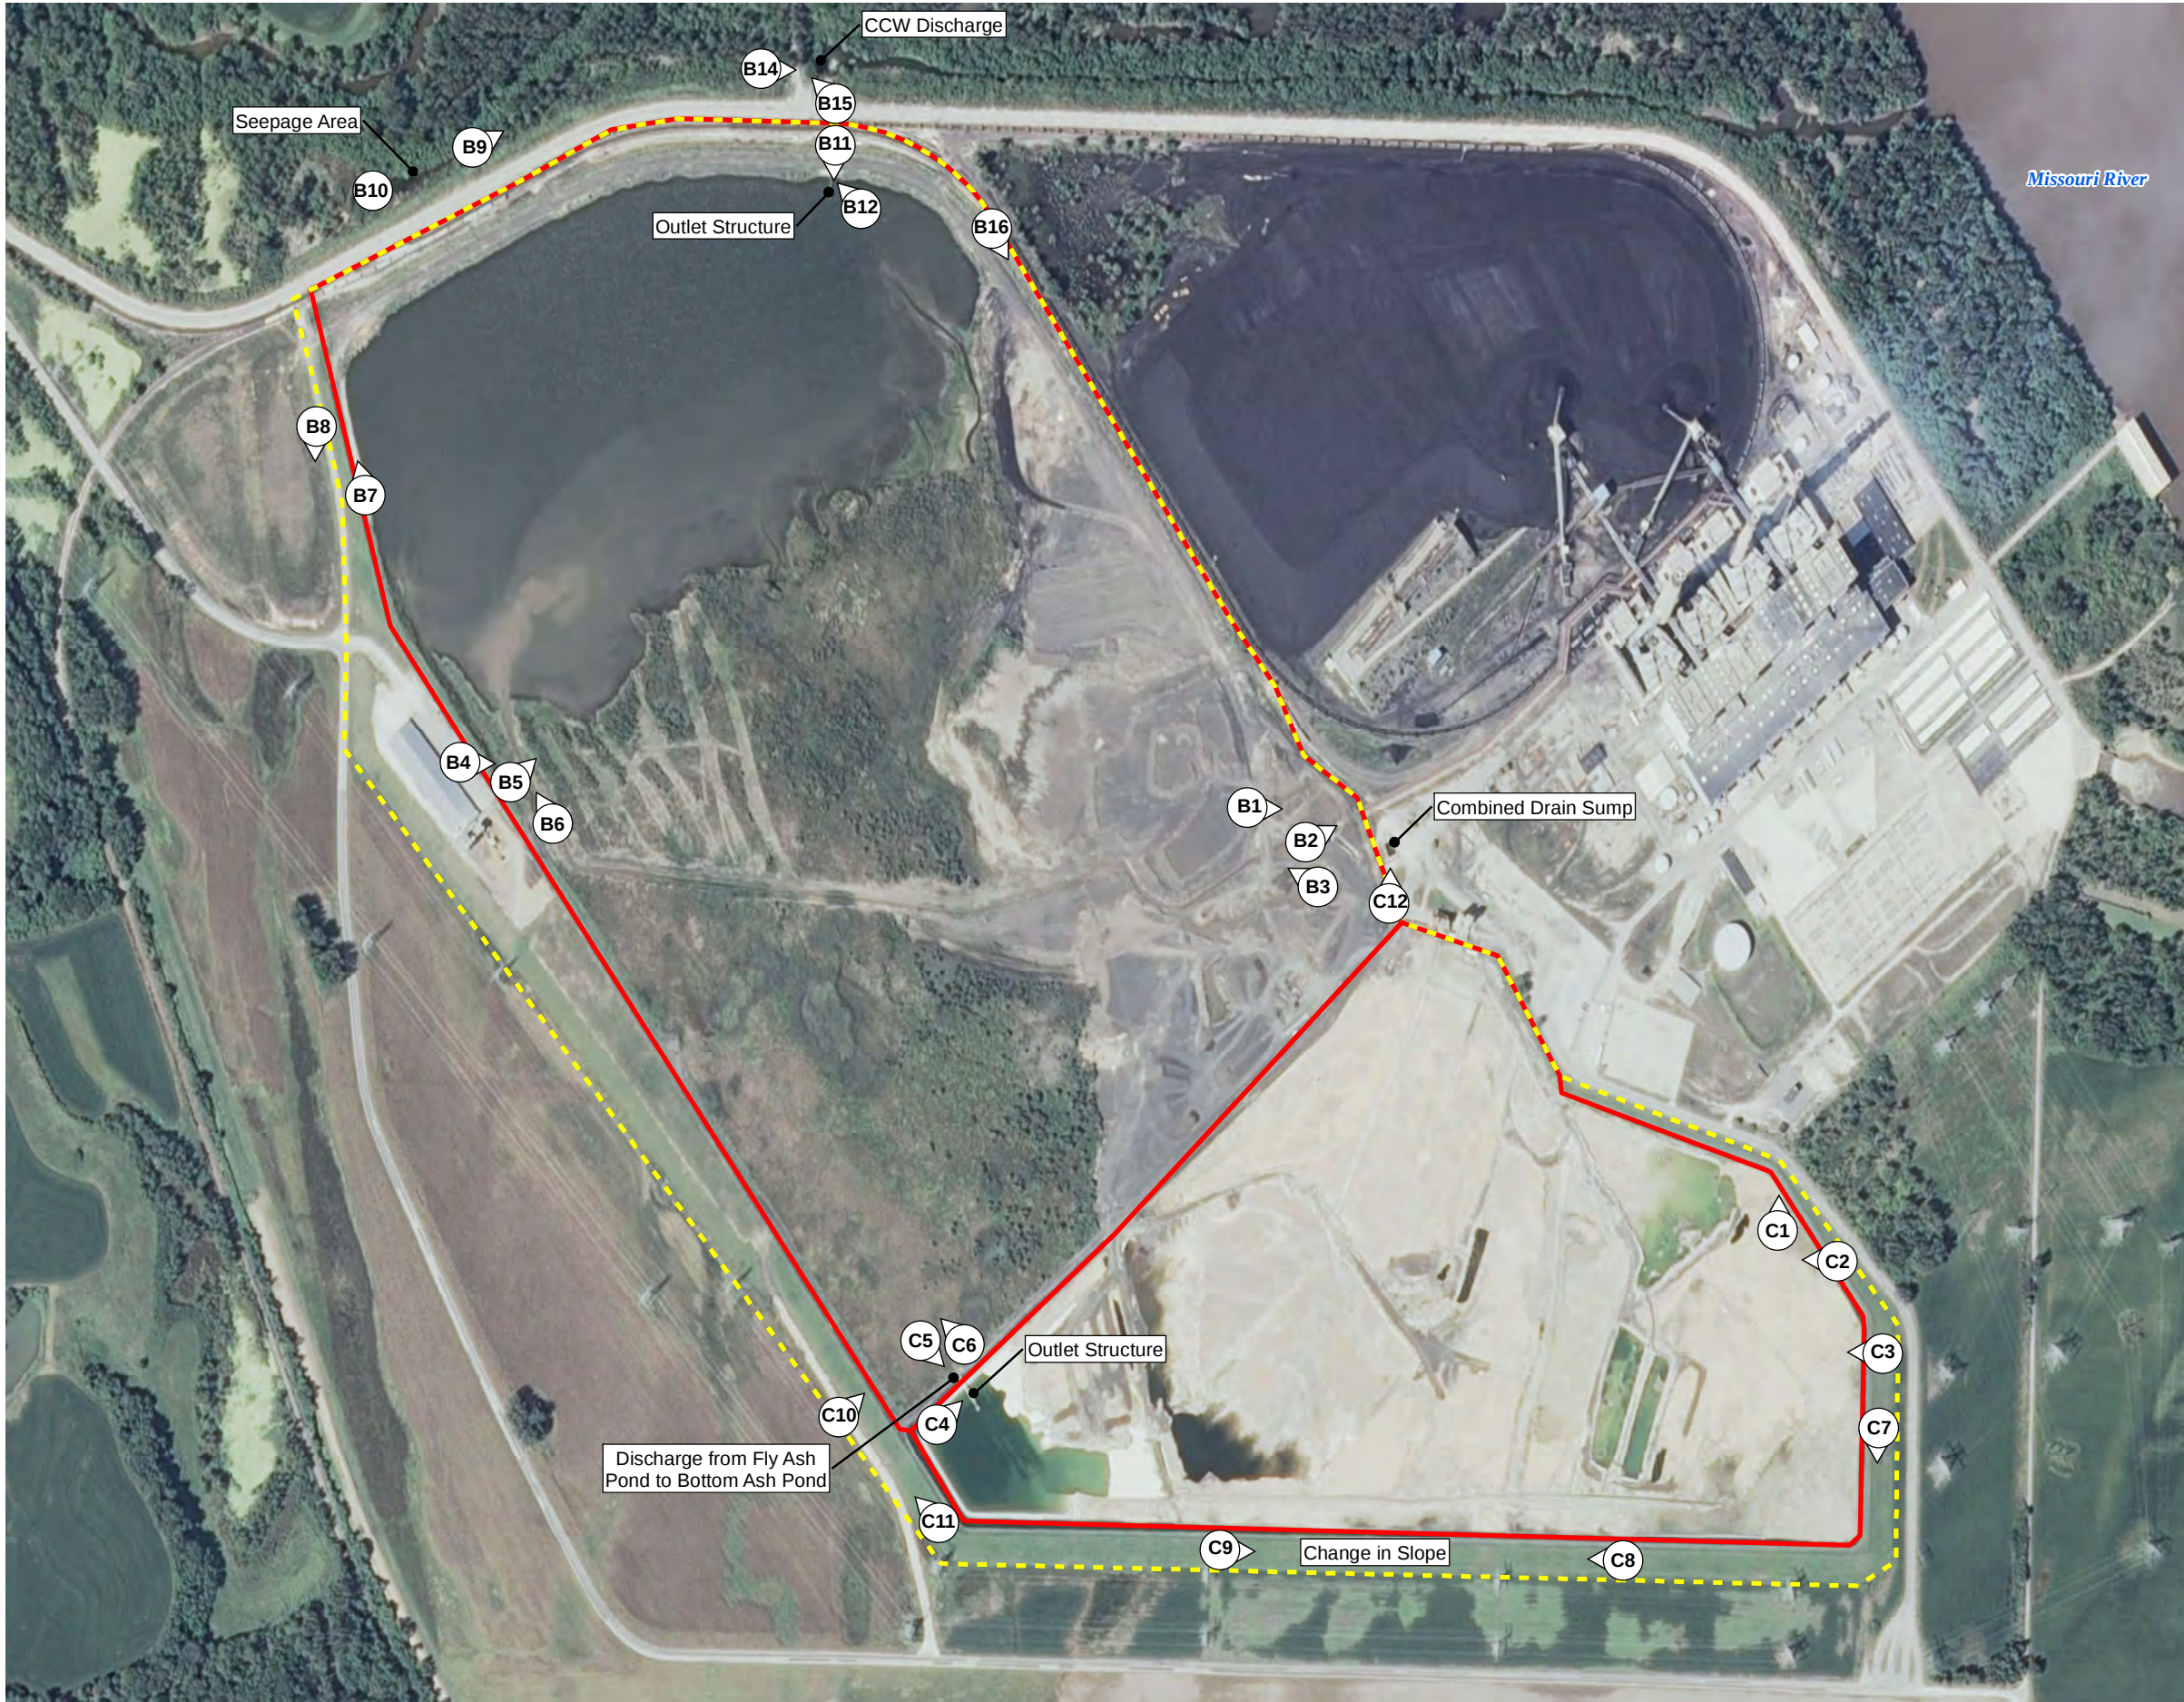
FIGURE 3

- The CCW has accumulated above the normal pool level over an estimated 60 percent of the pond area (Photos B4, B5 & B16). Water in the pond is isolated to the western third of the pond (Figures 2 & 3).

- The CCW has accumulated above the normal pool level over an estimated 90 percent of the pond area. Water in the pond is isolated to primarily the southern corner of the pond (Figures 2 & 3, Photos C1 - C4).
