FINAL REPORT

Dam Safety Assessment of CCW Impoundments

James M. Barry Electric Generating Plant

December 8, 2010

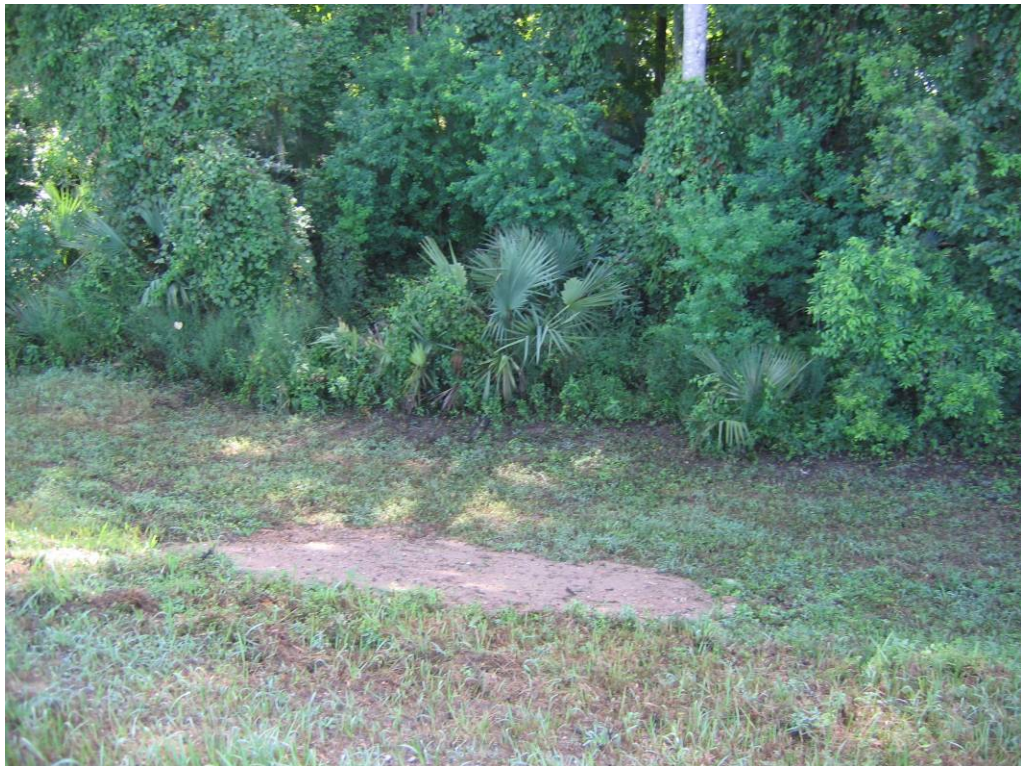
Photo Number:
B6

Description:
Repair area near outward toe of east embankment slope on east side of CCW Management Unit

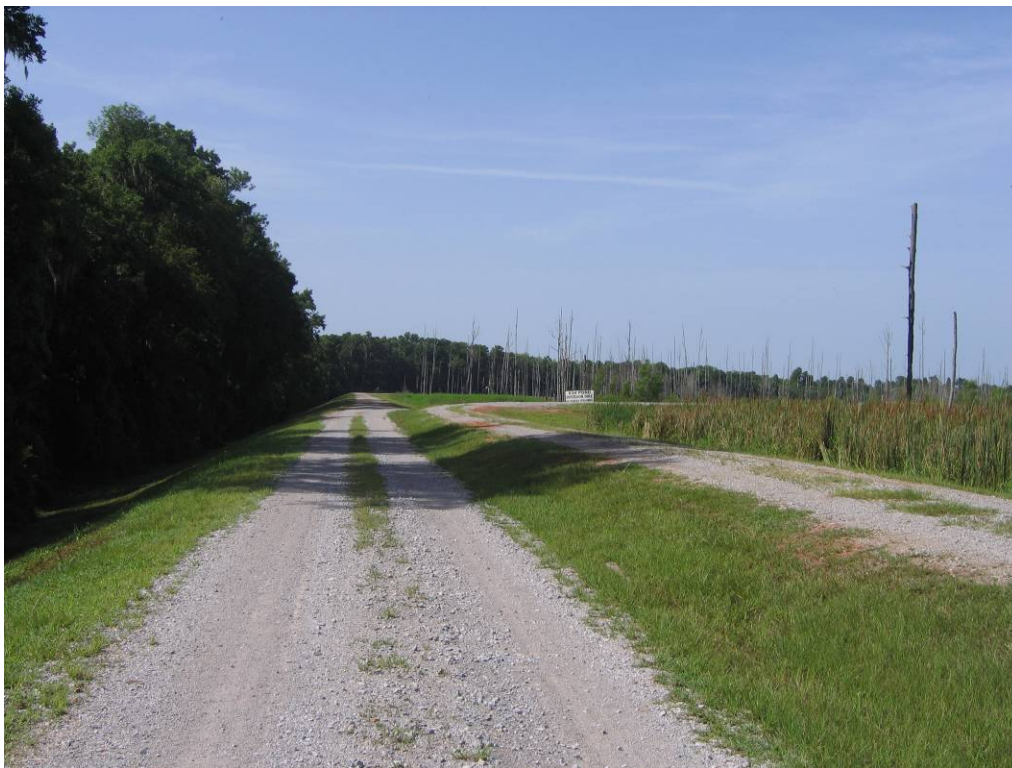
Photo Number:
B7

Description:
Looking south
along east
embankment.
Diversion Dike
is seen breaking
off to the right
(west) in the
photo.

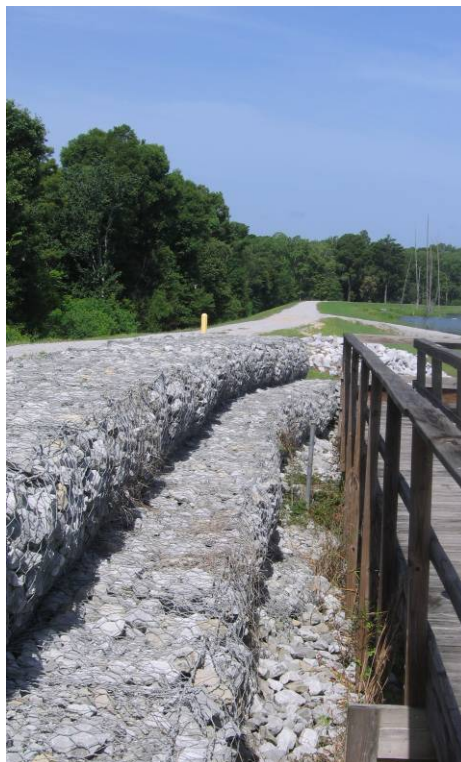
Gabion support on north side of south portion of embankment between embankment and discharge access structure

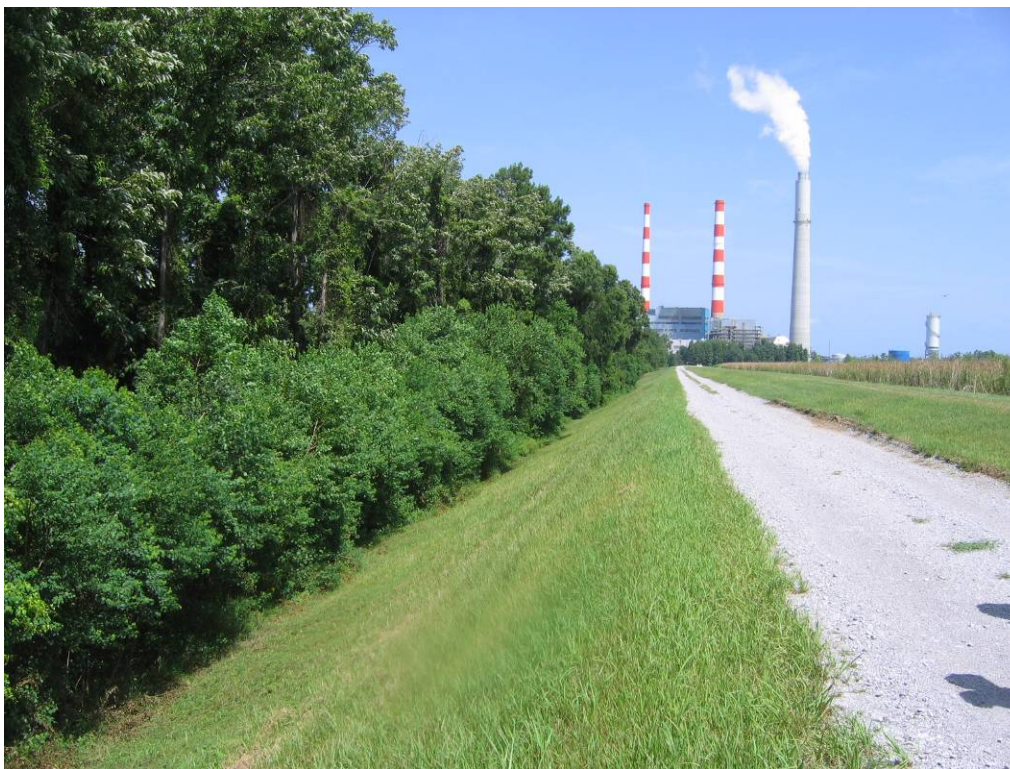
Looking east along south embankment towards Discharge Structure. Note rip rap protection added on inbound slope for wave protection

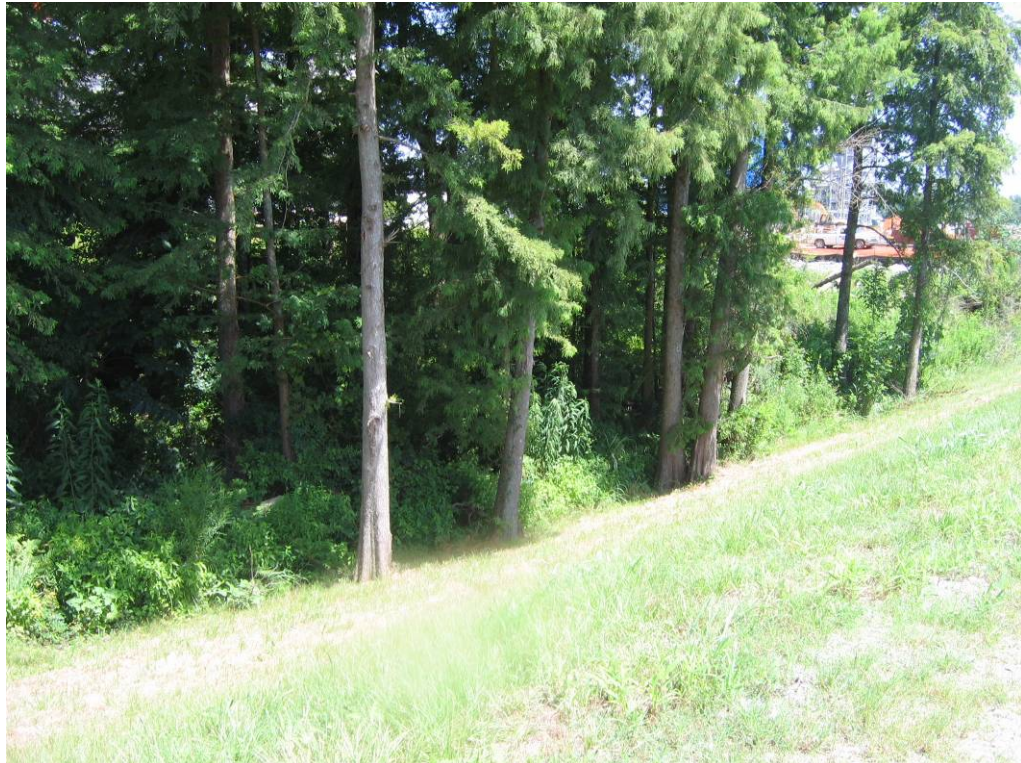
Trees near toe of outward slope of south embankment. This portion of embankment is in area where CCW Management Unit has been closed and stabilized

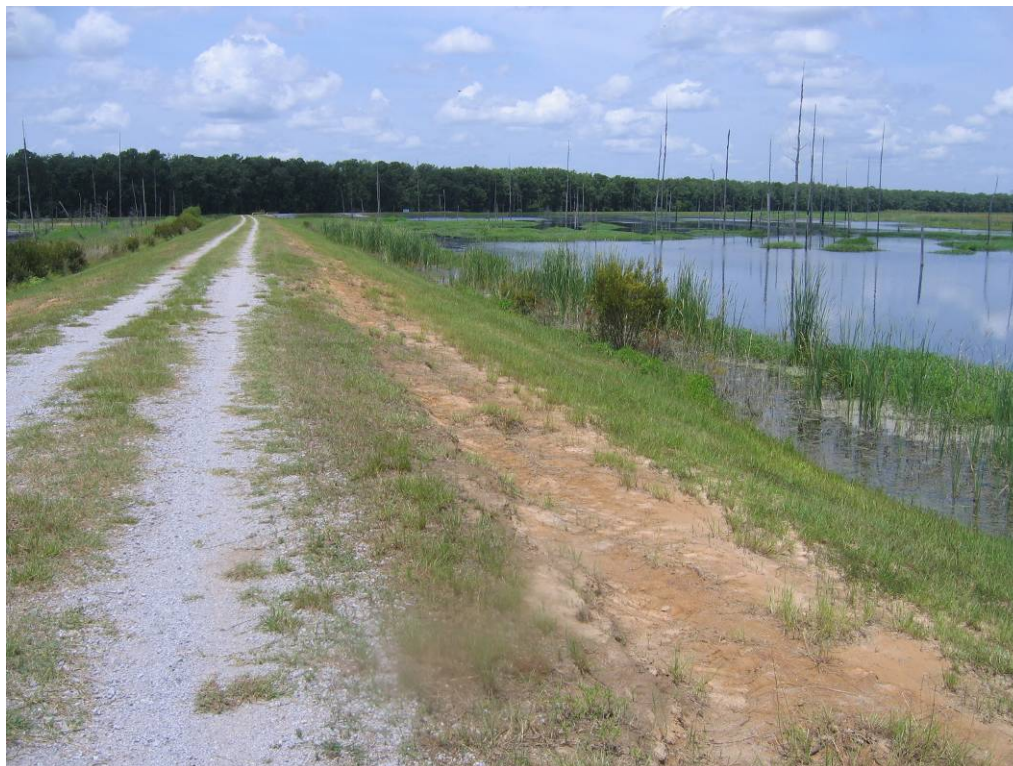
Looking east
along Diversion
Dike from
Primary
Diversion Dike
Outfall – Note
rutting from
machinery on
right side of
photo
