**Coal Combustion Residue Impoundment  
Round 9 - Dam Assessment Report**

*Plant Gadsden*

*Fly Ash Dike*

*Alabama Power Company*  
**Gadsden, Alabama**

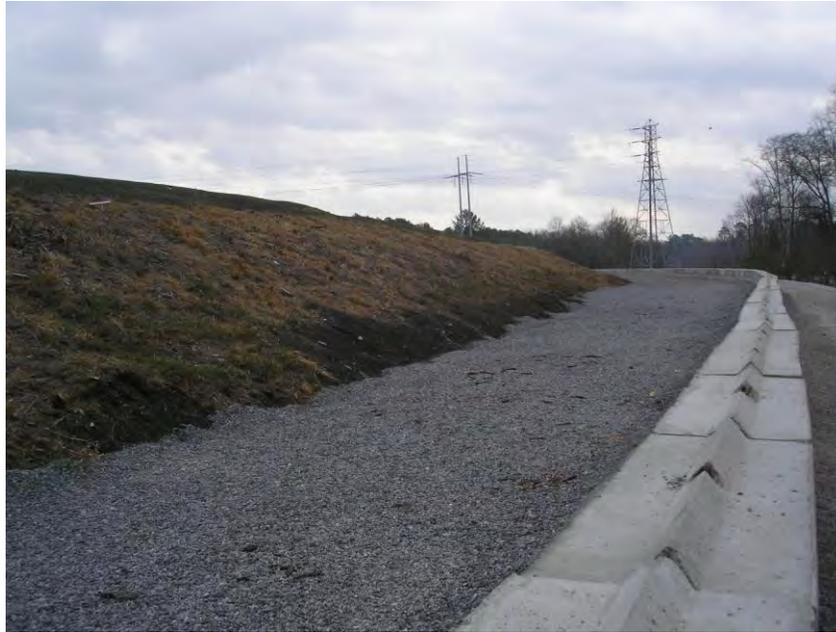
Figure 5.3.2-1: Upper Pond South Embankment Outside Slope, Gravel Lined Toe Ditch and Concrete Barrier Separating Ditch and Ash Stockpile Access Road

The exterior slope of the upper pond embankment is vegetated with various species of grass and short weeds. A new geotextile lined, subsurface toe drain and gravel ditch had been added along a new roadway constructed to access the ash stockpile. Figure 5.2.3-2 shows the outside slope of the south embankment outside slope, the gravel lined toe ditch and the short concrete barrier separating the ditch from the stockpile access roadway.

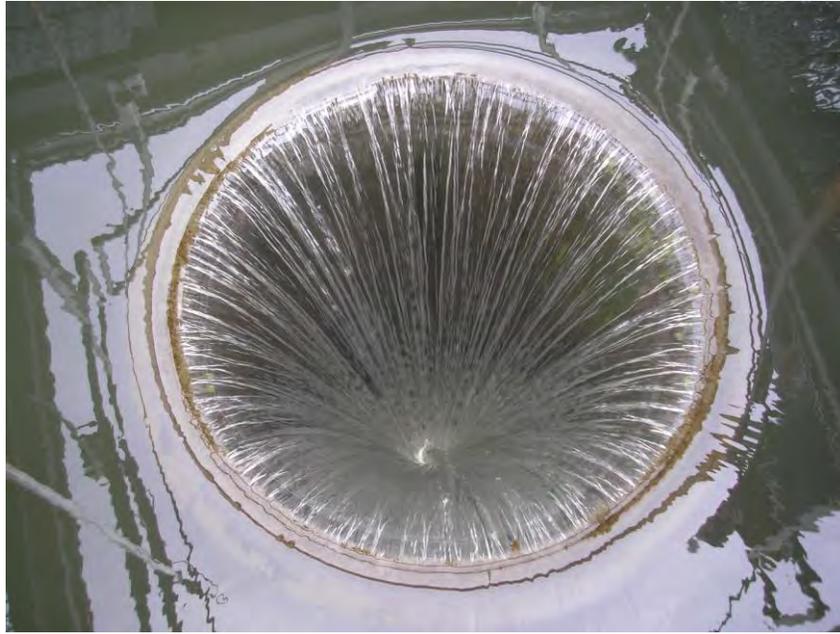
Figure 5.3.1-1: Gadsden Plant CCR Impoundment Primary Overflow Riser

The impoundment primary overflow structure is located in the southeastern corner of the lower pond. The overflow consists of a 48-inch diameter reinforced concrete pipe with an overflow elevation of 523 ft and an invert elevation of about 512 ft. The overflow spillway discharge is a 36-inch diameter concrete pipe that discharges into a partially riprap-lined channel that flows a short distance to the Coosa River. Figure 5.3.1-1 shows the overflow riser and Figure 5.3.1-2 shows the discharge channel to the Coosa River.

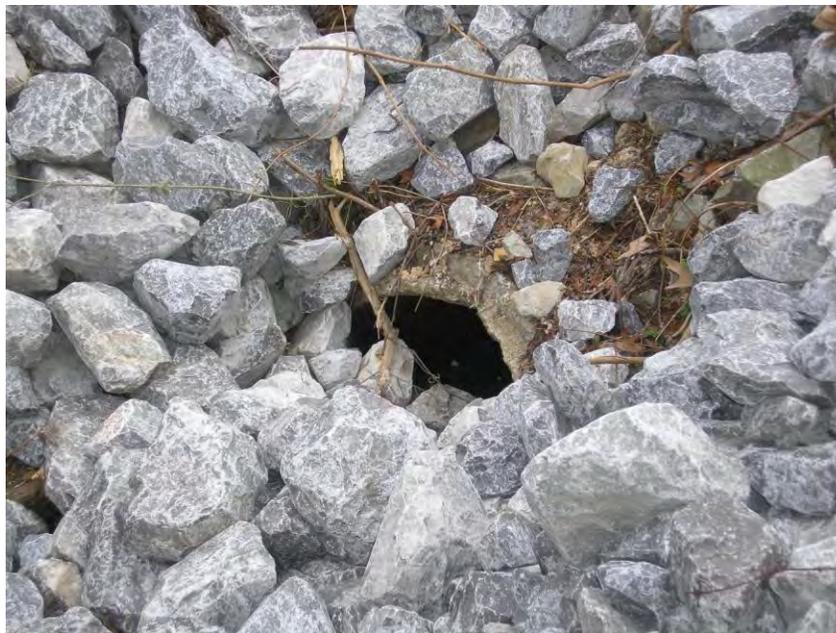
Figure 5.3.3-1: Gadsden Plant CCR Impoundment Emergency Spillway Outlet Conduit

The spillway constructed in conjunction with the lower pond was converted to an emergency spillway around 2001 when the new primary spillway was constructed. The emergency spillway consists of a 48-inch diameter concrete pipe with an overflow elevation of 524.5 ft. and an invert elevation of about 510 ft. The spillway outlet conduit is a 36-inch diameter concrete pipe. No water was observed entering the riser or leaving the spillway outlet during the Dewberry site inspection visit. The outlet conduit was covered by riprap which had to be moved to observe the end of the pipe. Figure 5.3.3-1 shows the emergency spillway riser and Figure 5.3.3-2 shows the outlet conduit.

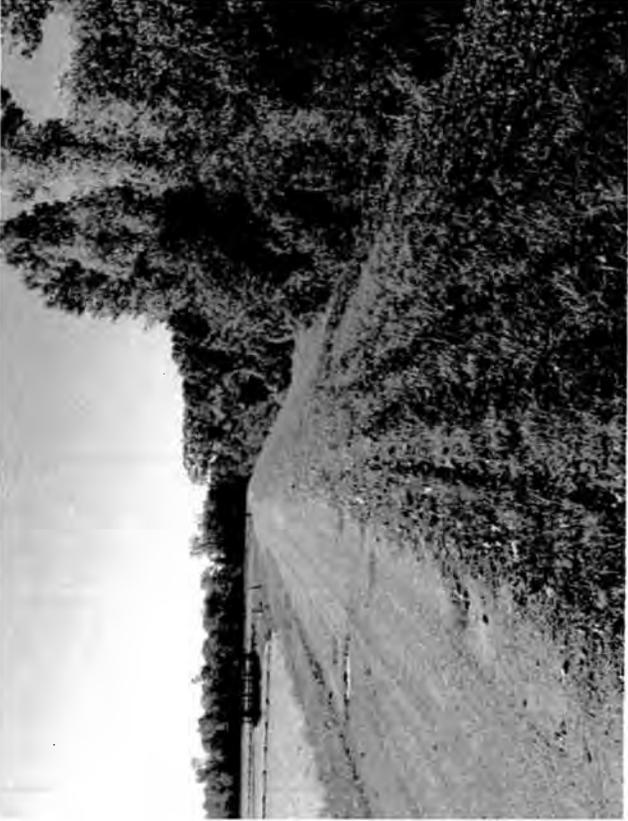
Photo 1: Downstream of Western Edge of Ash Pond (View North to South)

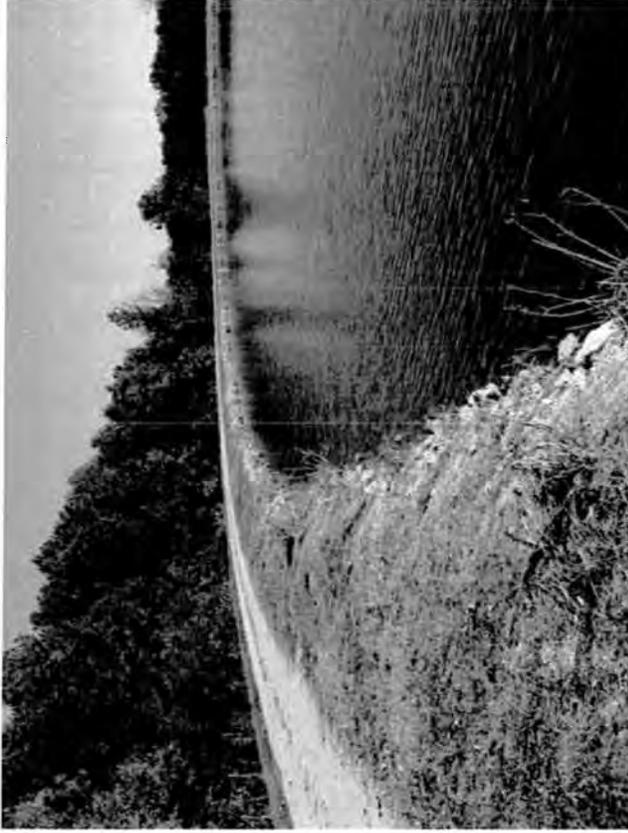
Photo 2: Upstream of Western Edge of Ash Pond (View South to North)

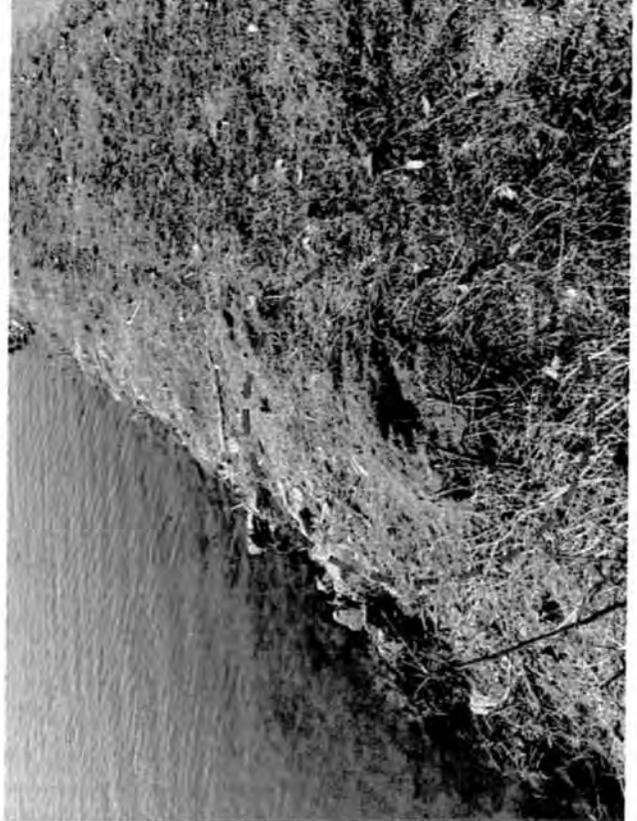
A fair number of sizable ant mounds were observed along the embankment crest (Photo 3). It is recommended that these mounds be destroyed using pesticides.

Photo 3: Ant Mounds on Upstream Side of Ash Pond Embankment (typical)

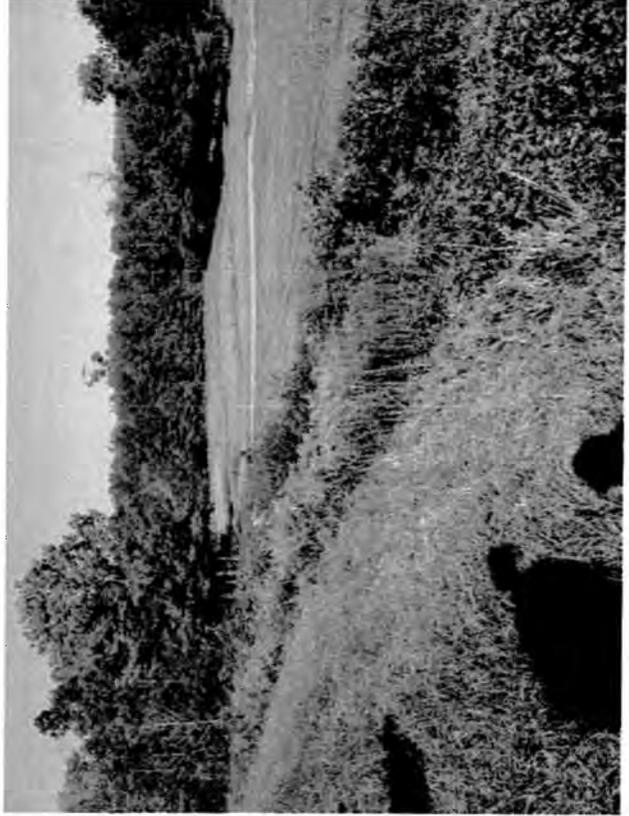
The need to continue efforts to keep the area around the toe of the dike free from brush and trees was discussed. At the northwestern corner of the dike, fairly dense vegetation was observed near the embankment toe (Photo 4). It is recommended that this vegetation be removed by bush-hogging (where accessible) or spraying.

Photo 4: Vegetation on Northwest Corner of Pond Embankment

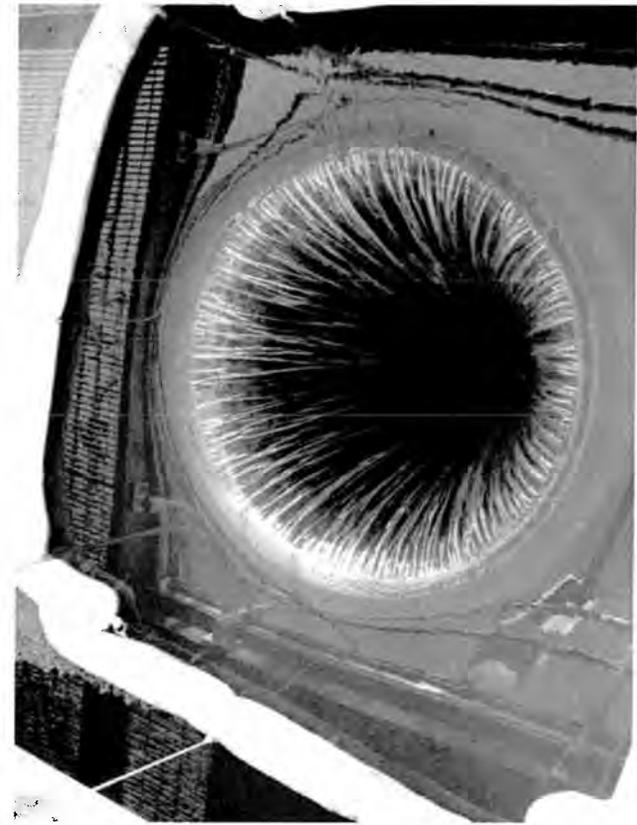
The discharge structure was observed. It appeared to be in good condition at both the release (Photo 7) and intake (Photo 8), and no unusual conditions were noted.

Photo 8: Discharge Pipe in Ash Pond

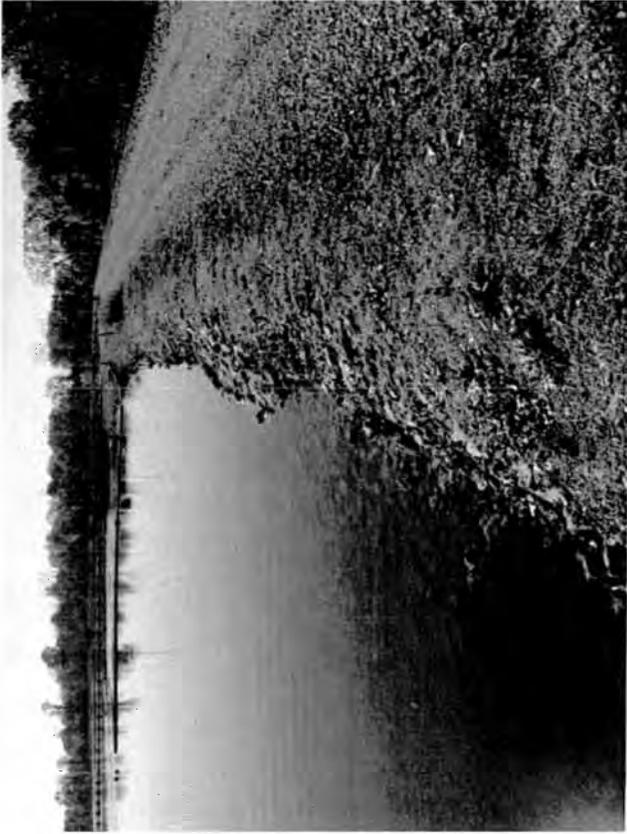
Photo 2: Upstream of Western Side of Ash Pond (View North to South)

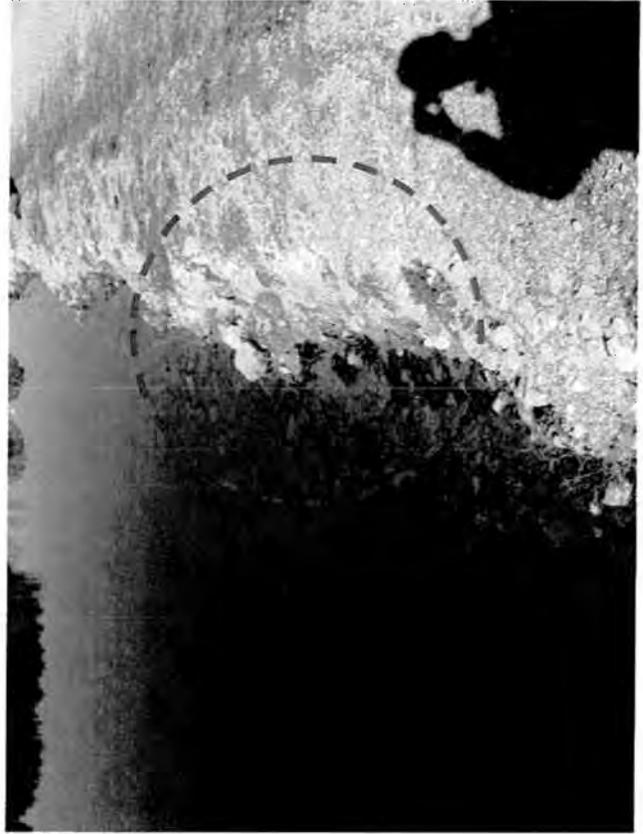
Some minor sloughing and washing of the upstream embankment, most likely due to wave action, were observed (Photo 4). This condition is noted fairly uniformly on the entire upstream side of the dam near the waterline. As the washing currently appears to be affecting only the upper 2 to 3 feet of the embankment, repair is not a critical need but attention to this condition is recommended. Should the washing continue further into the slope crest, the upper 2 to 3 feet of embankment will need to be protected using riprap.

Photo 4: Typical Sloughing on Upstream Side of Dam

<b>No.</b>	<b>Description</b>	<b>Location</b>
1	Eradicate all ant mounds on the embankments using pesticides.	1979 Extension Embankment (Photo 3)
2	Armor the upstream side of the crest of the embankment structures to protect against wave action induced erosion. The armoring can be achieved using riprap.	1979 Extension Embankment (Photo 4)
3	Clear vegetation and trees to a distance of 5 feet beyond the downstream toe of water-retaining embankments. At this time, large trees (i.e. greater than 4 inches in diameter) may be left in-place.	1979 Extension Embankment (Photo 5)
4	Remove fairly dense vegetation from northernmost corner of 1979 Extension Embankment (see Photo 6). The removal should be performed by bush-hogging (where accessible) or use of herbicides.	1979 Extension Embankment (Photo 6)

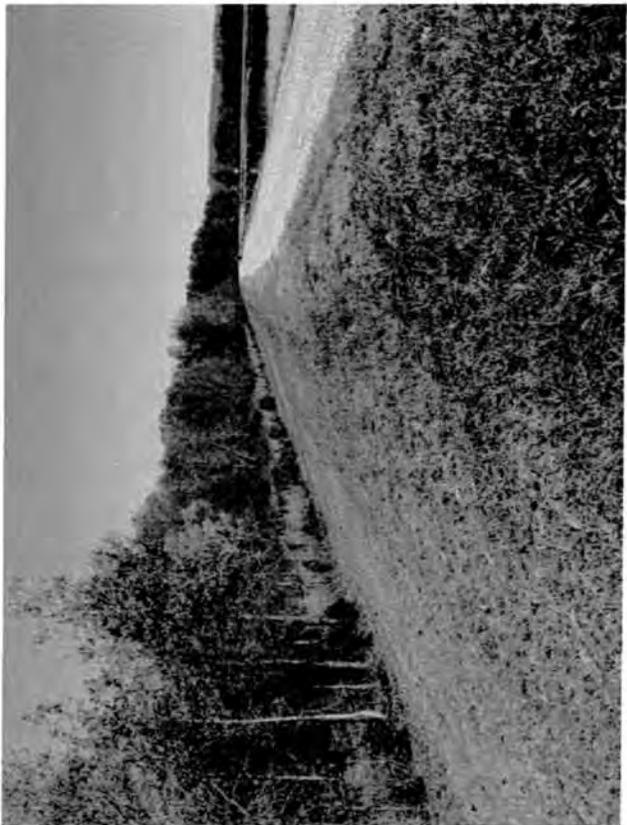
Photo 1: Downstream of Southern Portion of Ash Pond (View SE to NW)

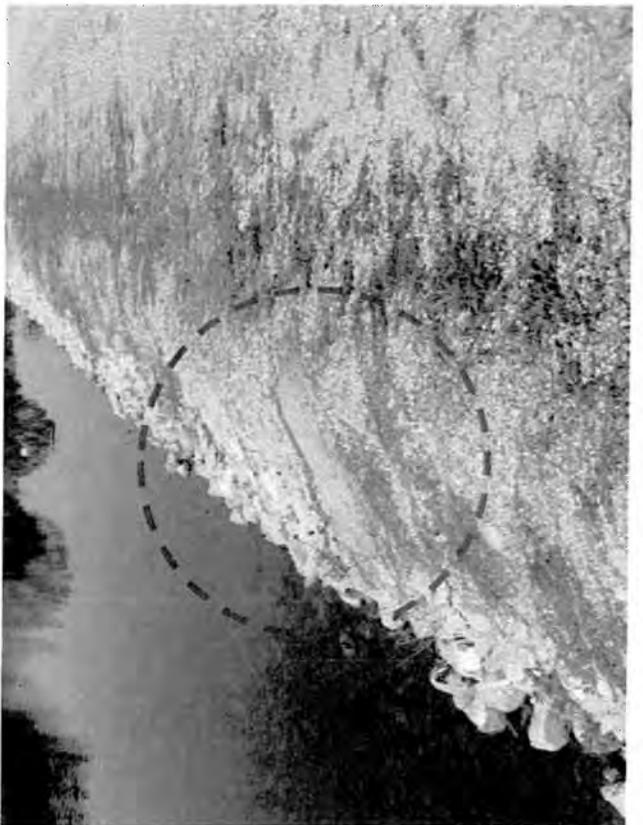
A fair number of sizable ant mounds were observed along the embankment crest (noted on Photo 3). It is recommended that efforts continue to control these mounds using pesticides.

Photo 3: Ant Mounds on Upstream Side of Ash Pond Embankment (typical)

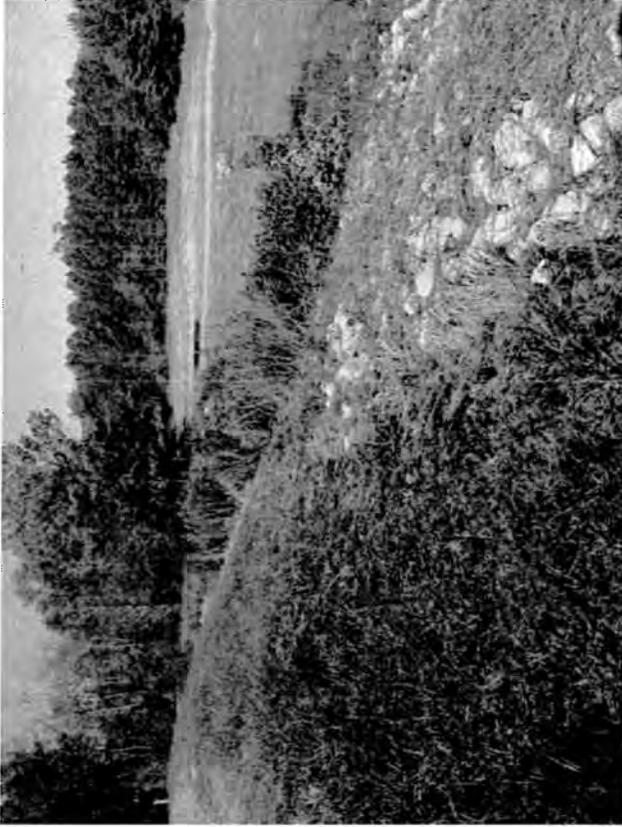
Photo 6: Dense Shrubs on Dam Toe at Northern Corner of Dam

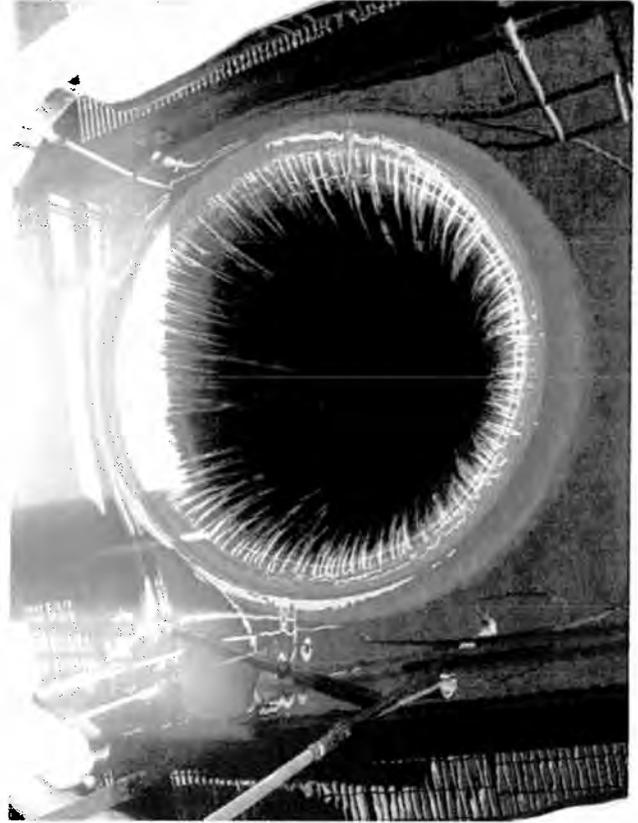
The discharge structure was observed. It appeared to be in good condition at both the release (Photo 7) and intake (Photo 8), and no unusual conditions were noted.

Photo 8: Discharge Pipe in Ash Pond

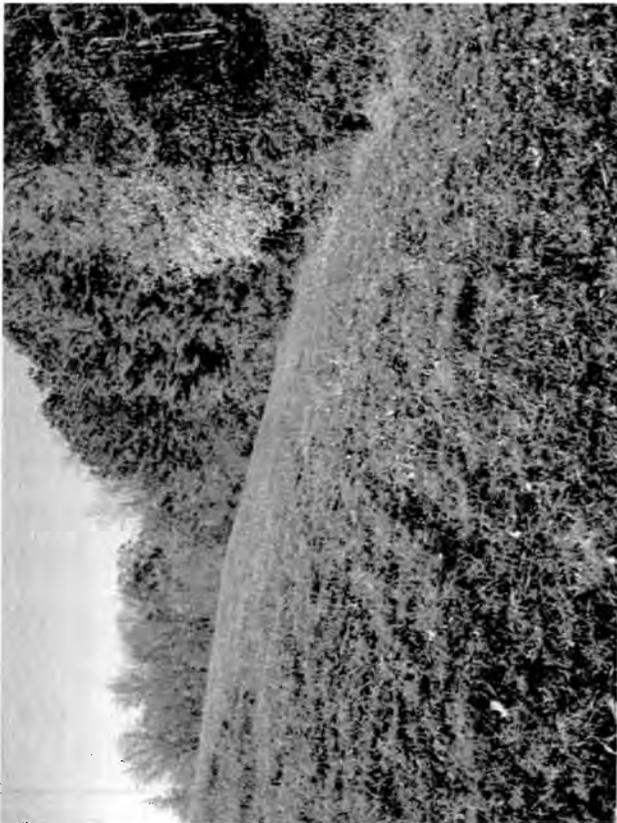
The need to continue efforts to keep the downstream slope and the area around the toe of the dike free from brush and trees was discussed (Photo 5). It is the recommendation of the inspection team that the downstream area of the dam be cleared and maintained to a distance of at least 5 feet past the toe. Any large trees in this area (greater than about 4 inches in diameter) could be left at this time due to the difficulties associated with their removal, but any shrubs or other small plants should be cleared. At the northernmost corner of the dike, fairly dense vegetation was observed on the embankment and at the toe (Photo 6). It is recommended that this vegetation be removed by bush-hogging (where accessible) or spraying herbicide.

Photo 5: Typical Vegetation Encroachment on Downstream Toe

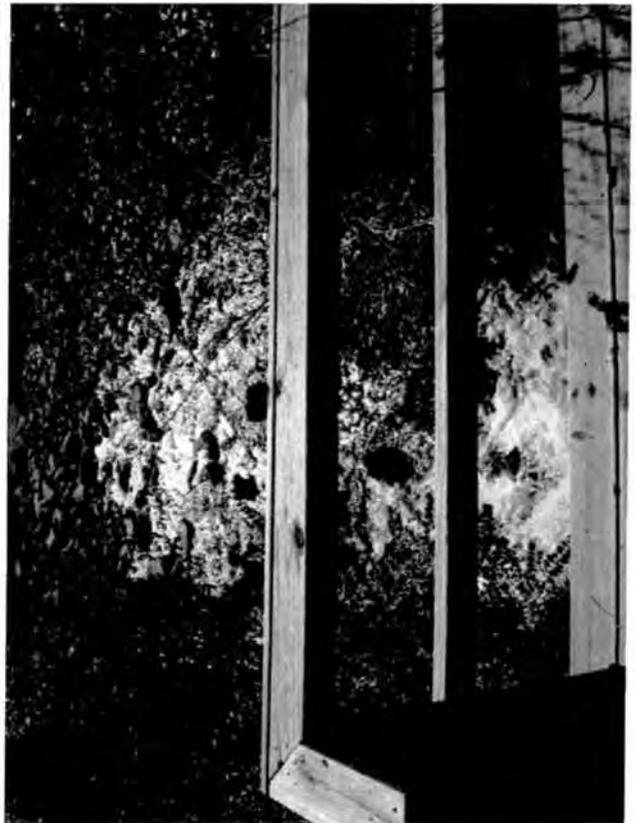
Photo 7: Pond Discharge Point to the Coosa River / Lake Henry

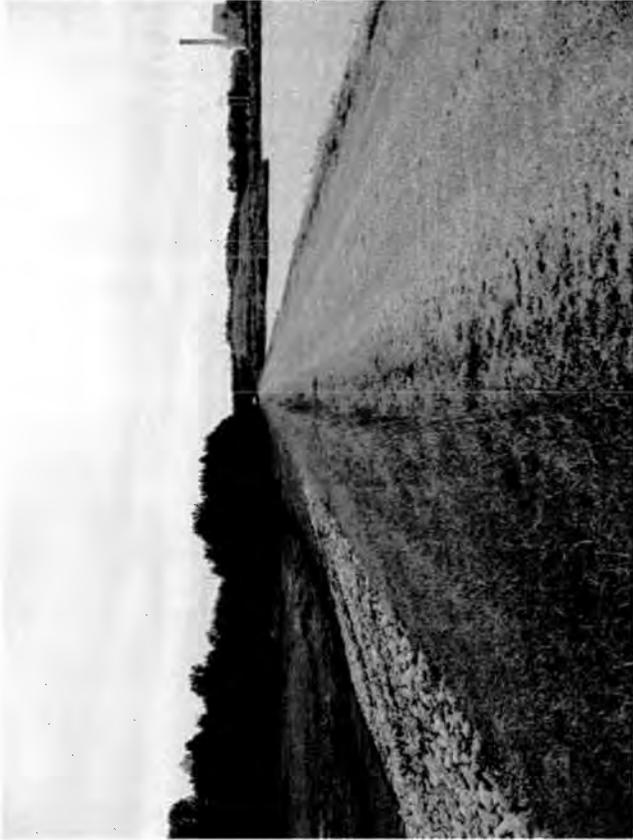
Photo 2: Downstream of Eastern Side of Ash Pond (Looking Southeast)

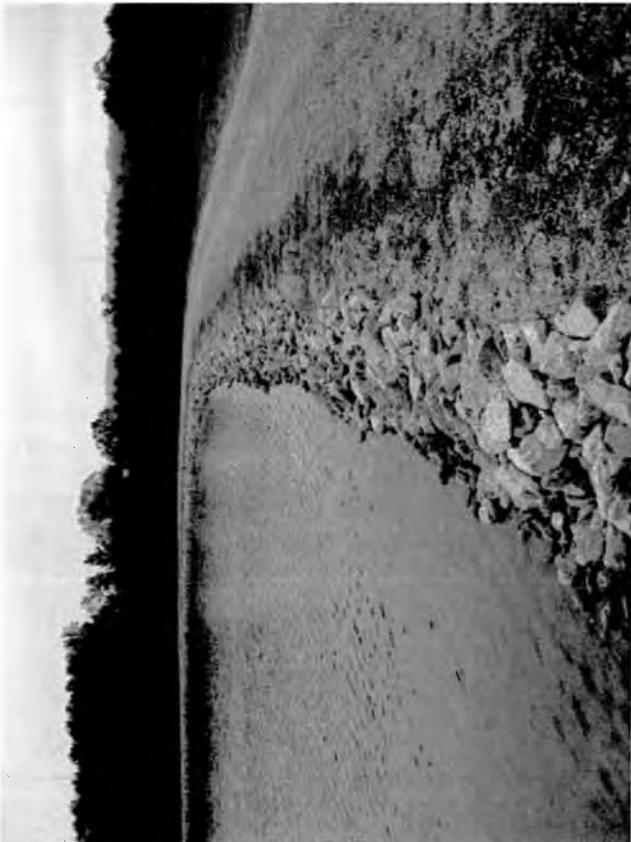
Photo 1: Riprap on Upstream Portion of 1979 Extension Dam (typ.)

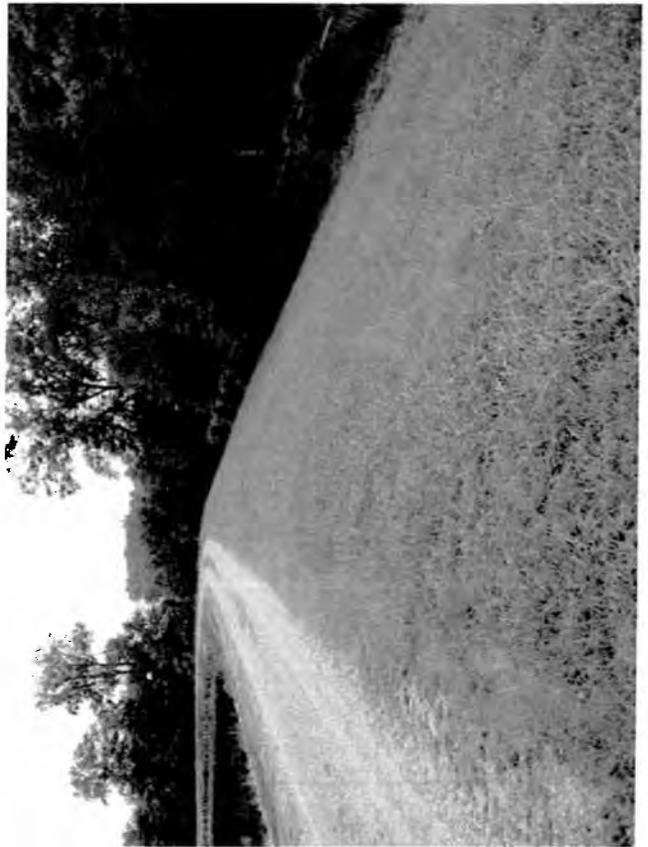
Photo 3: Downstream of Northwest Side of Ash Pond (Looking South)

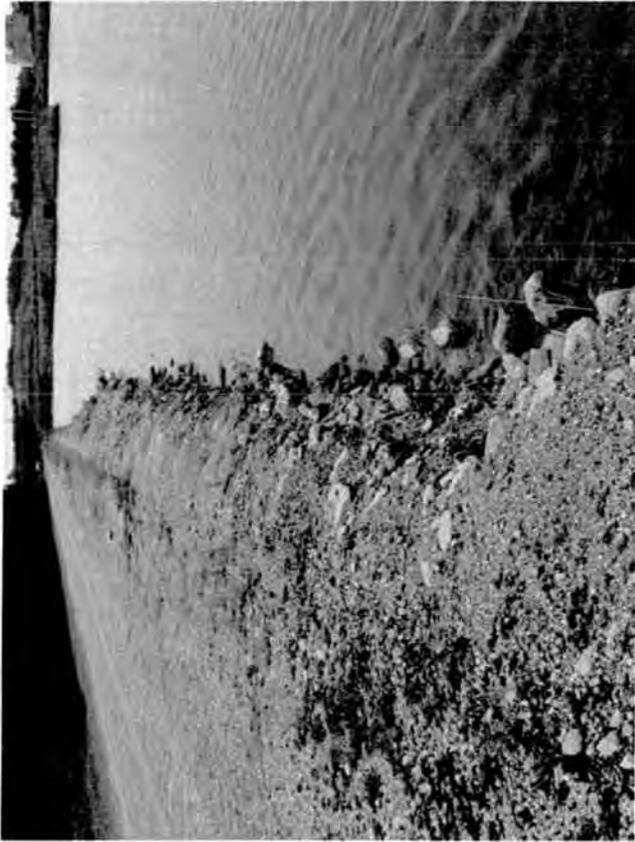
Photo 6: Minor Erosion on Upstream Side of Embankment

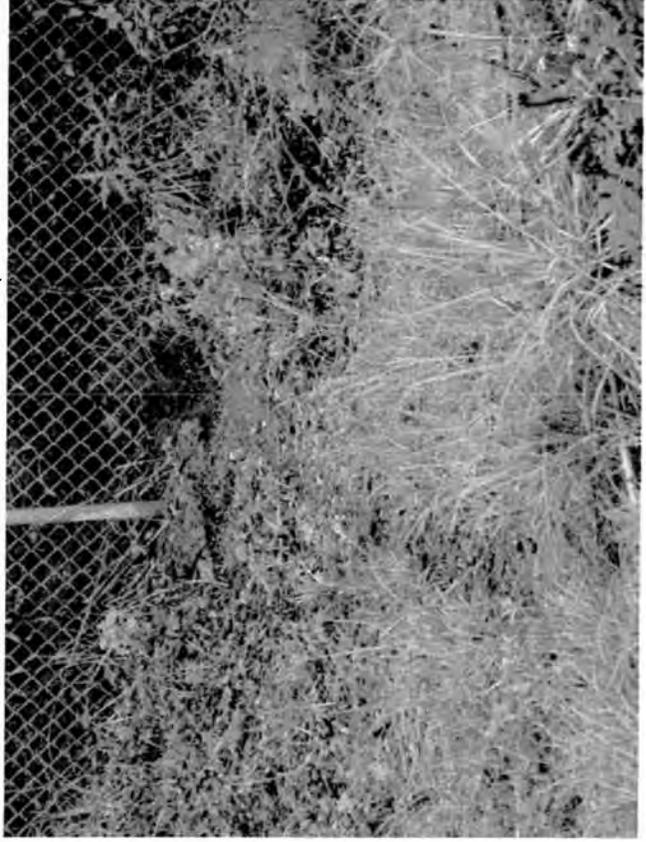
During the inspection, evidence of small animal activity, most likely beavers, was noted (see Photo 8). At this time the animal activity does not appear to be having any negative effect on the ash pond, but this should be monitored by the plant staff during their regular inspections.

Photo 8: Evidence of Beaver Activity in the Dam Area

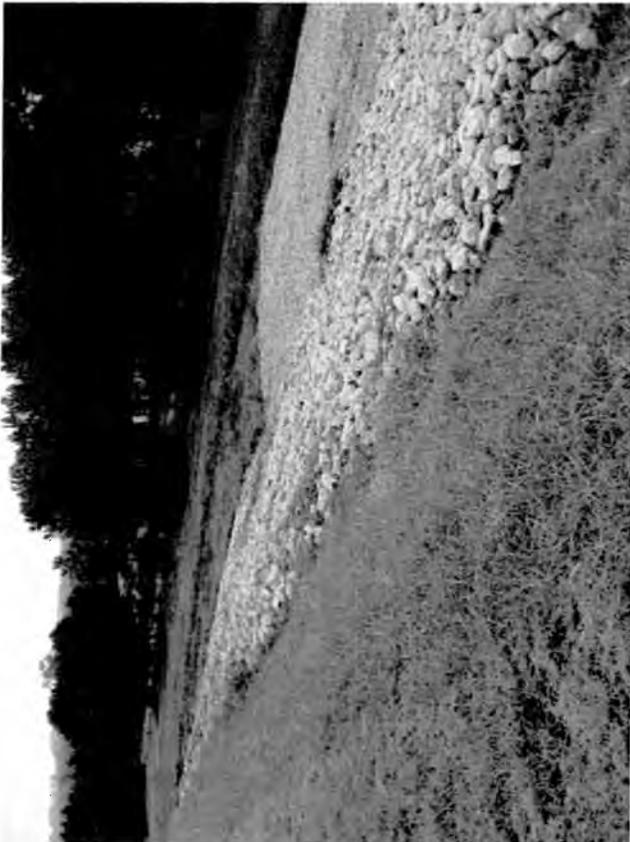
Photo 5: Photo of Weighted Filter on North Edge of Embankment

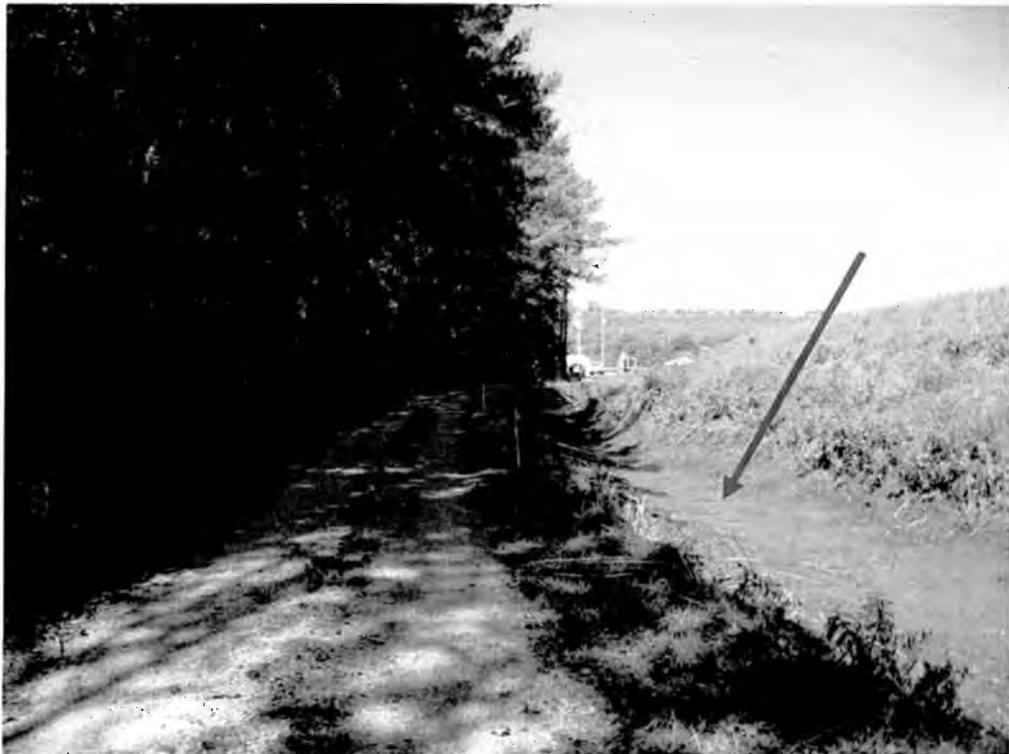
As noted above, issues with ponded water have been noted in a drainage ditch along the upstream face of the original dike section (see Photo 4). ***It is recommended that the drainage in this area be improved.*** The inspection team understands that the plant staff is working with SCG Civil Design and ES&EE staff to develop a plan to improve this problem. It seems that this condition is limited to the southern portion of the original dike. As plans to improve the drainage progress, the plant should continue to keep SCG Hydro Services informed.

**Photo 4 – Drainage Ditch Along Upstream Face of Original Dike**
