**Coal Combustion Residue Impoundment
Round 9 - Dam Assessment Report**

Miller Steam Plant

*Coal Combustion Residue Impoundment Dike
Alabama Power Company
West Jefferson, Alabama*

Dewberry & Davis, LLC
Fairfax, Virginia

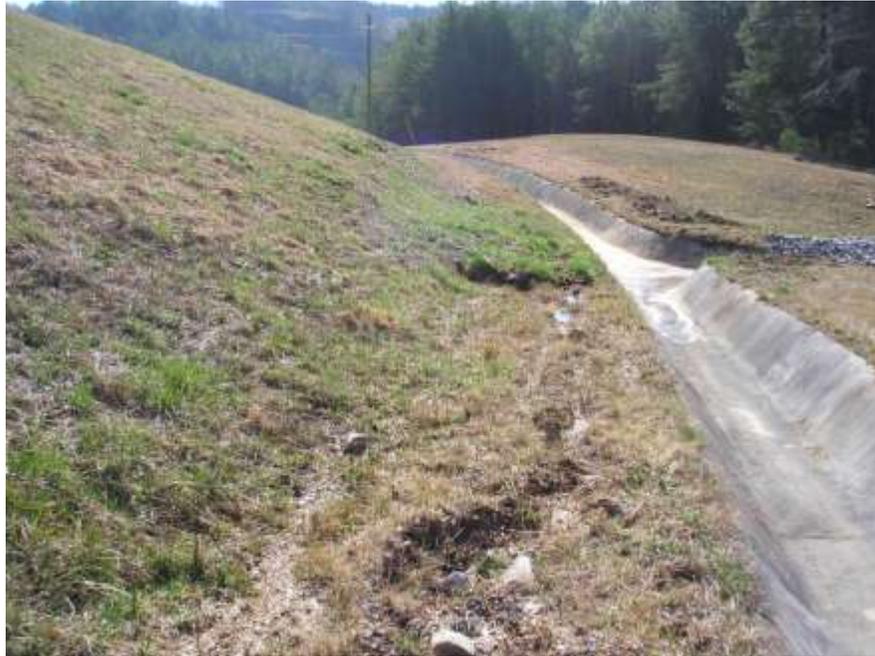
Stormwater runoff from the main dam outside slope is captured by a concrete lined ditch located along the abutments and toe of the slope. The drain discharges to a riprap lined ditch that empties into a creek in the woods beyond the toe of the dam embankment. Figures 5.2.3-3 and 5.2.3-4 show the concrete-lined ditch and the discharge drain, respectively.

Figure 5.2.3-3 Main Dam Surface Runoff Toe Drain Ditch

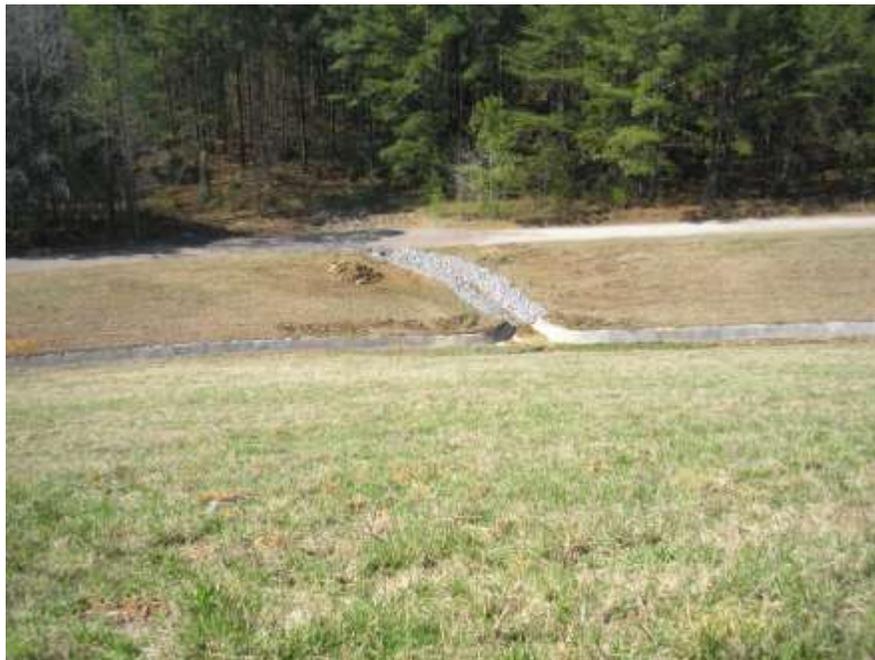
Figure 5.2.3-4 Main Dam Surface Water Toe Drain Discharge

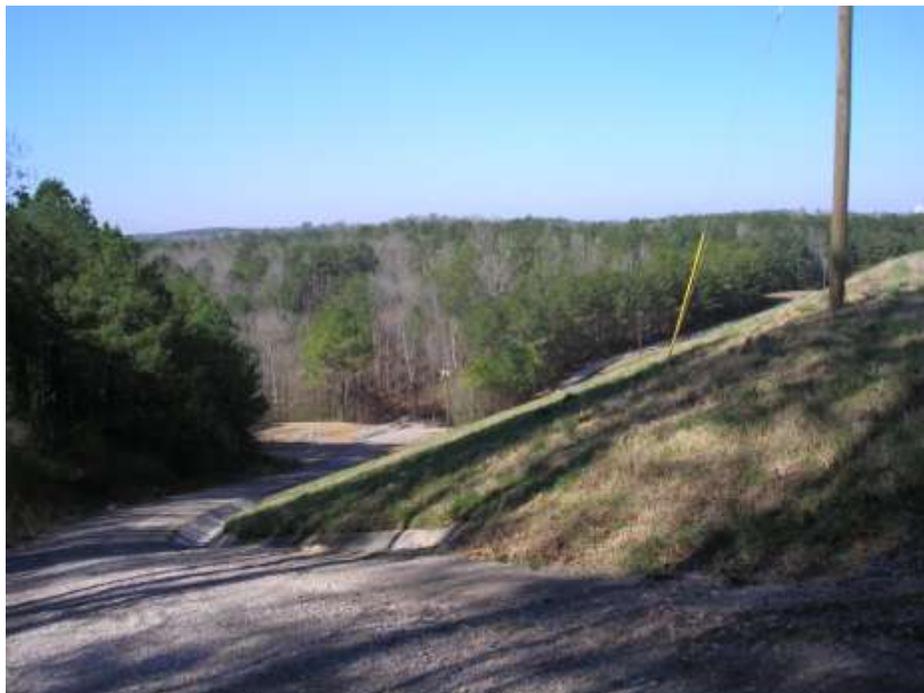
Figure 5.2.4-2 Main Dam South Abutment

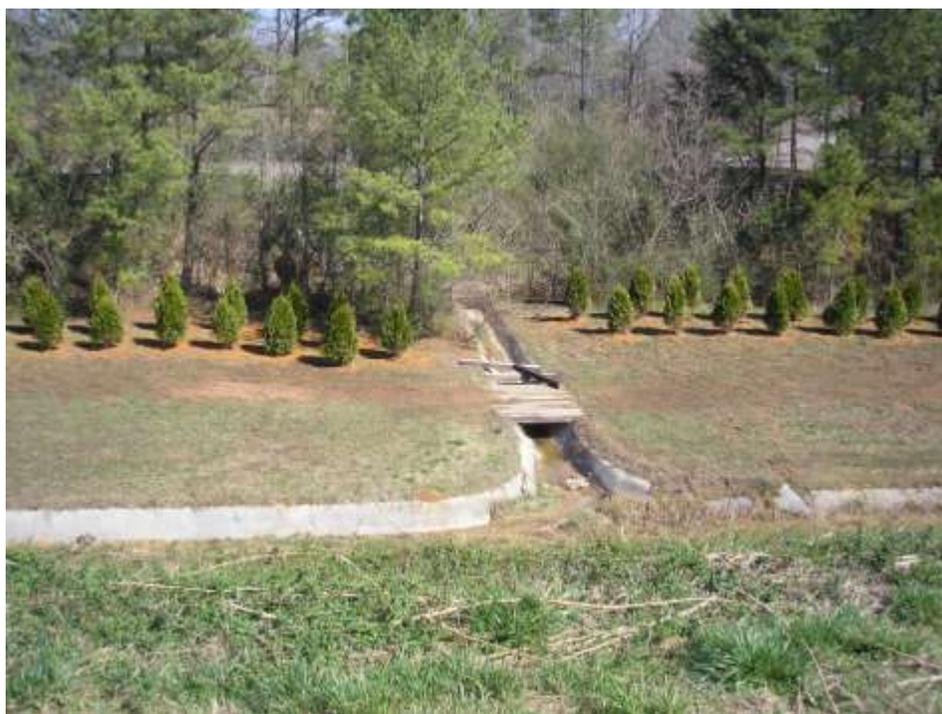
Stormwater runoff from the saddle outside slope is captured by a concrete lined ditch located along the abutments and toe of the slope. The drain is routed to a low laying area in the woods beyond the toe of the dam embankment. Figure 5.3.3-2 shows the discharge drain.

Figure 5.3.3-2 Saddle Dike Outside Slope Toe Drain Discharge

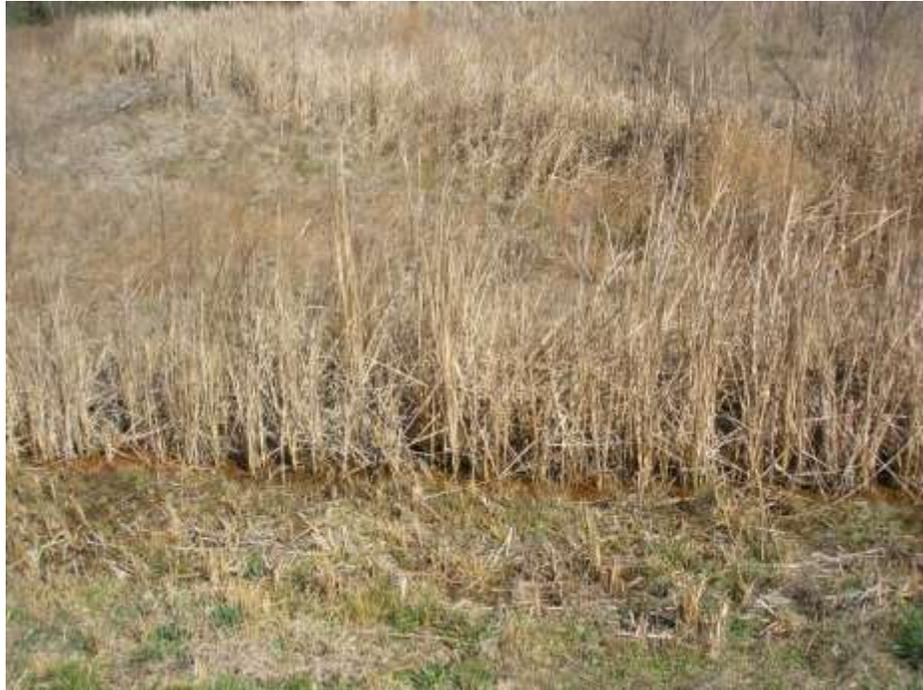
A small area of standing water was observed along the outside toe of the saddle dike. Figure 5.3.3-3 shows the observed wet area. Since the impoundment in the area of the saddle dike has been filled with ash it is expected that the observed wet area was the result of recent precipitation events.

Figure 5.3.3-3 Small Wet Area Along Outside Toe of Saddle Dike

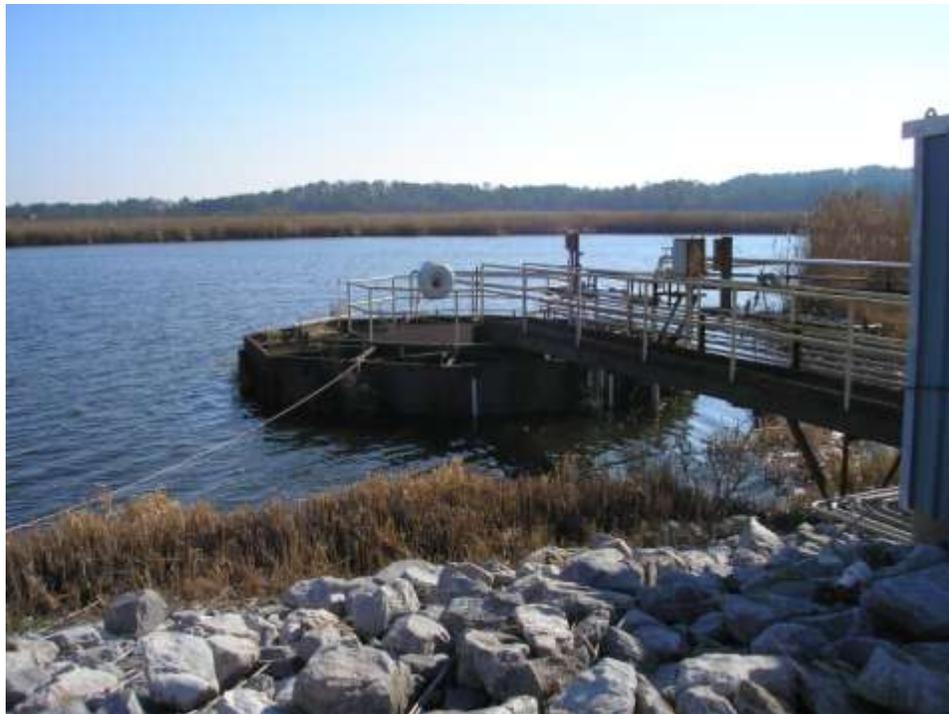
The impoundment overflow structure is located along the eastern side of the impoundment near the north abutment of the main dam. The CCR impoundment overflow structure consists of a concrete decant riser approximately 8 feet in diameter with an overflow elevation of about 420 Ft. and an invert elevation of 400 ft. The riser discharges to a 96-inch concrete pipe spillway located in natural ground beneath the south abutment of the main dike. The spillway discharges into an excavated drainage ditch that flows to the Locust Fork of the Warrior River. Access to the decant riser is provided by a fixed, steel frame, steel grate walkway. Figure 5.4.1-1 shows the overflow structure.

Figure 5.4.1-1 CCR Impoundment Overflow Structure

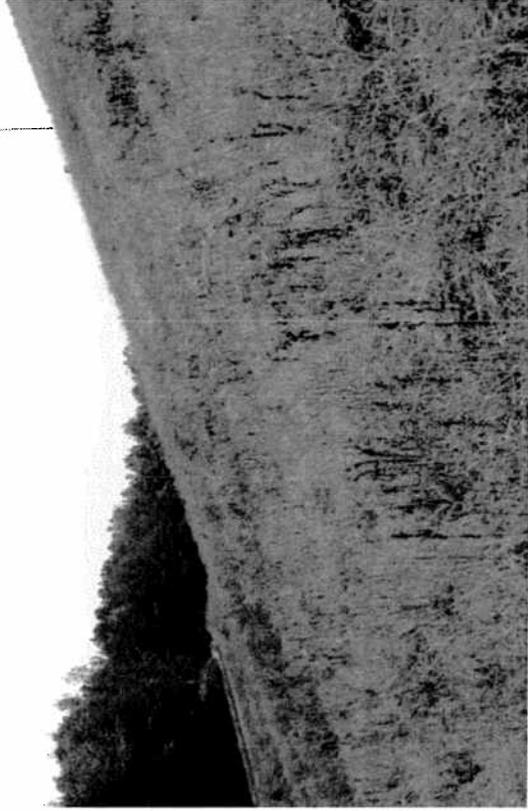
The inspection was started at the southern edge of the embankment, near Station 125+00. The downstream slope in this area, which is the maximum embankment section, was observed to be in good condition with a reasonably maintained cover of grass (see Photos 1 and 2). The small trees observed during the previous inspection had been removed. The concrete-lined toe ditches were reasonably clear but had accumulated some dead vegetation. The spring drainage system installed downstream of Station 121+00 was inspected and no problems were noted. The outlets were in good condition and flowing freely (Photo 3). The area around the outlets was maintained free of brush. Based on a review of photographs from the 2004 inspection, the flow through the outlets appeared to be similar to previous inspections.

Photo 2: Downstream Slope at Maximum Section, N to S

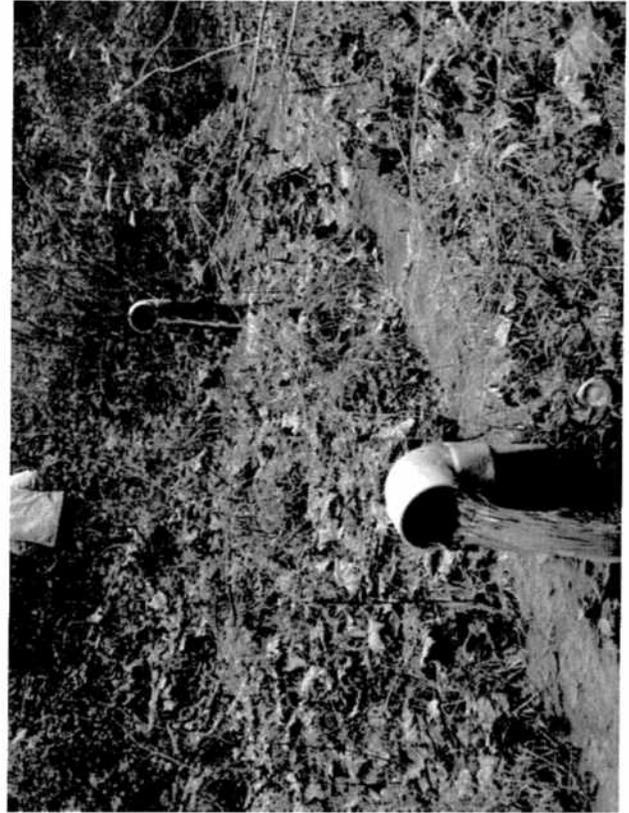
Photo 3: Spring Outlets Downstream of STA 121+00

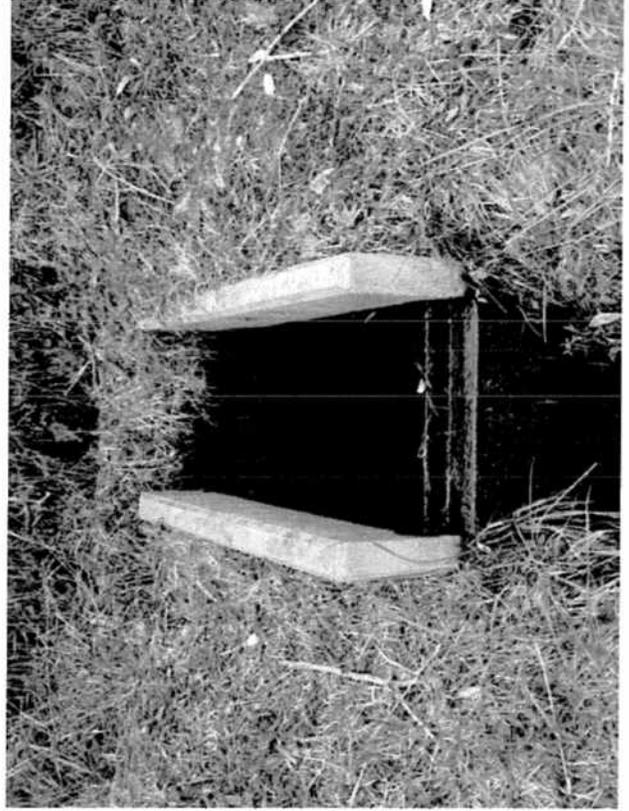
The inspection team then traveled along the access road which generally follows the toe of the dam. Along this route, inspection was made of Weir #1, located near station 107+00 (Photo 4), and Weir #2, located near Station 103+00 (Photo 6). Along the road between the two weirs, flow was surfacing at a point estimated to be about in line with Station 105+00 (Photo 5). Flow has been observed in this area in prior inspections and, although difficult to estimate, it was judged to be about the same as previously noted.

Photo 4: Weir 1

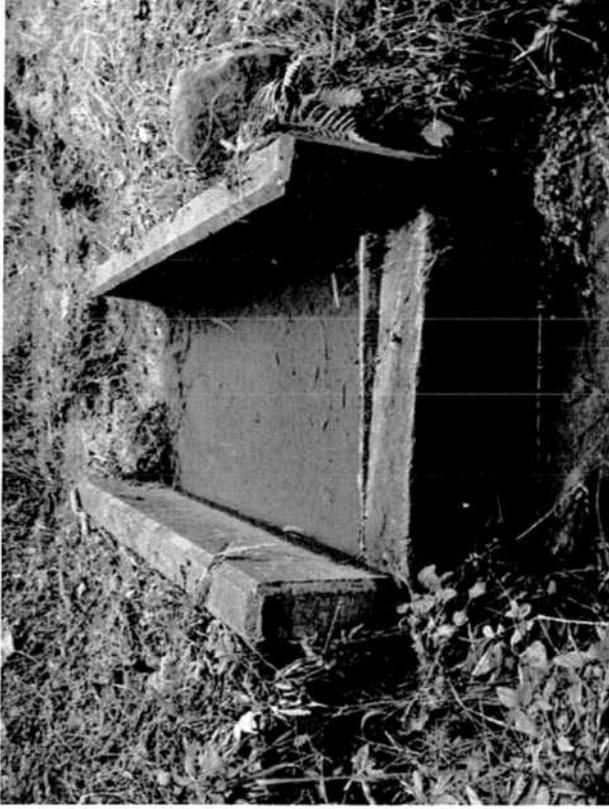
Photo 6: Weir 2

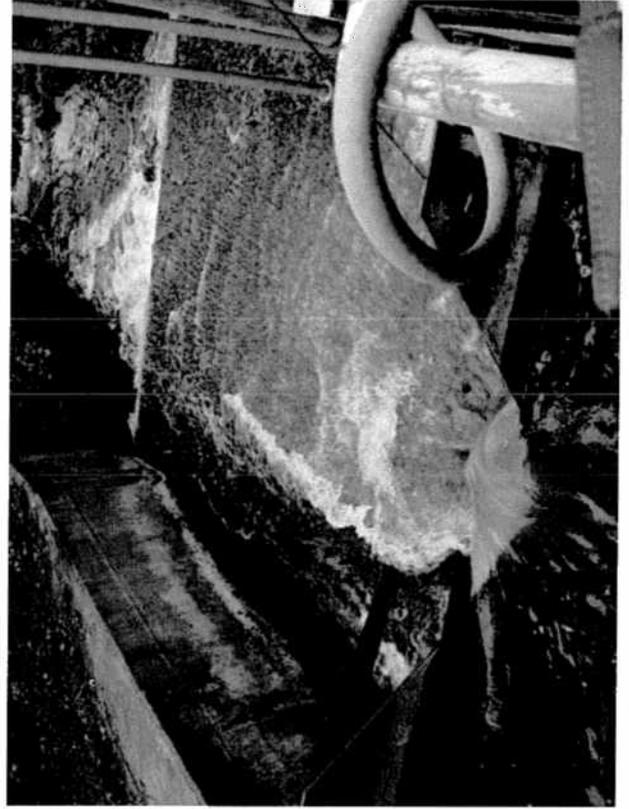
The inspection team then observed the discharge structure at 96+18 of the main dam. There was flow through the structure at the time of the inspection (Photos 7 and 8). No problems were noted at either the inlet or the outlet. Following the observation of the discharge structure, the crest of the dam was inspected. The wide crest road and the upstream riprap were observed to be in excellent condition. Vegetation was observed in portions of the riprap (Photo 9). It is recommended that this vegetation be removed by spraying.

Photo 8: Outlet Discharge Flow, Looking Downstream

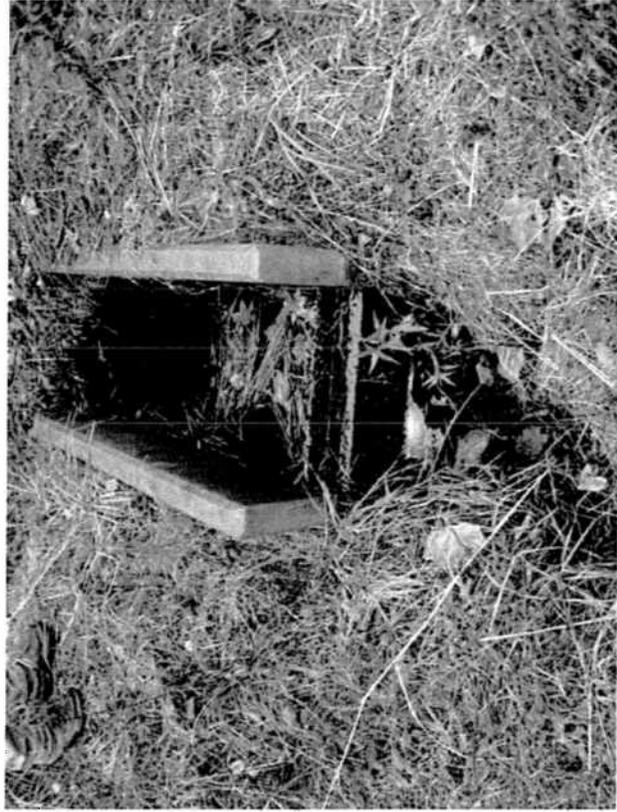
Photo 6: Weir 1

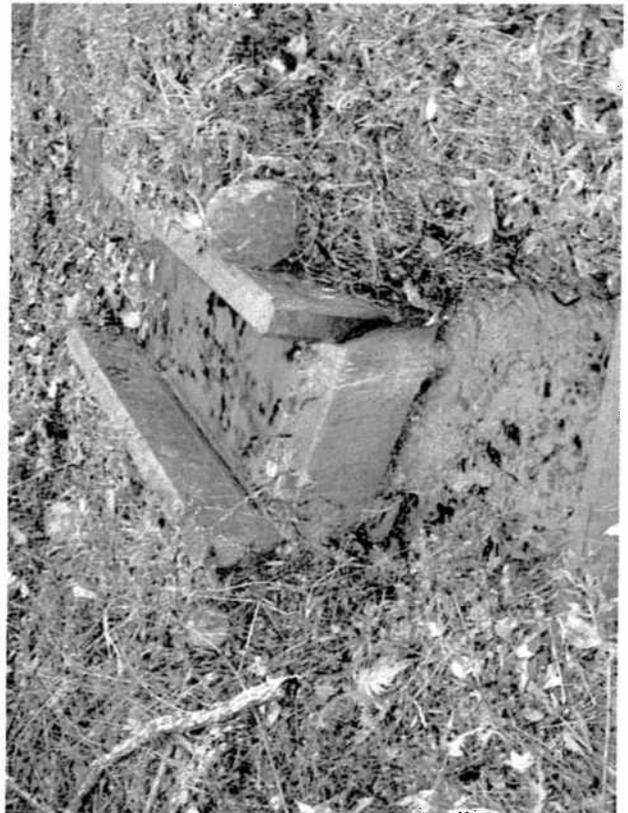
Photo 7: Weir 2

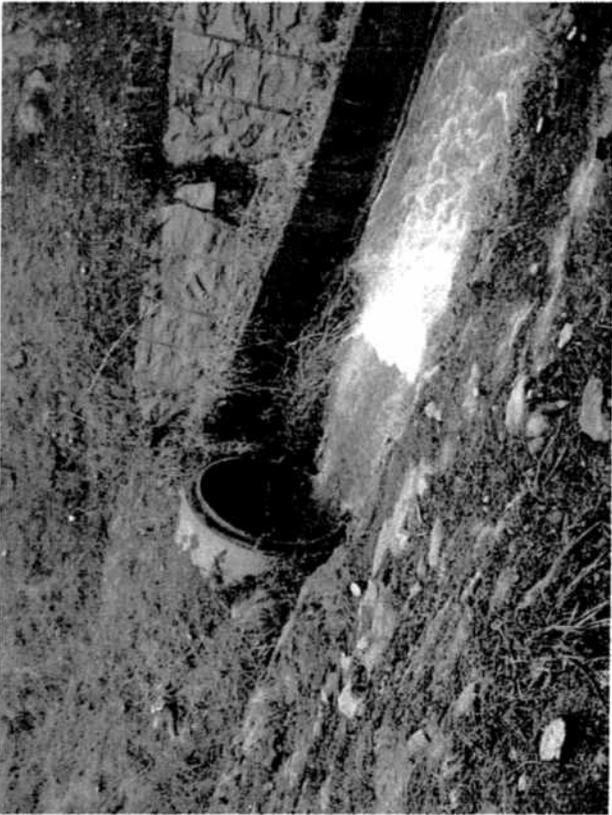
Photo 9: Outlet Discharge from Ash Pond

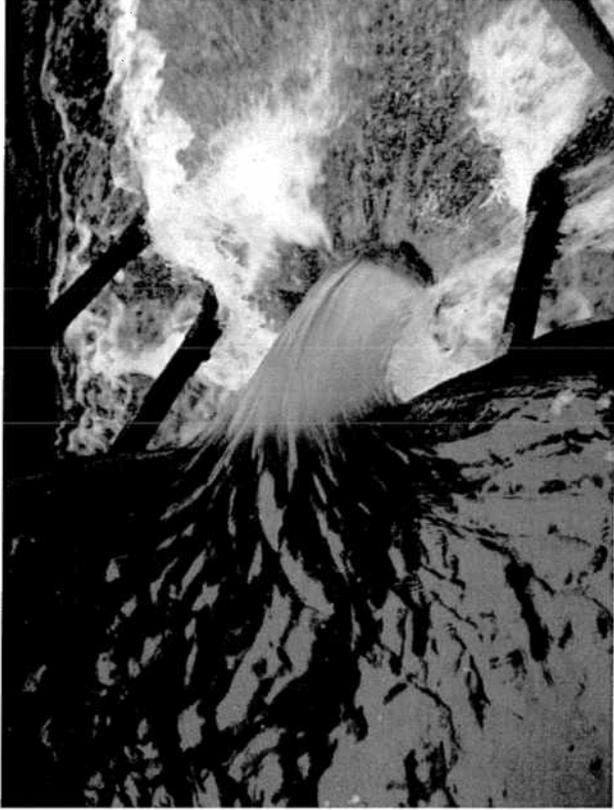
Photo 10: Outlet Discharge Flow Over Weir Blade

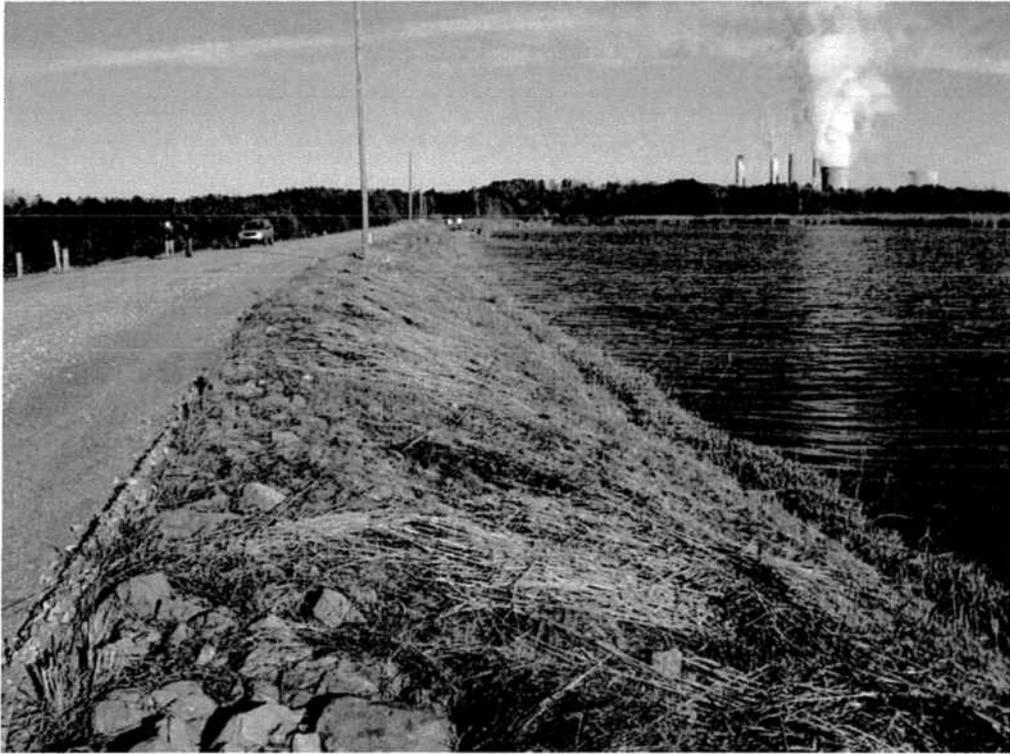
The inspection of the main ash pond dam started along the dam crest. The roadway along the crest was in excellent condition, and the embankments appeared to be very well maintained along both upstream (see Photo #1) and downstream (see Photo #2) faces. Also worthy of note is the effort taken to keep vegetation clear from the interface between the embankment upstream face and the pond waterline. *It is recommended that this level of embankment maintenance (on both the upstream and downstream slopes) be continued.* The downstream toe of the dike was inspected starting along the southern edge of the embankment near Station 125+00. This portion of the dam is the maximum height section. As was noted from the crest, the embankment vegetation appeared to be well-maintained and the concrete lined toe ditch was reasonably clear (see Photo #3). Along the toe of the embankment in this area, the plant emergency filter material stockpile was noted (see Photo #4).

Photo 1: Upstream Face of Main Ash Pond Dam

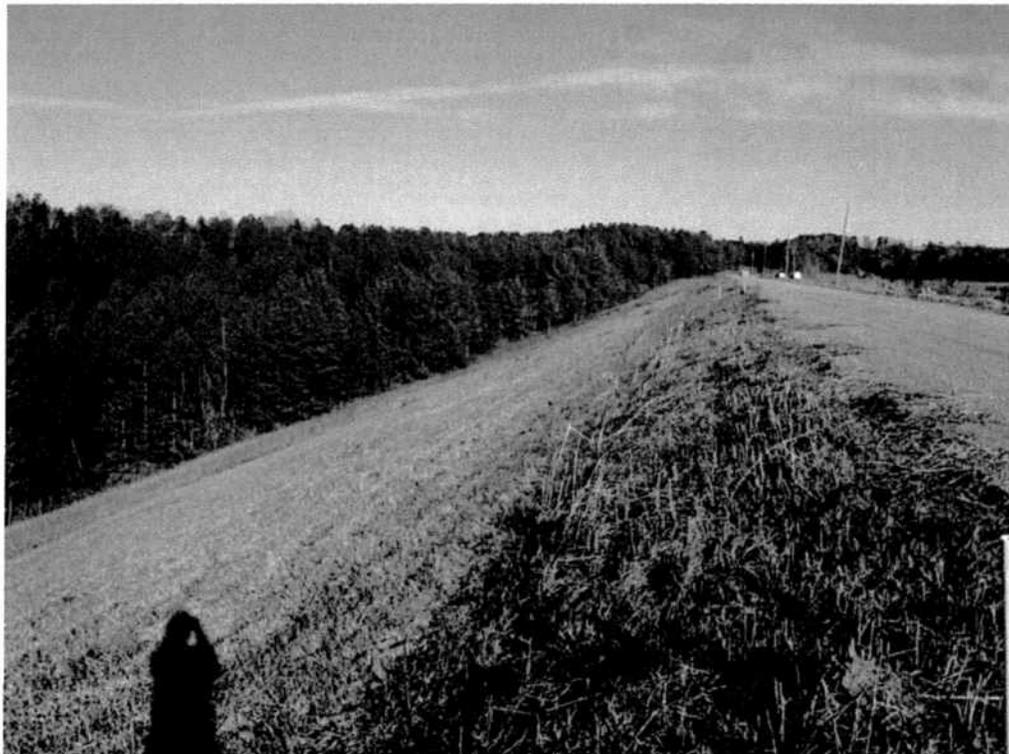
Photo 2: Downstream Face of Main Ash Pond Dam

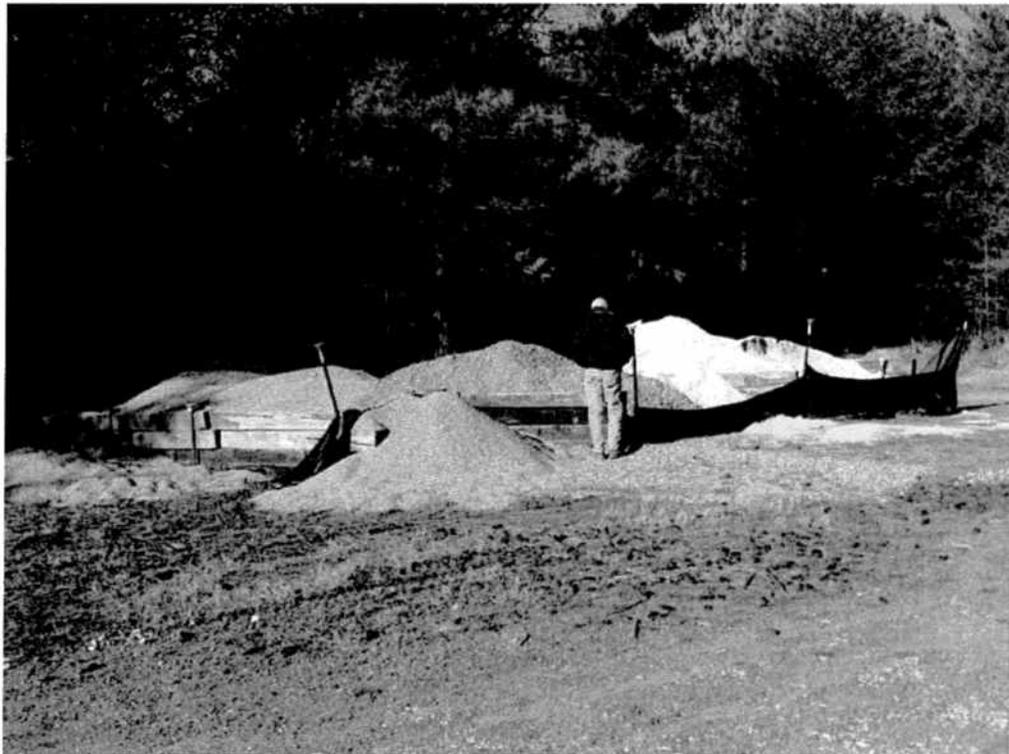
Photo 4: Emergency Filter Material Stockpile

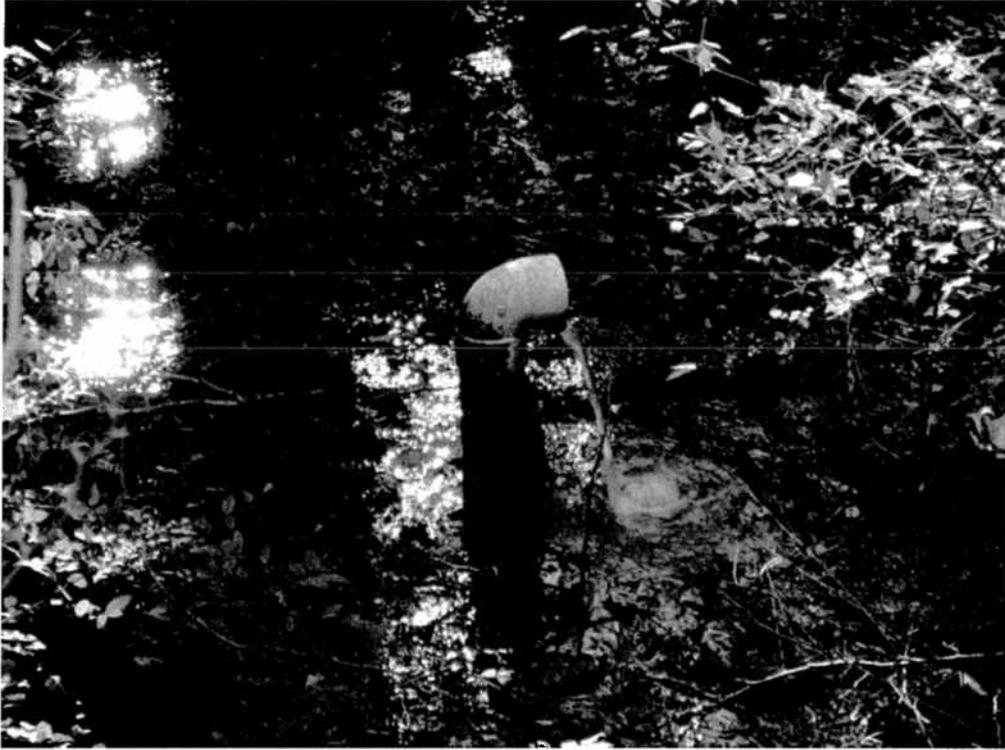
The spring drainage system installed downstream of Station 121+00 was inspected, and no problems were noted. The outlets were in good condition and flowing freely (see Photo #5). The area around the outlets was maintained and free of brush. Based on a review of photographs from previous inspections, the flow through the outlets appeared to be similar.

Photo 5: Spring Relief Drain Outlet Downstream of Main Ash Pond Dam

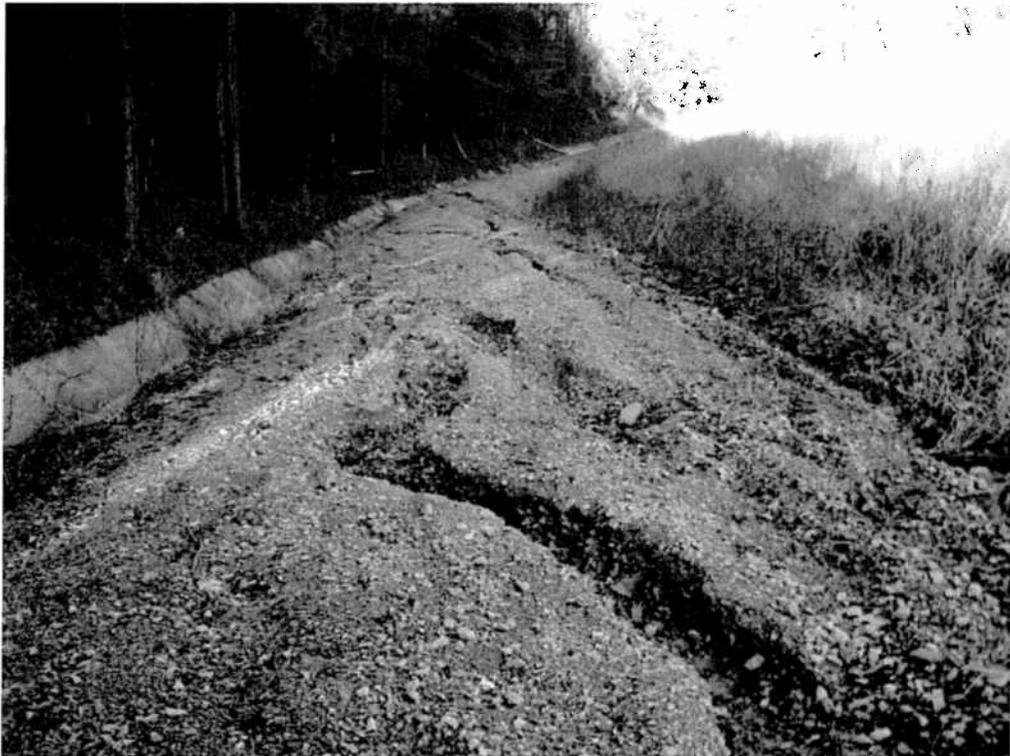
As a result of concentrated surface flows, significant rilling of the embankment toe access road was observed (see Photo #6). At the time of the inspection, it was recommended that the rilling be repaired to maintain the access for inspection, and it is the inspection team's understanding that this work has been completed. *It is recommended that future surface erosion of the access road be repaired as it is noted during the plant's regular dam safety inspections.*

Photo 6: Erosion Along Ash Pond Dam Toe Access Road

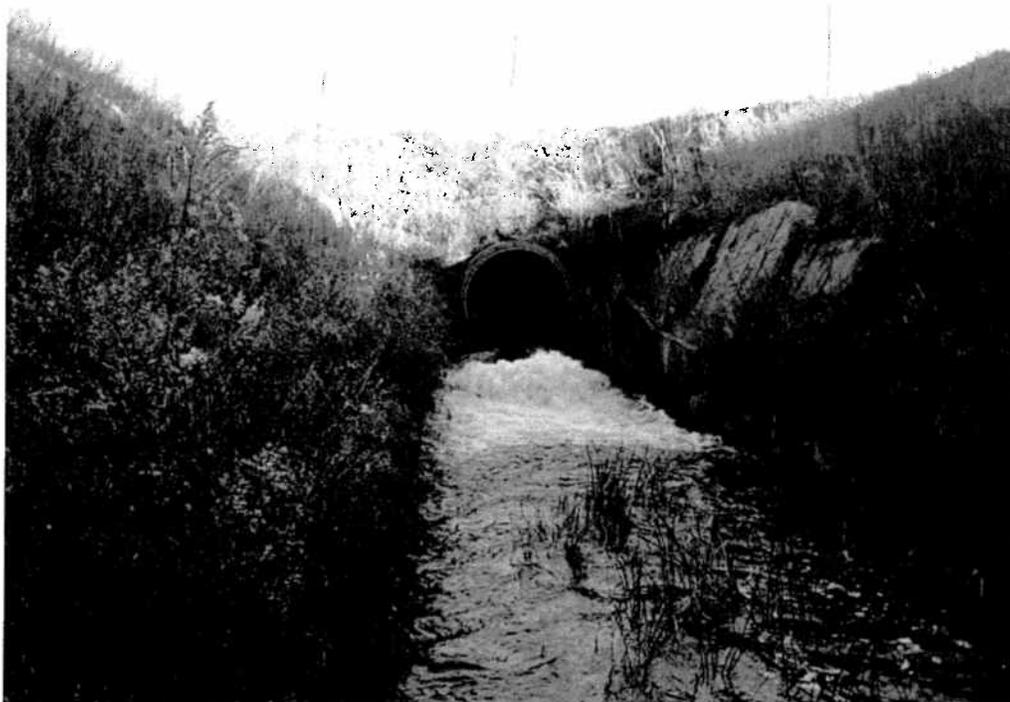
The discharge inlet and outlet structures were inspected (outlet on Photo #10), and no problems were noted.

Photo 10: Discharge Outlet Structure

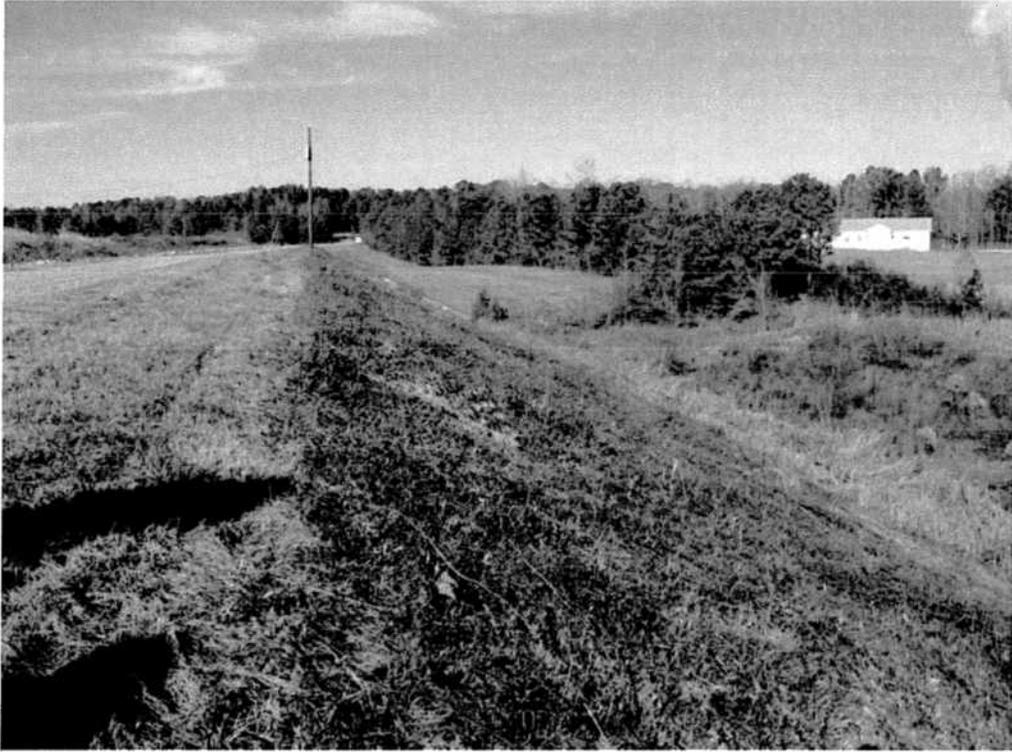
The saddle dike adjacent to Porter Road was inspected, starting at the southeastern end and moving to the northwest. As has been mentioned in previous inspection reports, the operations at the plant have resulted in most of the pond in the area being filled with ash, so the loading on the saddle dam as a water-retaining structure is likely reduced. At the time of the 2009 inspection, the embankment appeared to be in excellent condition (see Photos #11 and #12).

Photo 11: Saddle Dike Crest, Looking NW

As was noted in the 2008 inspection report, the embankment maintenance at the saddle dam continues to be significantly improved over years past, and this effort by the plant staff is appreciated. ***It is recommended that this level of embankment vegetation maintenance be continued at the saddle dike, and inspection of the saddle dike should continue to be a part of the plant's regular dam safety inspections.***

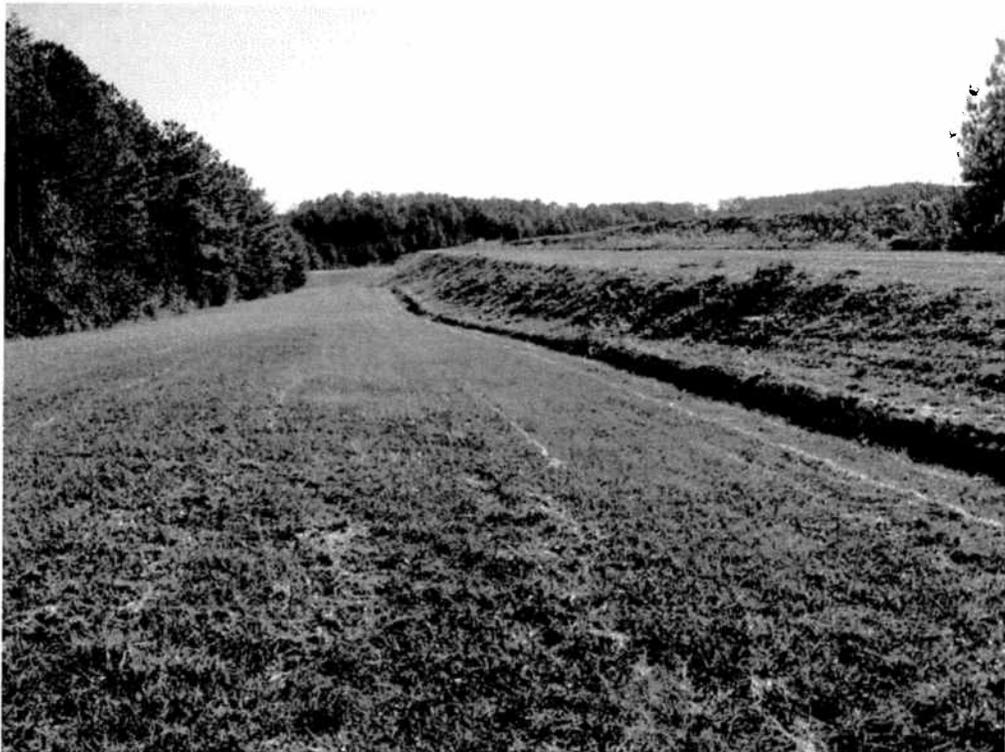
Photo 12: Saddle Dike Toe, Looking SE

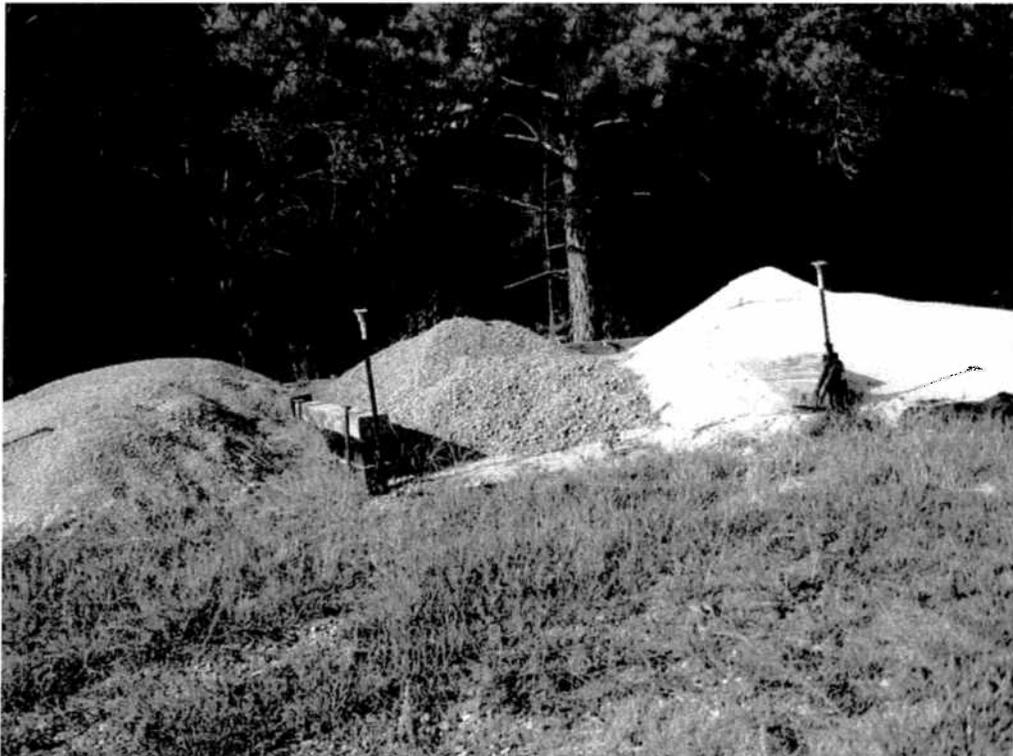
The emergency filter stockpiles were observed and noted to be stored adequately (see Photo #6).

Photo 6: Emergency Filter Stockpile
