**FINAL**  
**Coal Ash Impoundment -**  
**Specific Site Assessment Report**  
**Arizona Public Service**  
Four Corners Power Plant

Submitted by:  
**GEI Consultants, Inc.**  
6950 South Potomac Street, Suite 300  
Centennial, CO 80112

September 2009  
Project 091330

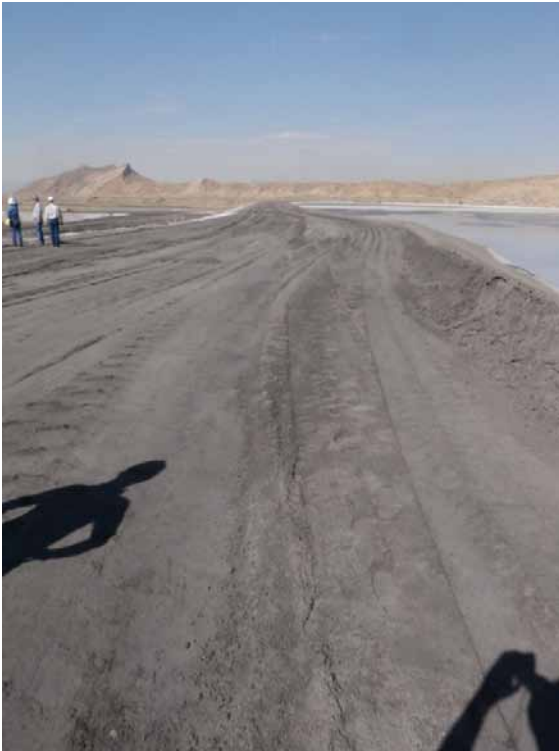
**Photo 5 – LAI Dam crest on south dam, looking to left. Note small bottom ash 'berm' at slope crest for construction traffic safety.**
