FINAL
Coal Ash Impoundment Specific
Site Assessment Report
Arizona Public Service
Cholla Power Plant

Submitted to:
Lockheed-Martin Corporation
2890 Wood Bridge Avenue
Building 209 BAYF
Edison, NJ 08837

Submitted by:
GEI Consultants, Inc.
6950 South Potomac Street, Suite 300
Centennial, CO 80112

December 2009
Project 091330

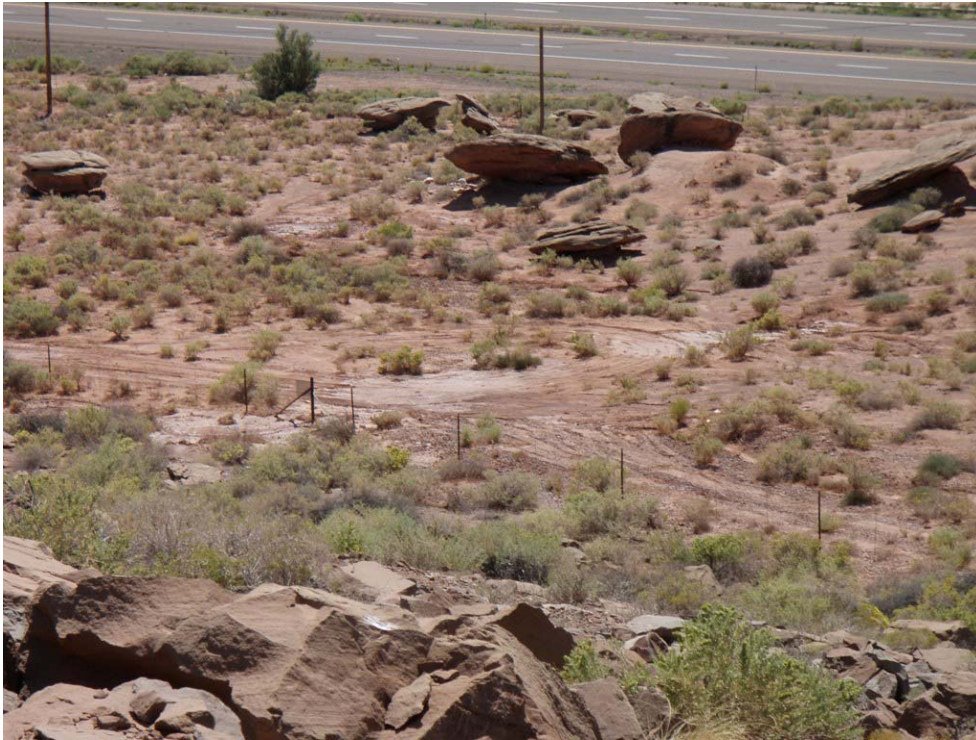
Seepage locations were observed at and beyond the downstream toes of both dams. APS monitors flow and water quality at these seepage locations, collects seepage and returns the water to the reservoirs. The seepage locations are monitored closely mainly due to environmental concerns associated with dam material entering the nearby waterways. The major seepage locations monitored by APS are described below. Signs of seepage including salt patches and tamarisk growth have been observed at other locations along the toe (e.g. Photos 19 and 20), and these minor seepage locations are observed daily for changes and to determine whether seepage collection measures should be taken.

Photo 19: Fly Ash Pond - Salt patch associated with seepage near right abutment toe (known as the "Hoodoo Salt Patch").

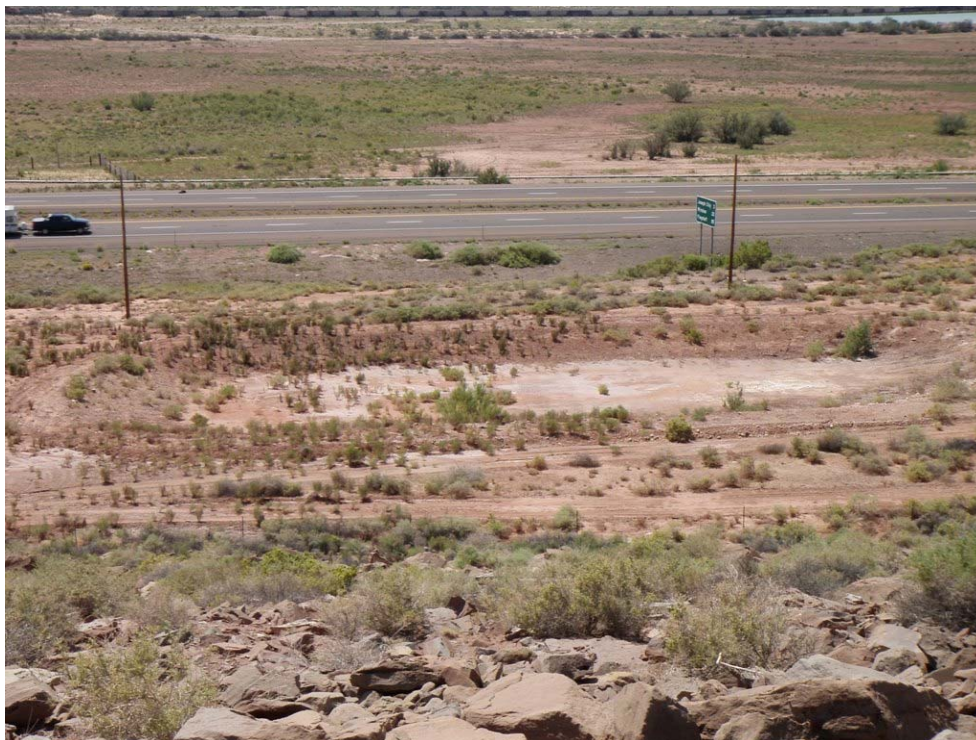
I-40 Seep: The I-40 Seep is located just beyond the downstream toe of the Fly Ash Pond Dam at the right abutment. This seep does not have drain system to return water to the pond, but an evaporation pond was constructed to collect seepage in this area (Photo 21).

Photo 21: Fly Ash Pond - Evaporation Pond for I-40 Seep.

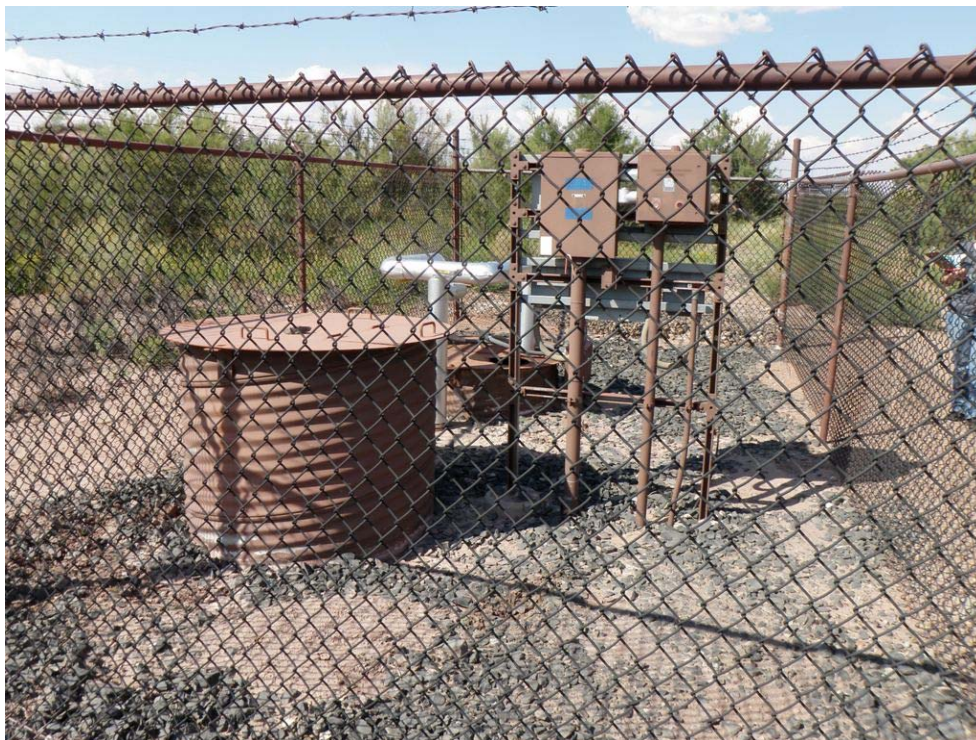
Tanner Wash Seep: The Tanner Wash Seep is located about 350 feet beyond the toe of the Bottom Ash Pond Dam near the left abutment. Seepage is collected and measured via an underground french drain system with a totalizer (Photo 29). Both salt patches (Photo 30) and flowing surface water (Photo 31) were observed at this seep at the time of our assessment. A maximum flow of about 15 gpm has been measured at this location since 1995. This seep is far enough from the dam that it is not considered a dam safety concern. This seep prevents a greater environmental concern than other seeps due to its proximity to Tanner Wash (Photo 32).

Photo 29: Bottom Ash Pond - Seepage collection system for Tanner Wash Seep.
