**DRAFT FINAL**  
**Coal Ash Impoundment**  
**Specific Site Assessment**  
**Report**  
**Arizona Public Service**  
**Cholla Power Plant**

Submitted by:  
**GEI Consultants, Inc.**  
6950 South Potomac Street, Suite 300  
Centennial, CO 80112

October 2009  
Project 091330

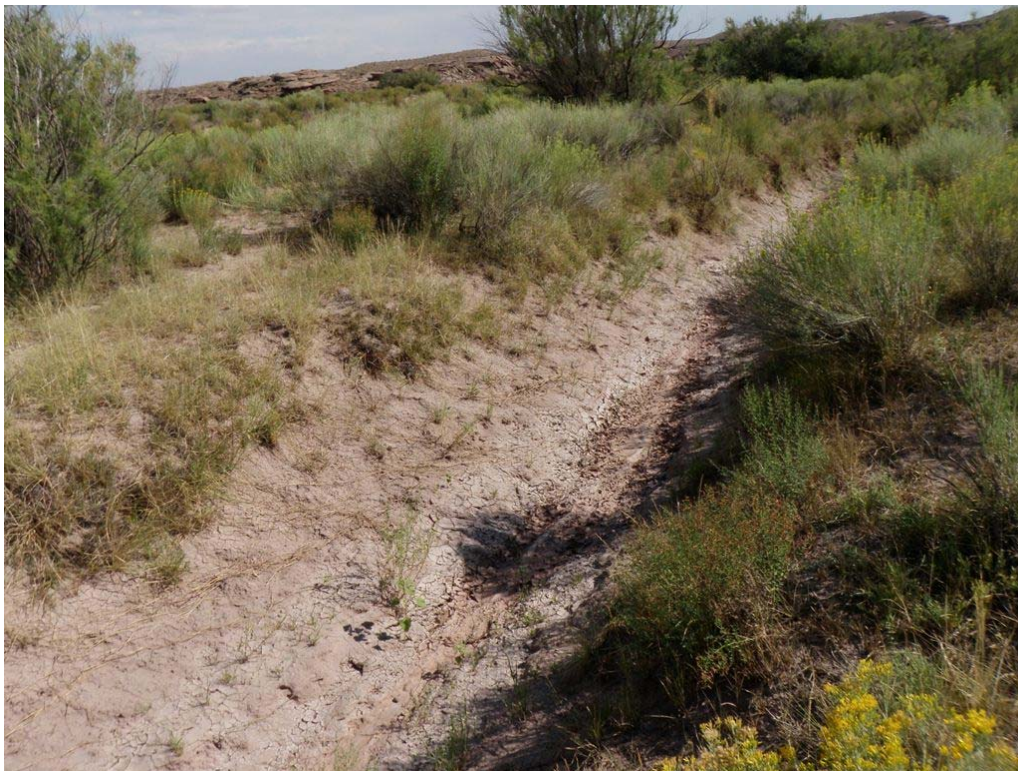
**Photo 31 – Bottom Ash Pond: Flowing surface water at Tanner Wash Seep.**
