**FINAL**  
**Coal Ash Impoundment Specific**  
**Site Assessment Report**  
**Arizona Public Service**  
Cholla Power Plant

Submitted by:  
**GEI Consultants, Inc.**  
6950 South Potomac Street, Suite 300  
Centennial, CO 80112

December 2009  
Project 091330

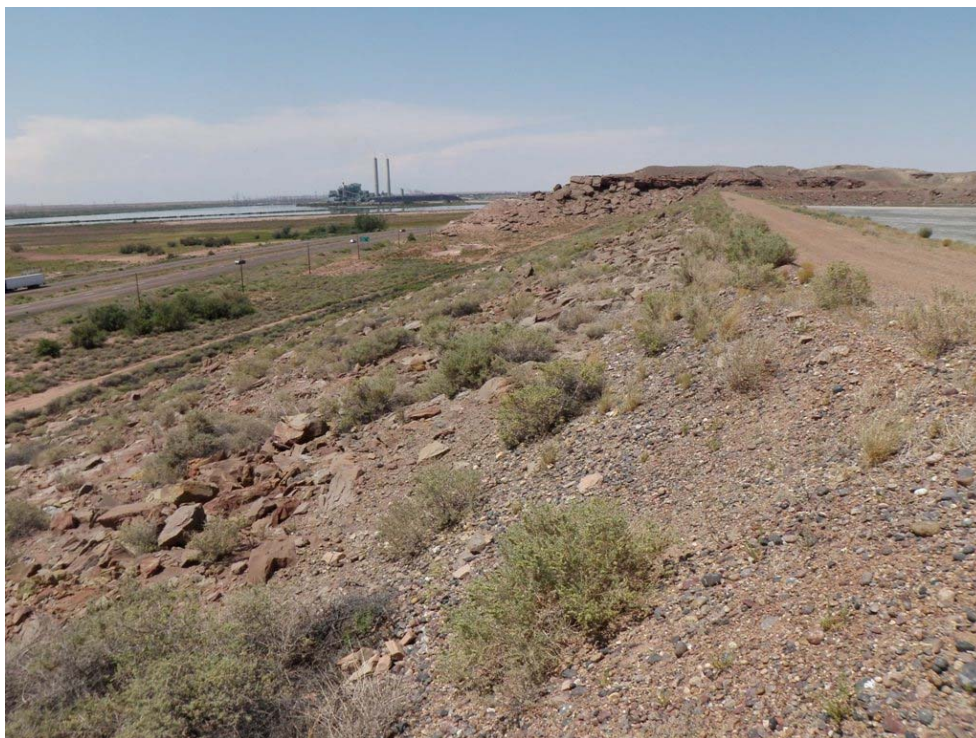
The downstream slope of the embankment is protected from erosion by riprap and appeared to be in good condition (Photo 7). Some vegetation was present on the downstream slope. The slurry discharge pipes traversing the downstream face are shown in Photo 8.

Photo 7: Fly Ash Pond Dam - Downstream slope, looking west. Note vegetation.

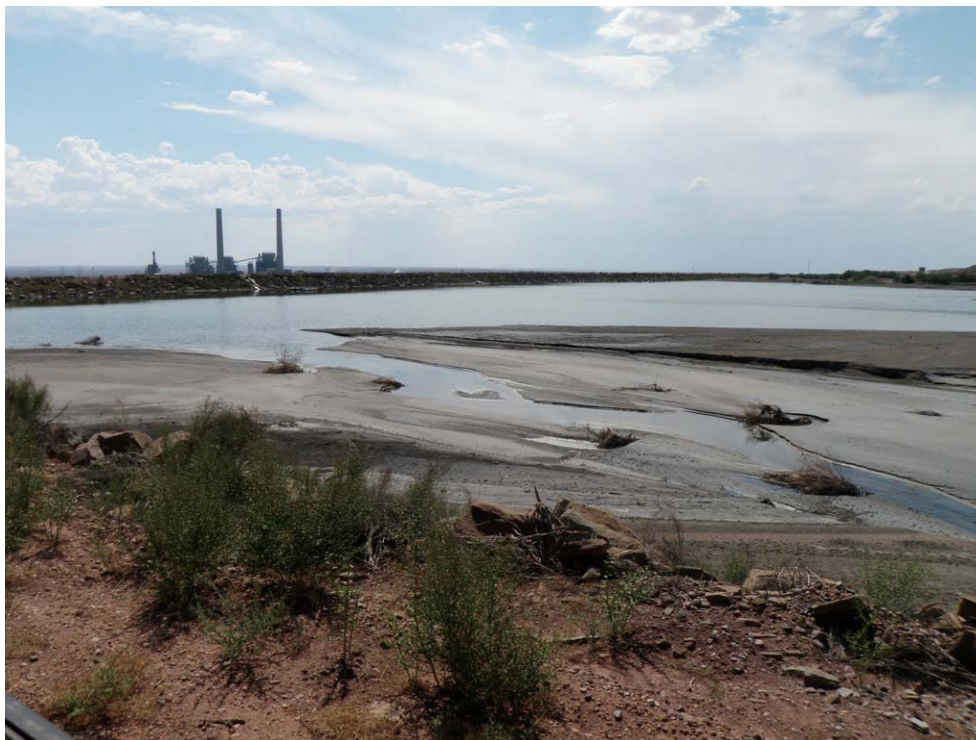
**Photo 9: Bottom Ash Pond - Main reservoir, looking southwest from left abutment.**

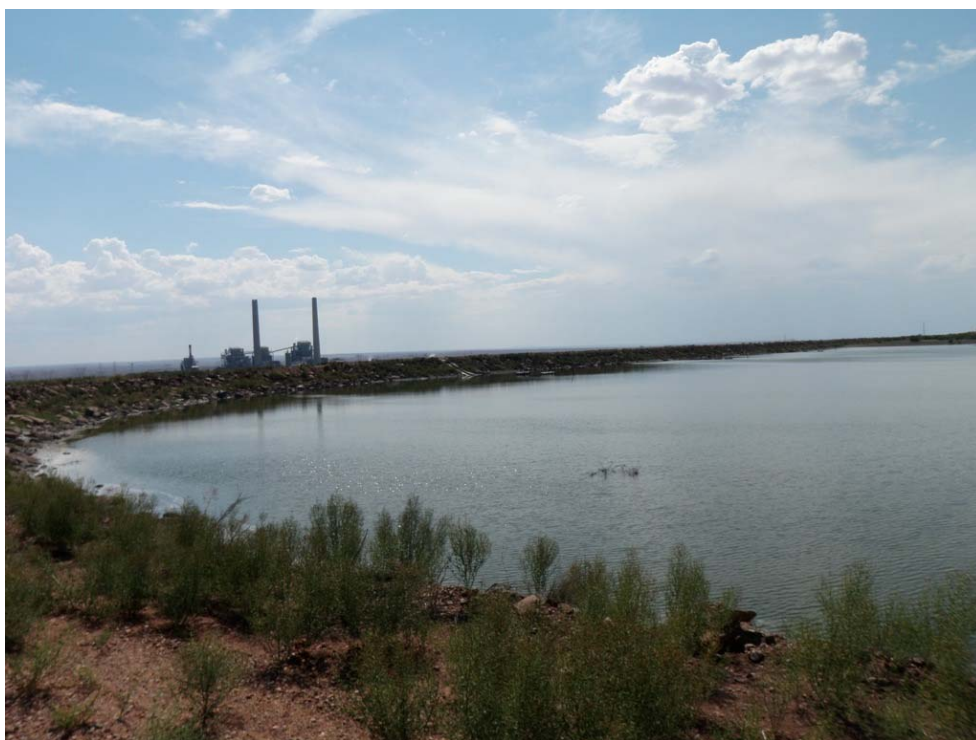
**Photo 10: Bottom Ash Pond - Main Reservoir, looking west along upstream face of dam.**

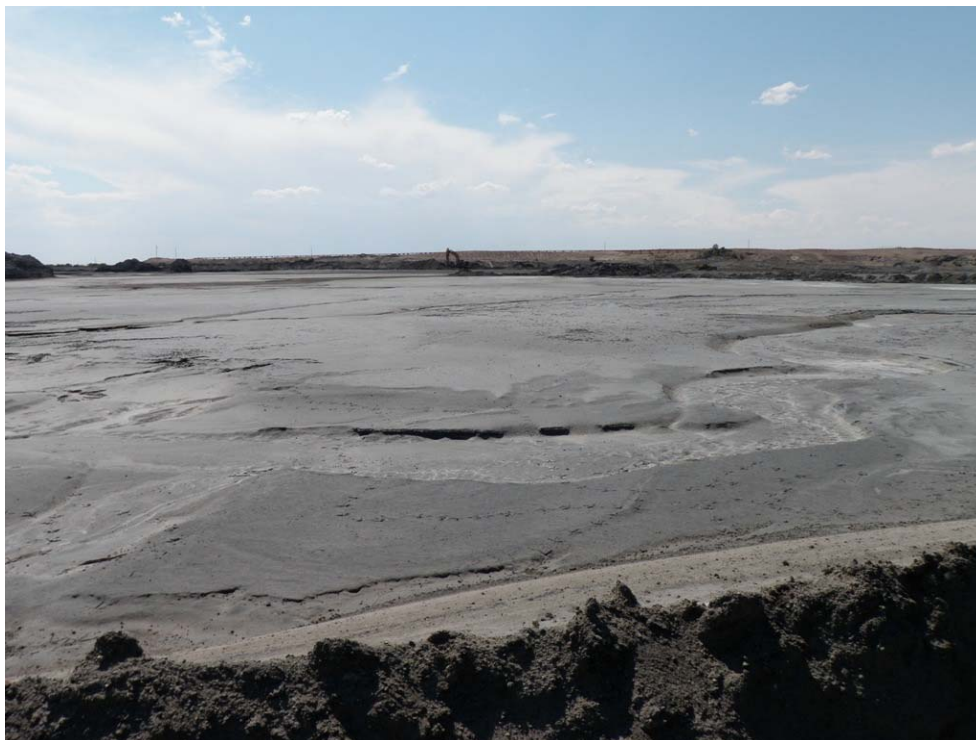
**Photo 11: Bottom Ash Pond - East cell with drained bottom ash. Note construction operations moving bottom ash to monofill.**

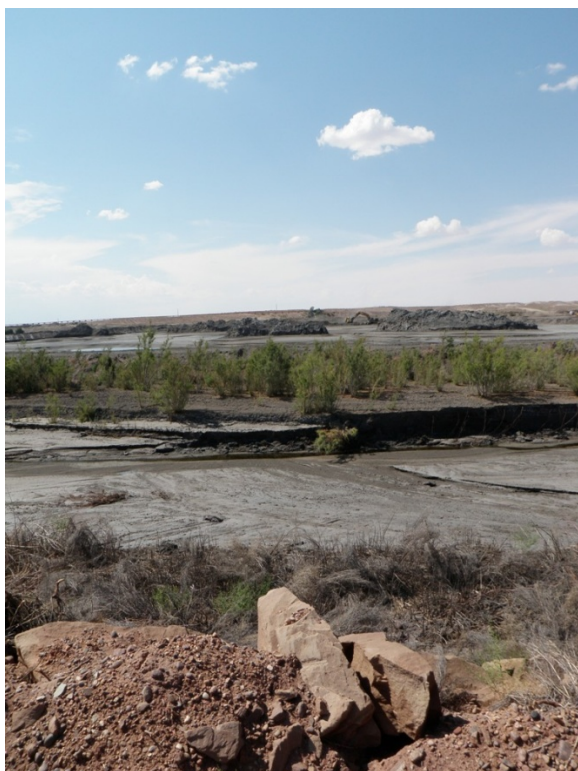
Field assessment of the Bottom Ash Pond included driving around the pond and along the entire length of the embankment crest and toe, walking representative sections and closely investigating areas of interest. We saw no obvious signs of settlement or displacement. Several seepage locations were observed at and beyond the downstream toe of the dam. These are closely monitored by APS and are discussed further in Section 6.4.4. The Bottom Ash Pond has one main reservoir (Photos 9 and 10) as well as two upstream cells used to store bottom ash slurry as well as drained bottom ash prior to its final storage in the monofill north of the pond. The east cell, which currently stores drained bottom ash, is shown in Photo 11. The west cell currently receives bottom ash slurry (Photo 12). A vortex is visible in Photo 12 where water is exiting through a pipe to be discharged in the main reservoir. The monofill is shown in Photo 13. Excess water from the two upstream cells drains to the main reservoir near the left abutment of the Bottom Ash Pond Dam (Photo 14).

**Photo 14: Bottom Ash Pond - Drainage way for overflow water from upstream cells to main reservoir.**

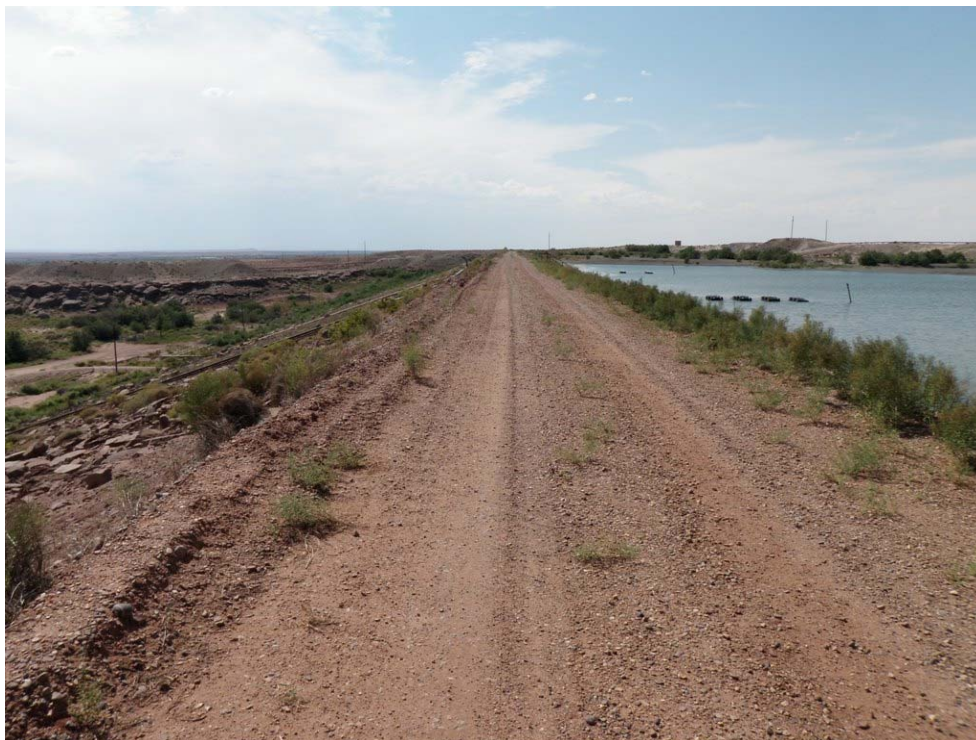
The embankment crest appeared to be in good condition (Photo 15). No signs of cracking or settlement were observed during the assessment. Occasional vegetation (brush) was present on the dam crest. This vegetation should be cleared in routine maintenance. The 3.3-foot dam crest raise that took place in 1993 is evident in Photo 16.

**Photo 15: Bottom Ash Pond Dam - Crest of embankment with dirt road, looking west.**

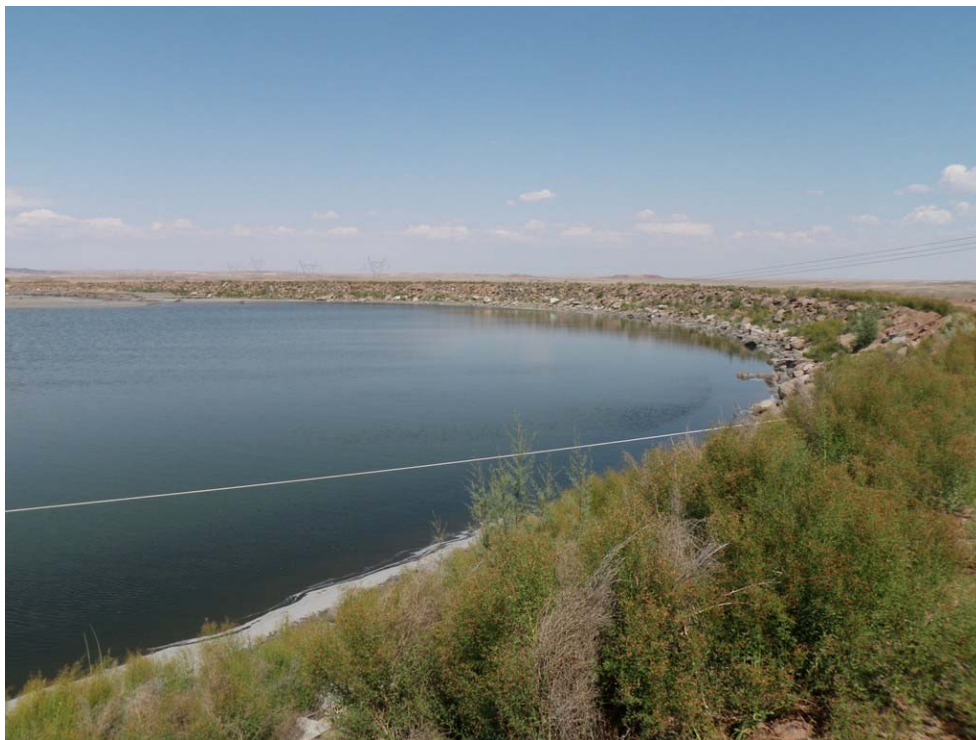
The upstream slope of the embankment is protected from erosion by riprap and appeared to be in good condition (Photo 17). Some vegetation is present on the upstream slope.

**Photo 17: Bottom Ash Pond Dam - Upstream slope, looking east.**

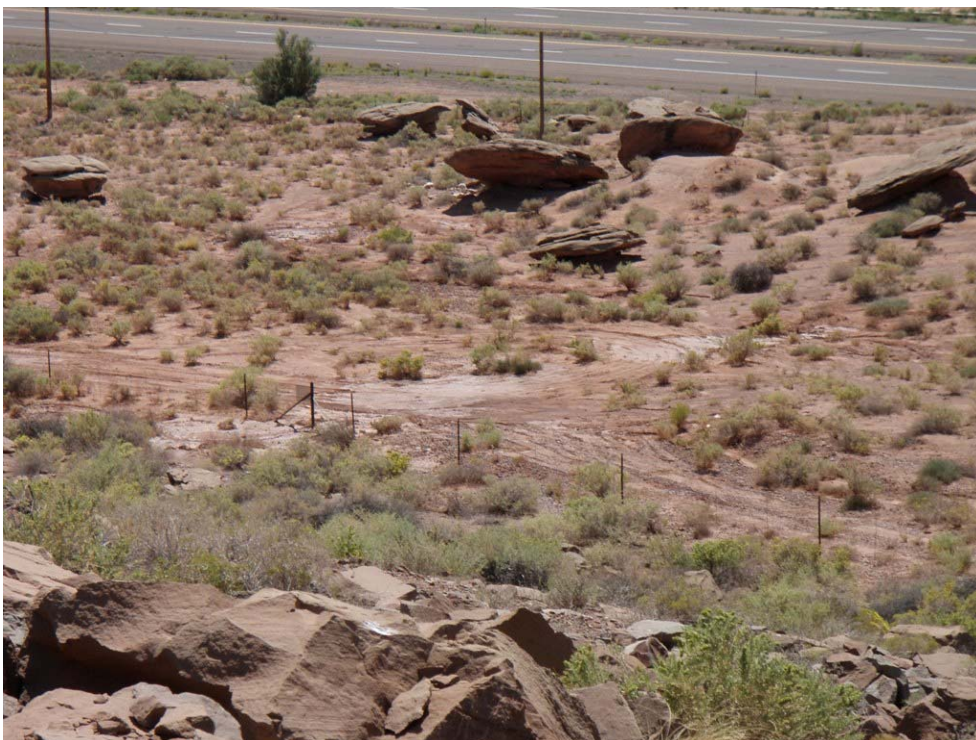
**Photo 19: Fly Ash Pond - Salt patch associated with seepage near right abutment toe (known as the "Hoodoo Salt Patch").**

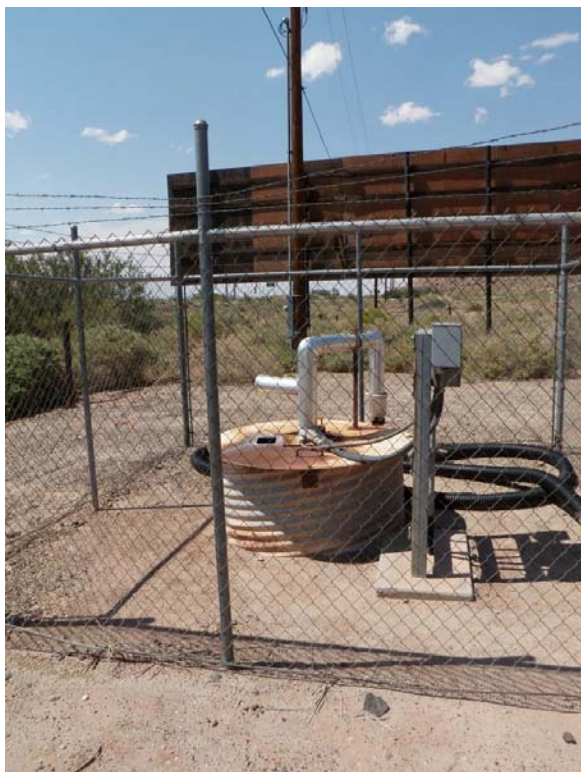
**Geronimo Seep:** The Geronimo Seep is located less than 50 feet beyond the downstream toe of the Fly Ash Pond Dam, about 2,000 feet from the right abutment. An underground french drain system and wellpoints have been installed to monitor and collect the seepage in this area (Photos 22 and 23). Relatively large flows (up to about 47 gpm) have been measured at this location, but APS indicates that the totalizer at this location has malfunctioned recently and readings may not be accurate. No flowing surface water was observed at this seep location at the time of our assessment.

**Photo 23: Fly Ash Pond - Seepage collection system for Geronimo Seep.**

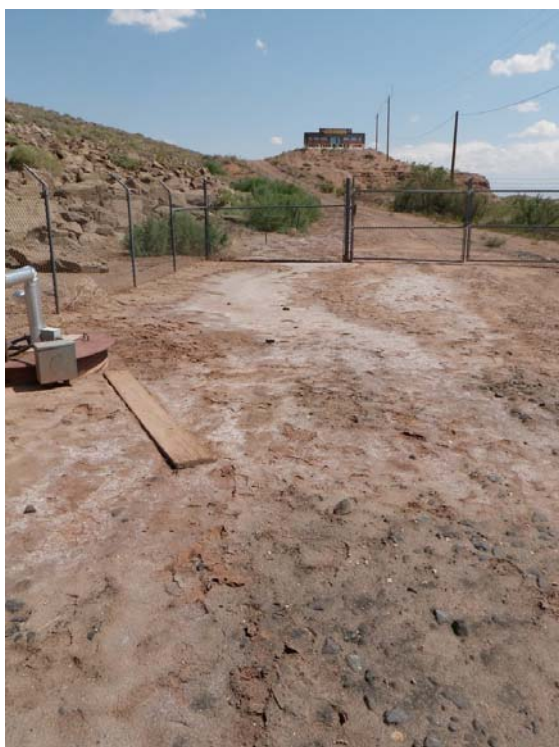
**Hunt Seep:** The Hunt Seep is located more than 1,500 feet beyond the downstream toe of the Fly Ash Pond Dam. The previously-damp soil indicating the seep in this area is shown in Photo 24. An underground french drain system is used to monitor and collect seepage in this area. No flowing water was observed at the time of the dam assessment at this location. The Hunt Seep is far enough from the dam that it is not considered a potential threat to dam safety.

**Photo 24: Fly Ash Pond - Hunt Seep area. Note seepage collection system on left. Also note the highway embankment seen on the top left of this photo.**

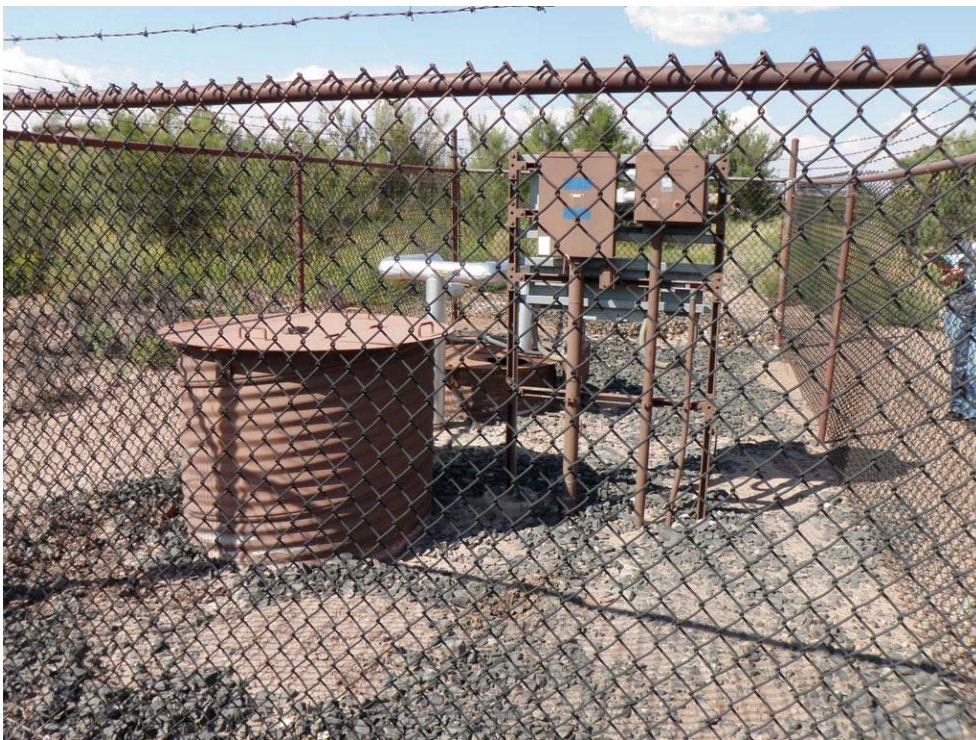
**Tanner Wash Seep:** The Tanner Wash Seep is located about 350 feet beyond the toe of the Bottom Ash Pond Dam near the left abutment. Seepage is collected and measured via an underground french drain system with a totalizer (Photo 29). Both salt patches (Photo 30) and flowing surface water (Photo 31) were observed at this seep at the time of our assessment. A maximum flow of about 15 gpm has been measured at this location since 1995. This seep is far enough from the dam that it is not considered a dam safety concern. This seep prevents a greater environmental concern than other seeps due to its proximity to Tanner Wash (Photo 32).

**Photo 29: Bottom Ash Pond - Seepage collection system for Tanner Wash Seep.**

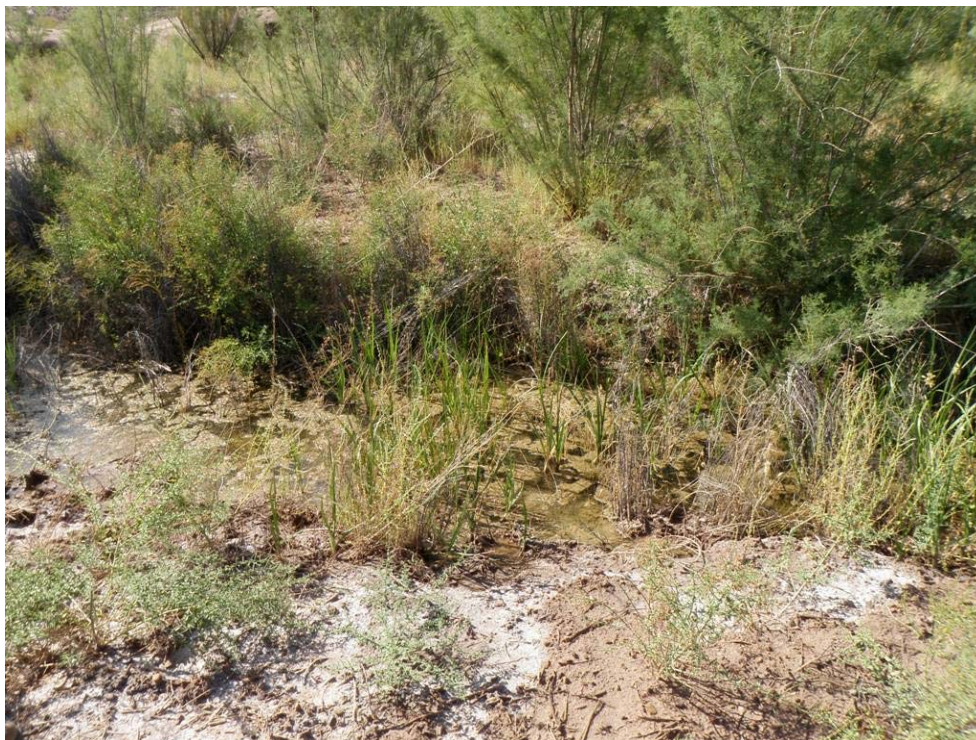
**Photo 31: Bottom Ash Pond - Flowing surface water at Tanner Wash Seep.**

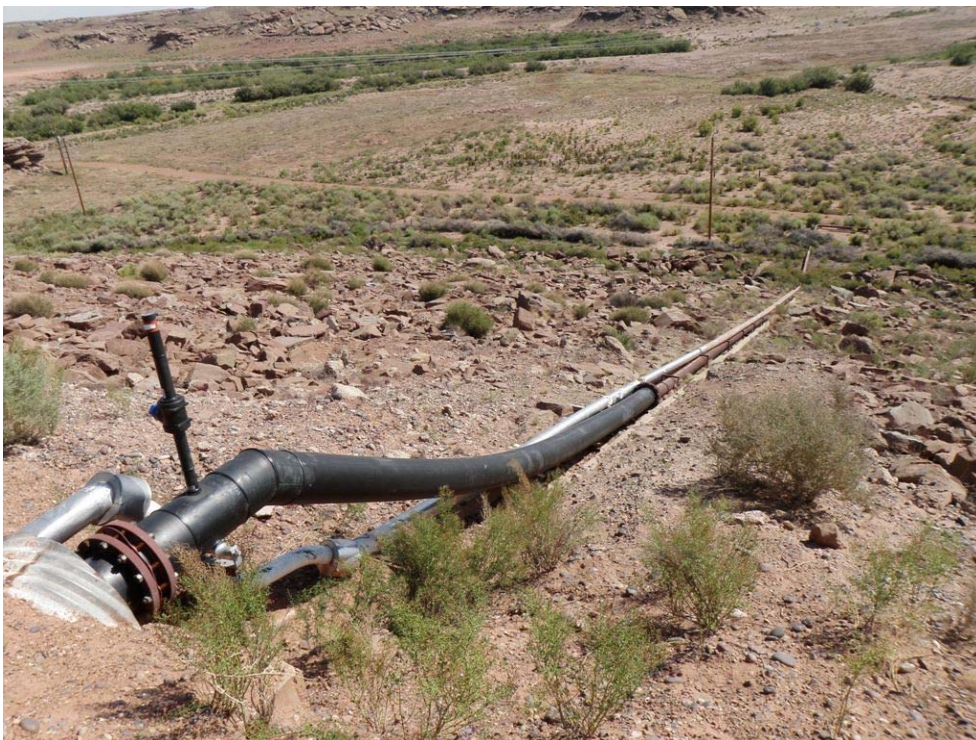
There are no spillways at either dam, and the Fly Ash Pond has no outlet. Four siphon pipes are the only outlet for the Bottom Ash Pond, and they appear to be in good condition. The siphon pipes are shown in Photos 36 (upstream side) and 37 (downstream side). The siphon pipes extend through the dam crest in a 36-inch diameter corrugated metal pipe (CMP) culvert, providing a potential discharge pathway through the dam at about El. 5120.5, according to the drawings (Exhibit 5). The drawings show a the culvert is sealed by a 4-inch thick concrete plug at the upstream end of the CMP and the integrity of this seal must be maintained to prevent the culvert becoming a discharge pathway. The condition of the concrete plug was not verified in the field. The siphon collection point, where water from the siphon pipes is combined and routed to the plant, is shown in Photos 38 and 39.

**Photo 37: Bottom Ash Pond - Siphon pipes extending along downstream slope of dam.**

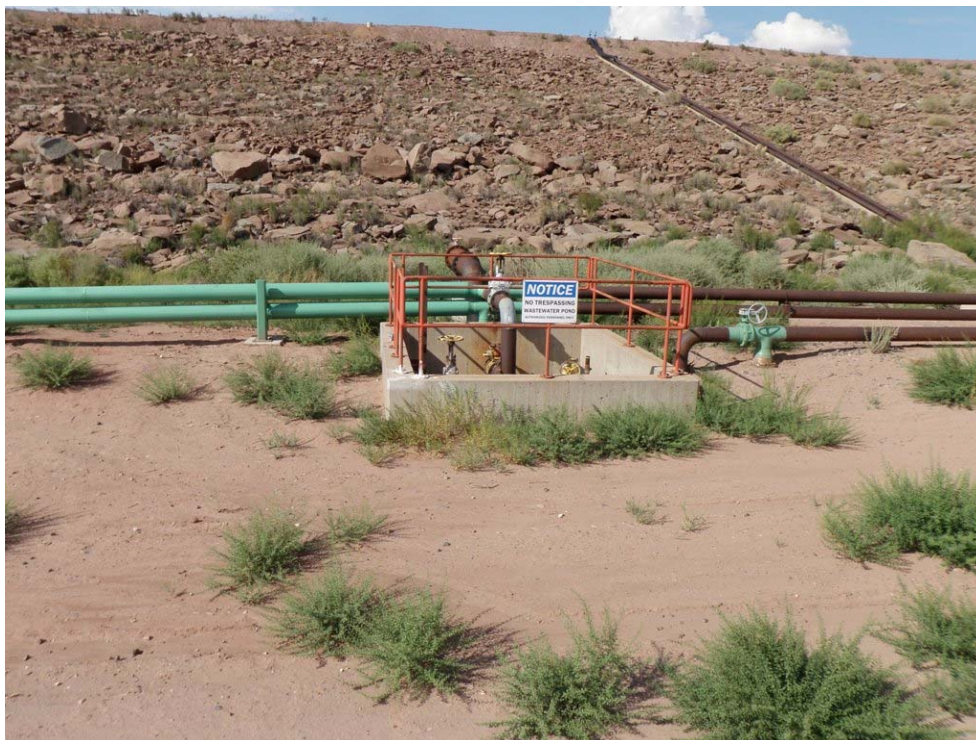
**Photo 39: Bottom Ash Pond - Siphon pipes extending along downstream slope, and siphon collection station.**
