**DRAFT FINAL**  
**Specific Site Assessment for**  
**Coal Combustion Waste**  
**Impoundments at Arizona**  
**Electric Power Cooperative**  
**(AEPCO) Apache Power Plant**  
Cochise, Arizona

Submitted by:  
**GEI Consultants, Inc.**  
6950 South Potomac Street, Suite 300  
Centennial, CO 80112

October 2009  
Project 091330

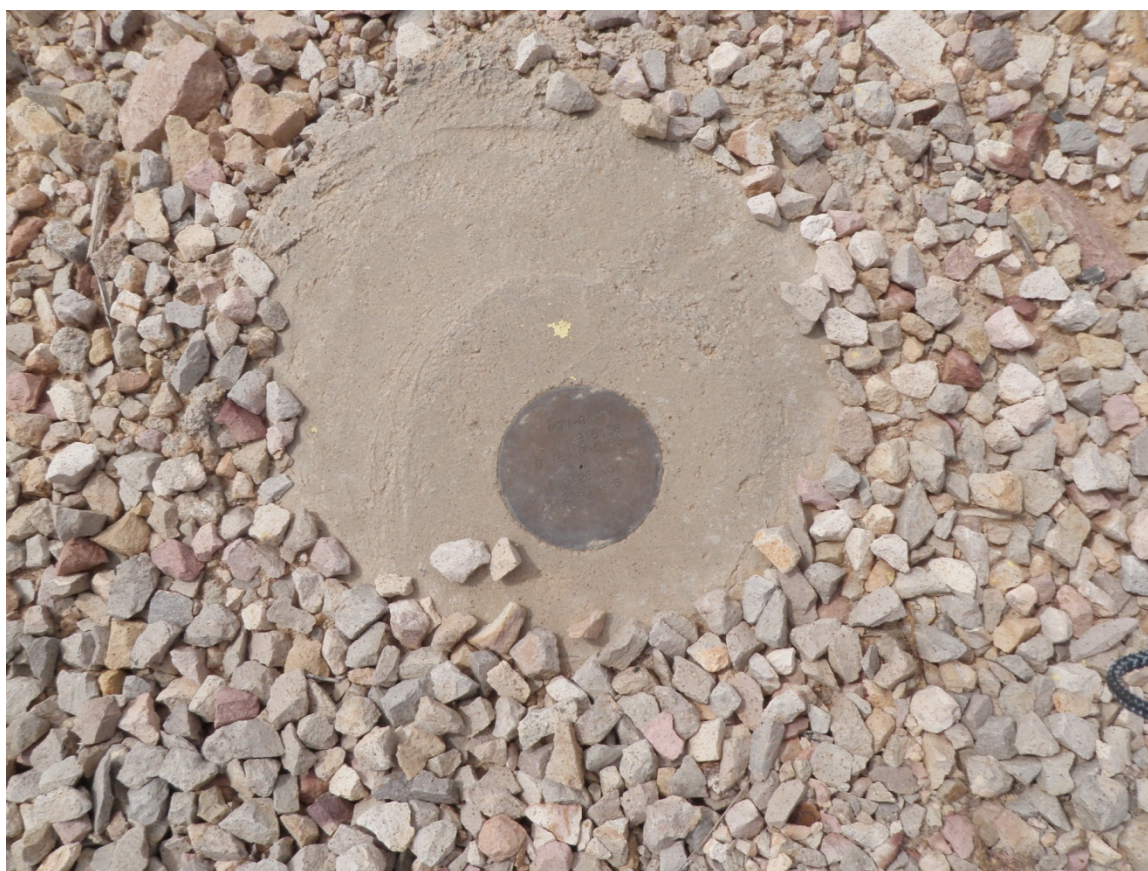
Photo 34: Survey Monument on crest of Ash Pond 2.
