**Dam Safety Assessment of CCW
Impoundments**

**Reid/Green/HMP&L Station II
Report**

**Lockheed Martin
Contractor for the USEPA**

October 2009

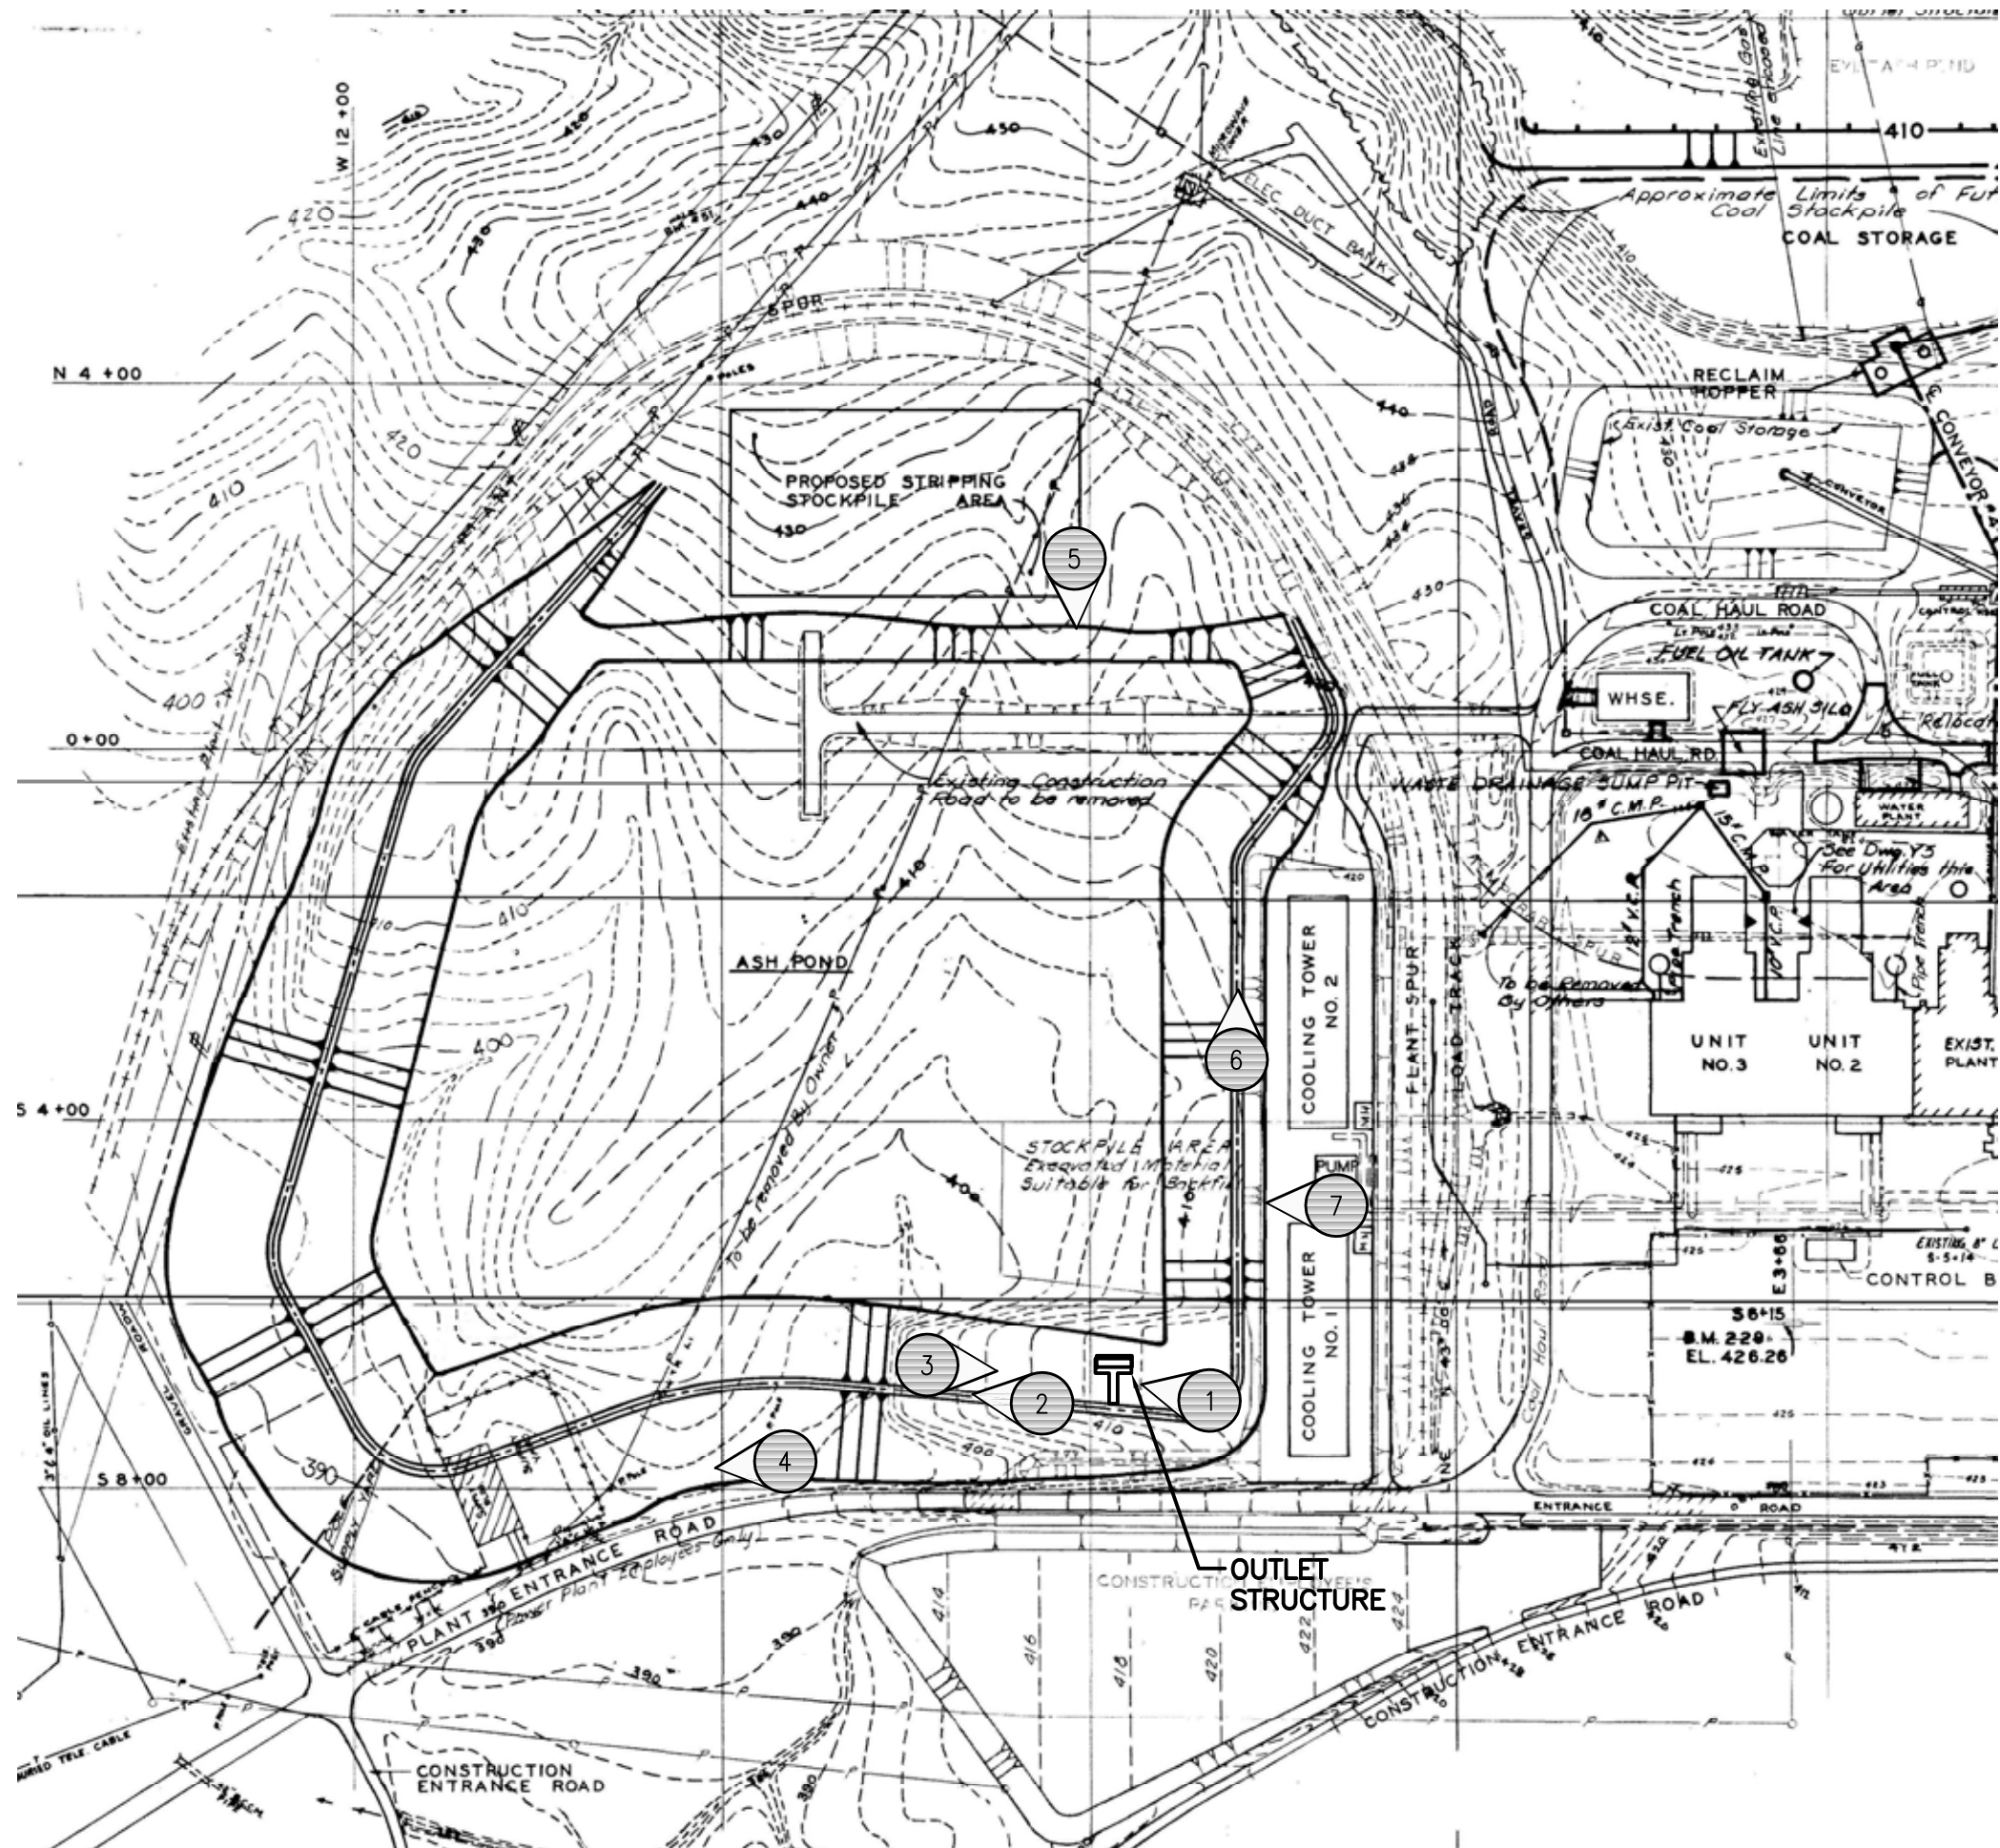
FIGURE 3

Photos of relevant features and conditions observed during the inspection were taken by O'Brien & Gere and are provided in Appendix B and C for the Reid/HMPL Ash Pond and the Green Ash Pond, respectively. Site Plans of the Reid/HMPL Ash Pond and the Green Ash Pond are presented as Figure 3 and 4, respectively, which provide photograph locations and directions.
