**Pennsylvania Department of Environmental Protection's Comments On:  
Draft Report – Little Blue Run Dam Inspection Report  
Bruce Mansfield Power Plant  
Beaver County, Pennsylvania**

The Draft Report has been prepared for the U.S. Environmental Protection Agency, Washington, D.C., by CHA.

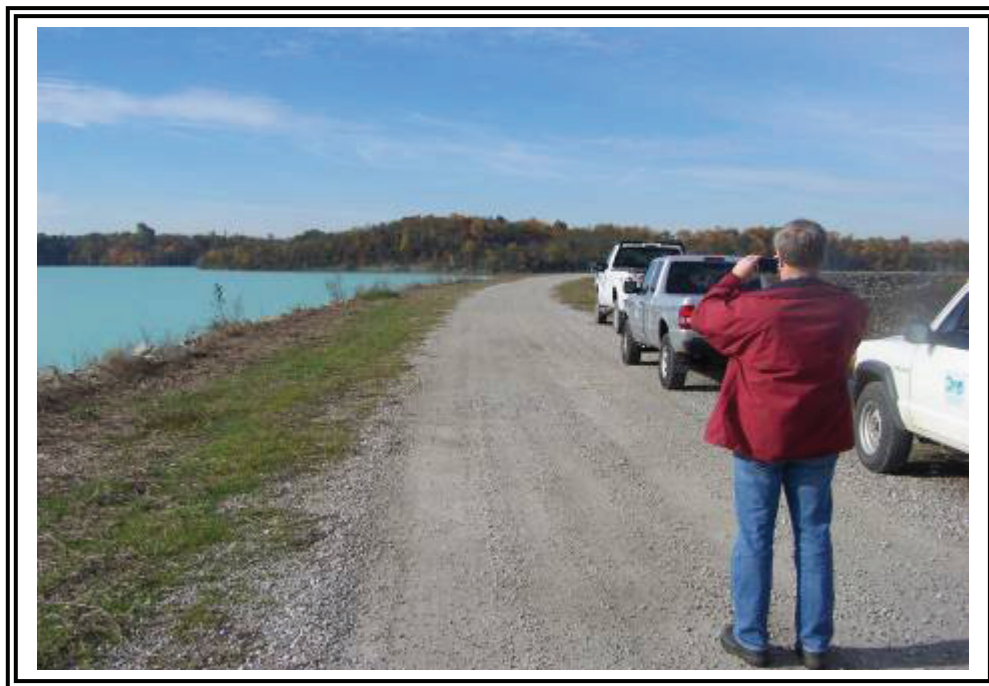
3

Dam crest, looking southwest.

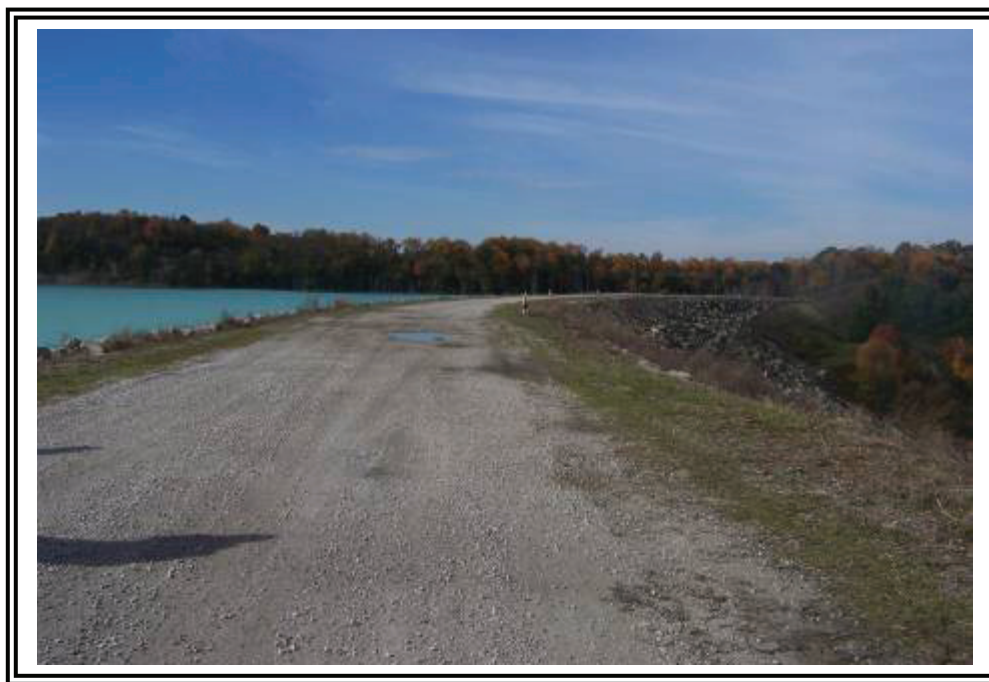
4

Dam crest, looking west.

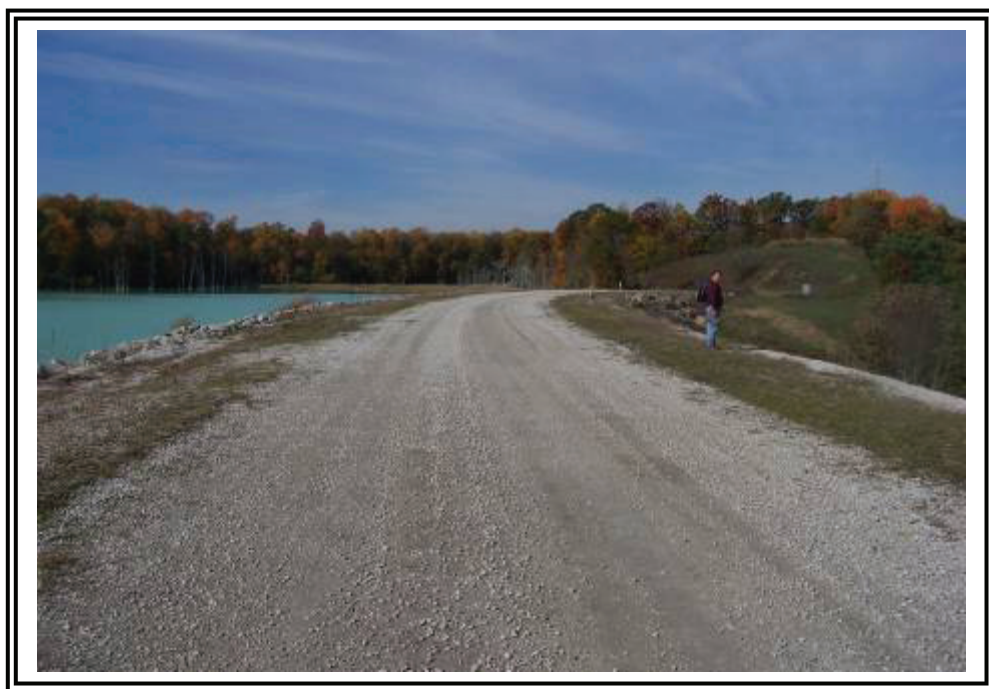
5

Dam crest, looking west.

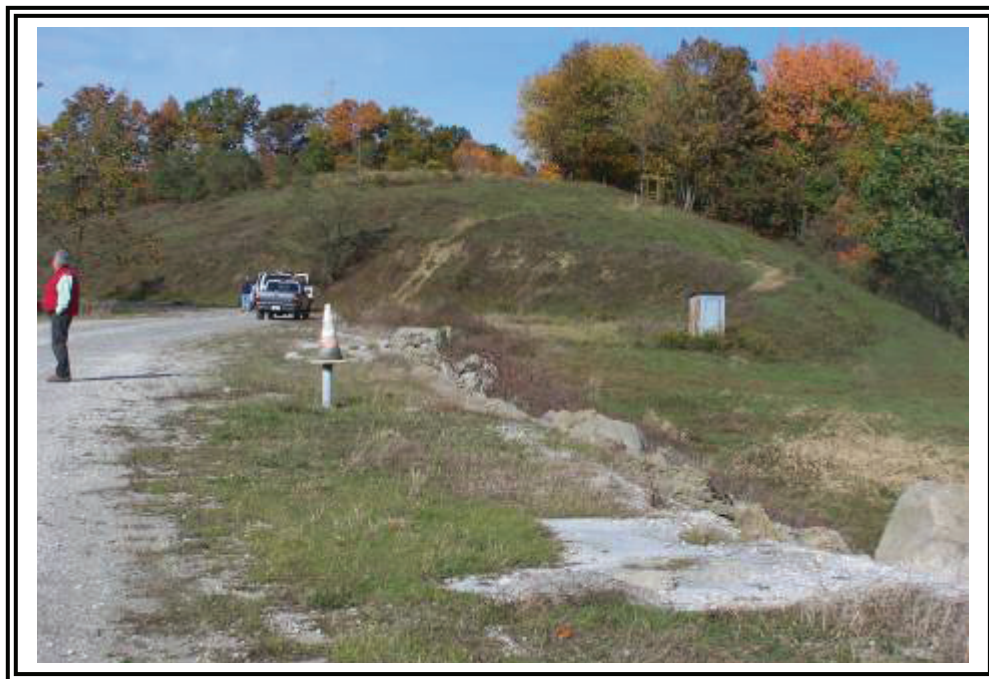
6

West abutment, looking west.

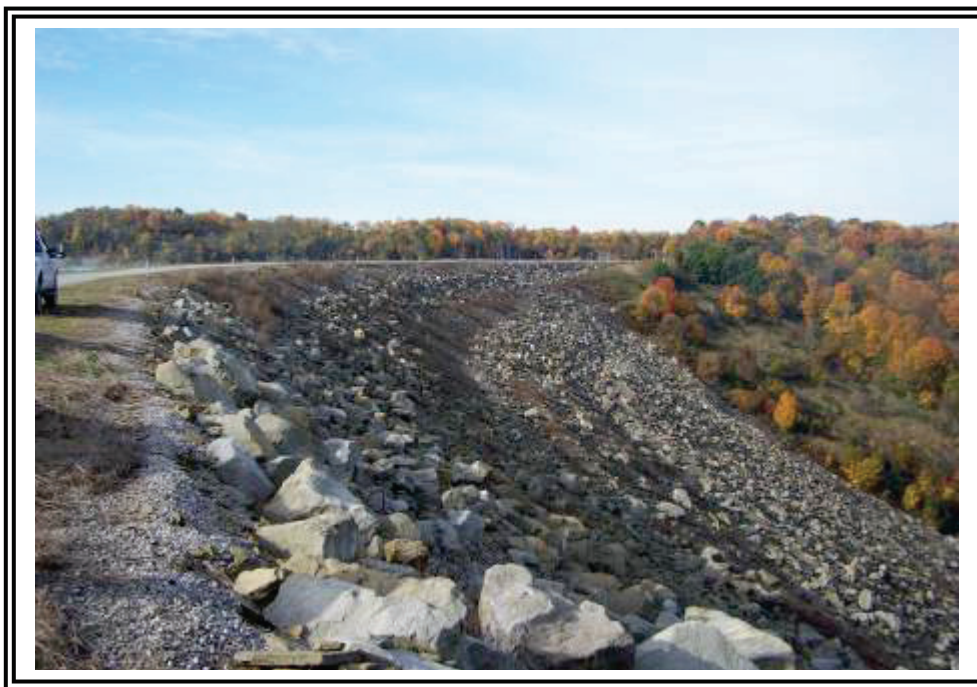
7

Downstream slope, looking west.

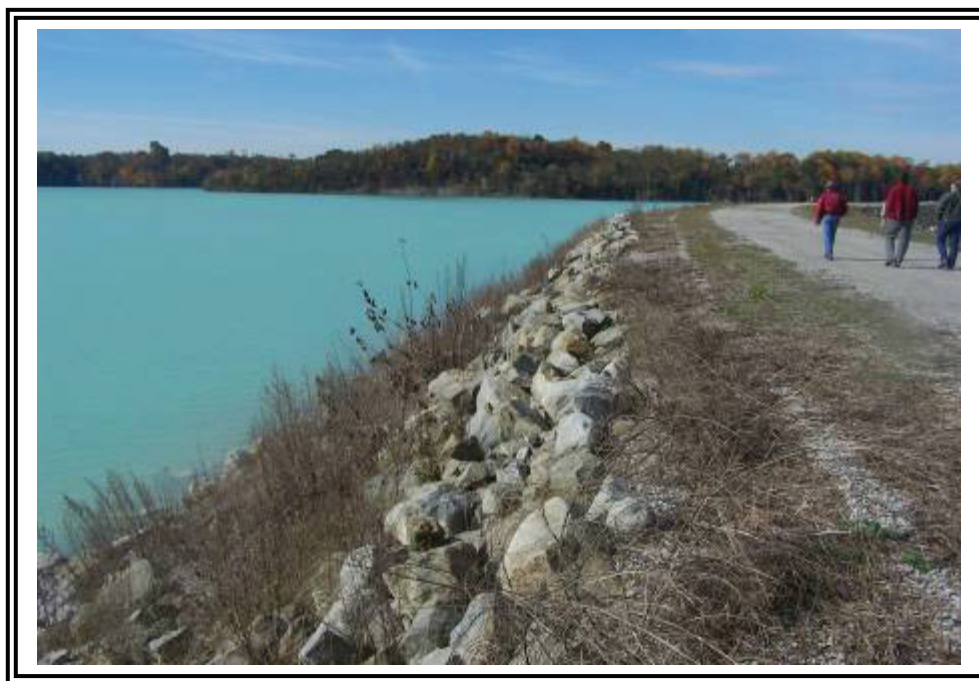
A gravel access road runs the entire length of the crest of the Little Blue Run Dam (Photo Nos. 2 through 5). The downstream embankment slope is covered with large rip rap which is reportedly sprayed for vegetation control every two years (Photo Nos. 7 and 8). Near the toe of the downstream slope there is a stilling basin (Photo No. 9). Slope protection above the reservoir pool elevation on the upstream embankment slope was observed to be rip rap (Photo Nos. 14 and 15).

Upstream slope, looking southwest.

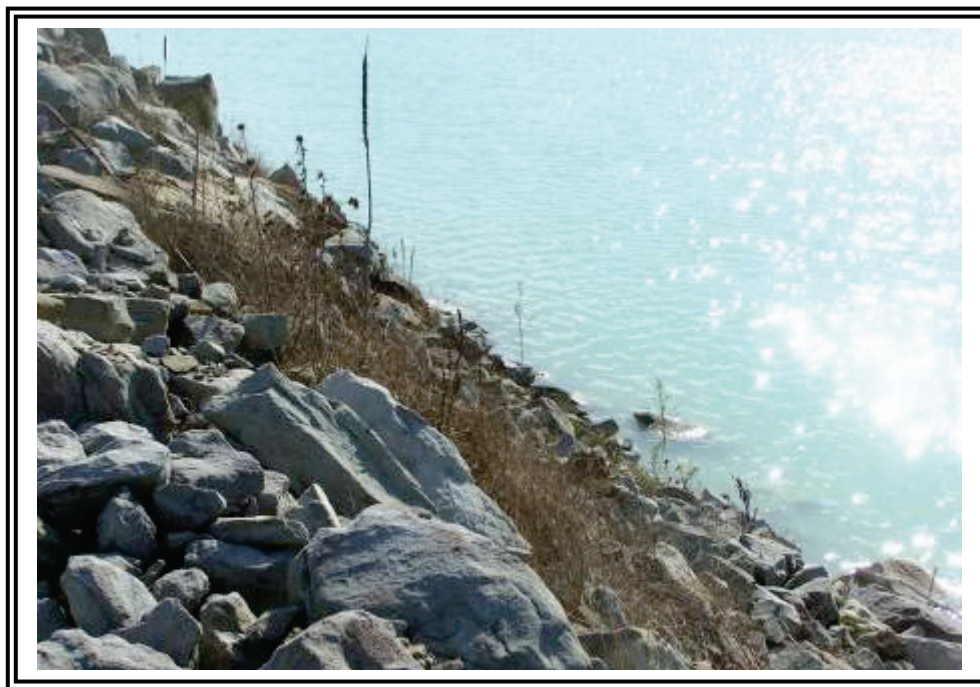
15

Upstream slope, looking southeast.

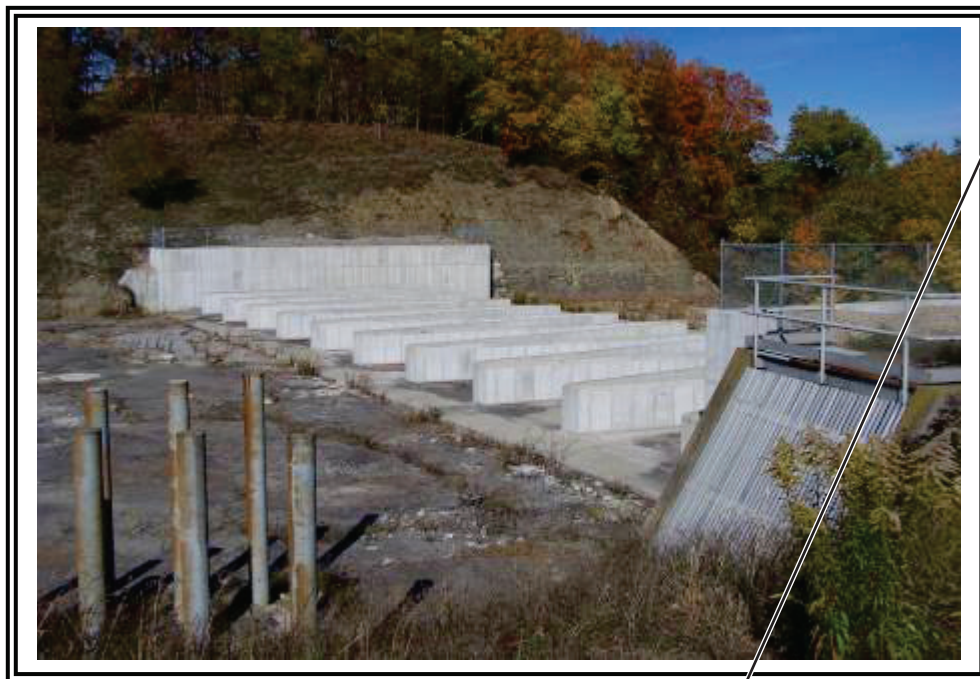
16

The three outlet structures at the Little Blue Run Dam were observed during the site visit. The service spillway is located on the left side of the dam and has an invert at elevation 1,090.3 feet (Photo No. 16). The spillway discharges to a 48-inch concrete pipe 1,000 feet long that discharges to the stilling basin (Photo 17).

Service spillway and emergency spillway.

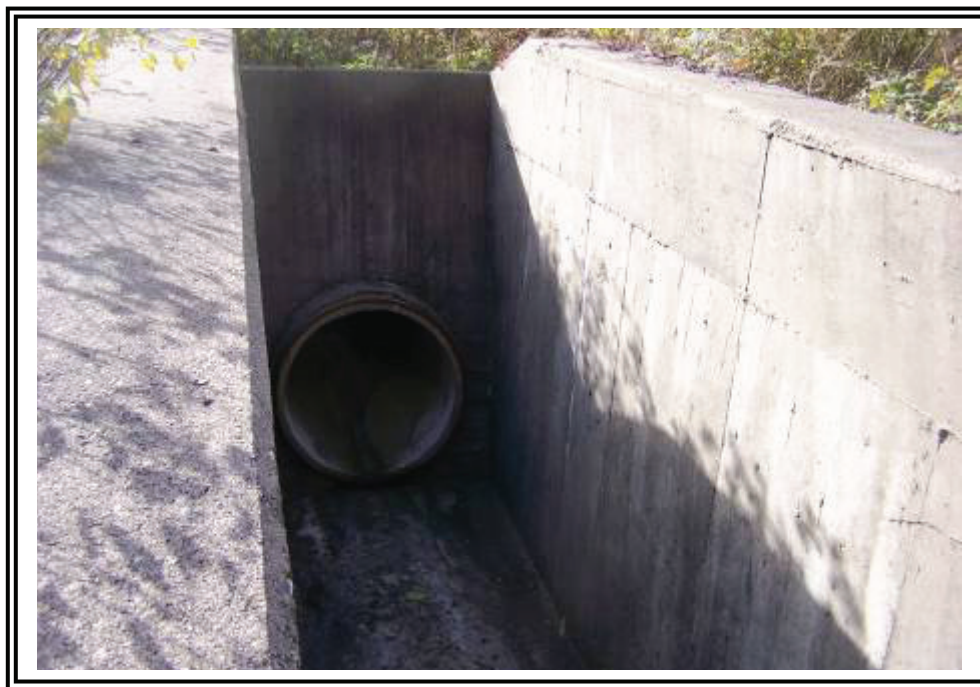
17

Terminus of service spillway at stilling basin.

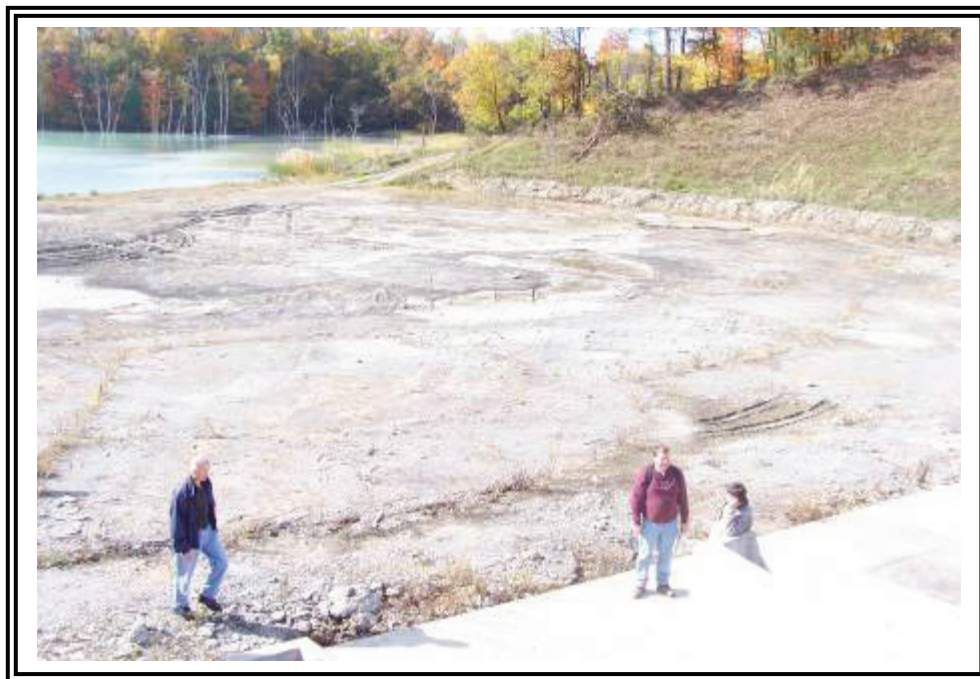
18

Approach to emergency spillway in bedrock.

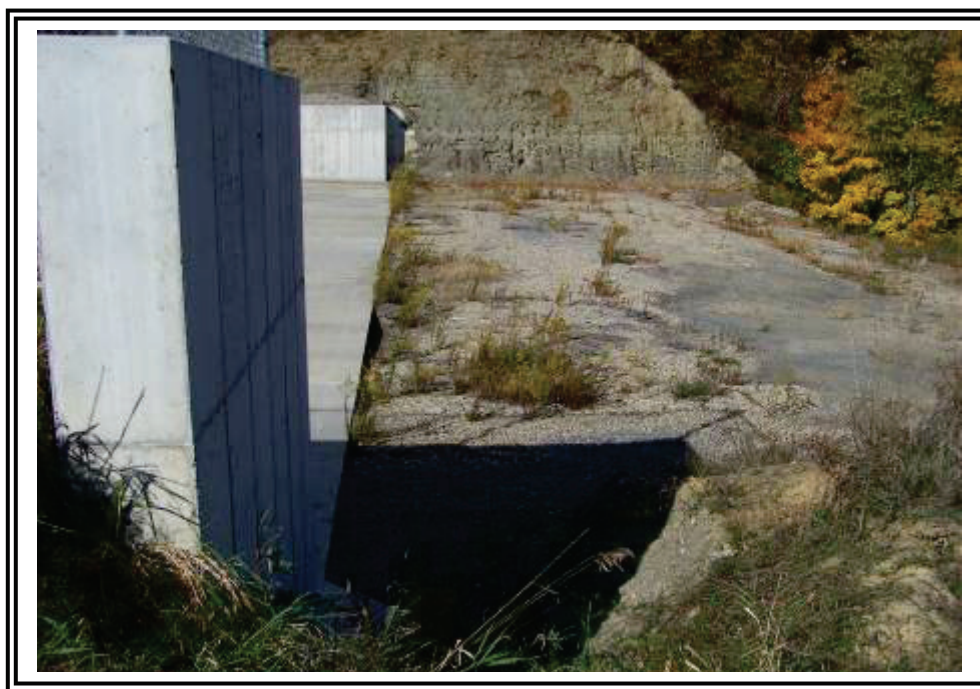
19

Downstream channel of emergency spillway.

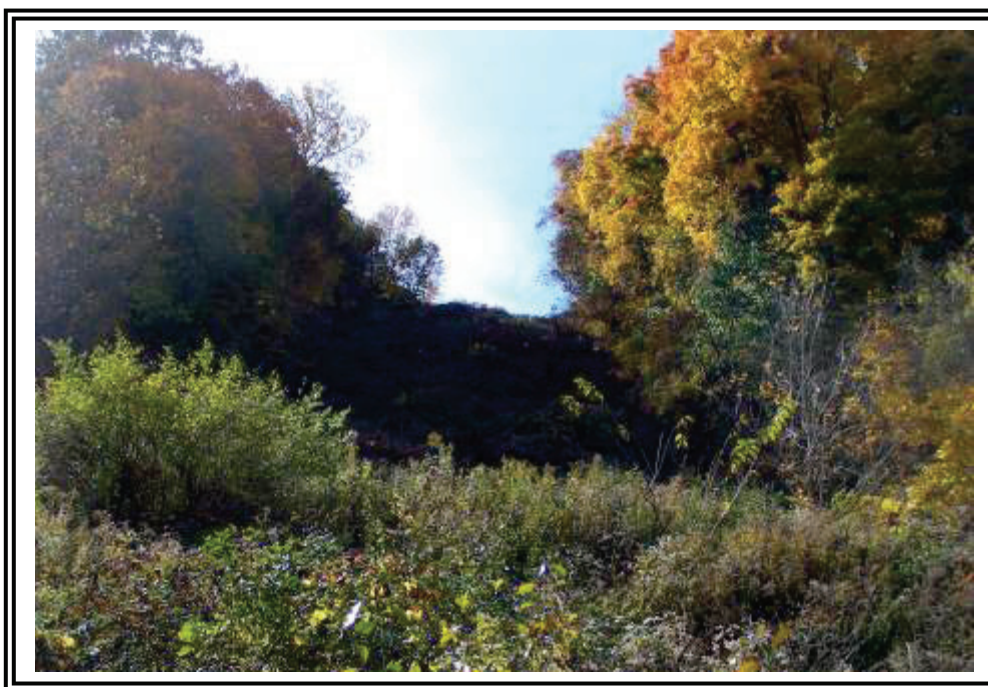
21

Emergency spillway channel over natural slope, looking upstream from the stilling basin.

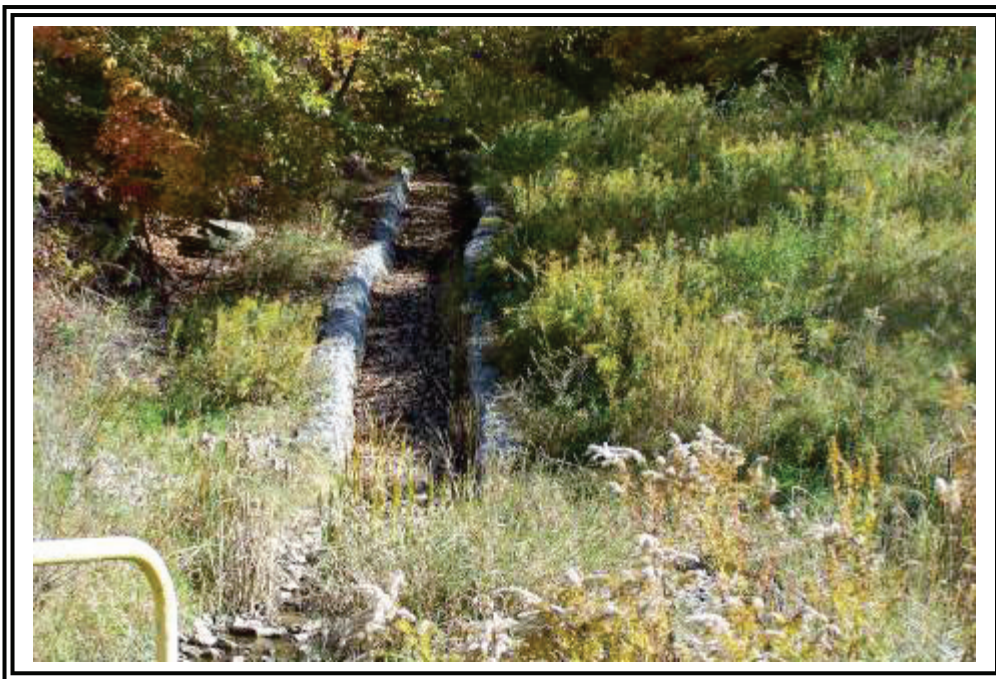
24

Gabion channel from secondary spillway.

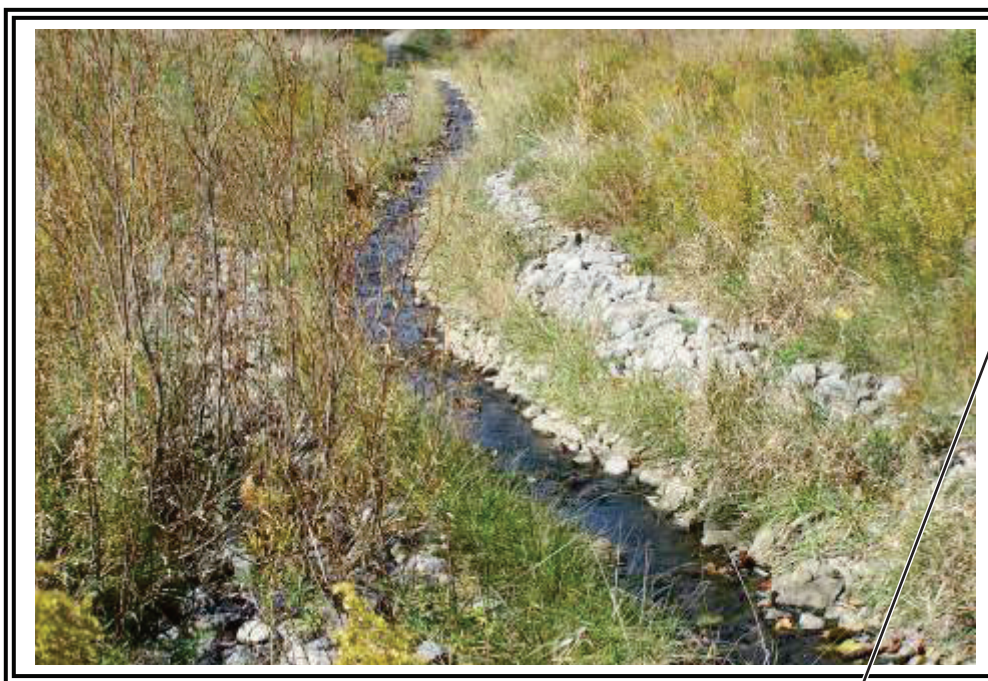
26

Channel downstream of east abutment v-notch to stilling basin.

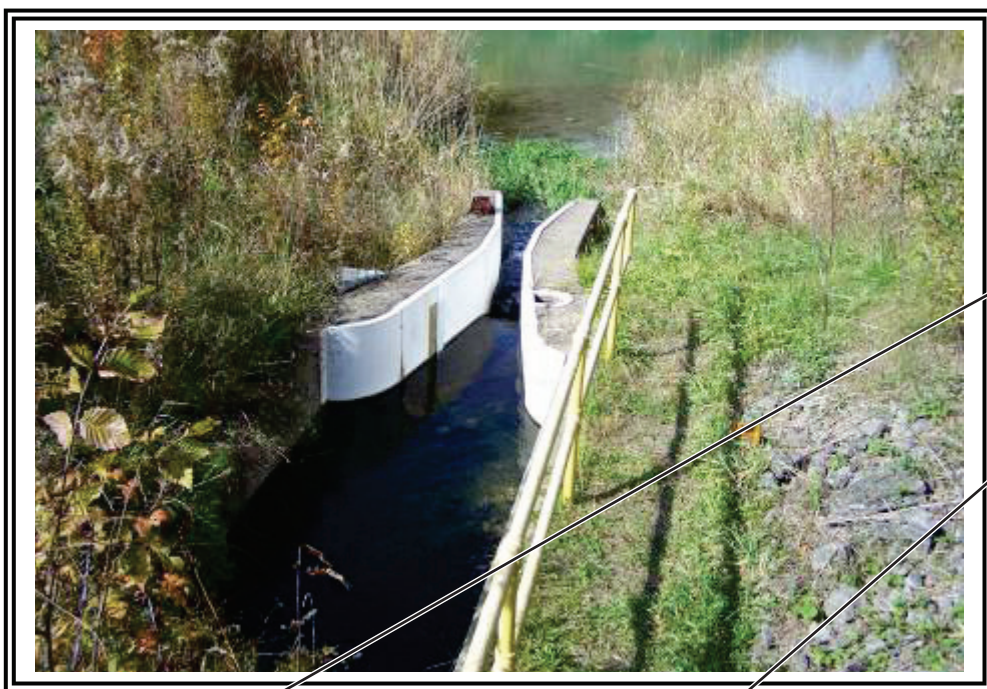
29

weir (ULA) was clogged causing back-flow in to the weir structure (Photo No. 30). The Parshall Flume toe drain (TD) which is a monitoring point for blanket drain seepage was also observed (Photo Nos. 28 and 29).

Parshall flume monitoring point for blanket drain seepage.

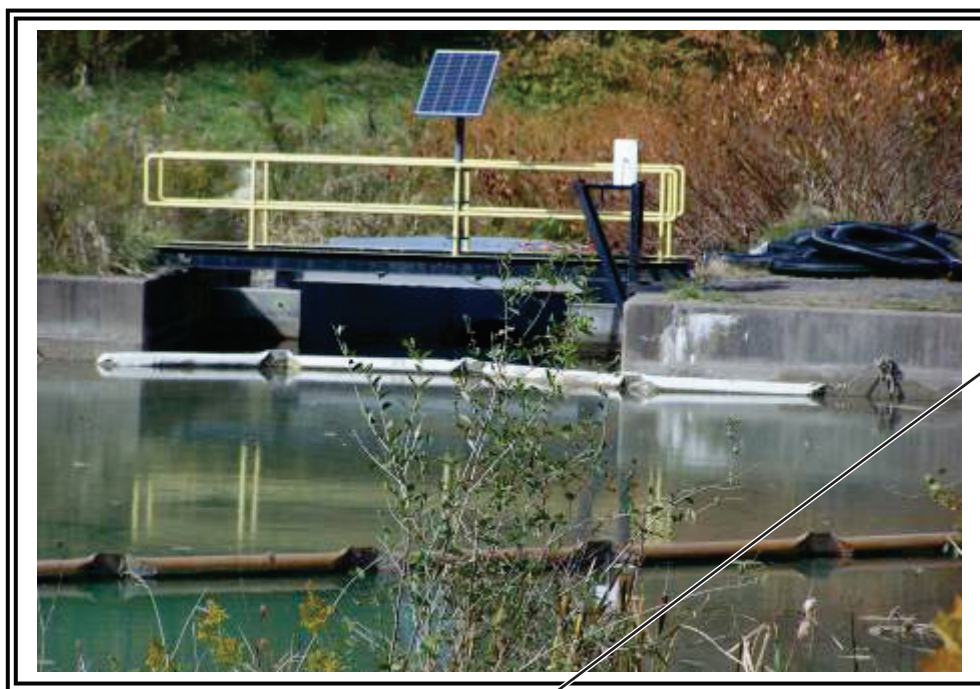
31

Stilling basin ~~sediment control.~~
