Dam Safety Assessment of CCW Impoundments

J.R. Whiting Plant

United States Environmental Protection Agency
Washington, DC

June 27, 2011

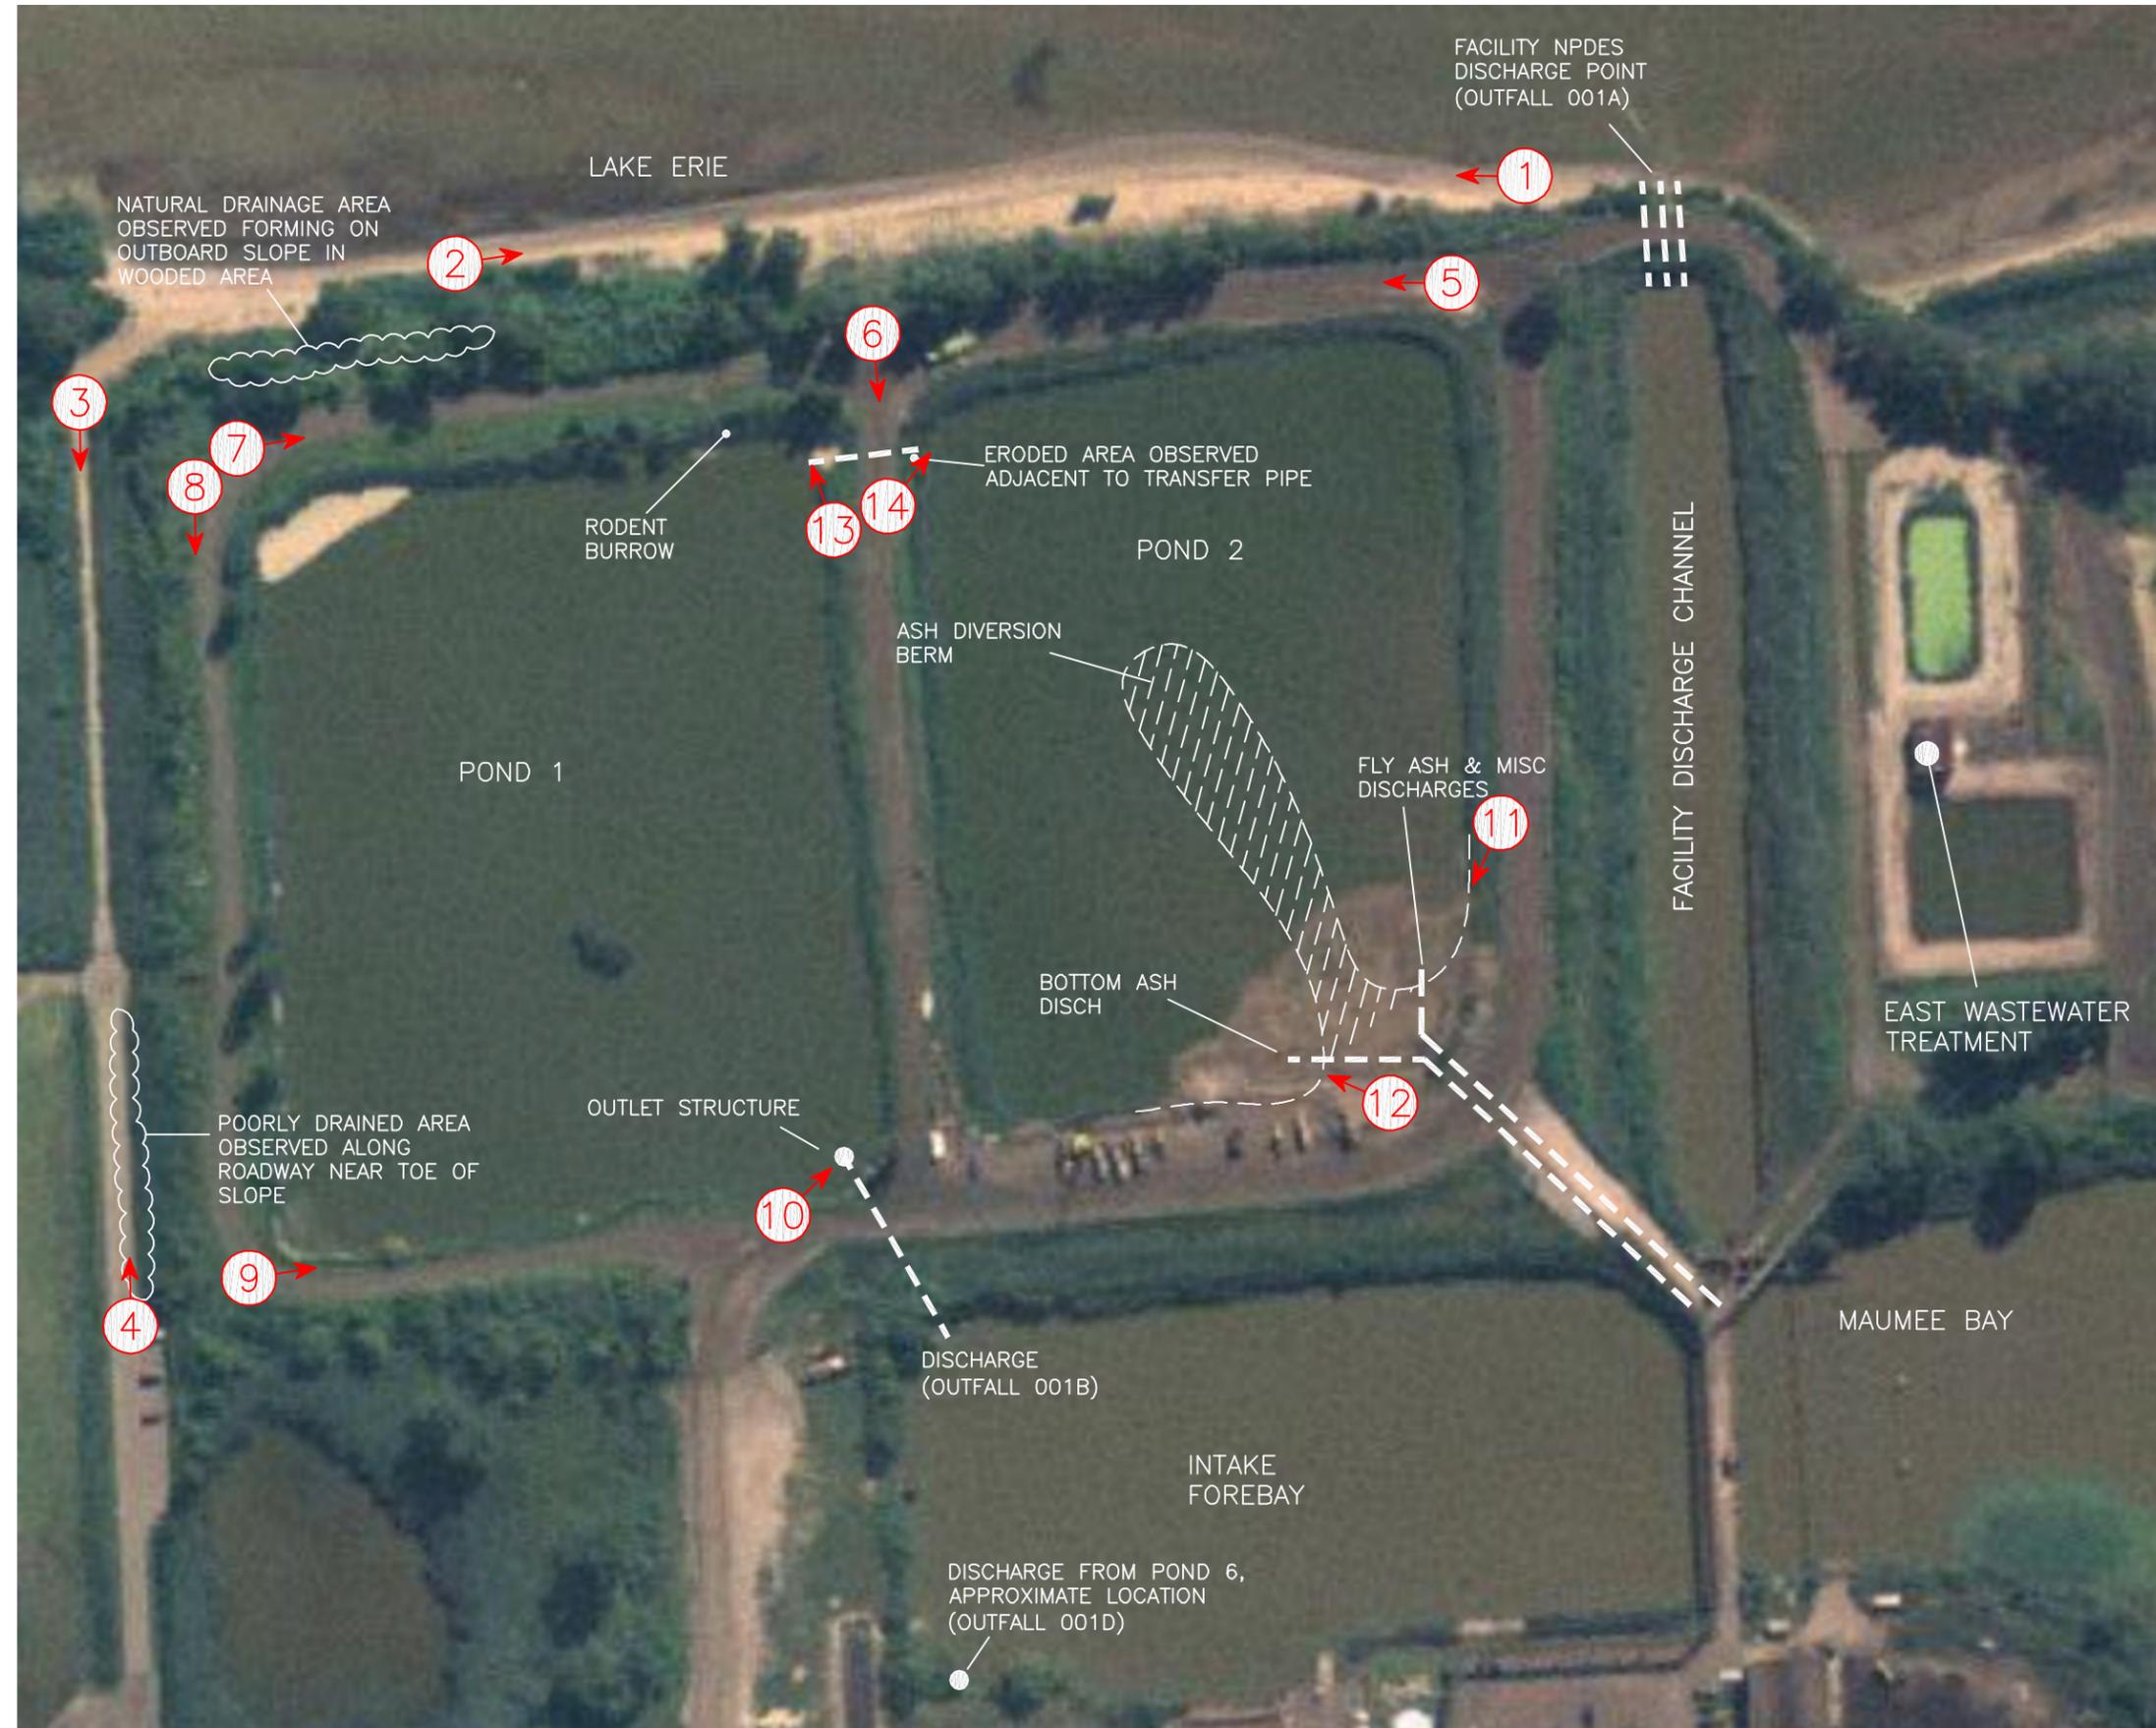
FIGURE 3

- NOTES:**
1. INSPECTION PERFORMED 9/23/10
 2. AERIAL PHOTO DATED 2005 OBTAINED FROM MICHIGAN CENTER FOR GEOGRAPHIC INFORMATION (MCGI) DATA LIBRARY WEBSITE
 3. TREES AND/OR HEAVY VEGETATIVE GROWTH WAS OBSERVED AROUND FULL PERIMETER OF IMPOUNDMENT AT TIME OF INSPECTION HINDERING OR PREVENTING DETAILED OBSERVATIONS

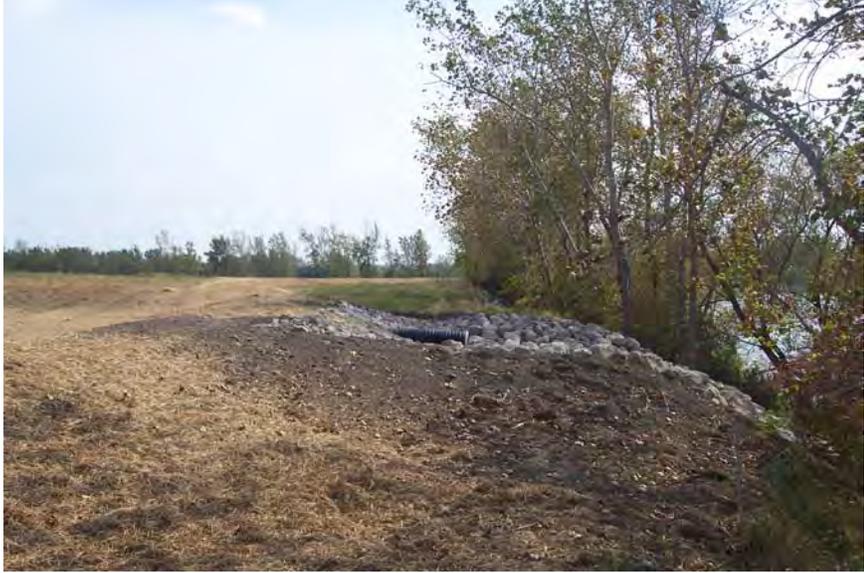
CLIENT NAME: US EPA		SITE LOCATION: CONSUMER'S ENERGY – J.R. WHITING	PROJECT NO. 13498 46122
PHOTO NO. A	DATE: 9/23/10

DESCRIPTION View looking south Newly constructed runoff berm and engineered "let down" area on western edge of landfill/former impoundments Note trees/vegetative growth on slope at right Photo directed along western crest of former impoundments

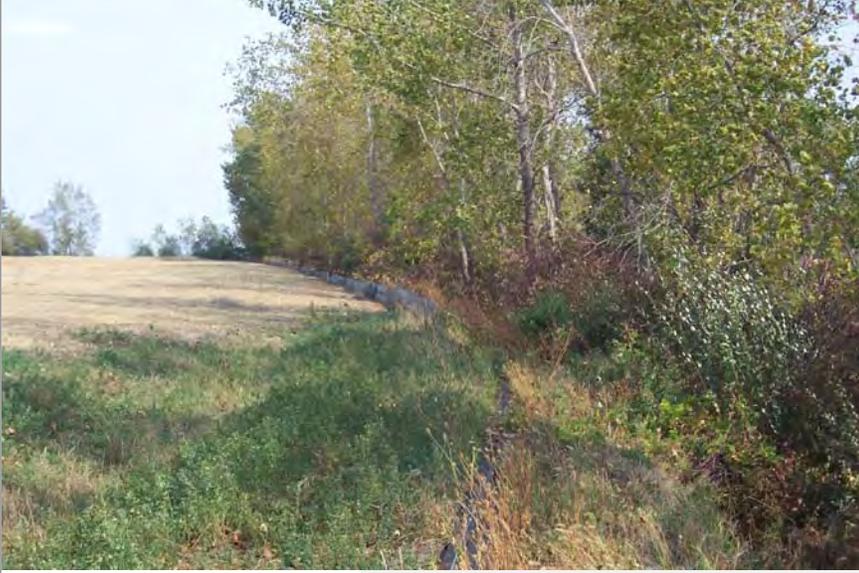
CLIENT NAME: US EPA		SITE LOCATION: CONSUMER'S ENERGY – J.R. WHITING	PROJECT NO. 13498 46122
PHOTO NO. B	DATE: 9/23/10

DESCRIPTION View looking east Freshly seeded/straw covered final grade at southern end of impoundments Note trees/vegetative growth on slope at right Photo directed along southern crest of former impoundments

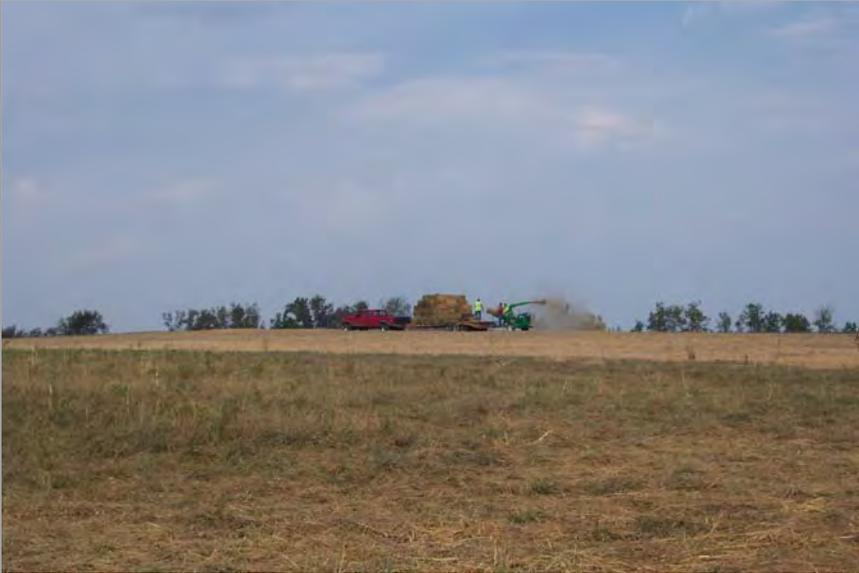
CLIENT NAME: US EPA		SITE LOCATION: CONSUMER'S ENERGY – J.R. WHITING		PROJECT NO. 13498 46122
PHOTO NO. C	DATE: 9/23/10

DESCRIPTION View looking east Application of seed and straw cover at center/top of landfill/former impoundments

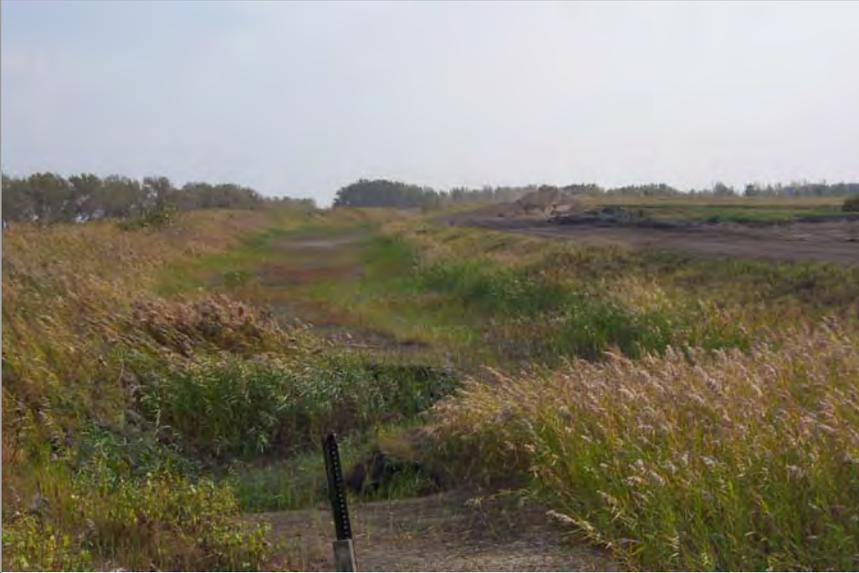
CLIENT NAME: US EPA		SITE LOCATION: CONSUMER'S ENERGY – J.R. WHITING		PROJECT NO. 13498 46122
PHOTO NO. D	DATE: 9/23/10

DESCRIPTION View looking south from north end of landfill/former impoundments Photo is directed along center of former impoundments. Note haul road for placement of final ash in landfill Depressed area in center of photo is last area where ash was wet sluiced to former impoundments

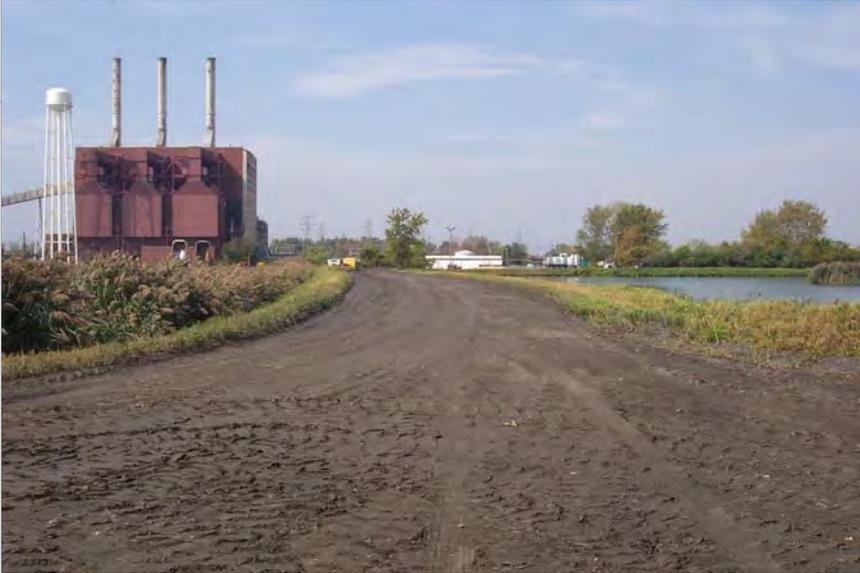
CLIENT NAME: US EPA		SITE LOCATION: CONSUMER'S ENERGY – J.R. WHITING	PROJECT NO. 13498 46122
PHOTO NO. 6	DATE: 9/23/10

DESCRIPTION View looking west View along crest of center road between Ponds 1 & 2

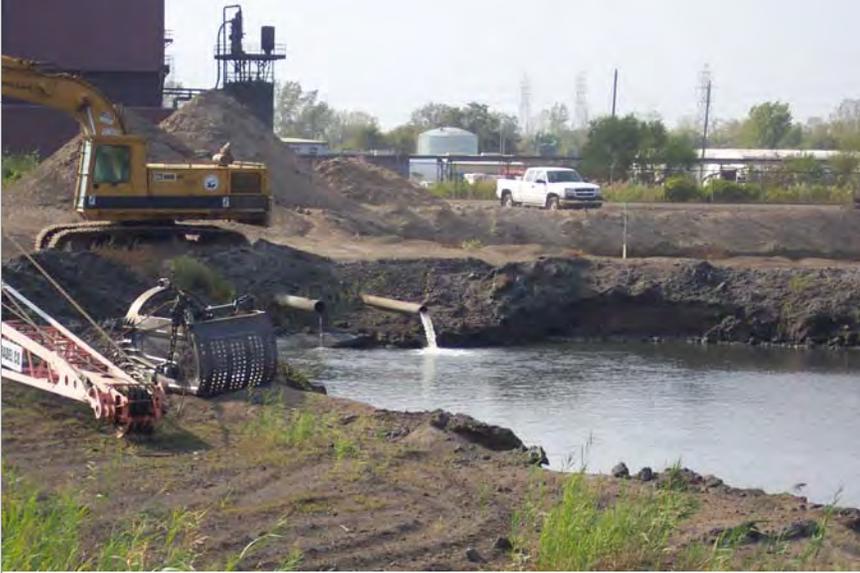
CLIENT NAME: US EPA		SITE LOCATION: CONSUMER'S ENERGY – J.R. WHITING	PROJECT NO. 13498 46122
PHOTO NO. 11	DATE: 9/23/10

DESCRIPTION View looking west Inlet piping for fly ash (back up use) and miscellaneous process wastewaters into Pond 2

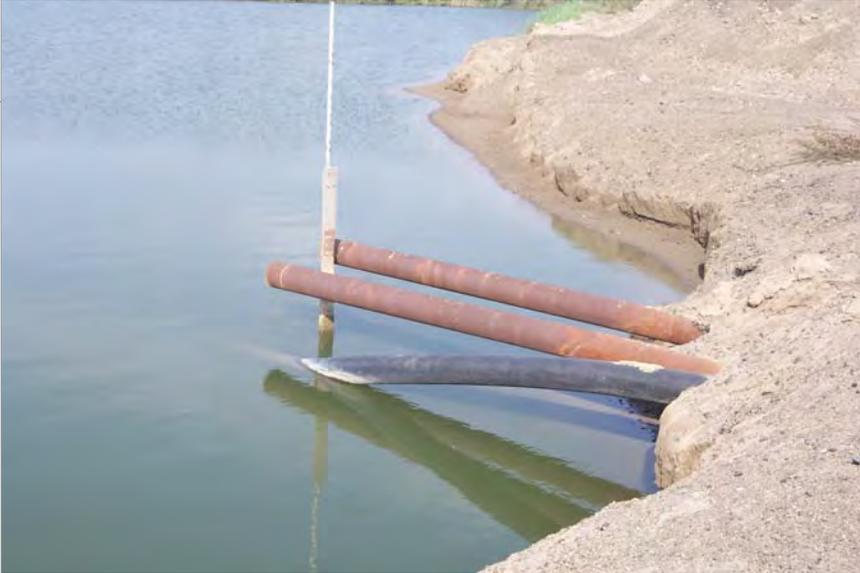
CLIENT NAME: US EPA		SITE LOCATION: CONSUMER'S ENERGY – J.R. WHITING	PROJECT NO. 13498 46122
PHOTO NO. 12	DATE: 9/23/10

DESCRIPTION View looking east Inlet piping for bottom ash into Pond 2

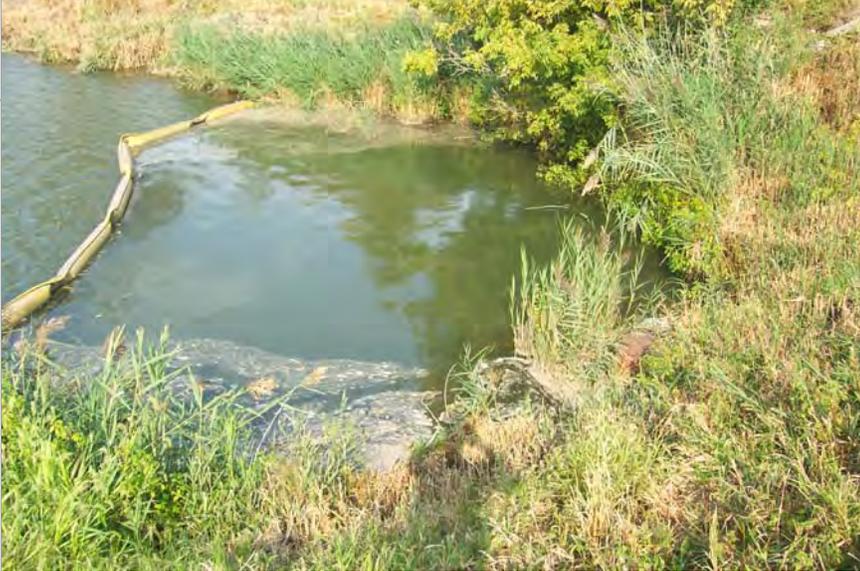
CLIENT NAME: US EPA		SITE LOCATION: CONSUMER'S ENERGY – J.R. WHITING	PROJECT NO. 13498 46122
PHOTO NO. 13	DATE: 9/23/10

DESCRIPTION View looking east View of outlet end (in Pond 1) of transfer pipe between Ponds 1 & 2

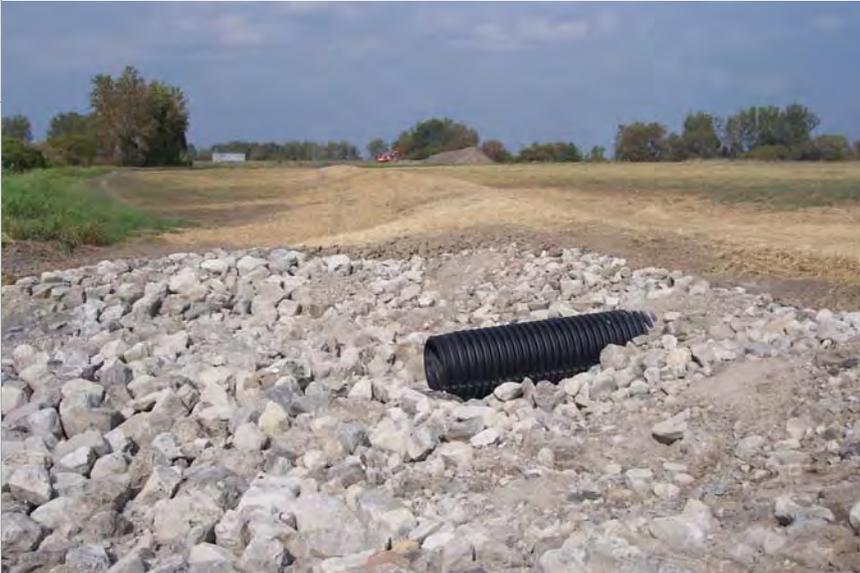
CLIENT NAME: US EPA		SITE LOCATION: CONSUMER'S ENERGY – J.R. WHITING	PROJECT NO. 13498 46122
PHOTO NO. 1	DATE: 9/23/10

DESCRIPTION View looking northeast Newly constructed runoff berm and engineered "let down" area on western edge of landfill/former impoundments Note trees/vegetative growth on slope at left Photo directed along western crest of former impoundments

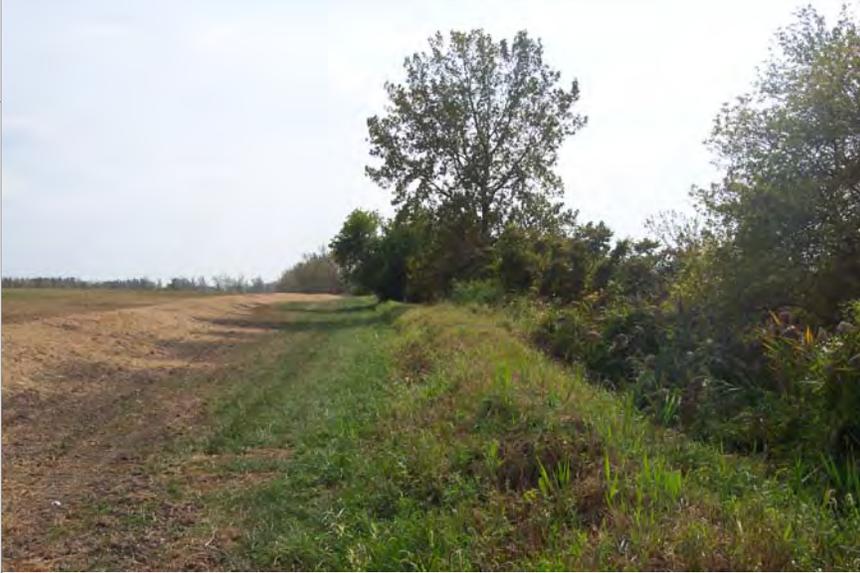
CLIENT NAME: US EPA		SITE LOCATION: CONSUMER'S ENERGY – J.R. WHITING	PROJECT NO. 13498 46122
PHOTO NO. 2	DATE: 9/23/10

DESCRIPTION View looking south Newly constructed runoff berm at left, original embankment slope at right Note trees/vegetative growth on slope at right Photo directed along western crest of former impoundments

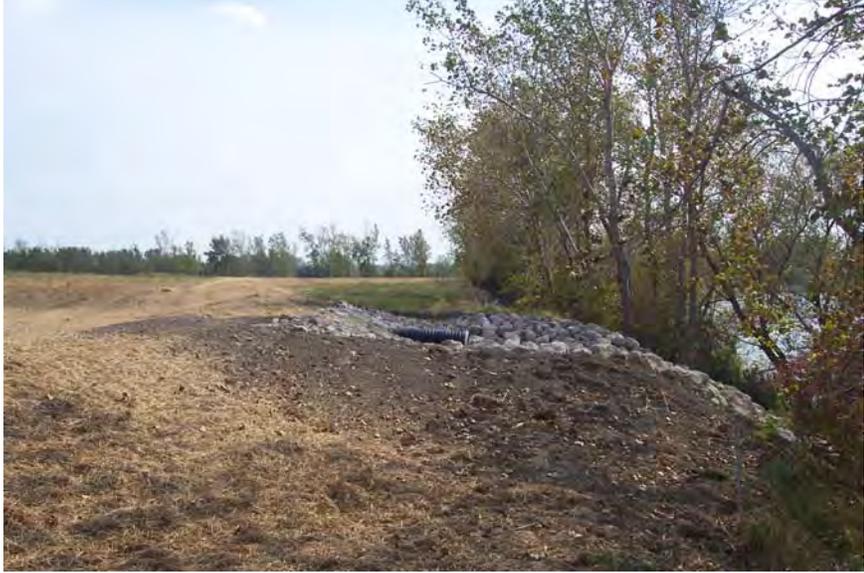
CLIENT NAME: US EPA		SITE LOCATION: CONSUMER'S ENERGY – J.R. WHITING	PROJECT NO. 13498 46122
PHOTO NO. 3	DATE: 9/23/10

DESCRIPTION View looking south Newly constructed runoff berm and engineered "let down" area on western edge of landfill/former impoundments Note trees/vegetative growth on slope at right Photo directed along western crest of former impoundments

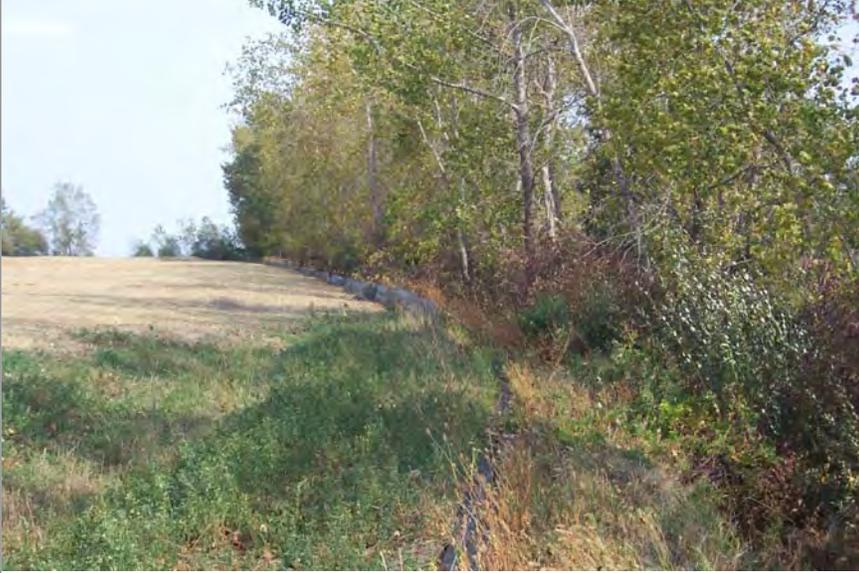
CLIENT NAME: US EPA		SITE LOCATION: CONSUMER'S ENERGY – J.R. WHITING	PROJECT NO. 13498 46122
PHOTO NO. 4	DATE: 9/23/10

DESCRIPTION View looking east Freshly seeded/straw covered final grade at southern end of impoundments Note trees/vegetative growth on slope at right Photo directed along southern crest of former impoundments

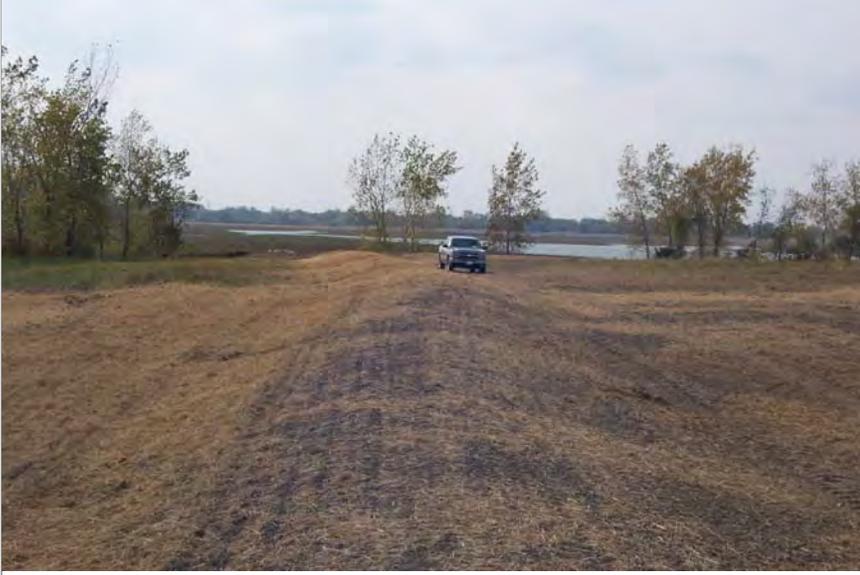
CLIENT NAME: US EPA		SITE LOCATION: CONSUMER'S ENERGY – J.R. WHITING	PROJECT NO. 13498 46122
PHOTO NO. 6	DATE: 9/23/10

DESCRIPTION View looking west View along newly constructed final cover and runoff berm on southern portion of former impoundments

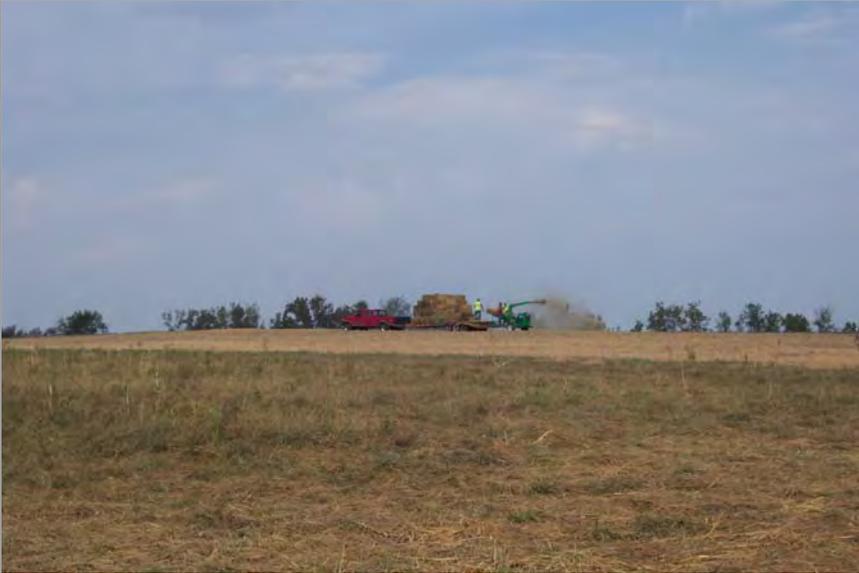
CLIENT NAME: US EPA		SITE LOCATION: CONSUMER'S ENERGY – J.R. WHITING	PROJECT NO. 13498 46122
PHOTO NO. 7	DATE: 9/23/10

DESCRIPTION View looking east Application of seed and straw cover at center/top of landfill/former impoundments

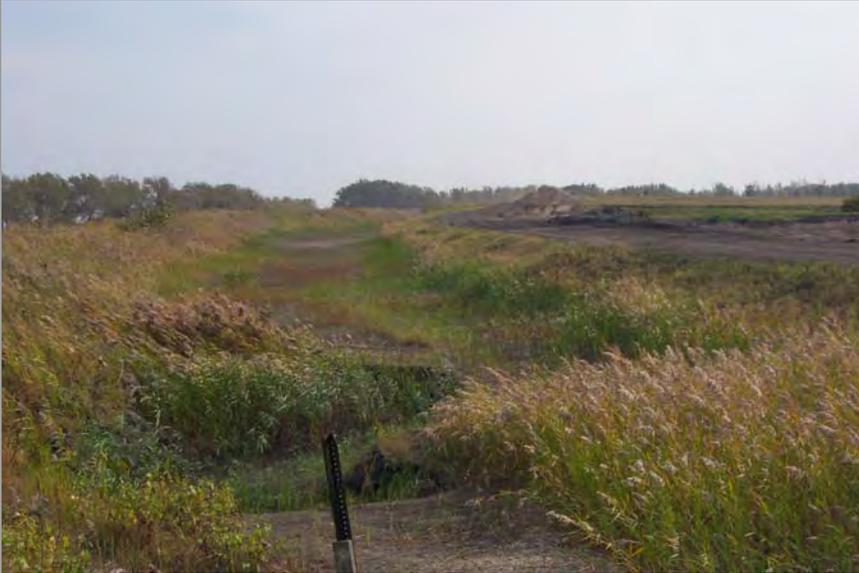
CLIENT NAME: US EPA		SITE LOCATION: CONSUMER'S ENERGY – J.R. WHITING	PROJECT NO. 13498 46122
PHOTO NO. 8	DATE: 9/23/10

DESCRIPTION View looking south from north end of landfill/former impoundments Photo is directed along center of former impoundments. Note haul road for placement of final ash in landfill Depressed area in center of photo is last area where ash was wet sluiced to former impoundments

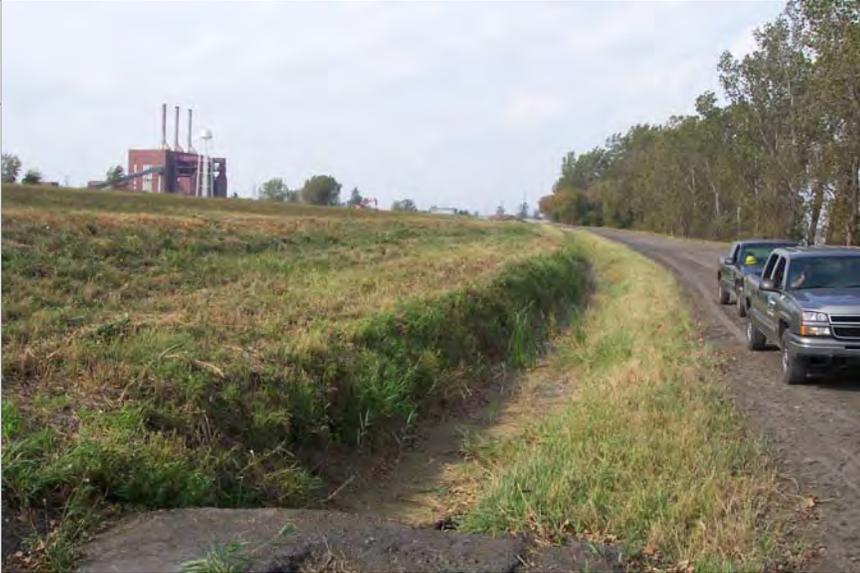
CLIENT NAME: US EPA		SITE LOCATION: CONSUMER'S ENERGY – J.R. WHITING	PROJECT NO. 13498 46122
PHOTO NO. 9	DATE: 9/23/10

DESCRIPTION View looking north. View along crest of former embankment Slope to the left is stored ash in footprint of former impoundment, final cover yet to be placed over subject area of photo

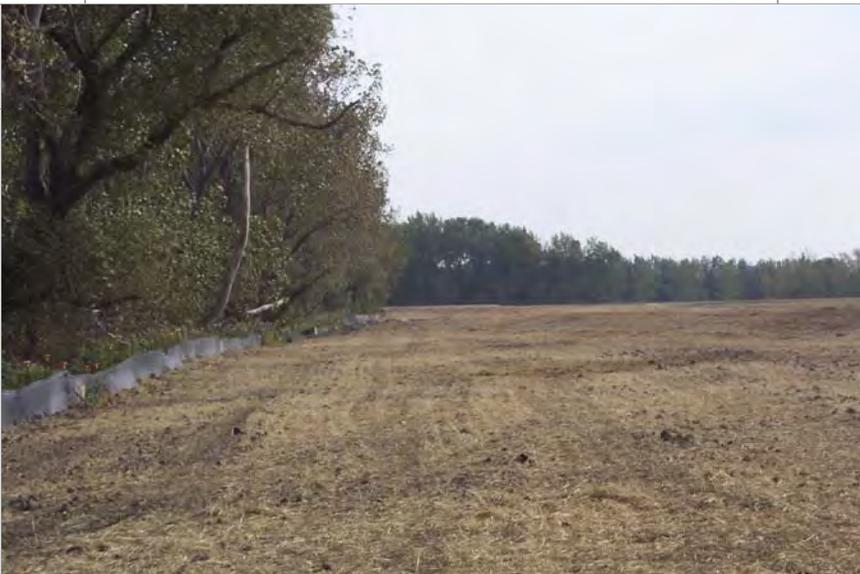
CLIENT NAME: US EPA		SITE LOCATION: CONSUMER'S ENERGY – J.R. WHITING	PROJECT NO. 13498 46122
PHOTO NO. 10	DATE: 9/23/10

DESCRIPTION View looking south View along crest of former east embankment Final cover has been completed and seeded

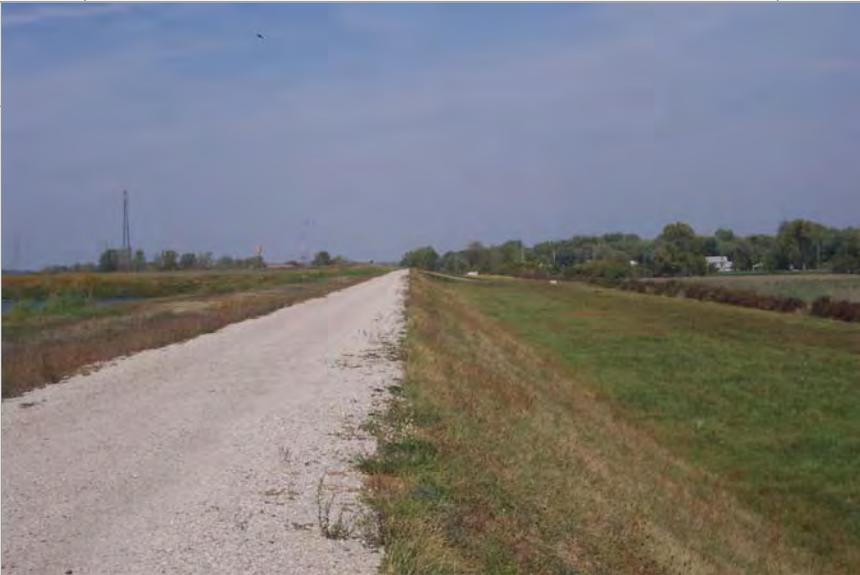
CLIENT NAME: US EPA		SITE LOCATION: CONSUMER'S ENERGY – J.R. WHITING	PROJECT NO. 13498 46122
PHOTO NO. 1	DATE: 9/23/10

DESCRIPTION View looking north View along crest and upper outboard slope of south portion of east embankment

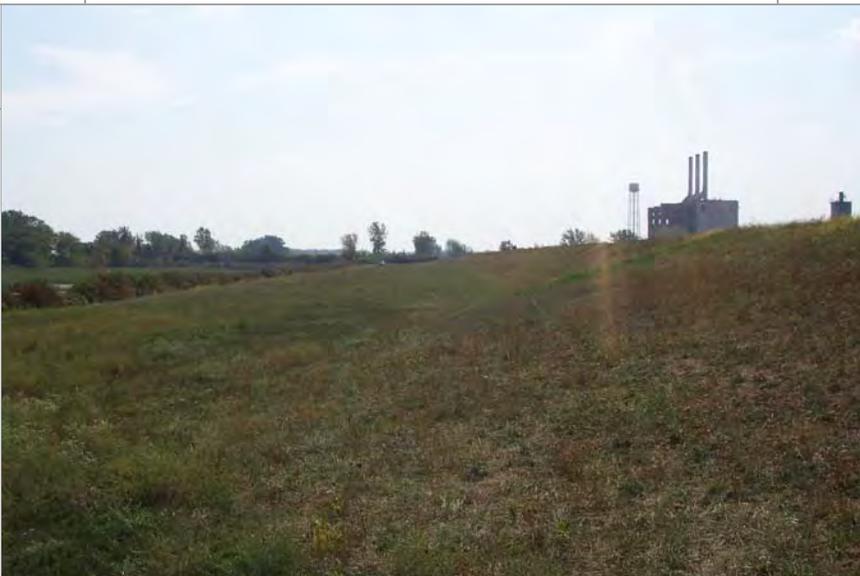
CLIENT NAME: US EPA		SITE LOCATION: CONSUMER'S ENERGY – J.R. WHITING	PROJECT NO. 13498 46122
PHOTO NO. 2	DATE: 9/23/10

DESCRIPTION View looking south View along upper outboard slope of south portion of east embankment

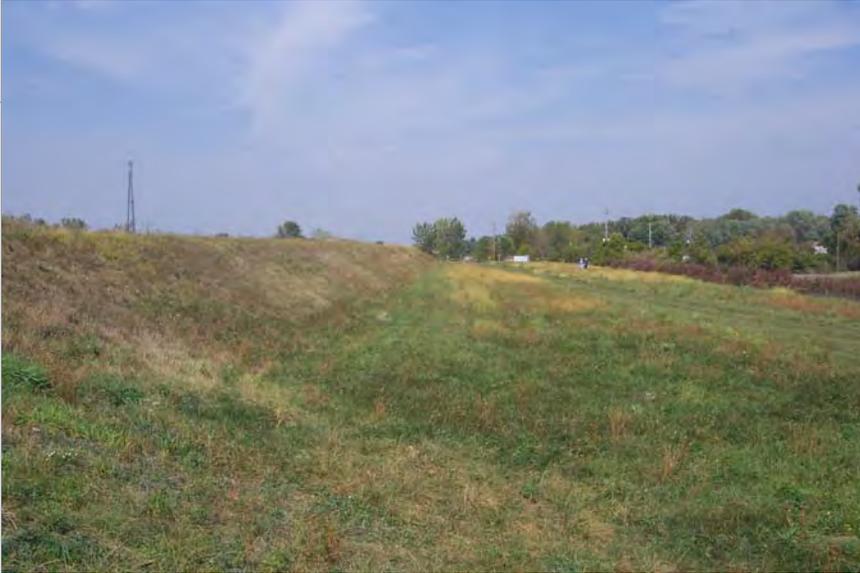
CLIENT NAME: US EPA		SITE LOCATION: CONSUMER’S ENERGY – J.R. WHITING	PROJECT NO. 13498 46122
PHOTO NO. 3	DATE: 9/23/10

DESCRIPTION View looking north View along crest and upper outboard slope of north portion of east embankment

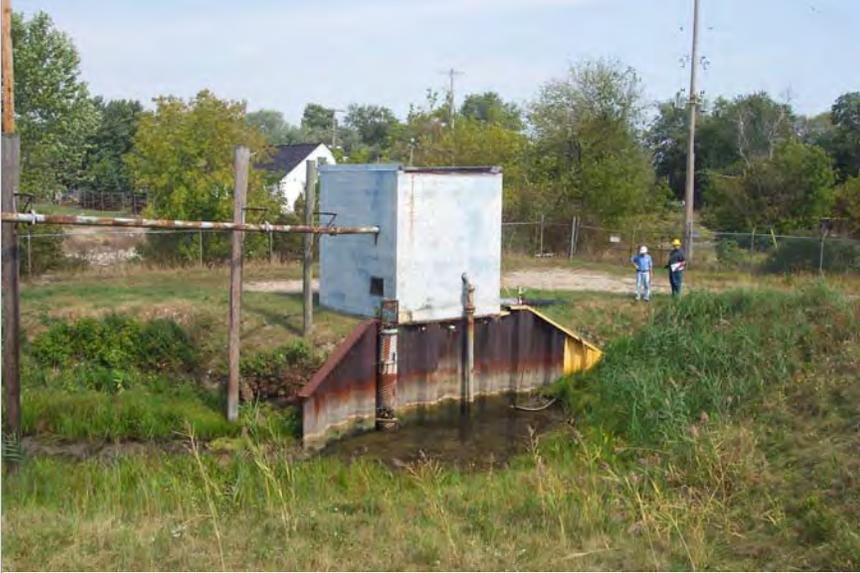
CLIENT NAME: US EPA		SITE LOCATION: CONSUMER’S ENERGY – J.R. WHITING	PROJECT NO. 13498 46122
PHOTO NO. 4	DATE: 9/23/10

DESCRIPTION View looking northeast View of intake water pumphouse that draws water out of LaPointe Drain to get water into impoundment

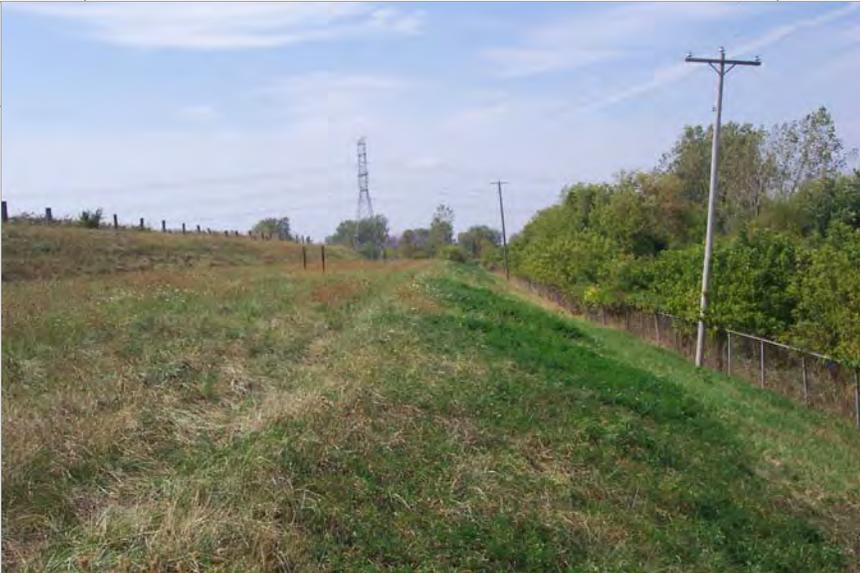
CLIENT NAME: US EPA		SITE LOCATION: CONSUMER'S ENERGY – J.R. WHITING	PROJECT NO. 13498 46122
PHOTO NO. 5	DATE: 9/23/10

DESCRIPTION View looking west View along lower outboard slope of north embankment

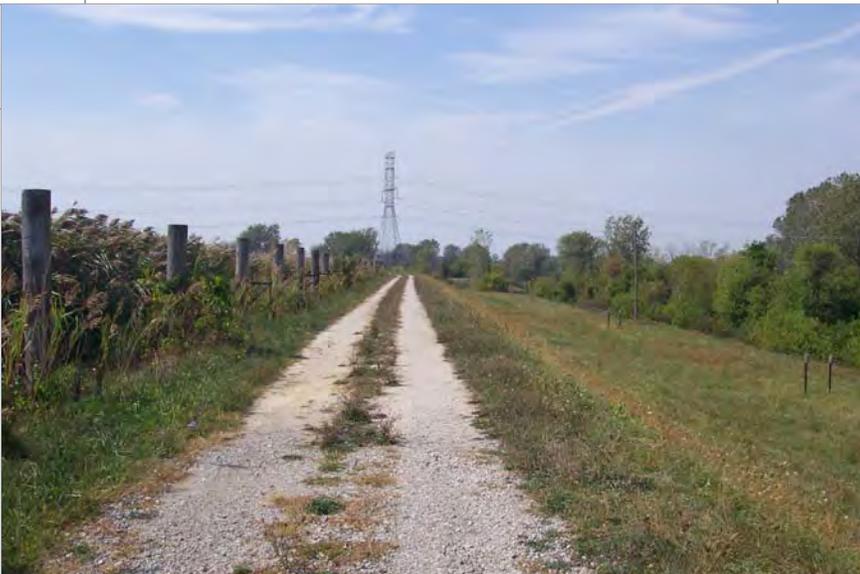
CLIENT NAME: US EPA		SITE LOCATION: CONSUMER'S ENERGY – J.R. WHITING	PROJECT NO. 13498 46122
PHOTO NO. 6	DATE: 9/23/10

DESCRIPTION View looking west View along crest of north embankment

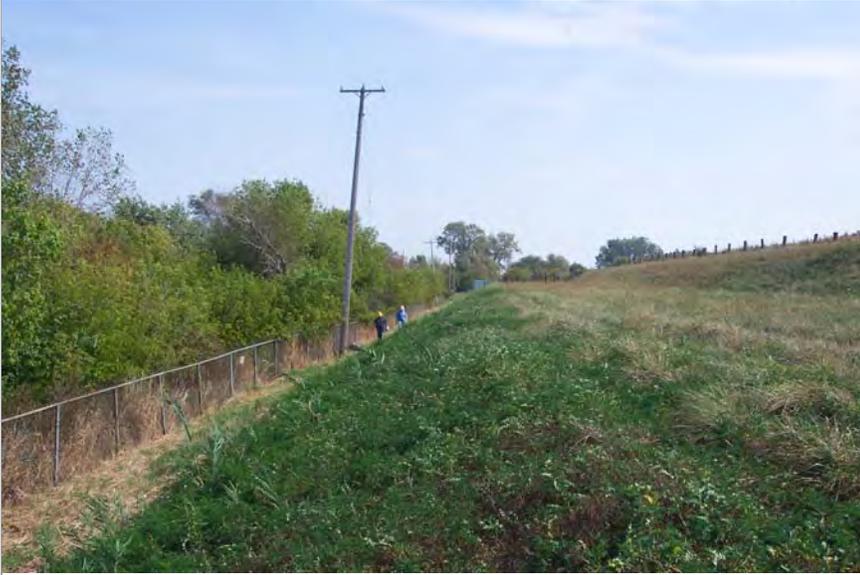
CLIENT NAME: US EPA		SITE LOCATION: CONSUMER'S ENERGY – J.R. WHITING	PROJECT NO. 13498 46122
PHOTO NO. 8	DATE: 9/23/10

DESCRIPTION View looking east View along lower outboard slope of north embankment

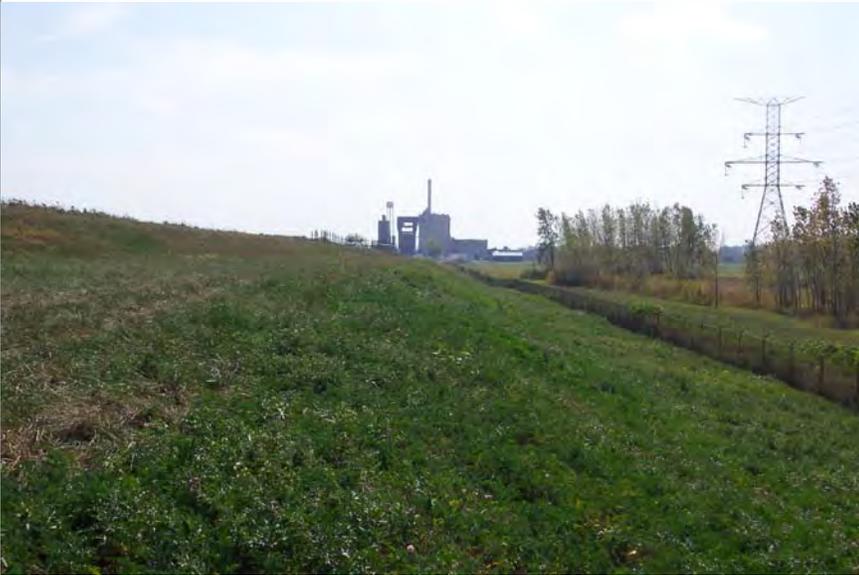
CLIENT NAME: US EPA		SITE LOCATION: CONSUMER’S ENERGY – J.R. WHITING	PROJECT NO. 13498 46122
PHOTO NO. 9	DATE: 9/23/10

DESCRIPTION View looking south View along lower outboard slope of north portion of west embankment

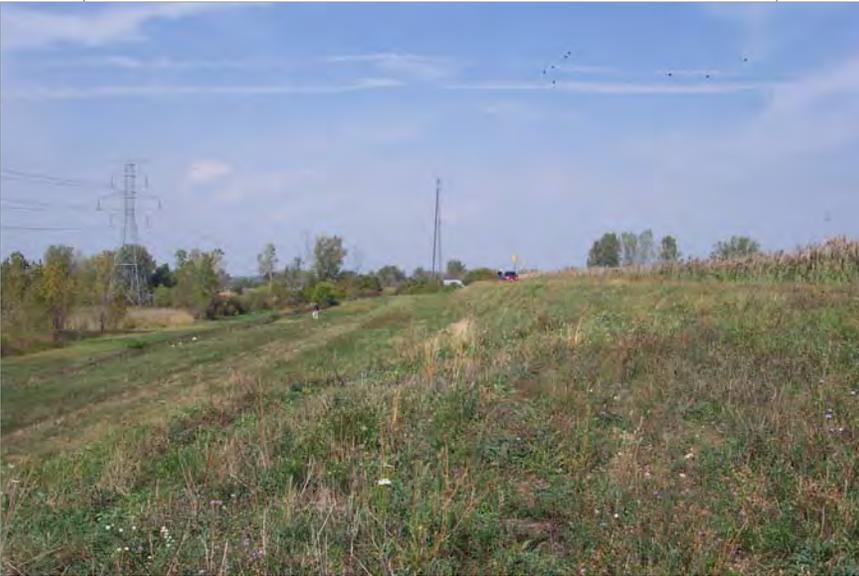
CLIENT NAME: US EPA		SITE LOCATION: CONSUMER’S ENERGY – J.R. WHITING	PROJECT NO. 13498 46122
PHOTO NO. 10	DATE: 9/23/10

DESCRIPTION View looking north View along upper outboard slope of north portion of west embankment

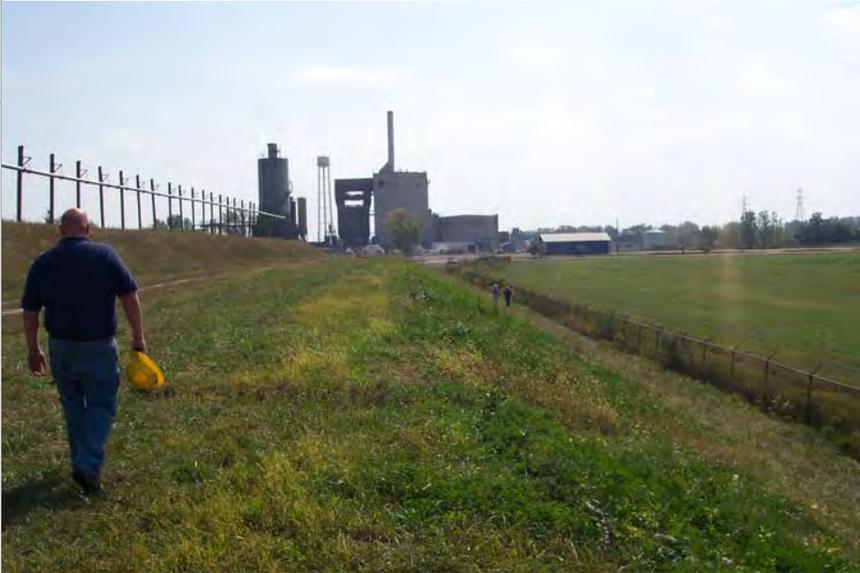
CLIENT NAME: US EPA		SITE LOCATION: CONSUMER'S ENERGY – J.R. WHITING	PROJECT NO. 13498 46122
PHOTO NO. 11	DATE: 9/23/10

DESCRIPTION View looking south View along lower outboard slope of south portion of west embankment

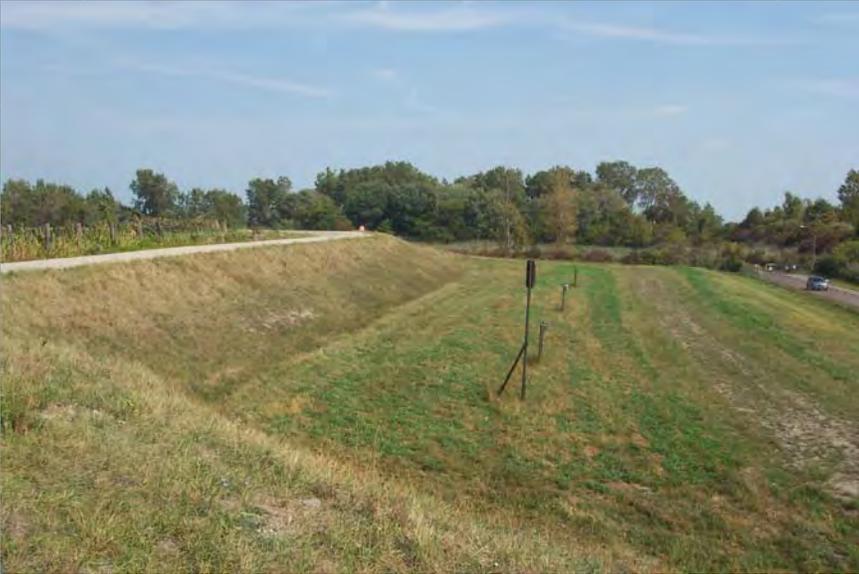
CLIENT NAME: US EPA		SITE LOCATION: CONSUMER'S ENERGY – J.R. WHITING	PROJECT NO. 13498 46122
PHOTO NO. 15	DATE: 9/23/10

DESCRIPTION View looking east View along upper slope of southern embankment

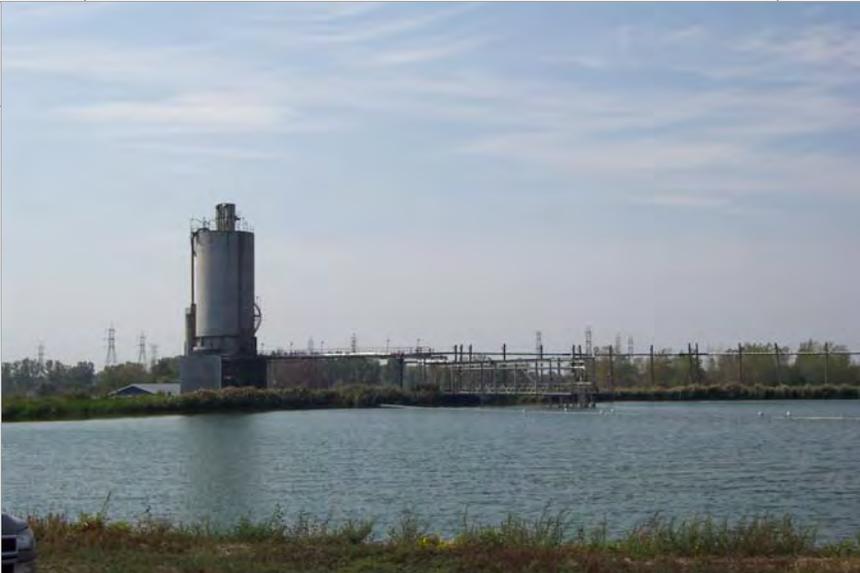
CLIENT NAME: US EPA		SITE LOCATION: CONSUMER'S ENERGY – J.R. WHITING	PROJECT NO. 13498 46122
PHOTO NO. 17	DATE: 9/23/10

DESCRIPTION View looking southwest View of recycle water/blend water intake platform and fly ash storage silo from across impoundment

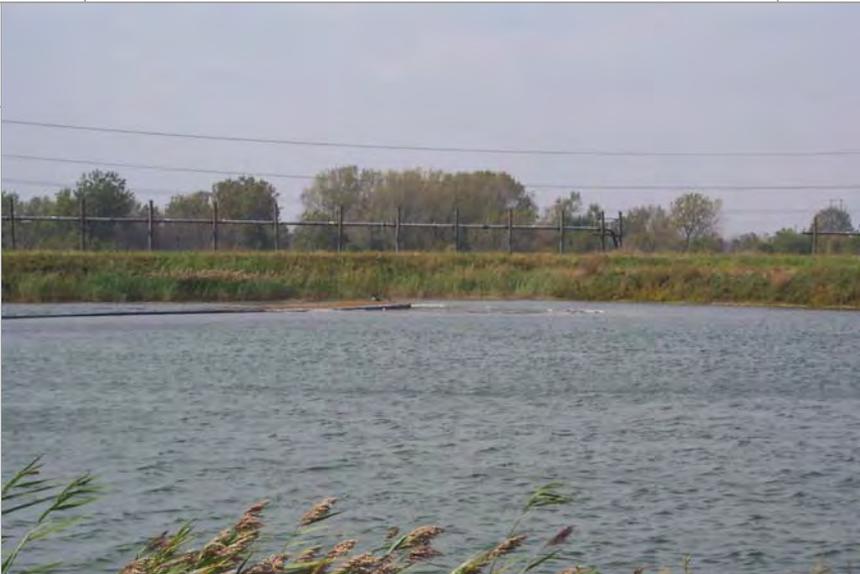
CLIENT NAME: US EPA		SITE LOCATION: CONSUMER'S ENERGY – J.R. WHITING	PROJECT NO. 13498 46122
PHOTO NO. 18	DATE: 9/23/10

DESCRIPTION View looking northwest View of recycle water being circulated in pond from across impoundment
