**DRAFT REPORT
ROUND 7 DAM ASSESSMENT
CONSUMERS ENERGY COMPANY - D.E. KARN PLANT
1 & 2 SOLID WASTE DISPOSAL AREA
ESSEXVILLE, MICHIGAN**

January 12, 2011

**GZA GeoEnvironmental, Inc.
19500 Victor Parkway, Suite 300
Livonia, MI 48152
GZA File No. 01.0170142.20**

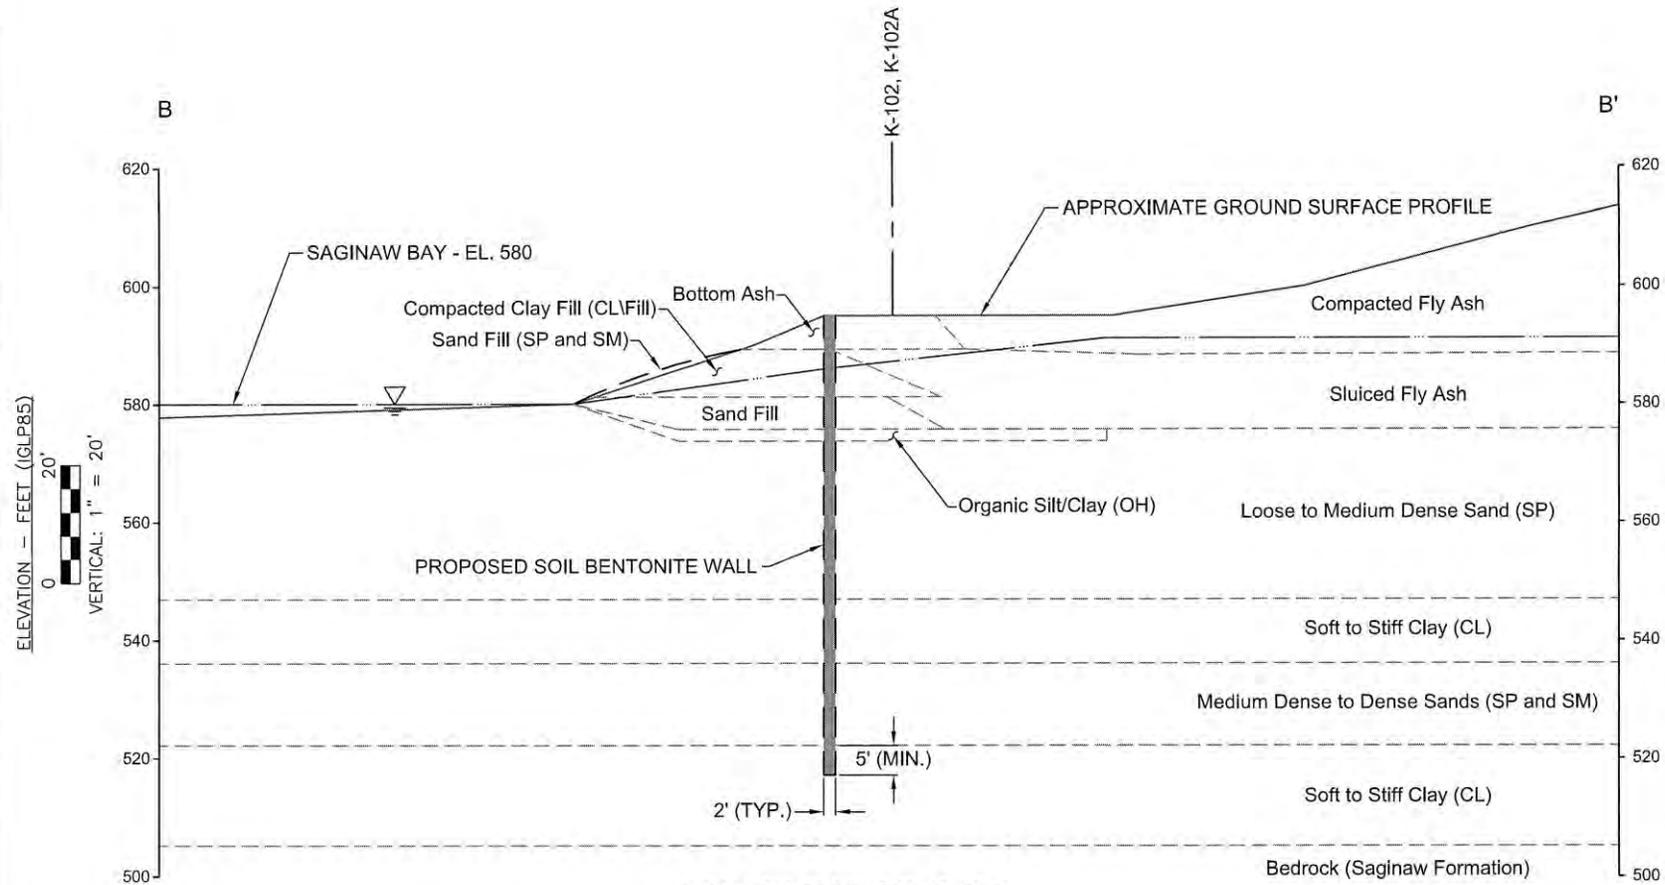
Figure 6

The reported subsurface profile of the northern and western perimeter dikes is presented on **Figure 6**. The dike in this area reportedly consists of a mechanically-placed clay dike constructed over sand fill. Fly ash is present along the upstream side of the dike but did not appear to extend below the original dike material. The dike fill materials are underlain by natural sands with interbedded clay layers. The natural sands are underlain by native stiff clays. A relatively thin strata of natural organic clay and/or organic silt is present at the interface between the dike material and natural foundation soils.

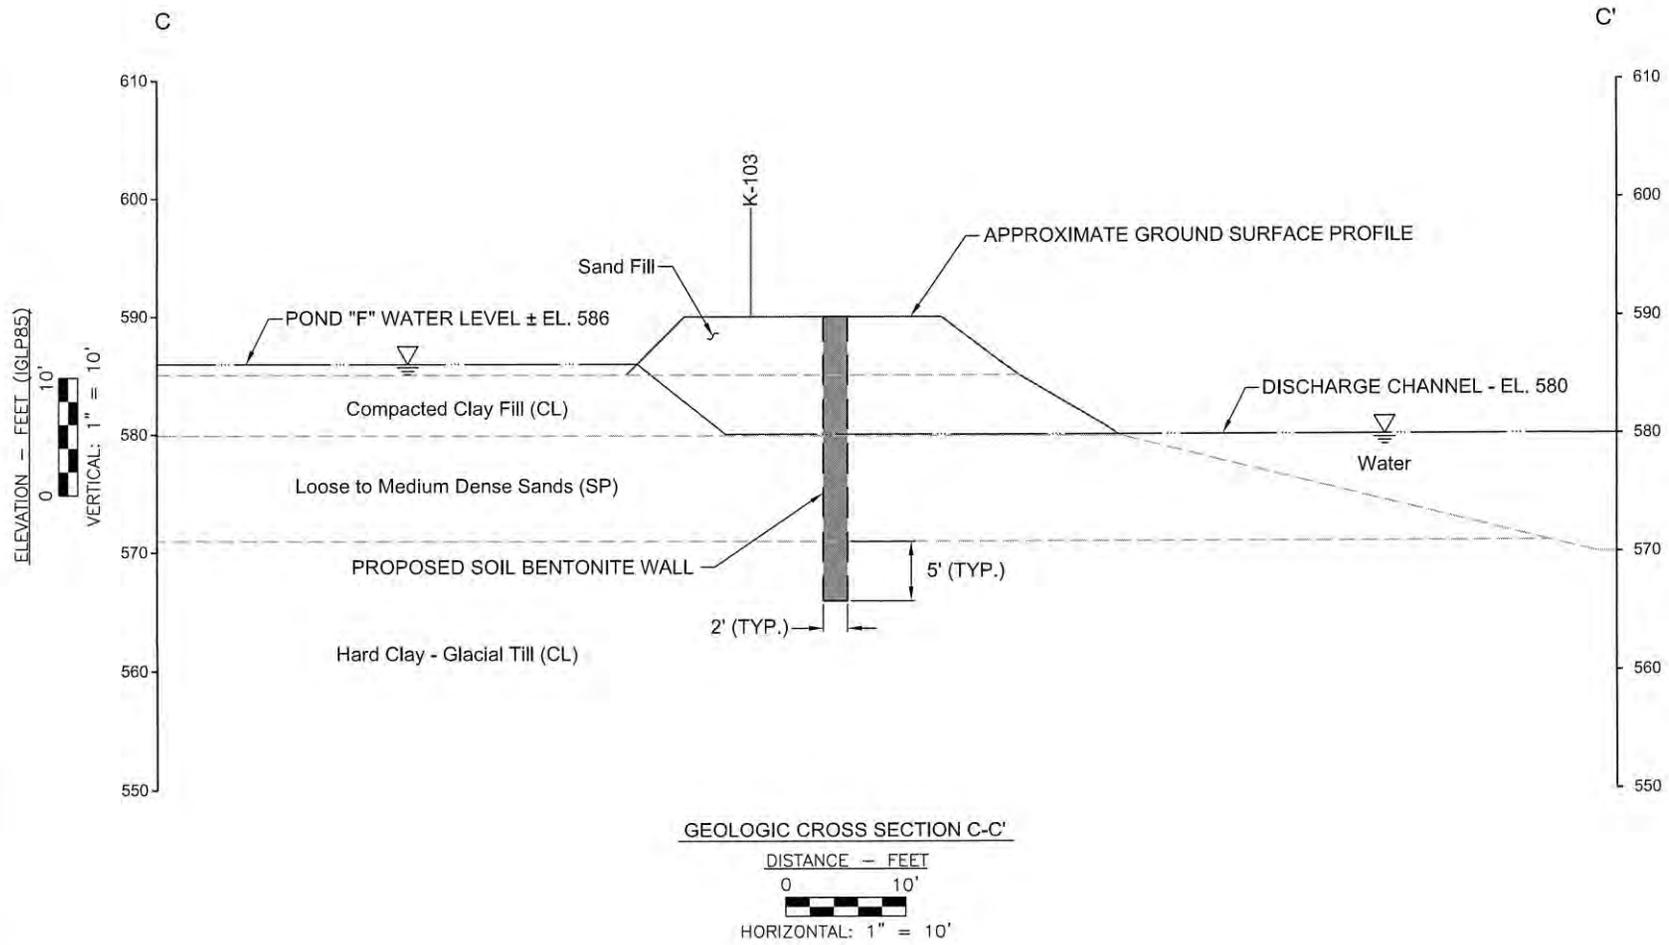
Figure 7

The reported subsurface profile of the dike area near the Discharge Canal is presented on **Figure 7**. The dike materials in this area reportedly consist of sand fill overlying clay fill. The dike materials are underlain by natural sands that overlie natural hard clays.

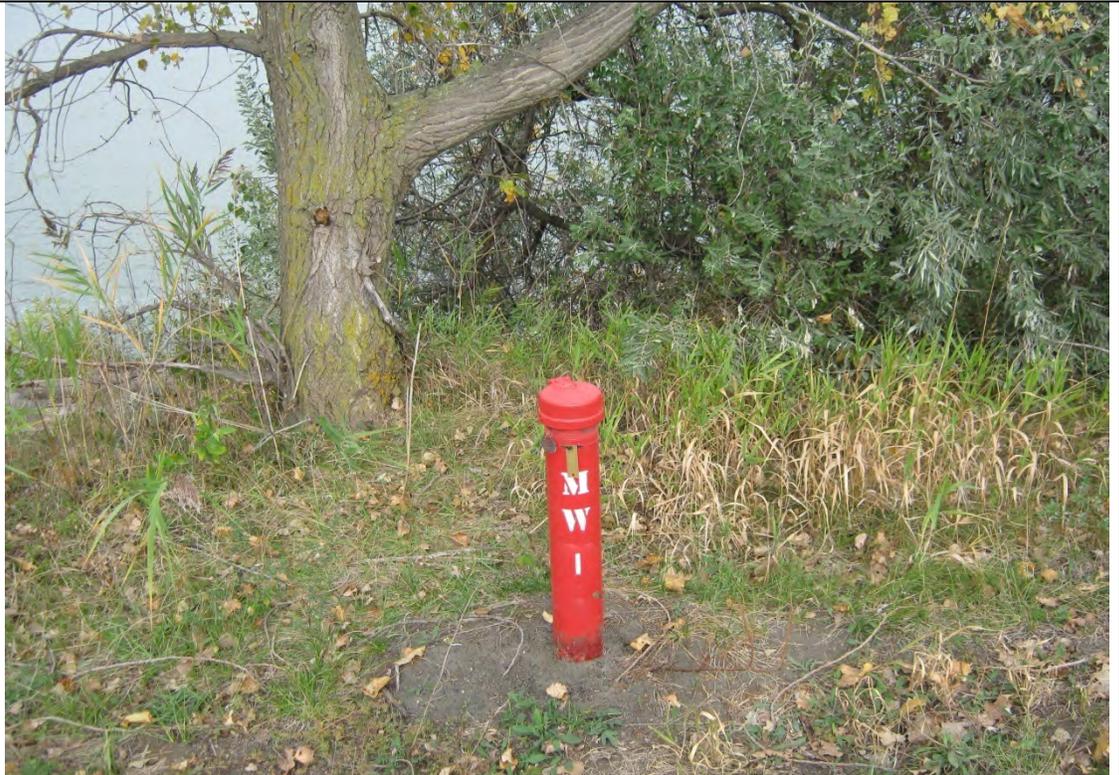
Photo No. 6

Description: One of the monitoring wells at the Karn Disposal Area.

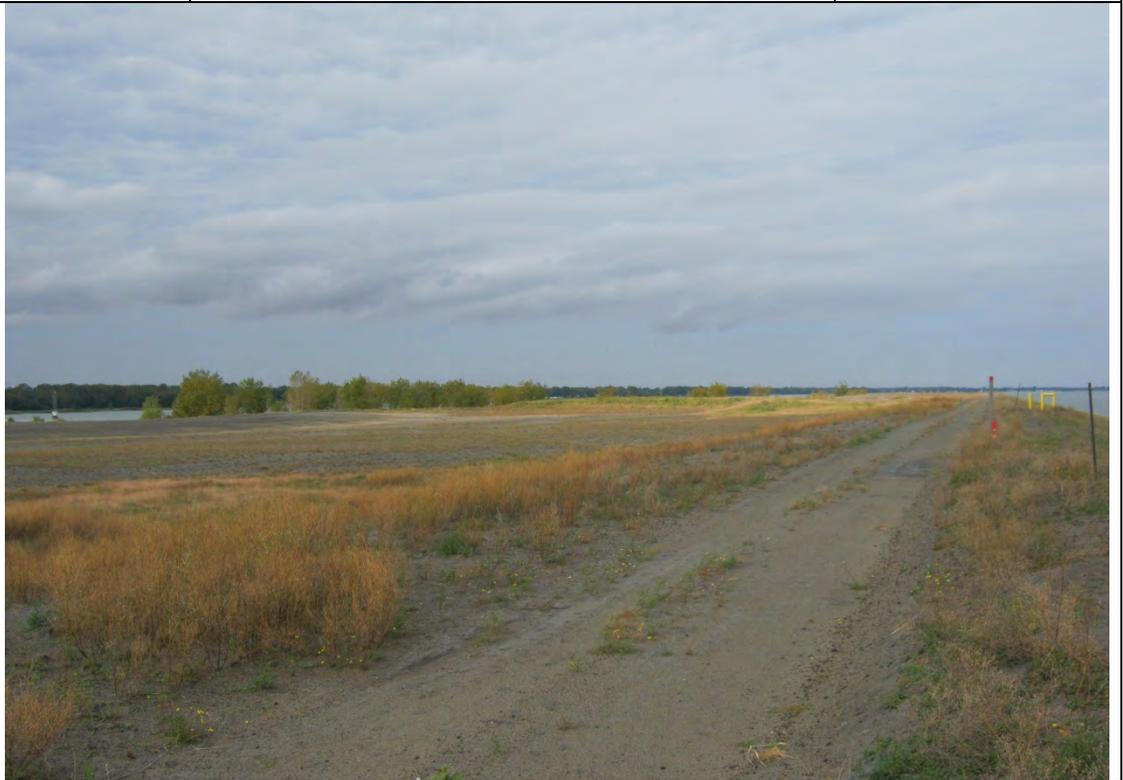
Photo No. 14

Description: View from approximately the mid point between the toe of the inner dike slope and the top of the fly ash disposal area.

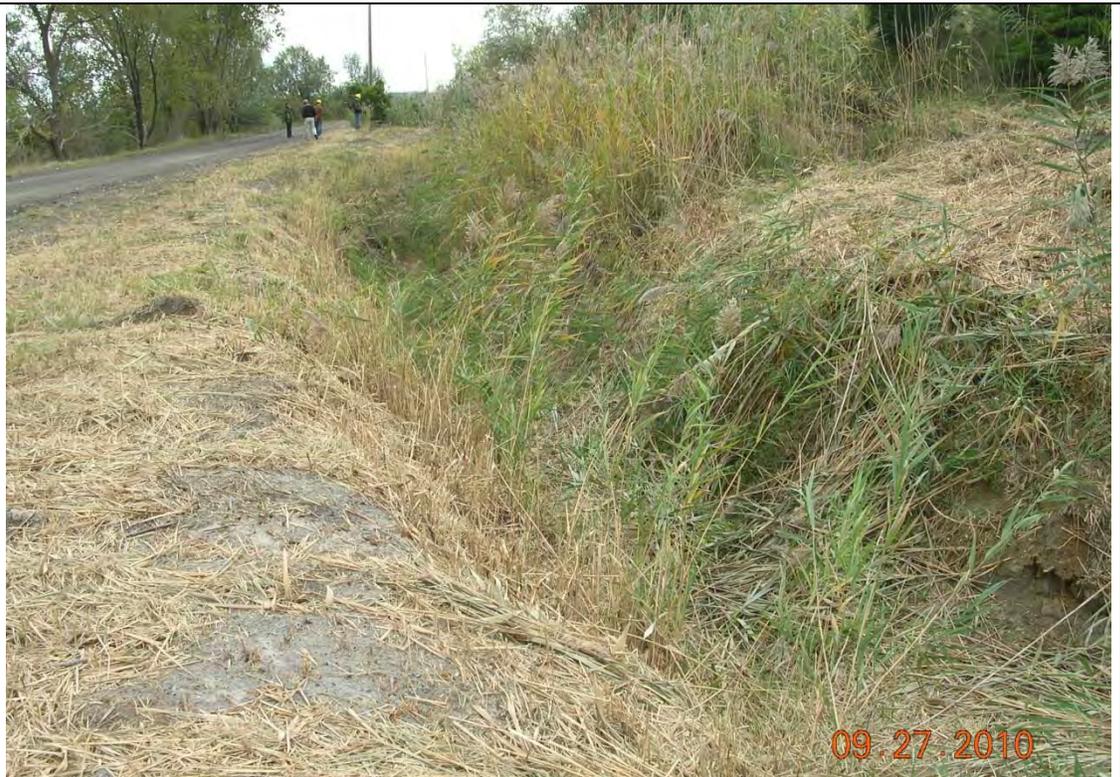
Photo No. 22

Description: The inner dike slope and stormwater drainage ditch.

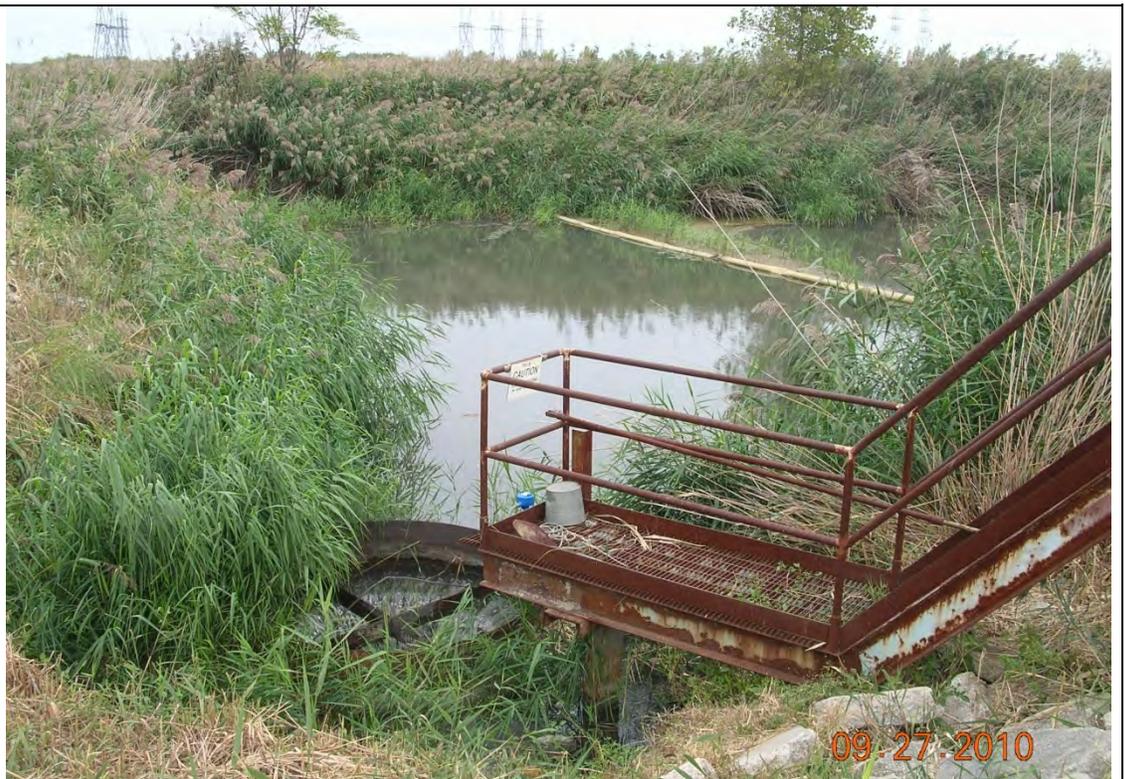
Description: The NPDES outlet structure in Pond F.

1. Remove the former NPDES discharge structure, including excavating and removing the former pipes, and replace with compacted fill.

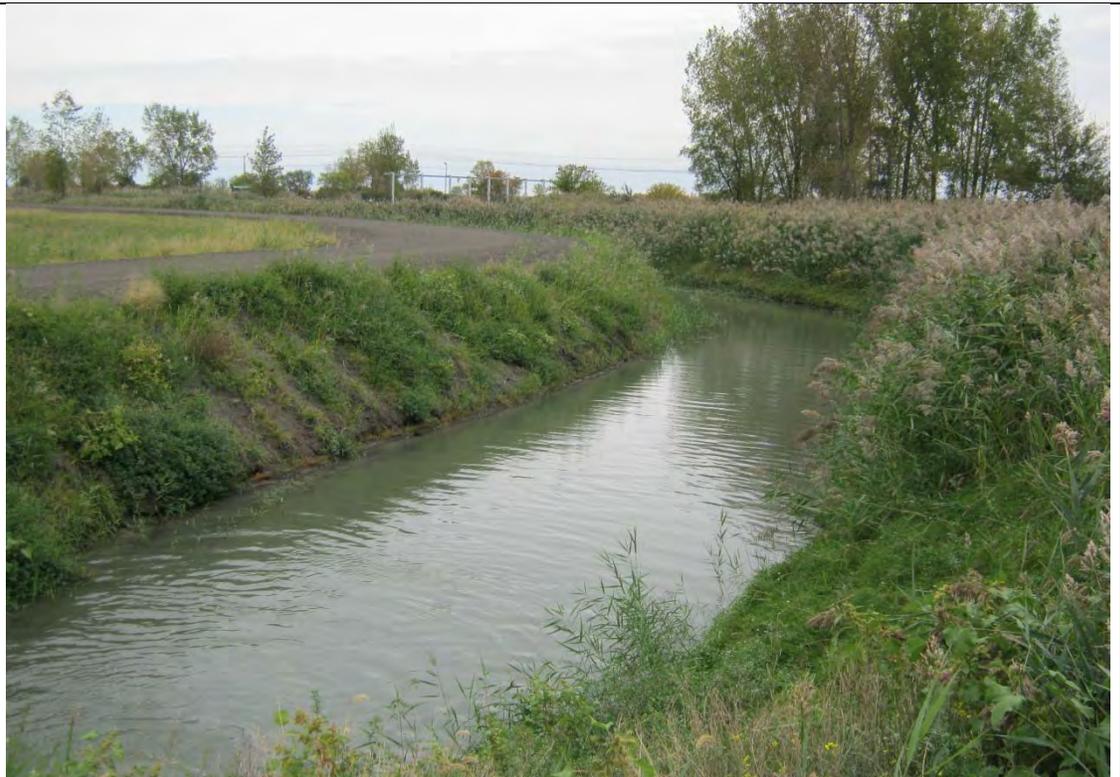
Photo No. 36

Description: One of the drainage ditches that conveys Bottom Ash wastewater to Pond F.

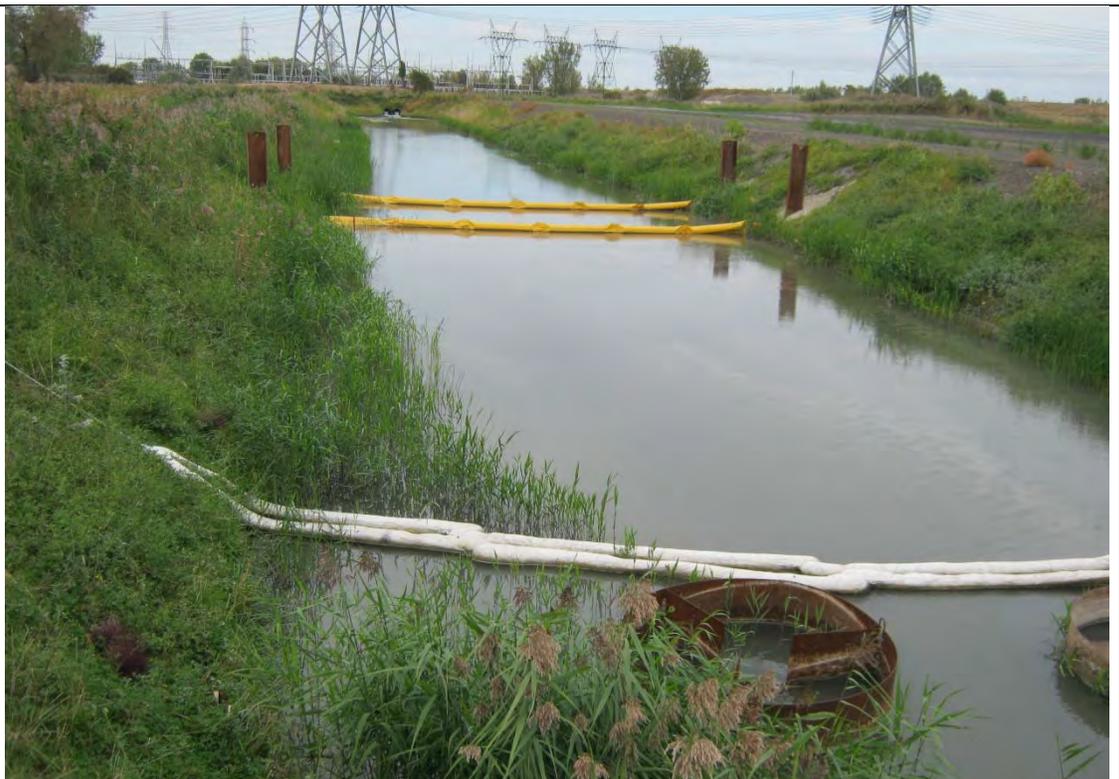
Photo No. 38

One of the drainage ditches that conveys Bottom Ash wastewater to Pond F. Yellow turbidity curtains reduce particulate in the wastewater.

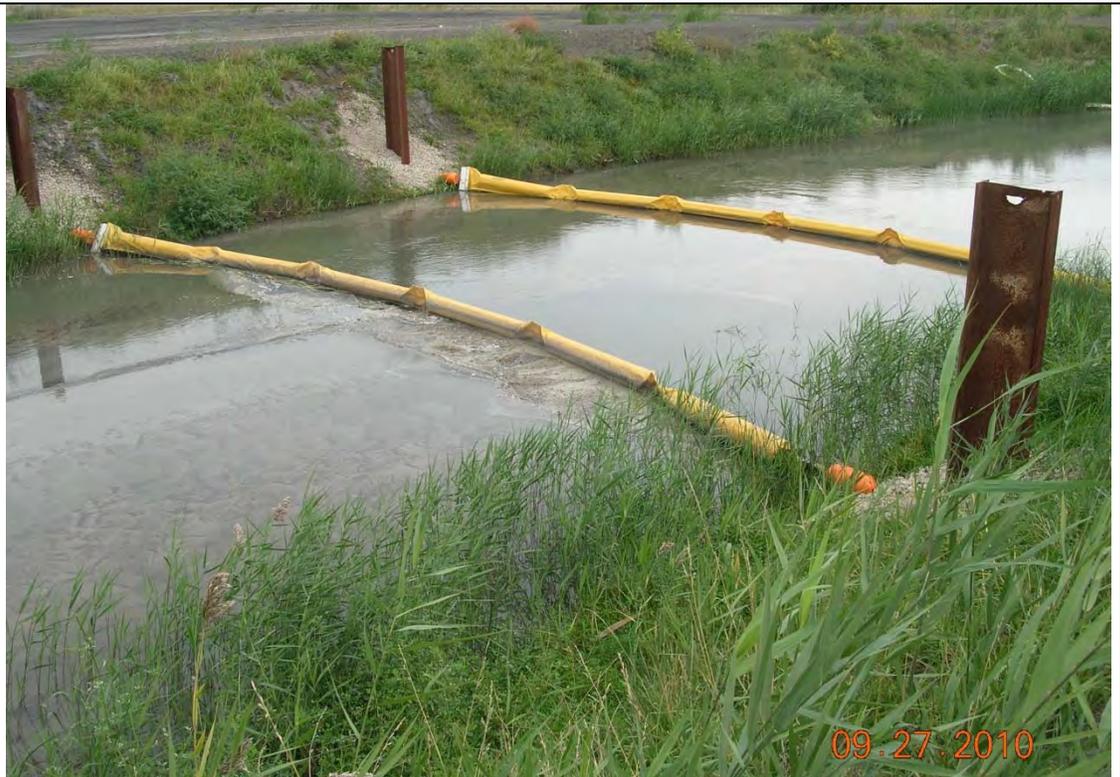
Photo No. 40

Description: Turbidity curtains in the bottom ash drainage ditches.

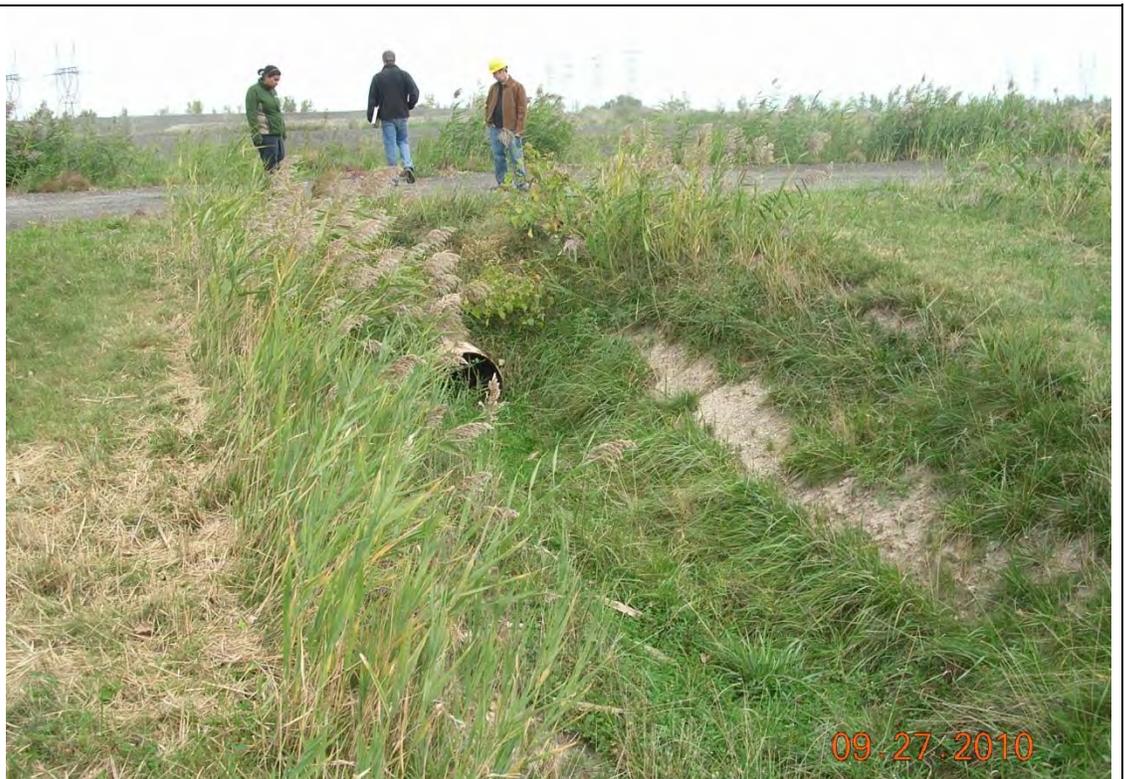
Photo No. 42

Description: Stormwater overflow outlet that empties the drainage ditches into the Discharge Canal.

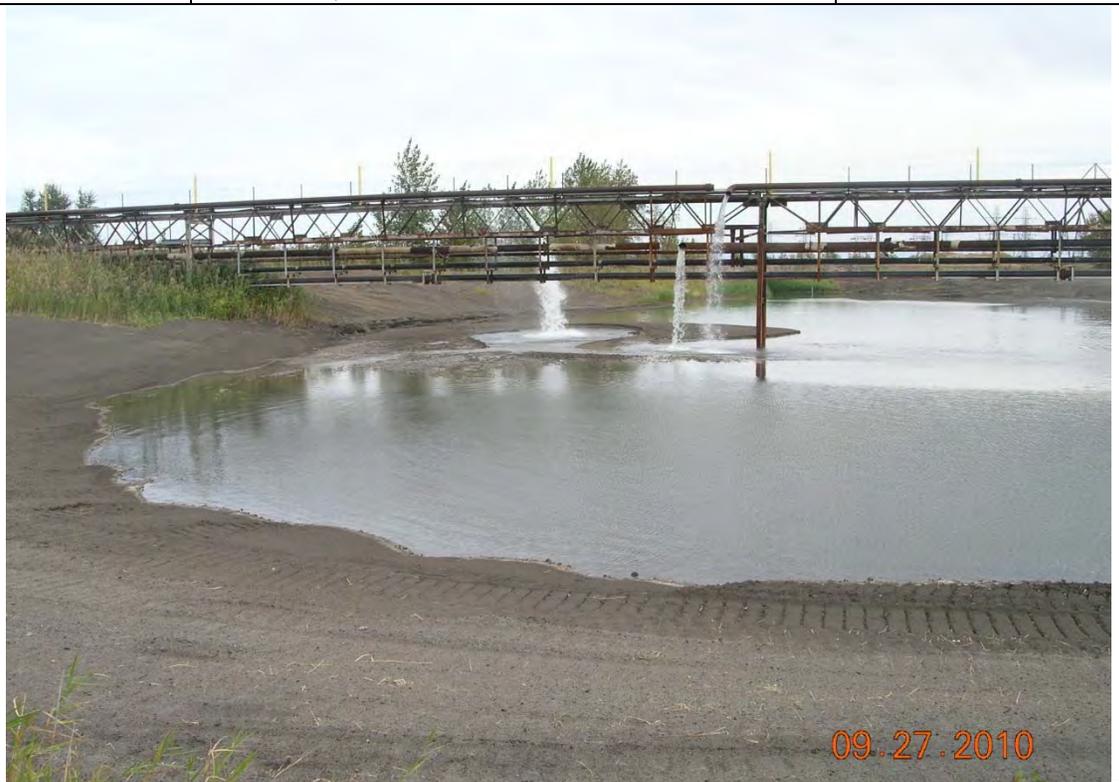
Photo No. 45	Date: 9/27/2010
Direction Photo Taken: East

Description:
Bottom Ash wastewater discharge pond and pipe trestle.

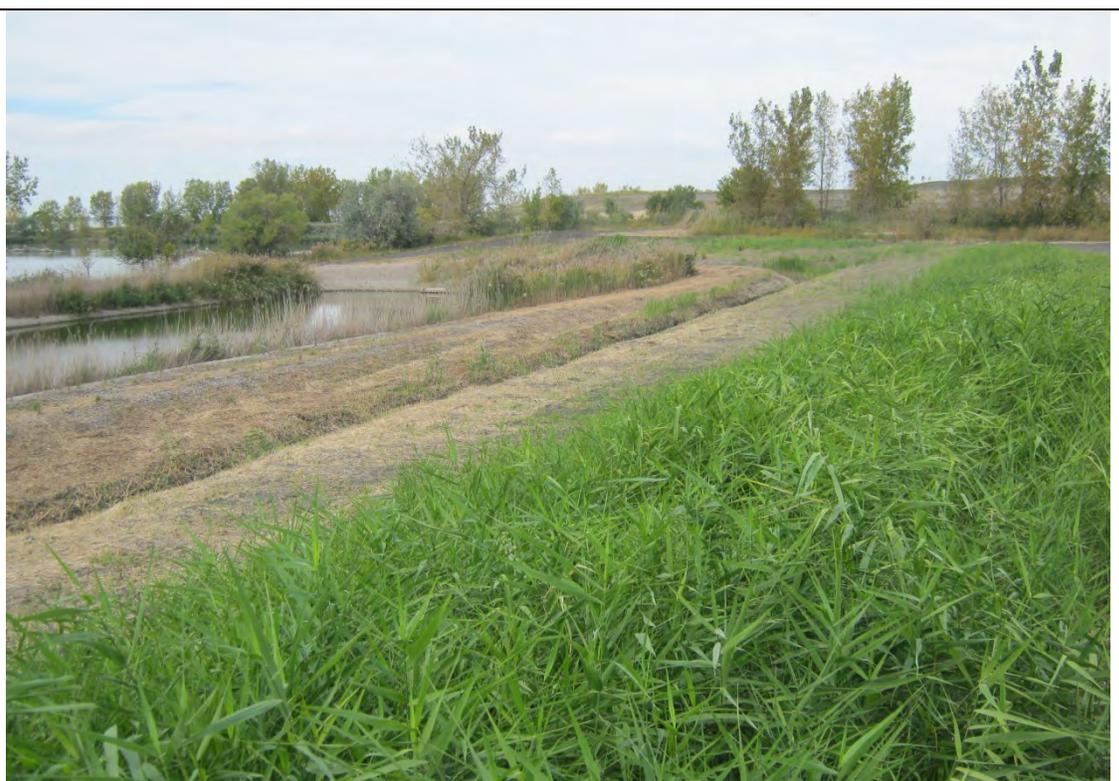
Photo No. 46	Date: 9/27/10
Direction Photo Taken: Northwest

Description:
Chemical treatment ponds are located within the Karn Disposal Area.
