**FINAL REPORT
ROUND 7 DAM ASSESSMENT
CONSUMERS ENERGY COMPANY - D.E. KARN PLANT
1 & 2 SOLID WASTE DISPOSAL AREA
ESSEXVILLE, MICHIGAN**

June 30, 2011

**GZA GeoEnvironmental, Inc.
19500 Victor Parkway, Suite 300
Livonia, MI 48152
GZA File No. 01.0170142.20**

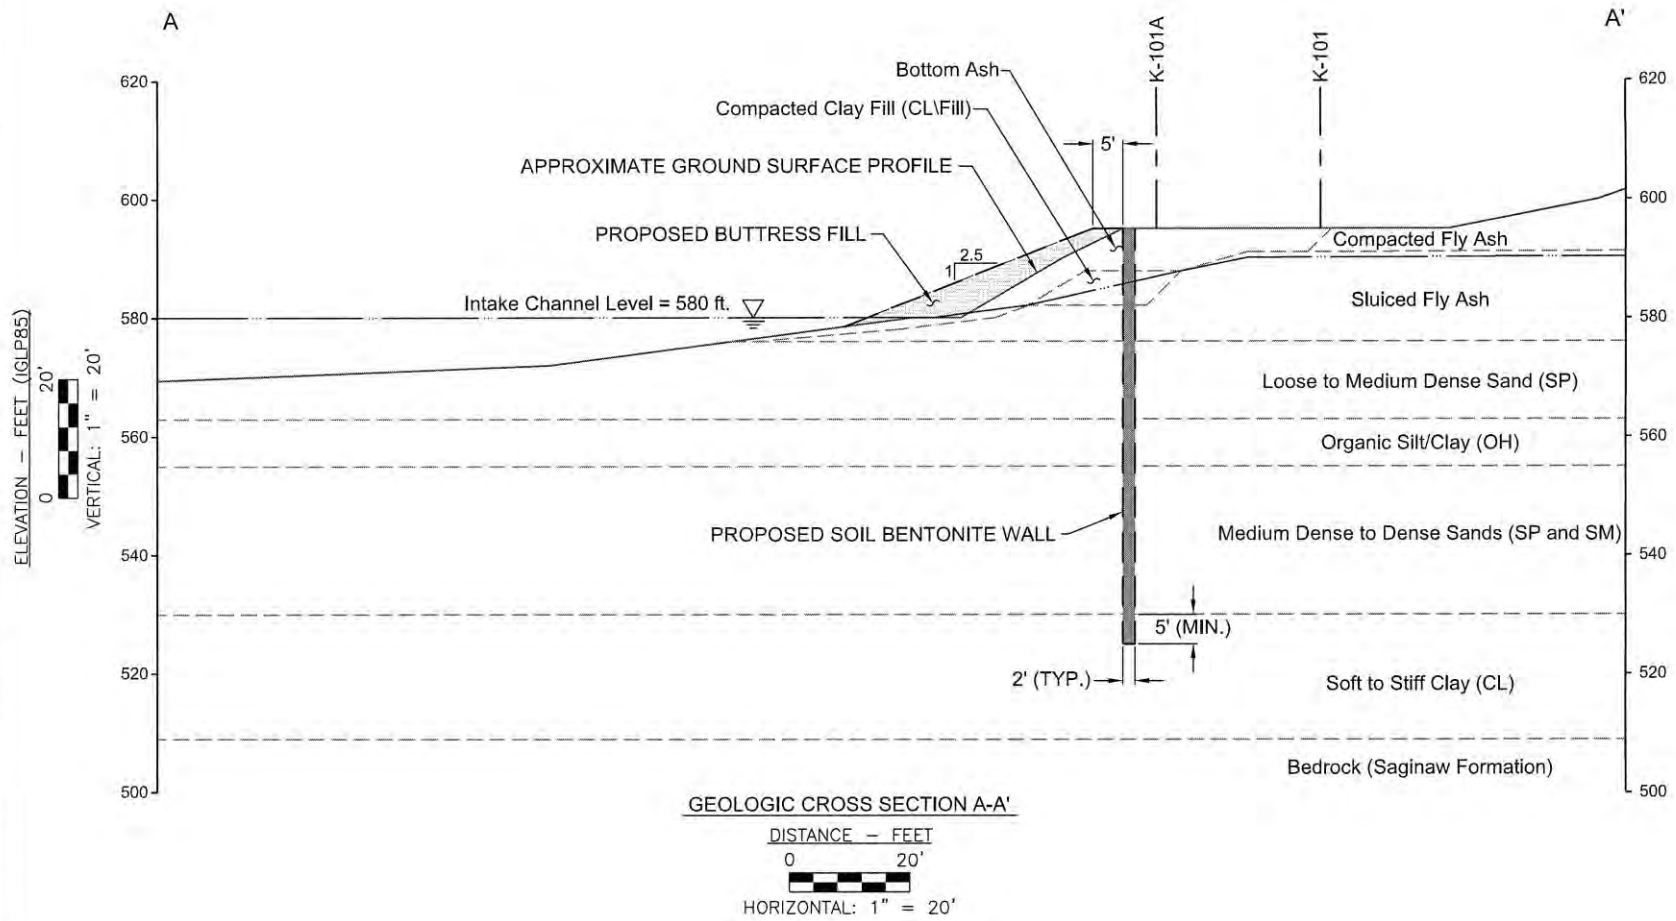
Cross Section A-A'

The reported subsurface profile of the dike area near the Intake Channel north of the Chemical Treatment Ponds is presented on **Figure 5**. The dike in this area was reportedly initially constructed with a mechanically-placed clay compacted over sluiced fly ash that was placed on the natural ground surface. A later expansion raised the dike elevation with

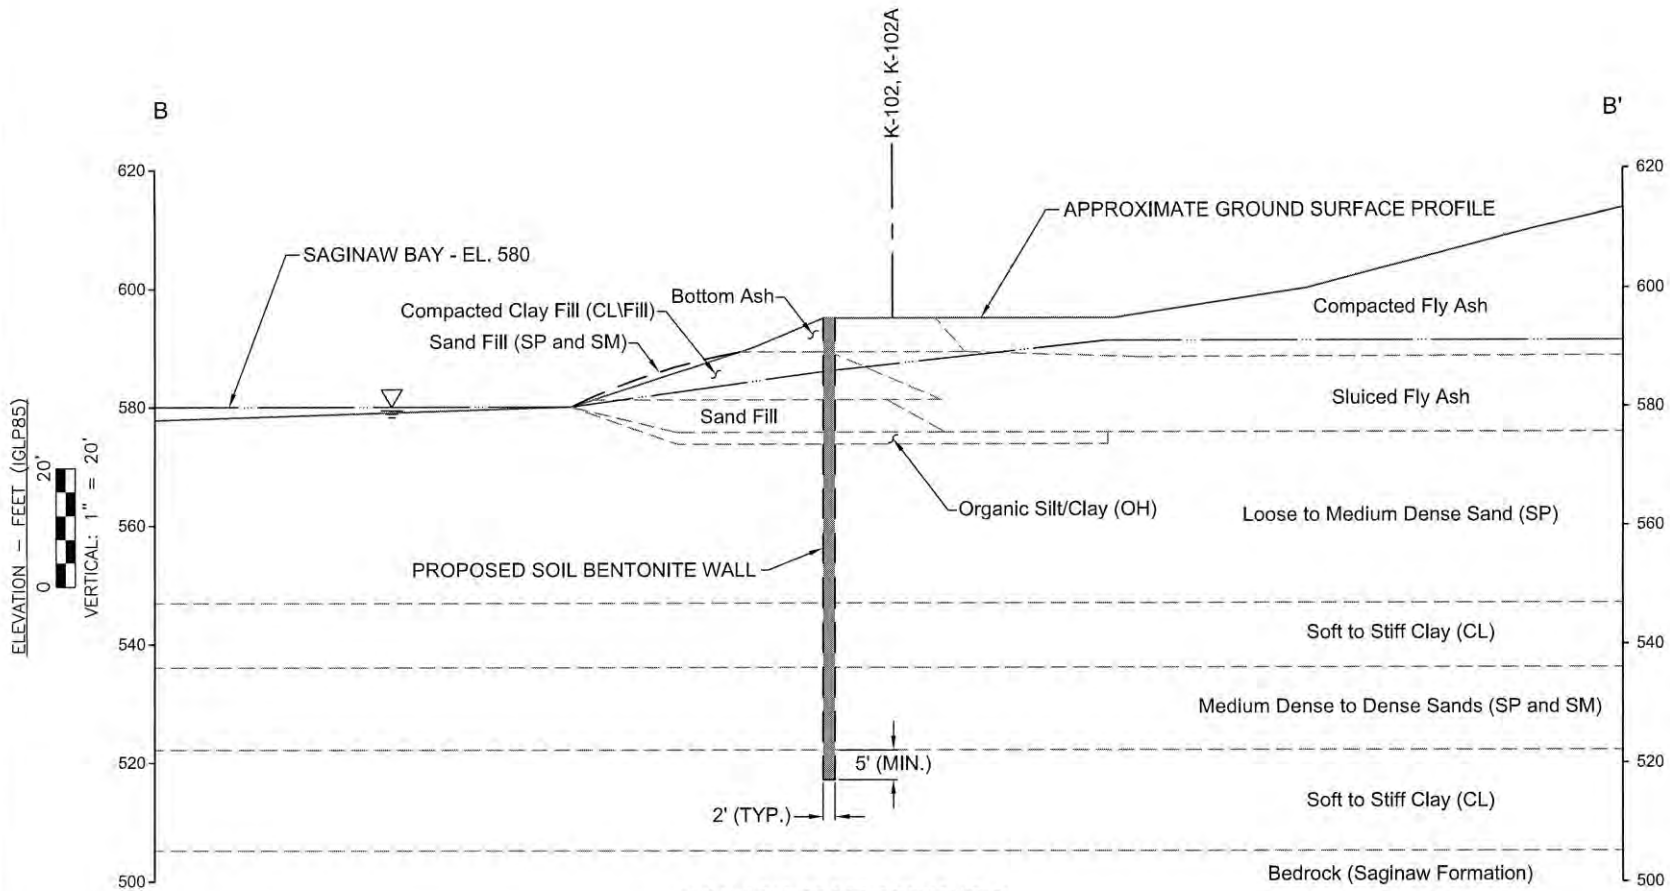
Cross Section B-B'

The reported subsurface profile of the northern and western perimeter dikes is presented on **Figure 6**. The dike in this area reportedly consists of a mechanically-placed clay dike constructed over sand fill. Fly ash is present along the upstream side of the dike but did not appear to extend below the original dike material. The dike fill materials are underlain by natural sands with interbedded clay layers. The natural sands are underlain by native stiff clays. A relatively thin strata of natural organic clay and/or organic silt is present at the interface between the dike material and natural foundation soils.

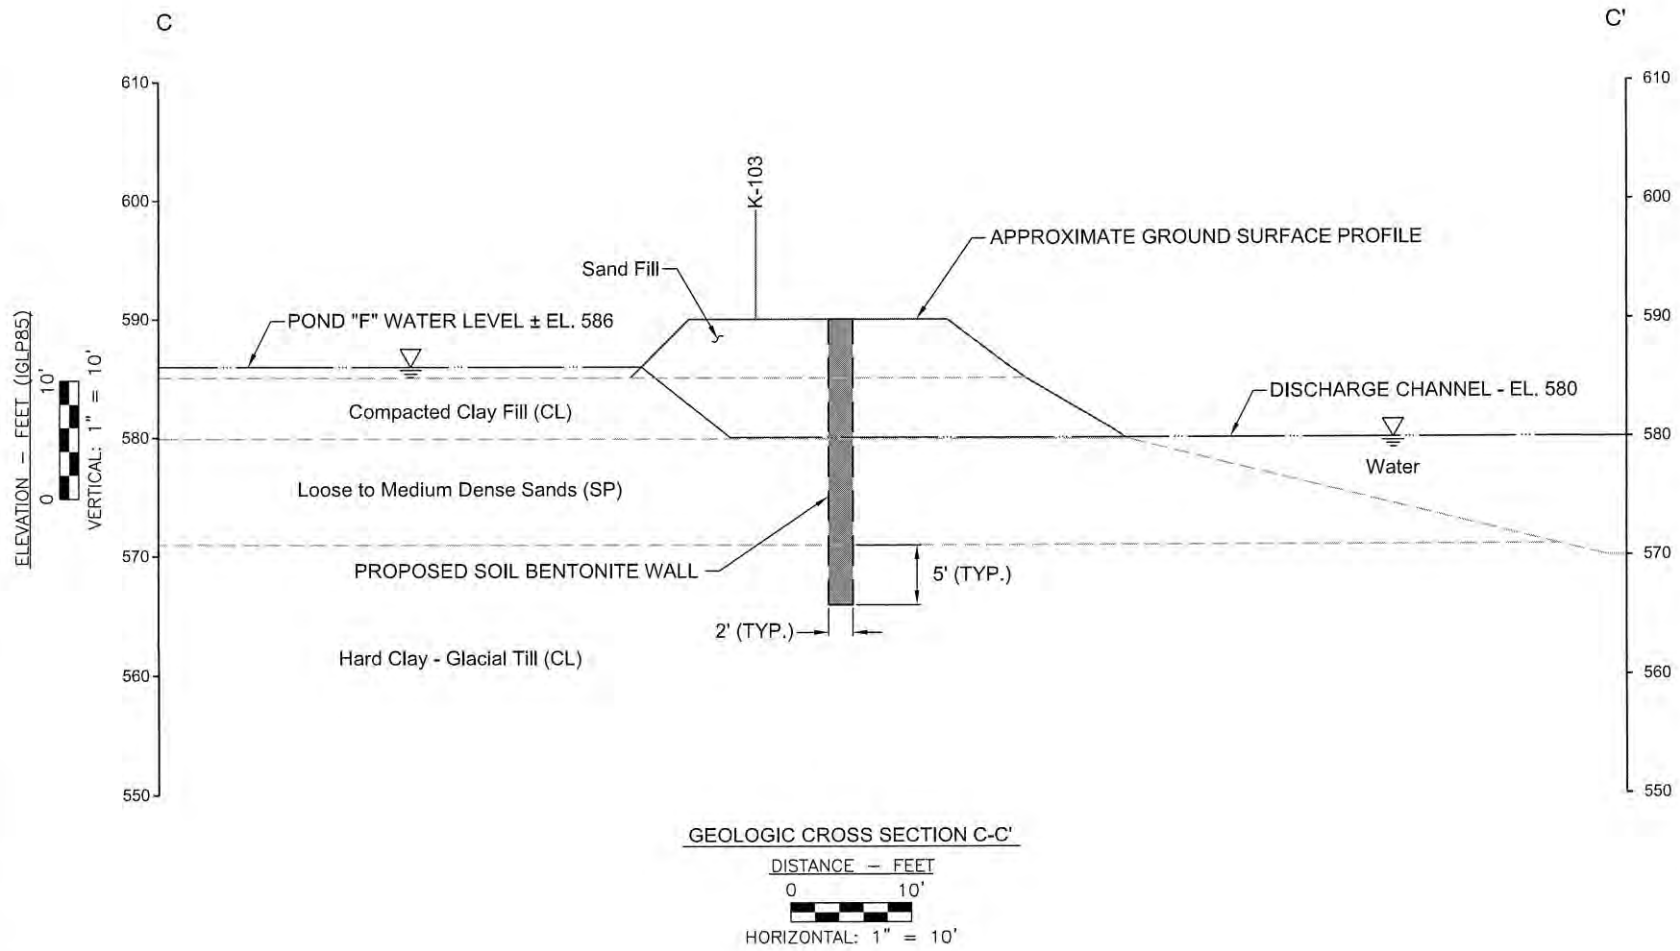
Cross Section C-C'

The reported subsurface profile of the dike area near the Discharge Canal is presented on **Figure 7**. The dike materials in this area reportedly consist of sand fill overlying clay fill. The dike materials are underlain by natural sands that overlie natural hard clays.

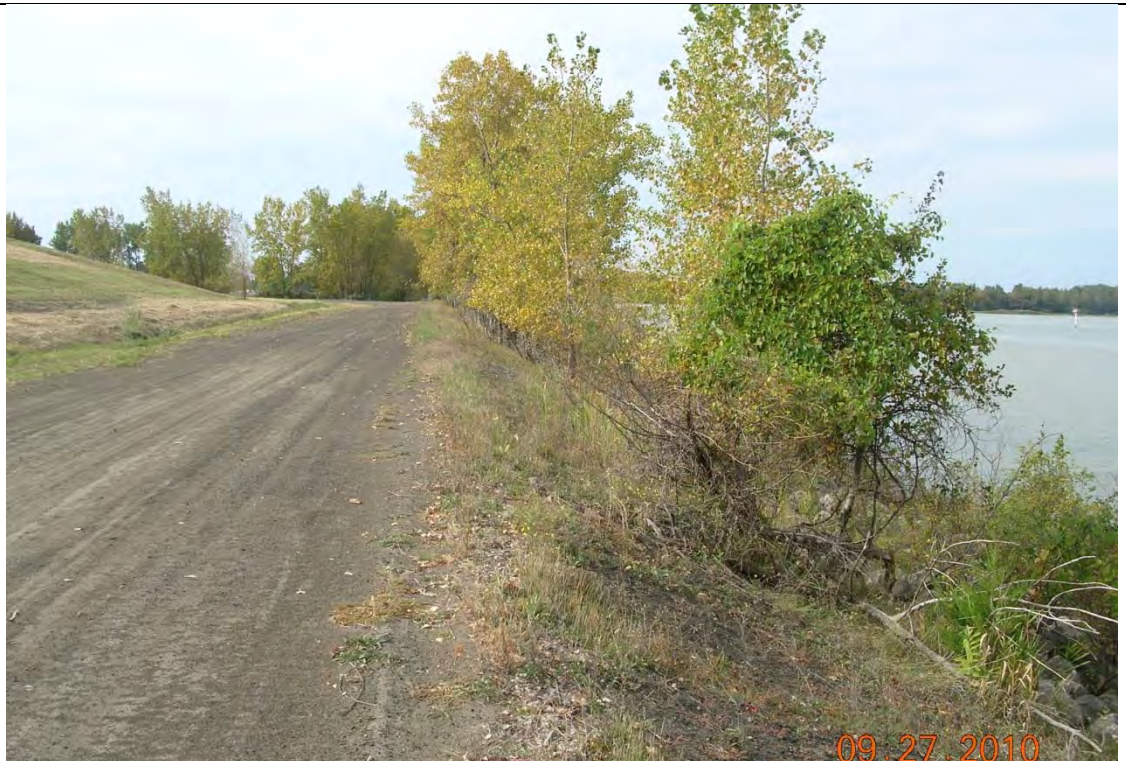
Photo No. 8	Date: 9/27/2010
Direction Photo Taken: Southwest

Description:
Crest and outer dike slope near the northwestern corner of the Karn Disposal Area.

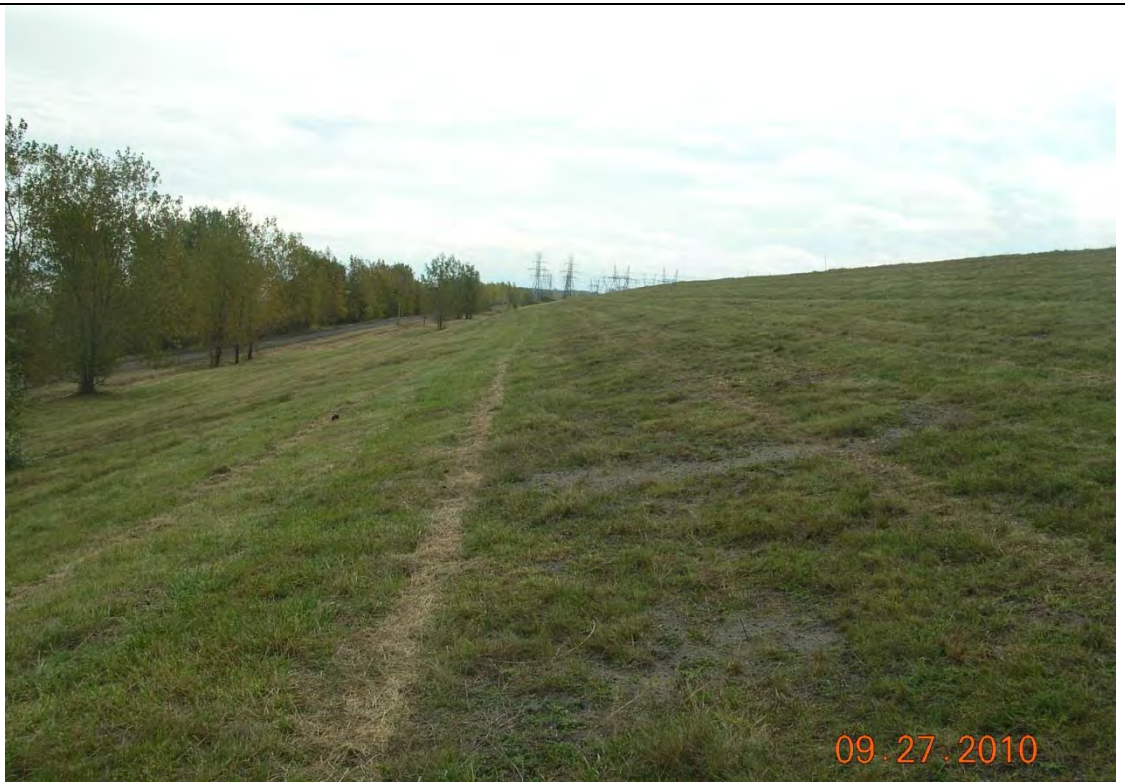
Photo No. 14

Description: View from approximately the mid point between the toe of the inner dike slope and the top of the fly ash disposal area.

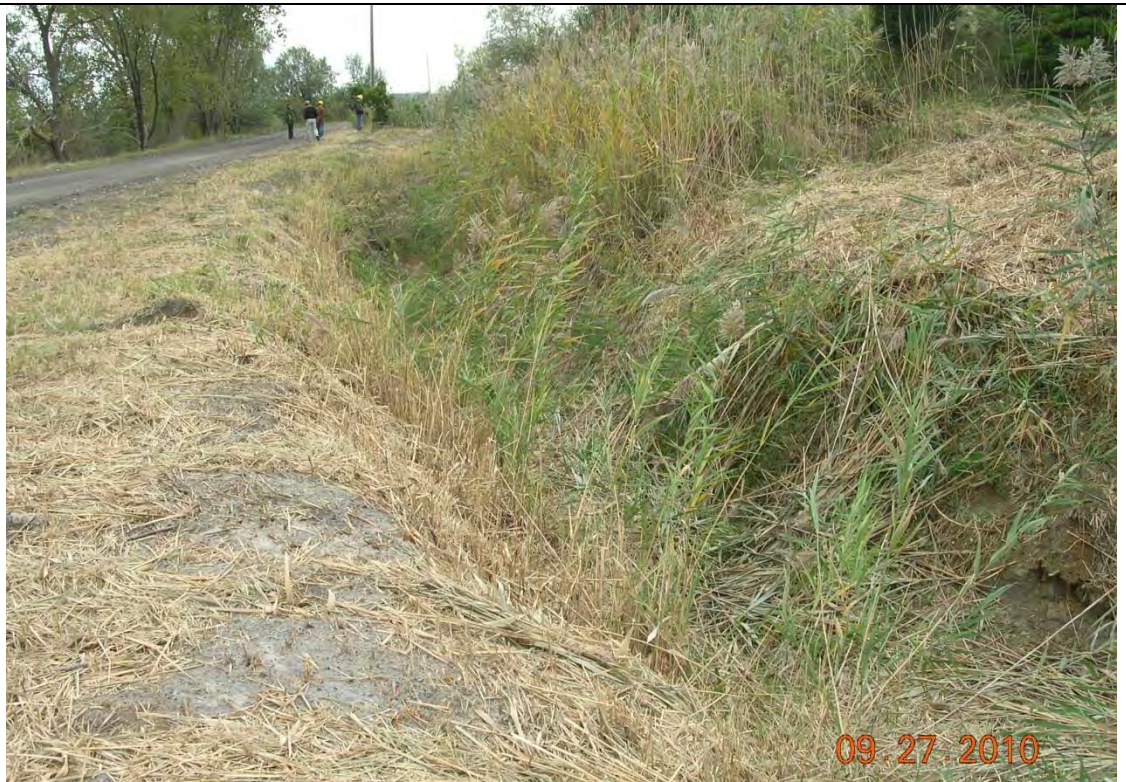
Photo No. 22

Description: The inner dike slope and stormwater drainage ditch.

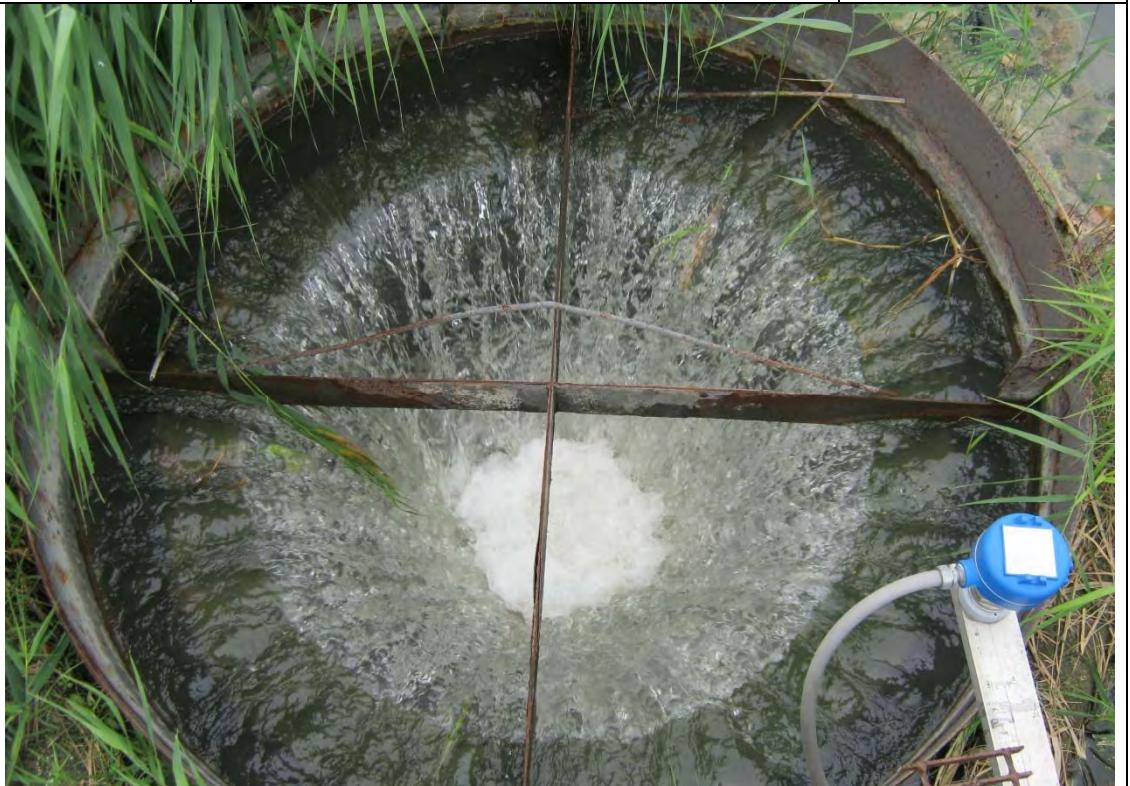
The metal ring and concrete pipe at the NPDES discharge structure. The electronic water level meter is in the lower right hand corner of the picture.

1. Remove the former NPDES discharge structure, including excavating and removing the former pipes, and replace with compacted fill.

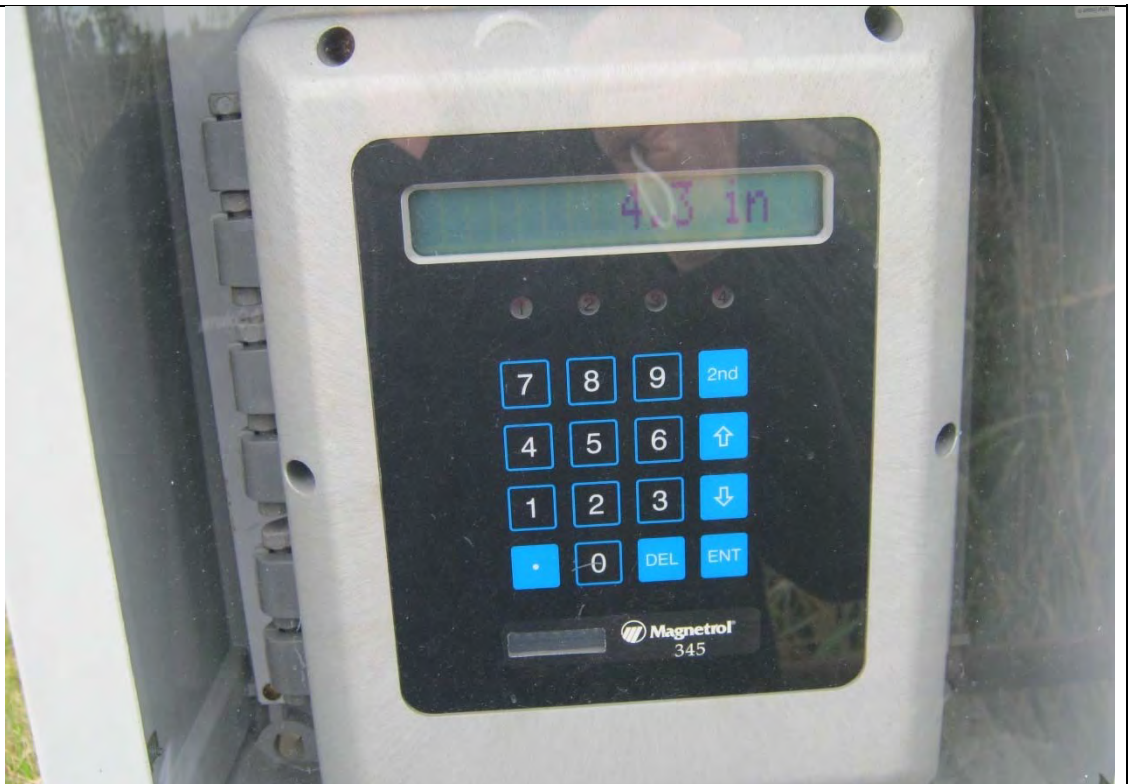
Photo No. 32

The readout for the electronic water level meter.

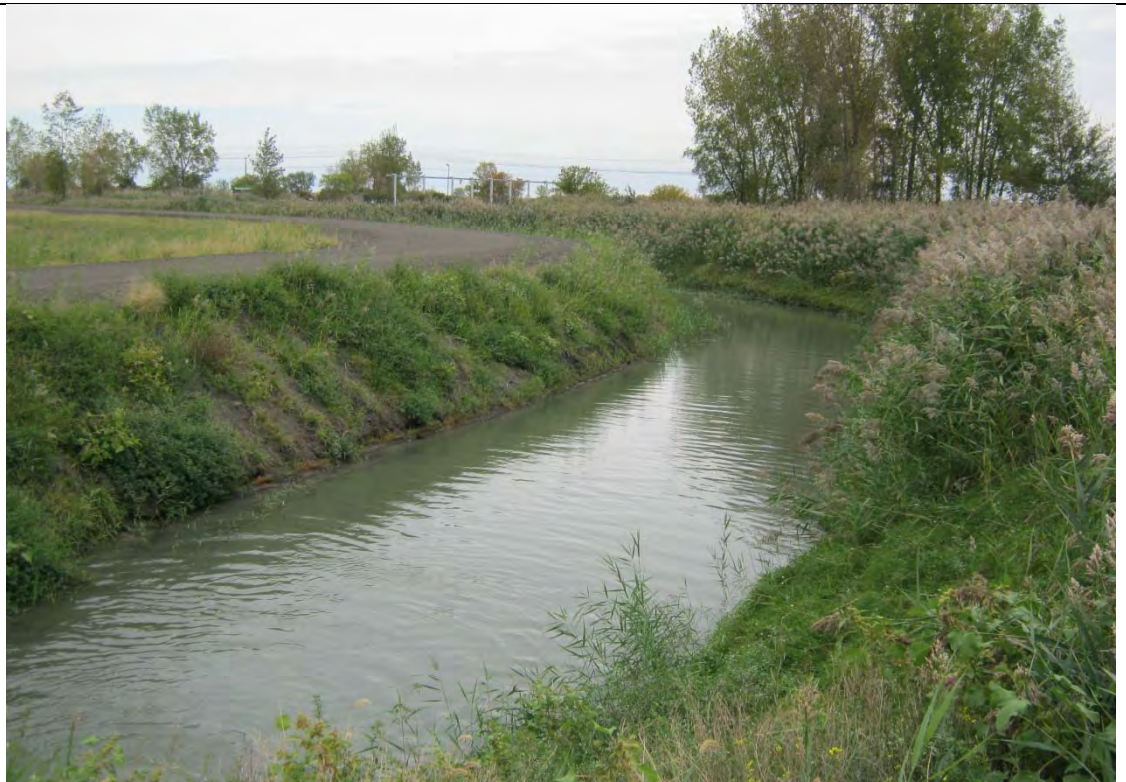
Photo No. 36

Description: One of the drainage ditches that conveys Bottom Ash wastewater to Pond F.

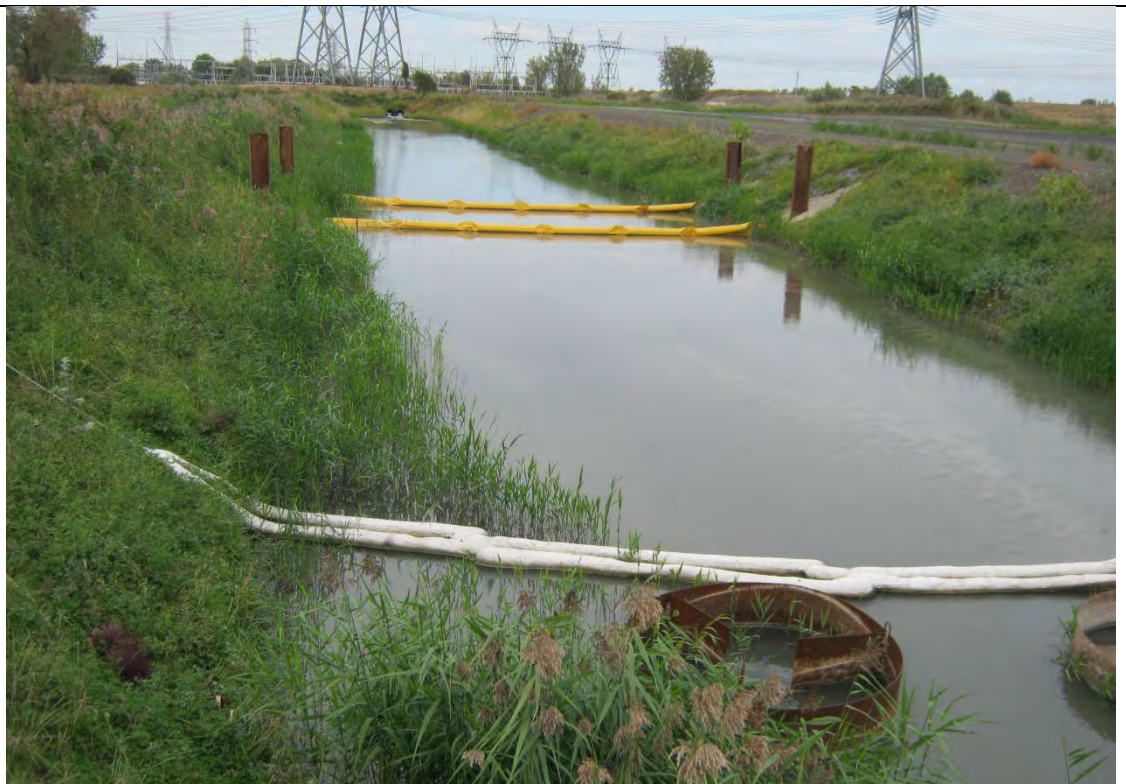
Photo No. 38

One of the drainage ditches that conveys Bottom Ash wastewater to Pond F. Yellow turbidity curtains reduce particulate in the wastewater.

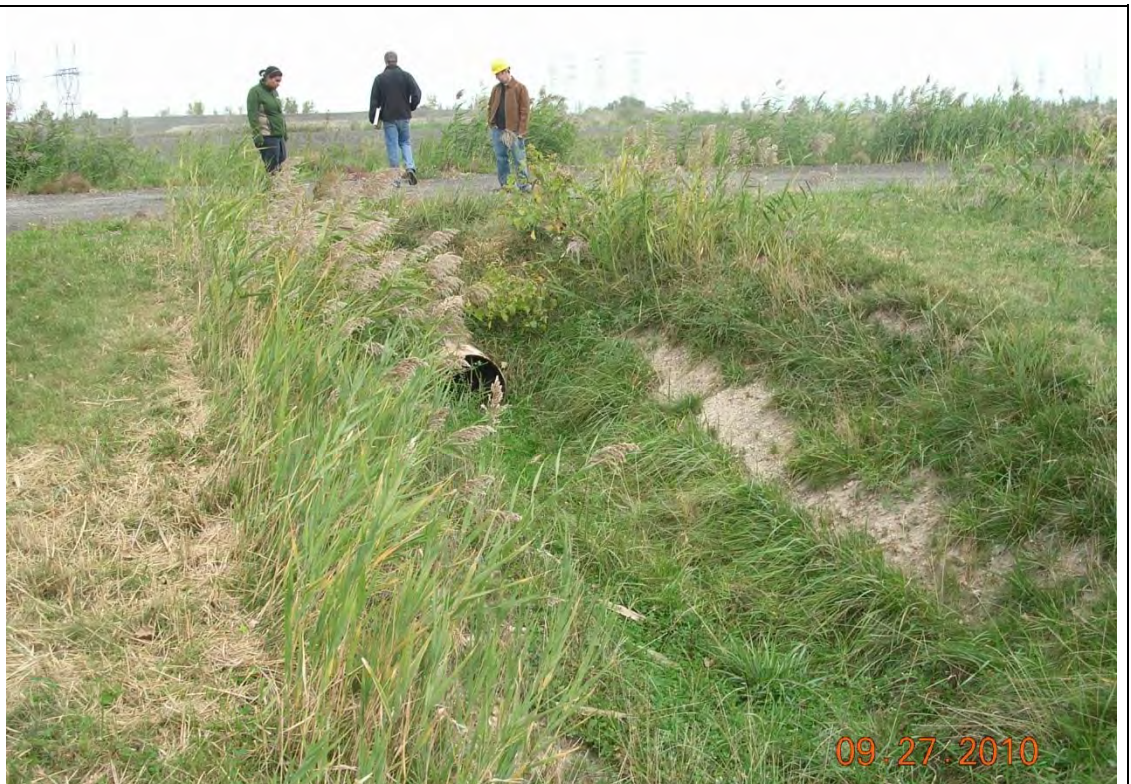
Photo No. 42

Description: Stormwater overflow outlet that empties the drainage ditches into the Discharge Canal.

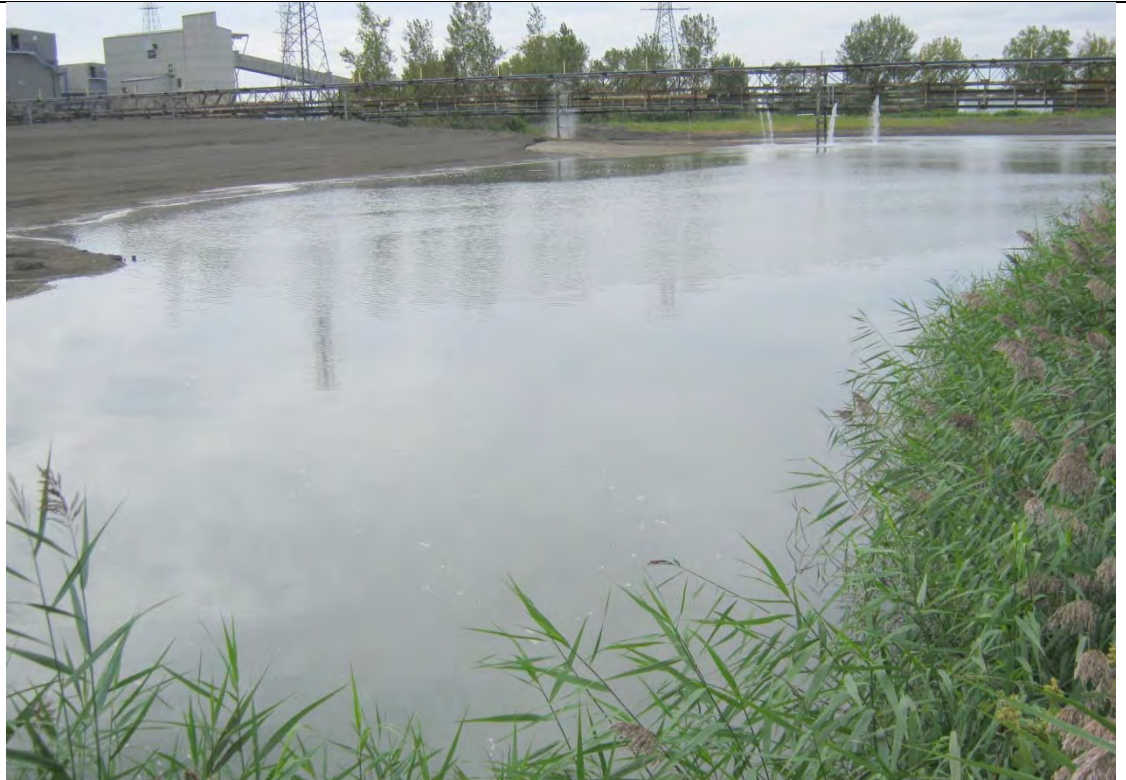
Photo No. 44

Description: Bottom Ash wastewater discharge pond.

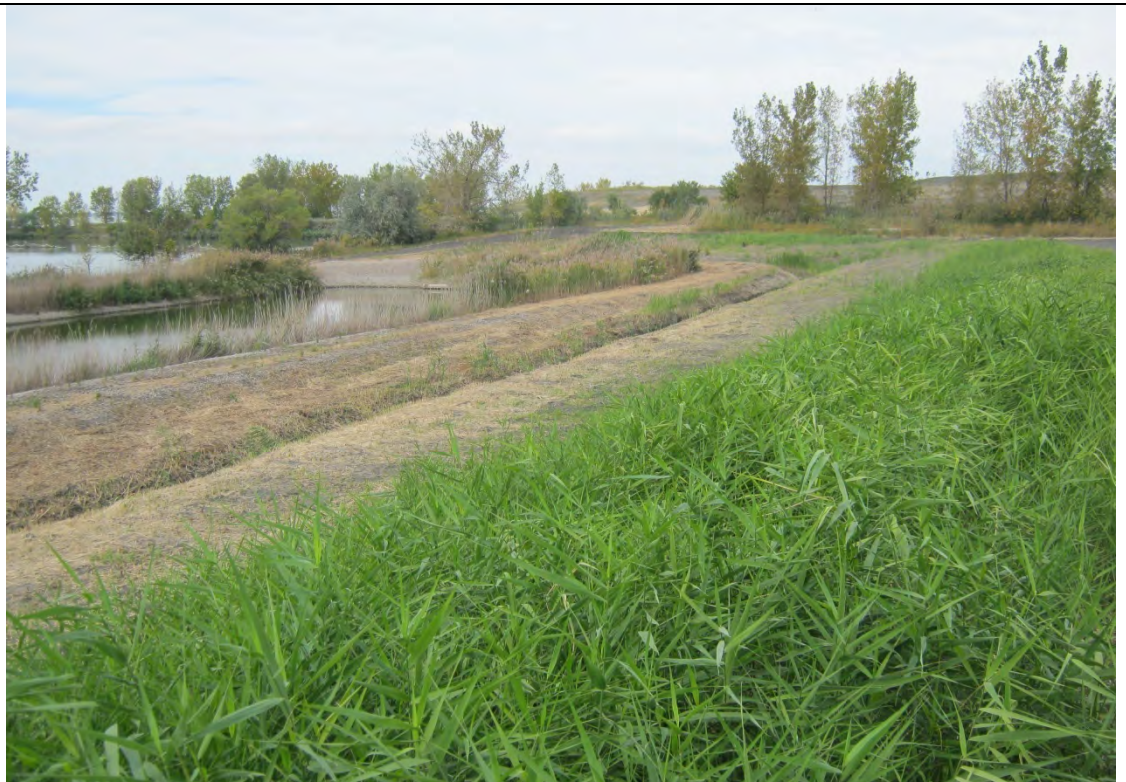
Photo No. 46

Description: Chemical treatment ponds are located within the Karn Disposal Area.
