Report of Dam Safety Assessment of Coal  
Combustion Surface Impoundments  
Central Louisiana Electric Company (Cleco)  
American Electric Power (AEP)  
Southwest Electric Power Company (SWEPCO)  
Dolet Hills Power Station, Mansfield, LA

AMEC Project No. 3-2106-0183.0004

November 2010

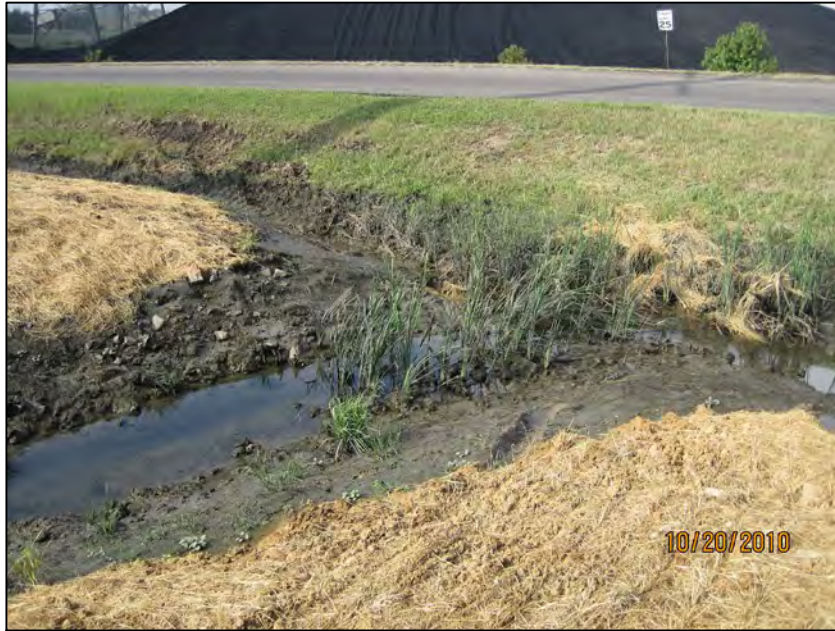
11  
**SECONDARY ASH POND-LOOKING SOUTHWEST  
 AT LPDES OUTFALL 002 CHANNEL**

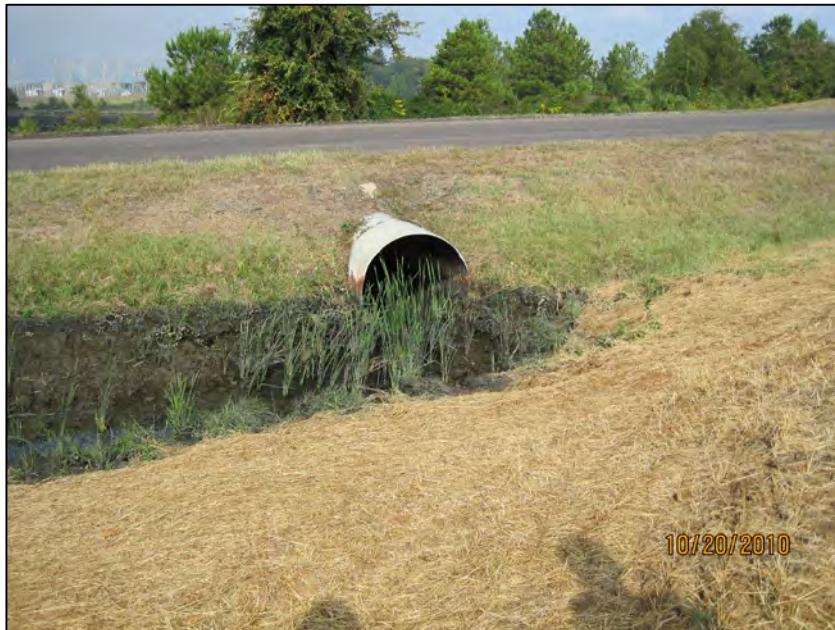
12  
**SECONDARY ASH POND-LOOKING WEST AT LPDES  
 OUTFALL 002 CHANNEL AND PIPE CULVERT UNDER ROADWAY**

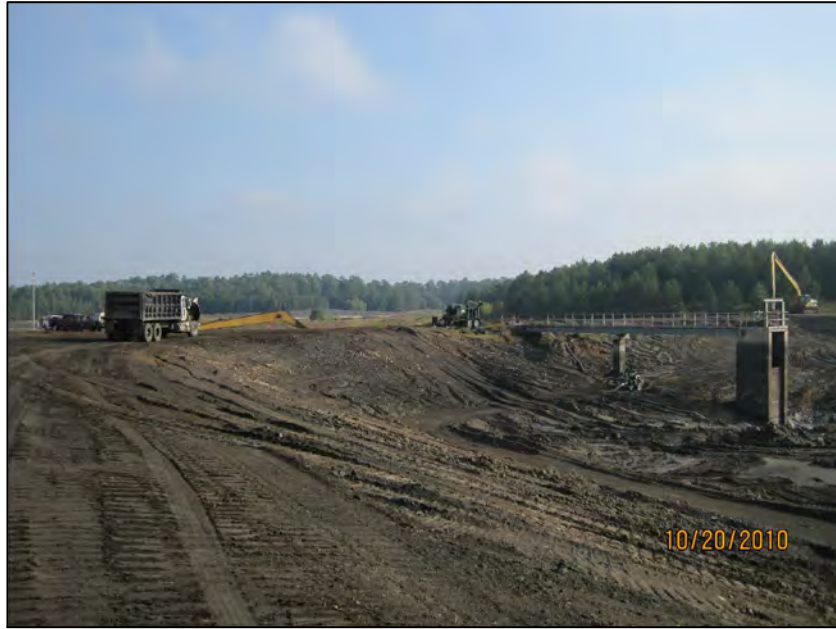
**15**  
**ASH POND 1-LOOKING NORTH FROM CREST**

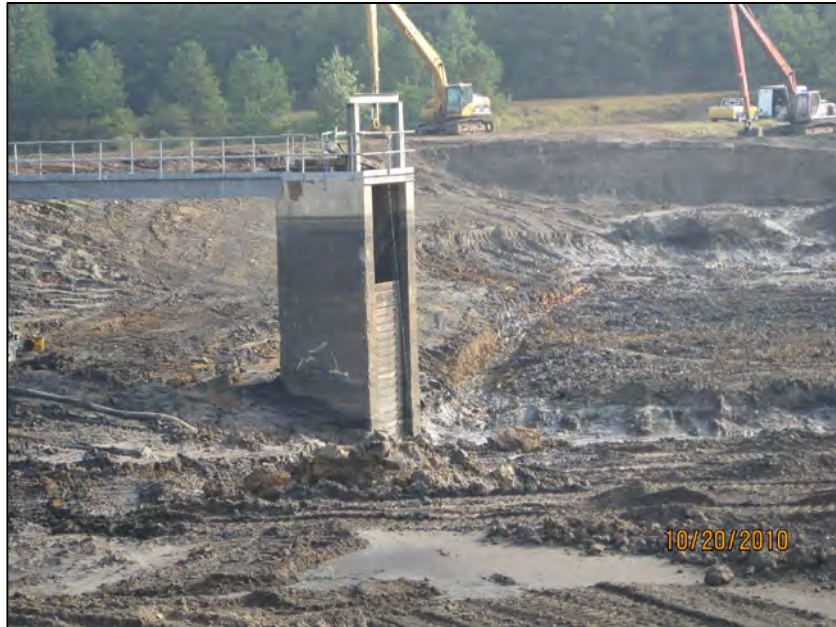
**16**  
**ASH POND 1-LOOKING NORTHEAST  
AT DISCHARGE STRUCTURE**

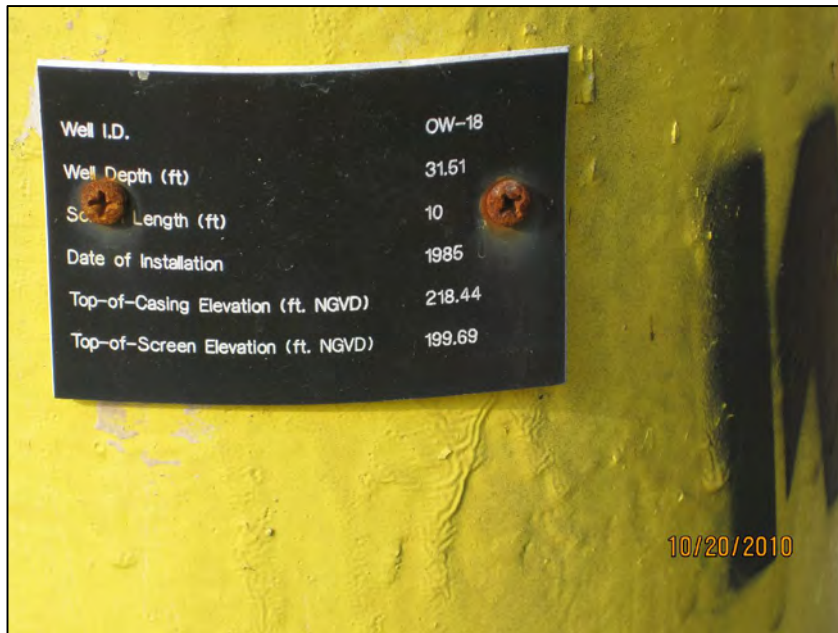
**31**  
**ASH POND 2-EXAMPLE OF OBSERVATION**  
**WELL IDENTIFICATION PLATE**

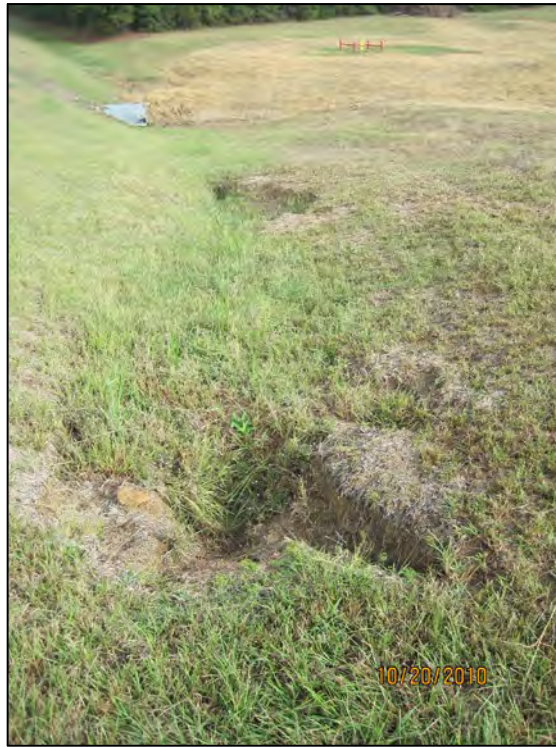
**37**  
**ASH POND 2-EROSION ON DRAINAGE SWALE OUTSIDE  
 AND AWAY FROM DOWNSTREAM EMBANKMENT TOE**

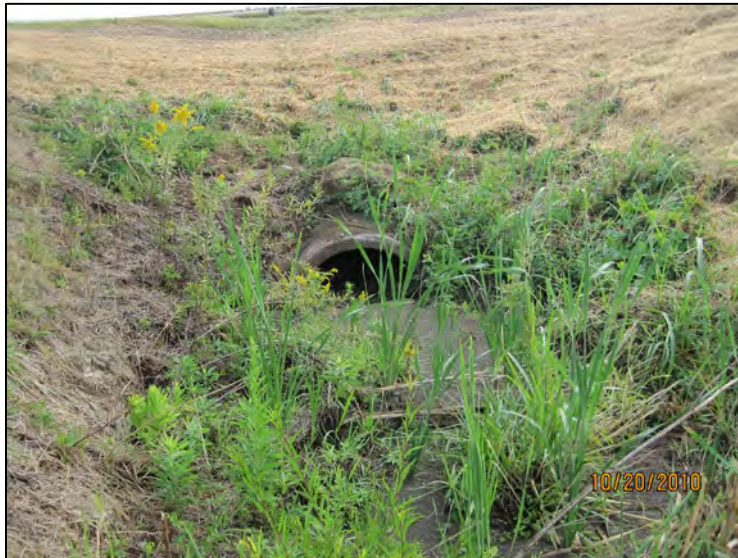
**38**  
**ASH POND 2-LOOKING UPSTREAM (EAST) AT  
 ROADWAY EMBANKMENT STORM DRAIN**

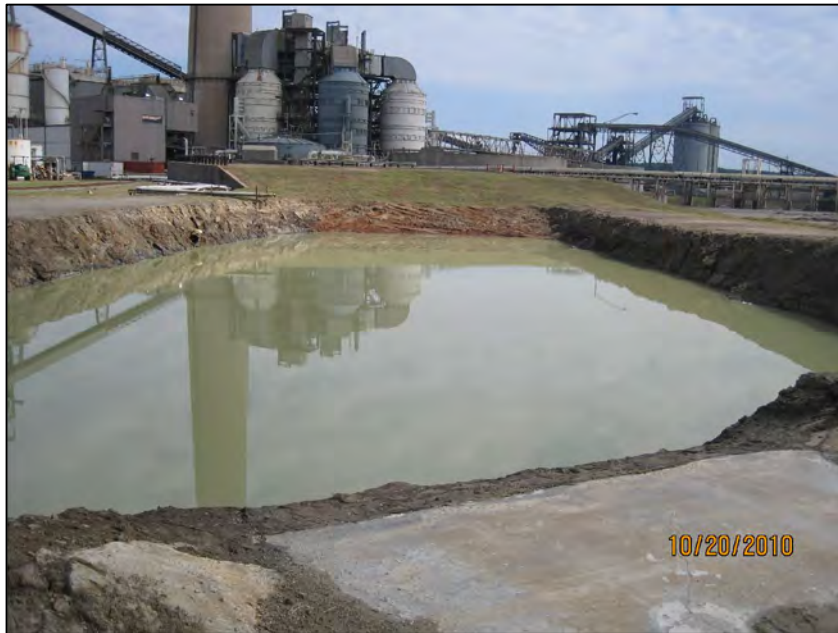
**41**  
**AUXILIARY SURGE POND-INFLUENT PIPE**

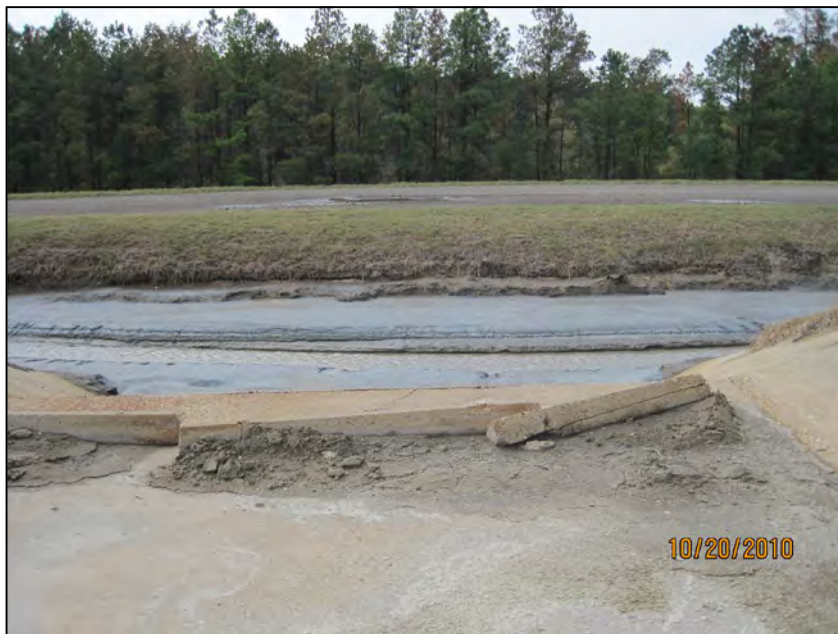
**42**  
**AUXILIARY SURGE POND-DISCHARGE SPILLWAY**

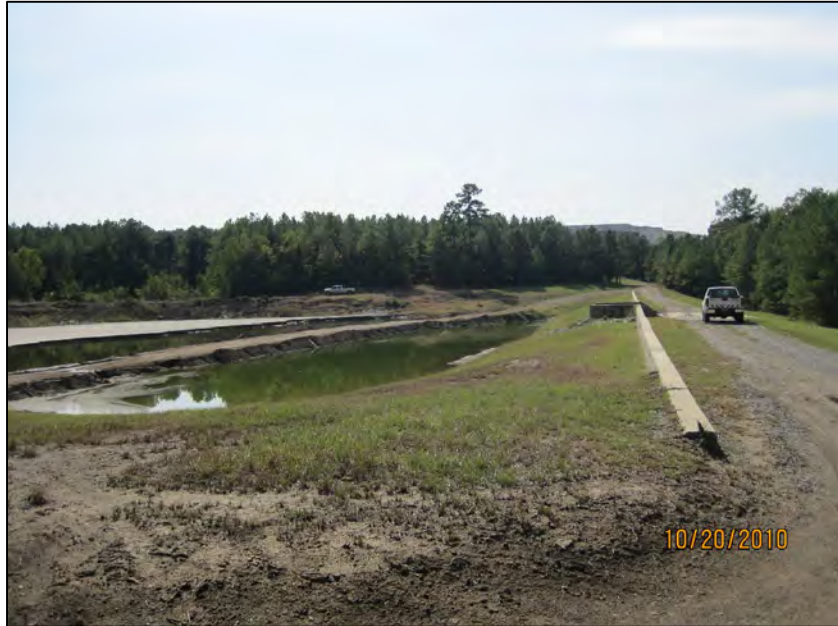
**61**  
**LANDFILL RUNOFF POND-LOOKING**  
**SOUTHWEST ALONG EMBANKMENT CREST**

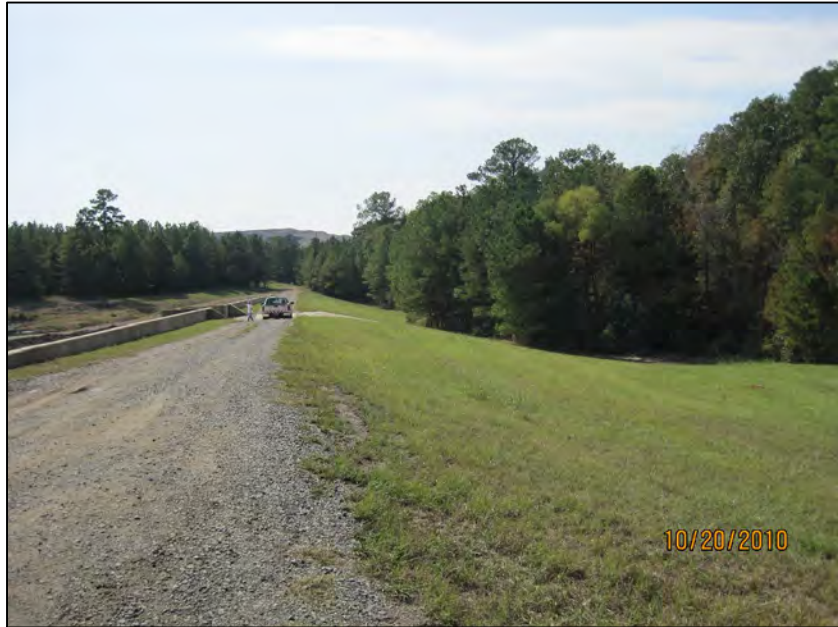
**62**  
**LANDFILL RUNOFF POND-LOOKING**  
**SOUTHWEST**  
**ALONG DOWNSTREAM EMBANKMENT**

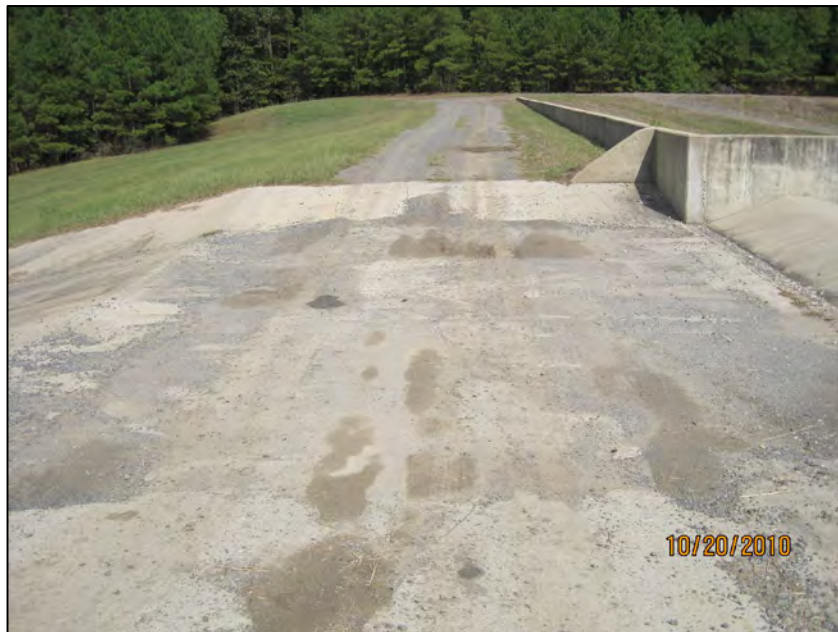
**66**  
**LANDFILL RUNOFF POND-LOOKING  
 NORTHEAST ACROSS EMERGENCY SPILLWAY**

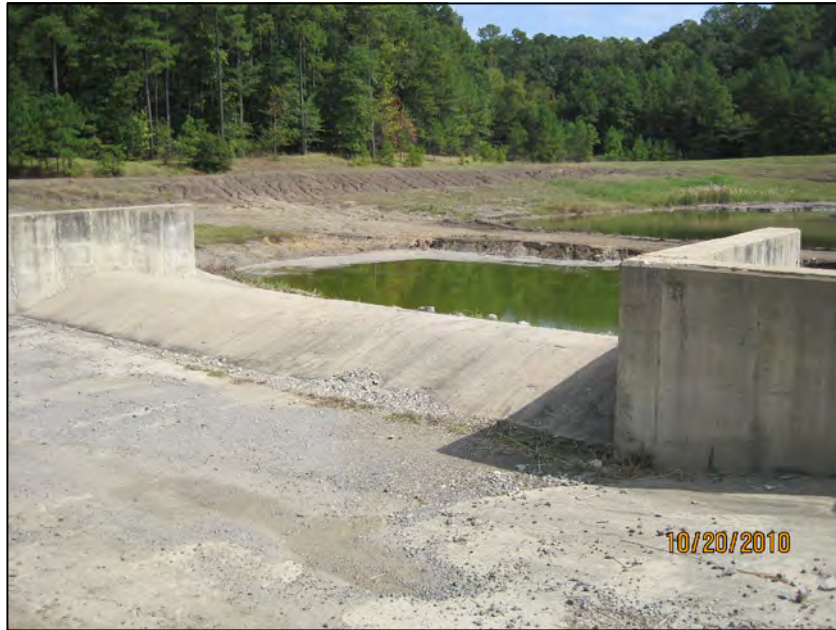
**67**  
**LANDFILL RUNOFF POND-LOOKING EAST AT EMERGENCY SPILLWAY**

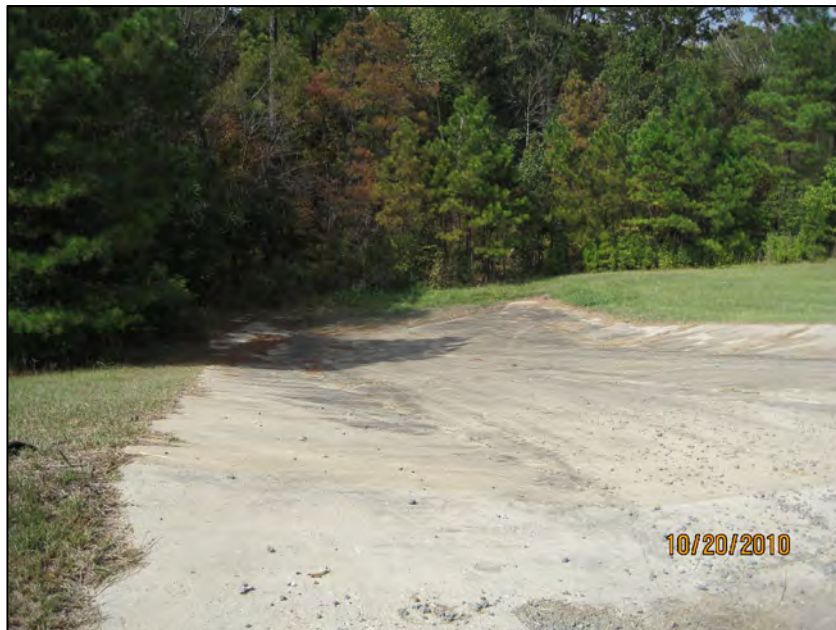
**68**  
**LANDFILL RUNOFF POND-DOWNSTREAM PORTION OF EMERGENCY SPILLWAY**

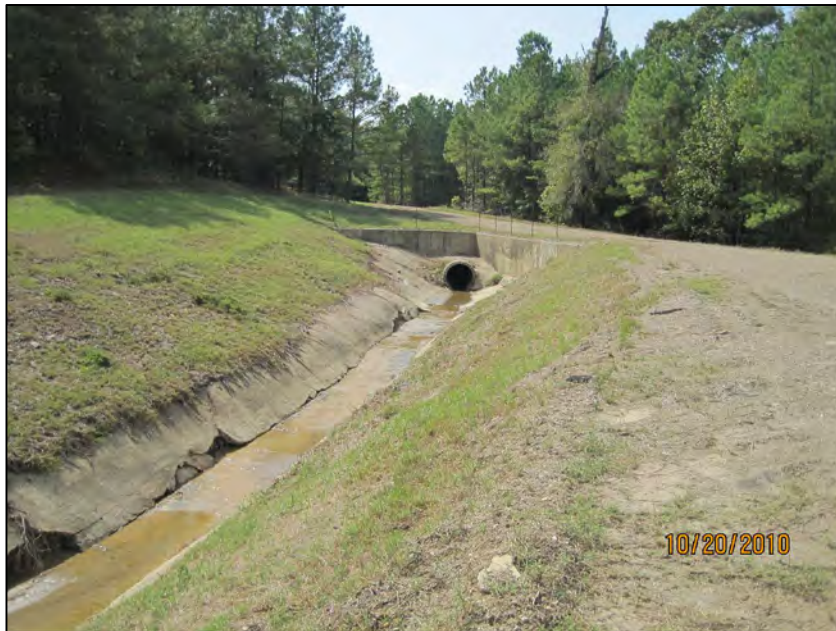
**69**  
**LANDFILL RUNOFF POND-LOOKING SOUTHWEST**  
**AT POND INFLUENT PIPE**

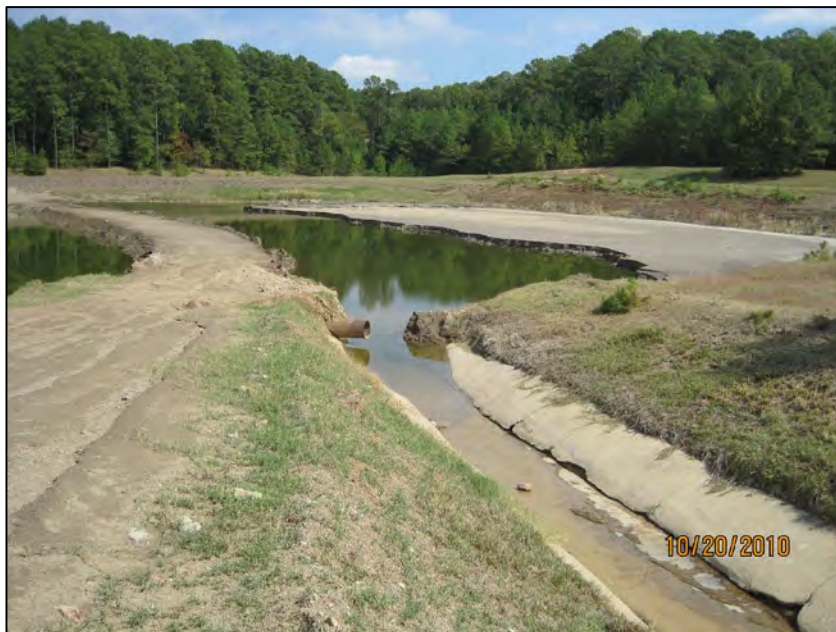
**70**  
**LANDFILL RUNOFF POND-LOOKING NORTHEAST**  
**AT POND INFLUENT CHANNEL**
