Report of Dam Safety Assessment of Coal Combustion  
Surface Impoundments  
Central Louisiana Electric Company (Cleco)  
American Electric Power (AEP)  
Southwest Electric Power Company (SWEPCO)  
Dolet Hills Power Station, Mansfield, LA

AMEC Project No. 3-2106-0183.0004

May 2011

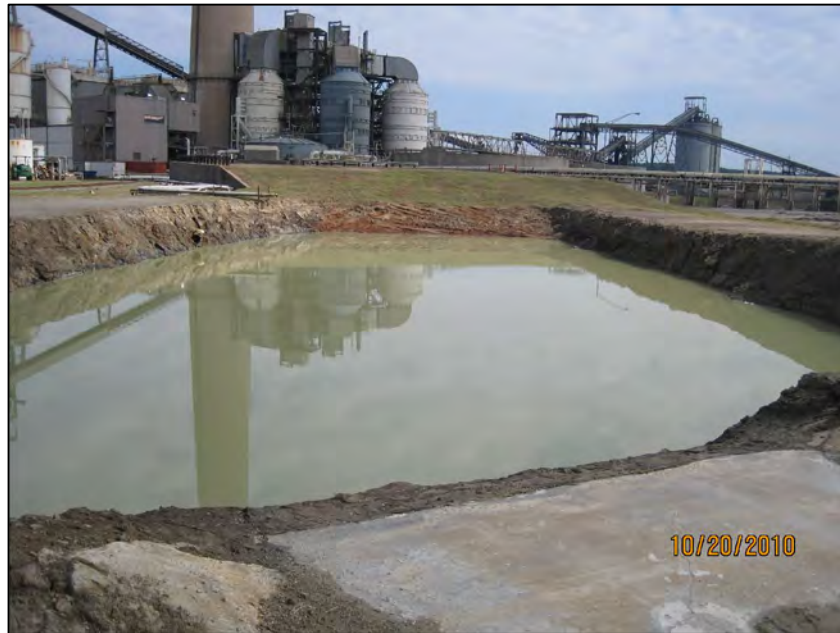
**41**  
**AUXILIARY SURGE POND-INFLUENT PIPE**

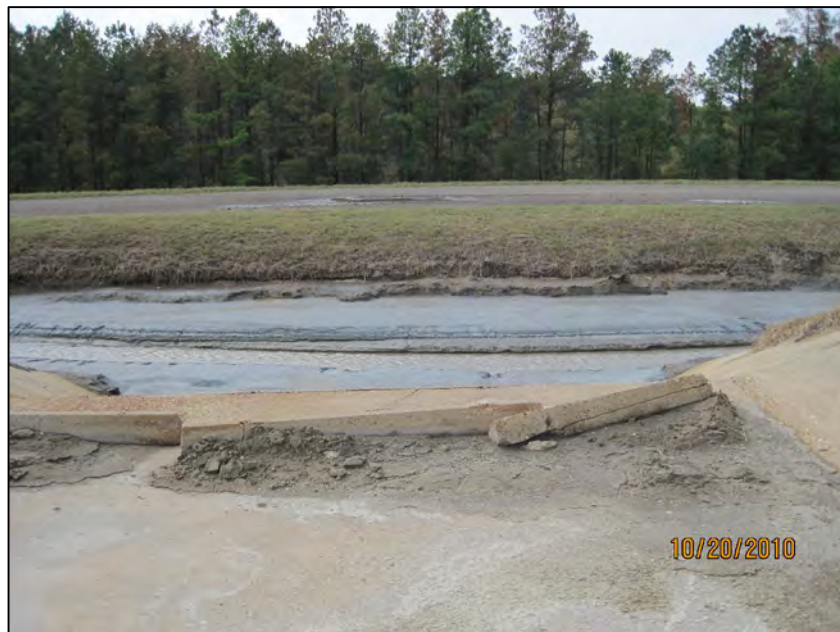
**42**  
**AUXILIARY SURGE POND-DISCHARGE SPILLWAY**

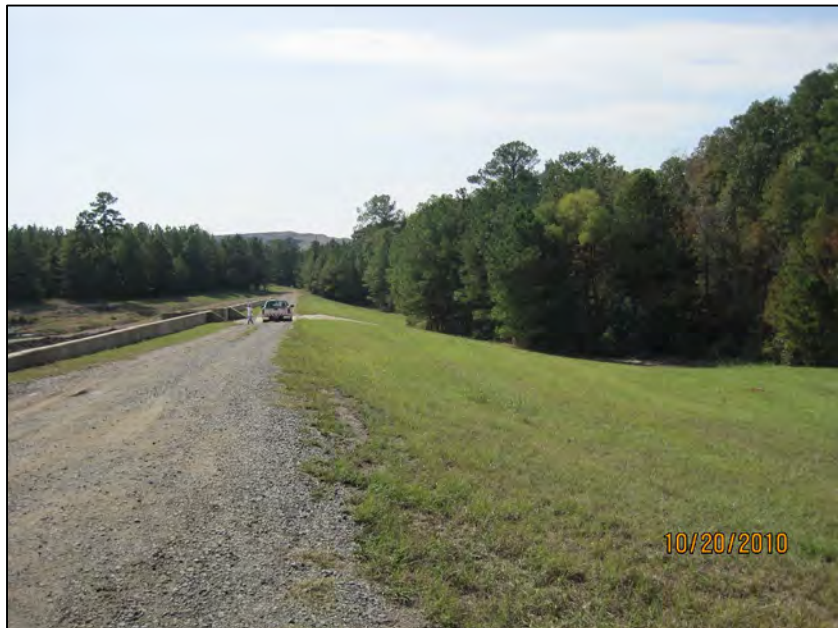
**62**  
**LANDFILL RUNOFF POND-LOOKING SOUTHWEST**  
**ALONG DOWNSTREAM EMBANKMENT**

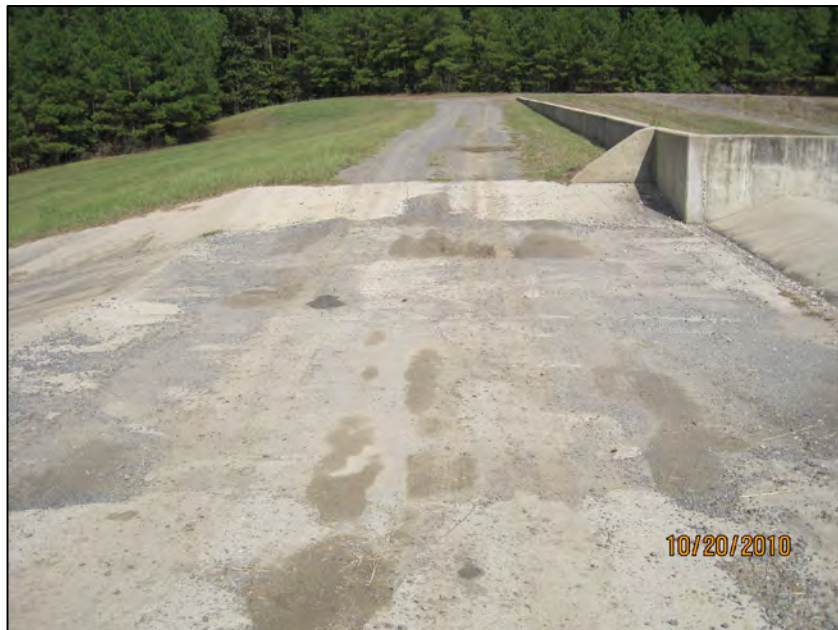
**66**  
**LANDFILL RUNOFF POND-LOOKING**  
**NORTHEAST ACROSS EMERGENCY SPILLWAY**

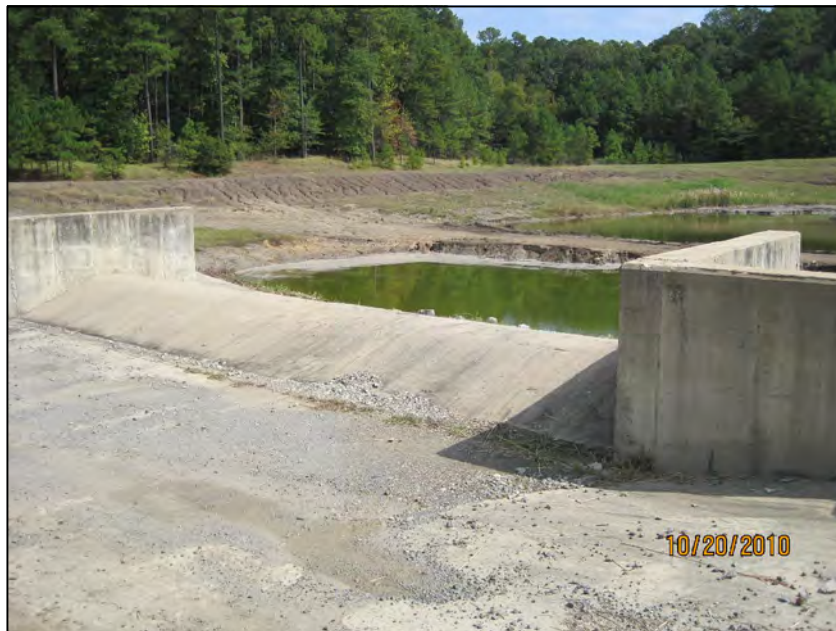
**67**  
**LANDFILL RUNOFF POND-LOOKING**  
**EAST AT EMERGENCY SPILLWAY**
