# Assessment of Dam Safety of Coal Combustion Surface Impoundments

**Coletto LP, LLC**

**Coletto Creek Power, LP**

**August 4, 2010**

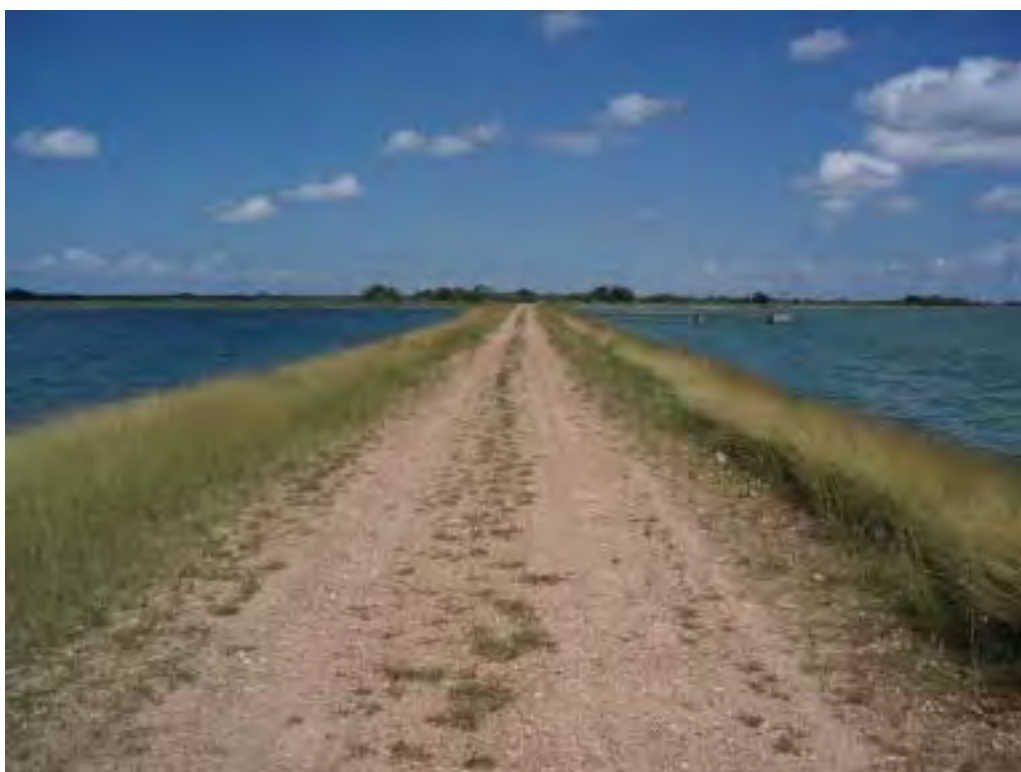
The crest of the Primary Ash Pond generally appeared to be in fair condition (Photos 2, 14, 50, 57, 63, 73, 77, 79, 82, 85, 86, 87, 89, 92, 95, 100, 103, 112, and 115). The crest was approximately 20 feet wide. The crest is surfaced with compacted gravel and is used as an access road. Sparse vegetation was growing in the middle and on both sides of the roadway. Desiccation cracks approximately a ¼ inch wide were observed at various locations on the crest (Photo 68). Observed freeboard at the time of the visit was approximately three feet with an approximate water level at El. 137.

Photo No. 2: Crest of divider embankment from northwest corner, looking southeast.

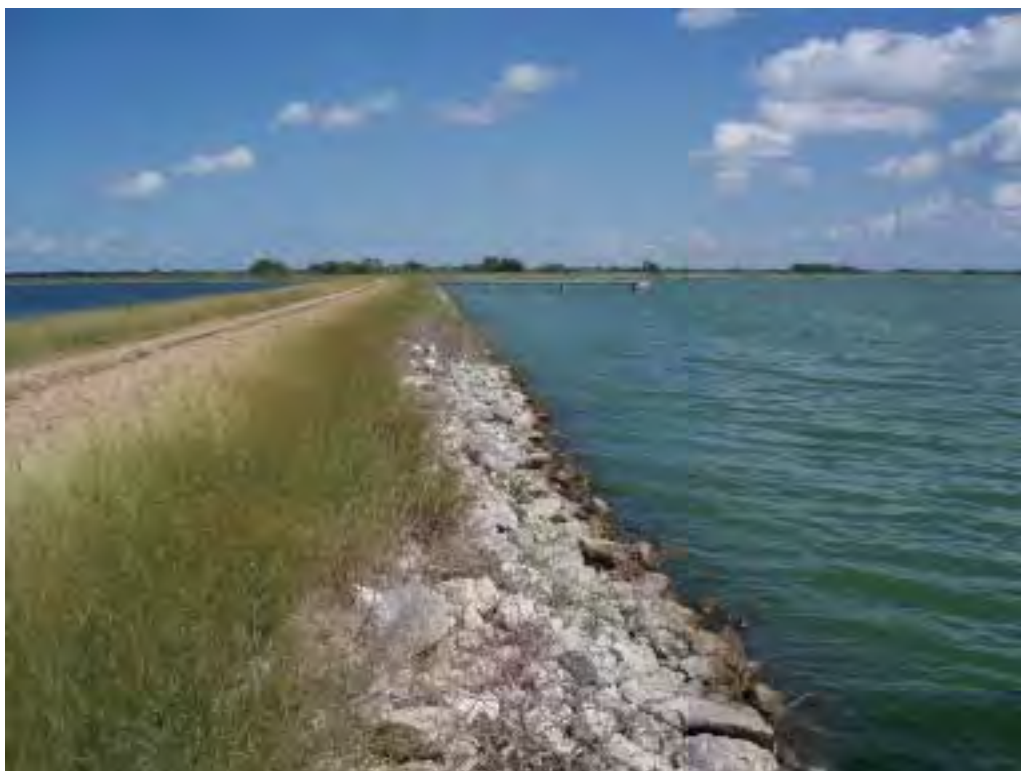
The visible portions of the interior slope generally appeared to be in fair condition (Photos 3, 9, 10, 12, 13, 51, 54, 58, 61, 64, 70, 74, 78, 79, 85, 87, 88, 93, 94, 101, 102, 110, 113, and 116). The north, east, and west interior slope and southwest slope of the divider embankment generally appeared to be armored with a layer of riprap. No riprap was observed on the southern embankments. Grass and brush approximately 24 to 36 inches tall was observed growing in the riprap. An 8-inch-diameter mesquite tree was observed on west end of the north embankment (Photo 54).

Photo No. 3: Primary Ash Pond - Southwest slope of divider embankment from northwest corner, looking southeast.

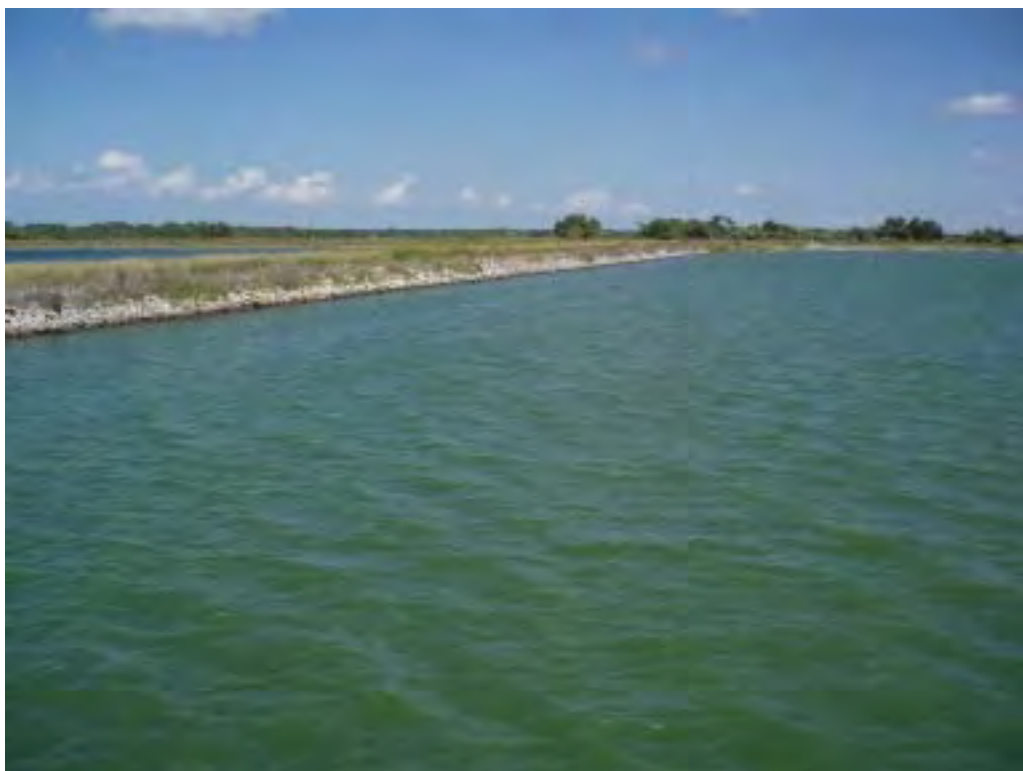
Photo No. 9: Primary Ash Pond - Southwest slope of divider embankment, looking southeast.

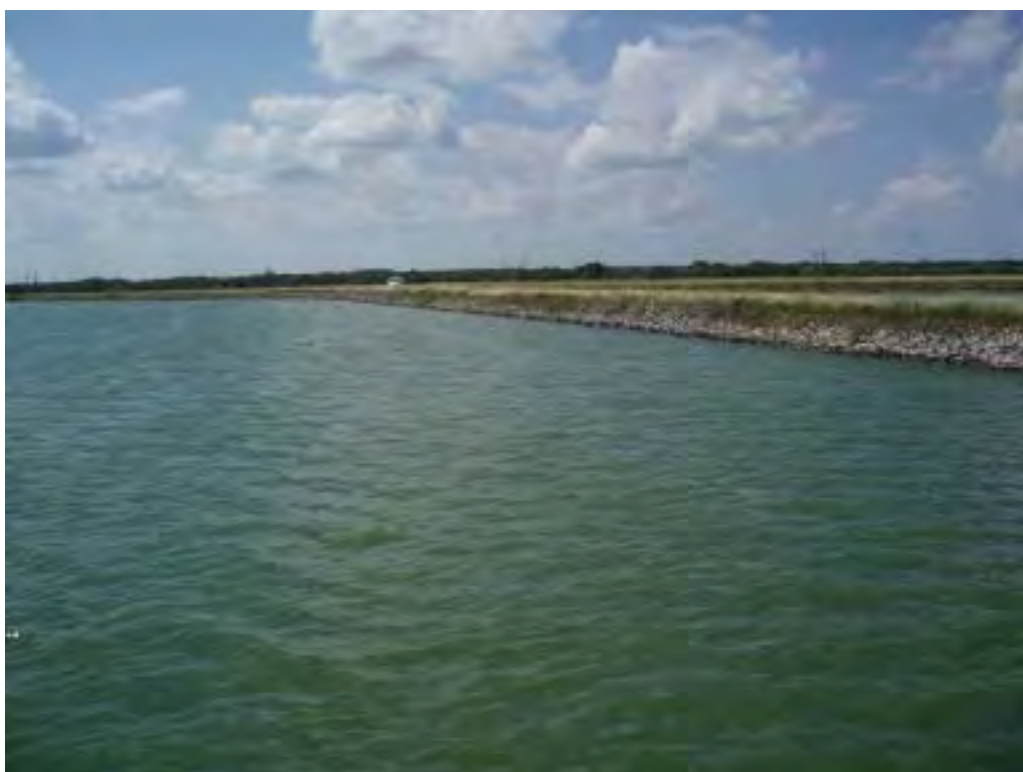
Photo No. 10: Primary Ash Pond - Southwest slope of divider embankment, looking northwest.

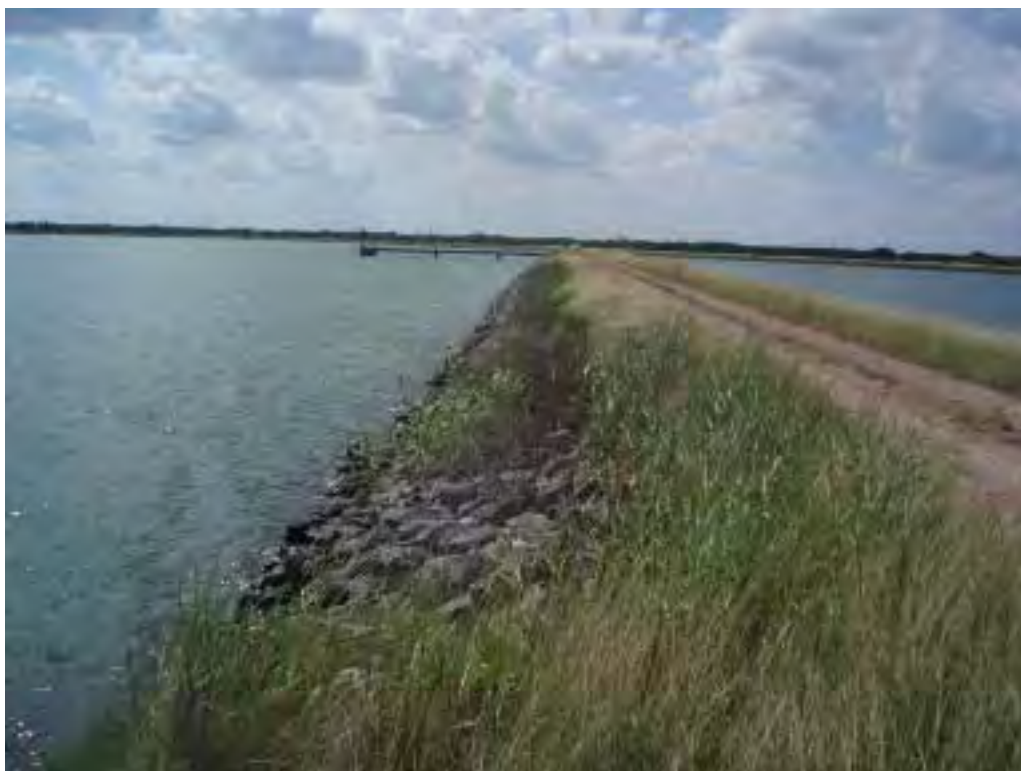
Photo No. 13: Primary Ash Pond - Southwest slope of divider embankment from southeast corner, looking northwest.

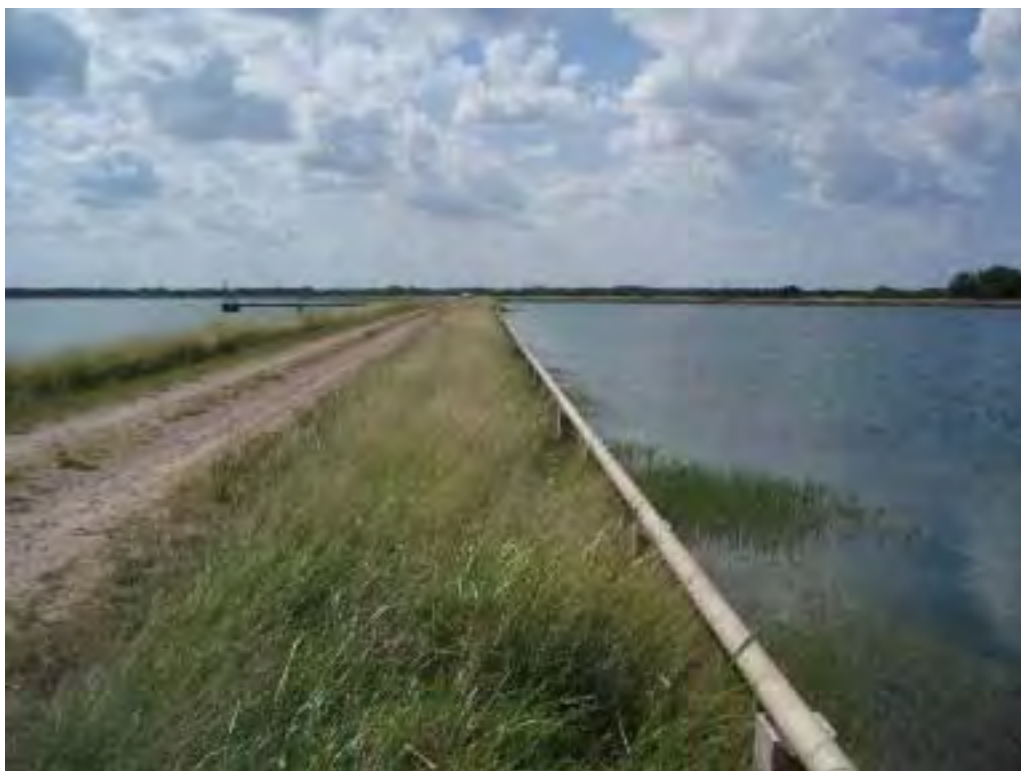
The exterior slopes appear to be in fair condition. The exterior slopes on the north, southern, west, and east embankments were approximately 2.5H:1V (Photos 49, 52, 53, 56, 62, 66, 67, 72, 76, 79, 82, 86, 90, 91, 96, 99, 104, 111, and 114). The northeast slope of the divider embankment between the Primary Ash Pond and Secondary Pond was approximately 3H: 1V (Photos 1 and 15).

The visible portions of the interior slope generally appeared to be in fair to poor condition (Photos 1, 15, 42, 43, 46, and 47). The interior slopes on the north and east embankments and the northeast slope of the divider embankment were approximately 3H: 1V.

Photo No. 15: Secondary Pond - Northeast slope of divider embankment, looking northwest.

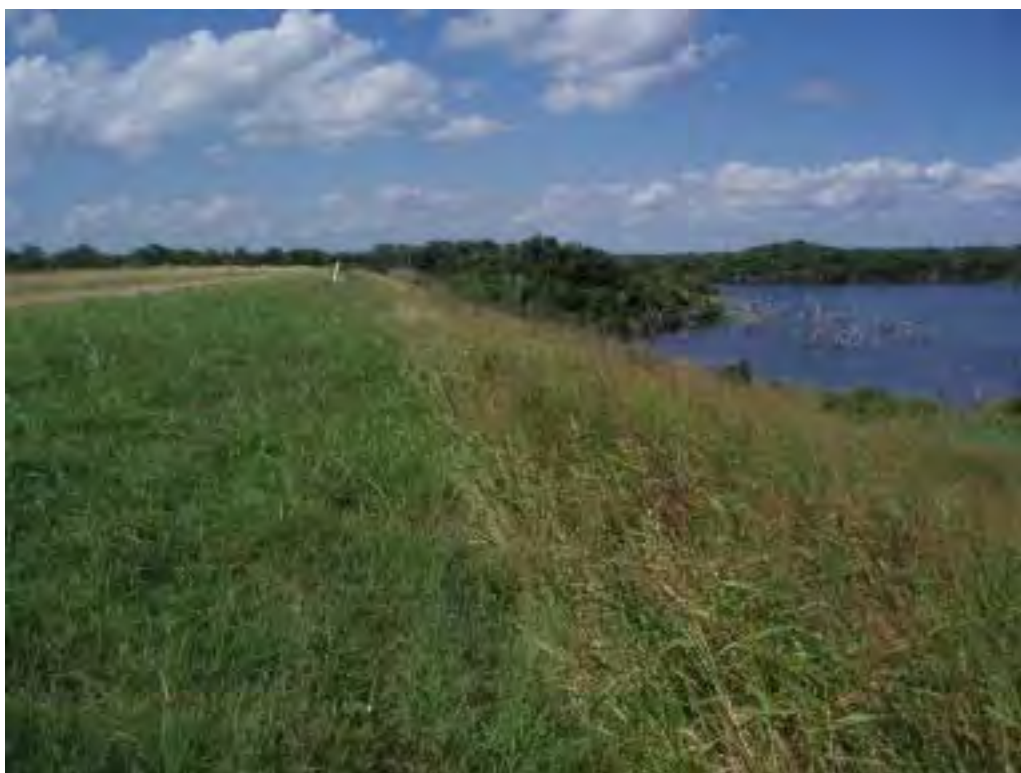
The exterior slopes appear to be in fair condition. The exterior slope on the north and east embankments were approximately 3H: 1V (Photos 18, 27, 29, 32, 35, 37, 38, and 40). Embankment vegetation consisted mainly of grass approximately 36 to 48 inches tall. On the east embankment, 8- to 12-inch-diameter dead mesquite trees and an area of thick brush were observed (Photos 27, 29 and 30). On the north embankment, small brush and mesquite trees less than 2 inches in diameter were observed (Photos 33 and 35).

Photo No. 18: Secondary Pond – East embankment exterior slope, looking northeast.

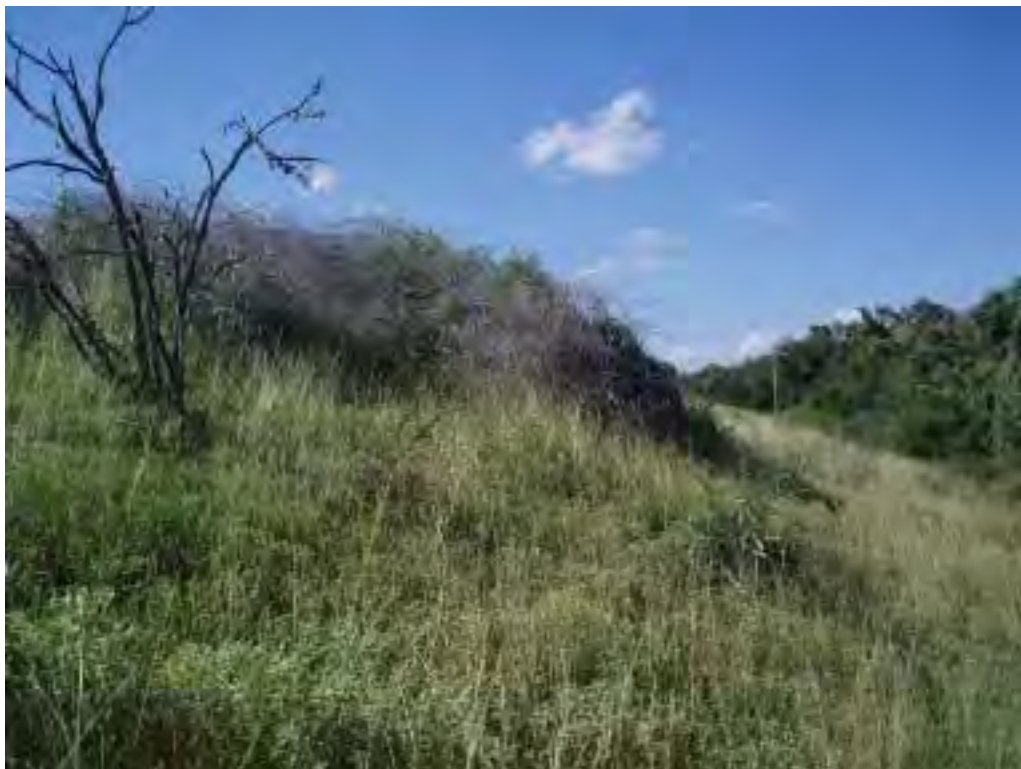
Photo No. 29: Secondary Pond - East embankment exterior slope, looking north at thick brush and dead trees.

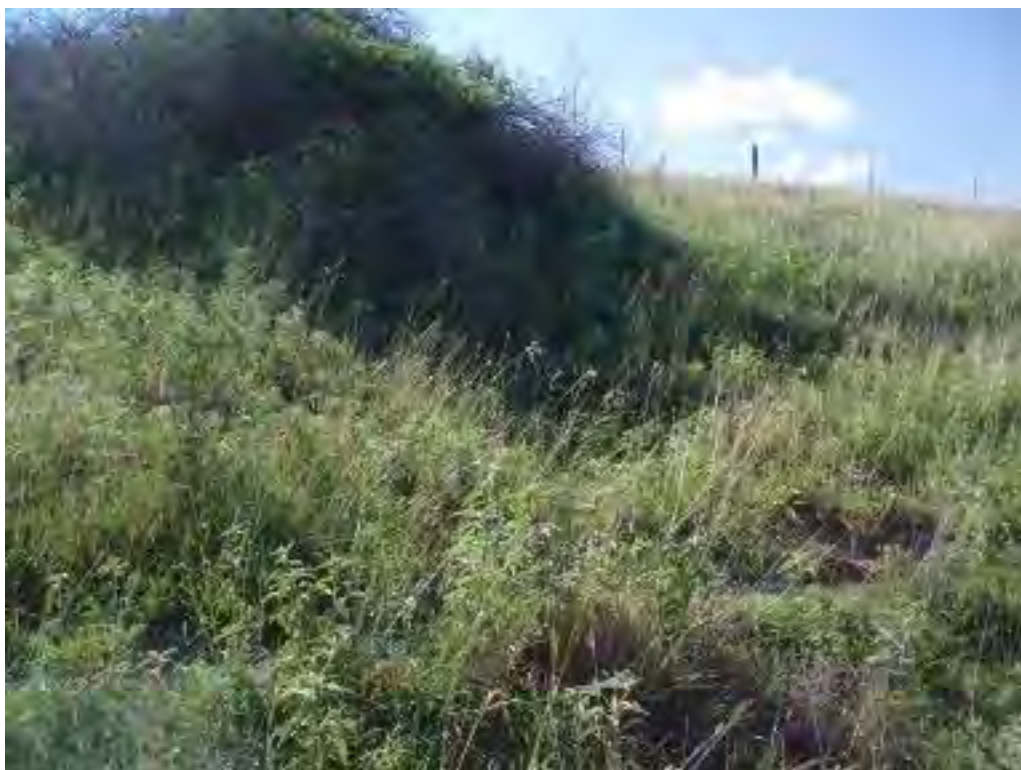
IPA leases portions of the east and north embankment area for cattle grazing. There is a barbed wire fence along the edge of the crest and along portions of the north and east embankment exterior slopes (Photos 27, 30, 32, 35, 37, 46, 47, 48). Bare areas, sparsely vegetated areas, and livestock trails were observed on the east and north embankment exterior slopes.

Photo No. 30: Secondary Pond - East embankment exterior slope, looking at 8'Lx8'Wx2'D depression.

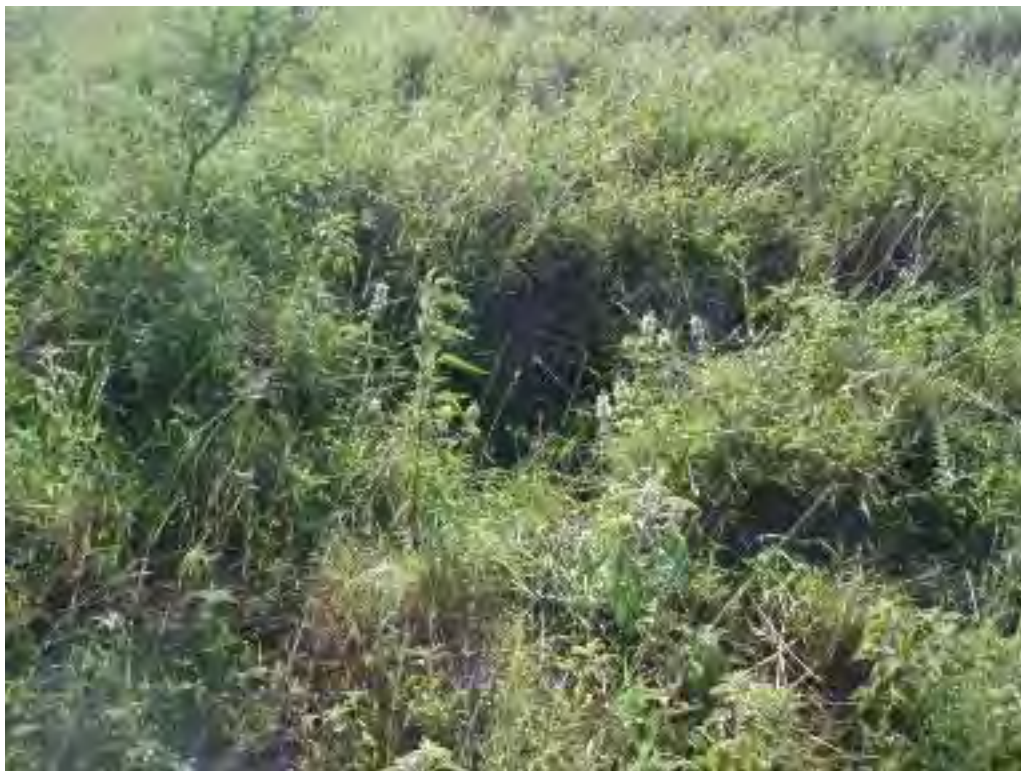
Multiple depressions were observed on the north and east embankment exterior slopes (Photos 28, 30, 31, 32, and 36). The depressions ranged in size from 4 to 8 feet long and up to 3 feet deep. The depressions appear to be grown in erosion rills because no displaced material was observed below the depressions. Multiple erosion rills were observed at the toe of the north embankment exterior slope (Photo 33, 34, and 36). The erosion rills ranged in size from 6 to 10 feet long and up to 3 feet deep.

Photo No. 31: Secondary Pond - East embankment exterior slope, looking at 6'Lx4'Wx3'D depression.

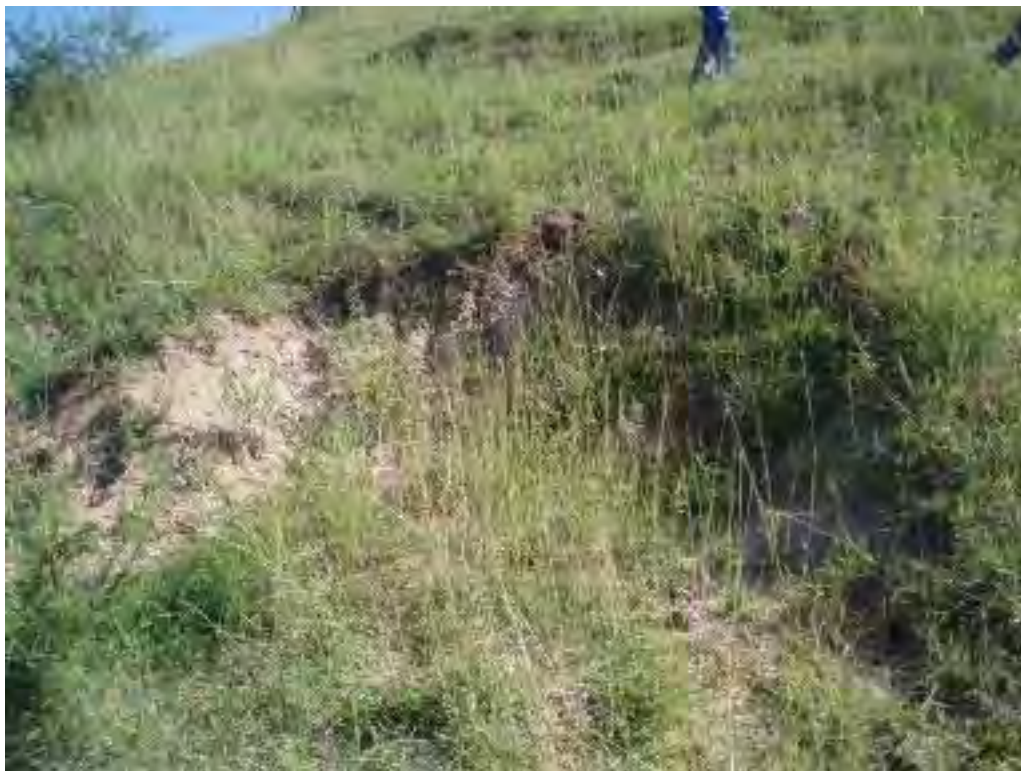
Photo No. 33: Secondary Pond - North embankment exterior slope, looking at 10'Lx4'Wx3'D erosion rill. Note the brush in background.

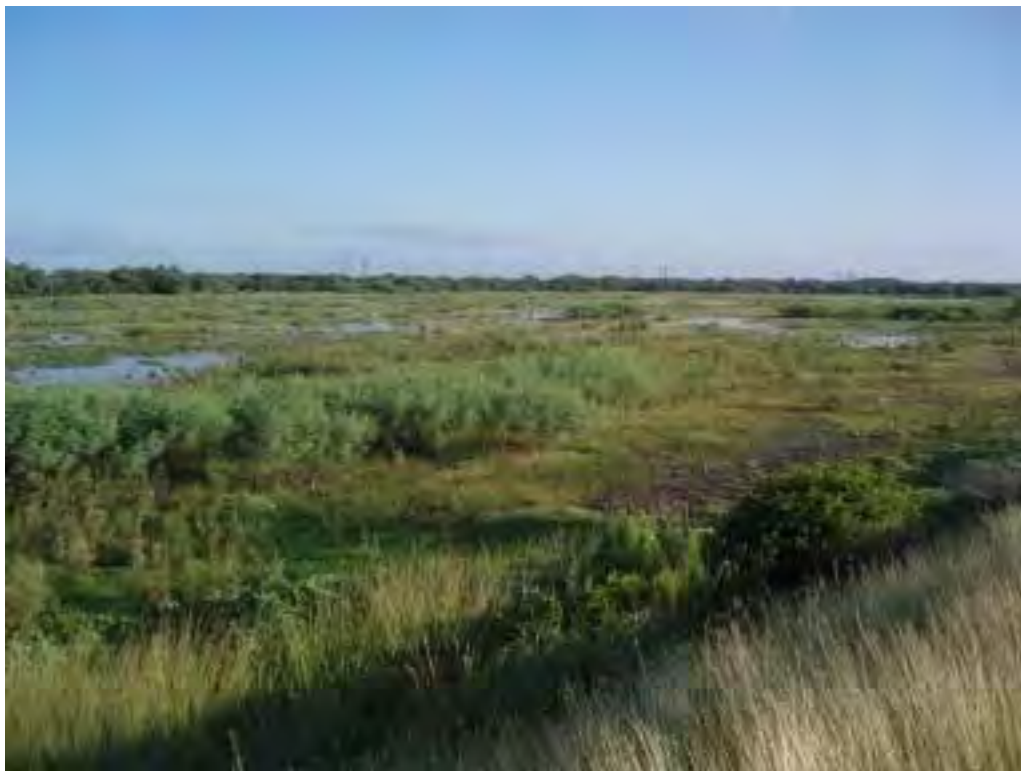
On the north embankment there was some minor surface erosion near the toe adjacent to the evaporation pond (Photo 55). Water was observed adjacent to the west embankment toe in the evaporation pond (Photos 67 and 69).

Photo No. 67: Primary Ash Pond – West embankment, looking northwest at Evaporation Pond.

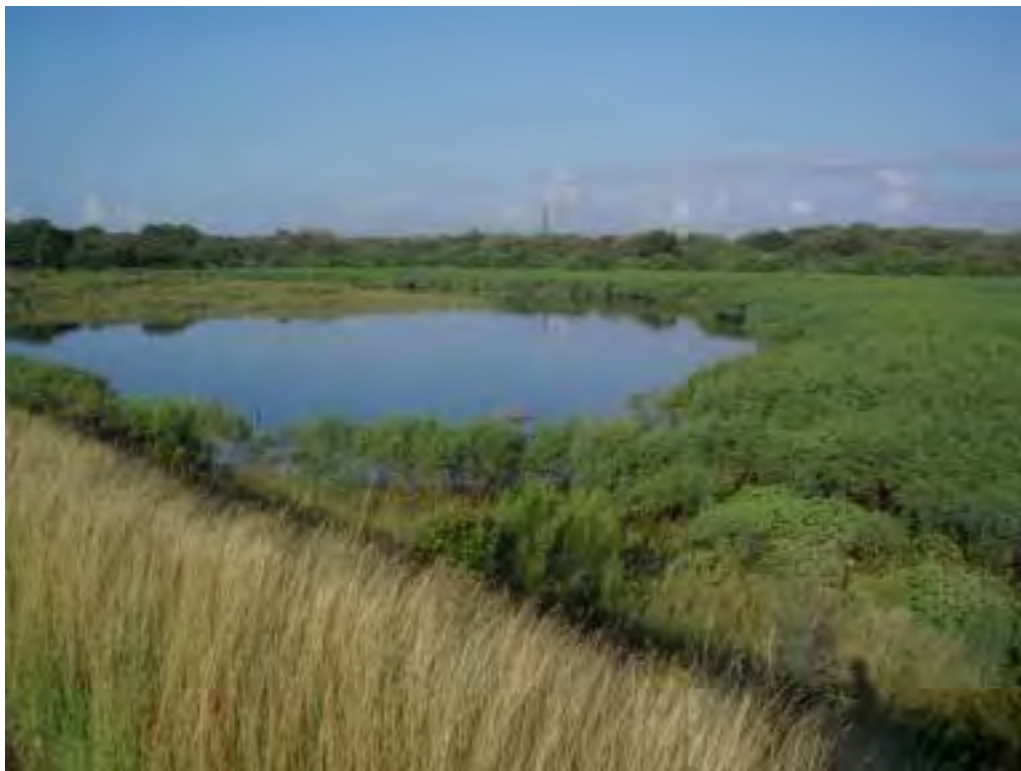
Photo No. 69: Primary Ash Pond – West embankment, looking southwest at Evaporation Pond.

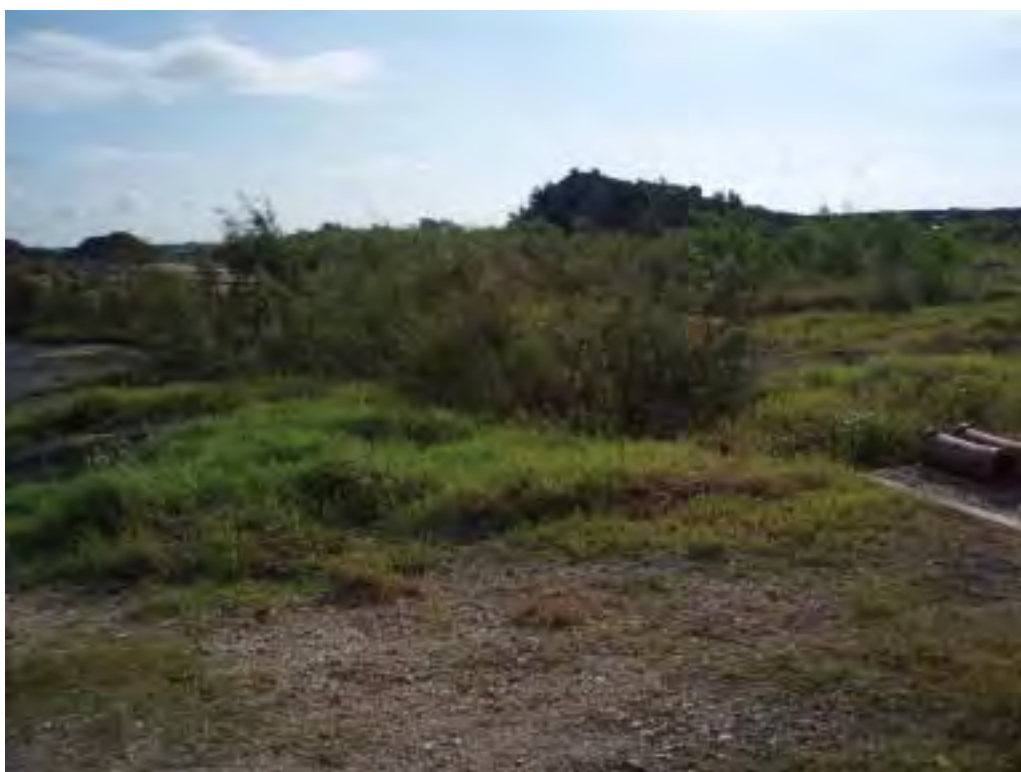
During the site visit, four sets of sluice pipes were observed. The two CCW sluice pipes on the southeast and south embankment appeared to be in fair condition (Photos 80, 81, 83, and 84). The boiler area sump sluice pipe on the west embankment and the demineralizer effluent sluice pipe on the southeast embankment also appeared to be in fair condition (Photos 75 and 85). No seepage was observed where the pipes penetrated through the embankment.

Photo No. 80: Primary Ash Pond – Southwest embankment, looking northeast at fly ash silo sluice area.

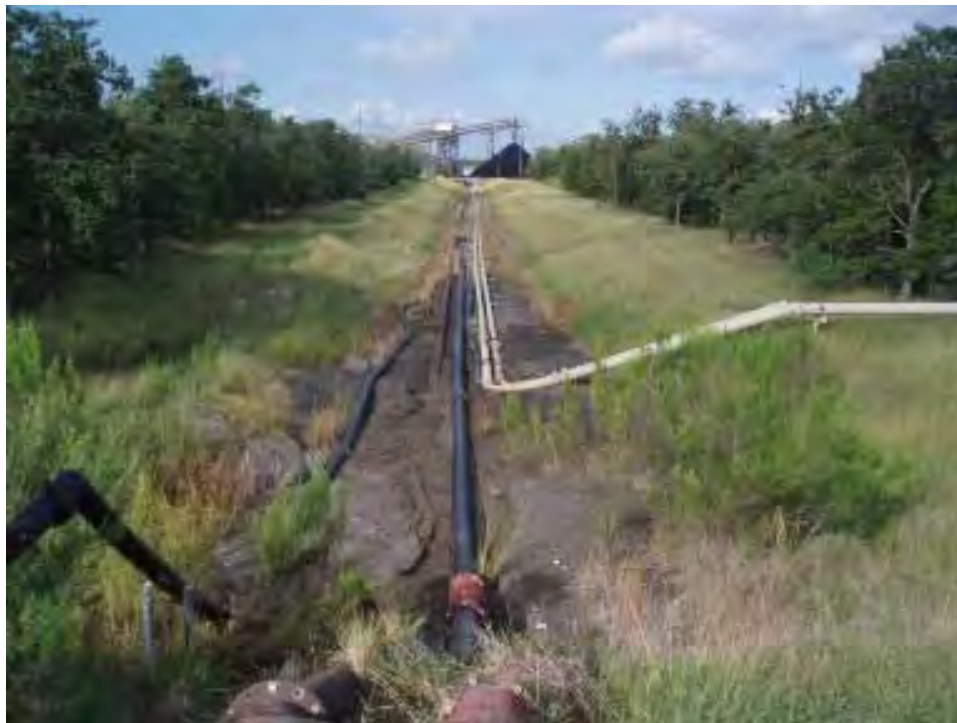
Photo No. 83: Primary Ash Pond – Southwest embankment, looking southwest at sluice pipe trench.

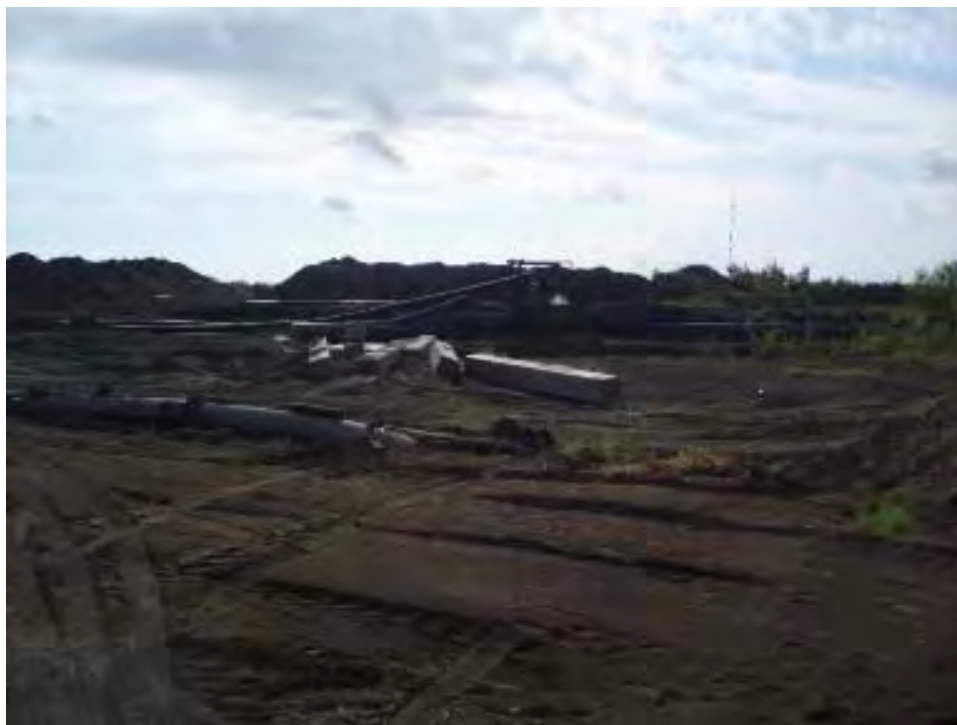
Photo No. 84: Primary Ash Pond – Southwest embankment, looking northeast at sluice pipe discharge into screen processor.

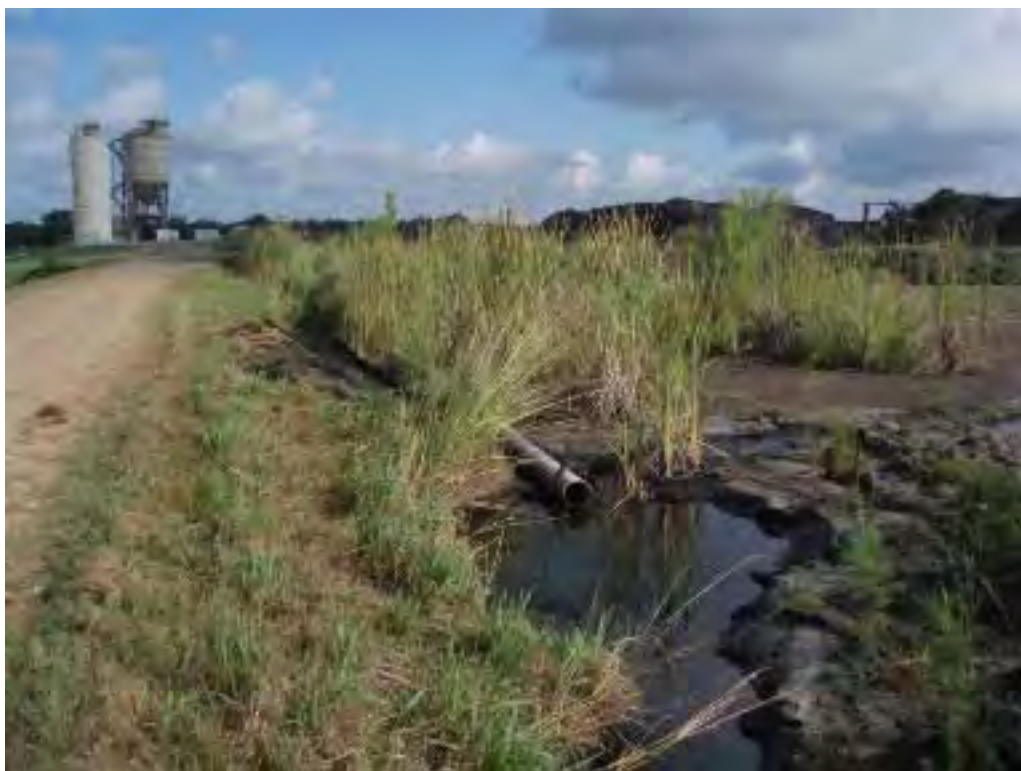
Photo No. 85: Primary Ash Pond – Southwest embankment interior slope, looking northwest at 8-inch-diameter demineralizer effluent pipe.

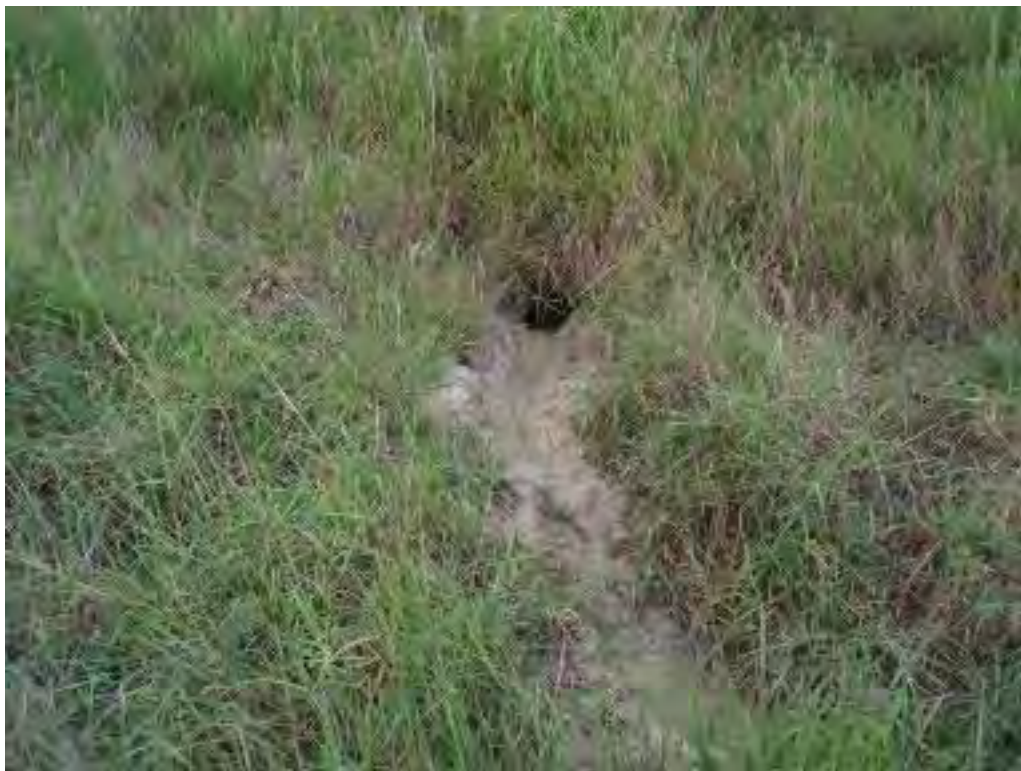
On the southeast embankment two seeps were observed. One of the seeps appeared to have developed at the location of an 8-inch-diameter animal burrow (Photo 97). The other seep observed on the southeast embankment was near the toe of the slope and was approximately 8-feet-long by 2-feet-wide (Photo 98). Flow from the seeps was estimated to be less than 10 gallons per day (gpd).

Photo No. 97: Primary Ash Pond – Southeast embankment exterior slope, looking at 8-inch-diameter rodent burrow hole and seep.
