# ASSESSMENT OF DAM SAFETY OF COAL COMBUSTION SURFACE IMPOUNDMENTS – DRAFT REPORT

**Columbia Power & Light  
Department**

**Columbia Municipal  
Power Plant  
Columbia, Missouri**

October, 2012  
Revision 1, July 2013

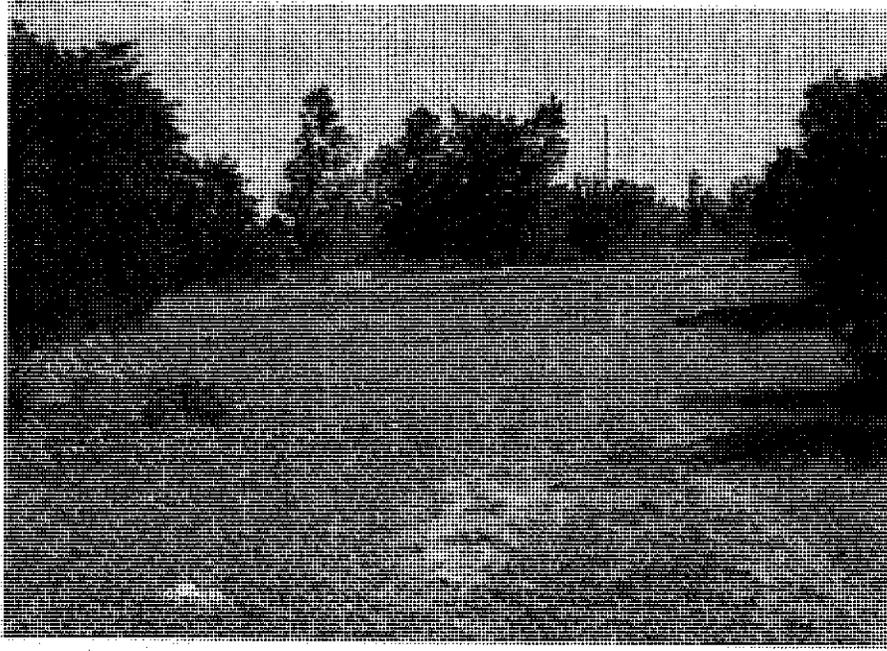
- Photo 3 - View of the top of dam showing the maximum top width at the mid-section of the dam.
- Photo 4 - View of the downstream slope from the right abutment showing the dense vegetation on the slope.

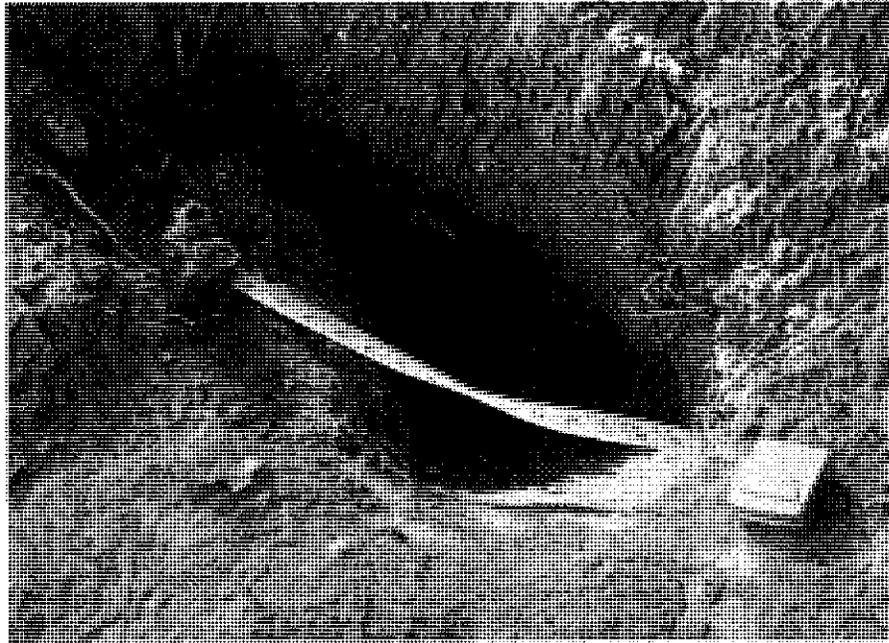
The downstream embankment slope is, in general, not adequately protected by grass cover, especially the middle two-thirds of the embankment. Consequently, erosion due to surface runoff has been most severe. There are erosion channels up to 6 feet deep by 10 feet wide (see Photo 7). Large trees and bushes cover the downstream face (see Photo 4). The left and right sides of the downstream face are covered with tall grass and fewer and smaller trees are growing on the slope in these areas. There are several large rodent holes, up to 16-inches wide (see Photo 5), on the downstream face.

- Photo 5 - View of an animal burrow on the downstream slope.
- Photo 6 - View of a large erosion scarp on the downstream slope just downstream of the two spillway pipes at the left abutment.

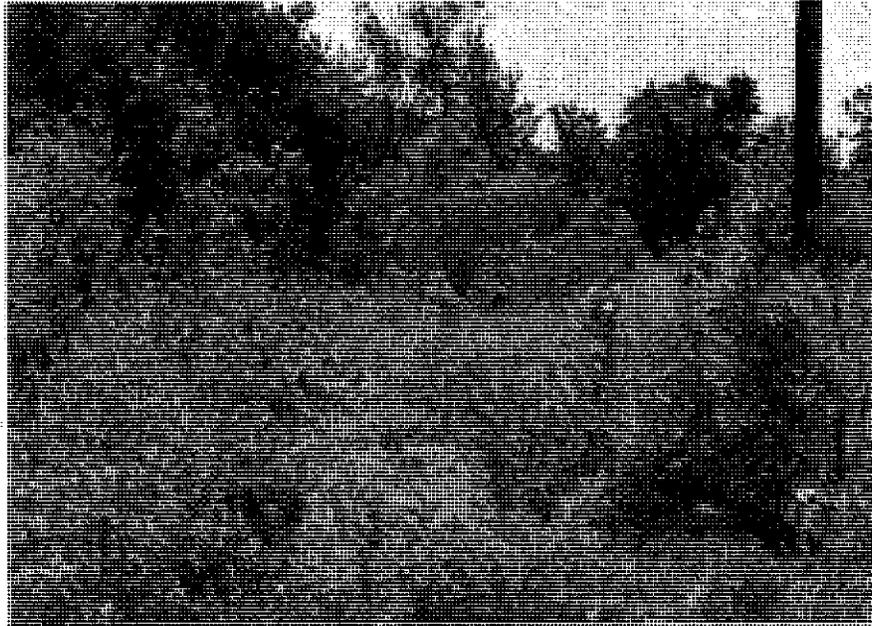
Photo 13

The downstream channel, which carries flows from the spillway and the low level outlet, is overgrown with the tall vegetation and trees (see Photo 13). The width of the channel is approximately 10 feet for approximately 50 feet with side slopes of about 1V on 1H on both sides and a depth of about 3 feet. The channel then widens out to about 100 feet until it flows into another sedimentation pond directly downstream of the reservoir. The heavy growth of vegetation in the channel will affect the hydraulic efficiency of the channel.
