# ASSESSMENT OF DAM SAFETY OF COAL COMBUSTION SURFACE IMPOUNDMENTS – FINAL REPORT

**City of Columbia, Water  
& Light Department**

**Columbia Municipal  
Power Plant  
Columbia, Missouri**

Prepared for  
*United States Environmental  
Protection Agency  
Washington, D.C.*

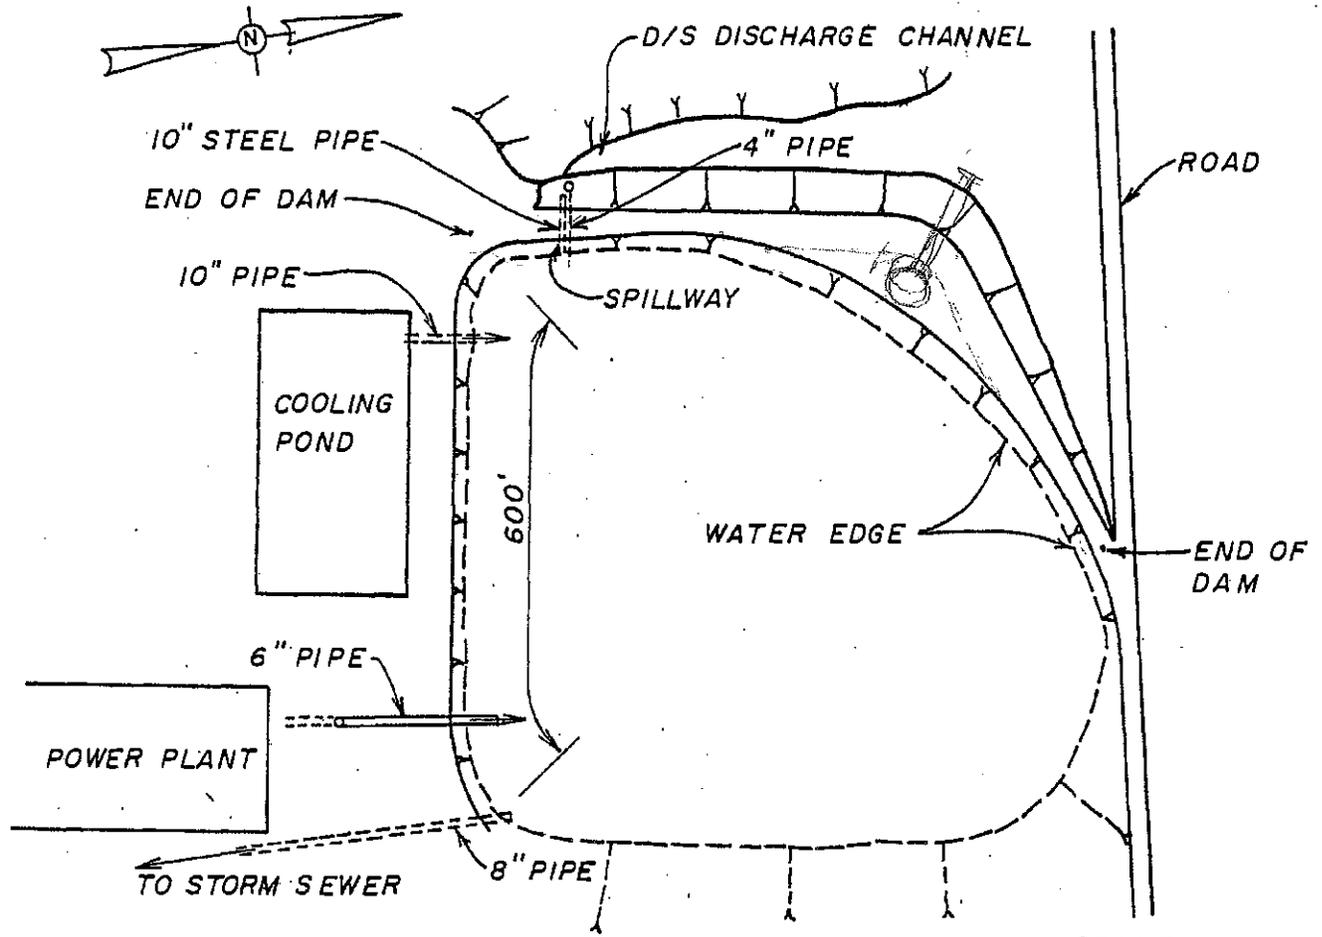
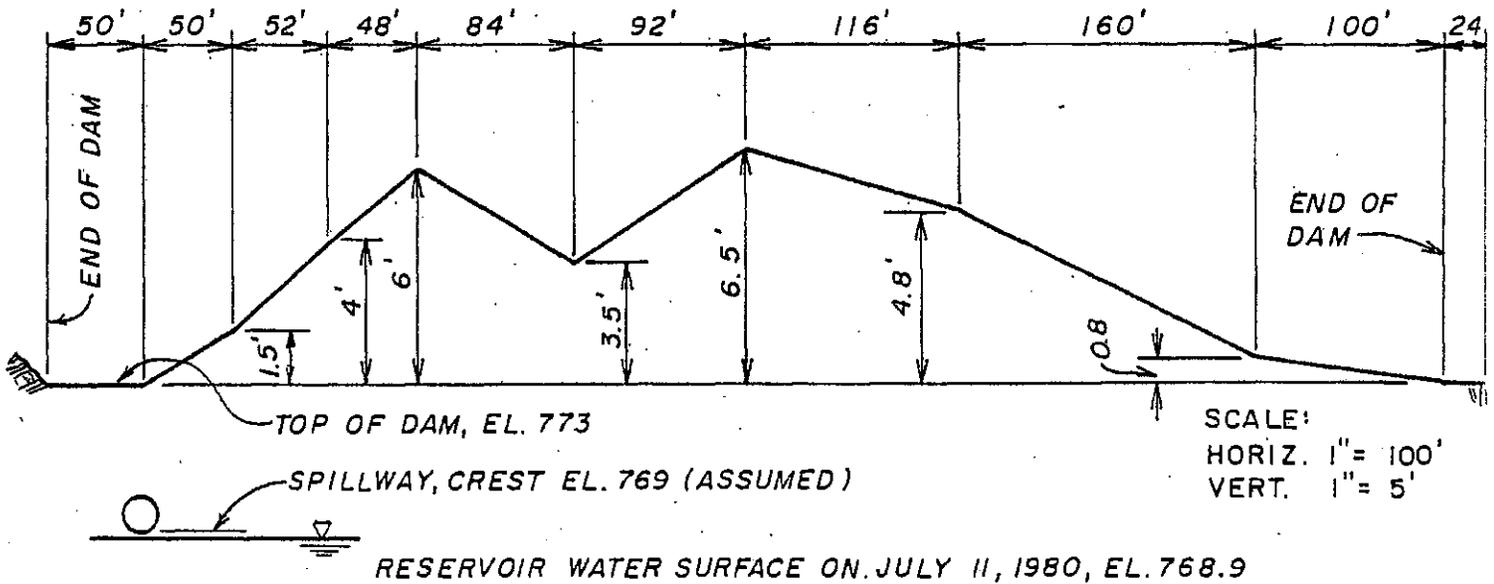
MOORES LAKE DAM (MO. 11173)  
PLAN AND ELEVATION

The dam embankment is an earthfill structure with variable section dimensions along its crest length. A plan and elevation of the dam are shown on Plate 2 and Photos 1 through 4 show views of the dam. The axis of dam is approximately a quarter circle

in shape and measures 752 feet long. The top width varies from 30 feet at the left abutment to approximately 90 feet at the midpoint of the dam and back to about 20 feet at the right abutment. The top of dam elevation varies non-uniformly (See Plate 2). The left and right sides of the dam were assumed to be at 773 feet above mean sea level (M.S.L.) with elevation increases of up to about 6.5 feet towards the middle of the embankment. The top of dam is crowned slightly and has many depressions. The maximum height of the embankment was measured to be 30 feet at approximately the mid-point along the axis of dam. The height of the dam at the left abutment near the two spillway pipes is 13 feet.

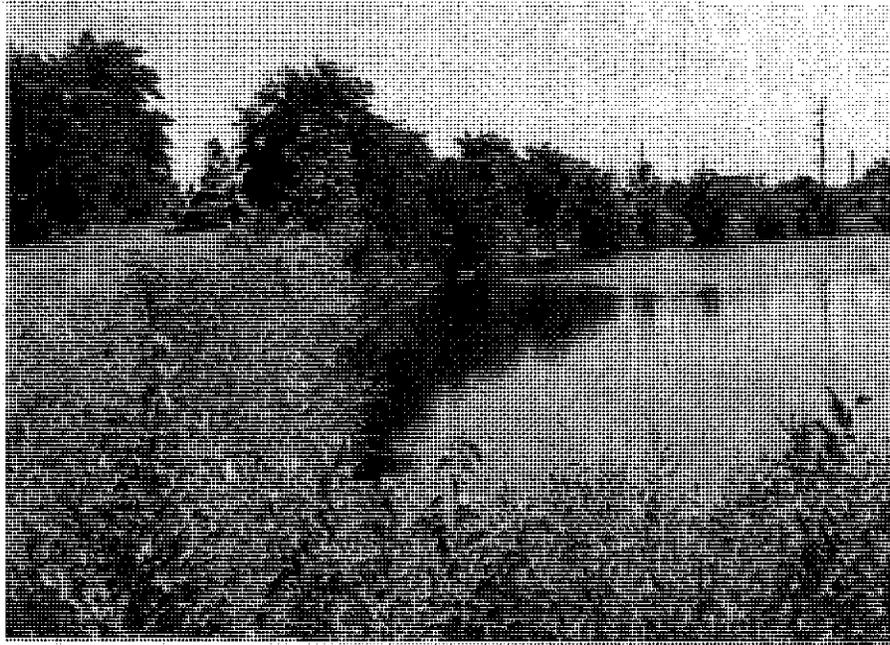
- Photo 1 - View of the upstream slope from the left abutment showing the dense vegetation.
- Photo 2 - View of a portion of the top of dam from the left abutment. Note the disturbed area of soil in the foreground due to the recently constructed 10-inch spillway pipe.

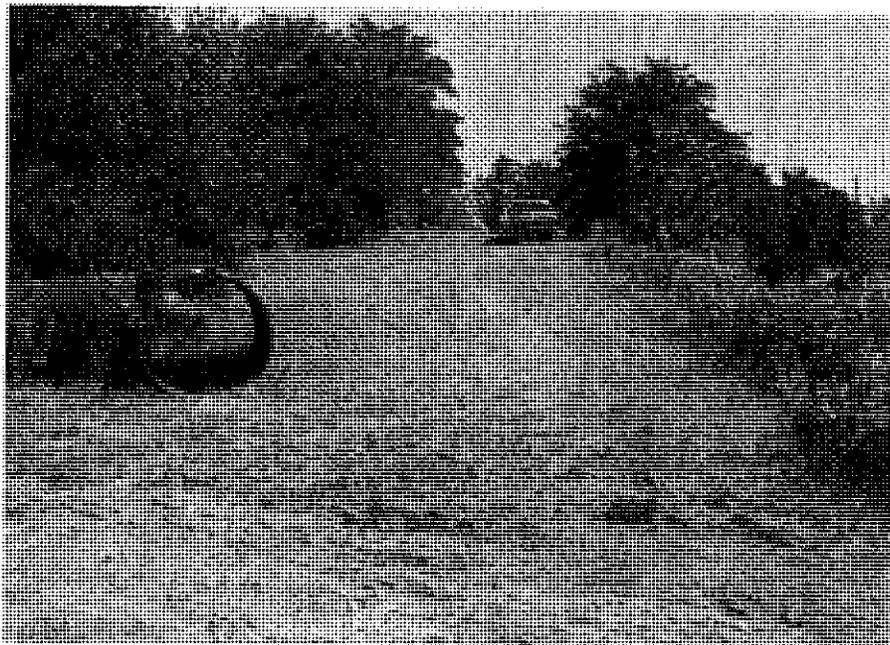
Photo 2

The top of dam has a grass cover which adequately protects the embankment material from surface erosion (see Photo 2). The grass was mowed at the time of our inspection and, according to Mr. Gary Anderson, is mowed periodically. The irregularity in the top of dam is apparently due to the addition of on site spoils materials in the past and not due to settlements. It is unknown whether or not the dam has ever been overtopped; however, no evidence was observed indicating that the dam had been overtopped.

Where the new spillway pipe was installed through the left side of the embankment, there is no vegetative cover on the pipe backfill (see Photo 2). Near the low level outlet manhole, located at the left abutment, the downstream slope is covered with dumped debris such as boulders and concrete block fragments. The downstream toe has been undermined in this area by the water, which

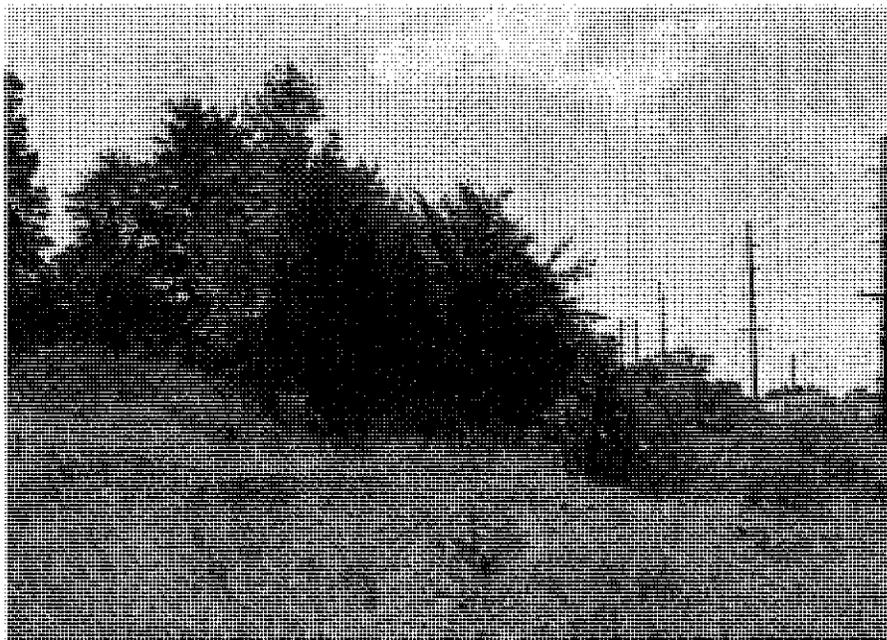
- Photo 3 - View of the top of dam showing the maximum top width at the mid-section of the dam.
- Photo 4 - View of the downstream slope from the right abutment showing the dense vegetation on the slope.

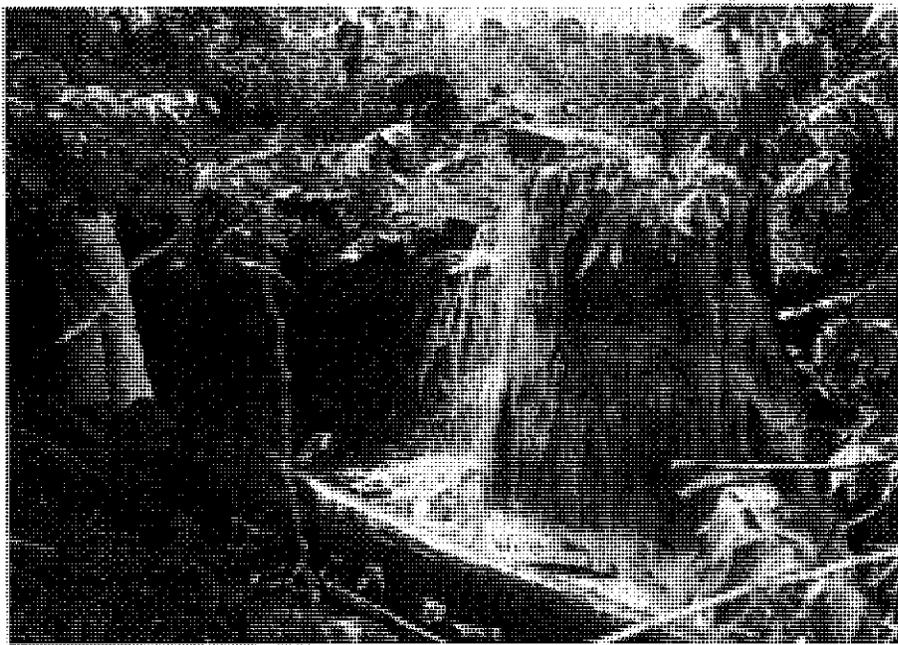
- Photo 7 - View of a large erosional gully on the downstream slope.
- Photo 8 - View of the discharge over the top of the manhole of the 4-inch outlet pipe showing the undermining of the toe of the embankment to the left of the manhole (in photo). Note the location of the outlet of the 10-inch pipe above and to the left (in photo) of the manhole.
