GZA  
GeoEnvironmental, Inc.

Re: Task 3 Dam Assessment Report - Draft  
Project #0-381  
SRP Coronado Generating Station Evaporation Pond Dam  
Apache County, Arizona

This Phase I Inspection/Evaluation Report presents the results of a visual dam inspection of the Salt River Project – Coronado Generating Station (SRP/CGS) Evaporation Pond Dam located off U.S. Highway 191 in Apache County, Arizona. The inspection was performed on September 9 and 10, 2009 by representatives of GZA GeoEnvironmental, Inc (GZA), accompanied by representatives of SRP/CGS the U.S. Environmental Protection Agency (EPA).

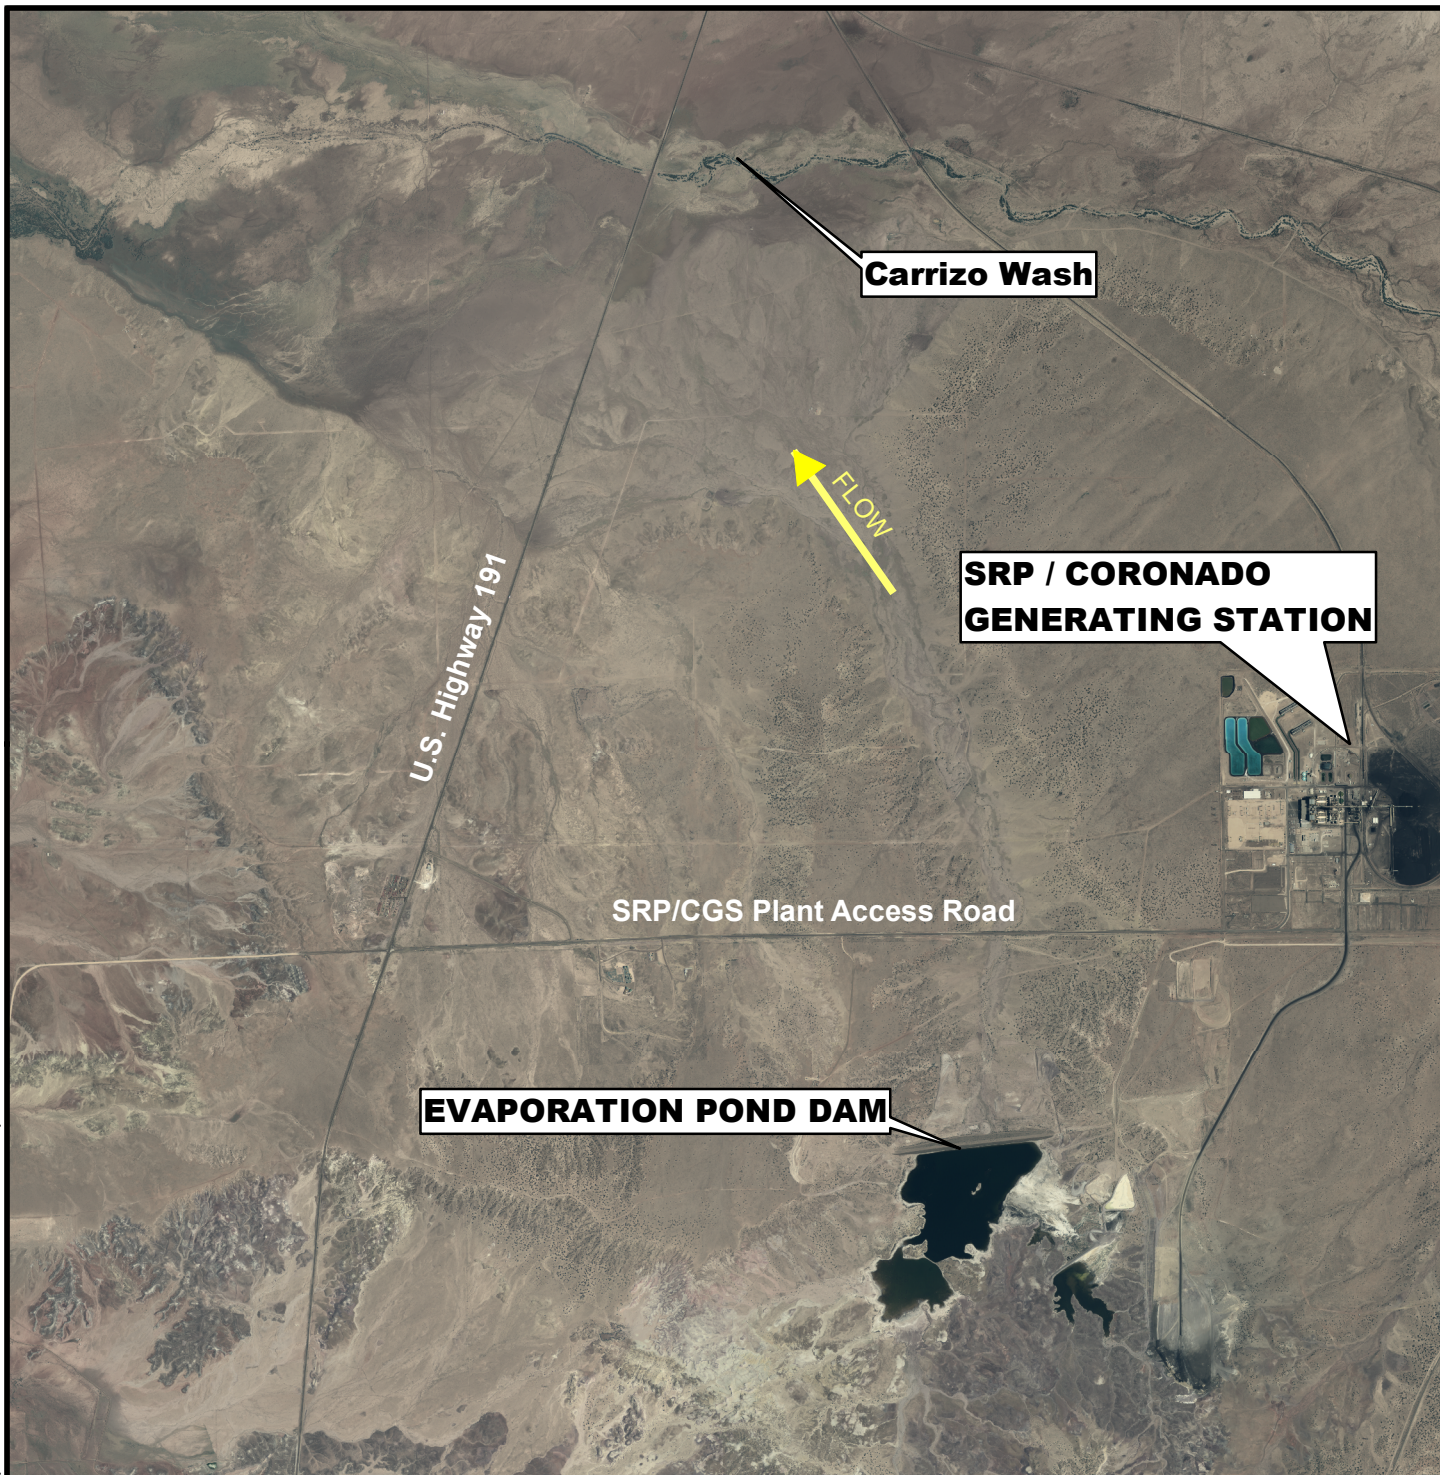
FIG. NO.  
**3**

and the potential environmental impacts and interruption of power generation due to a failure of the dam and subsequent loss of impoundment capacity. The area downstream of the dam is shown in **Figure 3**, and the dam break inundation area from the Evaporation Pond Dam Emergency Action Plan is shown in **Figure 9**.

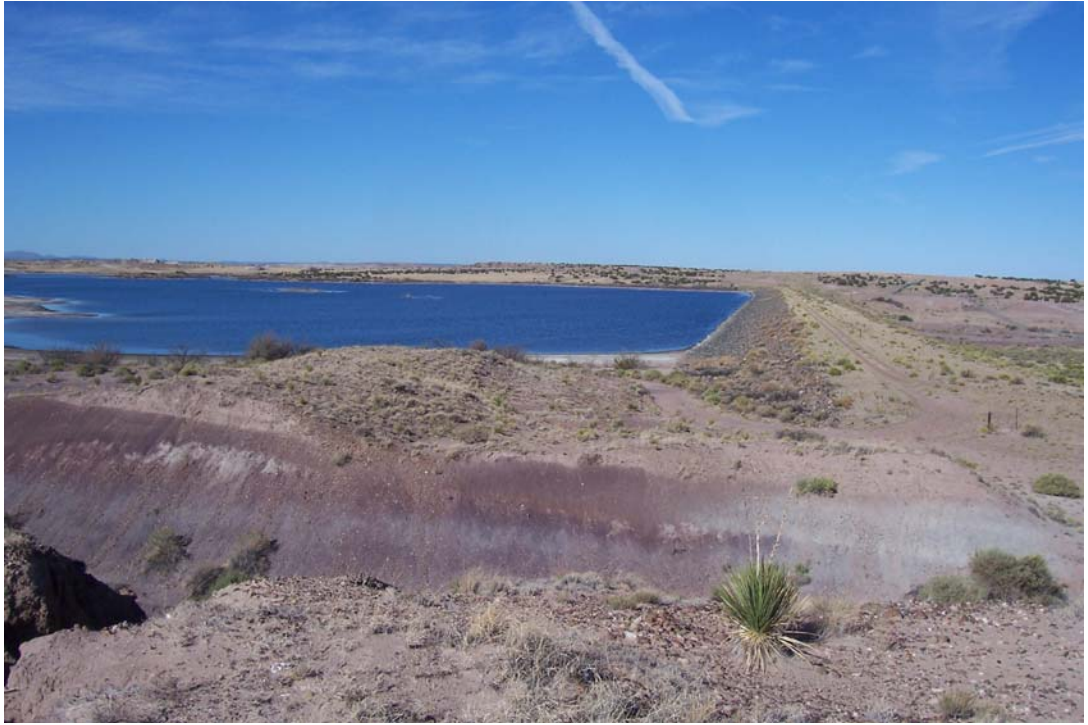
**Photo 1: Overview of Evaporation Pond and Dam from right abutment. Note emergency spillway cut in foreground.**

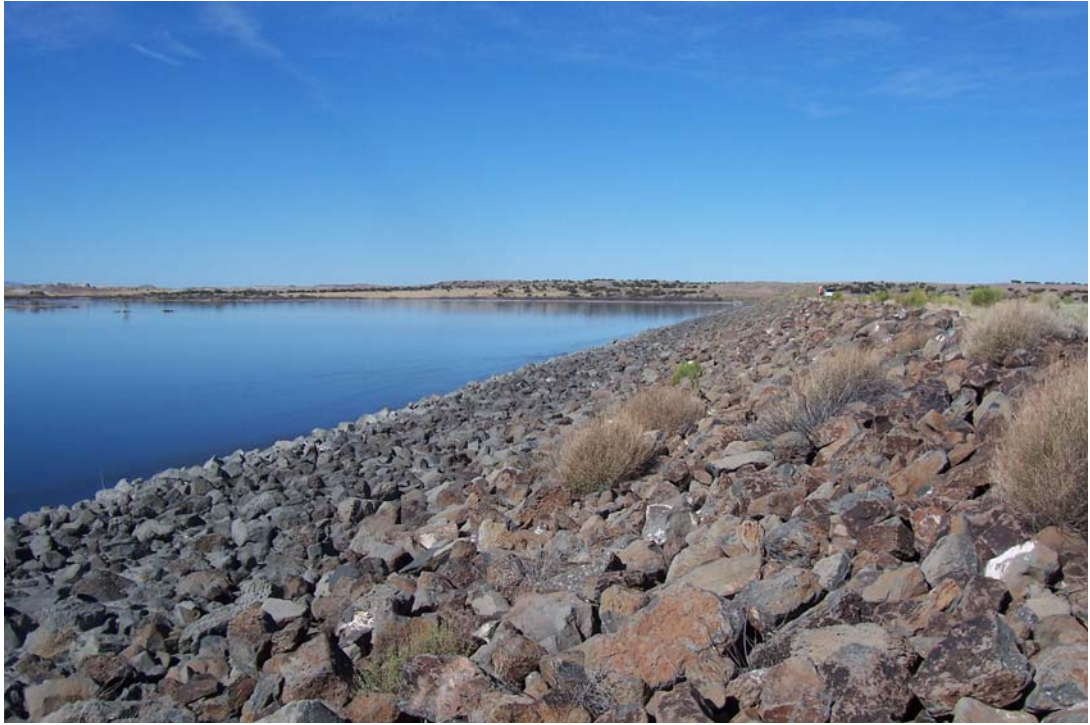
**Photo 3: View along upstream riprap slope from right side of dam. Note upstream berm and lower portion of upstream slope submerged by Pond.**

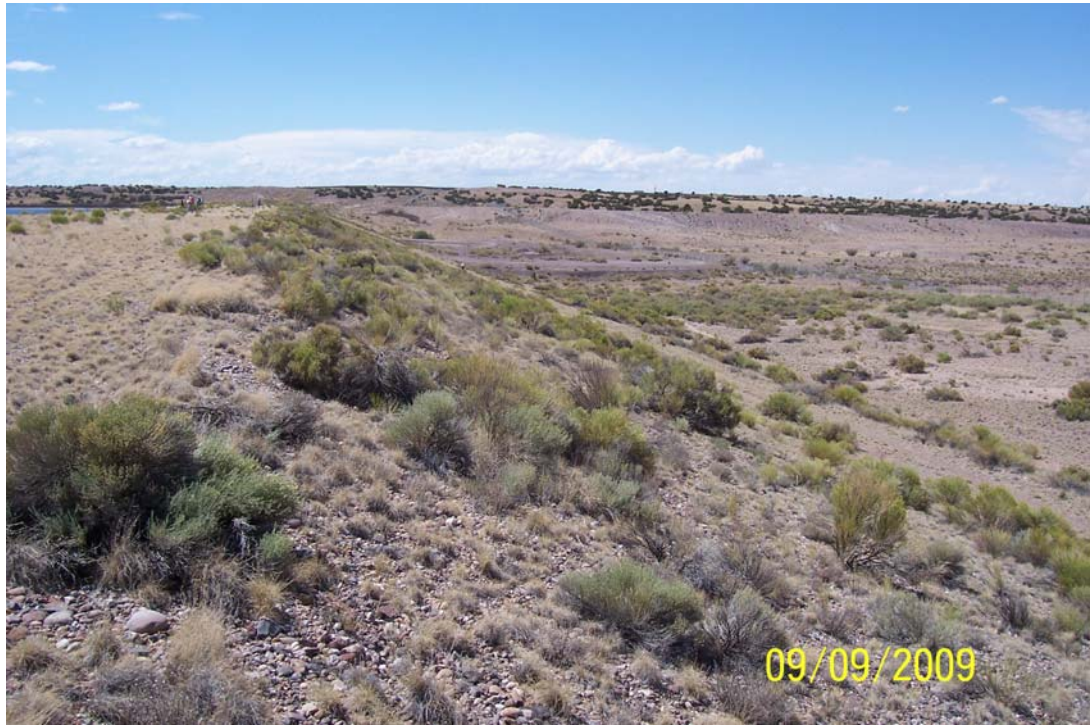
**Photo 5: View along downstream slope of dam from right side of dam. Note gravel surface, and grass and brush vegetative cover.**

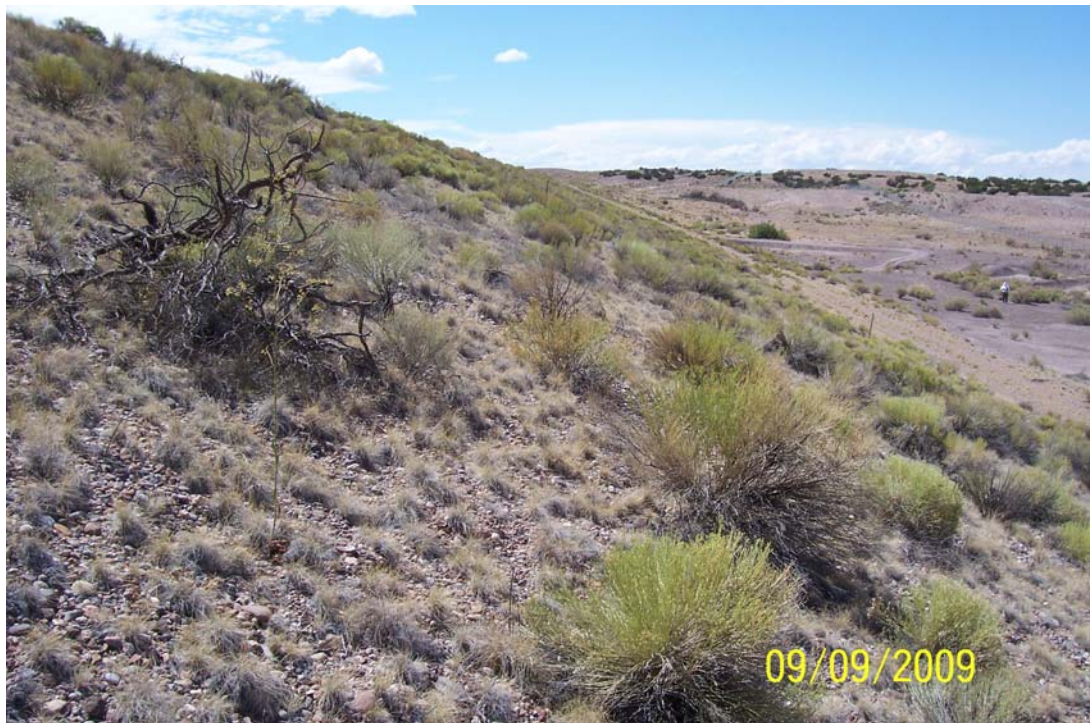
**Photo 6: View along downstream slope of dam from right side of dam.**

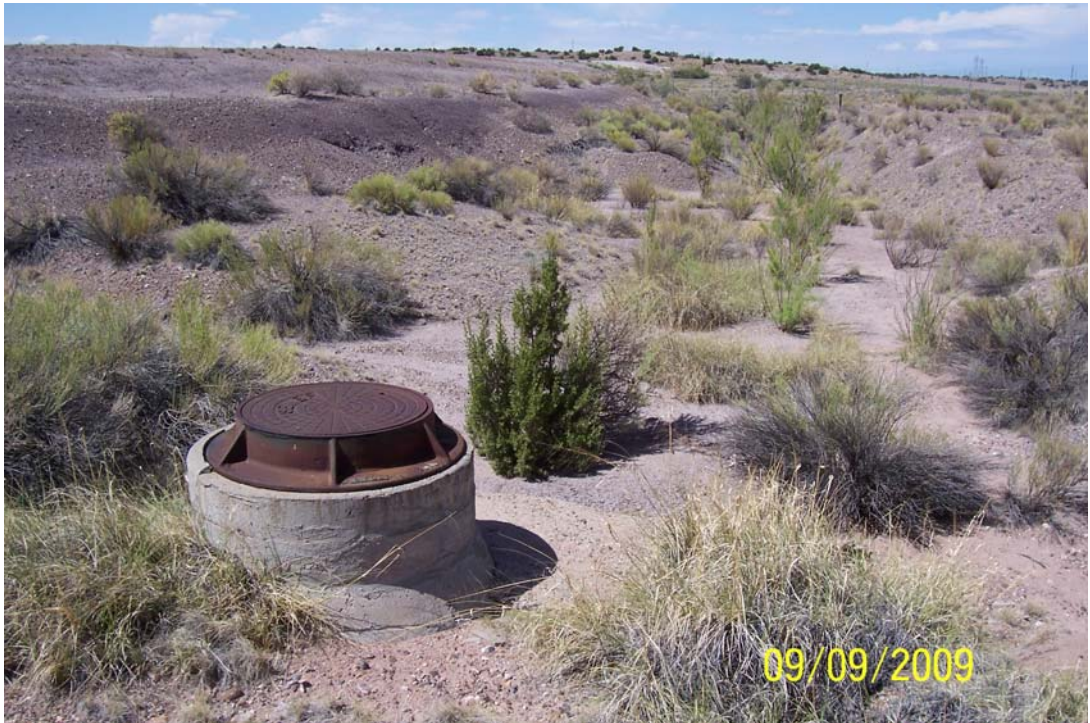
Additional erosion was observed at the toe of the downstream slope, especially to the right of the left toe drain manhole, where surface runoff appears to be eroding a channel in the secondary containment berm. Some minor to moderate erosion was observed on the slopes adjacent to the left and right toe drain manhole (Photos 9 and 10) and on the containment berm.

**Photo 9: View of right toe drain manhole at downstream toe of dam. Note dry discharge channel surrounded by secondary containment berms**

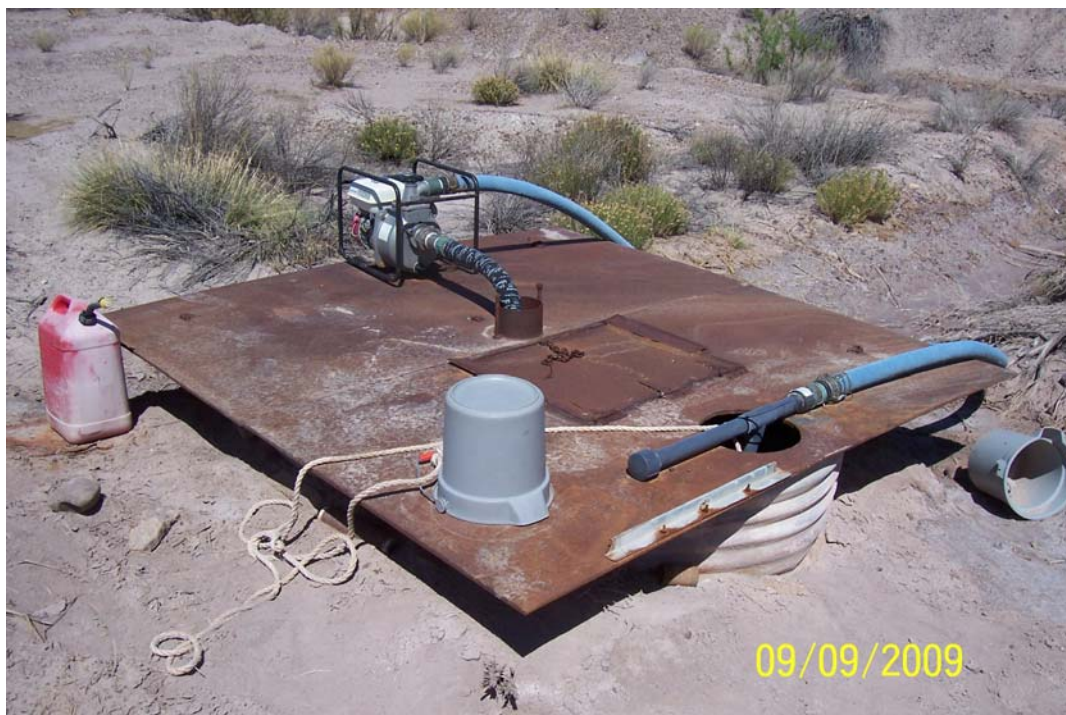
**Photo 17: View of left toe drain sump, with gas pump, recirculation piping, and bucket used for flow measurement and seepage observations.**

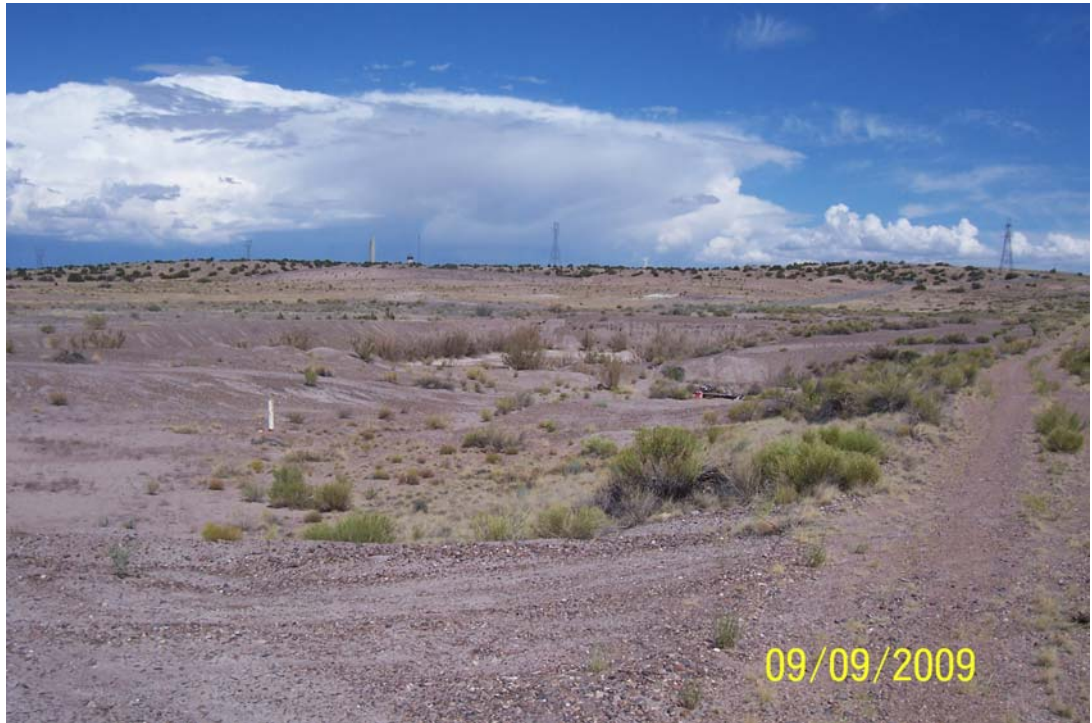
**Photo 19: Overview of downstream area, with secondary containment berms visible for containment of seepage discharge.**

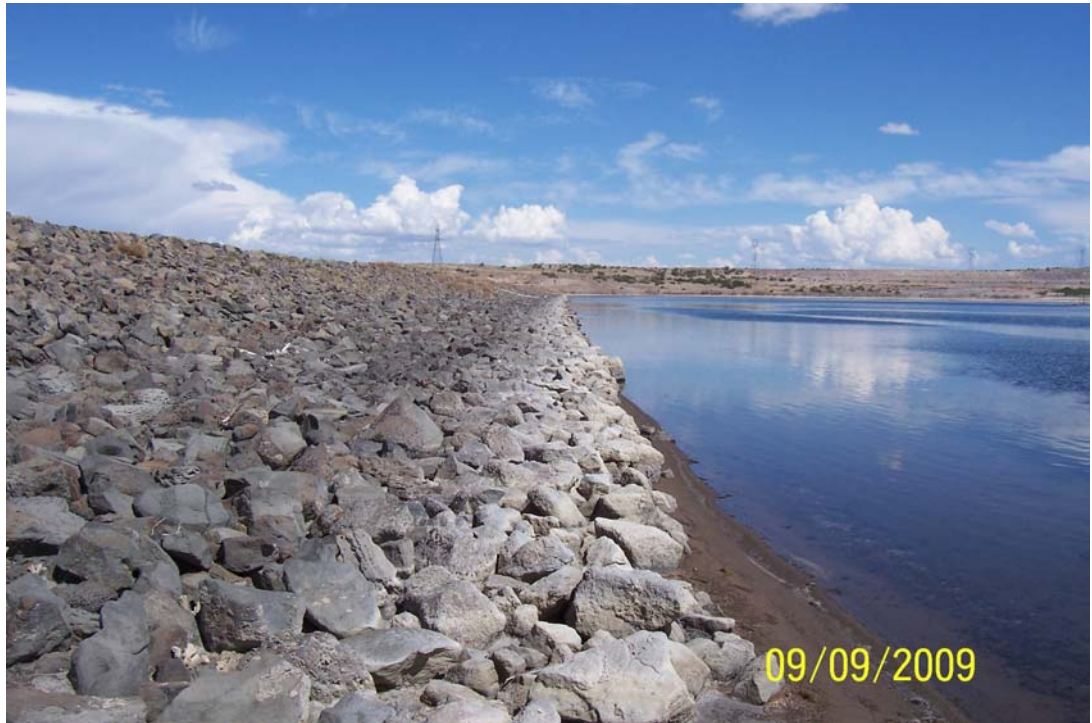
**Photo 23: View along upstream slope of dam from left side. Note upstream berm partially visible above water line.**

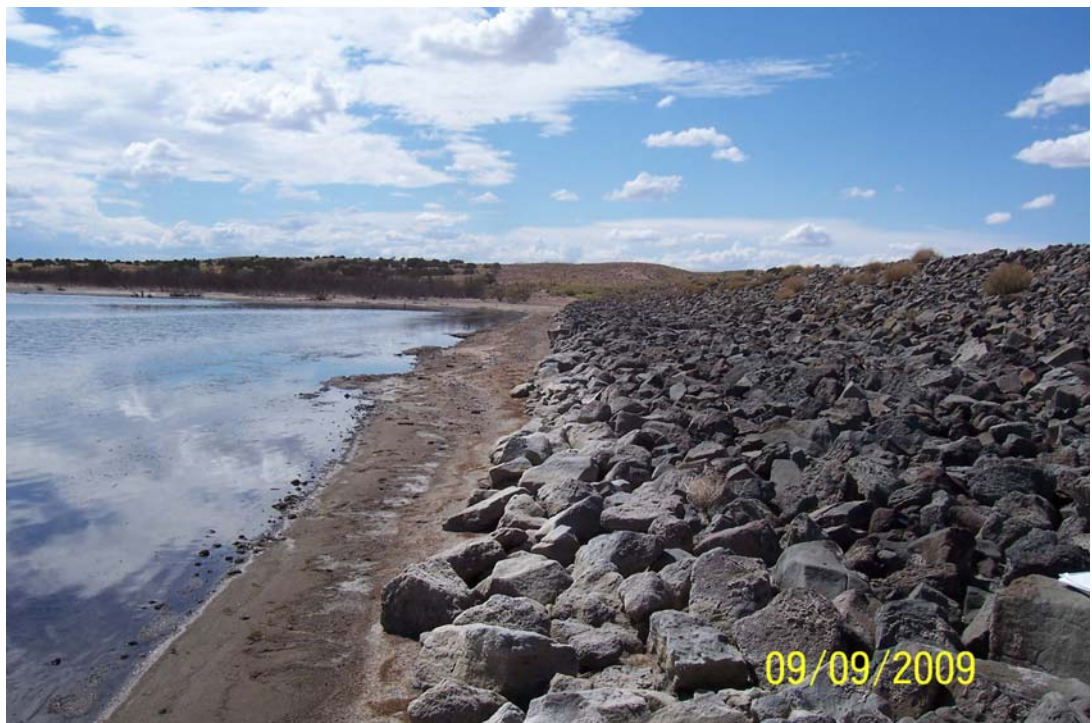
**Photo 24: View along upstream slope of dam looking towards left abutment.**

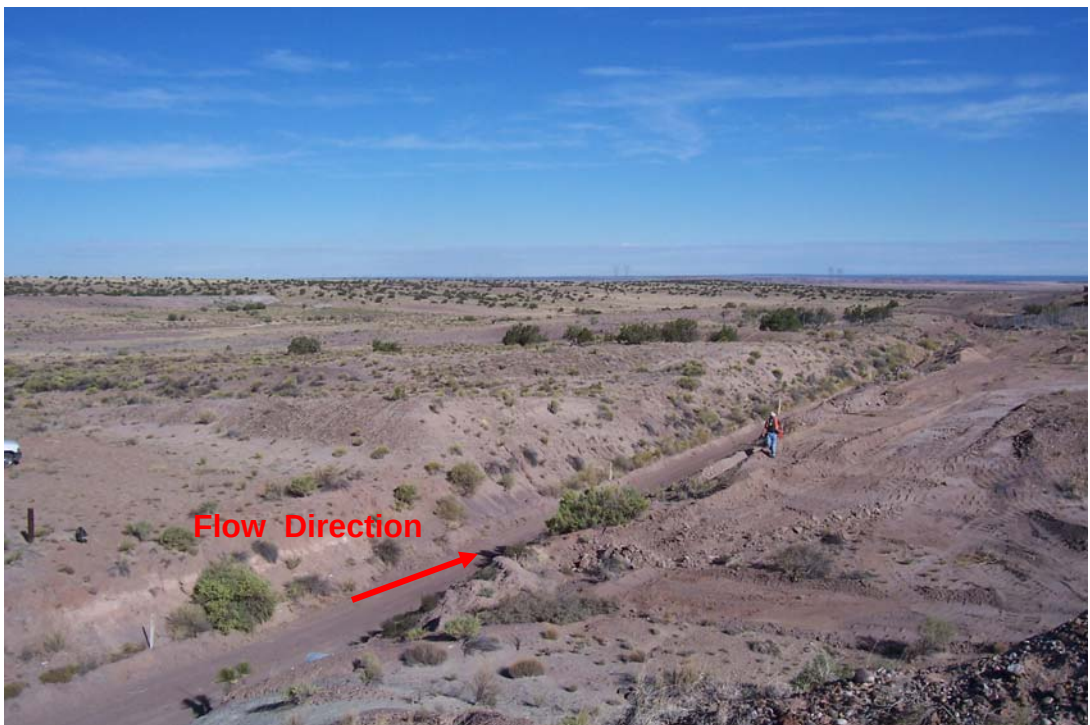
**Photo 30: Overview of emergency spillway channel from top of right channel slope. Channel invert in foreground, discharge area in background.**

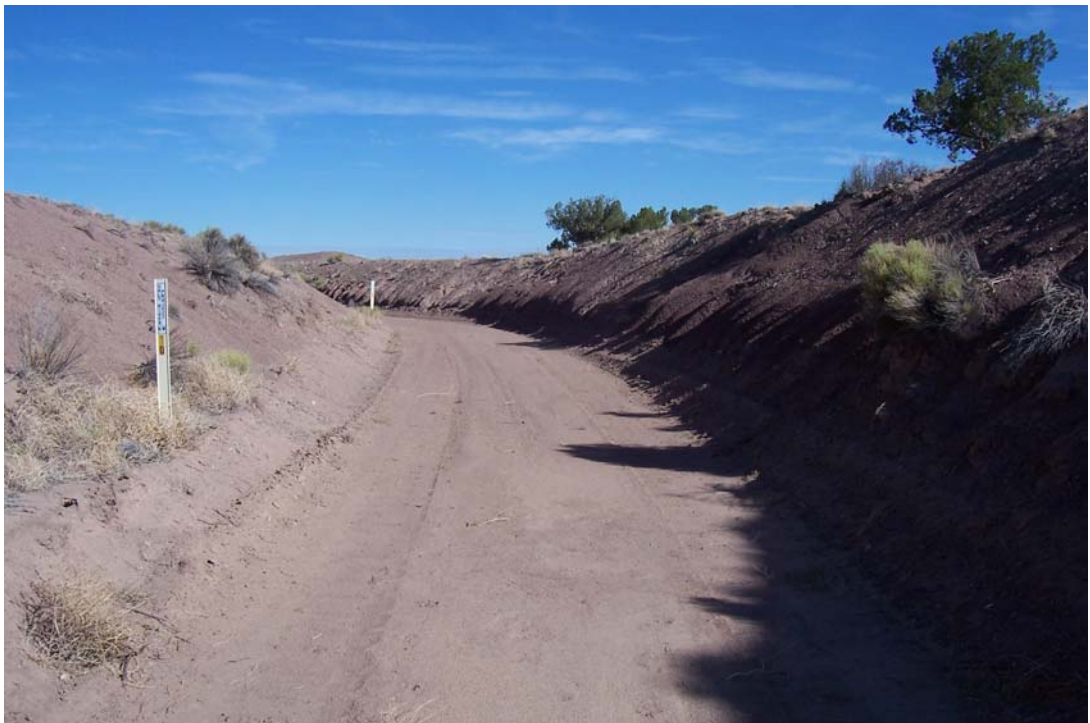
**Photo 32: View within emergency spillway channel, looking downstream towards discharge area. Note recent grading of spillway channel bottom.**

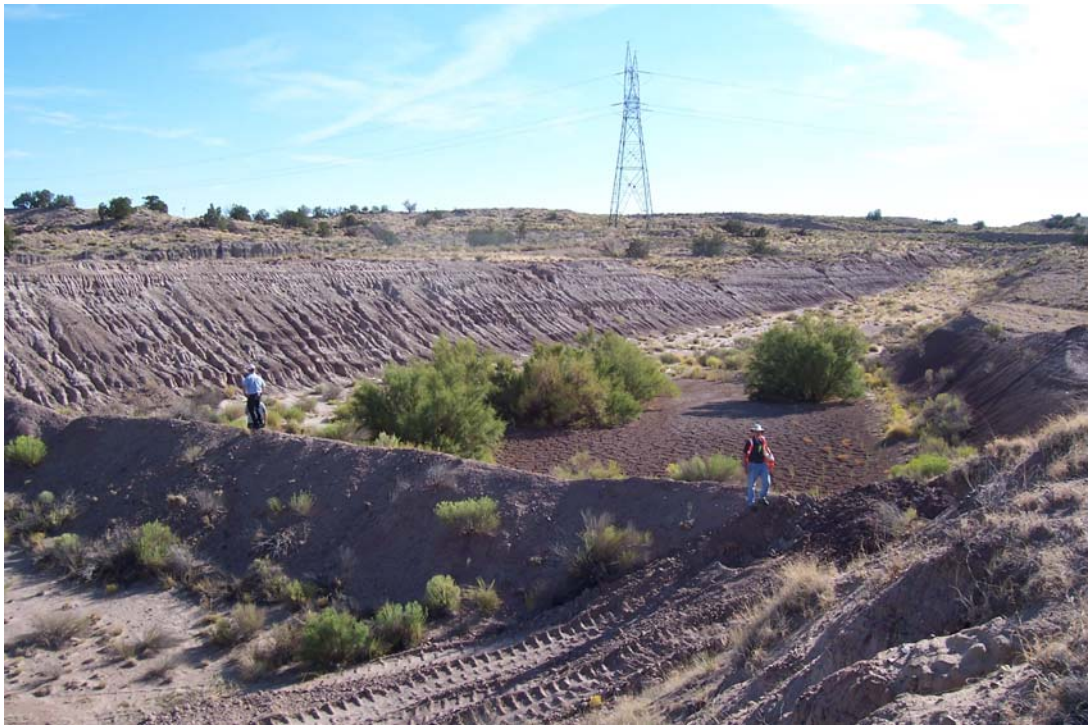
**Photo 34: View of excavated area at right abutment, with earthen berm constructed to prevent stormwater runoff from eroding spillway slopes.**

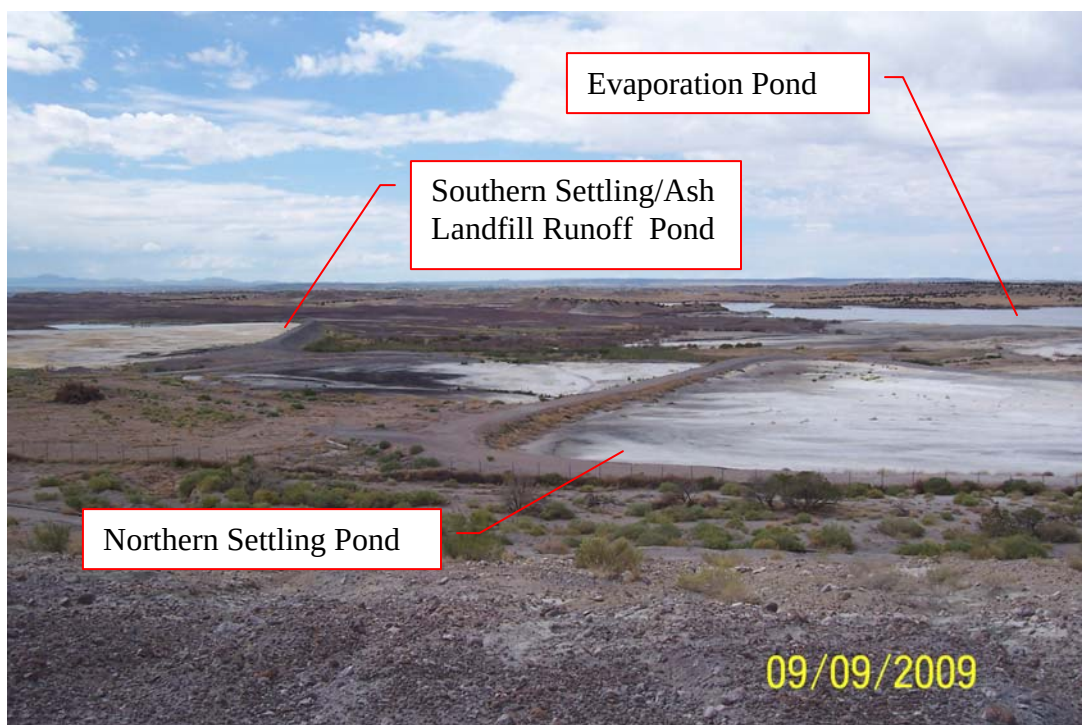
**Photo 40: View from Ash Landfill area towards settling ponds and Evaporation Pond.**
