# ASSESSMENT OF DAM SAFETY OF COAL COMBUSTION SURFACE IMPOUNDMENTS FINAL REPORT

**CPS Energy  
J.T. Deely Power Plant  
San Antonio, Texas**

Prepared for  
*U.S. Environmental  
Protection Agency  
Washington, D.C.*

February 2014  
Revised May 2014  
Revised June 2014

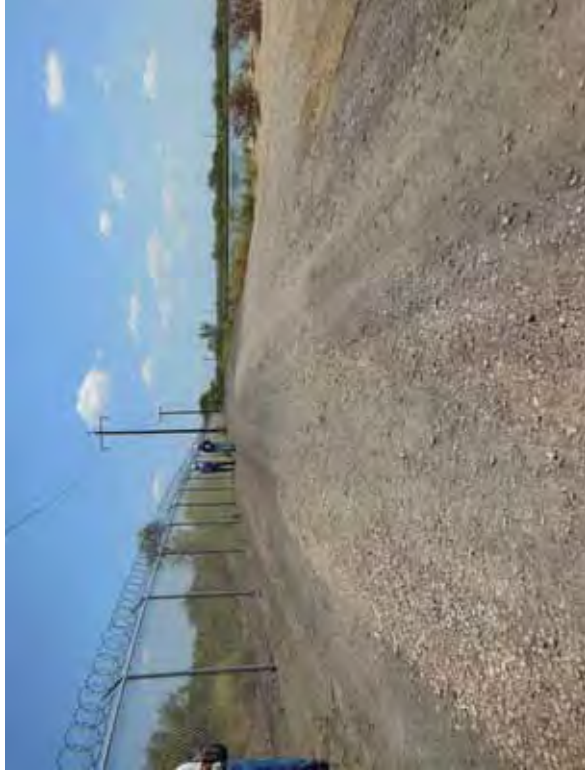
The crest of the North Bottom Ash Pond appeared to be in satisfactory condition (Photographs 1, 10, 29, and 42). The crest was approximately 15 feet wide at all embankments except the north embankment where the crest measured approximately 30 feet wide. The crest of the embankments consists of compacted granular soils and gravel and is exposed to minimal vehicle traffic. An area of erosion near a fence post was observed at the north embankment crest (Photographs 5 and 52). Wood support poles for overhead powerlines are located in the crest of the north embankment (Photograph 1). No depressions or evidence of settlement were observed on the crest.

**Photo 1: NP - North Embankment crest, looking east.**

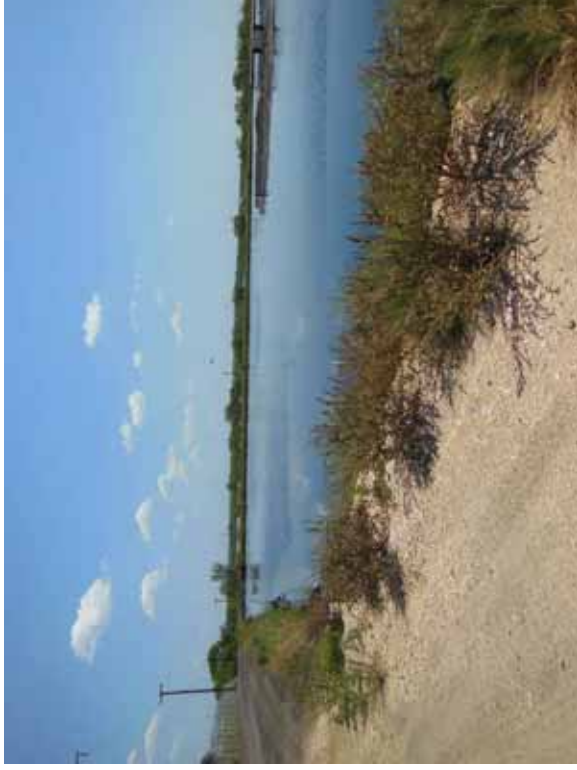
**Photo 2: NP - North embankment interior slope, looking east.**

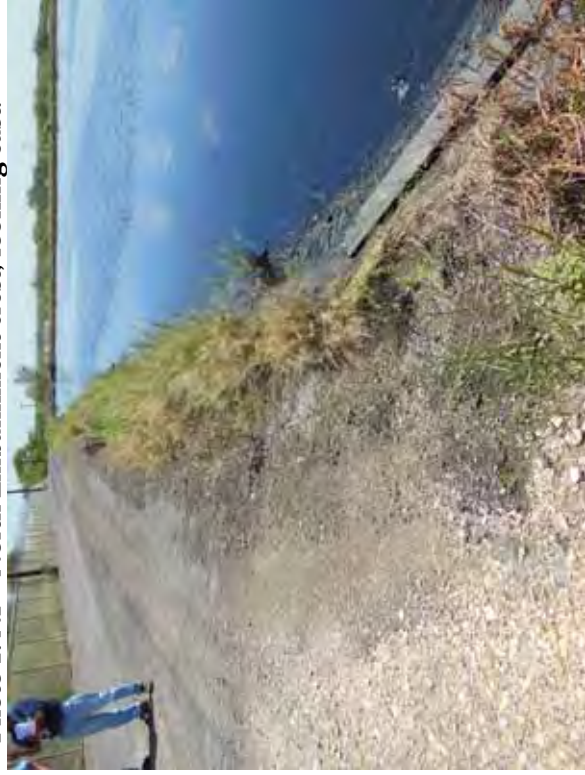
Due to the water level in the North Bottom Ash Pond during the assessment, only the upper 2 feet of the interior slopes were visible (Photographs 3, 12, 27, and 40). Based on construction drawings, the interior slopes were constructed at 2H:1V. The interior slopes were measured at approximately 3H:1V near the top of the embankment and included a layer of ash material (Photograph 28). Small areas of erosion into ash were observed on the interior slope at the east, south, and west embankments (Photographs 17, 23, 38, and 43) and an area of loose ash was observed on the east embankment interior slope (Photograph 14). Vegetation covered some portions of the interior slopes that were visible (Photographs 6, 12, 32, and 35). Visible portions of interior slopes did not include riprap or other armoring.

**Photo 3: NP - North embankment interior slope, looking east.**

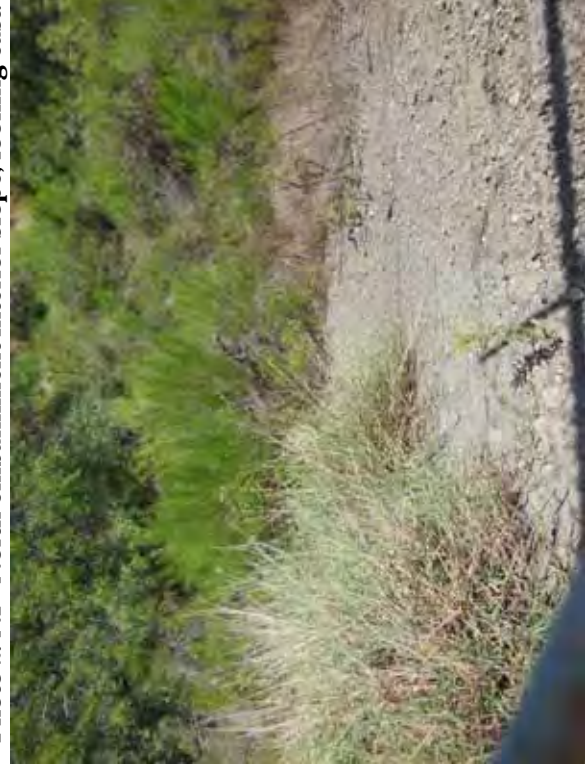
**Photo 4: NP - North embankment exterior slope, looking north.**

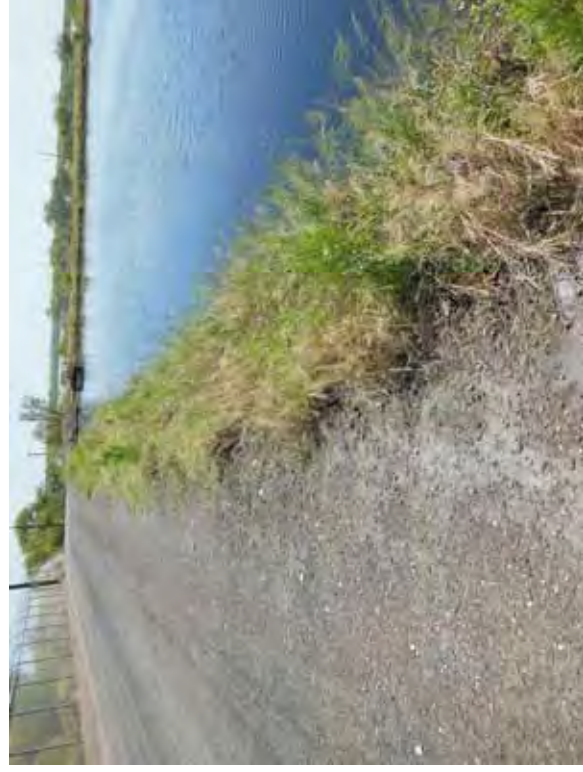
**Photo 6: NP - North embankment interior slope, looking east.**

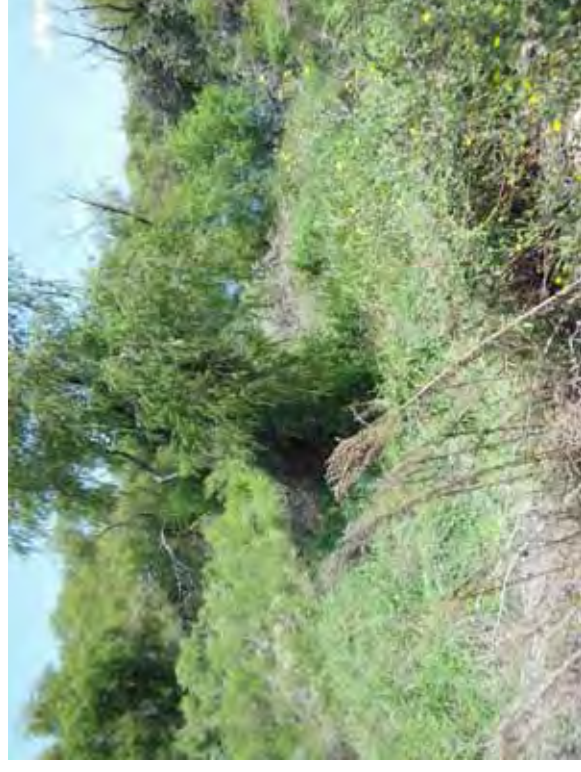
**Photo 8: NP - North embankment exterior slope, looking north. Calaveras Lake in distance.**

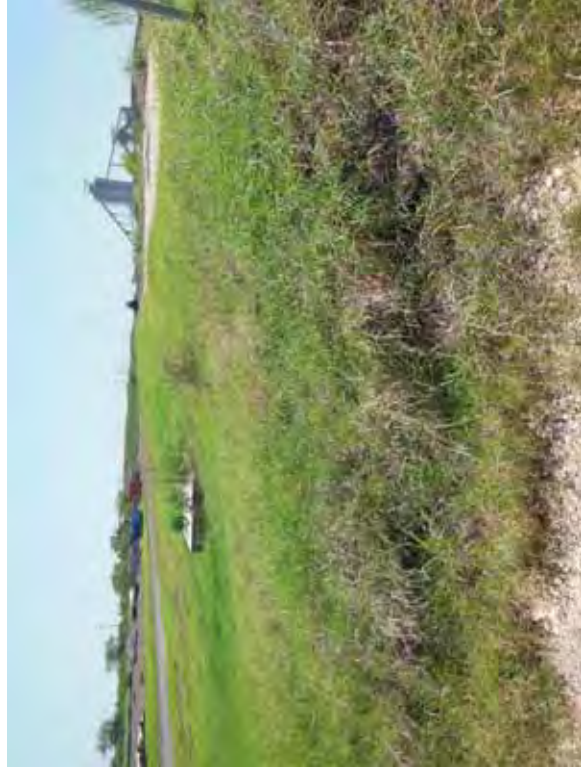
**Photo 9: NP - East embankment exterior slope, looking south.**

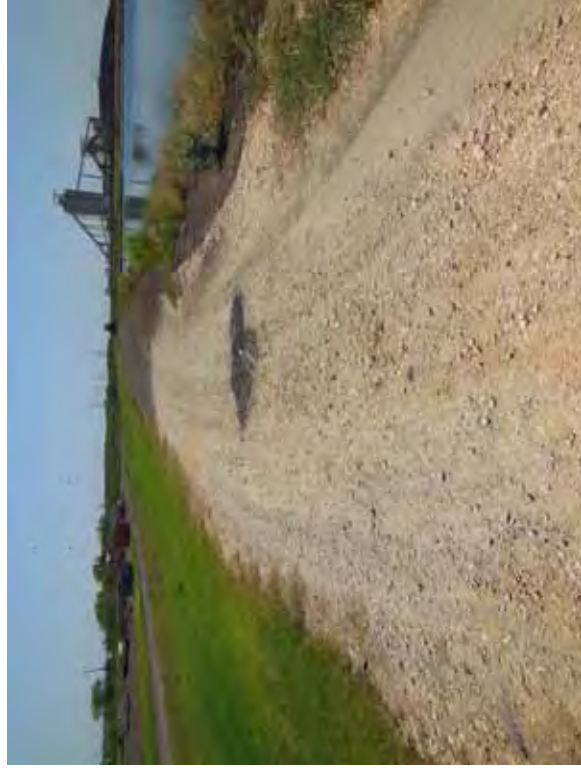
**Photo 10: NP - East embankment crest, looking south.**

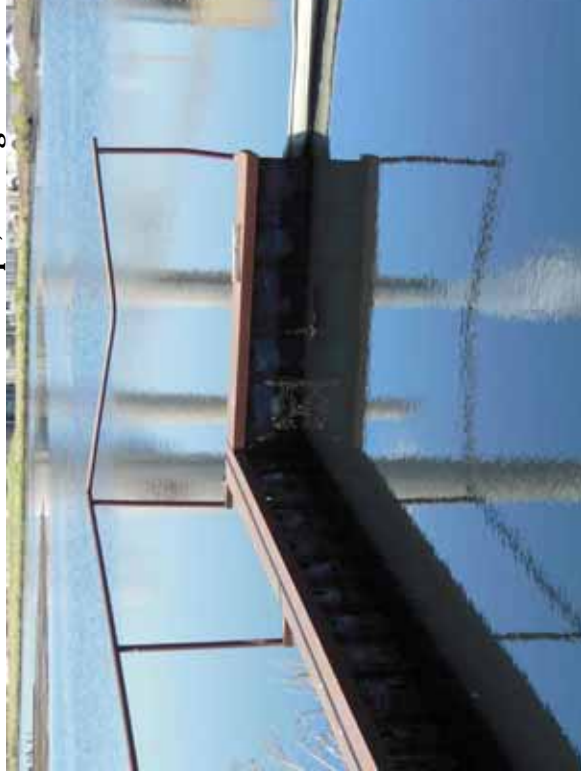
**Photo 11: NP - Outlet structure at northeast corner, looking west.  
Outlet riser pipe.**

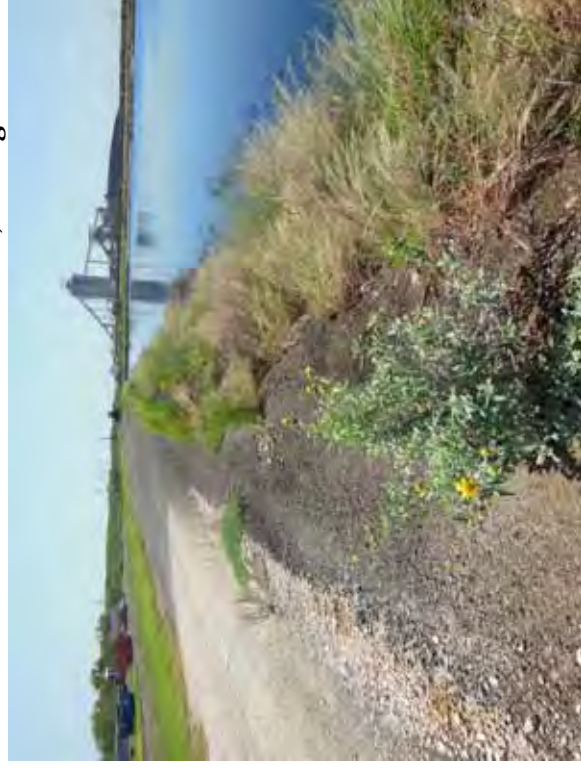
**Photo 12: NP - East interior slope, looking south.**

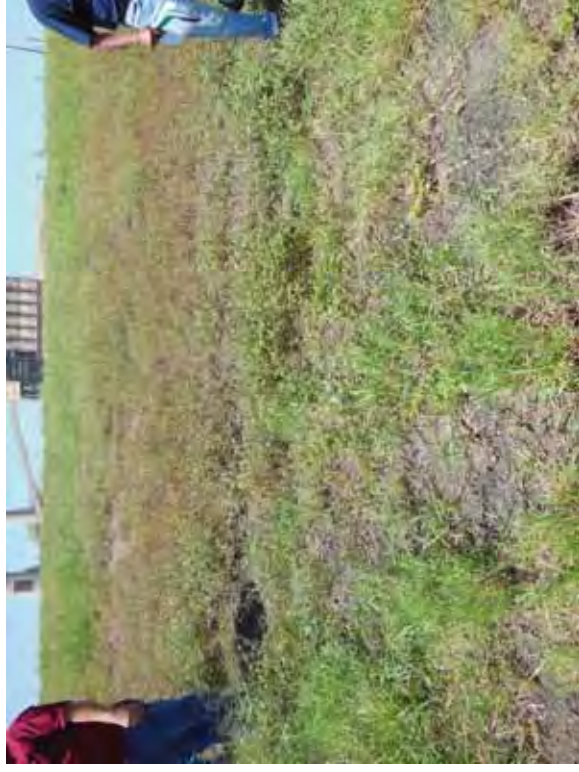
**Photo 16: NP - East embankment exterior slope, looking west.**

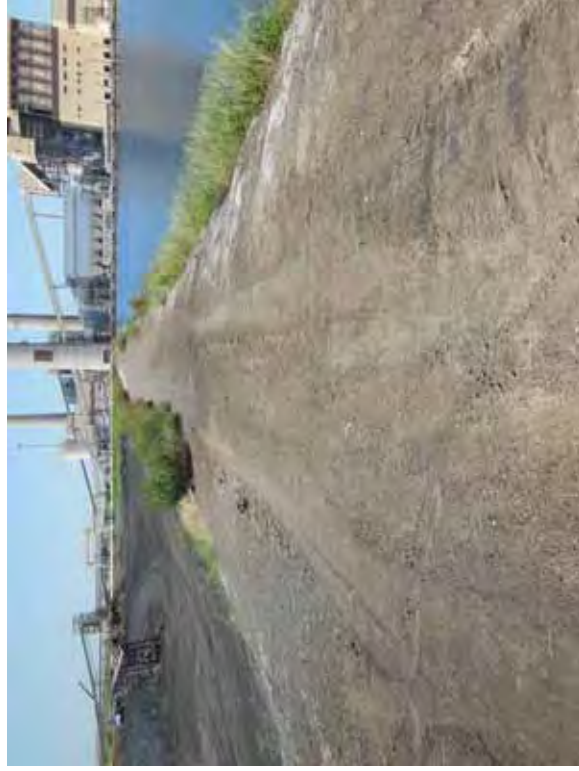
**Photo 21: NP/SP - Common embankment crest, looking west.**

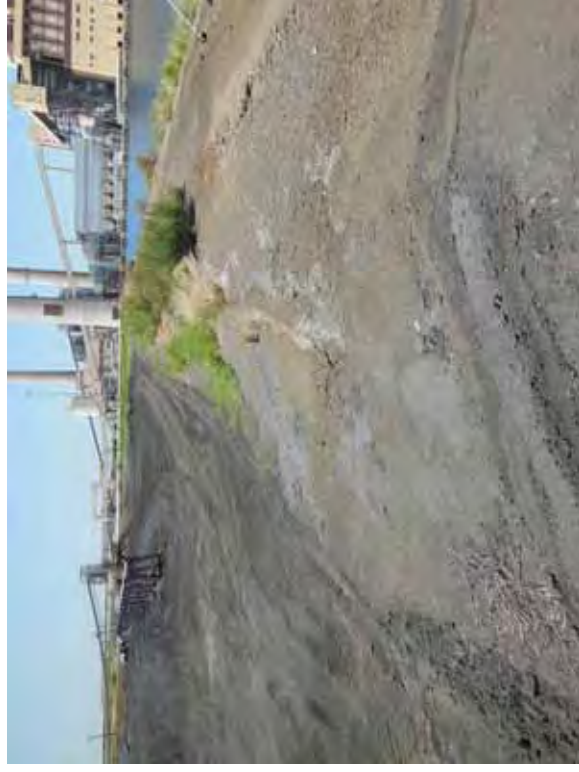
Interior slopes appeared to be in fair condition (Photographs 30, 59, 66, and 70). Based on construction drawings, the interior slopes were constructed at 2H:1V. The north embankment is shared with the North Bottom Ash Pond and is covered in ash material (Photograph 22). Vegetation is sparse, consisting primarily of grass and brush, approximately 2 feet high (Photographs 24, 25, 26, 59, 64, 70, and 84). Some areas of minor erosion into the ash material (Photographs 24, 25, and 26) were observed. A stockpile of CCW was observed on the east embankment interior slope (Photograph 57). Visible portions of interior slopes were not protected by riprap or other armoring.

**Photo 22: NP/SP - Common embankment south slope, looking west.**

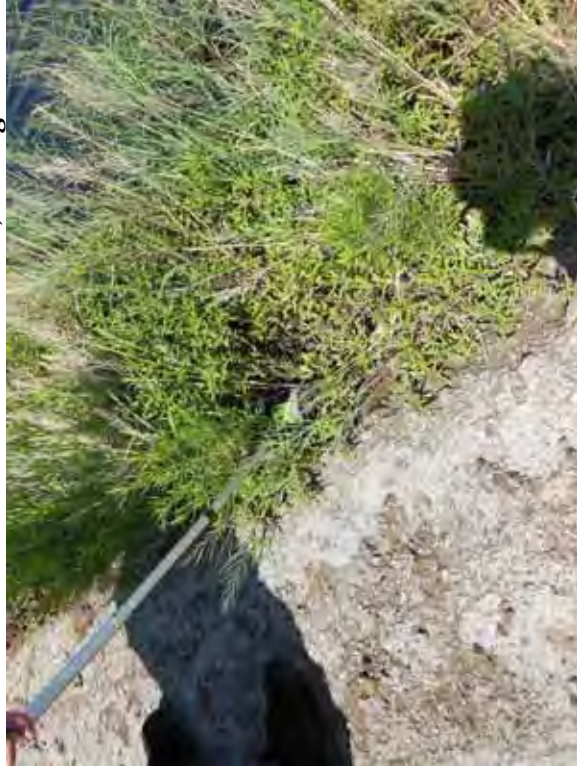
**Photo 23: NP/SP - Erosion of ash material on common embankment north slope.**

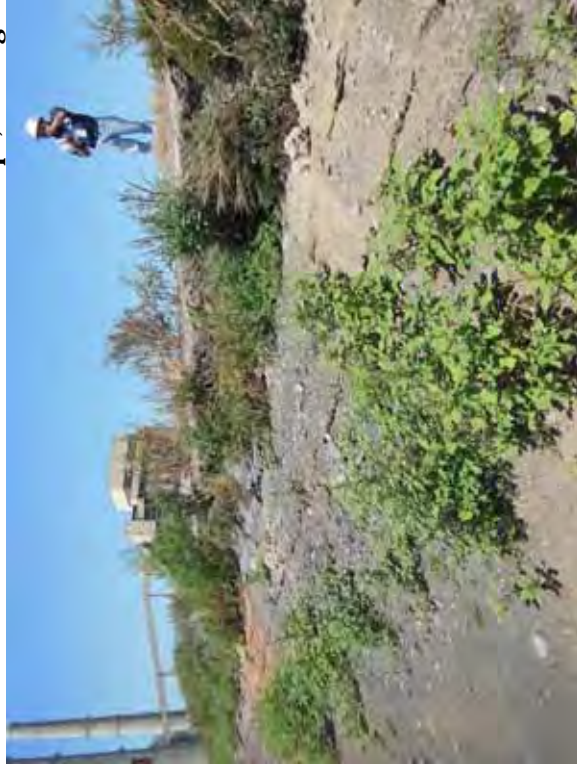
**Photo 24: NP/SP - Erosion of ash material on common embankment south slope, looking northwest.**

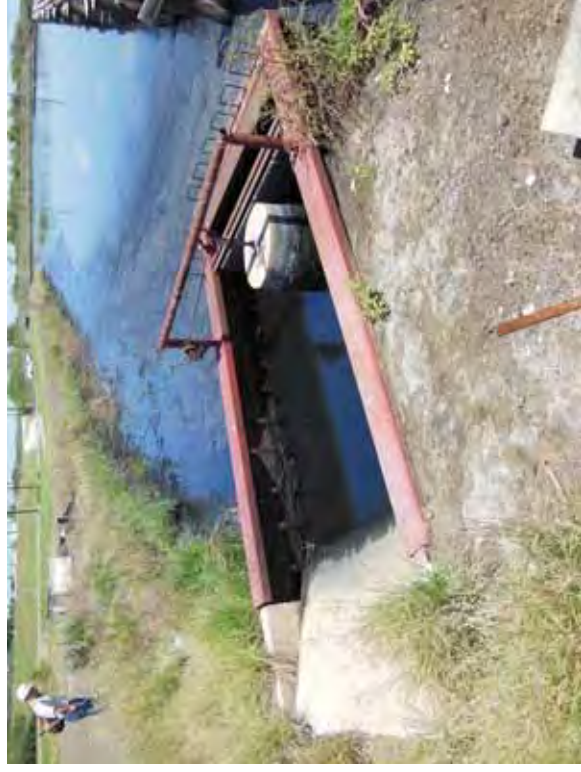
The outlet structure located near the interior slope of the northeast corner consists of a 12-inch-diameter welded steel vertical outlet pipe and a 12-inch-diameter welded steel drain pipe. The outlet pipes are partially surrounded by a steel sheet pile wall containing an opening, with a floating sorbent boom (Photographs 7 and 11). The outlet pipes discharge liquids from the North Bottom Ash Pond to outfalls at the Plant intake canal (Photographs 85, 86, 87, and 88). A 24-inch-diameter welded steel outlet pipe at the interior slope near the southwest corner returns liquids from the pond to the Plant (Photograph 34).

**Photo 34: NP - 24-inch-diameter Plant return outlet, looking north.**

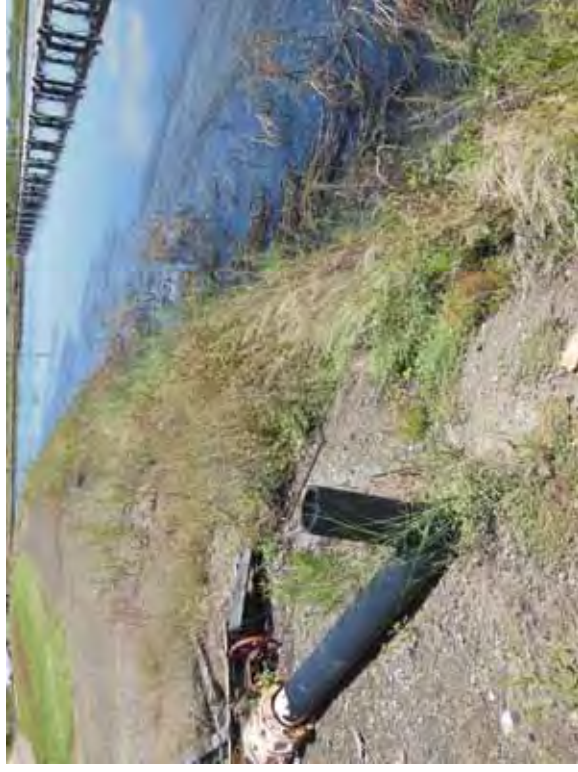
**Photo 36: NP - North embankment interior slope, looking northeast.**

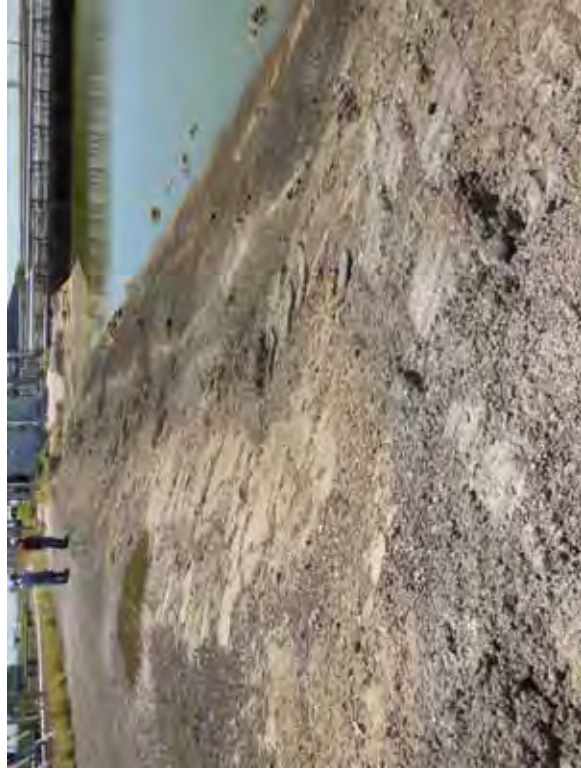
Exterior slopes of the North Bottom Ash Pond appear to be in fair condition (Photographs 15, 30, 39, and 49). Due to the terrain and vegetation on the exterior slope of the north embankment, the slope was only visible from the embankment crest (Photograph 50). A few small trees and brush less than 8 inches in diameter were observed on the exterior slope of the north embankment (Photographs 47 and 48). The exterior slopes of the west and east embankments are approximately 3H:1V and covered in grassy vegetation approximately 3 inches tall (Photographs 16 and 39). The south embankment is shared with the South Bottom Ash Pond and is covered in ash material with sparse vegetation consisting primarily of grass and brush, approximately 2 feet high. Some areas of minor erosion into the ash material (Photographs 24, 25, and 26) were observed. The #1 Stormwater Runoff Pond is located at the west embankment exterior toe and the SRH Pond is located at the exterior toe of the southwest corner (Photograph 37).

**Photo 37: NP - West embankment exterior slope, looking south.**

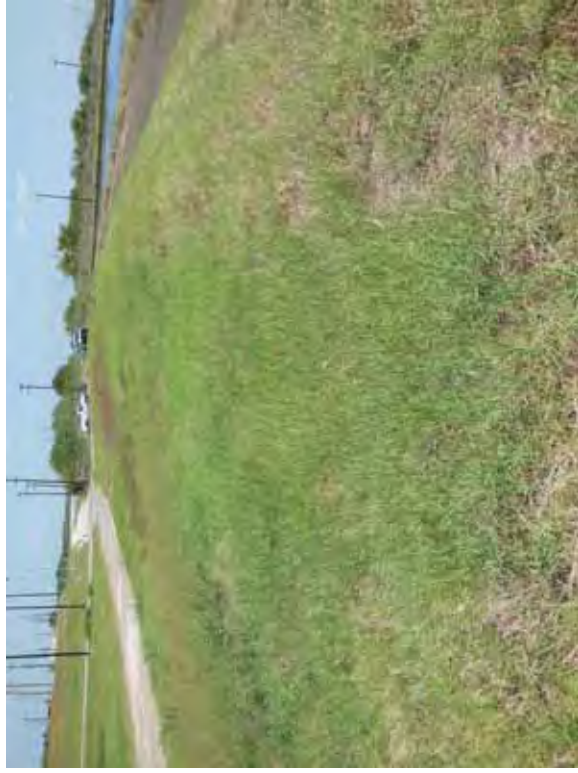
**Photo 39: NP - West embankment exterior slope, looking northeast.**

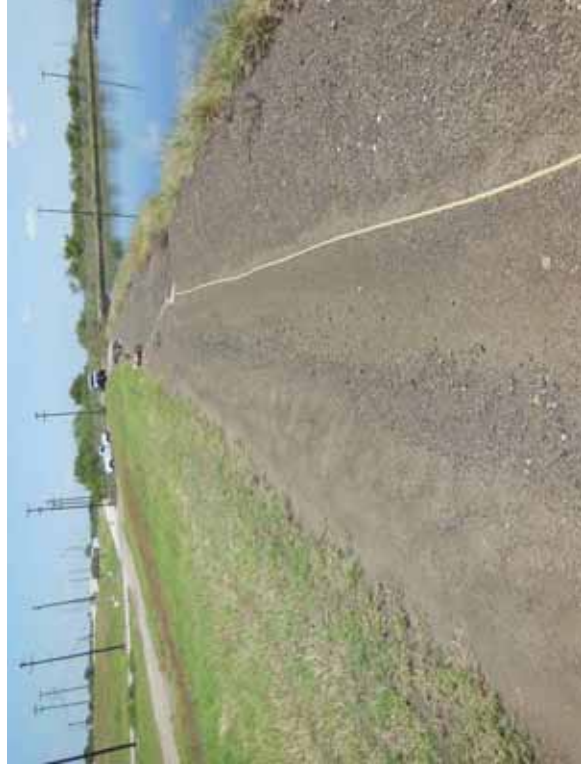
**Photo 42: NP - West embankment crest, looking northeast.**

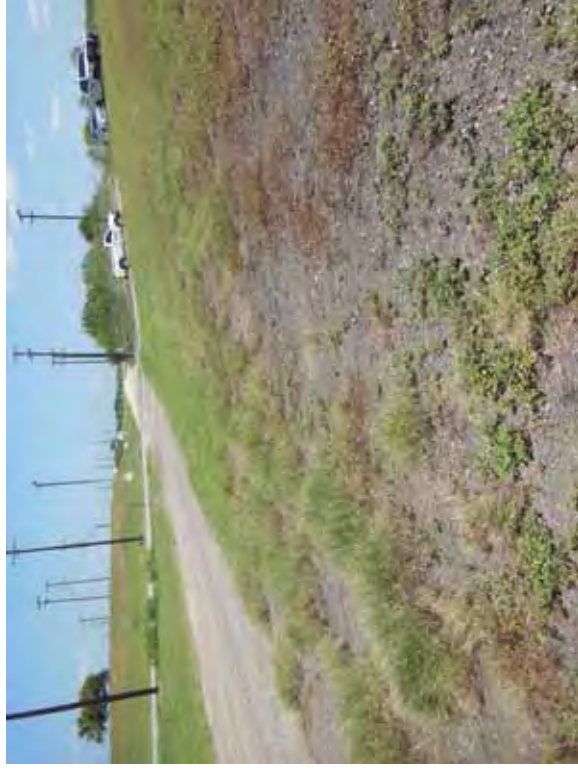
**Photo 44: NP - West embankment exterior slope, looking north.**

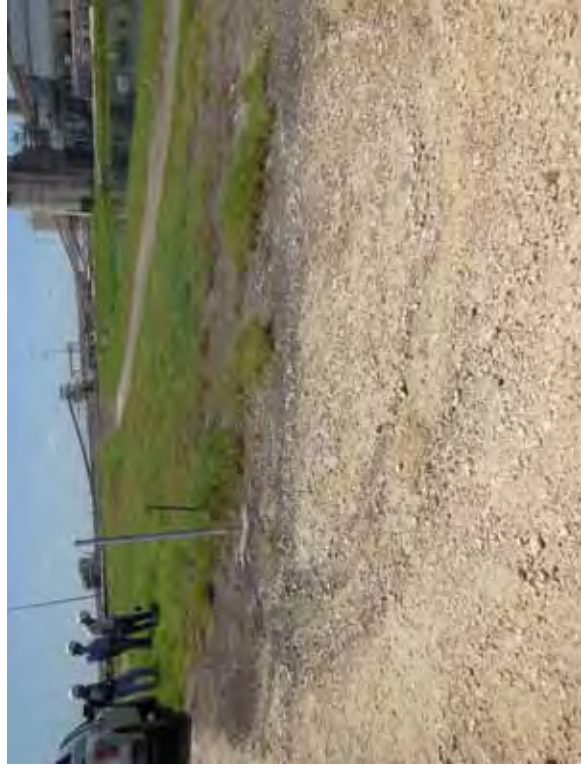
**Photo 46: NP - Northwest corner exterior slope, looking south.**

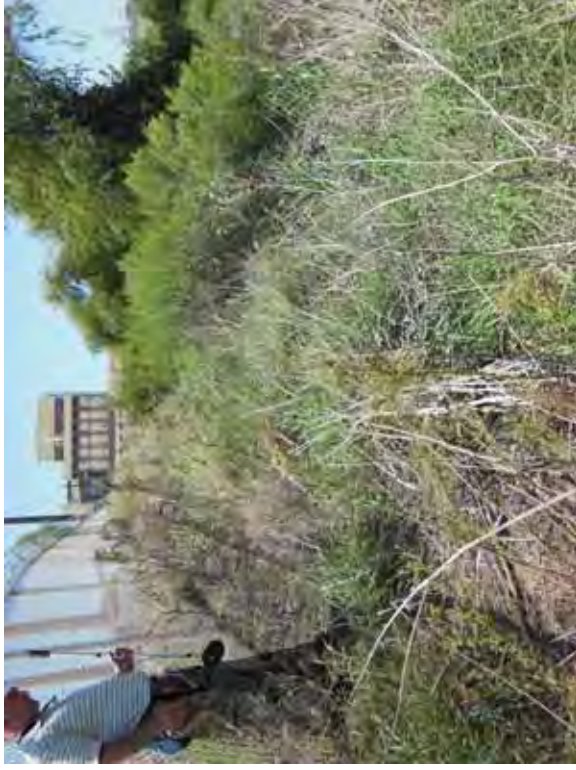
**Photo 48: NP - North embankment exterior slope, looking west.**

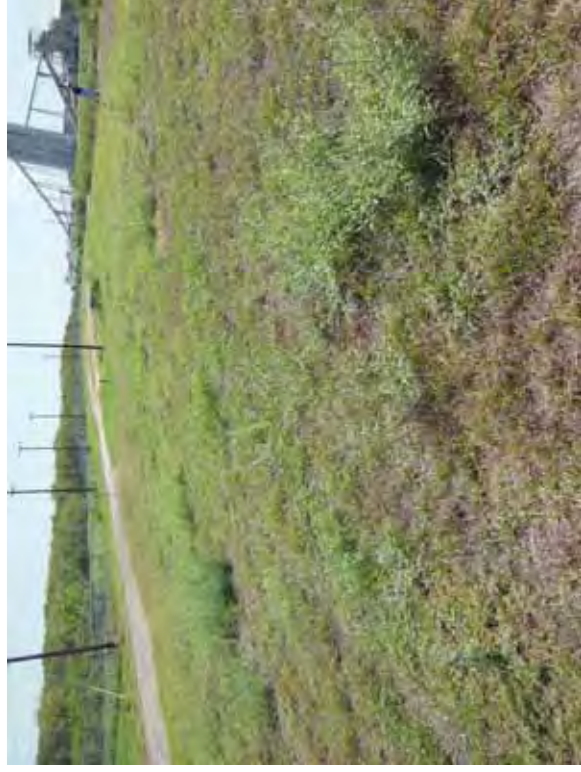
Exterior slopes of the South Bottom Ash Pond appear to be in fair condition (Photographs 27, 58, 62, and 74). The exterior slopes of the east and south embankments are approximately 3H:1V and covered in grassy vegetation approximately 3 inches tall (Photograph 63). The north embankment exterior slope is shared with the North Bottom Ash Pond and is covered in ash material with sparse vegetation consisting of grass and brush, approximately 2 feet high. Some areas of minor erosion were observed on the exterior slope, in the ash material (Photograph 23). The SRH Pond is located at the west embankment exterior slope and is covered with ash and other granular material (Photographs 74, 81, and 82). A drainage ditch is located at the south embankment exterior toe (Photograph 67).

**Photo 58: SP - East embankment exterior slope, looking south.**

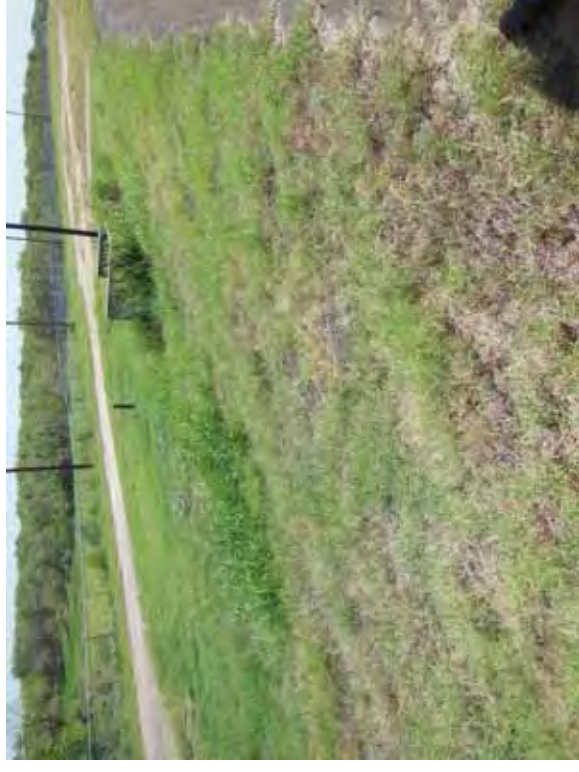
**Photo 60: SP - Exterior slope at southeast corner, looking south.**

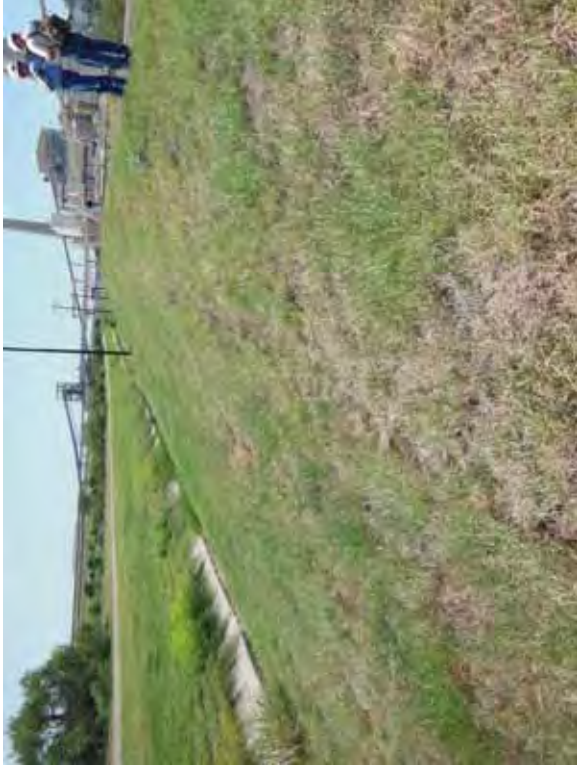
**Photo 62: SP - South embankment exterior slope, looking west.**

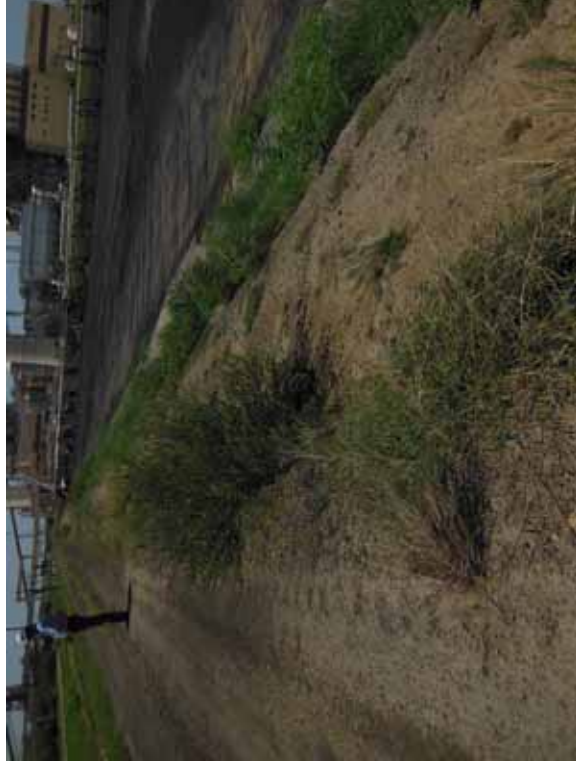
**Photo 64: SP - South embankment interior slope, looking west.**

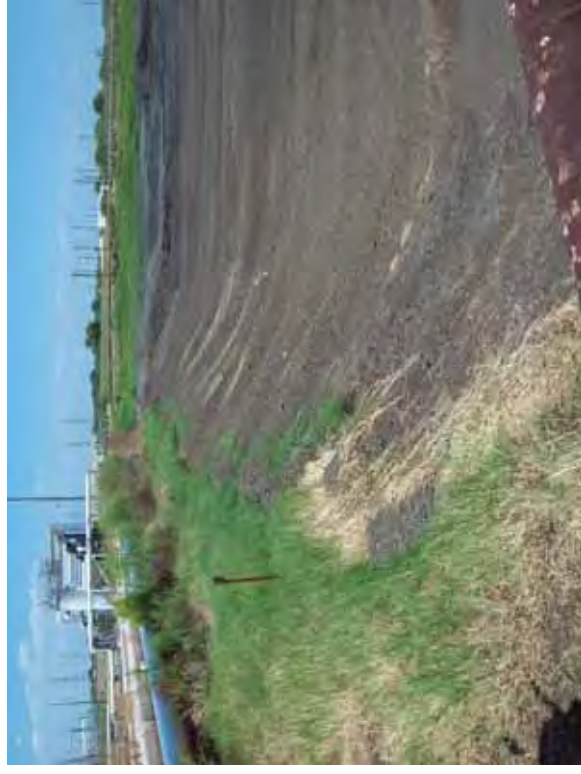
**Photo 70: SP - West embankment interior slope, looking north.**

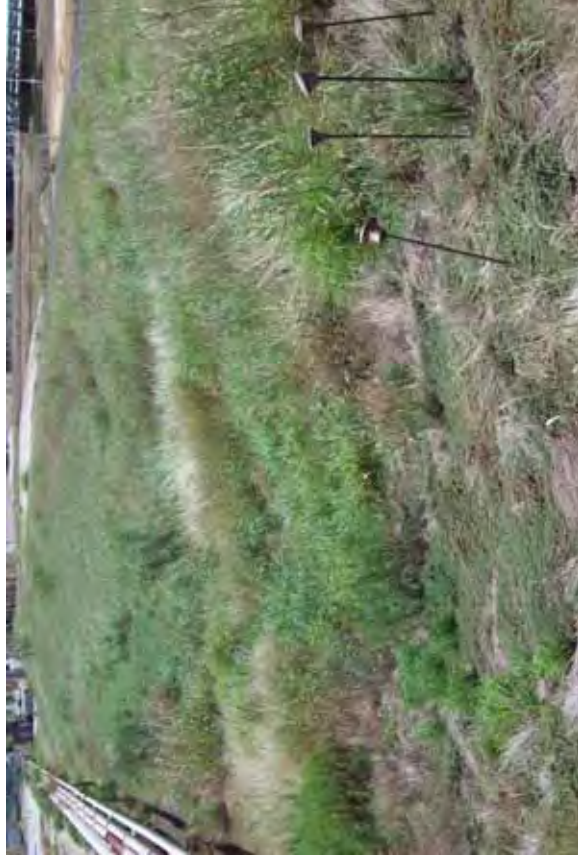
**Photo 72: SP - Exterior slope at southwest corner, looking west.**

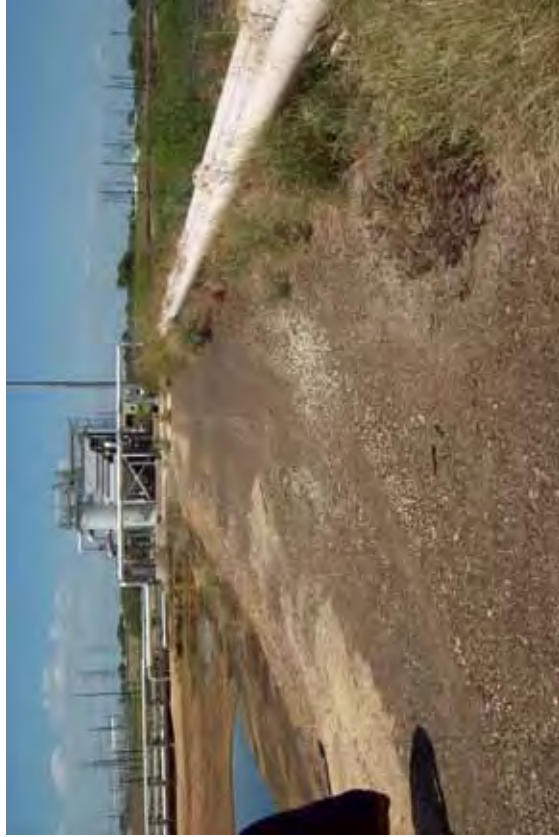
The crest of the South Bottom Ash Pond appeared to be in satisfactory condition (Photographs 29, 56, 65, and 73). All embankment crests were approximately 15 feet wide and consists of compacted granular soils and gravel and is exposed to minimal vehicle traffic. A clarifier structure associated with the adjacent SRH Pond was located on the west embankment crest (Photograph 78). The west embankment crest included two spillways connecting the SRH and South Bottom Ash Ponds (Photographs 75, 76, 77, 79, 80, and 81). No depressions or evidence of settlement were observed on the crest.

**Photo 73: SP - West embankment crest, looking north.**

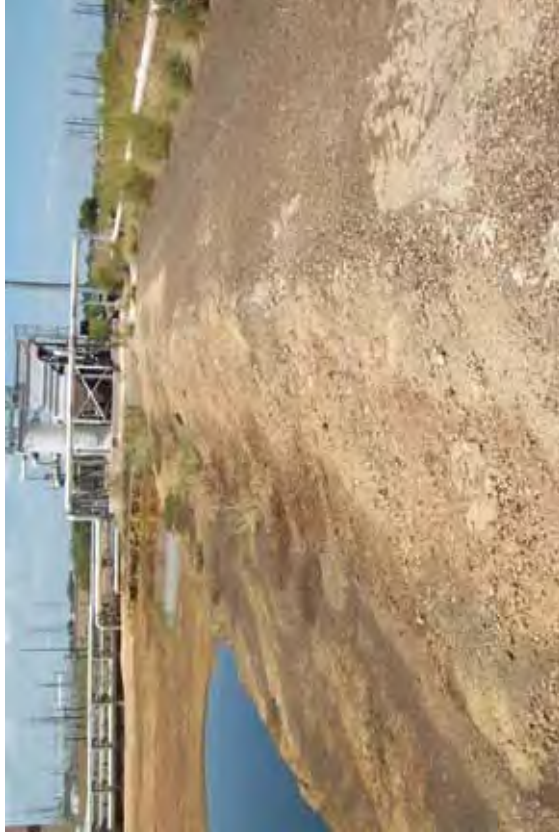
**Photo 74: SP - West embankment exterior slope, looking north.**

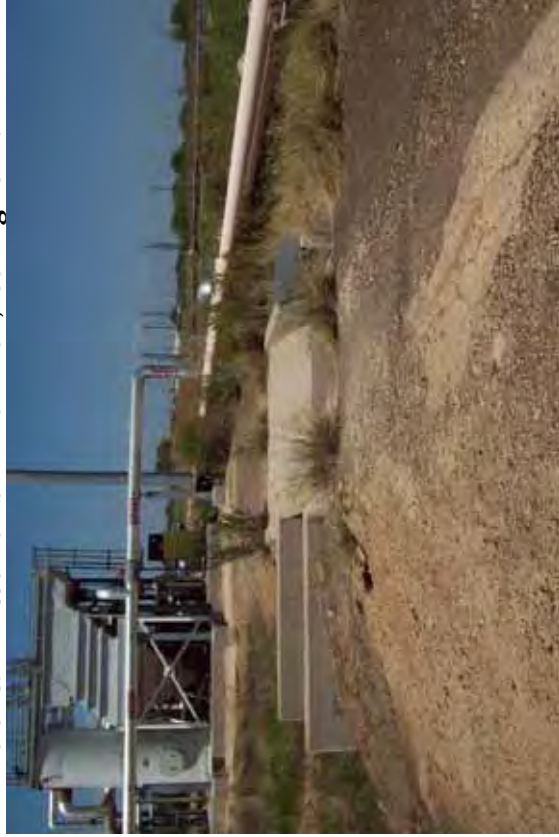
**Photo 75: SP - Spillway between SRH Pond and South Bottom Ash Pond at west embankment crest, looking north.**

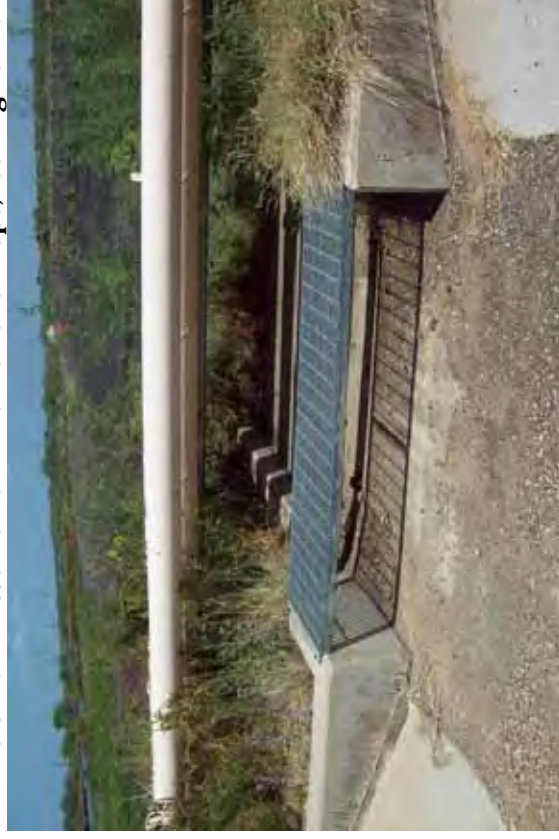
**Photo 76: SP - Spillway between SRH Pond and South Bottom Ash Pond at west embankment interior slope, looking east.**

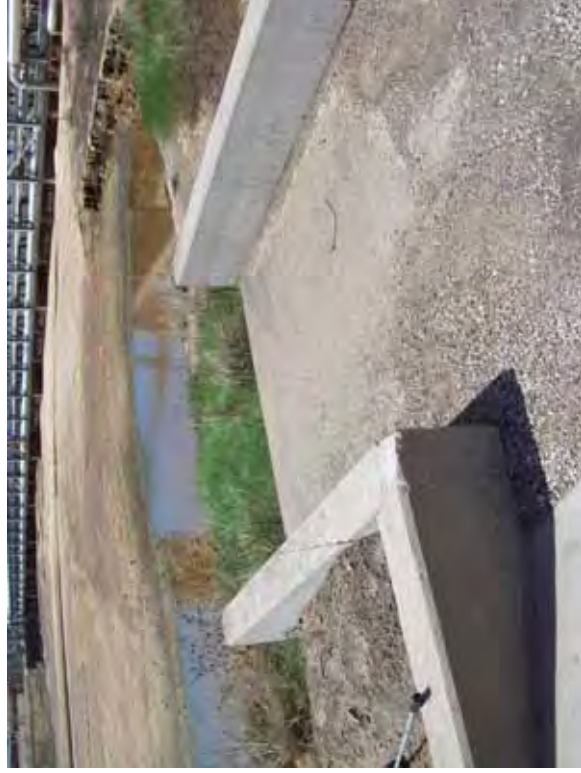
**Photo 77: SP - Spillway between SRH Pond and South Bottom Ash Pond at west embankment exterior slope, looking west.**

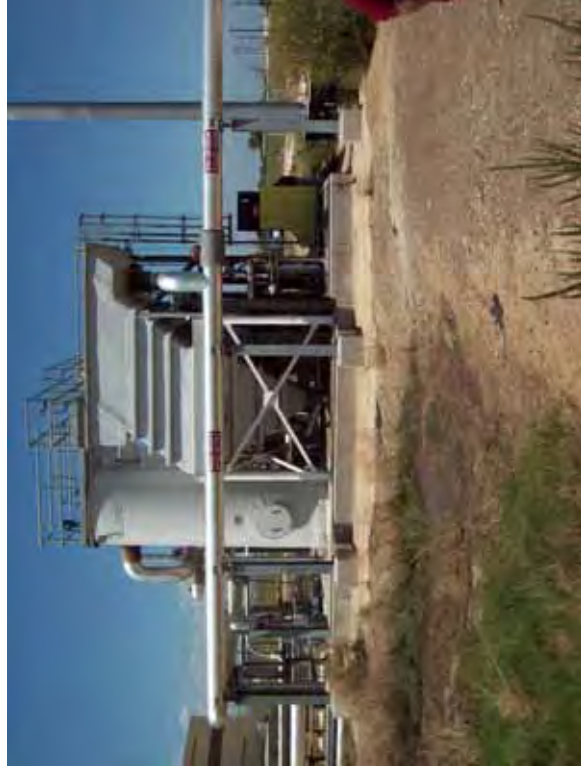
**Photo 78: SP - SRH Pond clarifier structure at west embankment crest, looking north.**

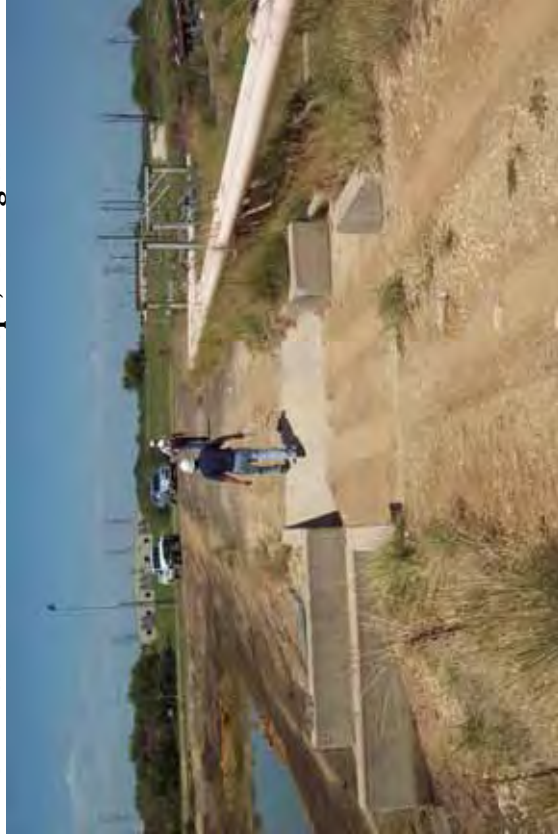
**Photo 79: SP - Spillway between SRH Pond and South Bottom Ash Pond at west embankment crest, looking north.**

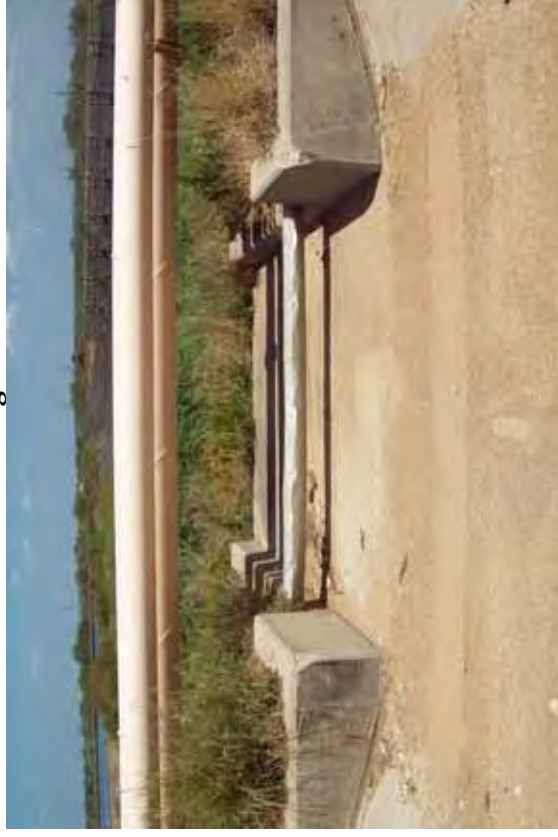
**Photo 80: SP - Spillway between SRH Pond and South Bottom Ash Pond at west embankment interior slope, looking east.**

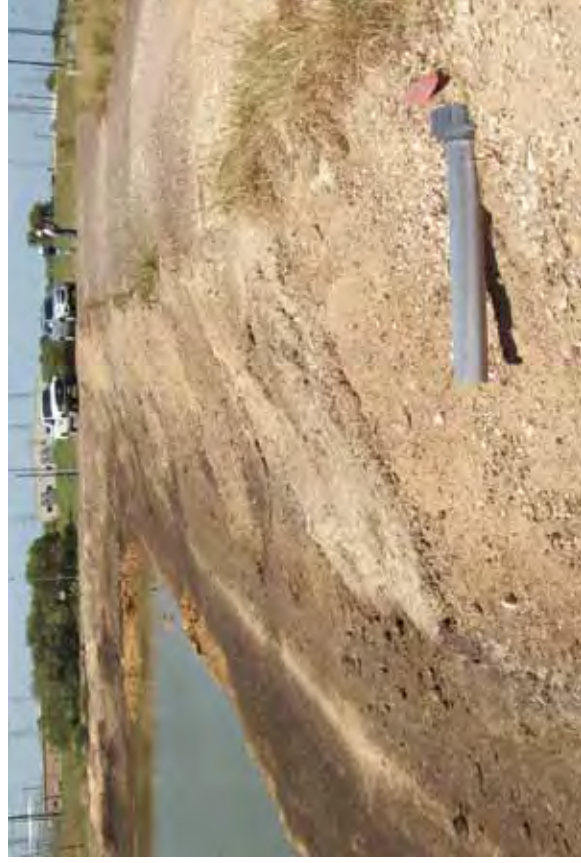
**Photo 82: SP - West embankment exterior slope, looking north.**

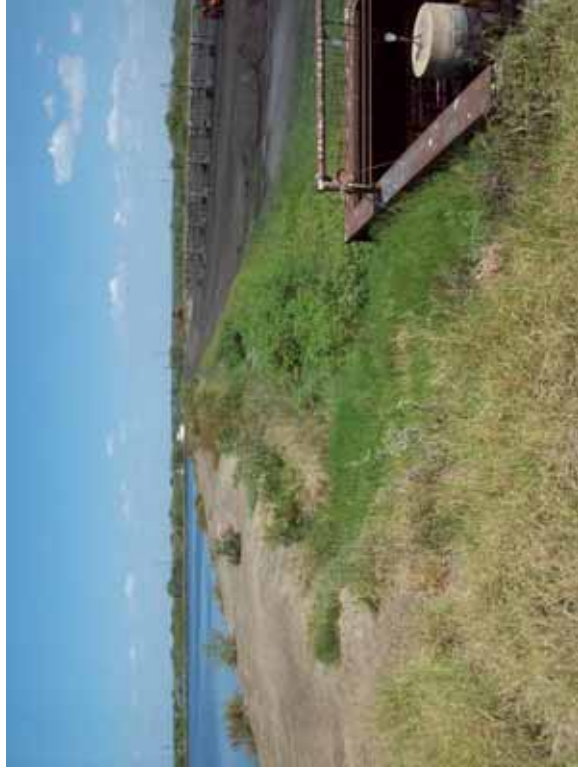
**Photo 84: NP/SP - Common embankment south slope, looking east.**

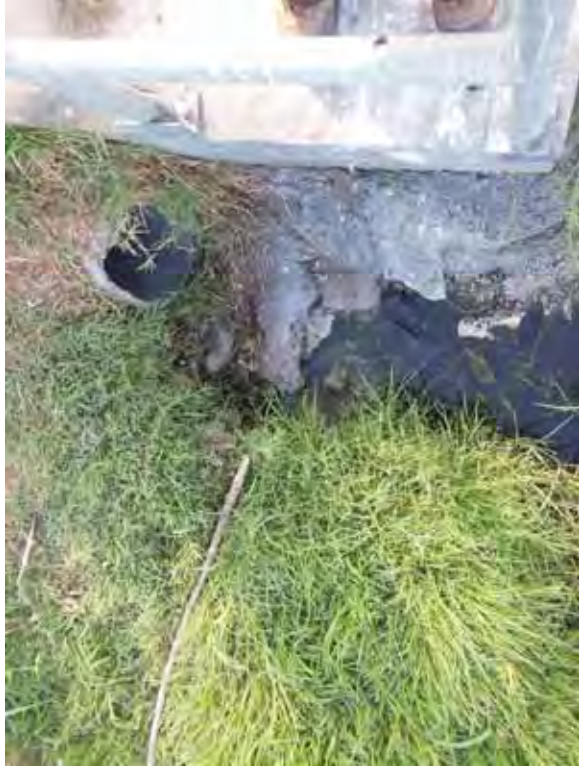
**Photo 89: SP – 12-inch-diameter piping at outfall 103B.**

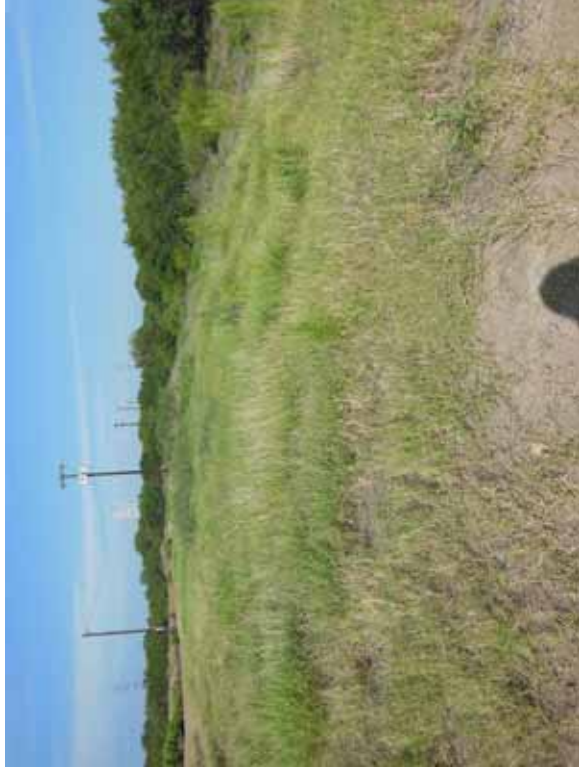
The exterior slopes appear to be in satisfactory condition and are covered in grassy vegetation approximately 2 feet high and a few small trees and bushes with diameters less than 6 inches in diameter (Photographs 93, 98, 109, and 119). Areas of loose soil were observed at the east embankment exterior slope (Photographs 92, 94, and 96) and an animal burrow was observed in the west embankment exterior slope (Photograph 110). An area of exposed soil was observed at the south embankment exterior slope (Photograph 117). Based on construction drawings, the exterior slopes are 3H:1V at all embankments, though slopes measured in the field ranged from 3H:1V to 4H:1V (Photographs 97 and 118). Trees up to 12 inches in diameter were located at the toe of all embankments (Photographs 95, 105, 112, and 119).

**Photo 98: North embankment exterior slope, looking west.**

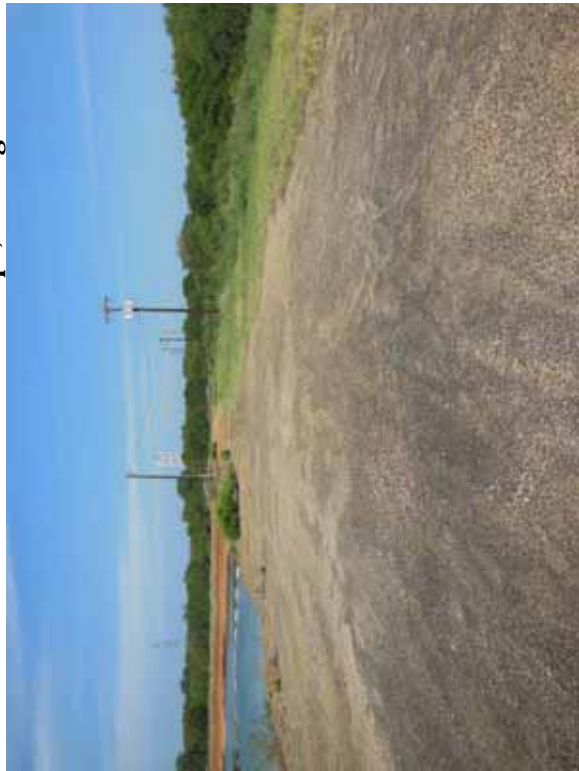
The embankment crest of the Evaporation Pond appeared to be in satisfactory condition (Photographs 90, 100, 108, and 114). The crest was approximately 15 feet wide at all embankments except the north embankment where the crest measured approximately 50 feet wide. The crest of the embankment consists of a compacted gravel drive and grass. The surface is exposed to minimal vehicle traffic. No depressions or evidence of settlement were observed on the crest.

**Photo 100: North embankment crest, looking west.**

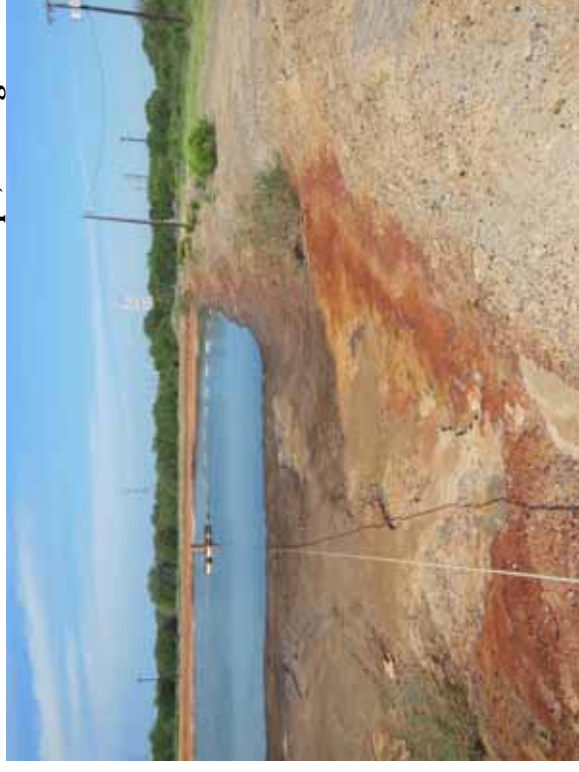
Due to the level of solids and water in the Evaporation Pond during the assessment, only the upper 0.5 to 2 feet of the interior slopes were visible (Photographs 91, 101, 102, 106, and 115). Vegetation covered some portions of the west and south embankment interior slopes (Photographs 111, 115, and 120). Ash and other solid material extend up to the crest near the southeast corner interior slope and on the east embankment interior slope (Photographs 91 and 122). Visible portions of interior slopes did not include riprap or other armoring.

**Photo 101: North embankment interior slope, looking west.**

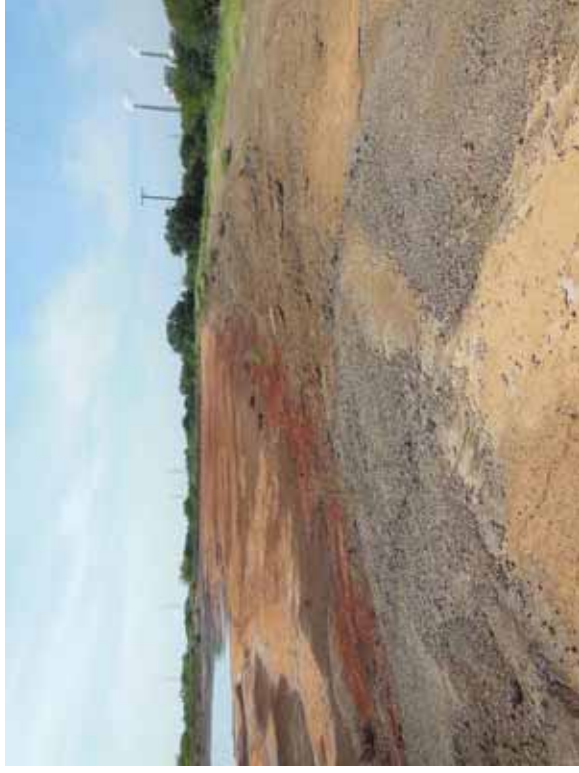
**Photo 106: West embankment interior slope, looking south.**
