# ASSESSMENT OF DAM SAFETY OF COAL COMBUSTION SURFACE IMPOUNDMENTS FINAL REPORT

**CPS Energy  
J.T. Deely Power Plant  
San Antonio, Texas**

Prepared for  
*U.S. Environmental  
Protection Agency  
Washington, D.C.*

February 2014  
Revised May 2014  
Revised June 2014

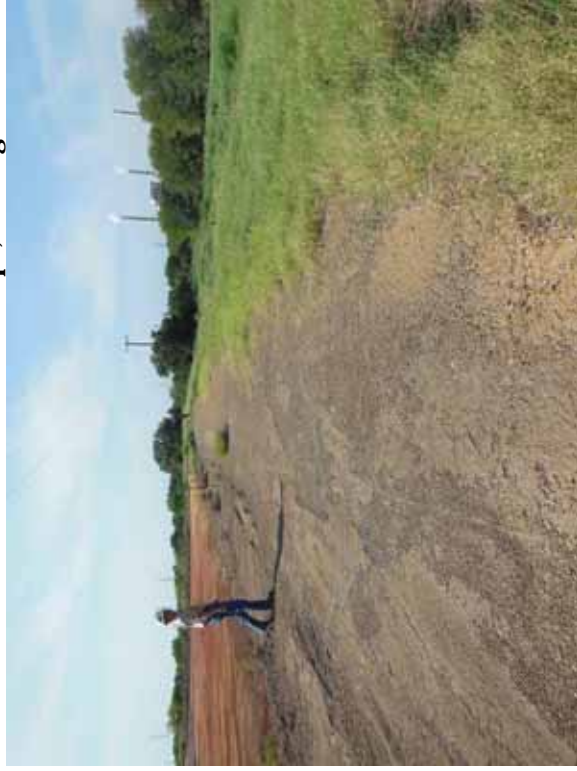
The embankment crest of the Evaporation Pond appeared to be in satisfactory condition (Photographs 90, 100, 108, and 114). The crest was approximately 15 feet wide at all embankments except the north embankment where the crest measured approximately 50 feet wide. The crest of the embankment consists of a compacted gravel drive and grass. The surface is exposed to minimal vehicle traffic. No depressions or evidence of settlement were observed on the crest.

**Photo 108: West embankment crest, looking south.**

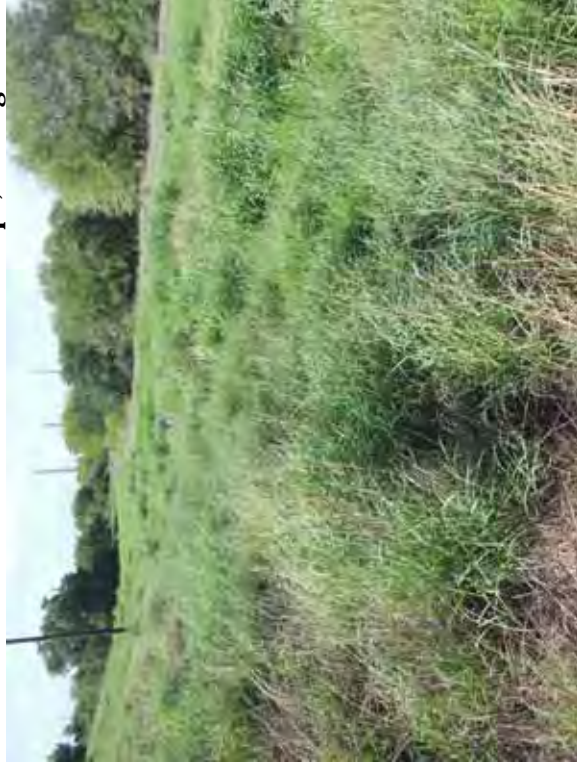
The exterior slopes appear to be in satisfactory condition and are covered in grassy vegetation approximately 2 feet high and a few small trees and bushes with diameters less than 6 inches in diameter (Photographs 93, 98, 109, and 119). Areas of loose soil were observed at the east embankment exterior slope (Photographs 92, 94, and 96) and an animal burrow was observed in the west embankment exterior slope (Photograph 110). An area of exposed soil was observed at the south embankment exterior slope (Photograph 117). Based on construction drawings, the exterior slopes are 3H:1V at all embankments, though slopes measured in the field ranged from 3H:1V to 4H:1V (Photographs 97 and 118). Trees up to 12 inches in diameter were located at the toe of all embankments (Photographs 95, 105, 112, and 119).

**Photo 109: West embankment exterior slope, looking southwest.**

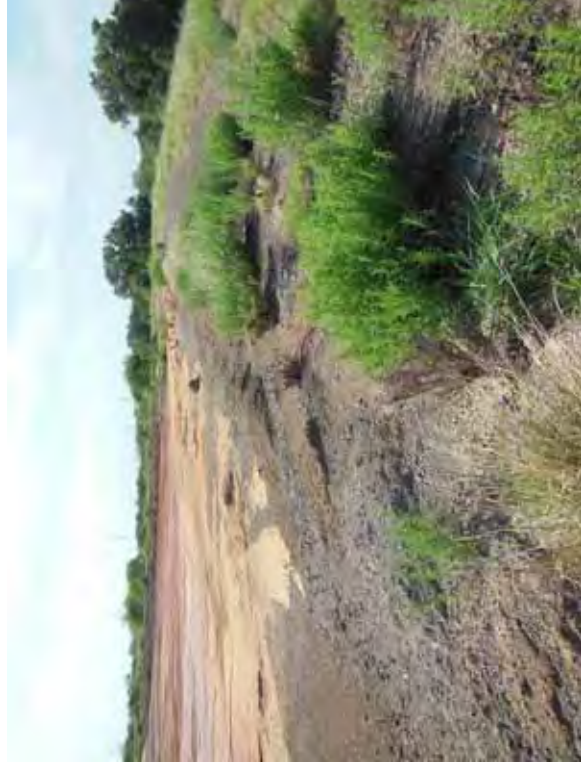
Due to the level of solids and water in the Evaporation Pond during the assessment, only the upper 0.5 to 2 feet of the interior slopes were visible (Photographs 91, 101, 102, 106, and 115). Vegetation covered some portions of the west and south embankment interior slopes (Photographs 111, 115, and 120). Ash and other solid material extend up to the crest near the southeast corner interior slope and on the east embankment interior slope (Photographs 91 and 122). Visible portions of interior slopes did not include riprap or other armoring.

**Photo 111: West embankment interior slope, looking south.**

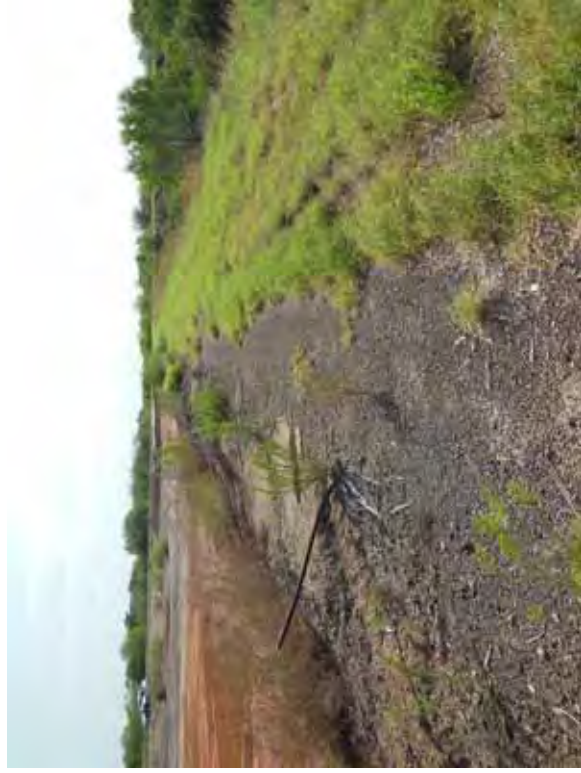
**Photo 114: South embankment crest, looking east.**

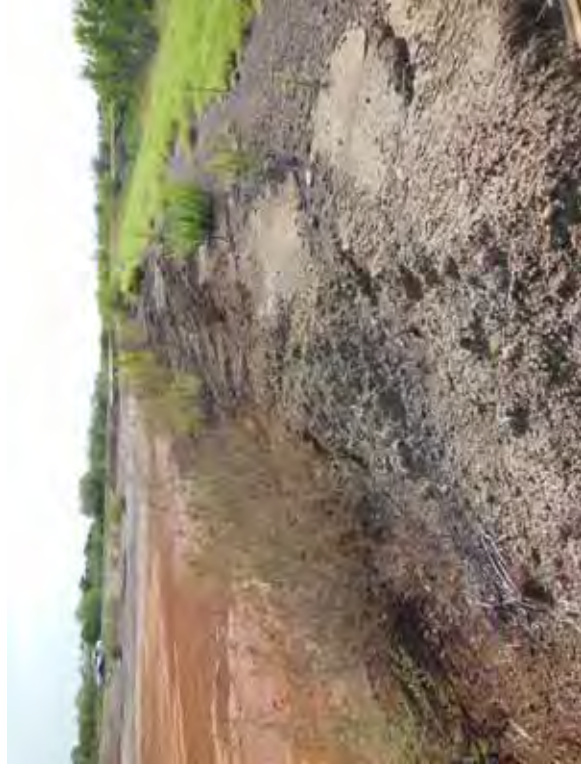
**Photo 115: South embankment interior slope, looking east.**

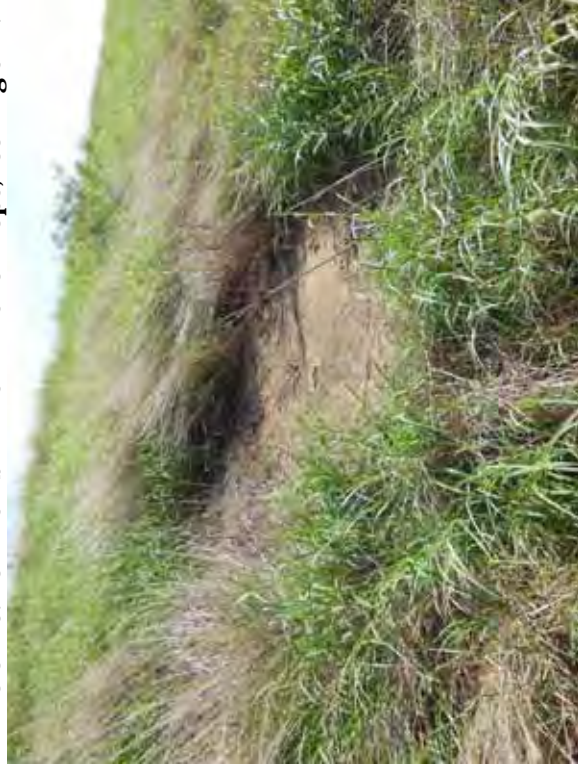
**Photo 117: Exposed soil at south embankment exterior slope, looking north.**

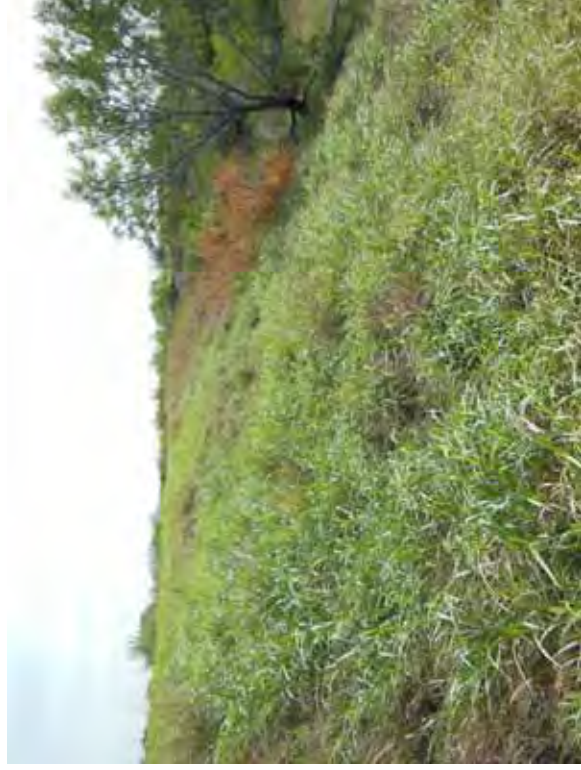
**Photo 119: South embankment exterior slope, looking east.**

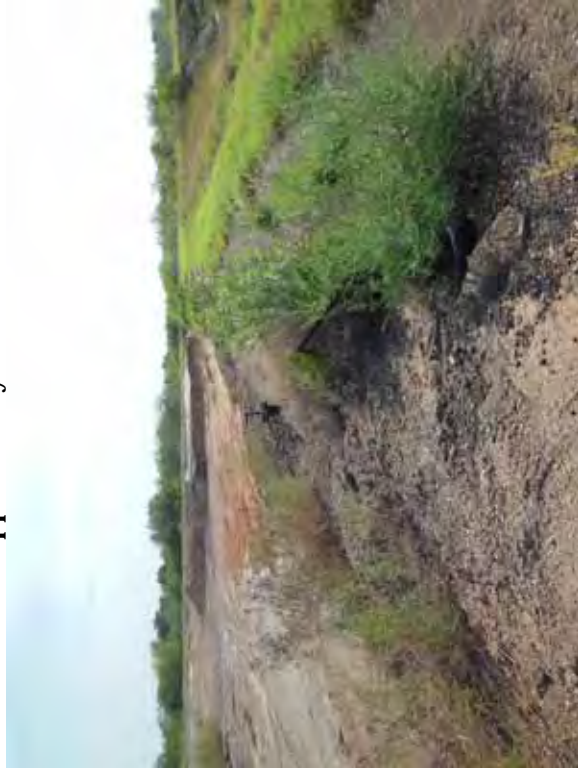
**Photo 120: South embankment interior slope, looking east.**

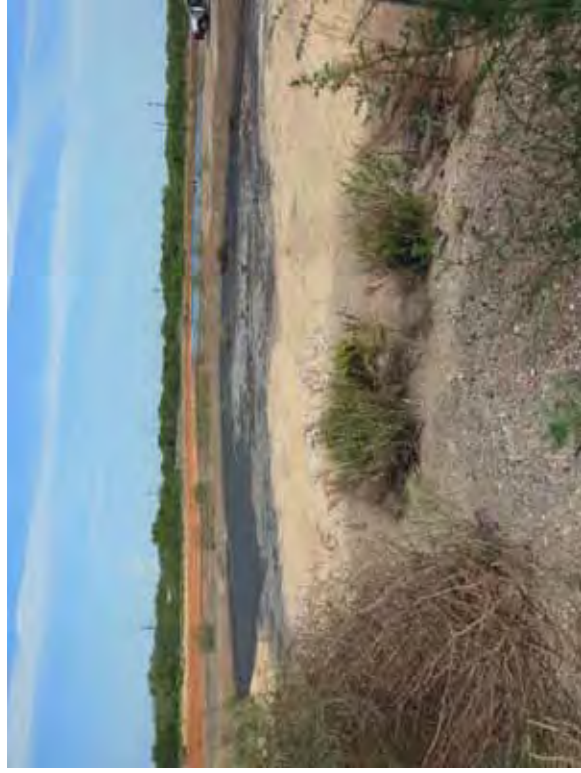
**Photo 122: Interior slope at southeast corner, looking northwest.**
