**DRAFT REPORT
ROUND 10 DAM ASSESSMENT
DAYTON POWER AND LIGHT COMPANY
KILLEN ELECTRIC GENERATING STATION
BOTTOM ASH POND AND FLY ASH POND**

Re: Round 10 Dam Assessment - Draft Report
EPA Contract No. EP10W001313
Dayton Power and Light Company – Killen Electric Generating Station
Bottom Ash Pond and Fly Ash Pond
Manchester, Ohio

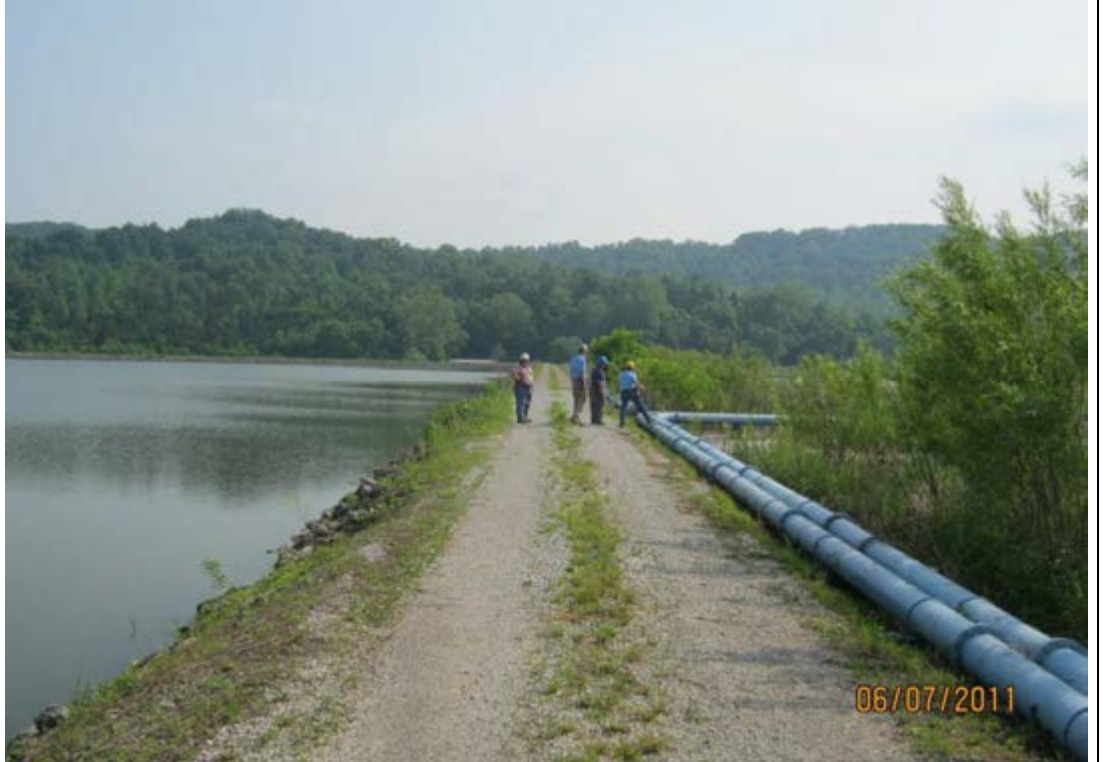
Photo No. 4

View of overflow structure between the Bottom Ash Pond and Fly Ash Pond. Structure contains stop logs to control Bottom Ash Pond water level. Pipe shown in picture carries liquids from the Plant Drain to the Fly Ash Pond.

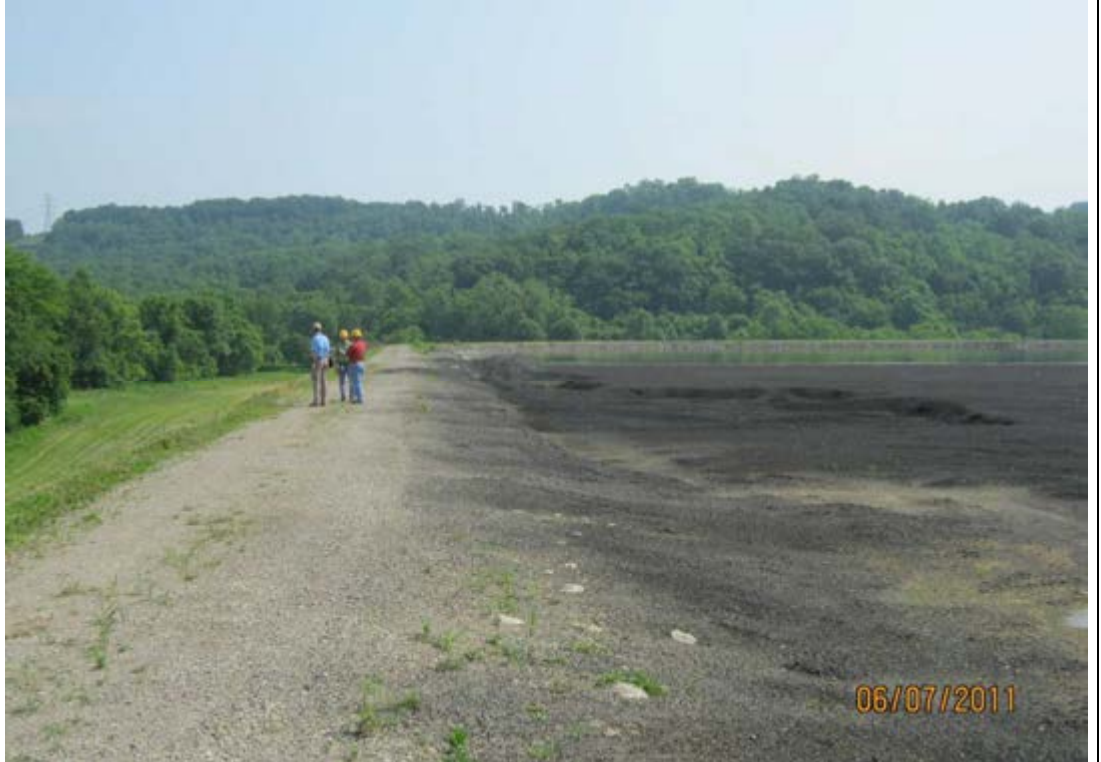
Photo No. 10

View of interior slope of the west-northwest dike of Bottom Ash Pond in the vicinity of Station 11+00.

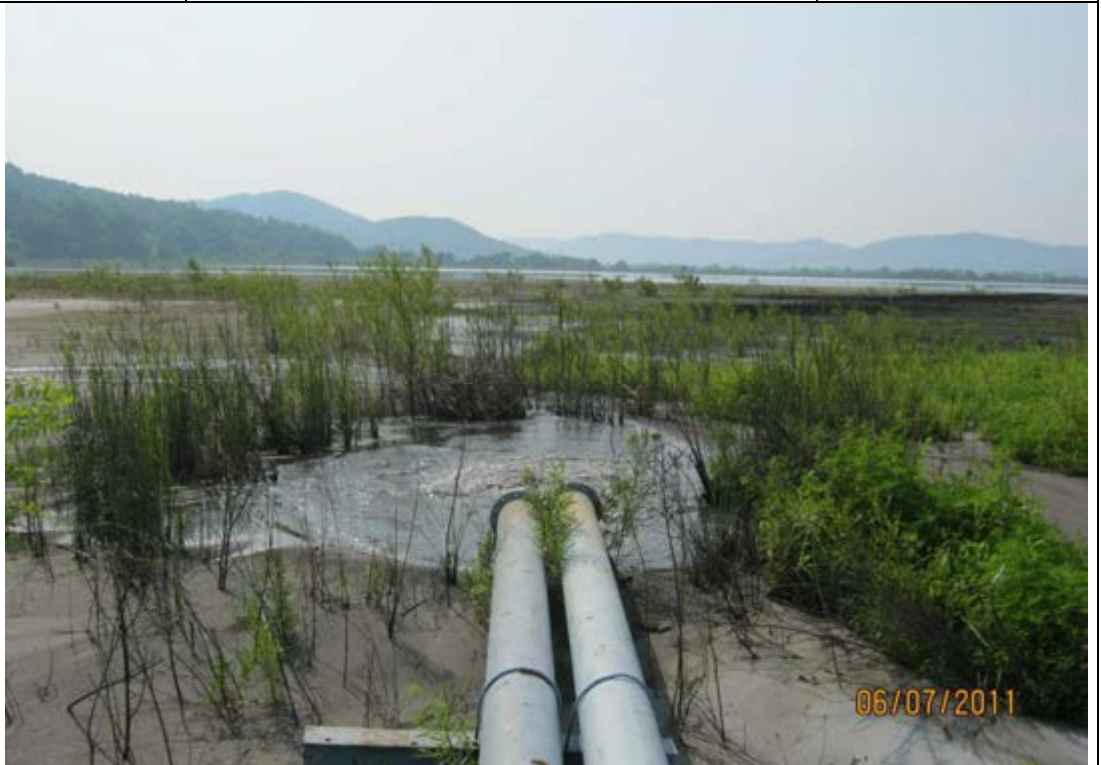
Photo No. 14

Description: Discharge of Plant Drain into the Fly Ash Pond.

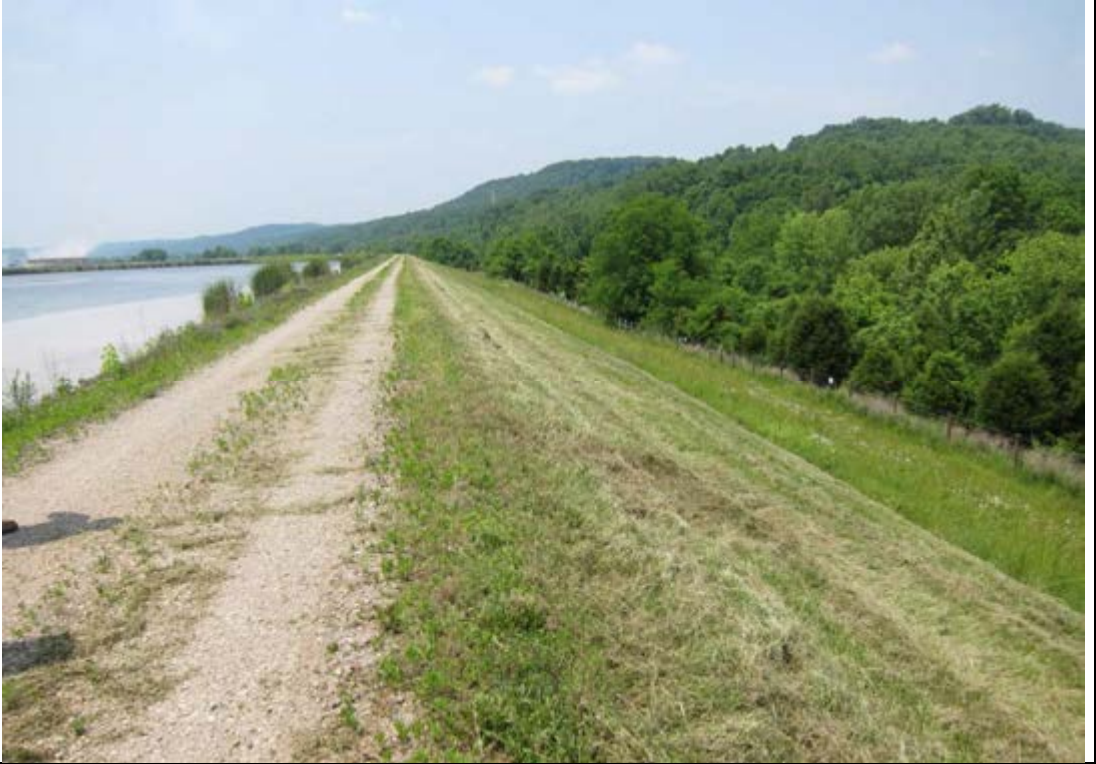
Direction Photo Taken: Northwest			
Description: View of exterior slope of Fly Ash Pond in the vicinity of Station 40+00.

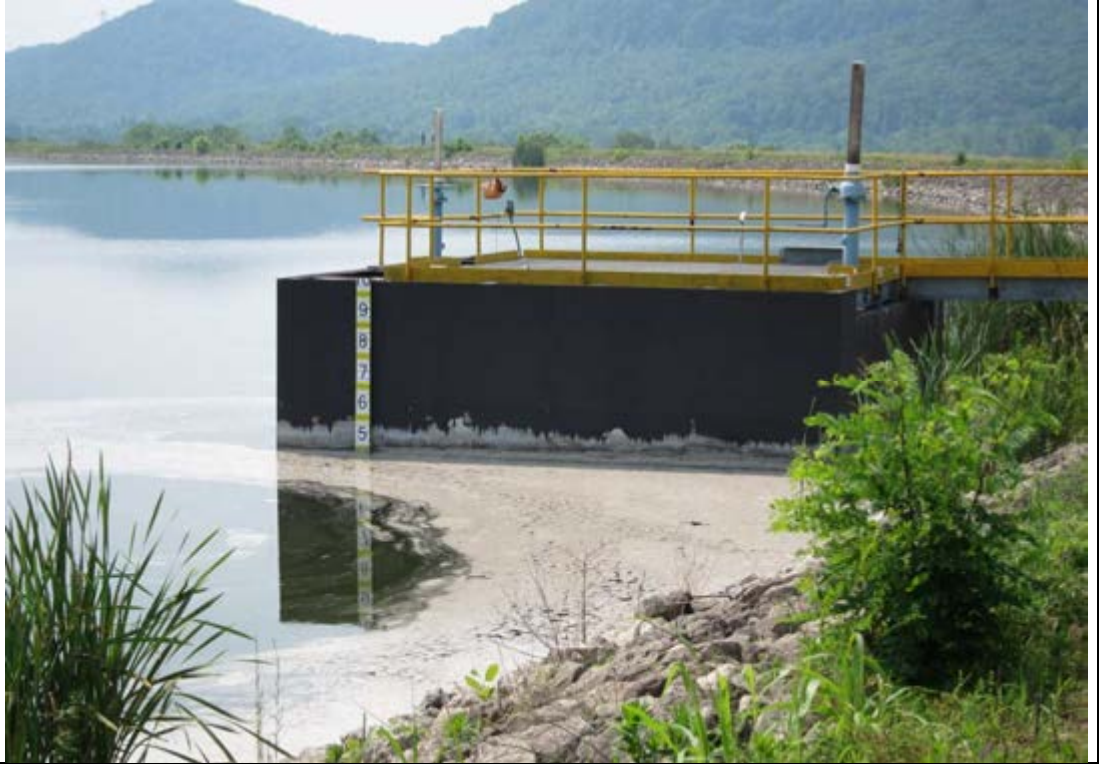
Photo No. 24

The decant structure is the only discharge structure located within the Fly Ash Pond (Photos 23, 24, and 25). This structure was observed to be in good condition and clear of debris, and the concrete visible above the water surface appeared intact. A staff gauge (Photos 23 and 24) was present on the exterior portion of the decant structure and was observed to be clean and in good condition. The interior of the decant structure could not be observed to evaluate sluice gates, piping or other features. The transfer pipes associated with the pump station inlet structure are below grade and could not be visually inspected during the assessment. However, DP&L reportedly has never had an issue with any of the discharge pipes since the Fly Ash Pond was originally constructed. Water from the decant structure is ultimately discharged to an energy dissipater (Photo 26) and Parshall flume that ultimately discharges to the Ohio River in accordance with DP&L's existing NPDES permit. The energy dissipater and Parshall flume were observed to be in good condition.

View of decant structure in the Fly Ash Pond.

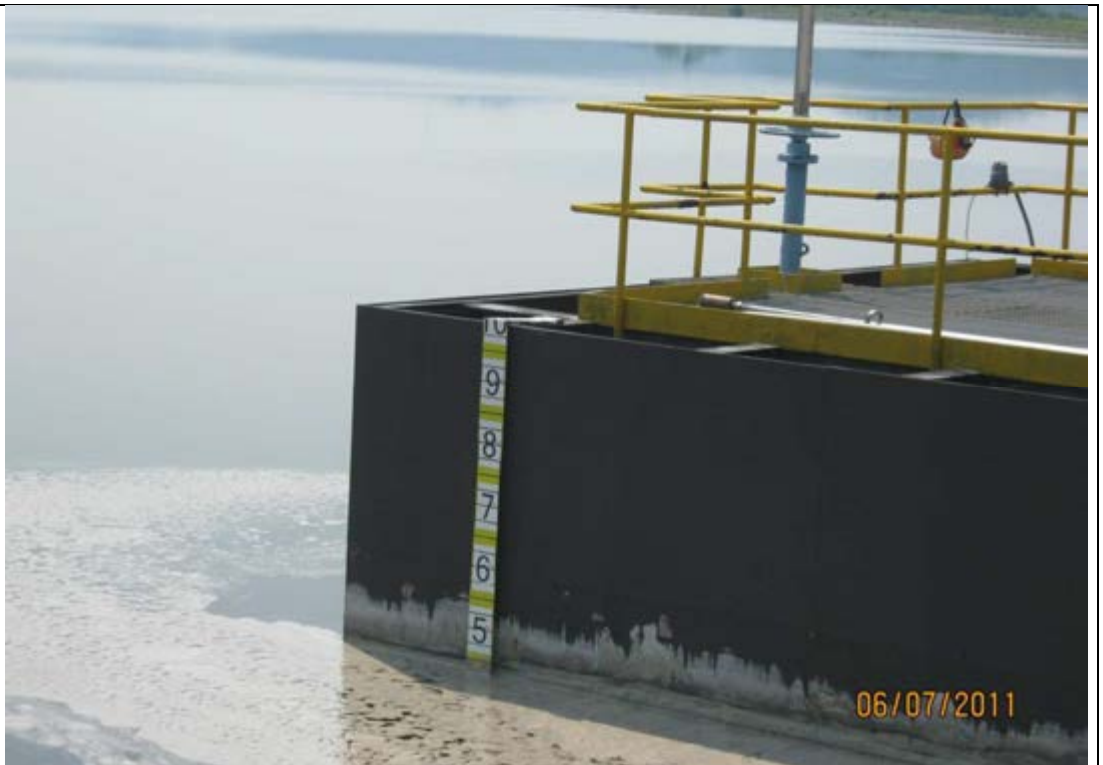
View of water from Fly Ash Pond entering the decant structure.

7. If DP&L has the opportunity to stop discharging from the Fly Ash Pond for a limited time period, inspect the discharge pipes from the decant structure to the outfall structure to verify that they are operating correctly and are in good condition. This may be performed by video photography.
