Dam Safety Assessment of CCW Impoundments

Chesapeake Energy Center

September 30, 2010

O'BRIEN & GERE
www.obg.com

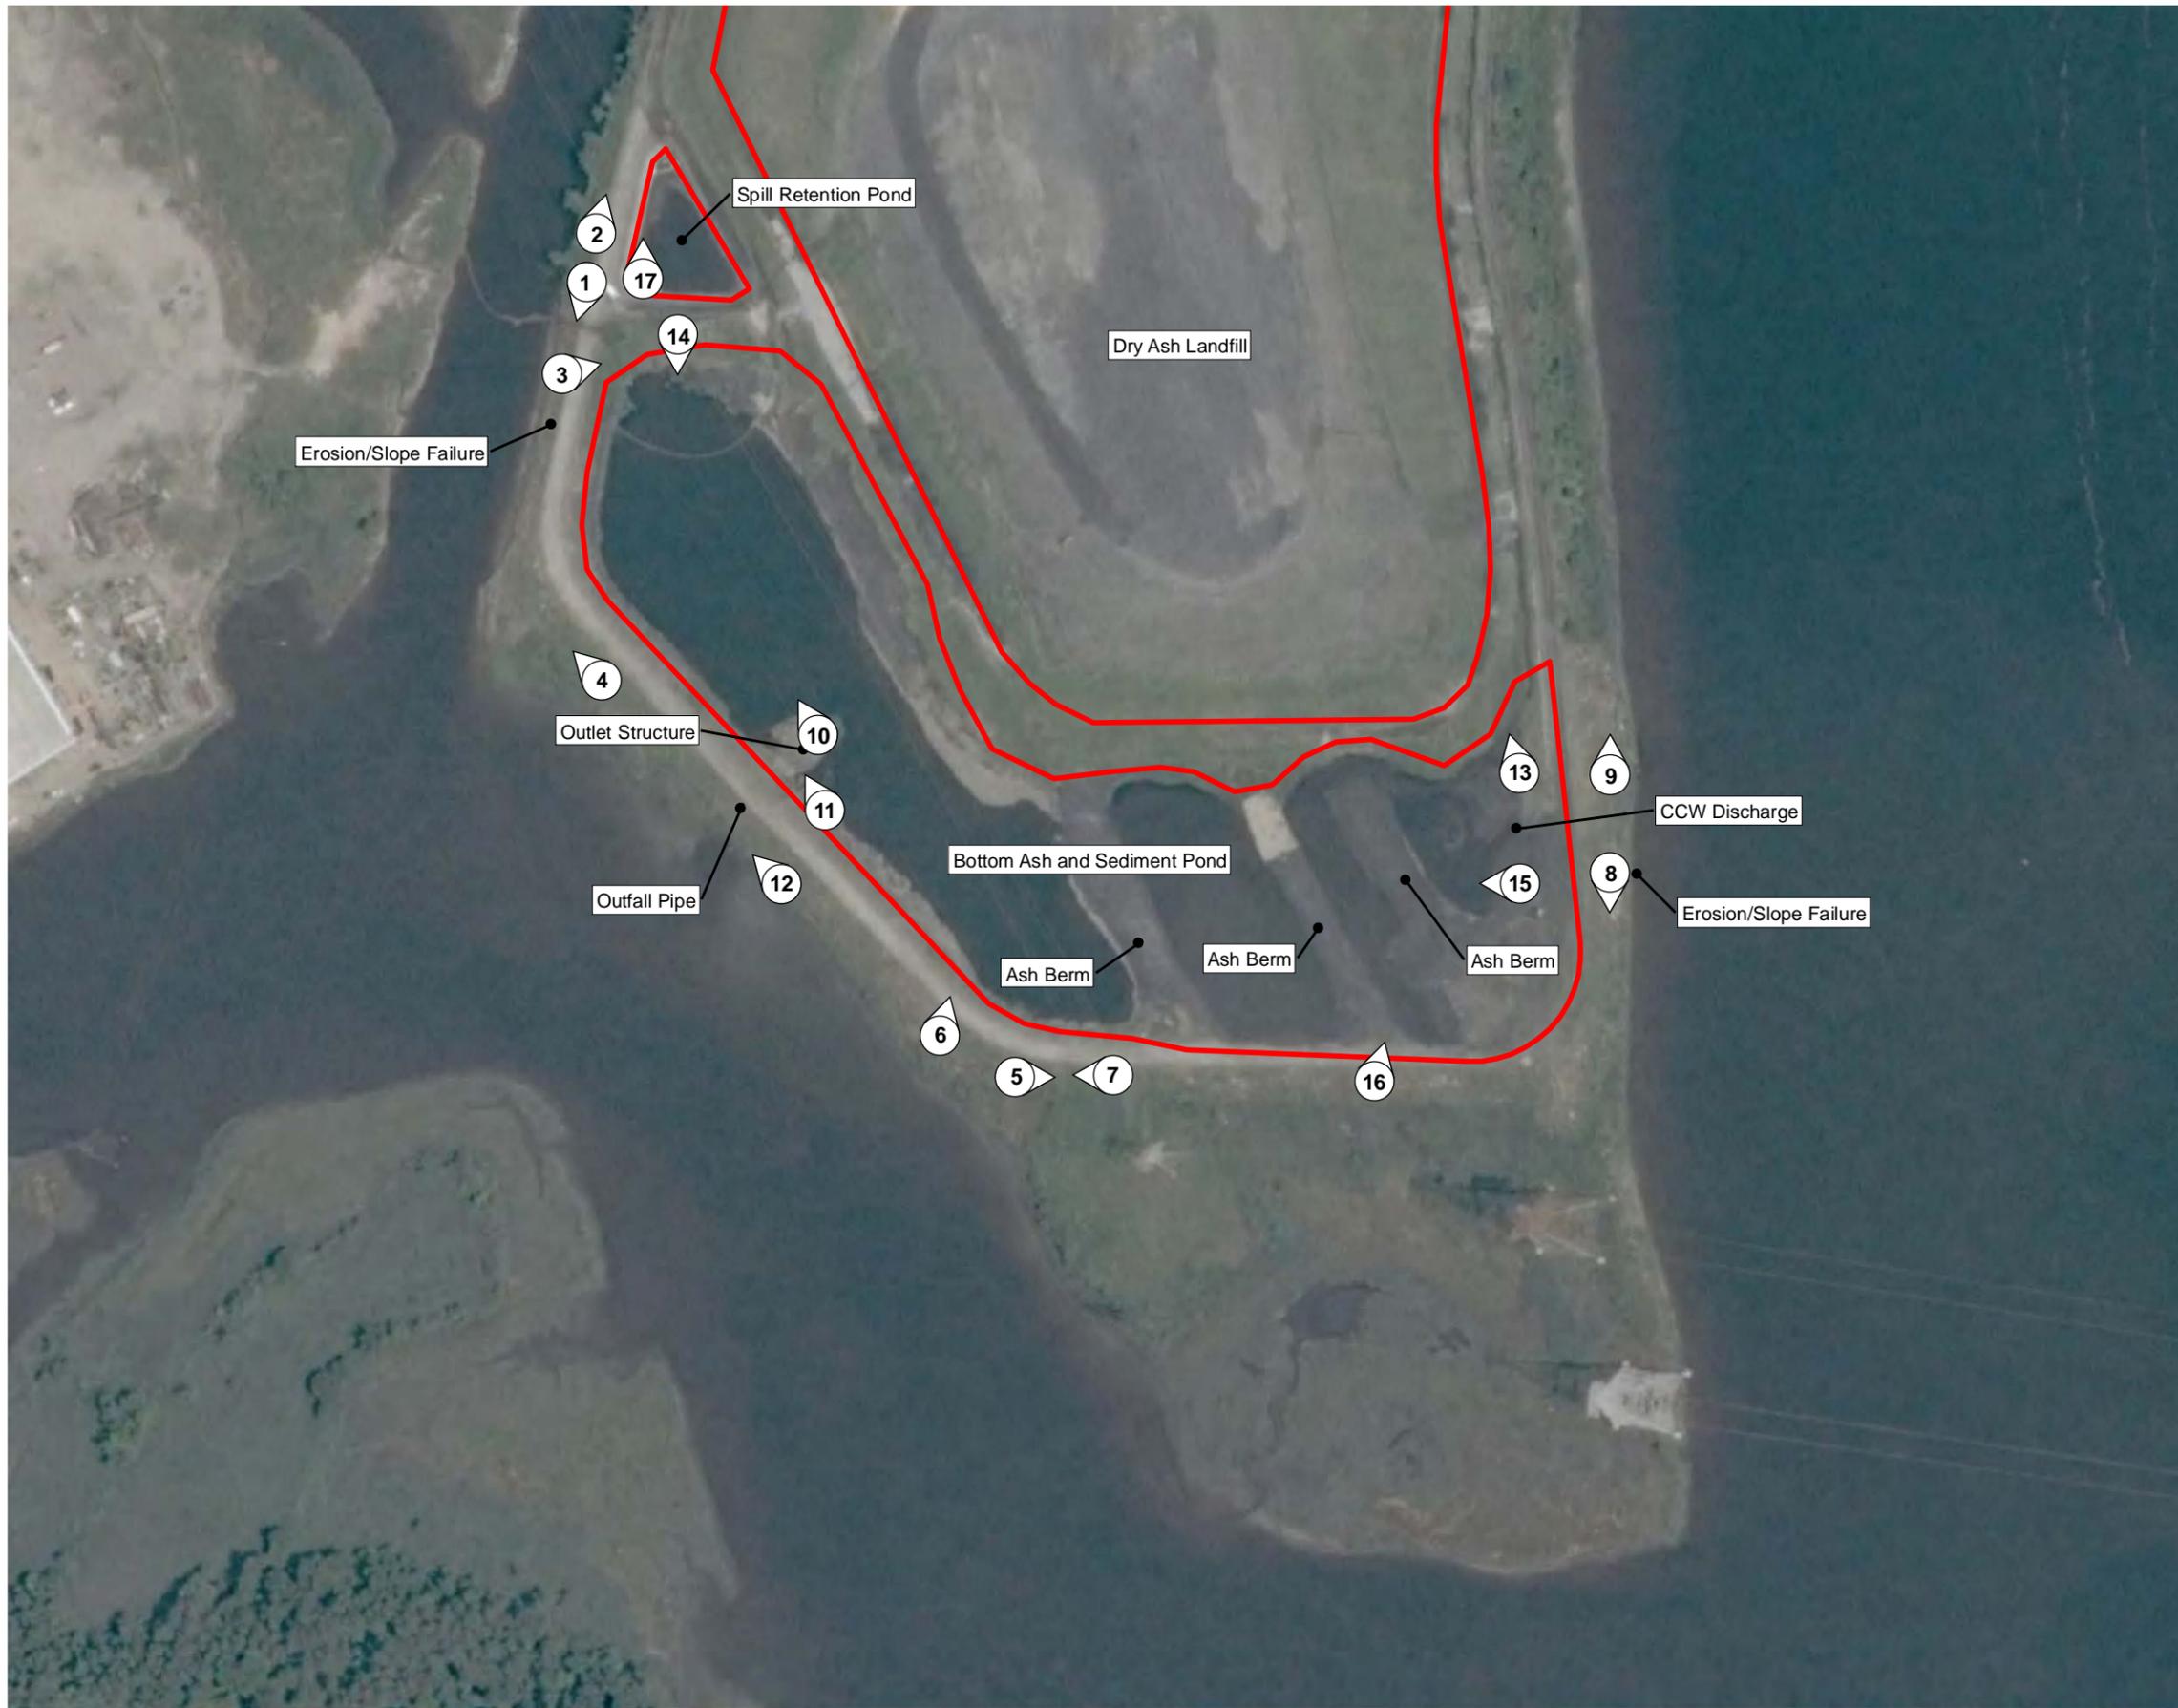
FIGURE 3

Photos of relevant features and conditions observed during the inspection were taken by O'Brien & Gere and are provided in Appendix B. A Site Plan of the Bottom Ash and Sedimentation Pond is presented as Figure 3, which also provides photograph locations and directions.
