**DRAFT REPORT**

# **Dam Safety Assessment of CCW Impoundments**

## **Chesterfield Power Station**

June 10, 2010

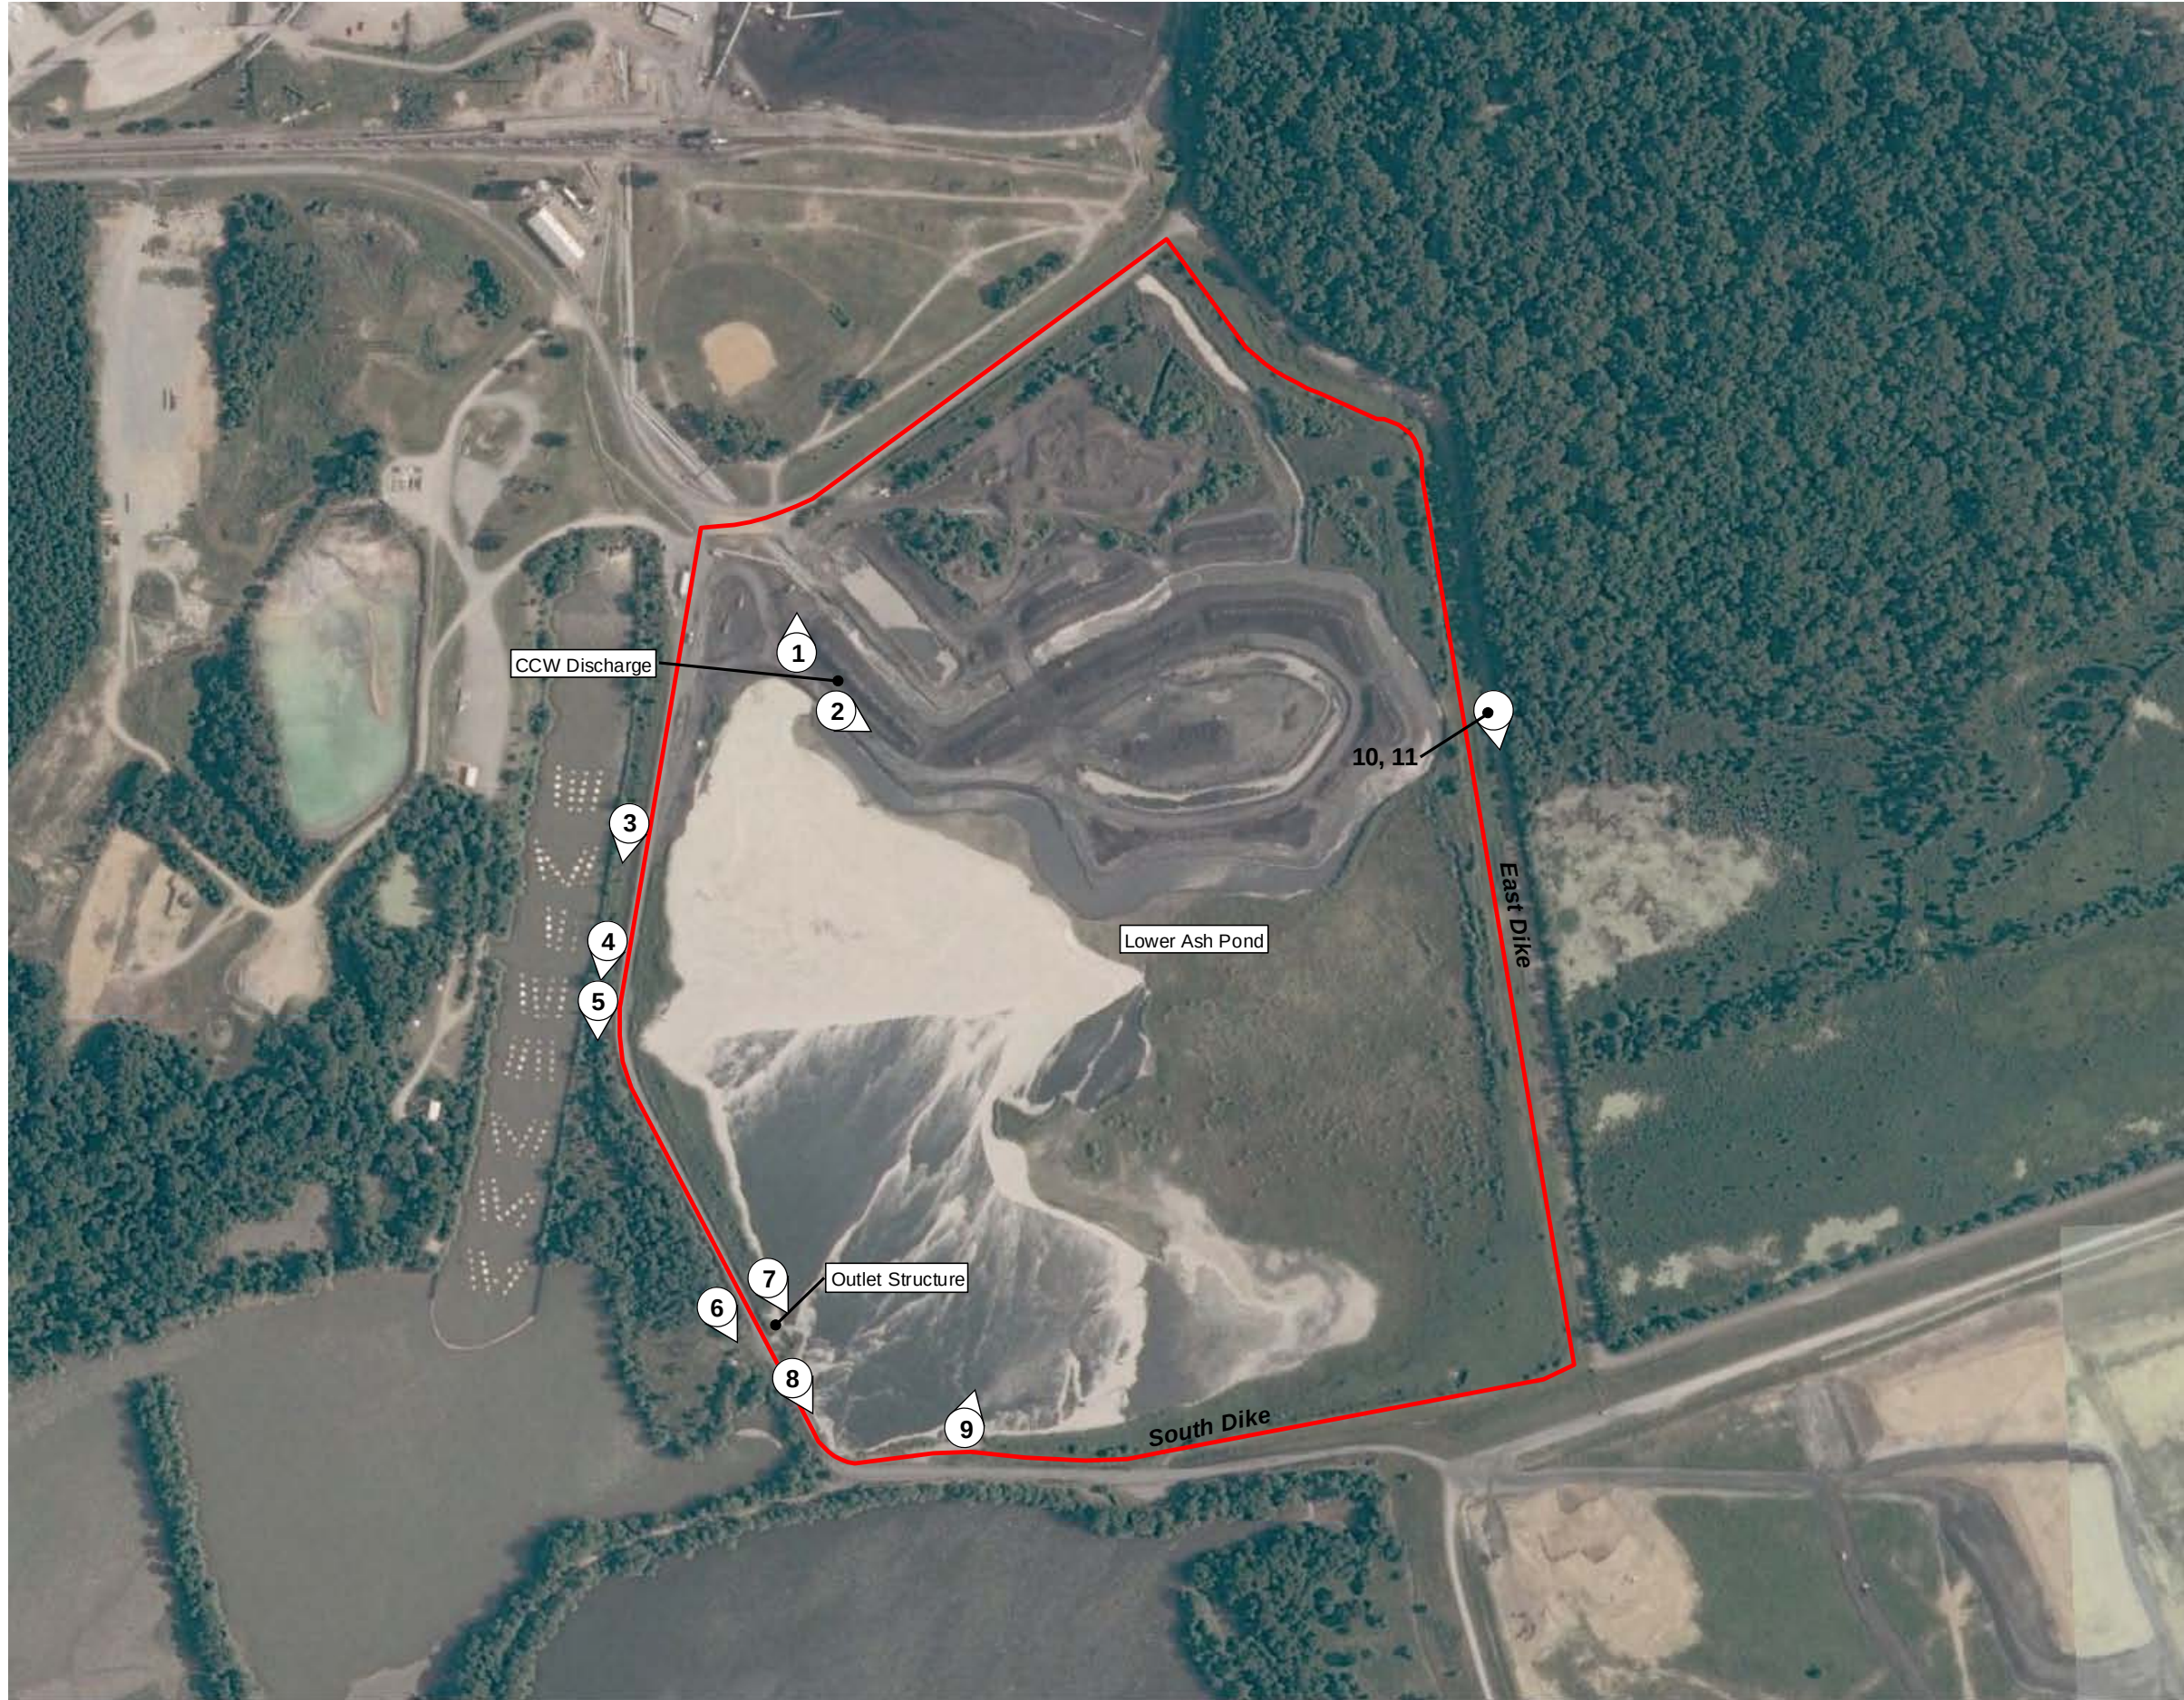
DRAFT FIGURE 3

- As can be seen in Figure 3, the CCW has accumulated above the normal pool level over an estimated 40 percent of the pond area. Water in the pond is isolated to primarily the south half of the pond.
