Dam Safety Assessment of CCW Impoundments

Chesterfield Power Station

September 29, 2010

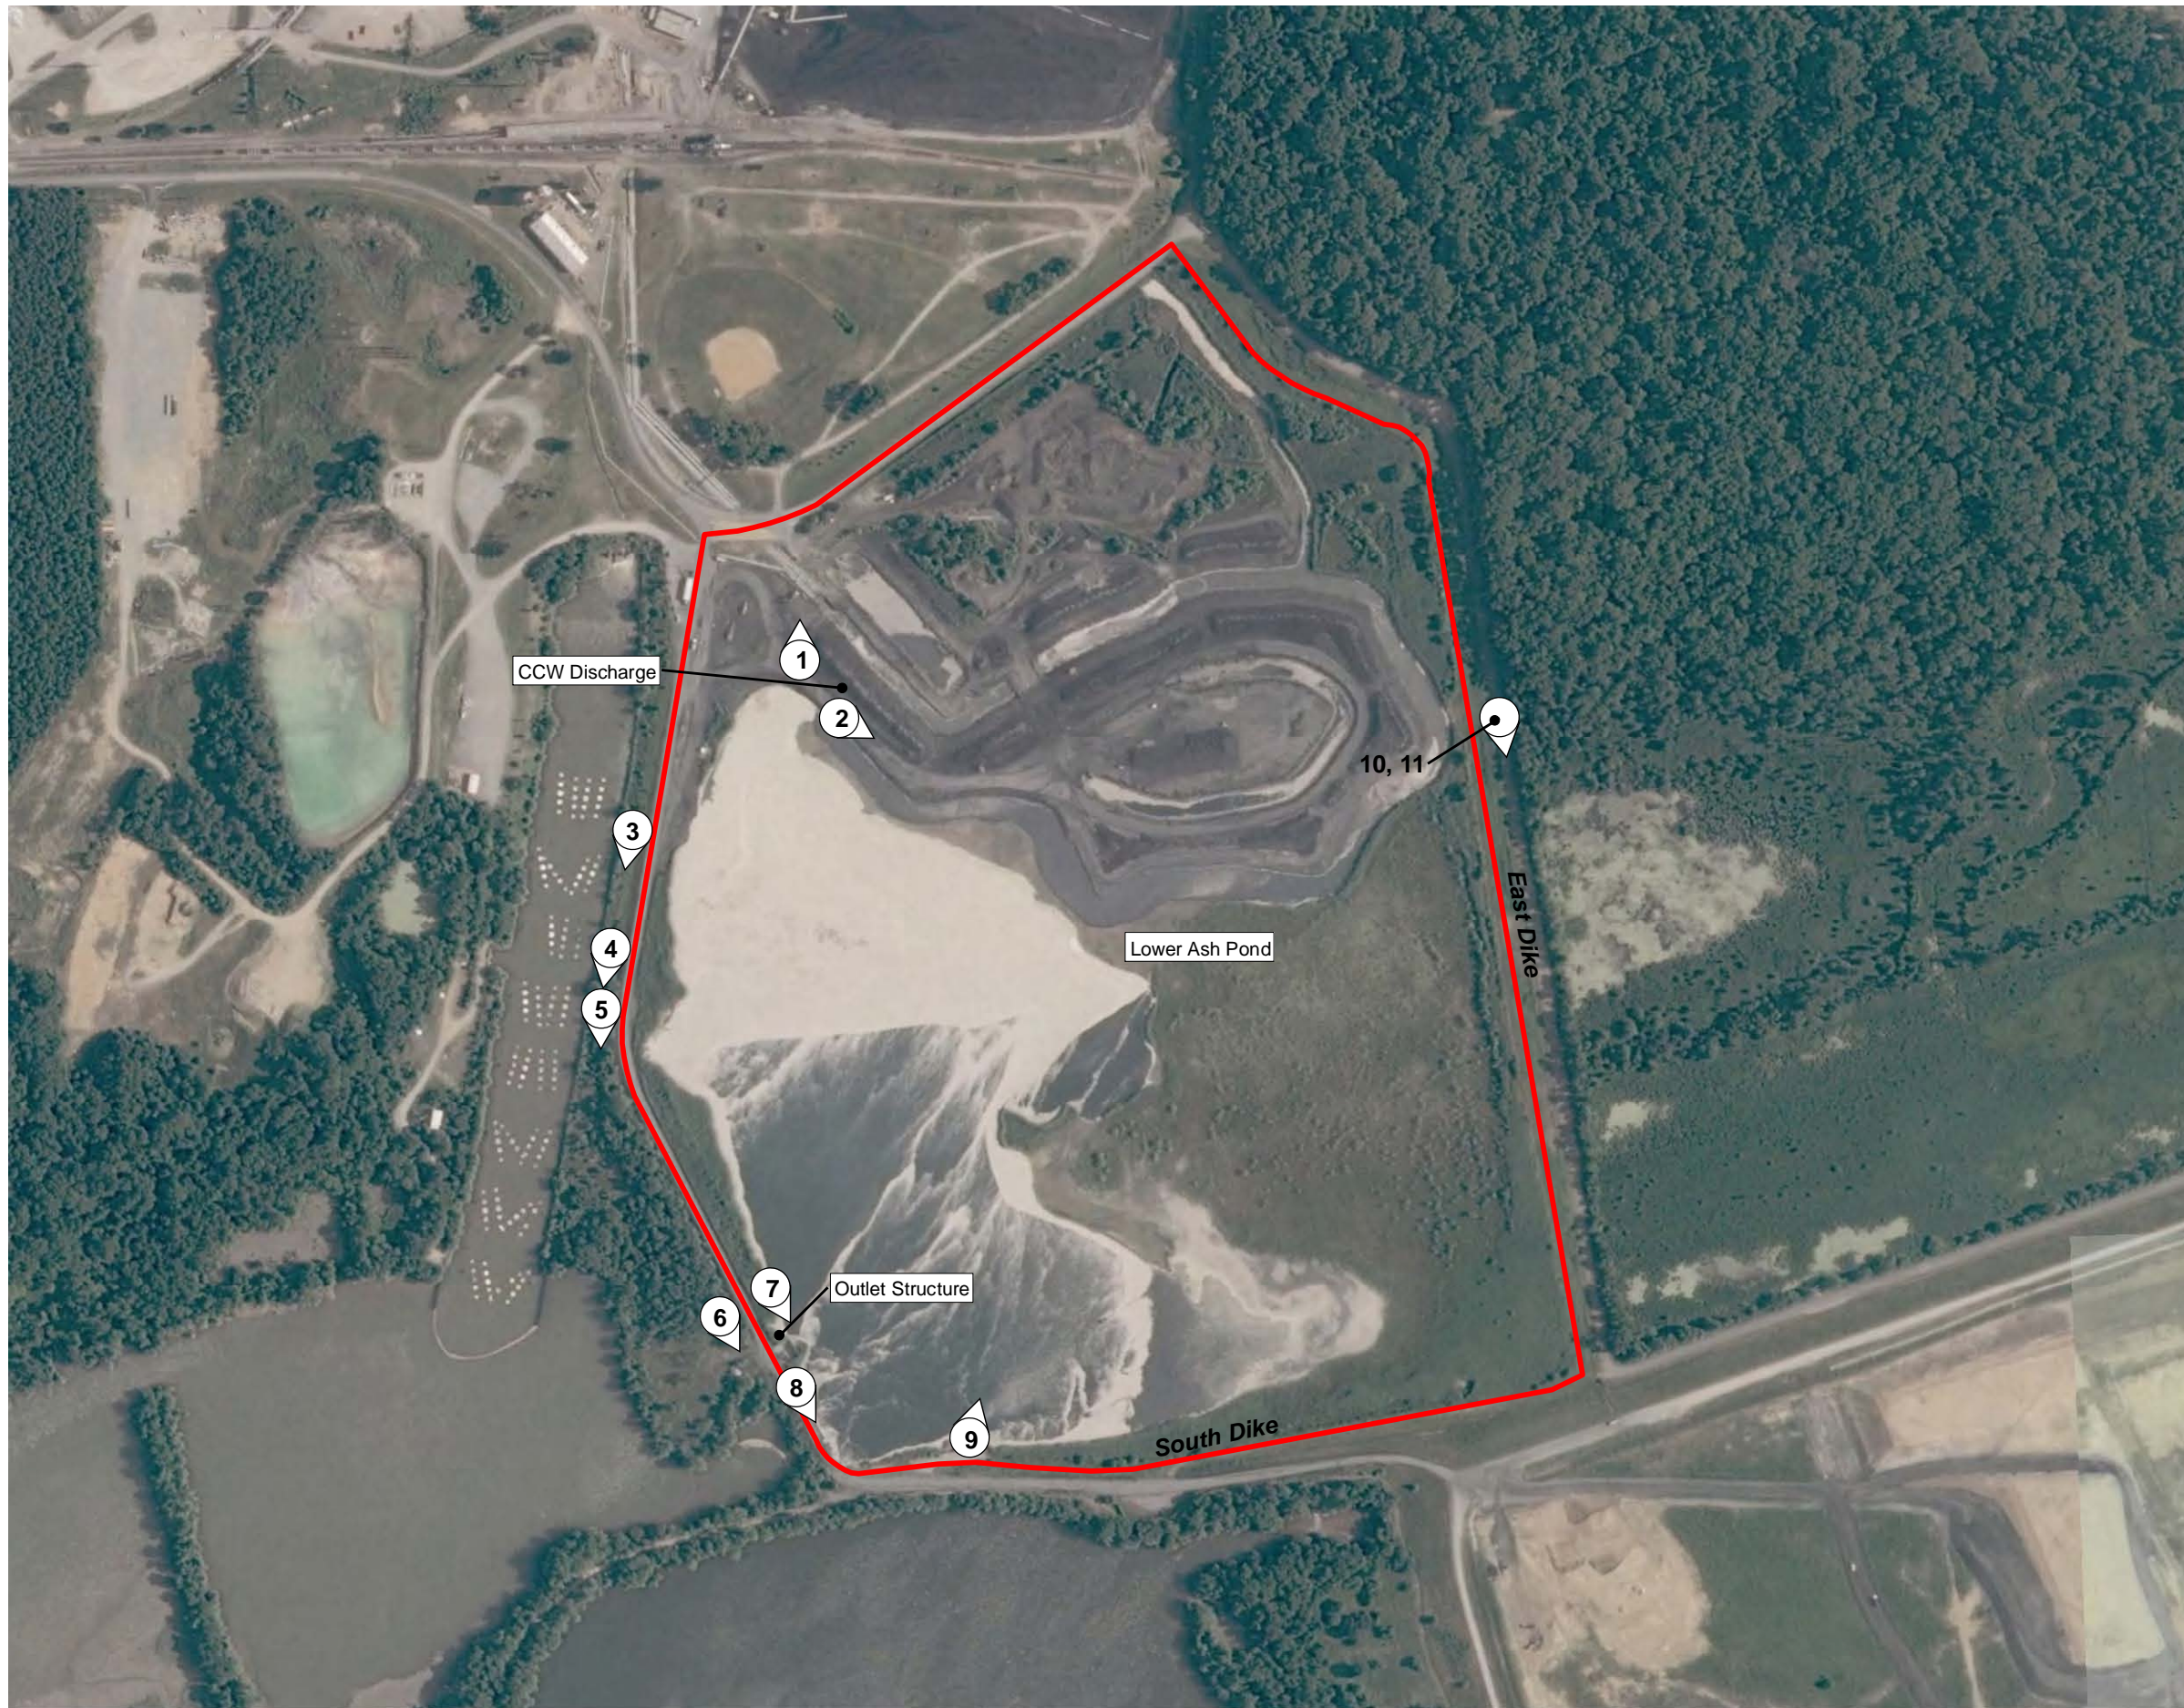
FIGURE 3

- As can be seen in Figure 3, the CCW has accumulated above the normal pool level over an estimated 40 percent of the pond area. Water in the pond is isolated to primarily the south half of the pond.
