# Assessment of Dam Safety

## Coal Combustion Surface Impoundments (Task 3)

Dayton Power &  
Light Company

JM Stuart Station

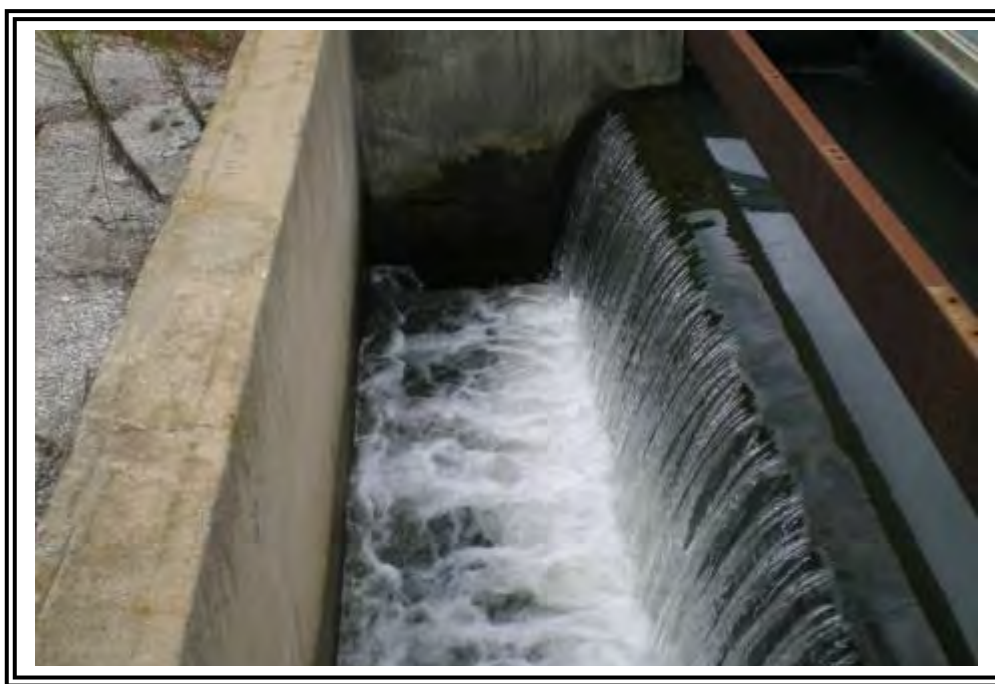
82

Close-up of outfall structure at Pond 7A
