**DRAFT REPORT  
ROUND 7 DAM ASSESSMENT  
DTE ENERGY MONROE POWER PLANT  
FLY ASH BASIN AND BOTTOM ASH STORMWATER POND**

**November 8, 2010**

**GZA GeoEnvironmental, Inc.  
19500 Victor Parkway, Suite 300  
Livonia, MI 48152  
GZA File No. 01.0170142.20**

Re: Round 7 Dam Assessment - Draft Report  
EPA Contract No. EP10W001313  
DTE Energy Monroe Power Plant  
Fly Ash Basin and Bottom Ash Stormwater Pond  
Monroe, Michigan

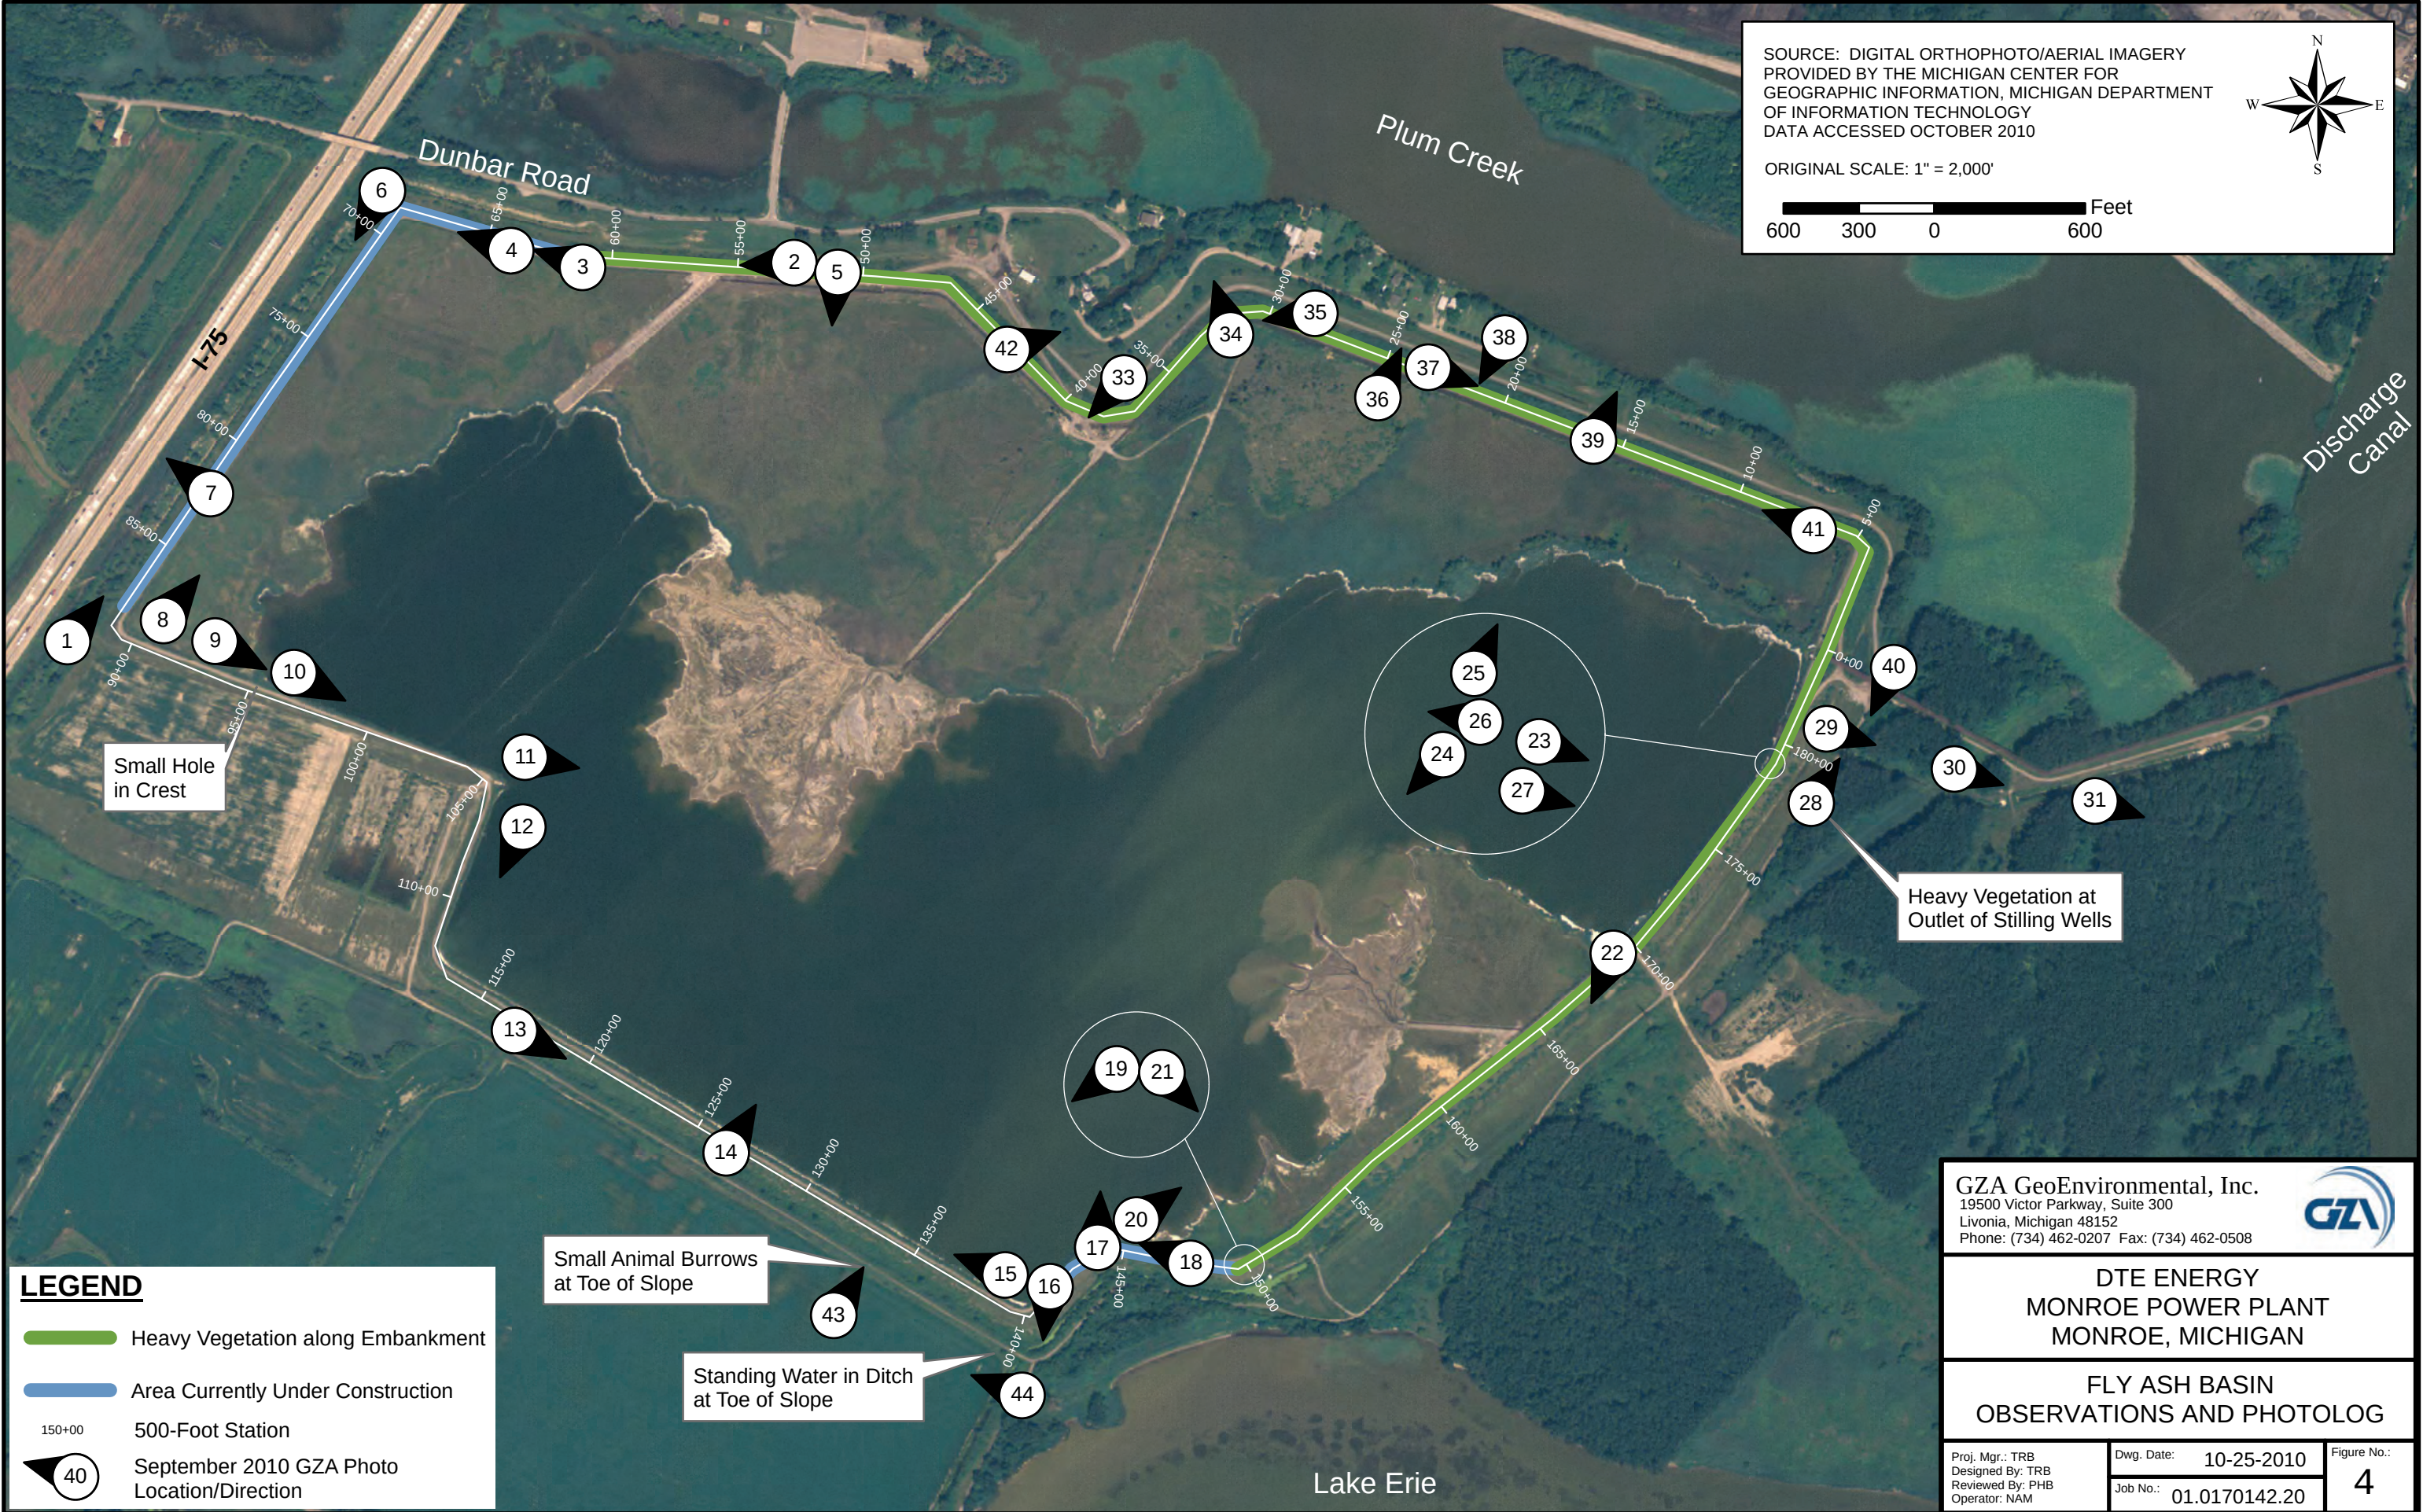
The outer embankment slope generally appeared to be in good condition. As shown on **Figure 4**, significant vegetation from Station 0+00 to 62+00 and from Station 150+00 to 182+00 obscured the slope and a visual inspection could not be performed in these areas (Photos 2, 22, 33, 37, 40, and 42). The embankment mitigation reconstruction began in 2009 and was occurring from Station 62+00 to 88+00 and from Station 138+00 to 150+00 during the time of the inspection (Photos 1, 3, 6, 9, 19, and 20). No unusual movement or sloughing was observed in the slope and the overall mitigation measures appeared to be progressing satisfactorily. It appeared that some excess construction debris was placed on the slope near Station 144+00 (Photo 20). Small animal burrows were noted near Station 132+00 along the toe of the slope (Photo 43). Standing water was observed in the ditch at the toe of the slope near Station 139+00 (Photo 44).

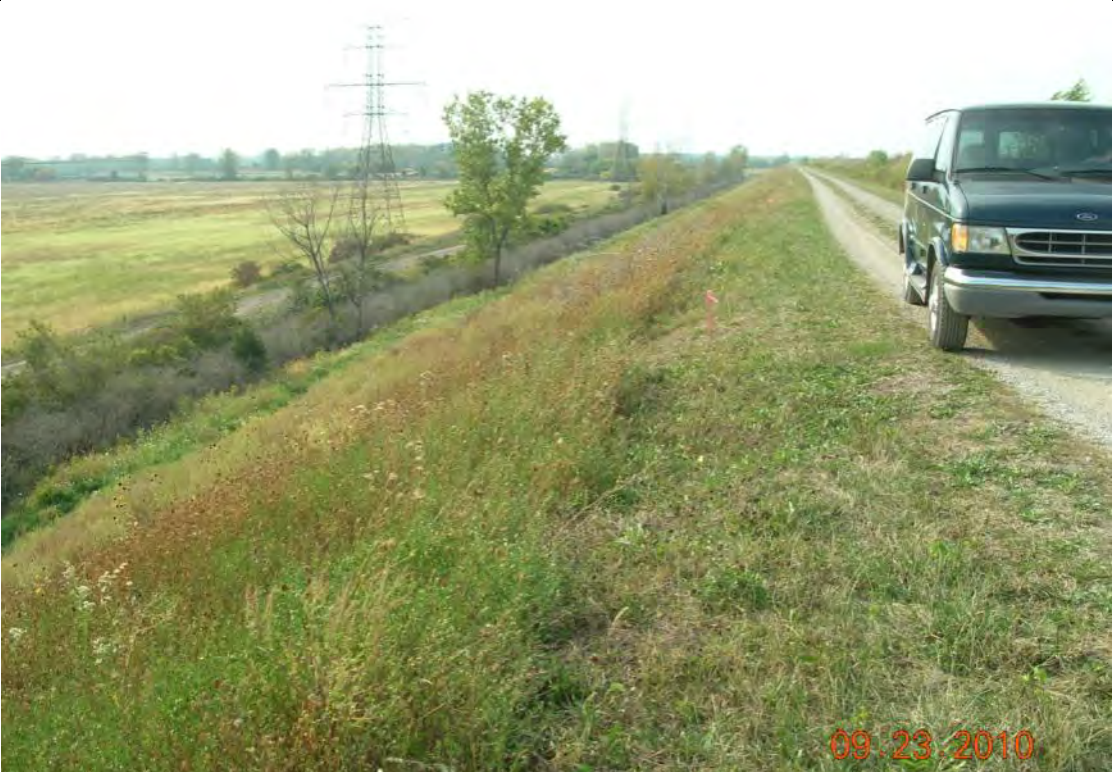
| <b>Photo No.</b><br><b>15</b> | <b>Date:</b><br>9/23/10 | | |

| <b>Description:</b><br>Crest and embankment at approximately Station 139+00. | | | |

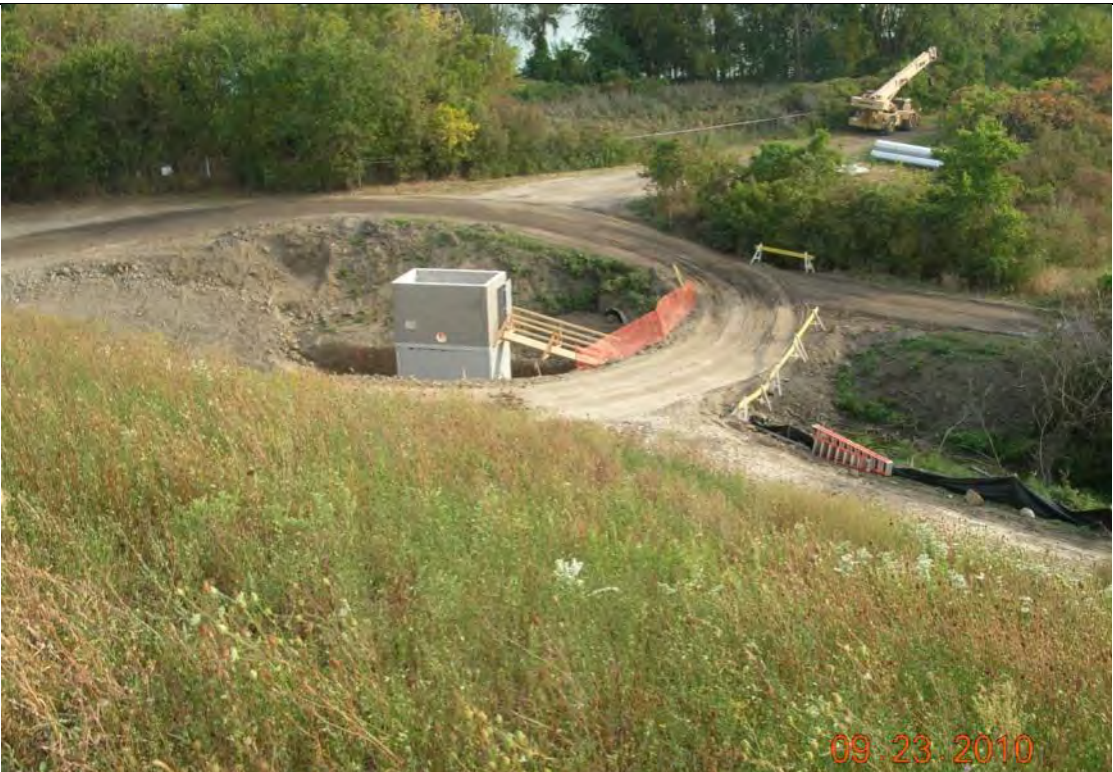
| <b>Photo No.</b><br><b>16</b> | <b>Date:</b><br>9/23/10 | |

| <b>Description:</b><br>Construction of the new pump house at Station 139+00. | | |

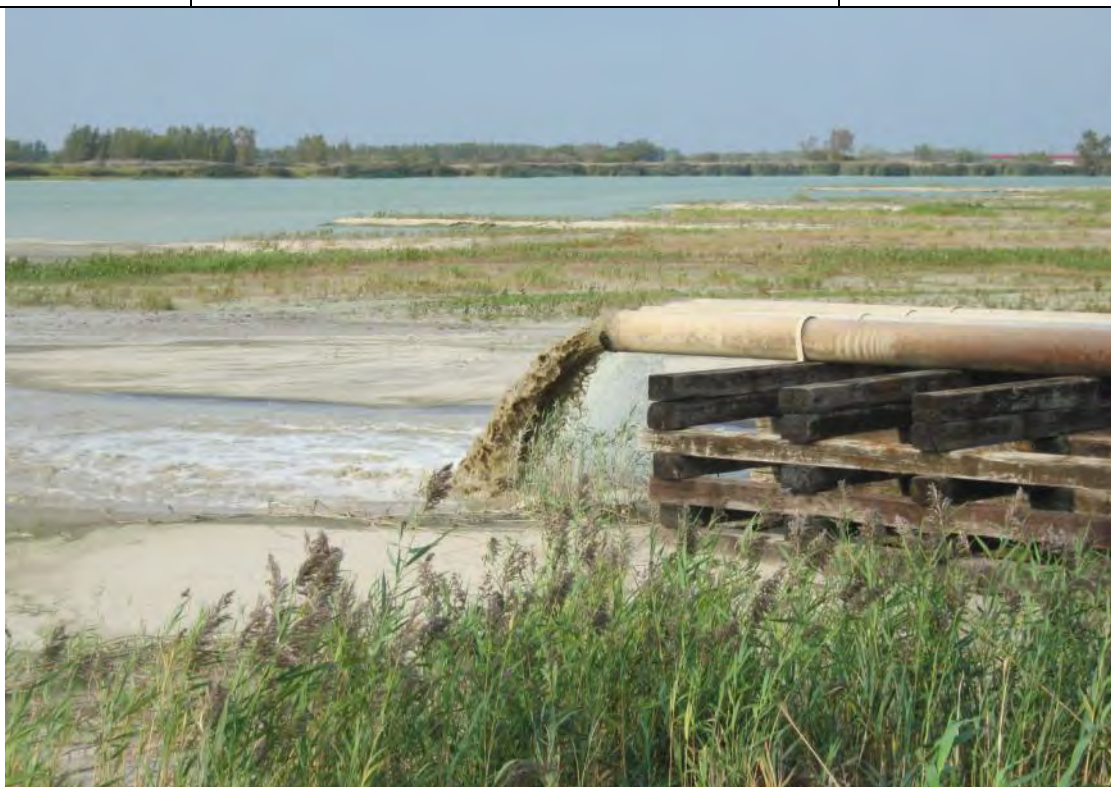
**Photo No.**  
**18**

**Description:**  
Four sluice pipes that  
discharge coal ash slurry into  
the Fly Ash Basin.

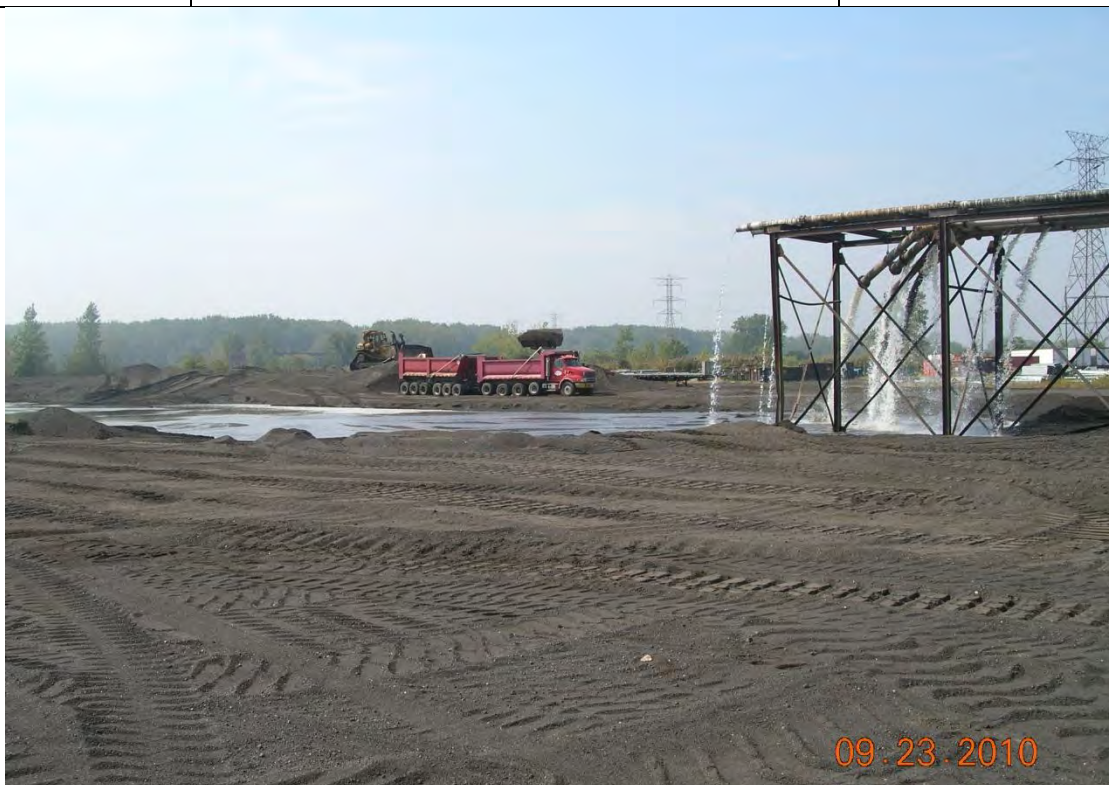
**Photo No.**  
**46**

**Description:**  
Bottom ash sluice outfall area. Bottom ash is bulldozed into piles at this location prior to off site transport.

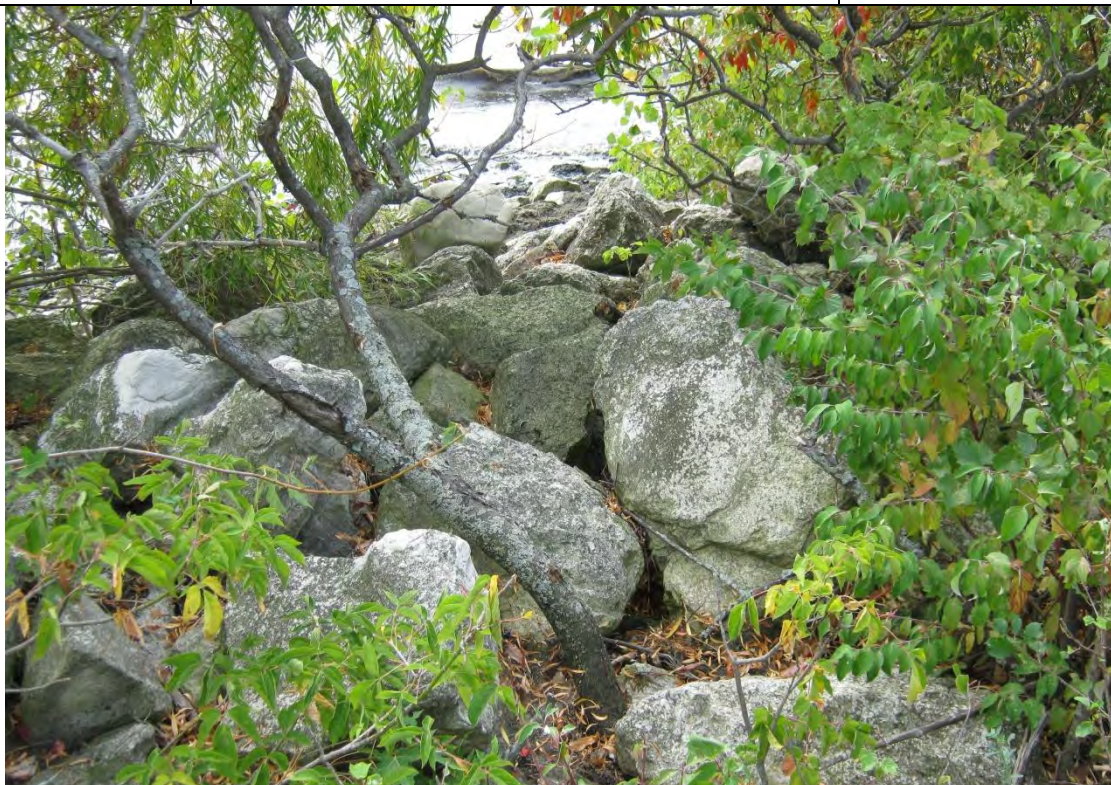
**Photo No.**  
**50**

**Description:**  
The embankment separating  
the Bottom Ash Stormwater  
Pond from Plum Creek.  
Plum Creek and Lake Erie  
are on the right side of the  
picture.

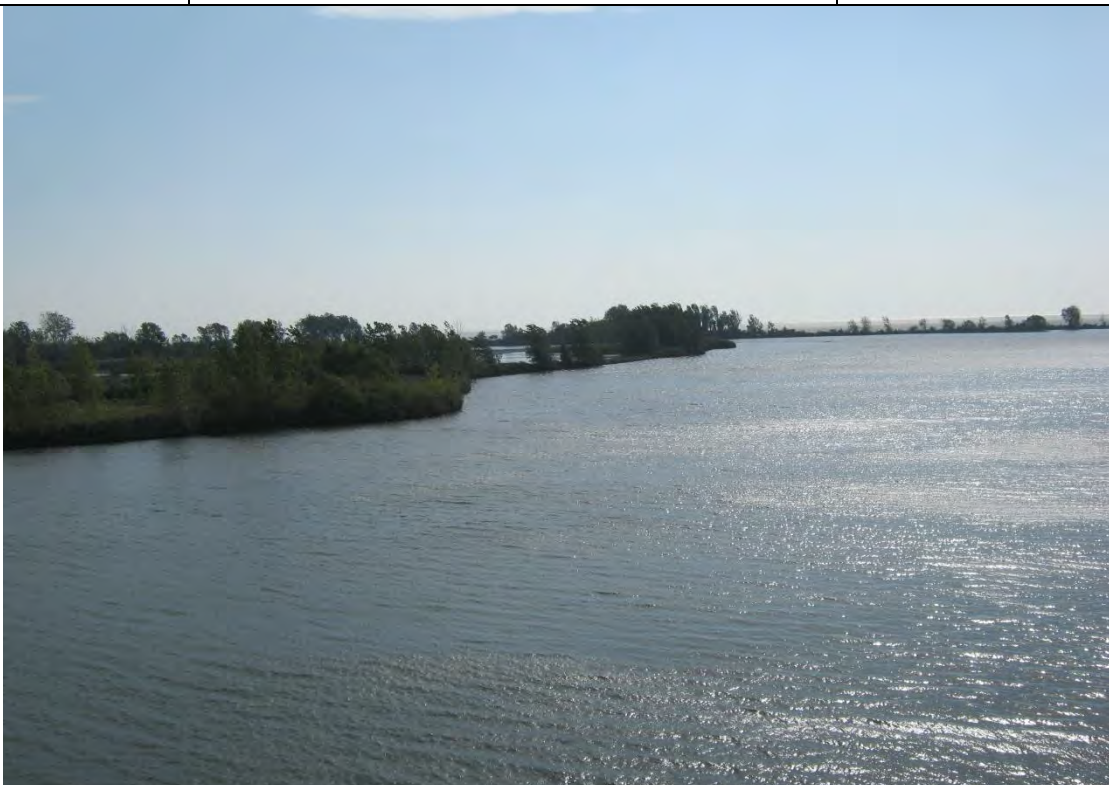
**Direction Photo Taken:**  
East

**Description:**  
Overview of the Bottom Ash Stormwater Pond.

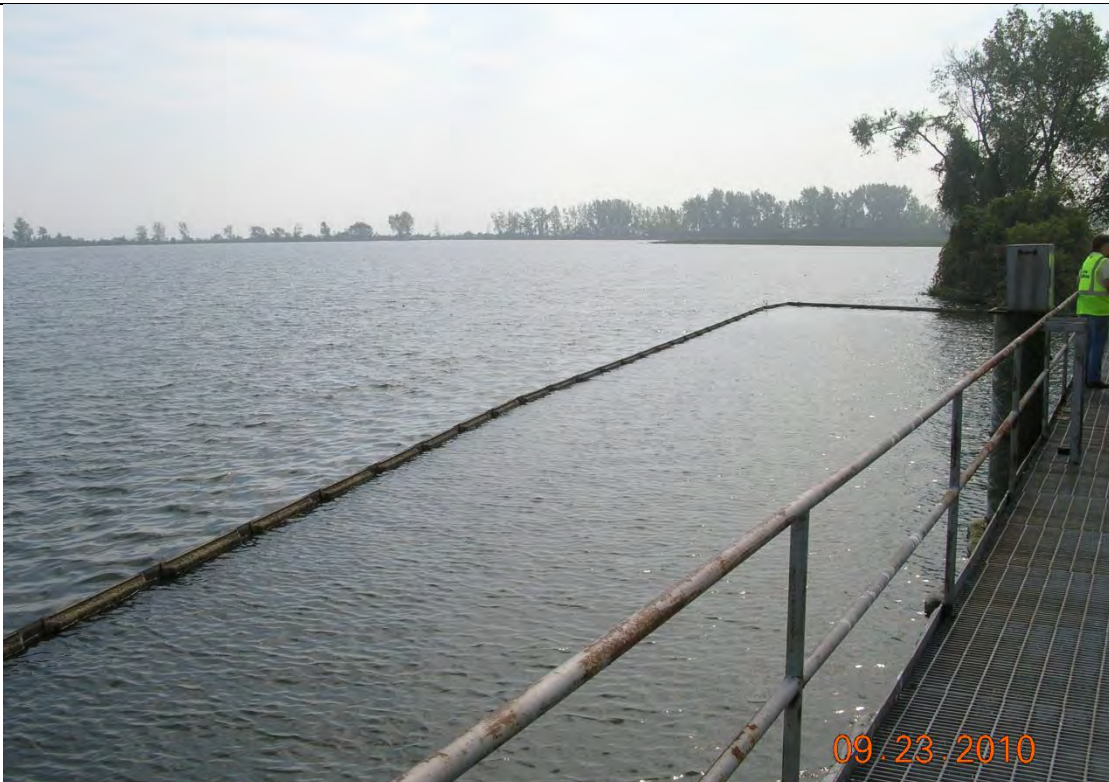
**Photo No.**  
**52**

**Description:**  
Overview of the Bottom Ash Stormwater Pond. The wastewater flows under the sheet piling shown in the picture.

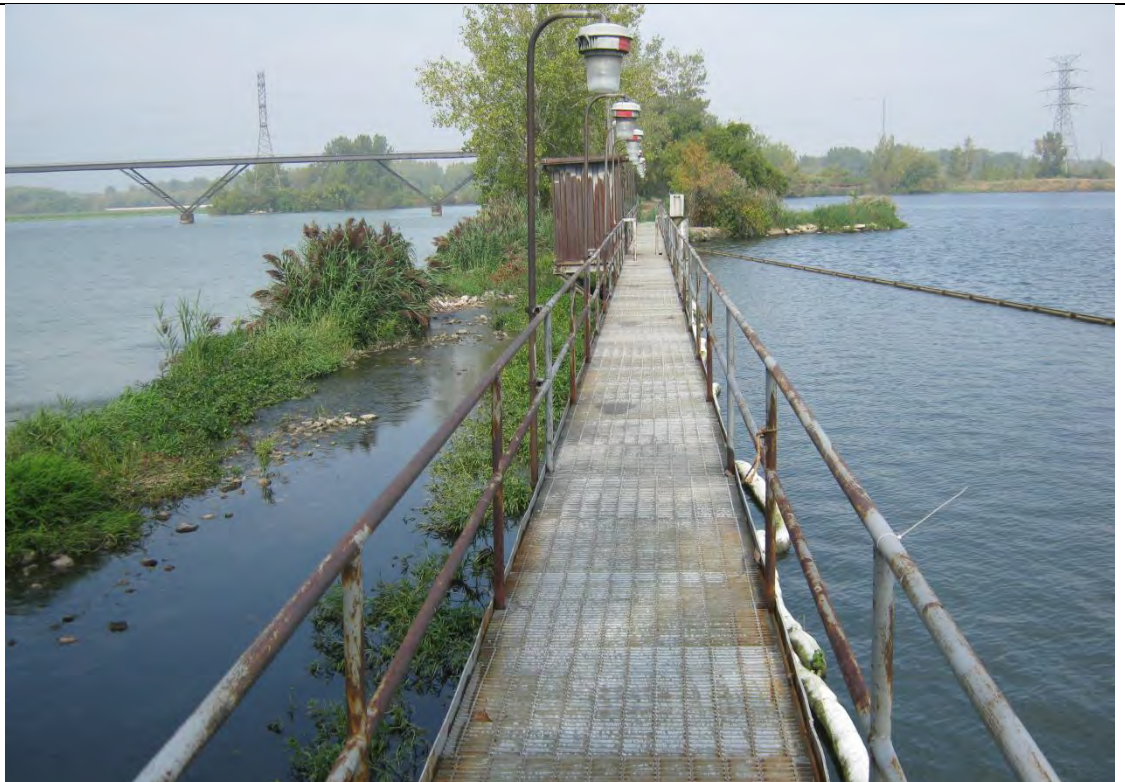
**Photo No.**  
**54**

**Description:**  
The weir and walkway  
separating the Bottom Ash  
Stormwater Basin from Plum  
Creek. The fly ash sluice  
pipe support bridge is visible  
in the background.
