**FINAL REPORT
ROUND 7 DAM ASSESSMENT
DTE ENERGY MONROE POWER PLANT
FLY ASH BASIN AND BOTTOM ASH STORMWATER POND**

June 2, 2011

**GZA GeoEnvironmental, Inc.
19500 Victor Parkway, Suite 300
Livonia, MI 48152
GZA File No. 01.0170142.20**

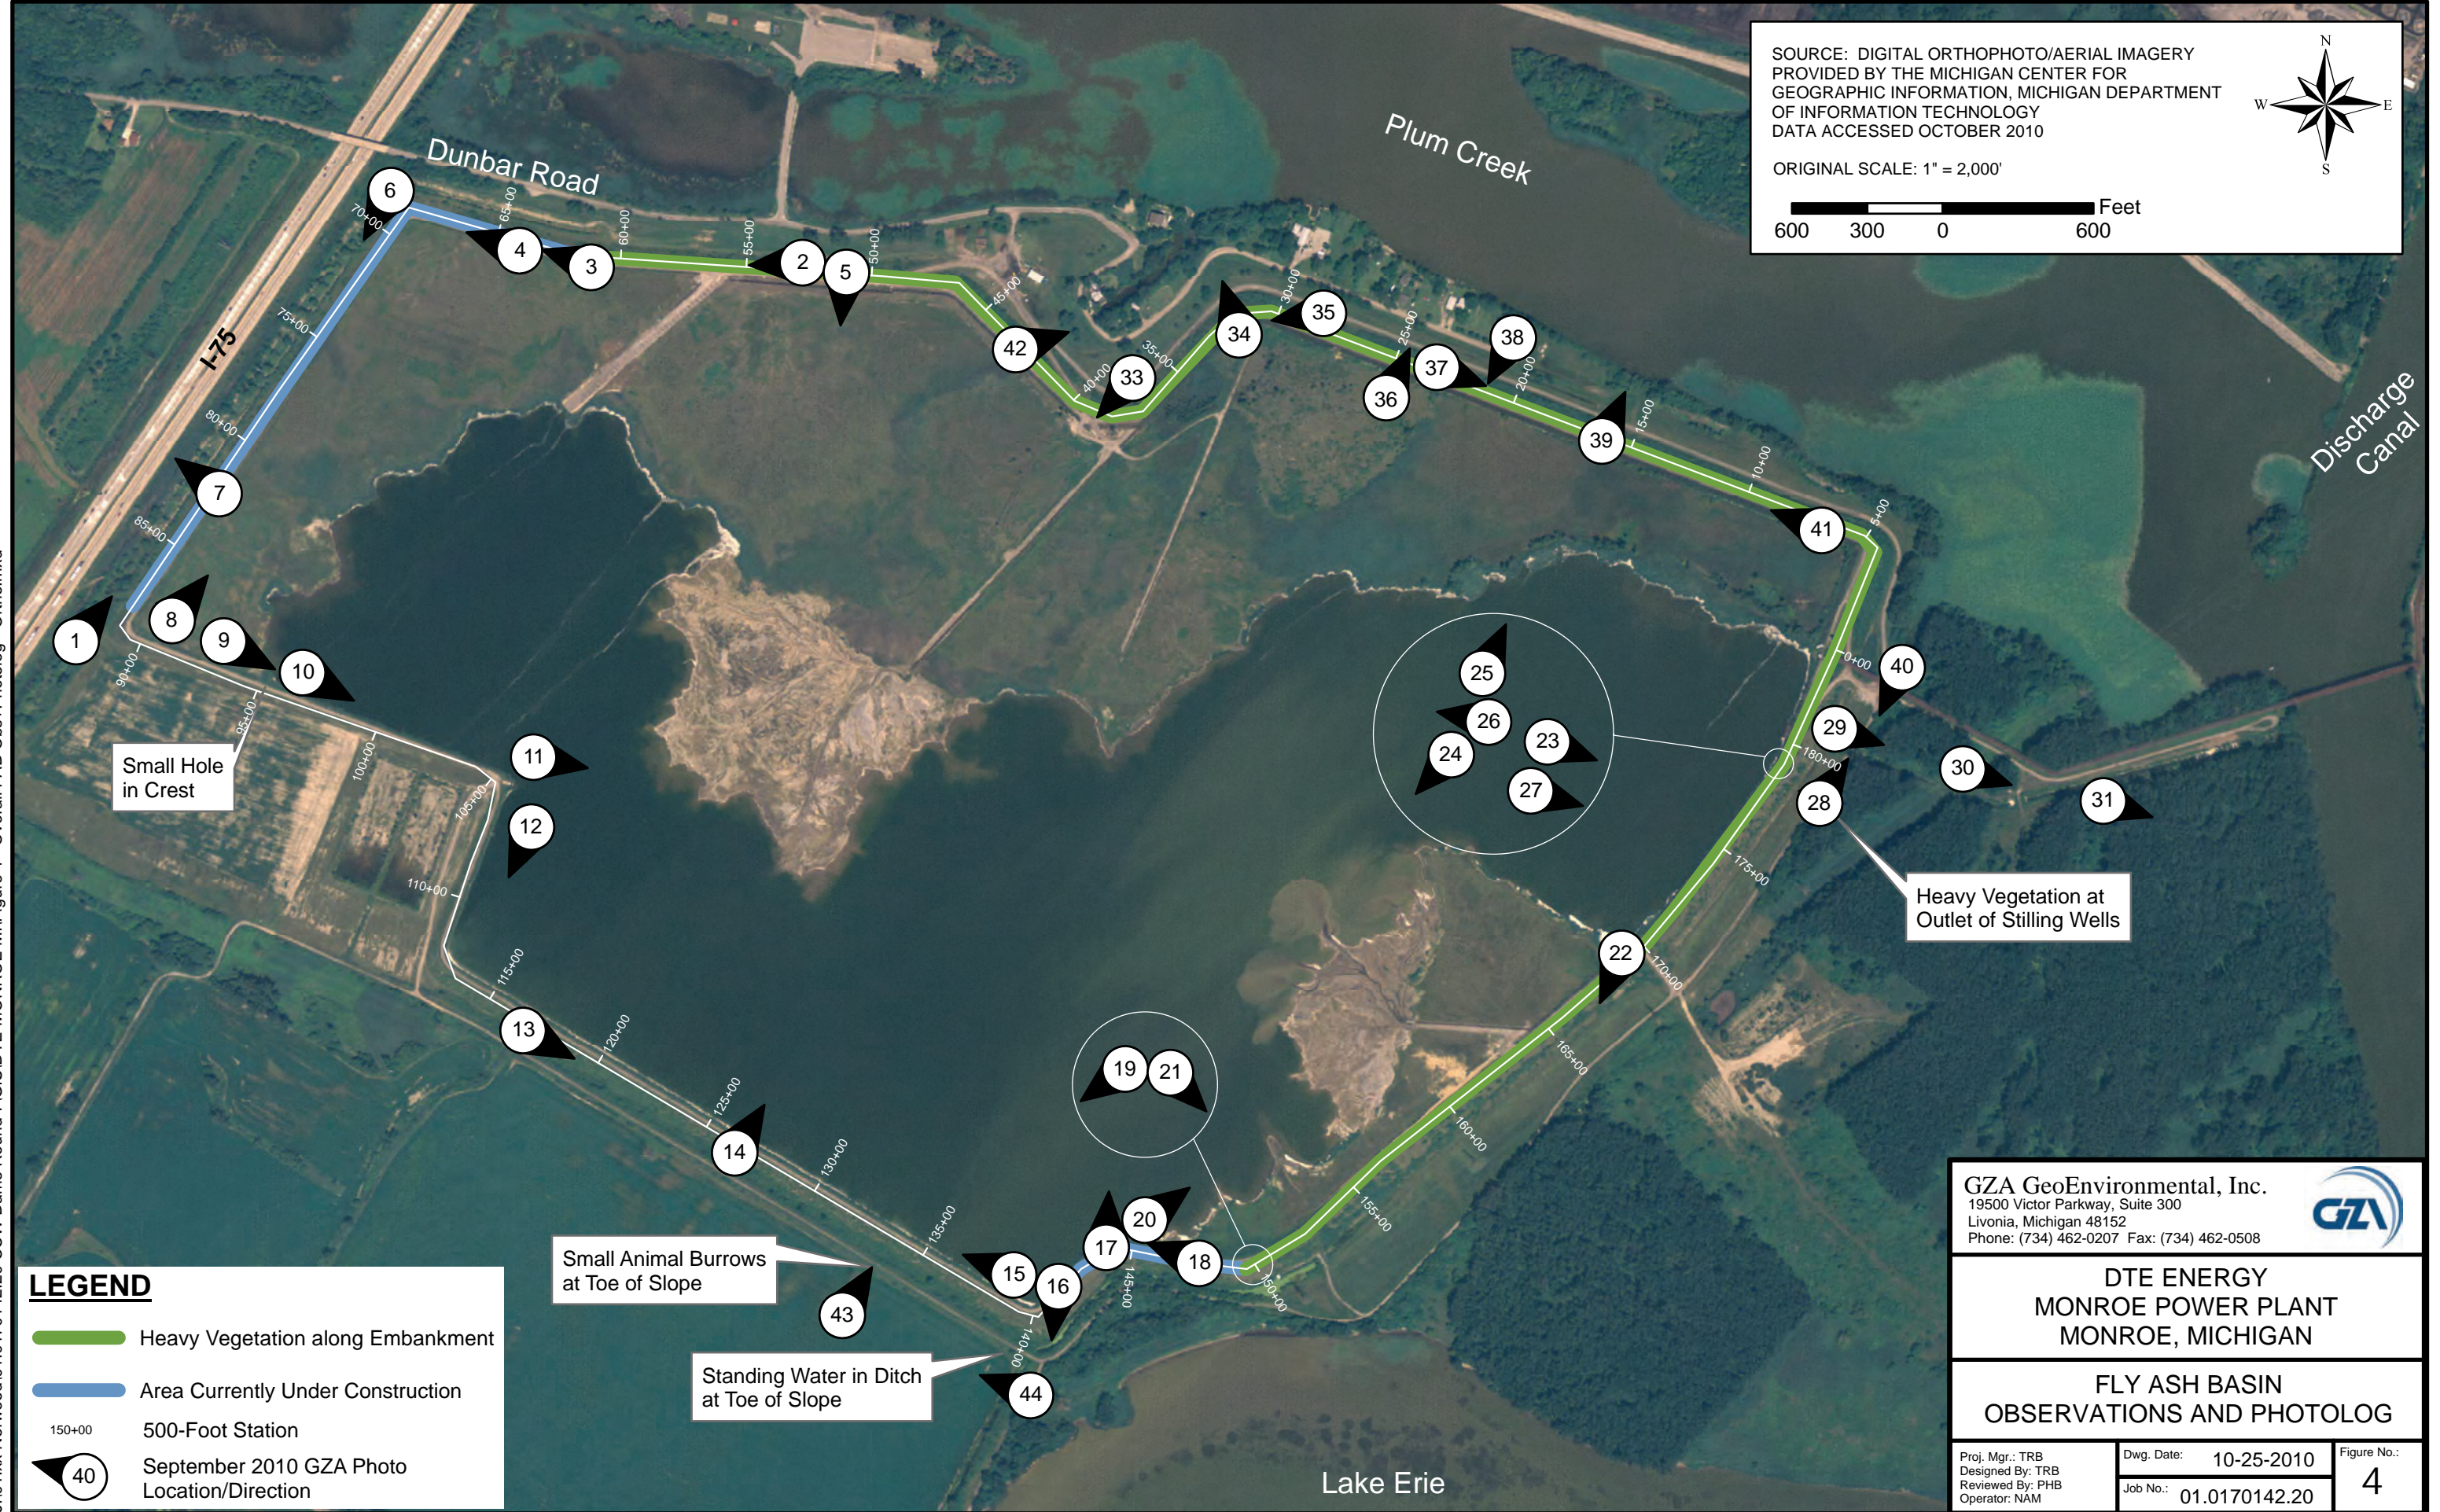
Proj. Mgr.: TRB Designed By: TRB Reviewed By: PHB Operator: NAM	Dwg. Date: 10-25-2010 Job No.: 01.0170142.20	Figure No.: 4
--	---	---------------

The outer embankment slope generally appeared to be in good condition. As shown on **Figure 4**, significant vegetation from Station 0+00 to 62+00 and from Station 150+00 to 182+00 obscured the slope and a visual inspection could not be performed in these areas (Photos 2, 22, 33, 37, 40, and 42). The embankment mitigation reconstruction began in 2009 and was occurring from Station 62+00 to 88+00 and from Station 138+00 to 150+00 during the time of the inspection (Photos 1, 3, 6, 9, 19, and 20). No unusual movement or sloughing was observed in the slope and the overall mitigation measures appeared to be progressing satisfactorily. It appeared that some excess construction debris was placed on the slope near Station 144+00 (Photo 20). Small animal burrows were noted near Station 132+00 along the toe of the slope (Photo 43). Standing water was observed in the ditch at the toe of the slope near Station 139+00 (Photo 44).

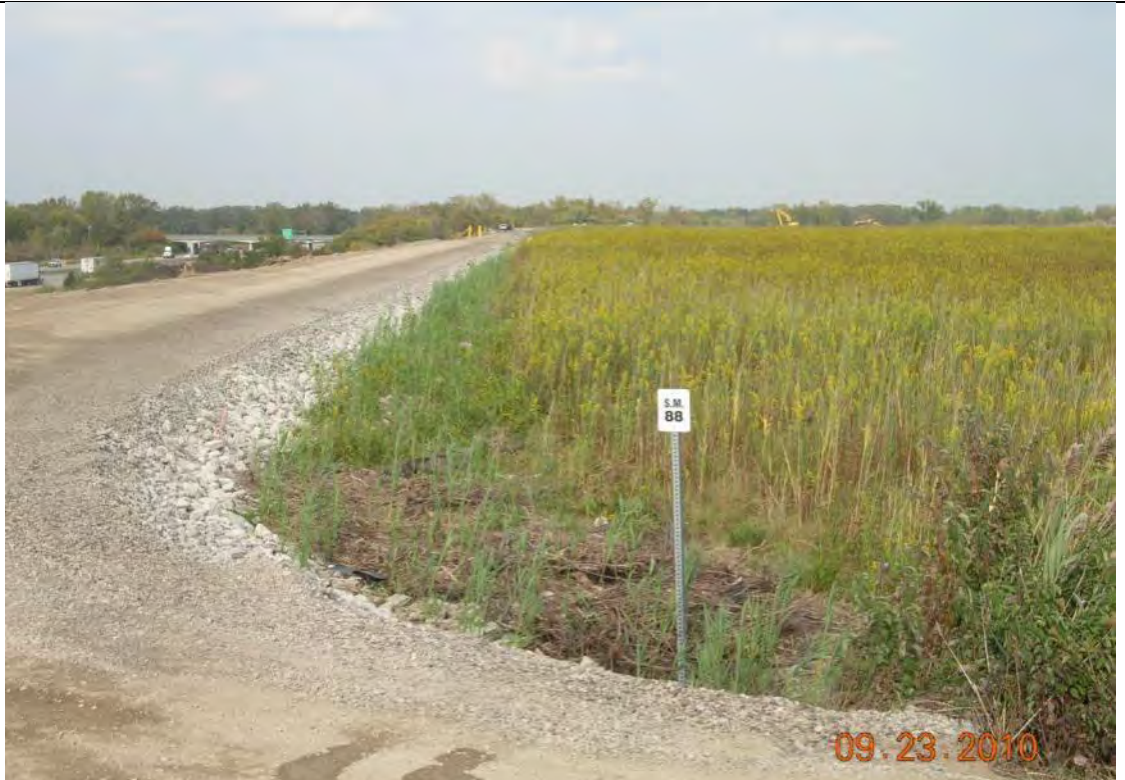
Photo No. 9	Date: 9/23/10
Direction Photo Taken: East

Description:
Crest, embankment, and toe near Station 92+00.

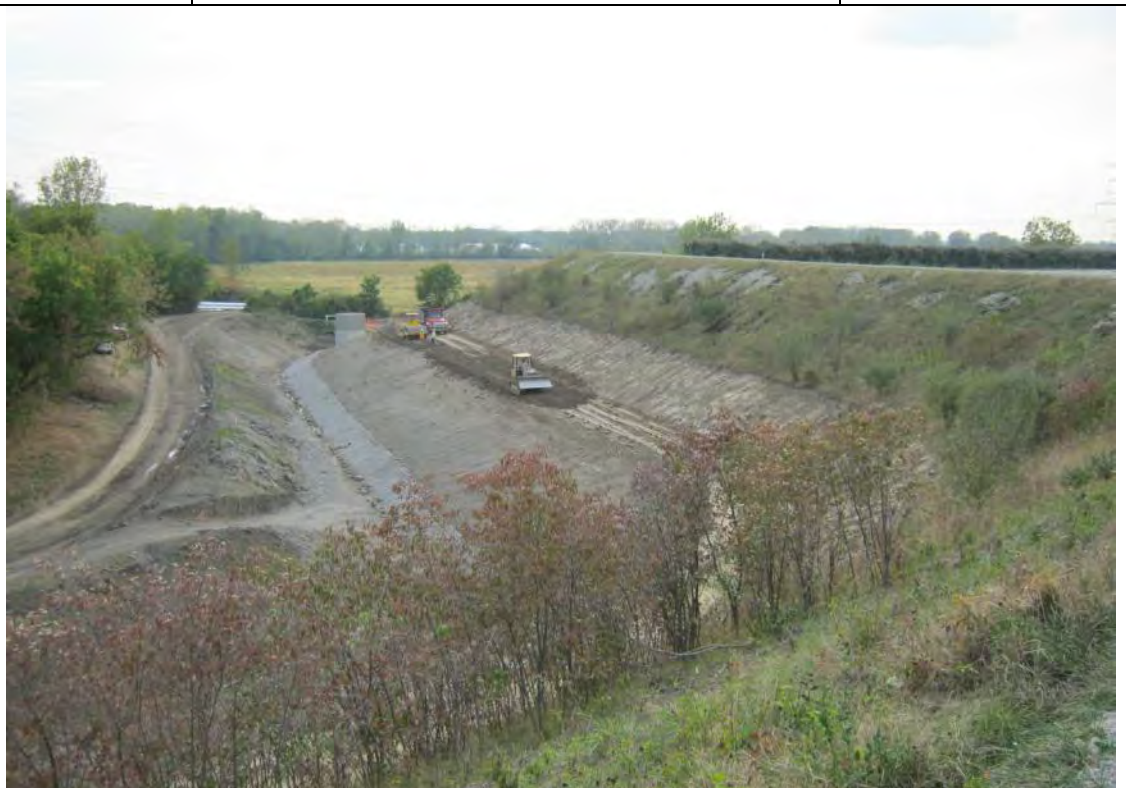
Photo No. 20	Date: 9/23/10
Direction Photo Taken: Northeast

Description:
Excess road construction material placed on the embankment near Station 144+00.

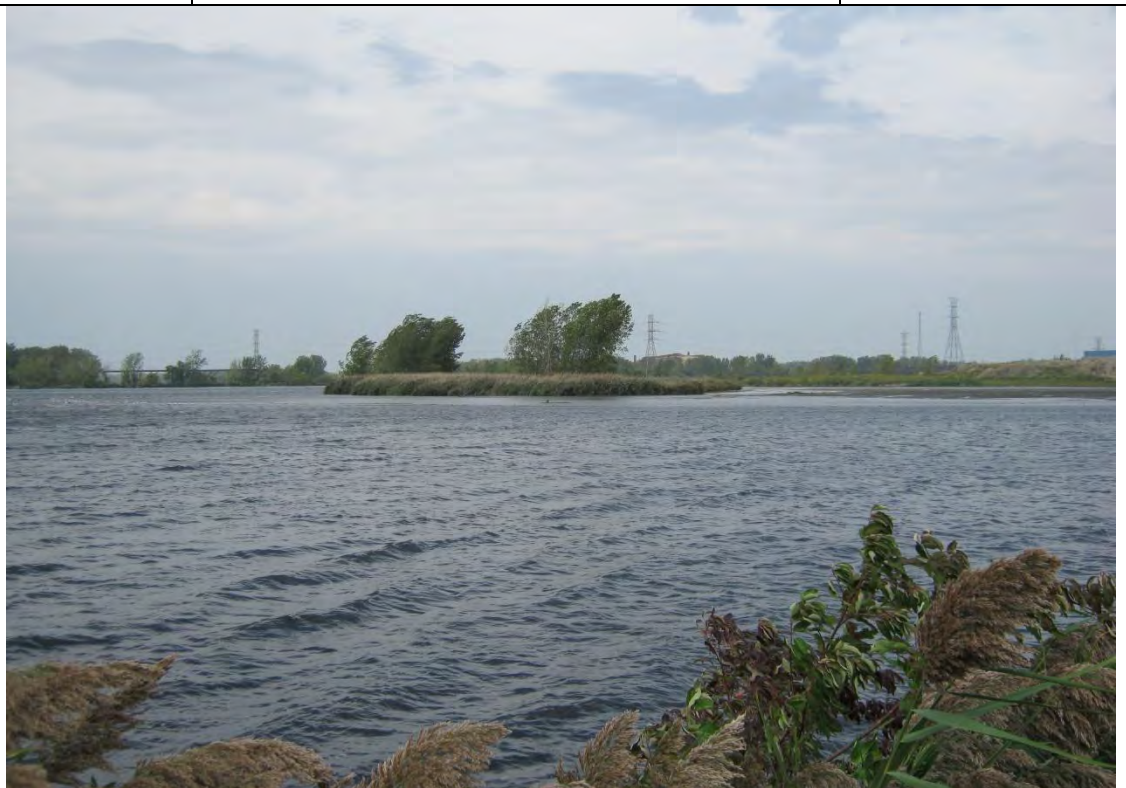
Photo No. 47	Date: 9/24/10
Direction Photo Taken: West

Description:
Overview of the Bottom Ash Stormwater Pond. The island shown on Figure 5 is in the center of the picture.

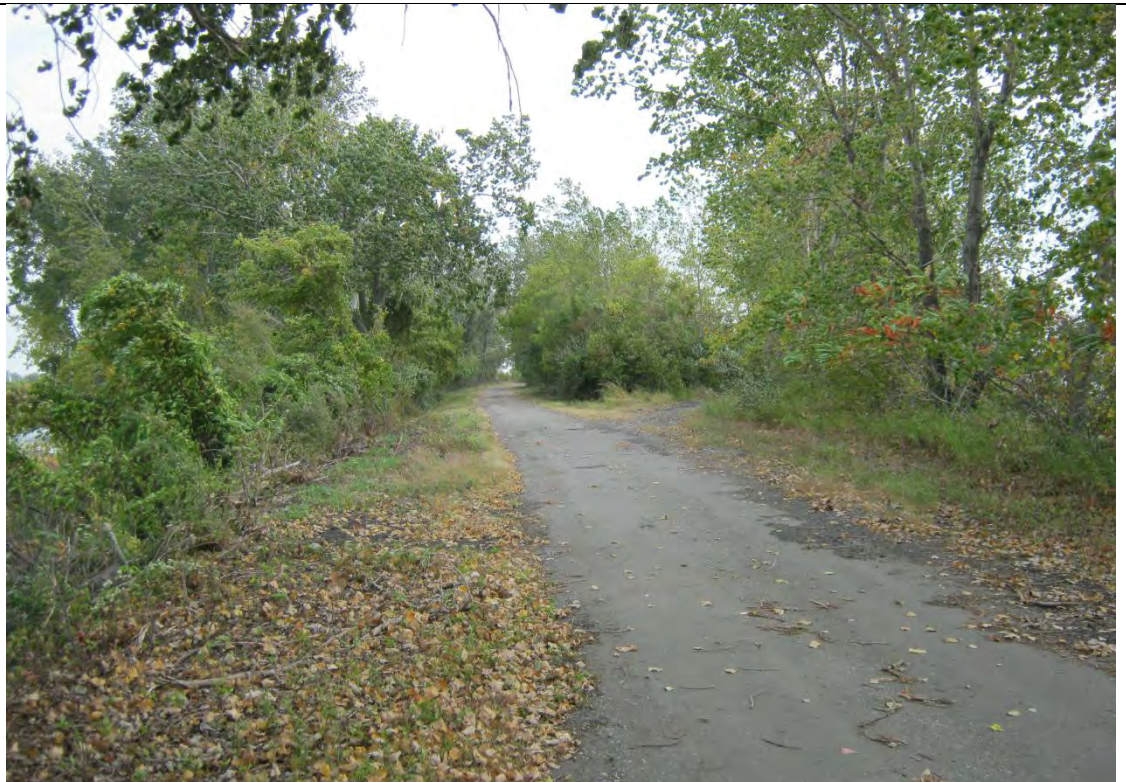
Photo No. 48	Date: 9/24/10
Direction Photo Taken: North

Description:
Road constructed on embankment.

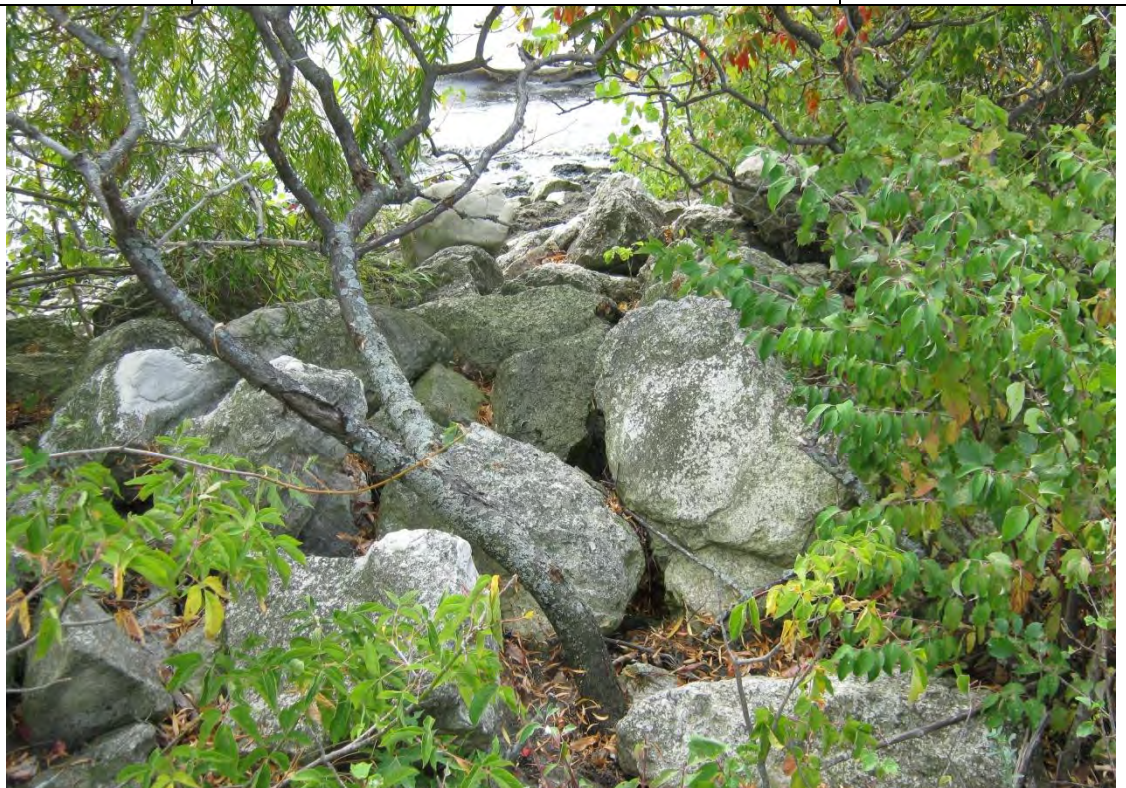
Photo No. 49	Date: 9/24/10
Direction Photo Taken: East

Description:
Armor placed on the Lake Erie shoreline side of the embankment.

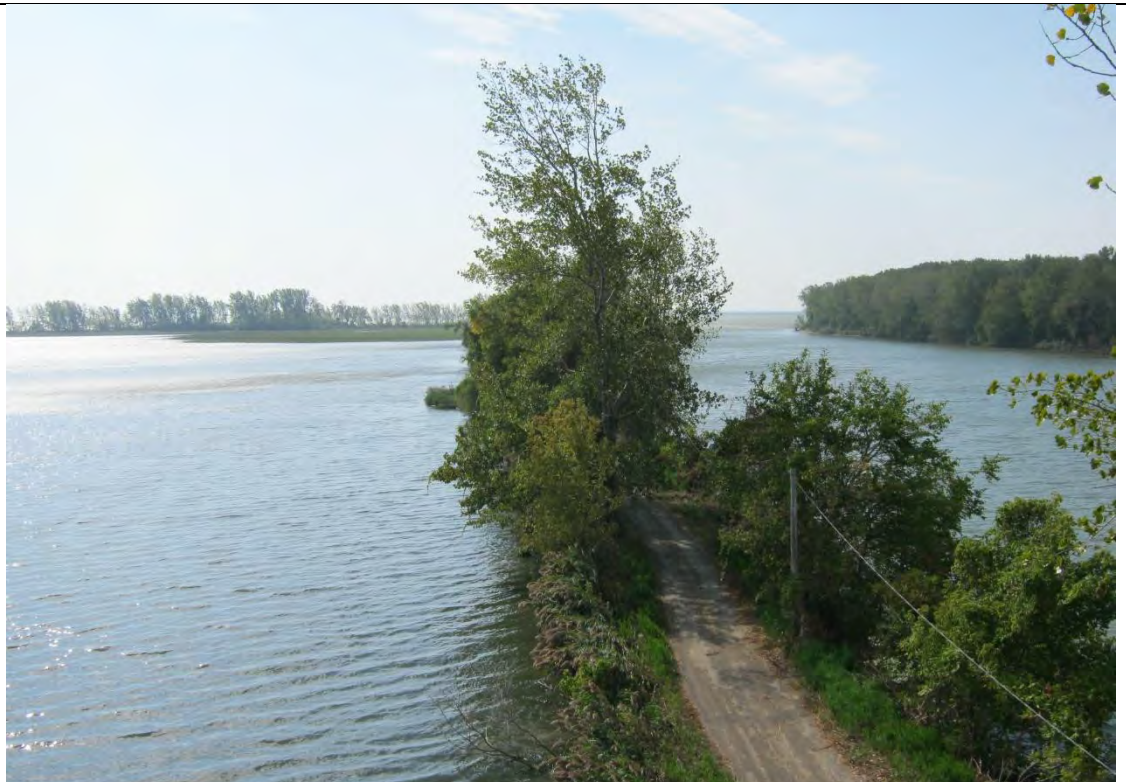
Photo No. 50	Date: 9/24/10
Direction Photo Taken: Southeast

Description:
The embankment separating the Bottom Ash Stormwater Pond from Plum Creek. Plum Creek and Lake Erie are on the right side of the picture.

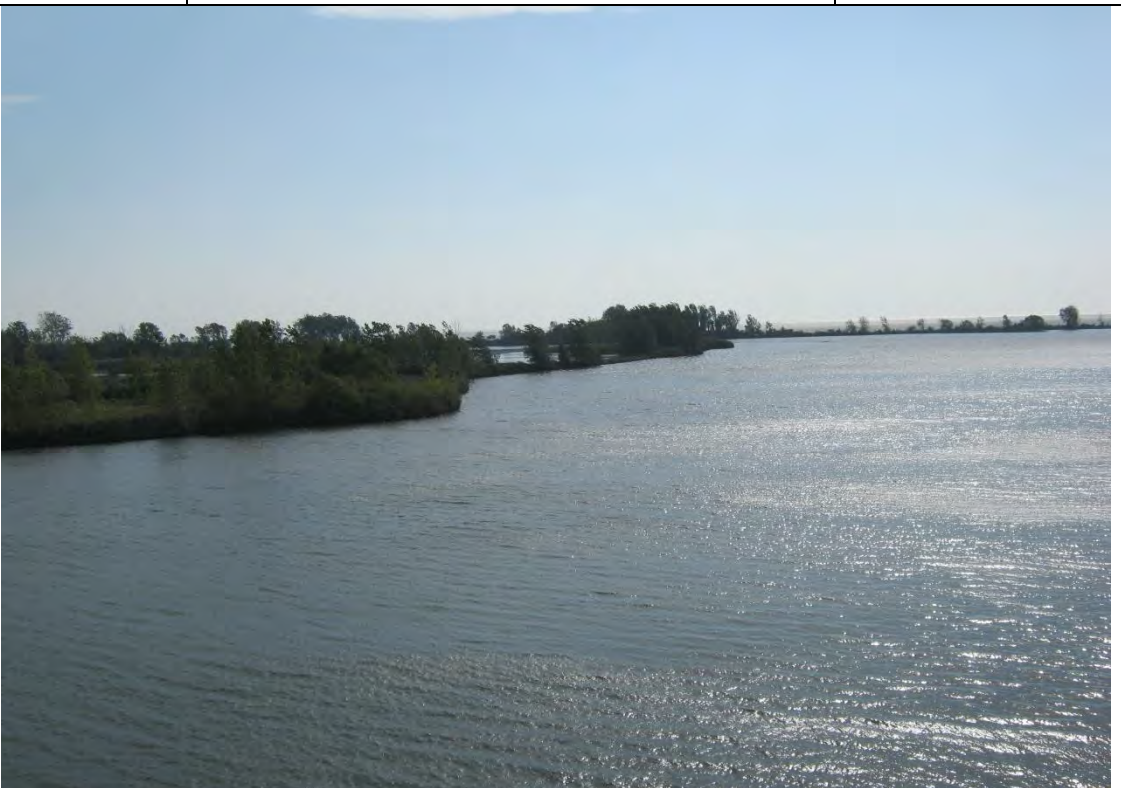
Photo No. 51	Date: 9/24/10
Direction Photo Taken: East

Description:
Overview of the Bottom Ash Stormwater Pond.

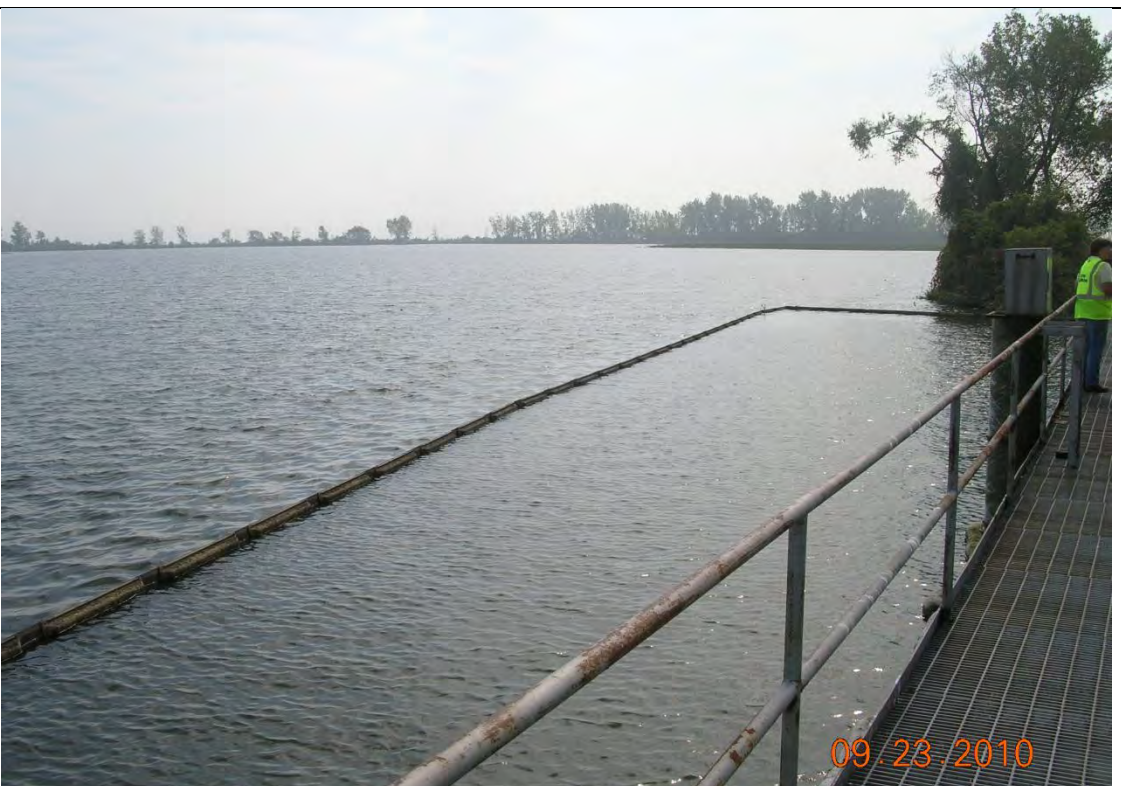
Photo No. 52	Date: 9/23/10
Direction Photo Taken: Southeast

Description:
Overview of the Bottom Ash Stormwater Pond. The wastewater flows under the sheet piling shown in the picture.

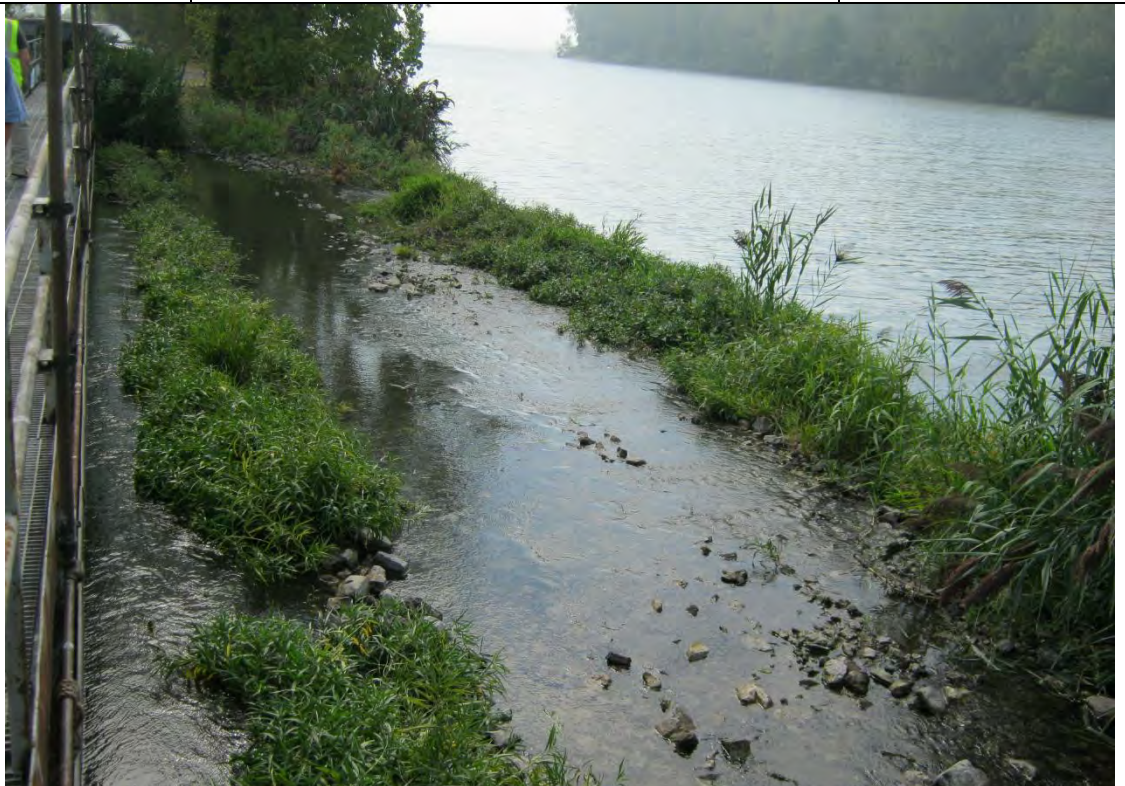
Description: Outfall of the Bottom Ash Stormwater Basin to Plum Creek.

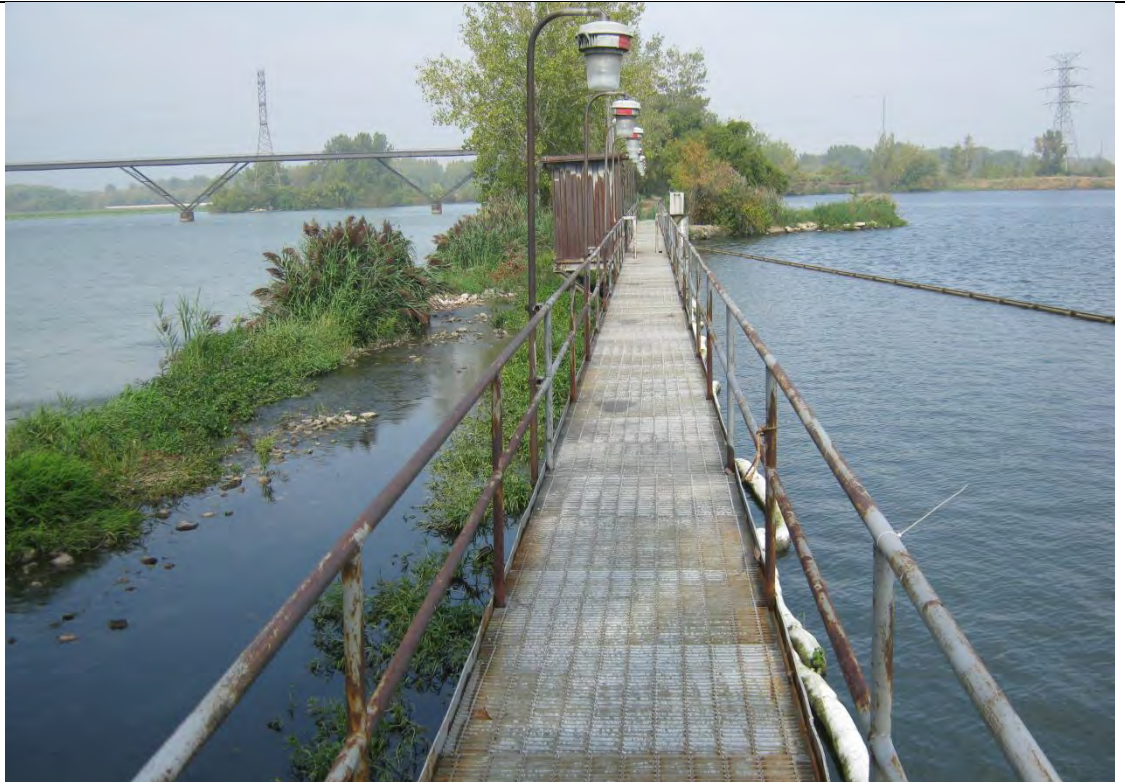
Photo No. 54

Description: The weir and walkway separating the Bottom Ash Stormwater Basin from Plum Creek. The fly ash sluice pipe support bridge is visible in the background.
