**Coal Combustion Residue Impoundment
Round 9 - Dam Assessment Report**

Cliffside Steam Station

Ash Basin Dikes

Duke Energy Corporation
Mooreboro, North Carolina

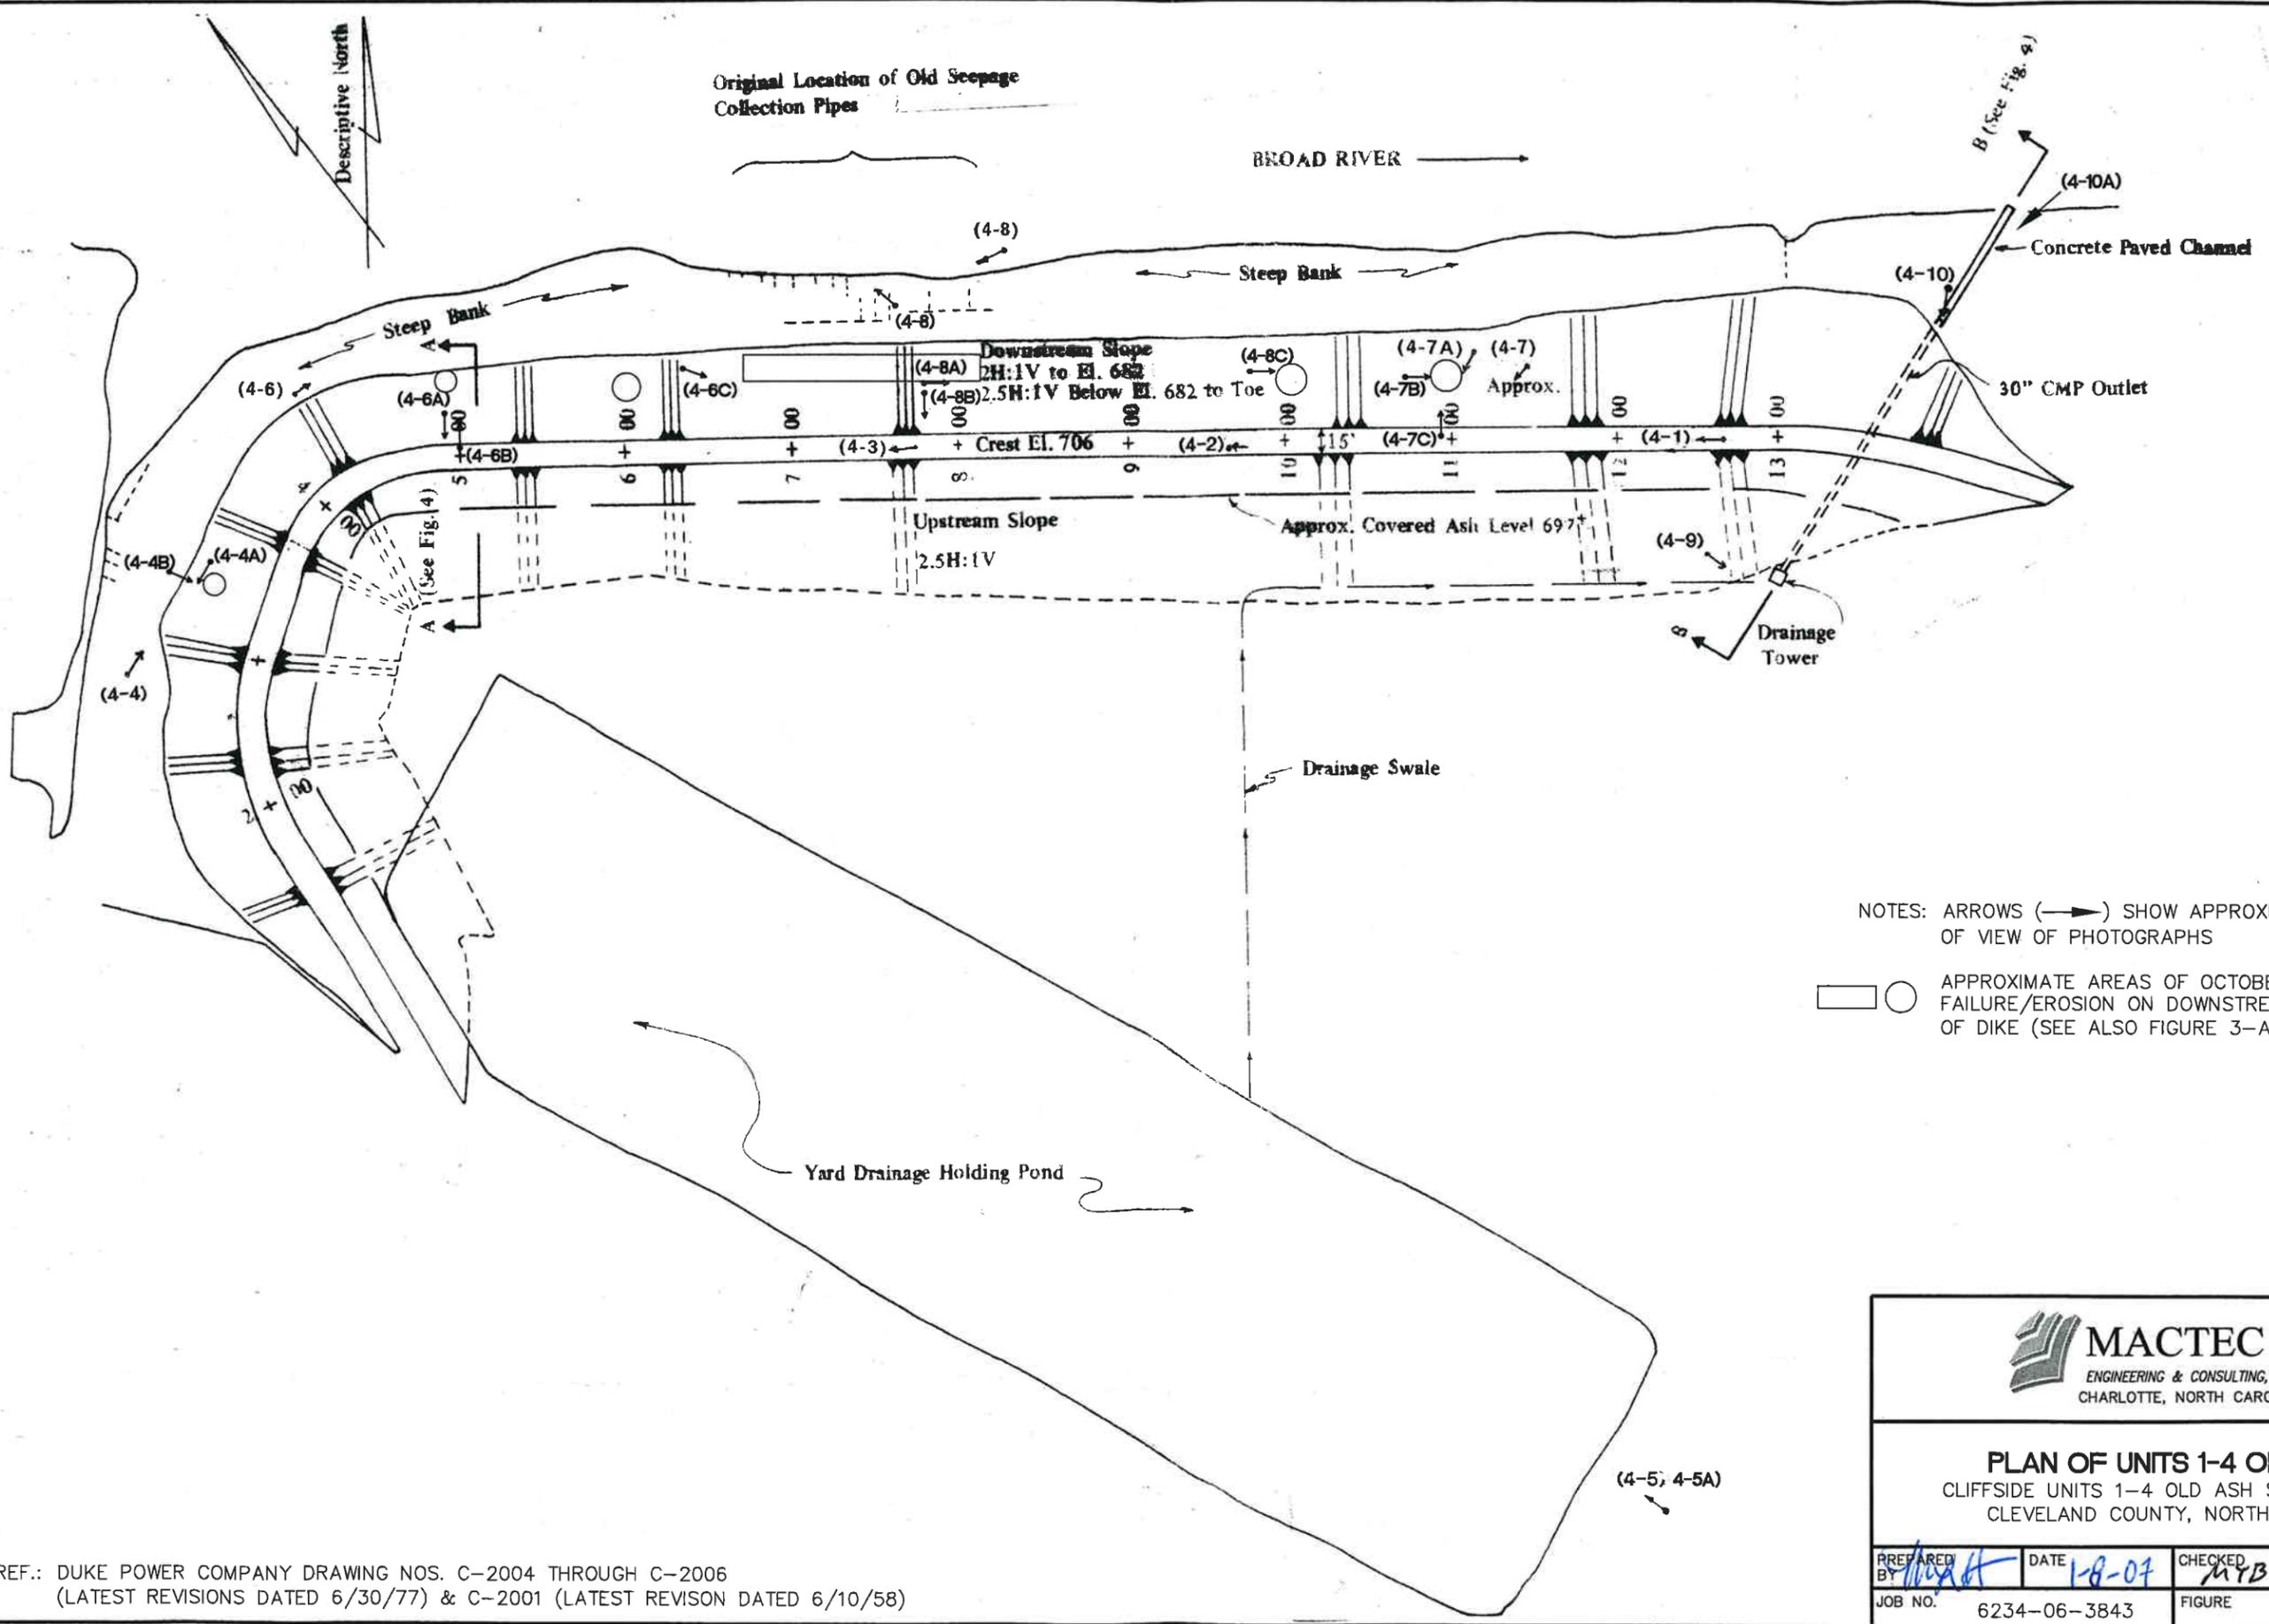
○ APPROXIMATE AREAS OF OCTOBER, 2005 FAILURE/EROSION ON DOWNSTREAM SLOPE OF DIKE (SEE ALSO FIGURE 3-A)

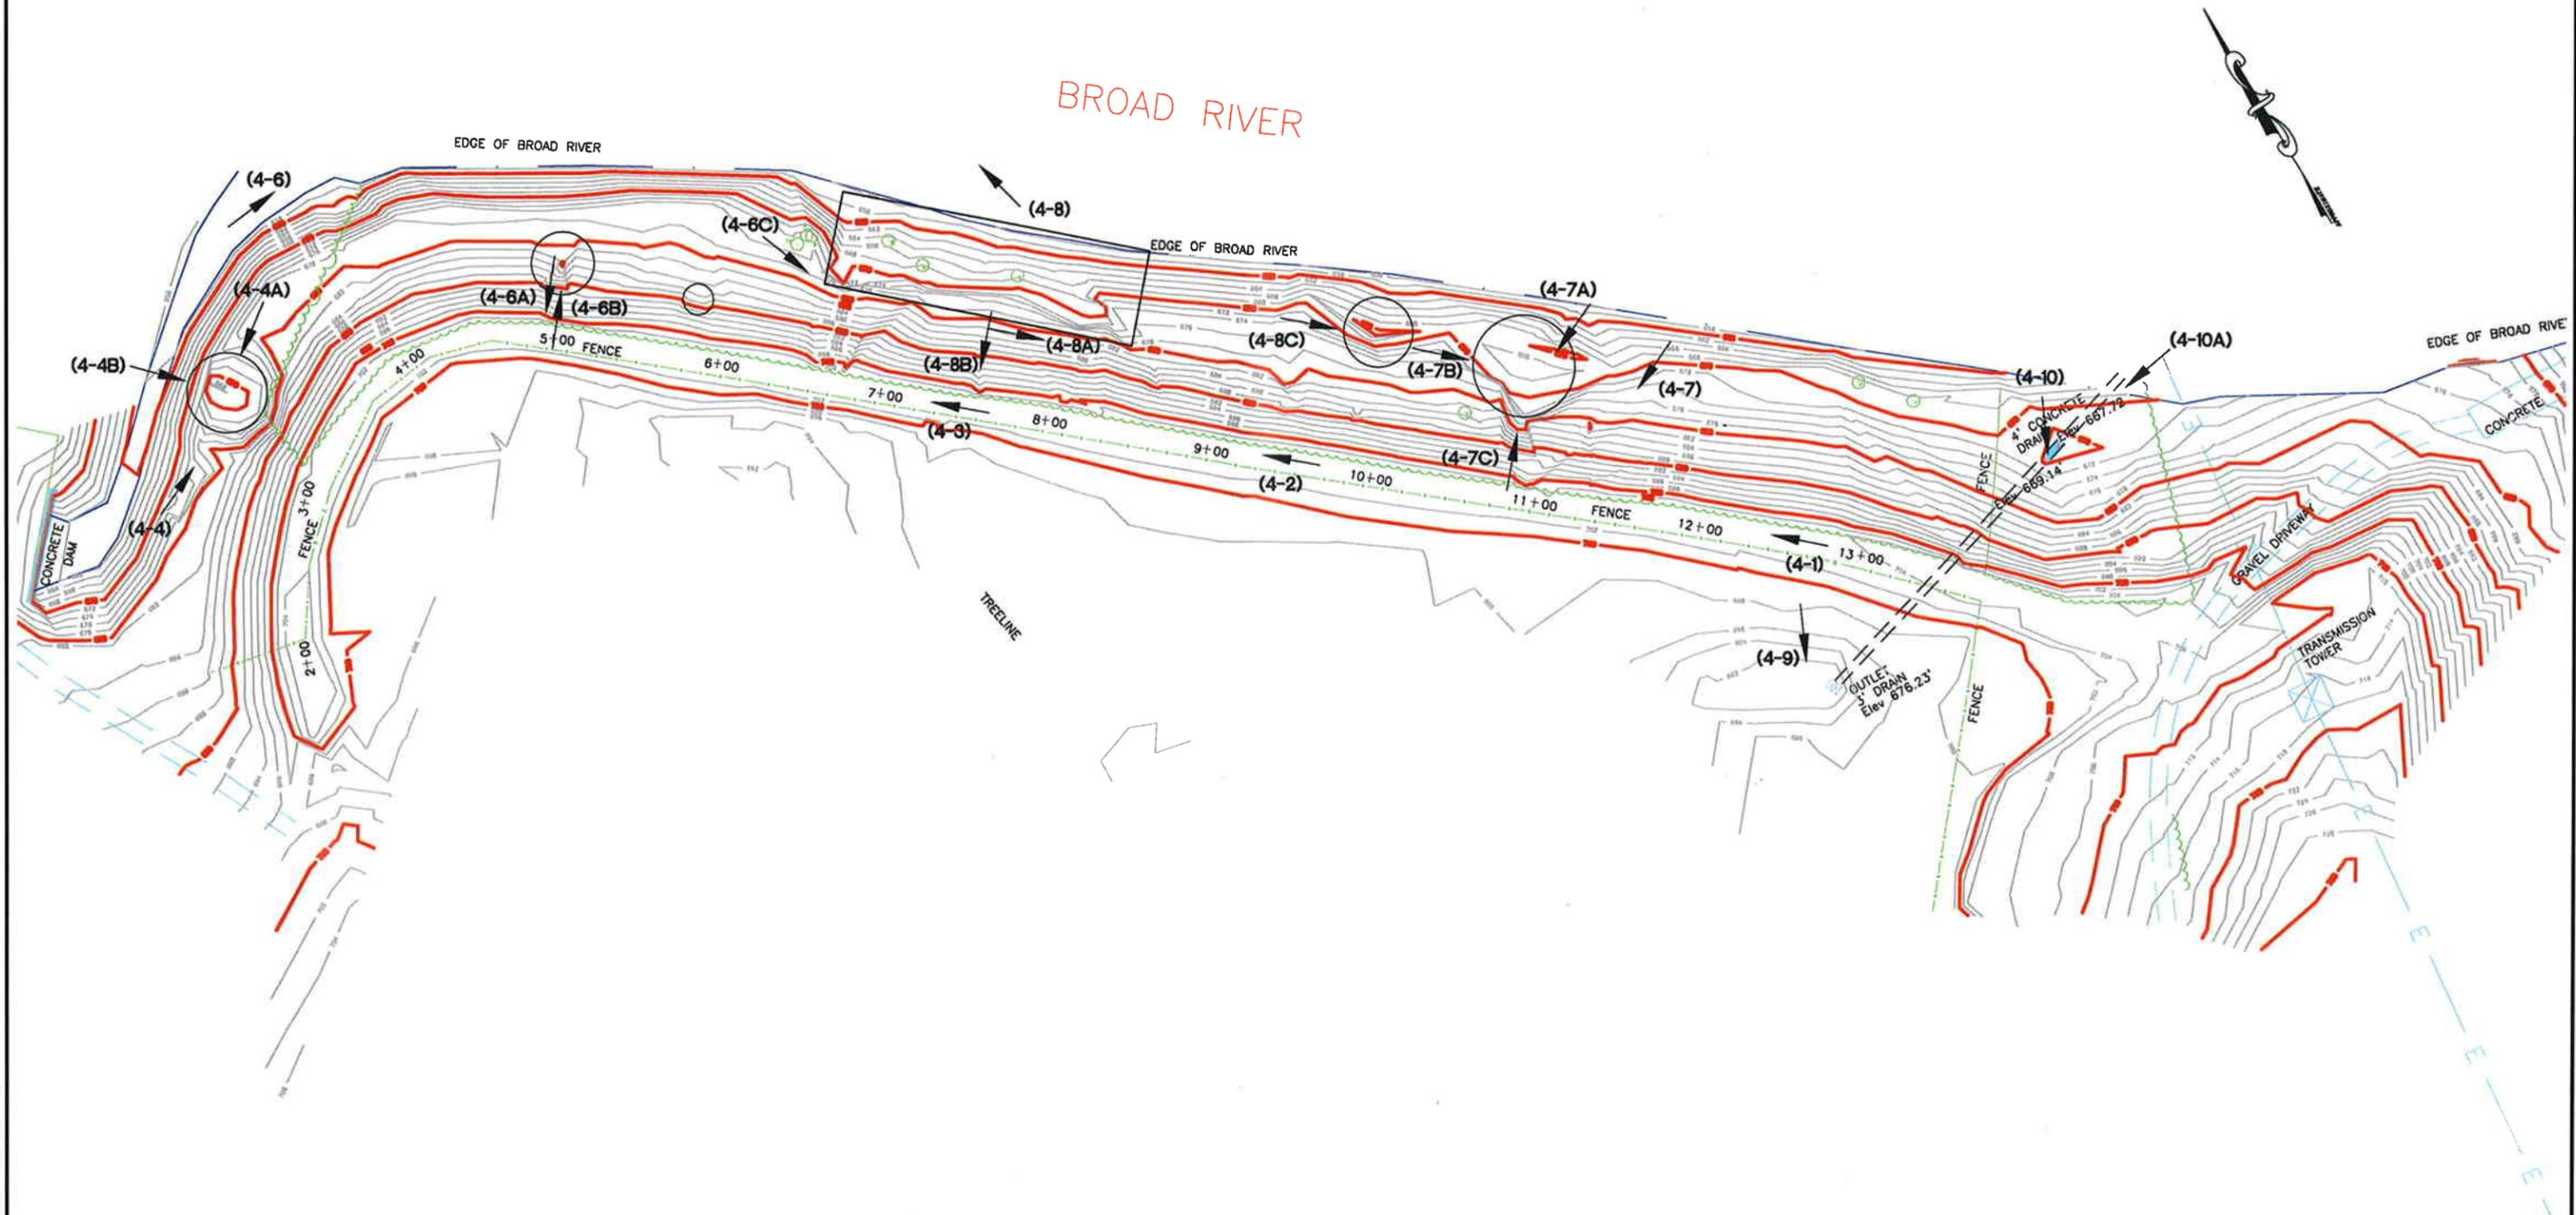
○ APPROXIMATE AREAS OF OCTOBER, 2005 FAILURE/EROSION ON DOWNSTREAM SLOPE OF DIKE

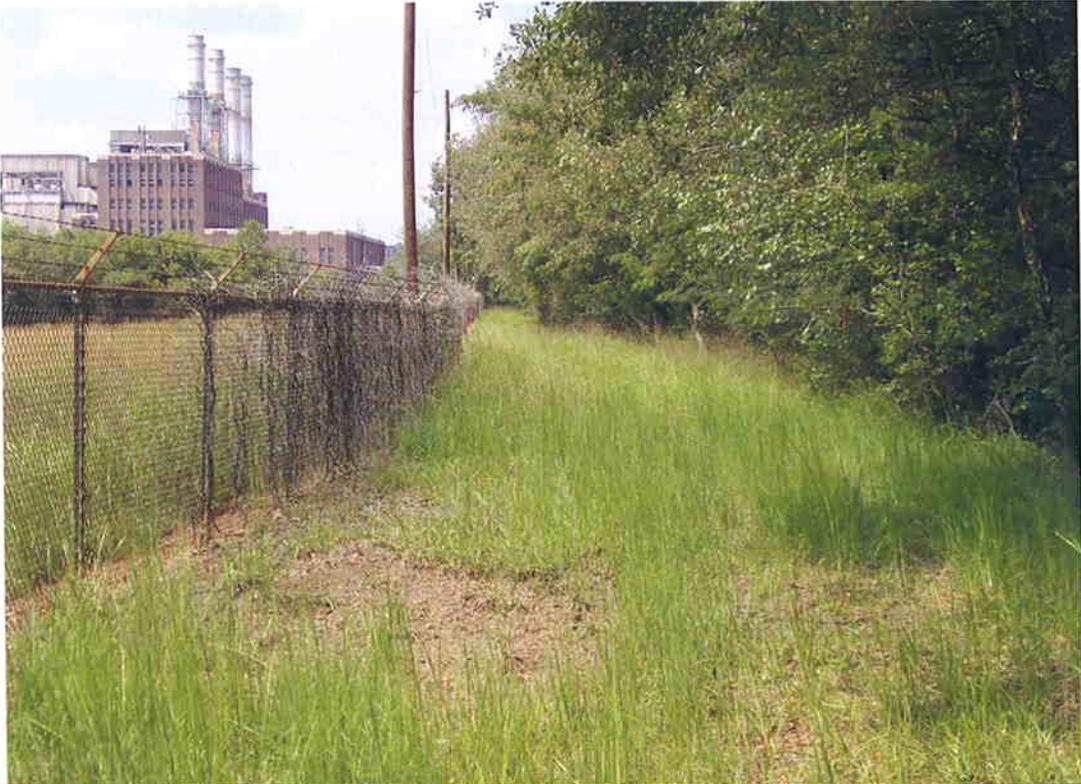
The downstream slope of the Units 1-4 retired ash basin dike is overgrown with trees and other vegetation as described in the earlier independent inspections. The crest, shown in Photographs 4-1, 4-2 and 4-3 has trees overhanging it. There are depressions that pond water at some locations in the surface of the crest, although no ponded water was present due to preceding dry weather. Depressions or “undulations” were first observed in the crest between approximately station 10+00 and 12+50 in the 1996 inspection. A chain link fence along the western (inside) edge of the crest that was added between the 1986 and 1991 independent inspections shows sags in the same area as the crest undulations (Photograph 4-2). This implies that the undulations formed since the fence was installed. These depressions or undulations were still evident in the current 2006 inspection, and appear essentially the same as they did in 1996 and 2001.

<p>Photograph 4-1</p> <p>Crest of Units 1-4 old ash basin dike (E to W view). Depressions present in crest as in 2001 inspection, but obscured in photograph by high grass.</p>
	Remarks

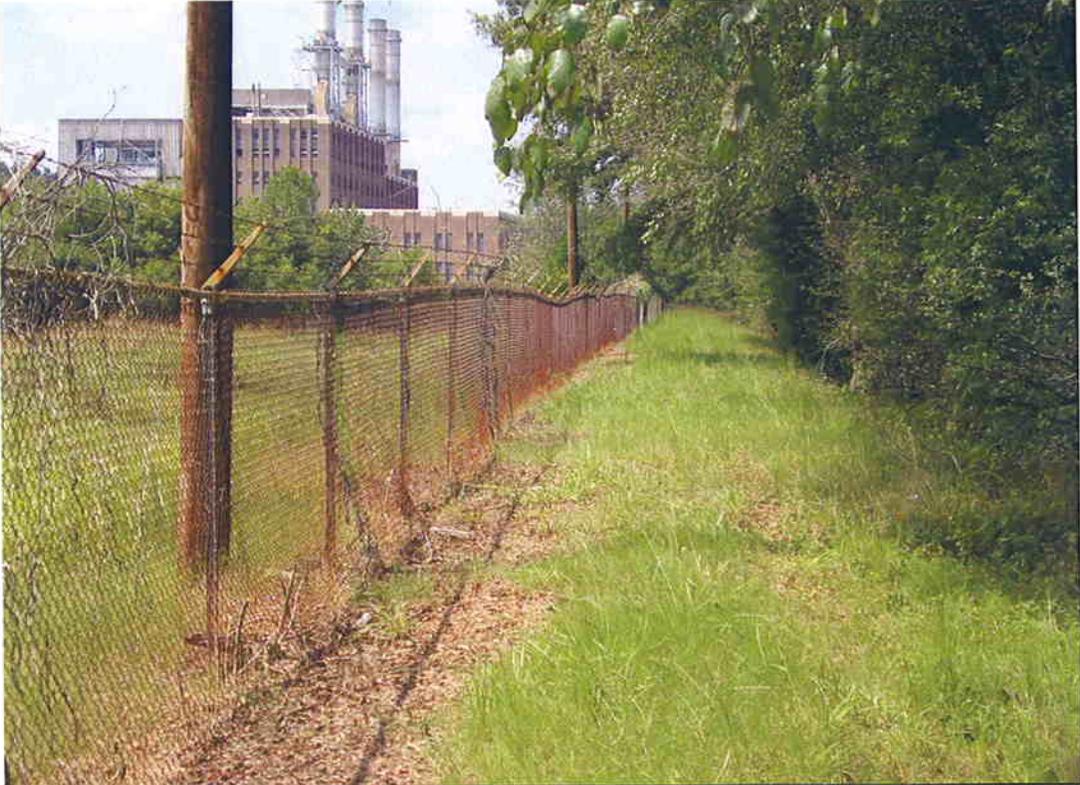
<p>Photograph 4-2</p> <p>Crest of Units 1-4 old ash basin dike – undulations in fence unchanged from 2001.</p>

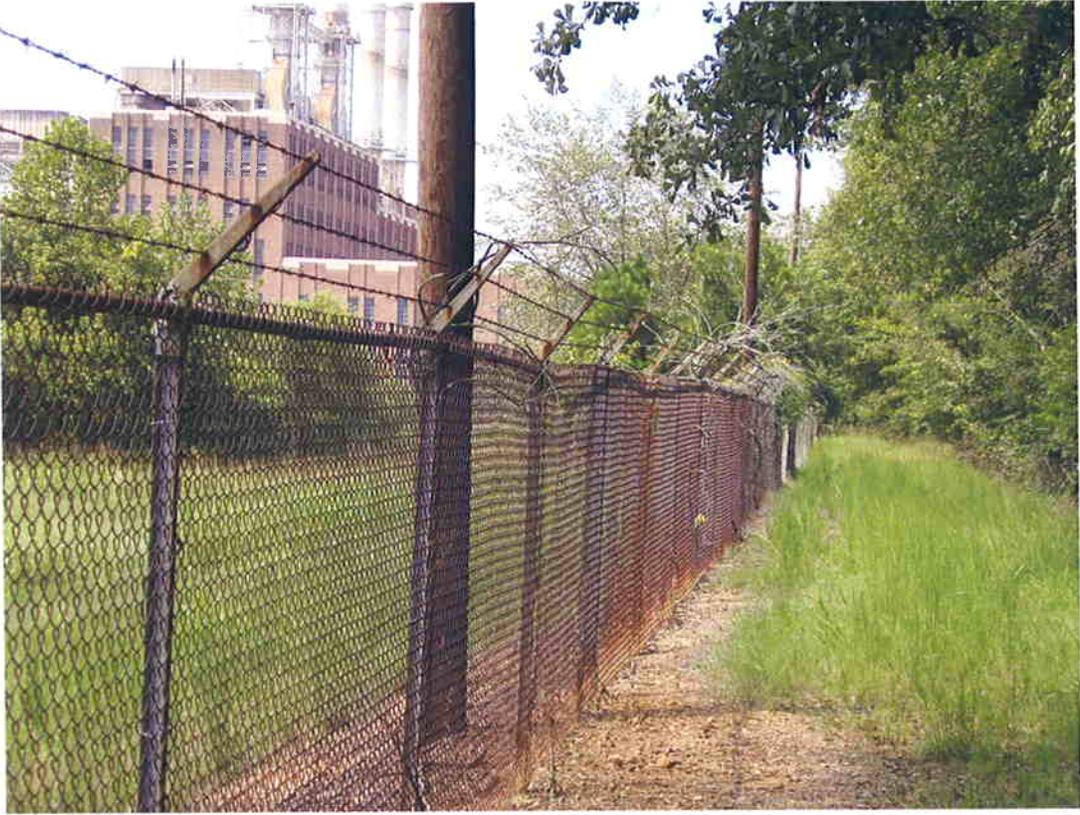
<p>Photograph 4-3</p> <p>Crest of Units 1-4 old ash basin dike (E to W view) west of undulating area. High grass obscures ground surface in photograph.</p>
	Remarks

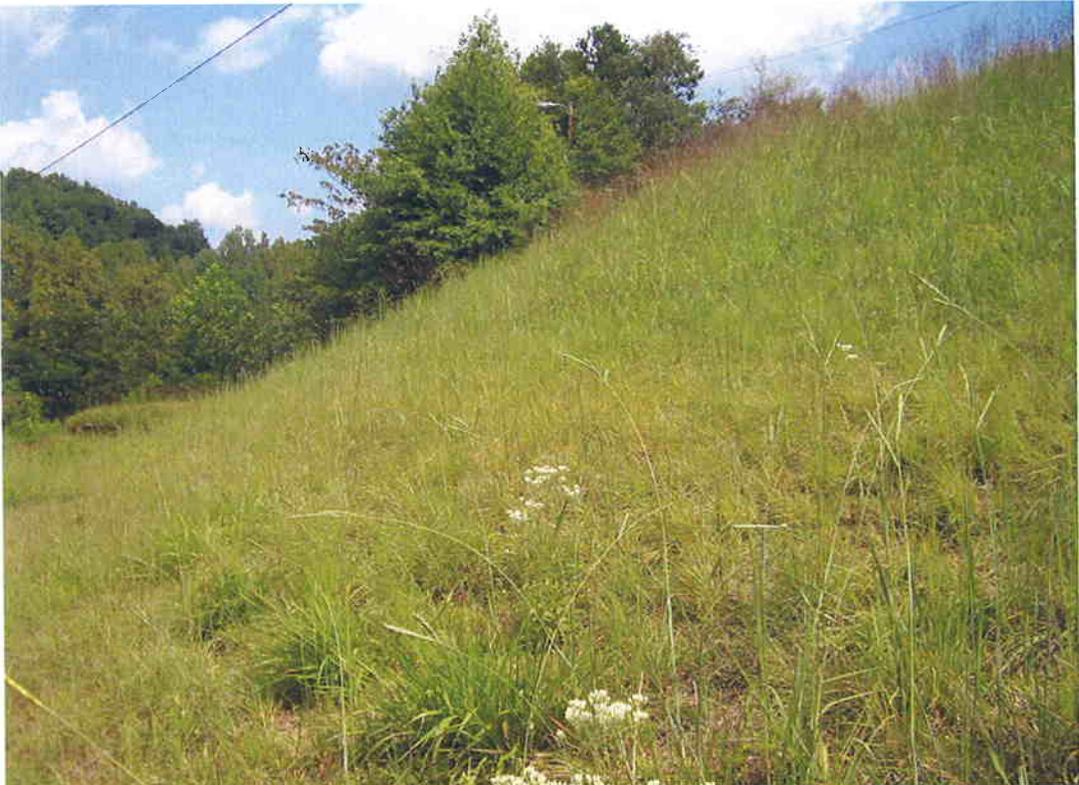
The inside (upstream) slope of the dike is almost completely buried with ash; only the upper part of the slope above ash level is visible. No signs of slumping or shear failure were observed on this slope. The outside (downstream) slope of the north end is grassed (Photograph 4-4). In 2001, the vegetation showed minor, insignificant disturbance by mowing equipment in a few local places. In 2006, the slope surface was obscured by high grass cover.

<p>Photograph 4-4</p> <p>Outside (downstream) slope north end of Units 1-4 old ash storage basin area. Slope surface obscured by high grass.</p>

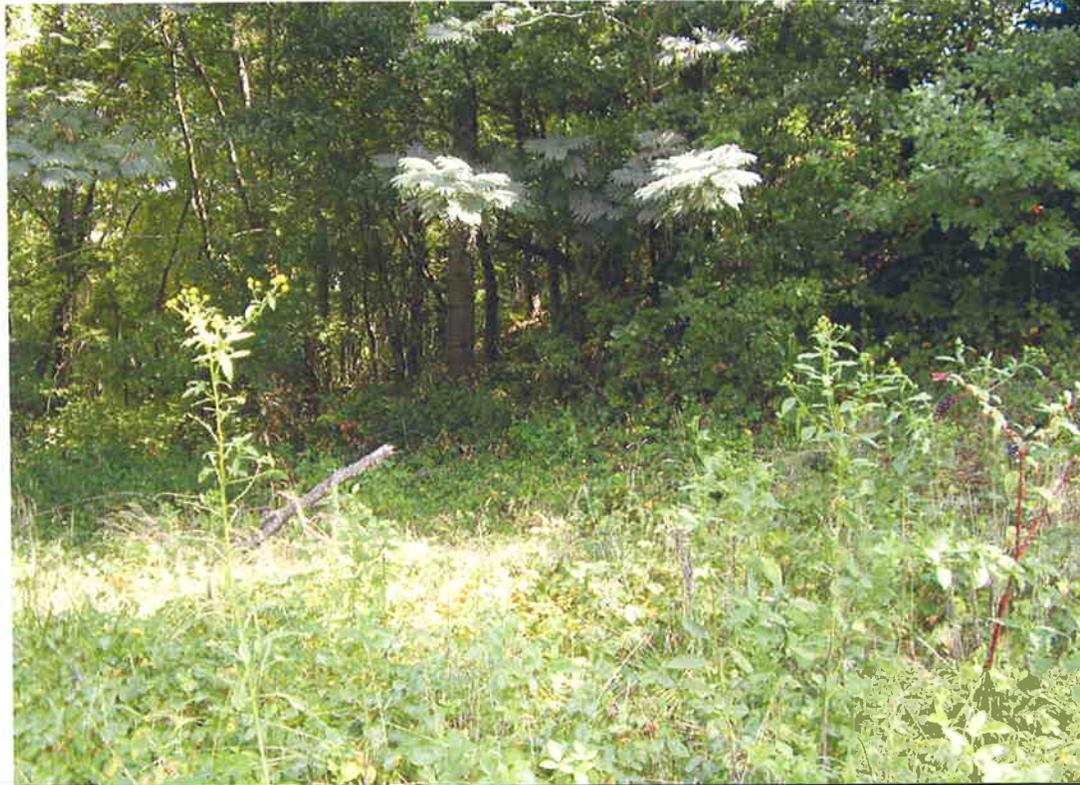
A view of the wooded outside (downstream) slope of the Units 1-4 ash basin dike is shown in Photograph 4-6. Trees on the downstream slope that had been overturned at the time of the 1991, 1996 and 2001 reports are still visible. As noted in earlier inspections, the inspection trail located along the toe of this slope is still overgrown (Photograph 4-6) and more so than 2001. In 2001, signs of shallow slope failures were observed on the slope between approximately stations 11+00 and 13+00. In 2006, such shallow slump failures and erosion were noted at several locations on the downstream slope, (Photographs 4-6A and 4-8B). However, much more significant distress was observed in the 2006 inspection, caused by the October 2005 storm event. Overflow of the retired Unit 1-4 Ash Basin, along with overflow of the Suck Creek Diversion Channel, caused localized failure and erosion on the downstream slopes of the dike at the numerous locations depicted on Figures 3 and 3A. Significant distress occurred within the original flat area between the toe of the dike and the bank of the Broad River, between about Station 6+50 to 8+50. Within this area, up to about 15 ft of the original soil overburden failed and was removed by the flood event, with a vertical soil face along the dike side of the failure area. Other similar but more localized soil failure areas are present at about Station 3+00 and 14+00. In these two latter areas,

Photograph 4-6
Wooded outside (downstream) slope of Units 1-4 old ash basin dike. Note uncleared access road. Additional vegetation on access road compared to 2001 inspection.

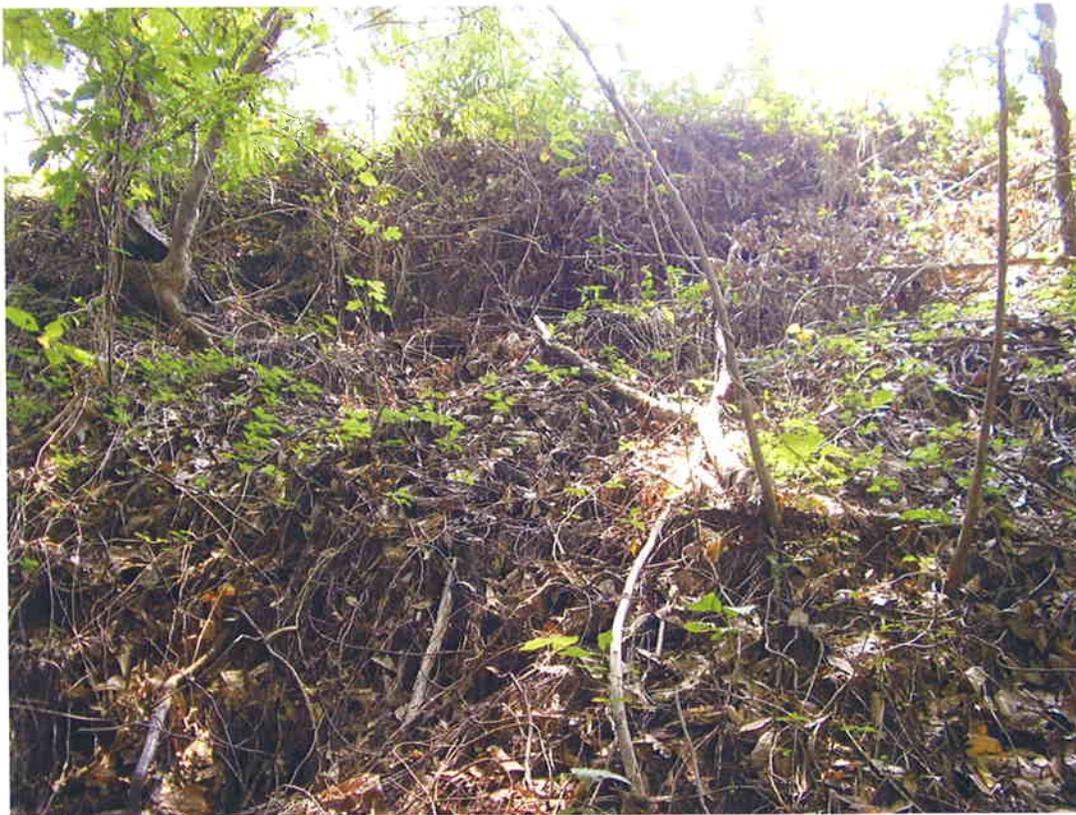
Photograph 4-6A
Apparent old eroded/slump area on upper portion of downstream slope of dike, at approximately station 5+00, above the gully of Photograph 4-6B.

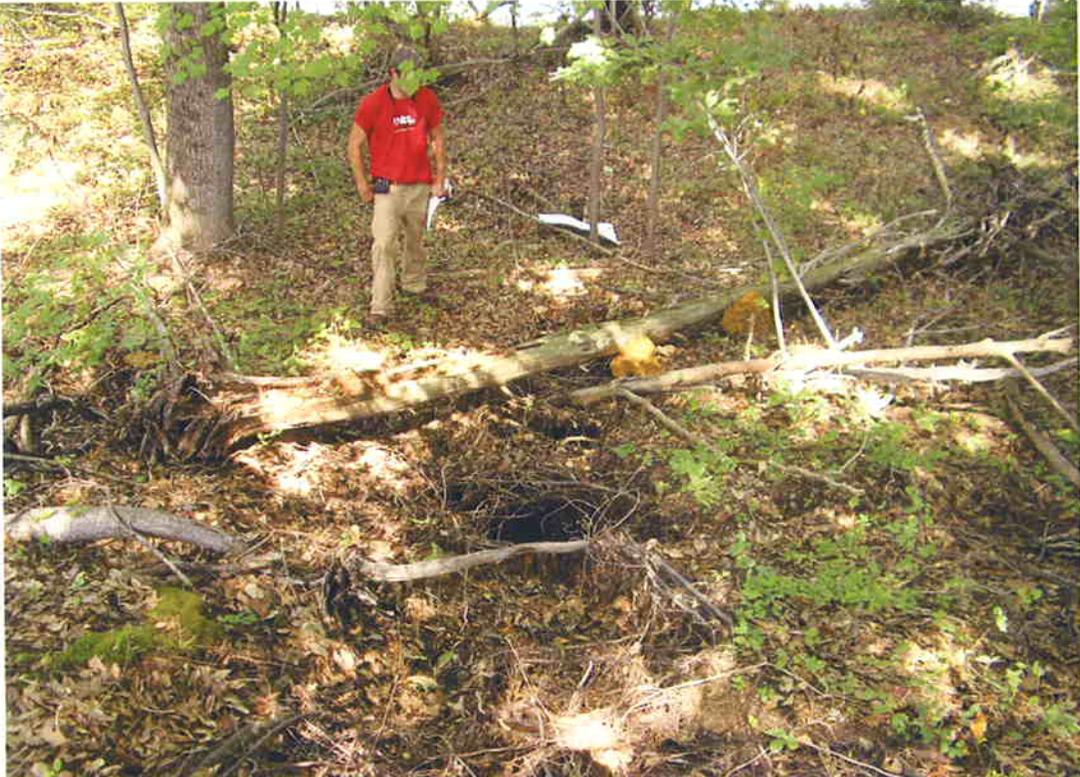
<p>Photograph 4-6B</p> <p>Eroded gully, about 5 ft deep, on downstream slope of Units 1-4 old ash basin dike, below upper slump/eroded area of photograph 4-6A.</p>
	Remarks

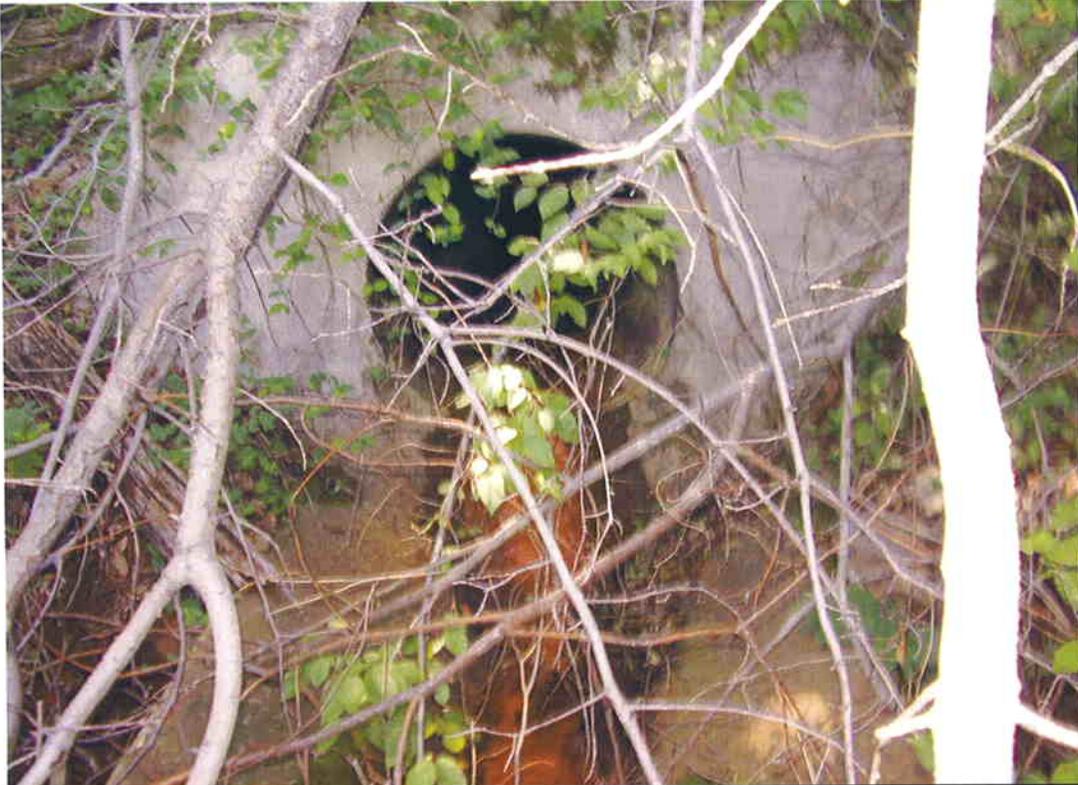
The visible part of the drainage tower is shown in Photograph 4-9, and the outlet end of the 30-inch diameter CMP outlet is shown in Photograph 4-10 and 4-10A. The drainage structure still appeared to be in fair condition. The steel frame on top of the drainage tower is rusty. High grass obscured the lower portion of the drainage tower legs. A small trickle of red colored water was observed to flow from the end of the outlet pipe. As part of the 1996 inspection, the sediment was sampled and sent to Duke's Metallurgy Laboratory where energy-dispersive spectroscopy was performed and the sample was determined to be primarily iron oxide (letter dated January 2, 1997 to Mr. Mike Martin from Ms. Sue Anderson of the Metallurgy Laboratory). As seen in photograph 4-10A, erosion and undermining of the outlet pipe concrete flume has occurred since 2001, apparently due to the October 2005 storm event.

<p>Photograph 4-10</p> <p>Outlet end of 30-inch CMP outlet for Units 1-4 old ash basin.</p>

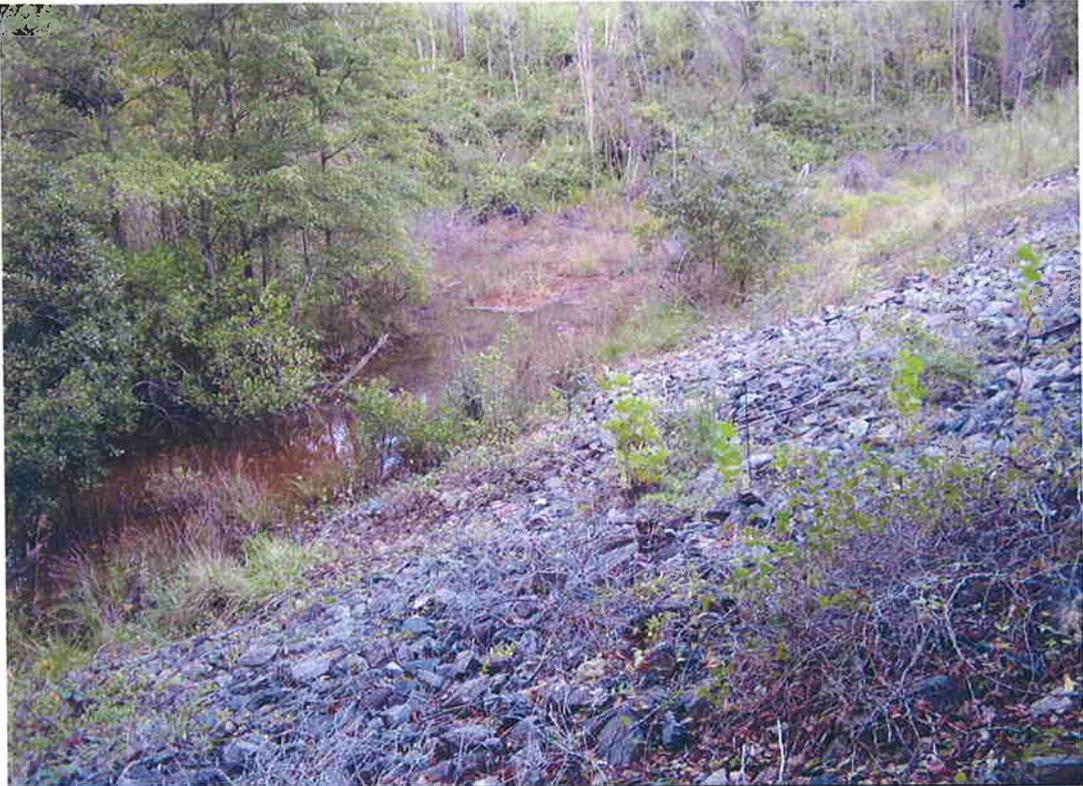
inspections were observed to be essentially unchanged. The swampy area located next to the riprapped toe below the right (east) abutment is shown in Photograph 4-12 and, as in 2001, is currently flooded to shallow depth by a beaver pond located downstream of the area. Bushes and small trees continue to grow in the riprap, and should be removed (Photograph 4-12A).

<p>Photograph 4-12</p> <p>Area of seepage and standing water at base of outside (downstream) slope of unit 5 retired basin main dike now covered by beaver pond.</p>
	Remarks

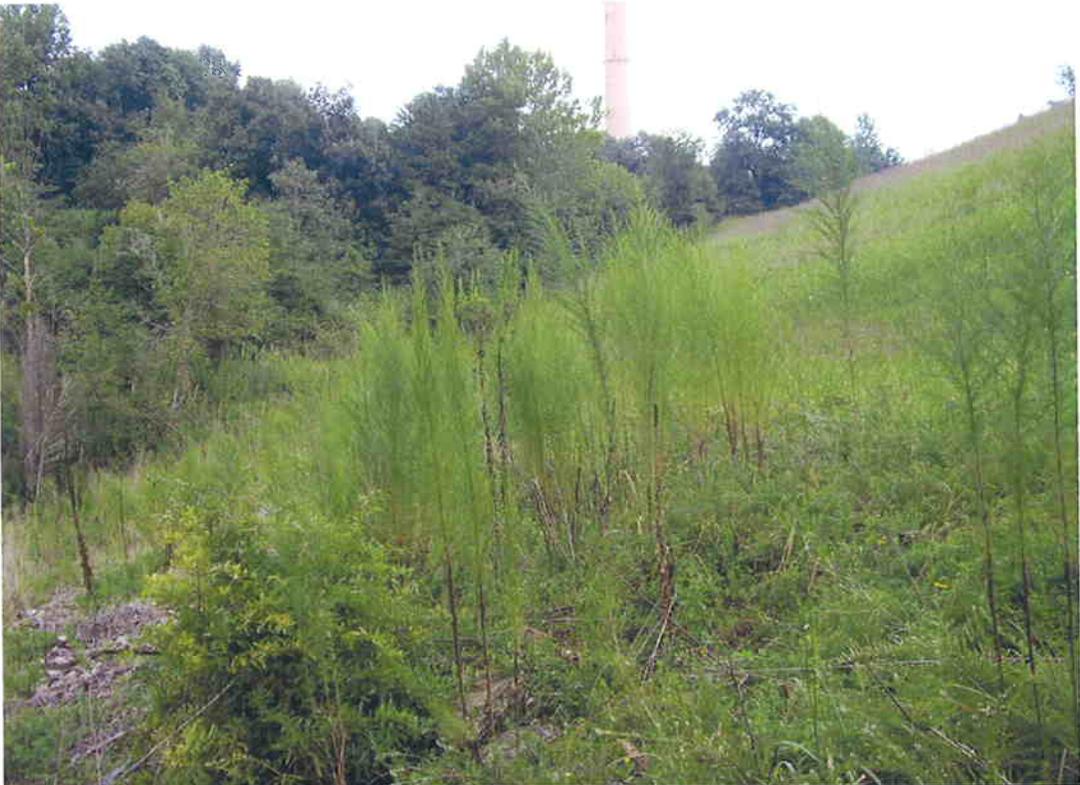
<p>Photograph 4-12A</p> <p>Rip-rap covered downstream lower slope of outside (downstream) slope of unit 5 retired ash basin main dike. Note bushes and vegetation growing in rip-rap.</p>

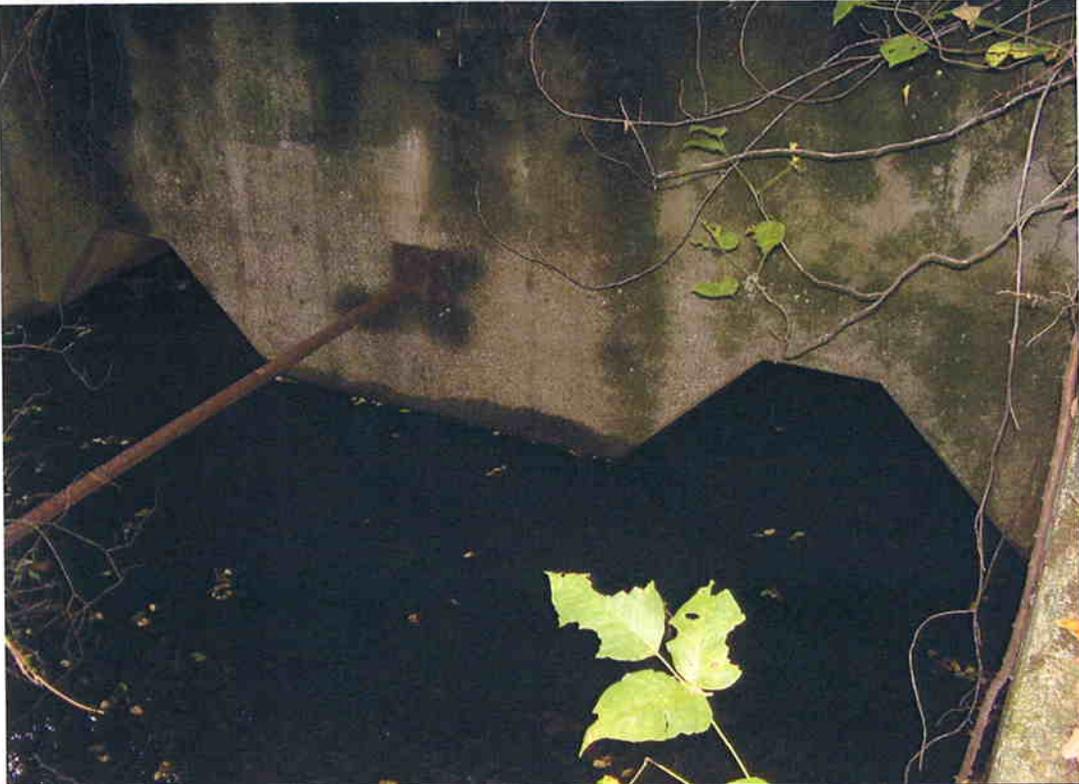
<p>Photograph 4-14</p> <p>Outlet end of 60-inch RCP outlet for unit 5 retired ash basin.</p>
	Remarks

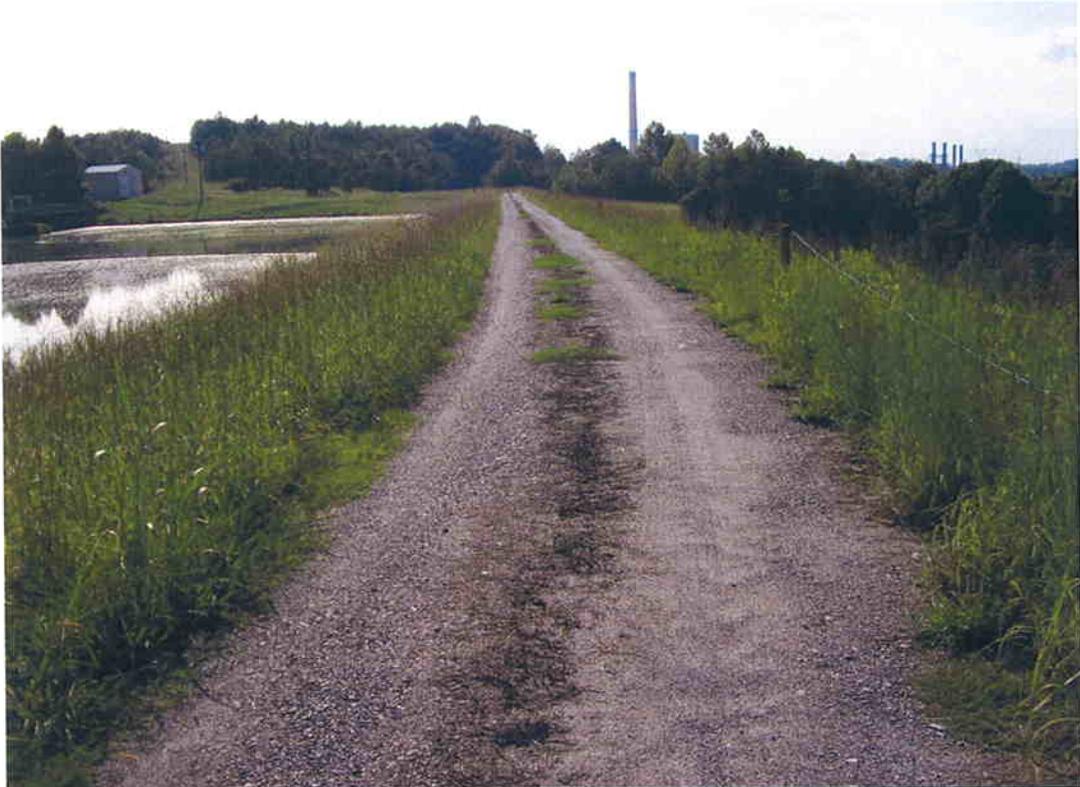
The crest of the downstream dike of the Suck Creek ash basin was observed to be in good condition with no visible tension cracks, major depressions, sags or other signs of shear failure or excessive settlement; a view of the crest is shown in Photograph 4-15.

<p>Photograph 4-15</p> <p>Crest of Suck Creek downstream dike (E to W view).</p> <p>Note high grass.</p>

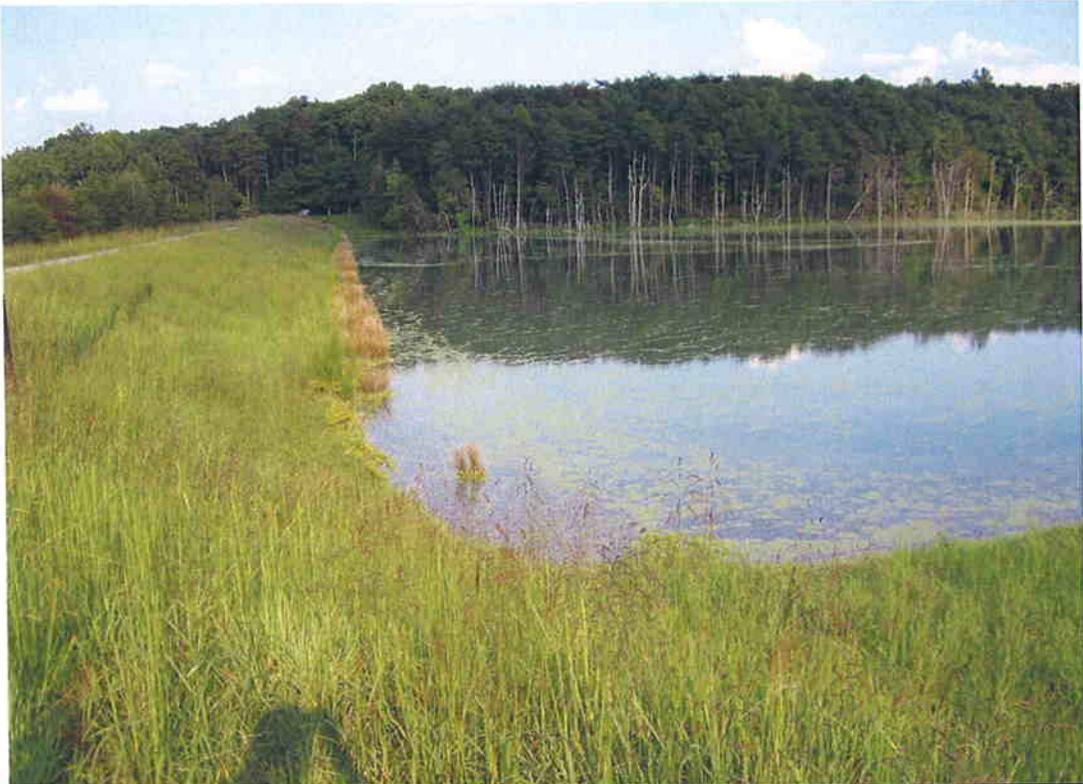
<p>Photograph 4-16</p> <p>Inside slope of Suck Creek downstream dike (W to E view). High grass obscures the slope surface.</p>
	Remarks

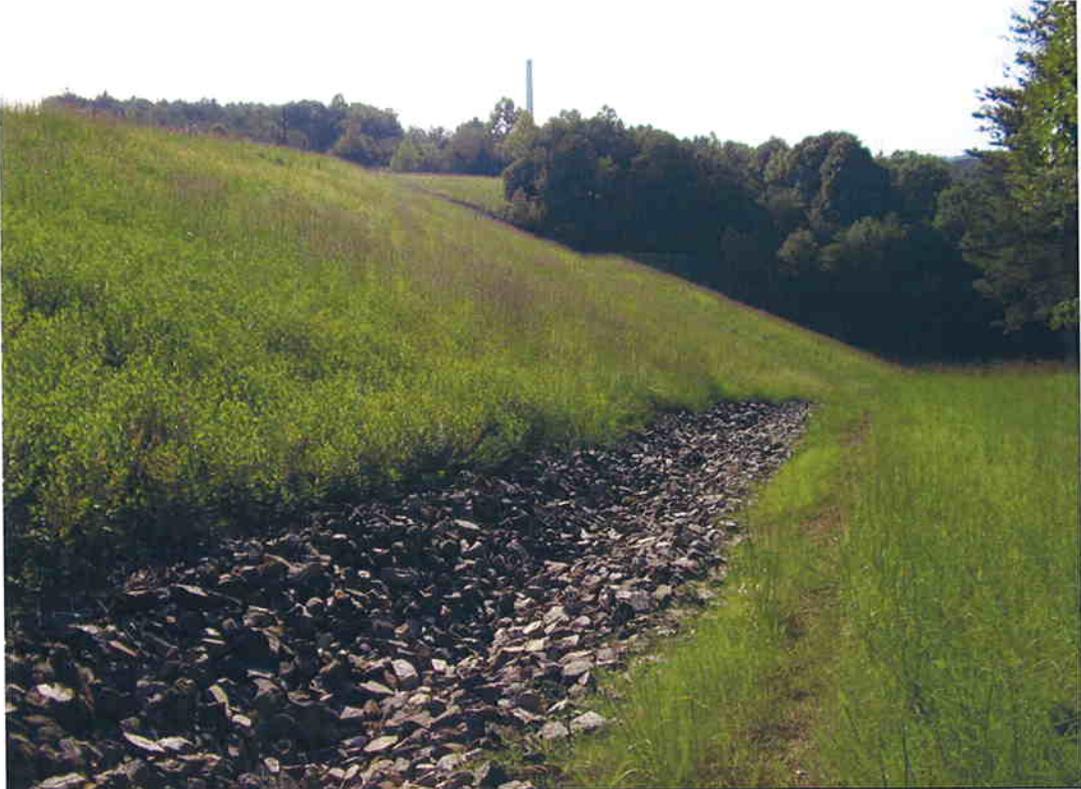
<p>Photograph 4-17</p> <p>Outside slope of Suck Creek downstream dike (E to W view). High grass obscures the surface of slope and OW-10 and OW-11 on slope.</p>

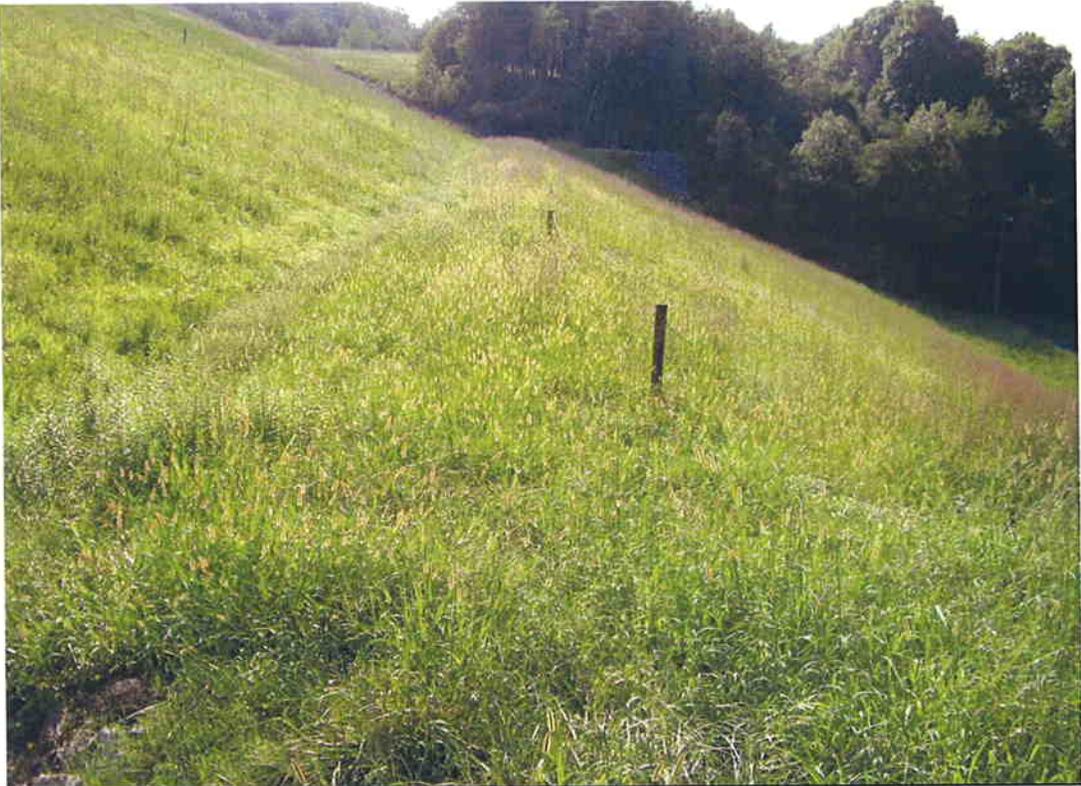
<p>Photograph 4-18</p> <p>View of upper berm on outside slope of Suck Creek downstream dike (E to W view). High grass obscures the slope surface.</p>
	Remarks

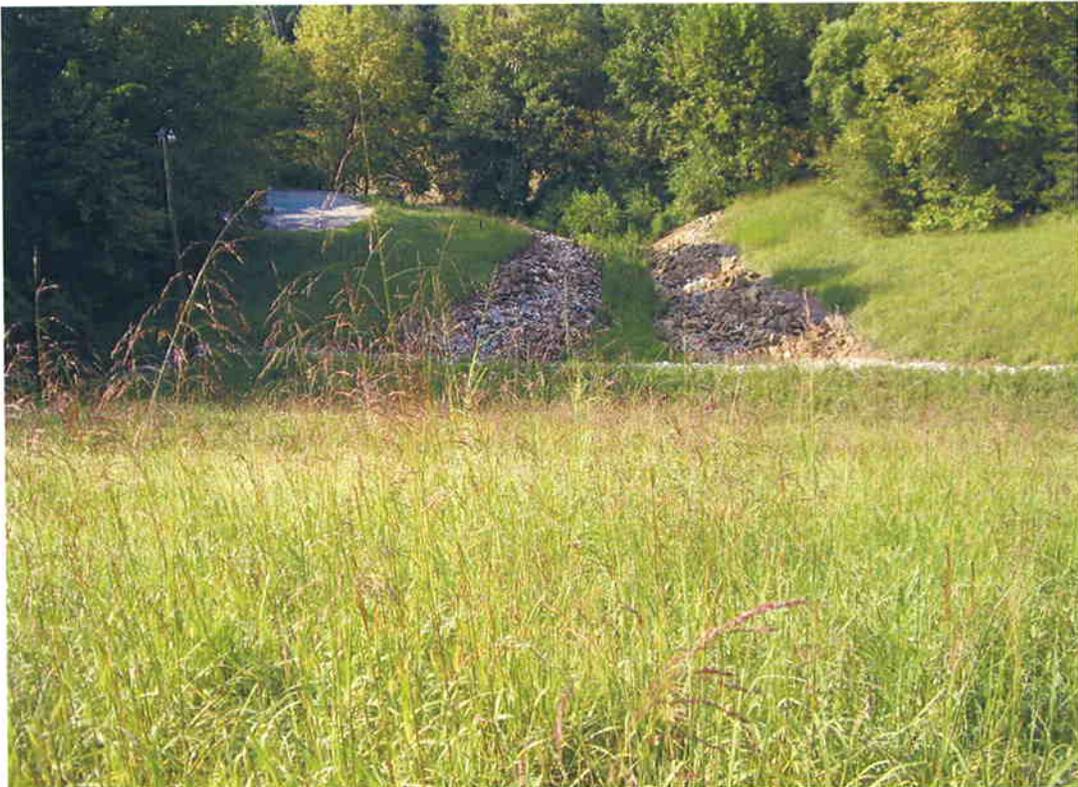
<p>Photograph 4-20</p> <p>Rip-raped channel below toe of outside slope of Suck Creek downstream dike. High grass obscures slope surface and bottom of spillway channel.</p>
