**Coal Combustion Residue Impoundment
Round 9 - Dam Assessment Report**

Cliffside Steam Station

Ash Basin Dikes

Duke Energy Corporation
Mooreboro, North Carolina

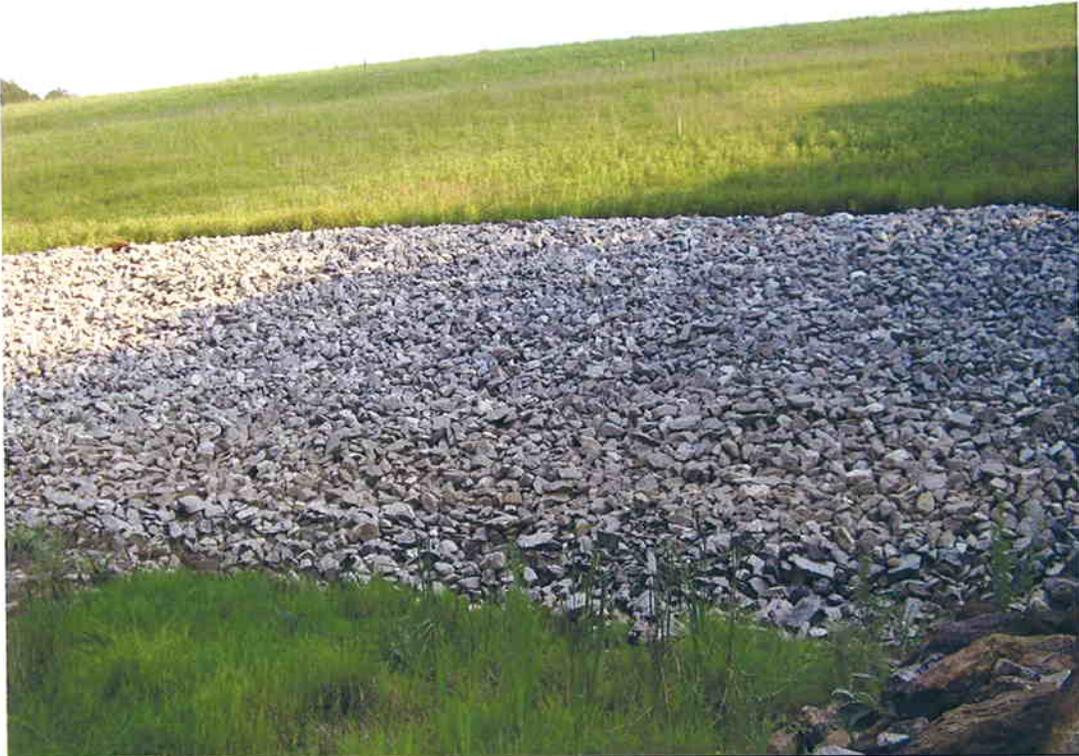
<p>Photograph 4-21</p> <p>Toe of outside slope of Suck Creek downstream dike. Vegetation obscures area below toe of the rip-rap, in area of former beaver dam pool.</p>
	Remarks

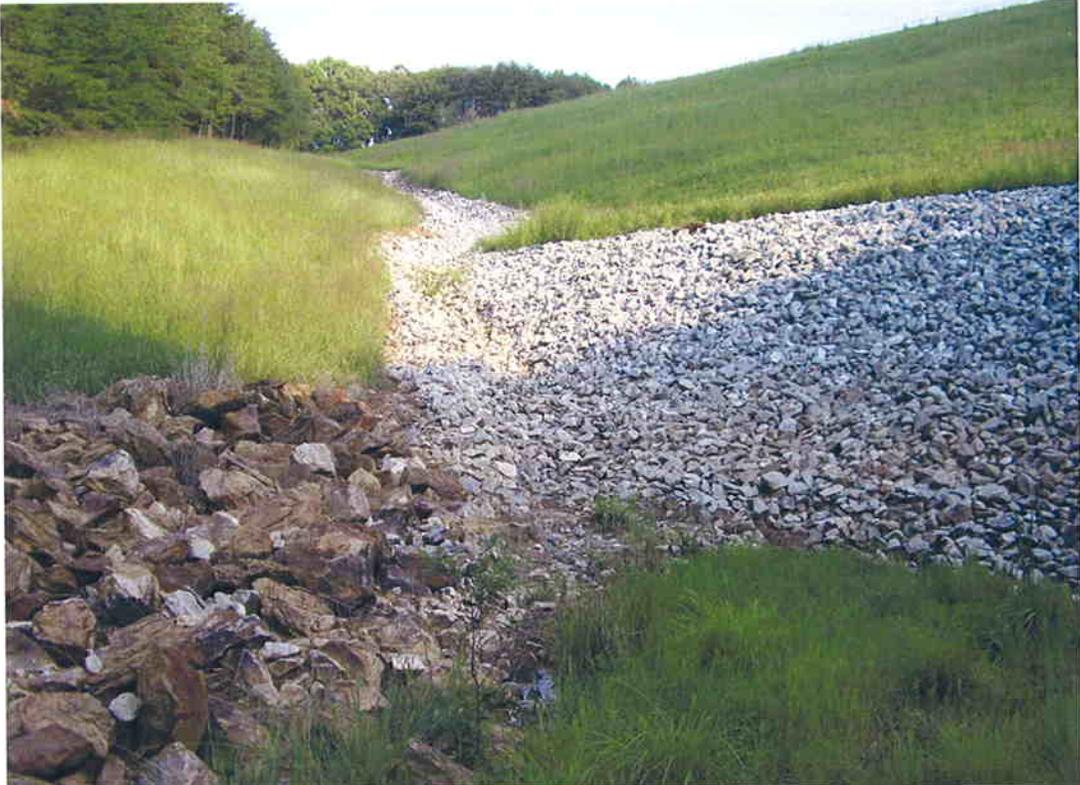
<p>Photograph 4-21A</p> <p>Right abutment rip-rap lined ditch viewed from toe. Note high grass on slope and in pool below toe of rip-rap.</p>

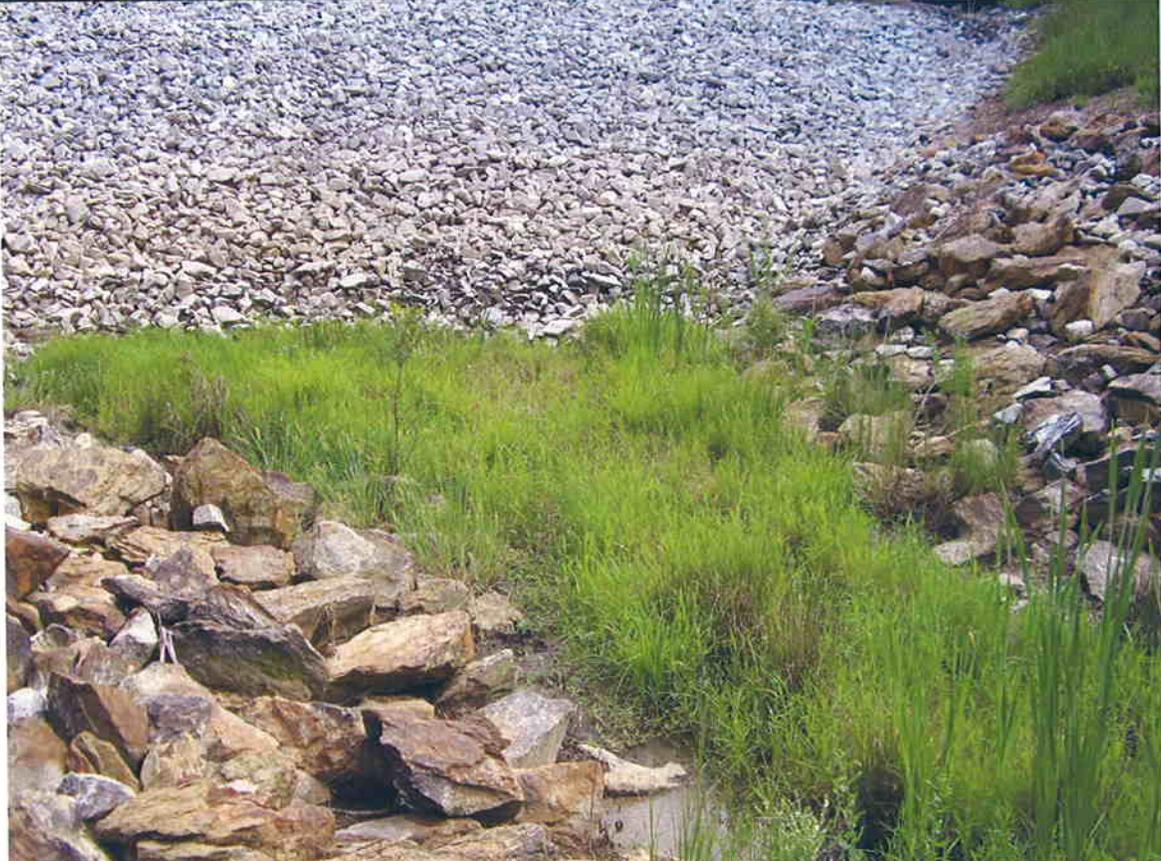
<p>Photograph 4-22</p> <p>As in 2001, seepage emerging from under rip-rap at base of both left and right banks near upstream end of channel shown in Photographs 4-20 and 4-21. Note high grass in bottom of channel.</p>
	Remarks

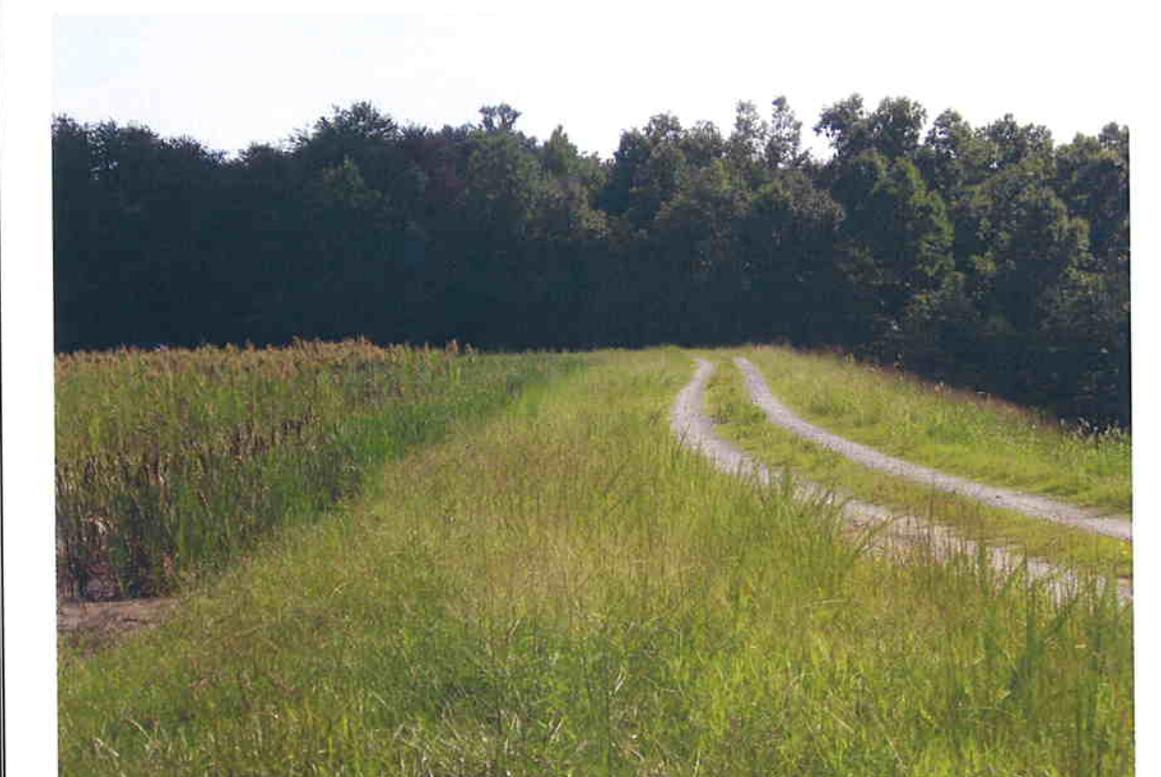
<p>Photograph 4-23</p> <p>Crest of Suck Creek upstream dike (NE to SW view). High grass growth obscures the dike side slopes.</p>

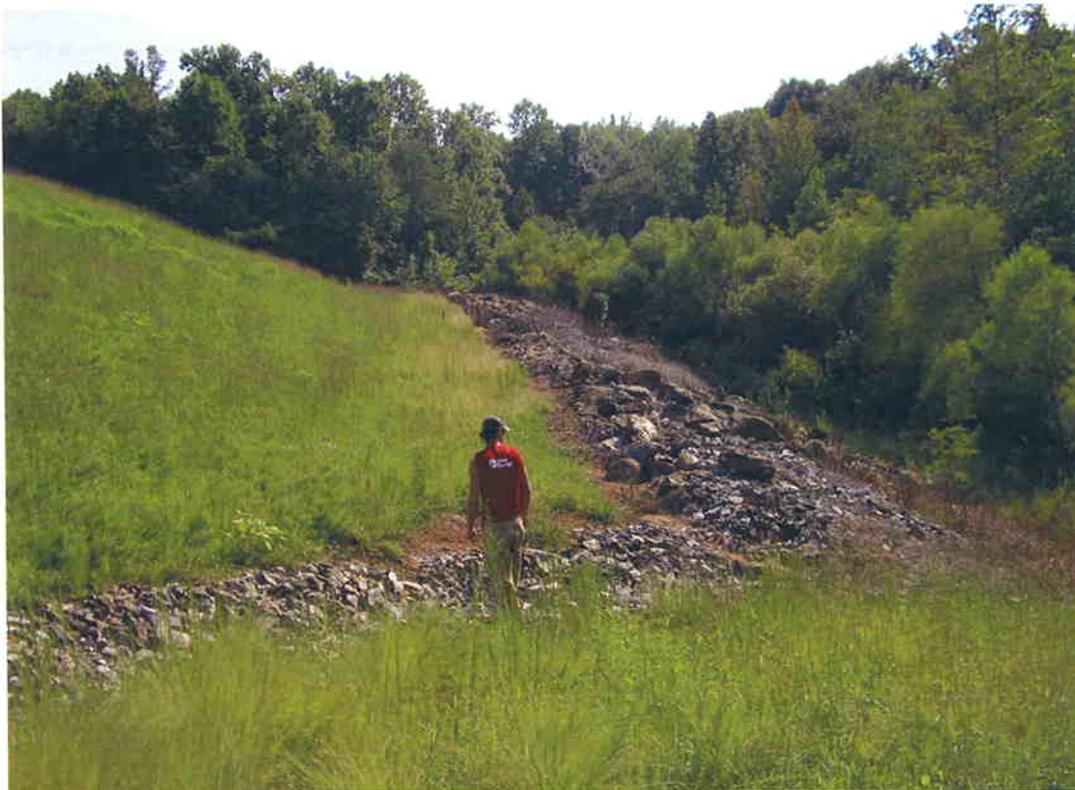
Photograph 4-24
Inside slope of Suck
Creek upstream dike
(SW to NE view).
Slope surface
obscured by high
grass.

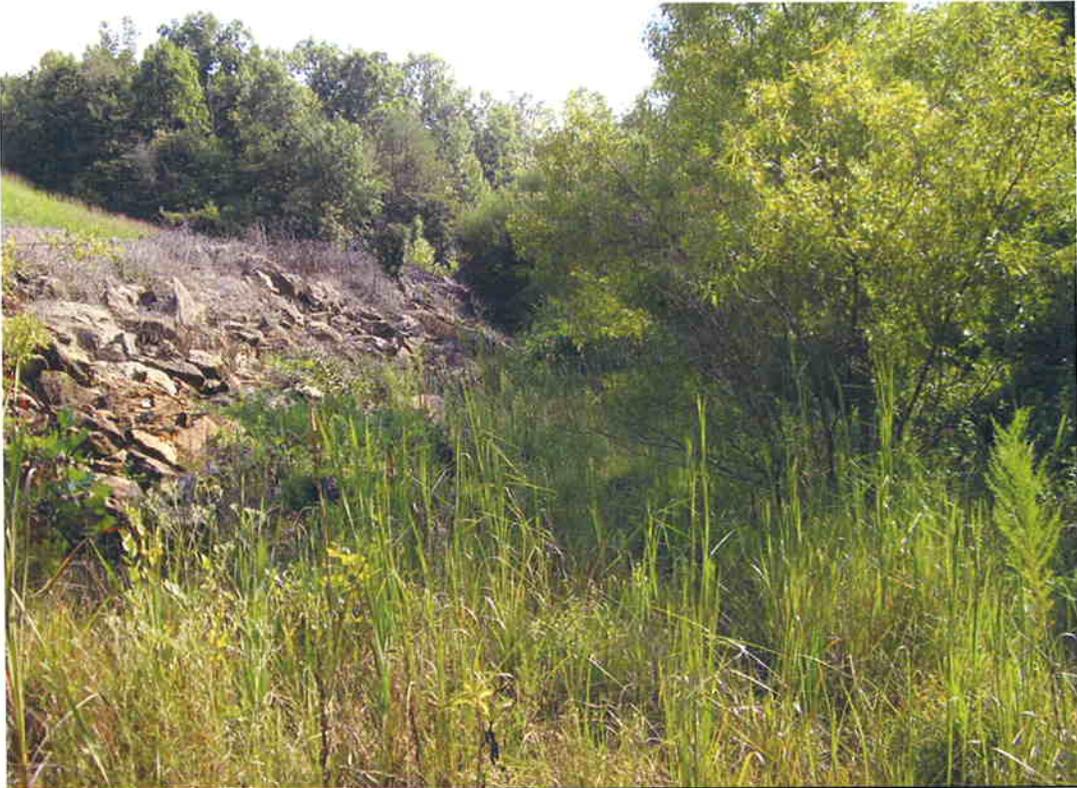
Photograph 4-25
Outside slope of Suck
Creek upstream dike
(NE to SW view).
Area to right of rip-
rap lined ditch was
wet

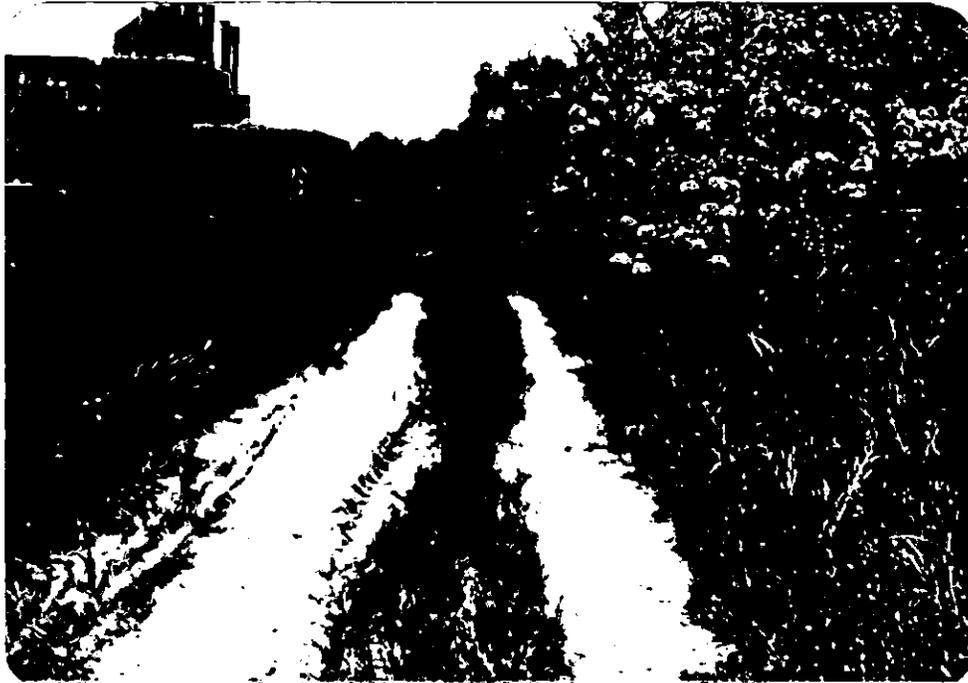
The Units 1-4 old ash retention dike is almost completely overgrown with trees and vegetation. The crest is little more than a rutted trail (Plate 1). The upstream slope and basin area generally are covered with a dense, tall growth of lespedeza grass and weeds (Plate 2), except in the area of the yard drainage holding pond which was nearly empty at the time of inspection (Plate 3). Spoil material from dredging operations at the plant intakes was being pumped into the holding pond, on a temporary basis, at the time of inspection. Mimosa trees (visible in Plates 1, 2 and 3) grow on or overhang much of the dike crest. The downstream slope is heavily overgrown with trees and underbrush, though there is a couple of relatively clear areas (Plate 4). Much of the downstream slope was inaccessible to inspection due to the thick vegetation.

PLATE 1. - CREST OF UNITS 1-4 OLD BASIN DIKE

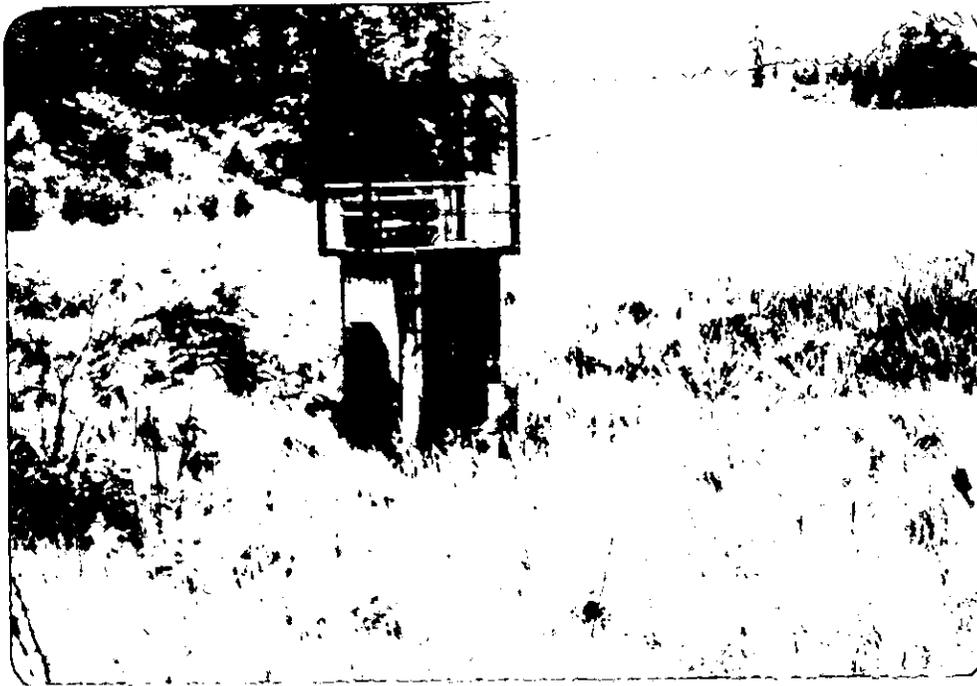
The visible portion of the drainage tower (Plate 7) and the outlet end of the 30-inch diameter corrugated metal bottom discharge pipe (Plate 8) appear to be in fair condition. No seepage, drop-outs or erosion were seen in the embankment over the pipe. There was a small trickle of water flowing from the end of the pipe at the time of inspection.

PLATE 7. - VIEW OF UNITS 1-4 OLD ASH BASIN DRAINAGE TOWER

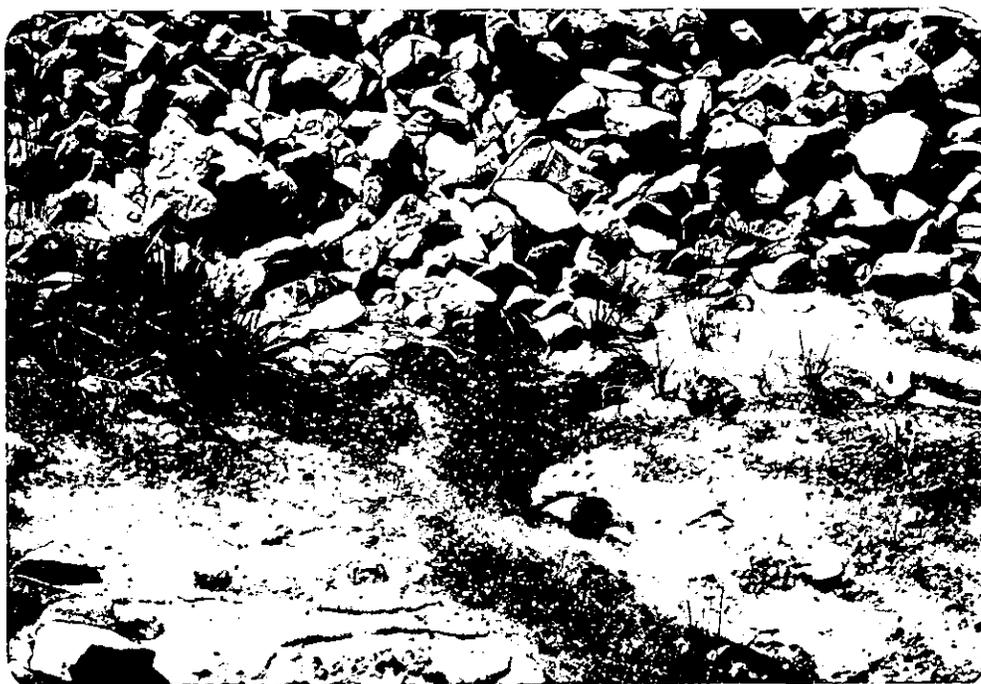
PLATE 20. - CLEAR SEEPAGE FLOW FROM DOWNSTREAM TOE OF SUCK CREEK
DOWNSTREAM DIKE

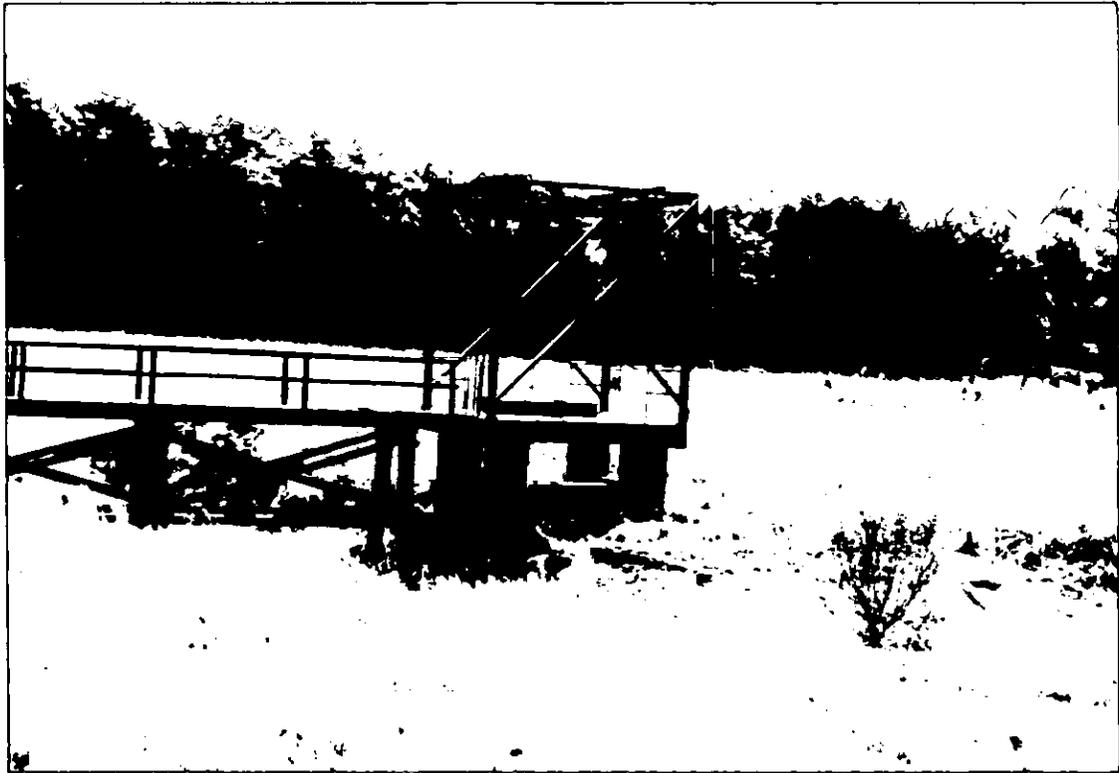
The visible part of the Unit 5 retired ash basin drainage tower is shown in Photo 4-13; the structure was observed to be in good condition. The outlet end of the 60-inch diameter RCP outlet is shown in Photo 4-14. There appeared to be some spalling along the invert of the pipe, but otherwise the pipe was in good visual condition.

PHOTO 4-13 View of Unit 5 Retired Ash Basin Drainage Tower

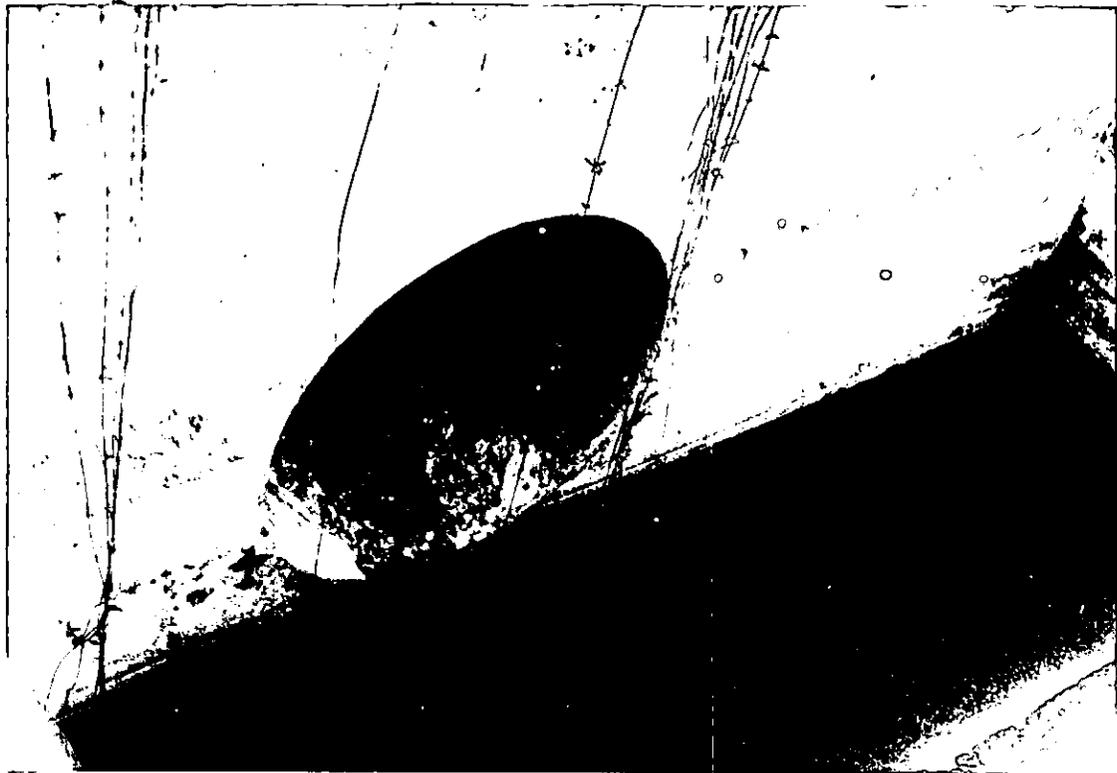
PHOTO 4-14 Outlet End of 60-Inch RCP Outlet for Unit 5 Retired Ash Basin

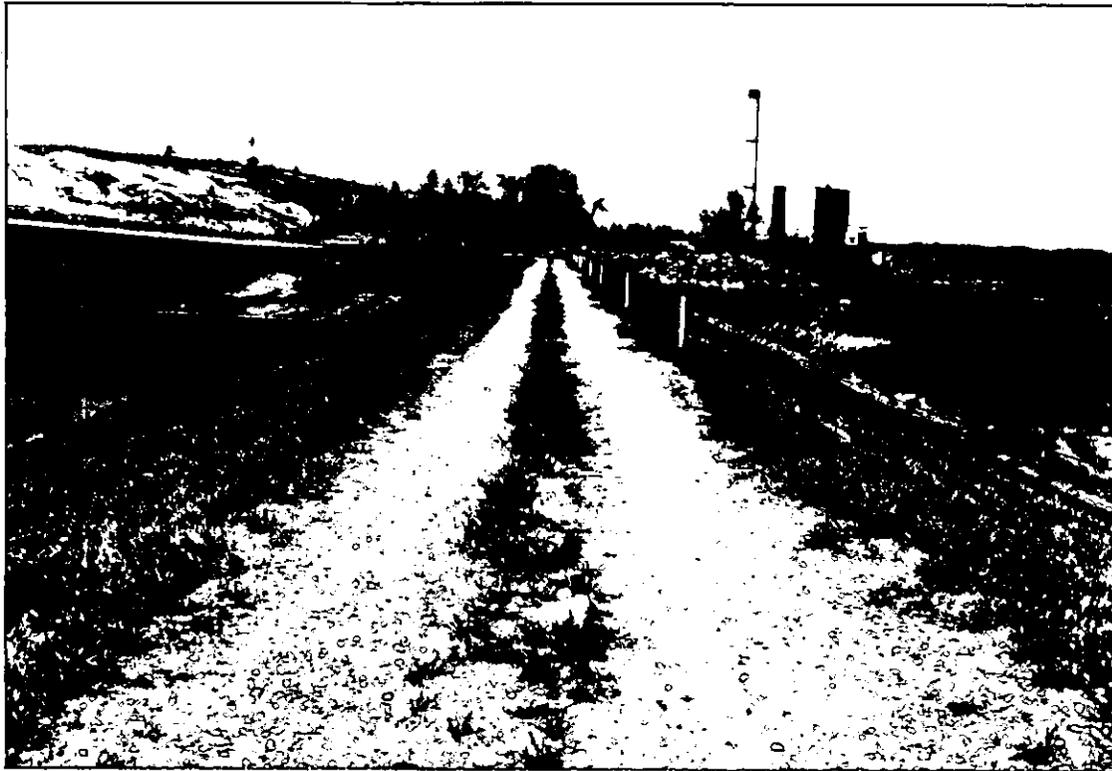
The crest of the downstream dike of the Suck Creek ash basin was observed to be in good condition with no visible tension cracks, major depressions, sags or other signs of shear failure or excessive settlement; a view of the crest is shown in Photo 4-15.

PHOTO 4-15 Crest of Suck Creek Downstream Dike (E to W View)

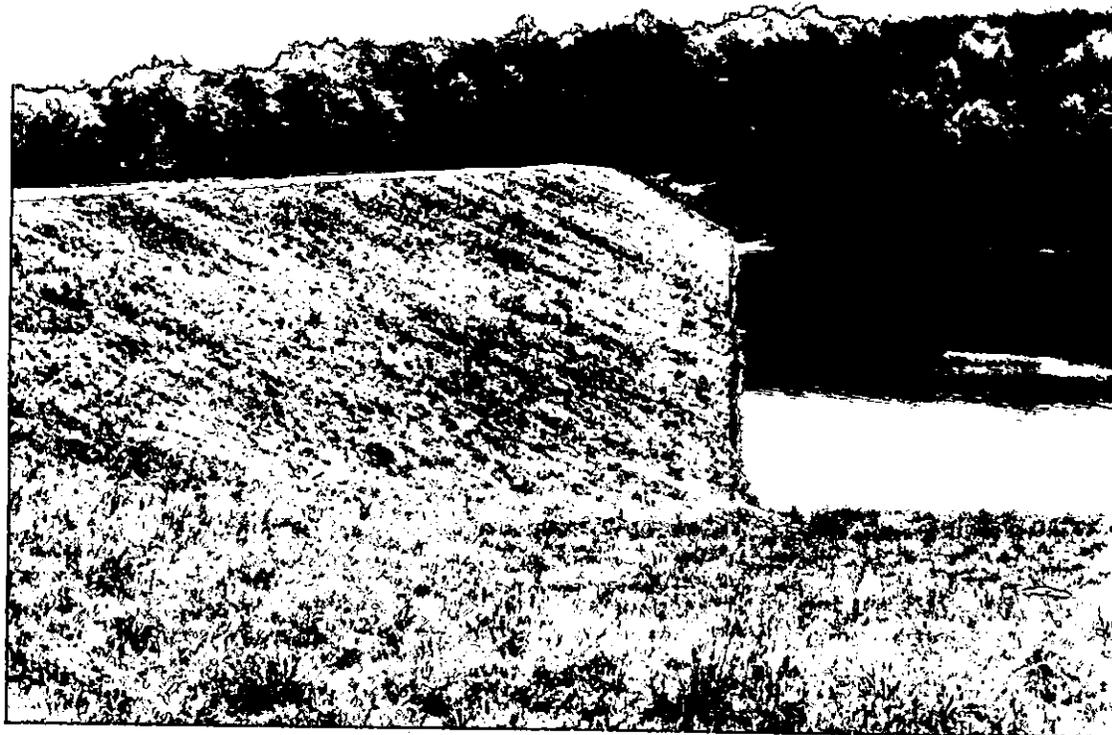
The inside slope of the downstream dike was observed to be in good condition with a well maintained grass cover as shown in Photo 4-16. There were no signs of shear failure or major erosion on this slope. The riprapped-lined intercept ditches at the abutment contacts were in good visual condition.

PHOTO 4-16 Inside Slope of Suck Creek Downstream Dike
(W to E View)

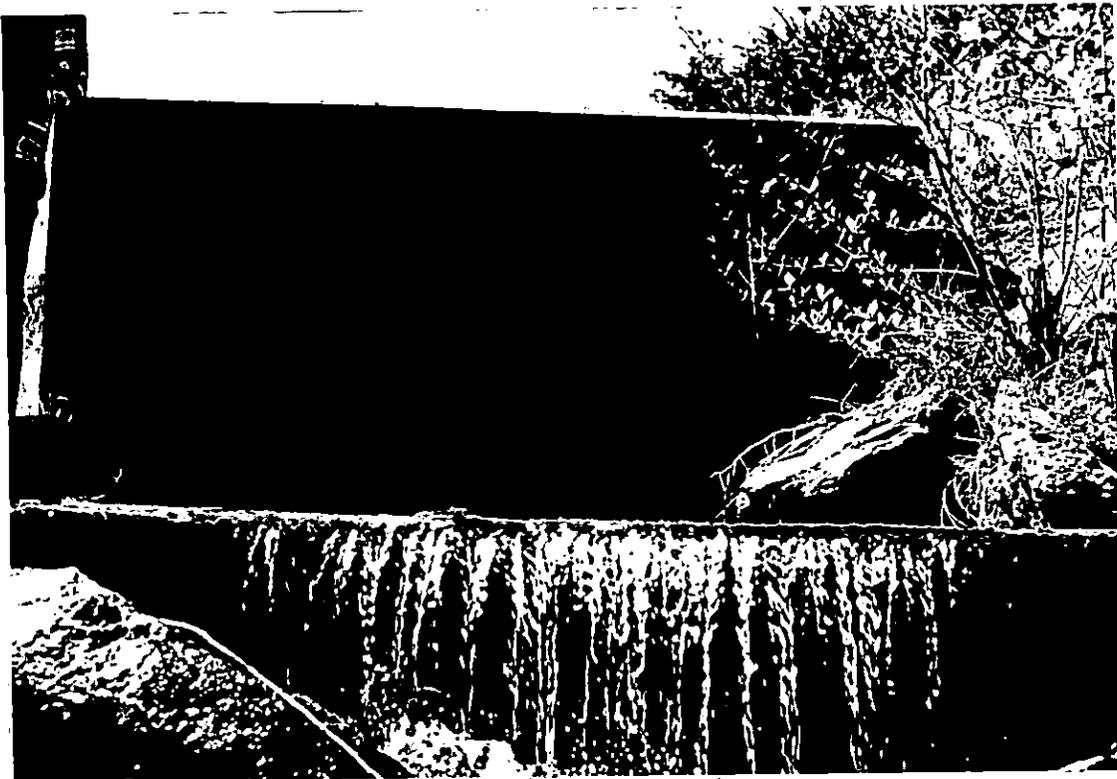
The visible part of the drainage tower is shown in Photo 4-29, and the outlet end of the 42-inch diameter reinforced concrete bottom discharge pipe is shown in Photo 4-30. These structures were observed to be in good condition. Discharge from the pipe was clear, and no dropouts or sinkholes were observed in the soils over the buried outlet pipe. No seepage was observed around the outside of the pipe at the outlet end.

PHOTO 4-29 View of Suck Creek Ash Basin Drainage Tower
