Re: Task 3 Dam Assessment Report  
Project #0-381  
Allen Steam Station Coal Ash Retention Dam  
Belmont, North Carolina

**FINAL REPORT**

This Phase I Inspection/Evaluation Report presents the results of a visual dam inspection of the Allen Steam Station Coal Active Ash Basin North and East Dikes located off State Highway 273 in Belmont, North Carolina. The inspection was performed on June 11 and June 12, 2009 by representatives of GZA GeoEnvironmental, Inc (GZA).

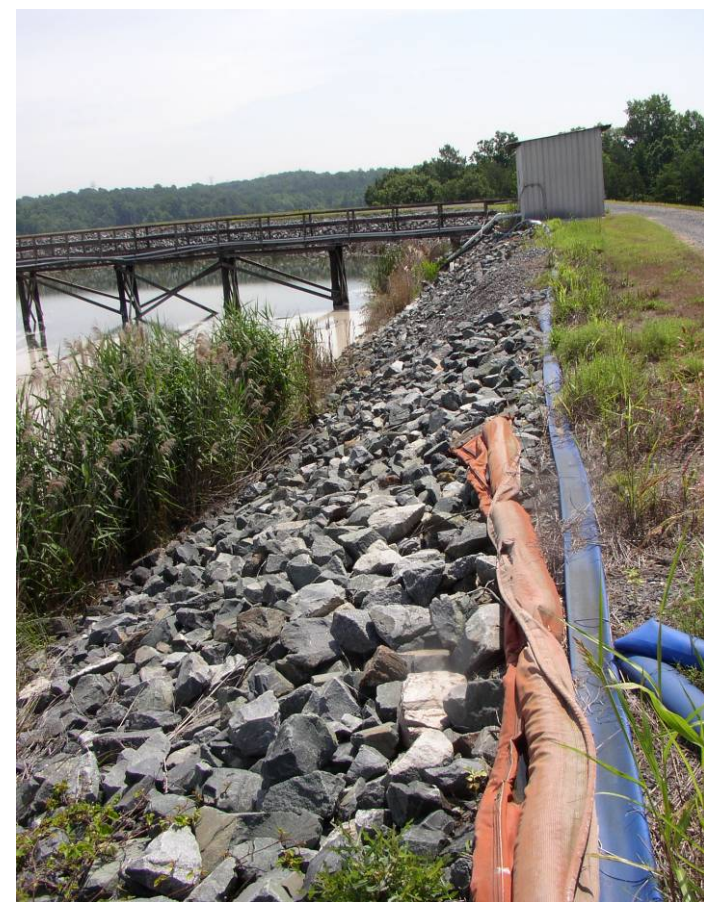
#3 Upstream Slope & Bridge to Drop Inlet Structure

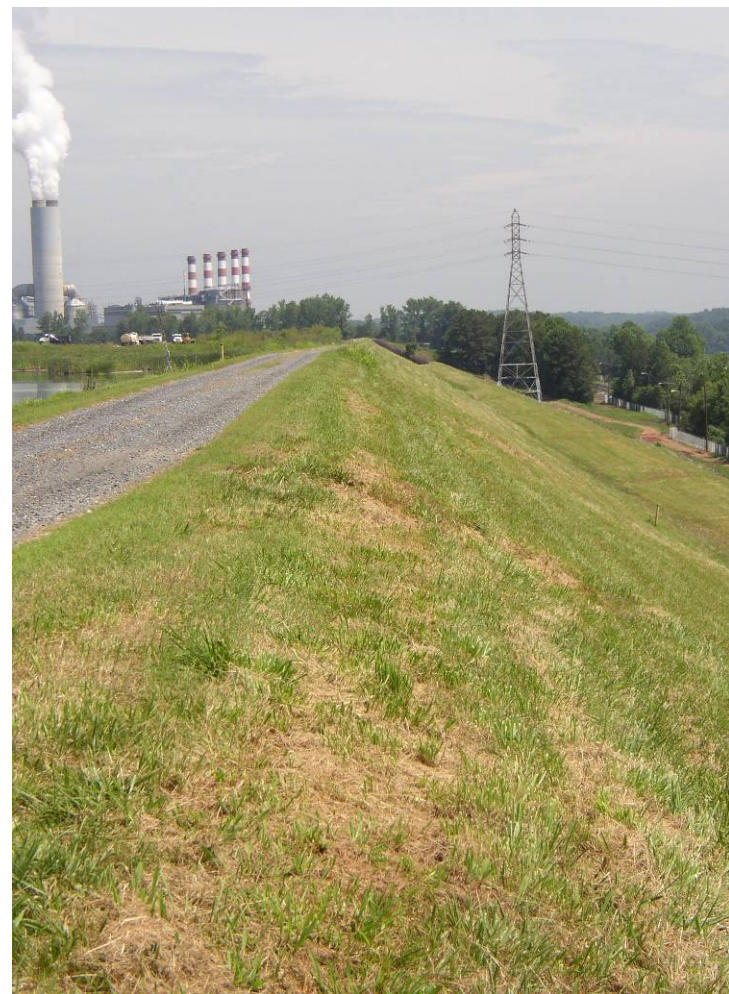
**#6 Crest & Downstream Slope of East Dike**

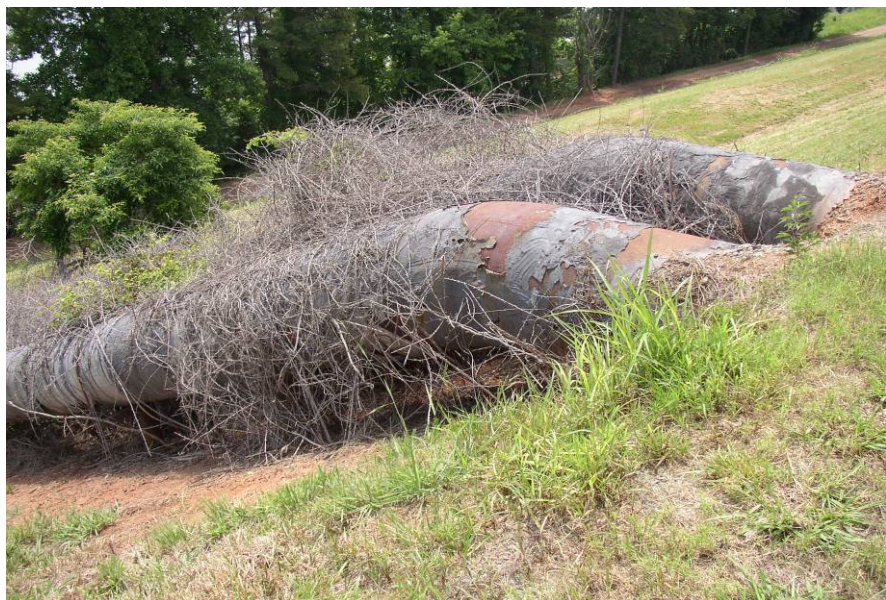
#16 Wastewater Sump Discharge Pipes @ Cell 3

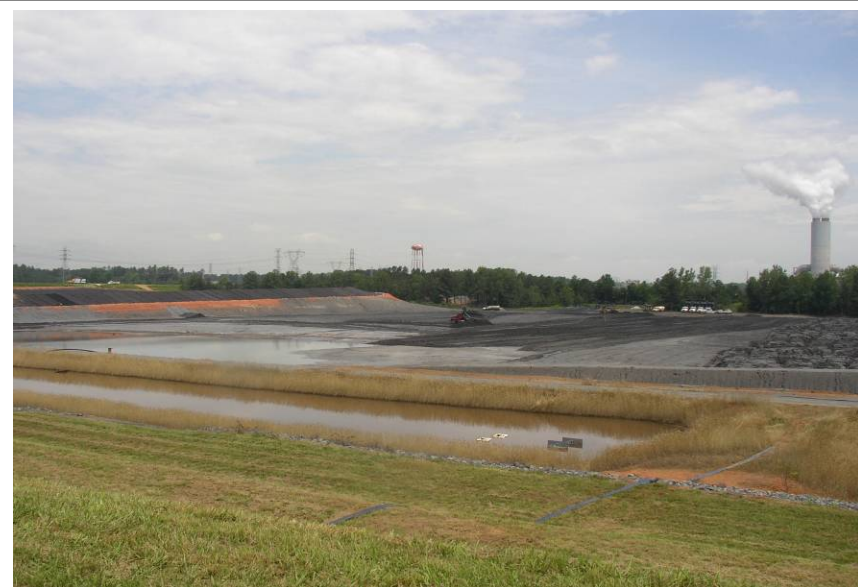
#18 New Ash Landfill Construction

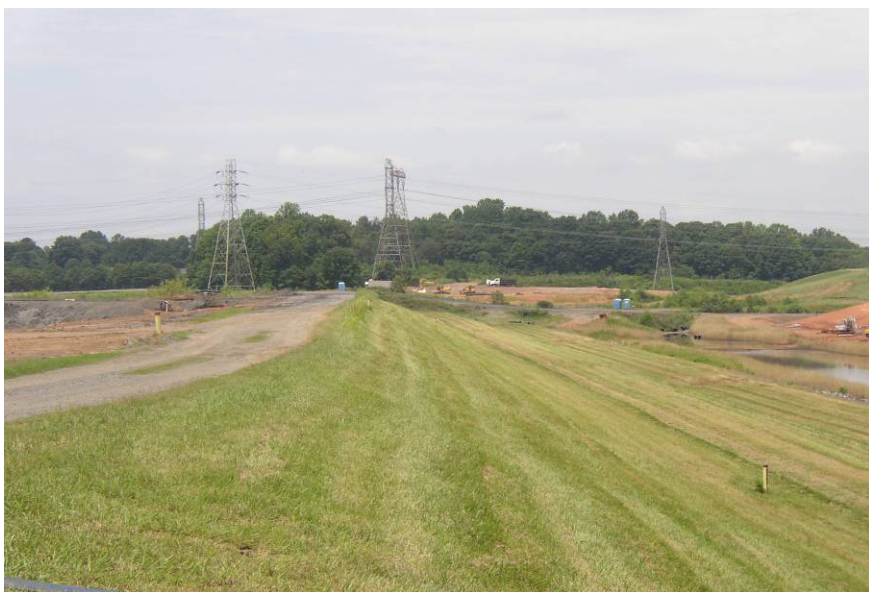
**#20 Overview of Central Portion of North Dike**

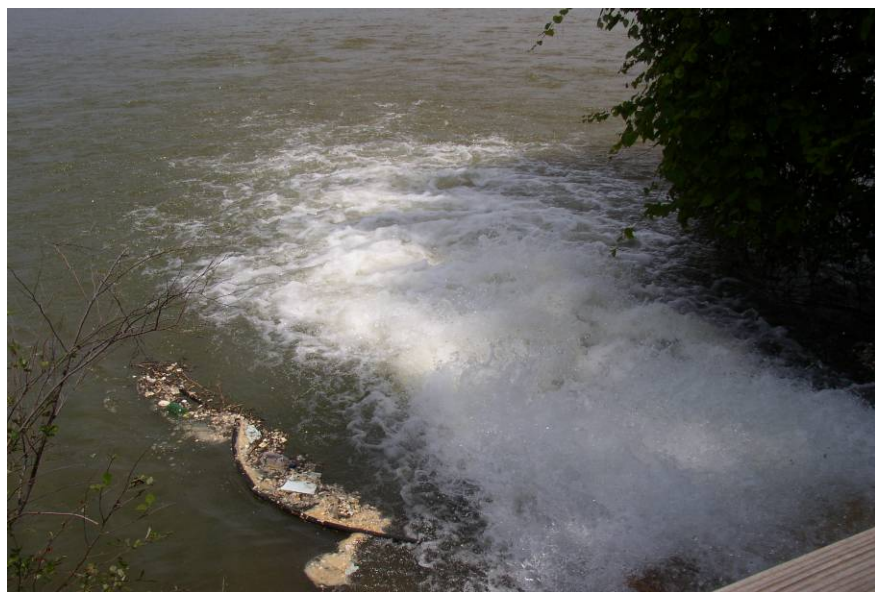
#31 Discharge at Outlet Pipe

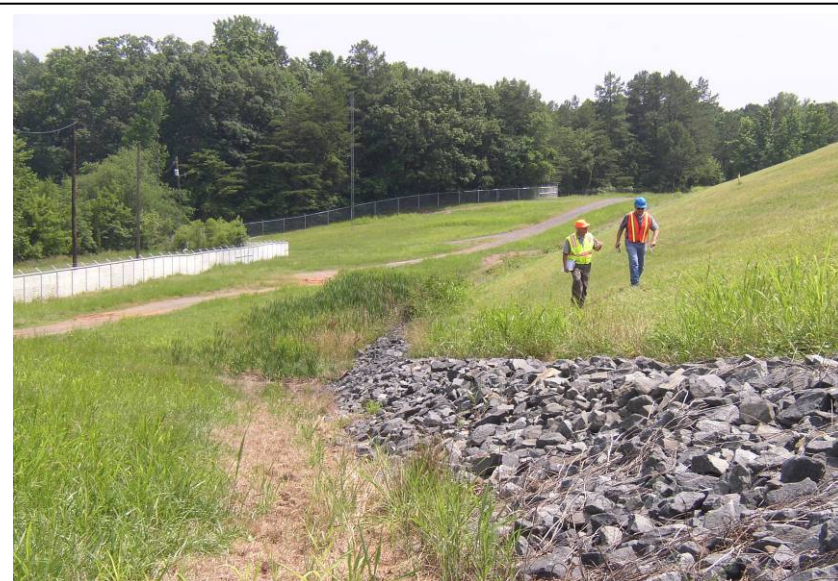
#37 Seepage Area Near Maximum Section of East Dike

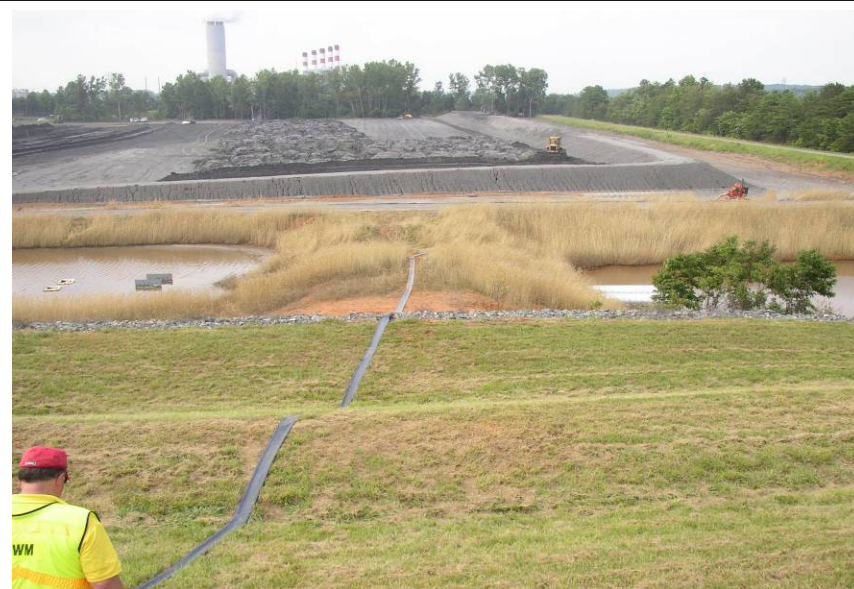
**#43 Stabilizing Berm from Crest**

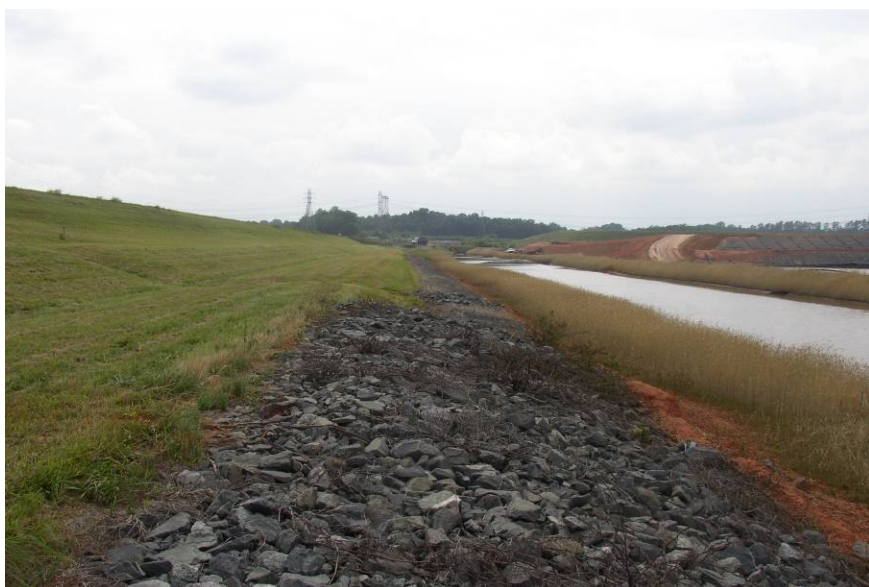
#45 Downstream Toe of North Dike

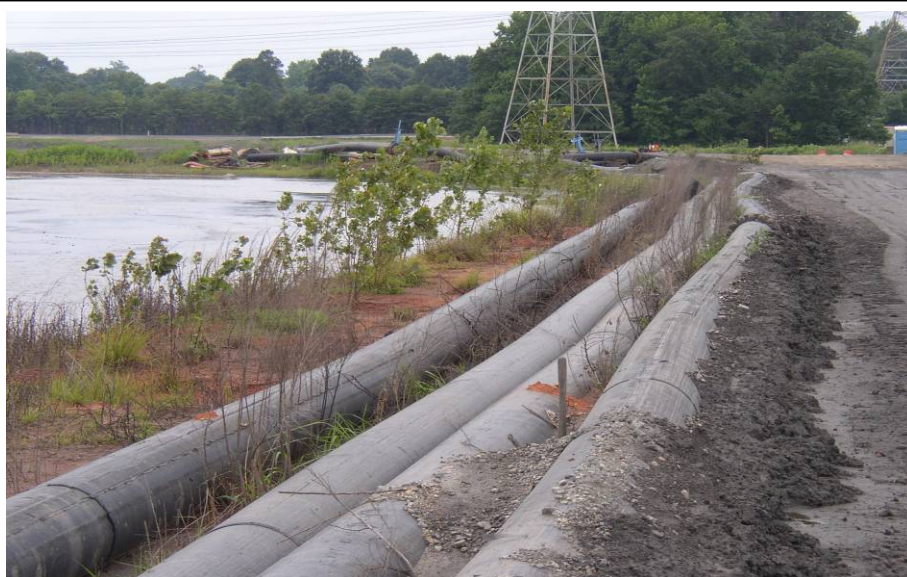
**#50 Pipes Used for Sluicing**

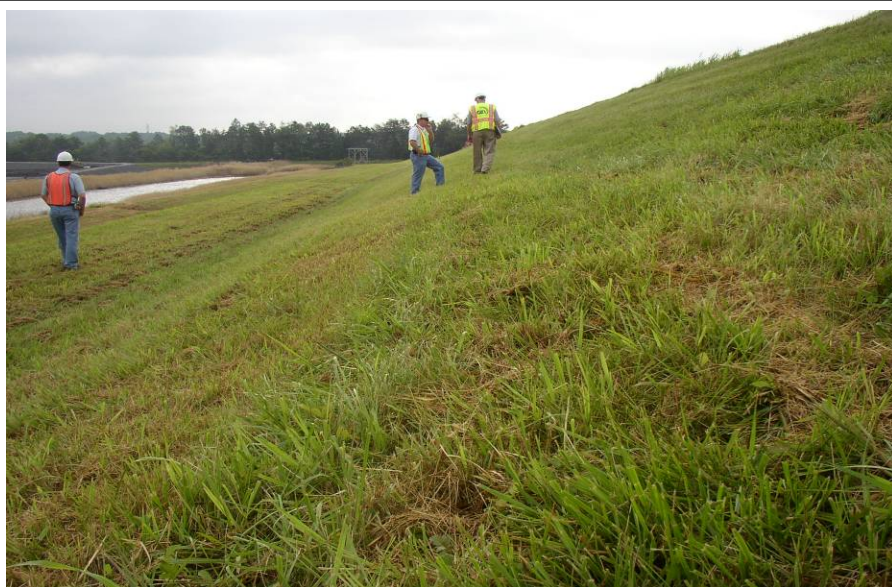
#53 Downstream Slope of North Dike (Central Area)

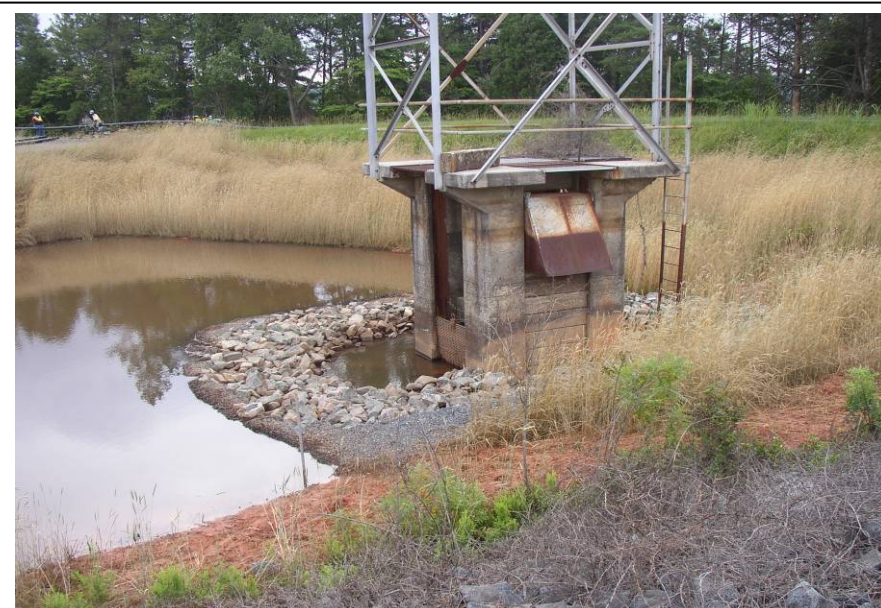
#55 Drop Inlet for Retained Ash Basin

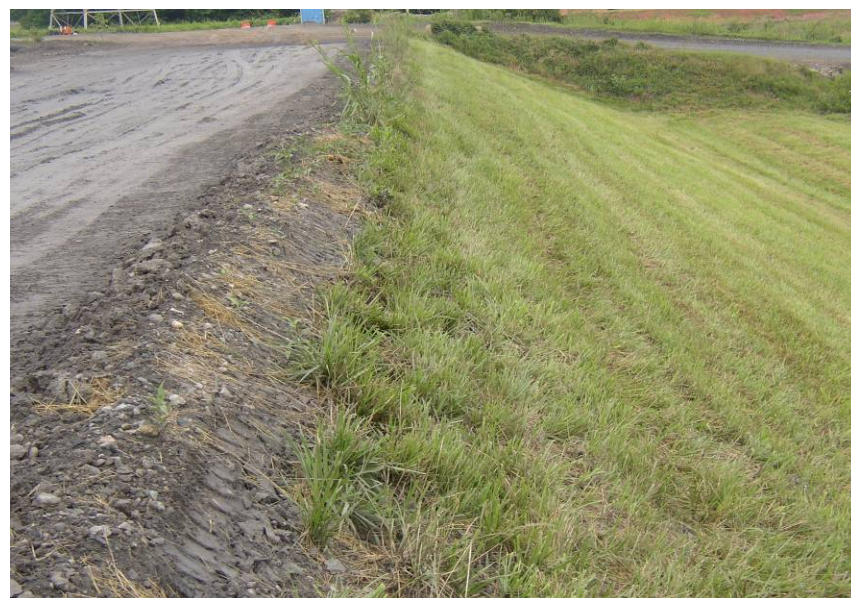
#62 Crest of Western Portion of North Dike

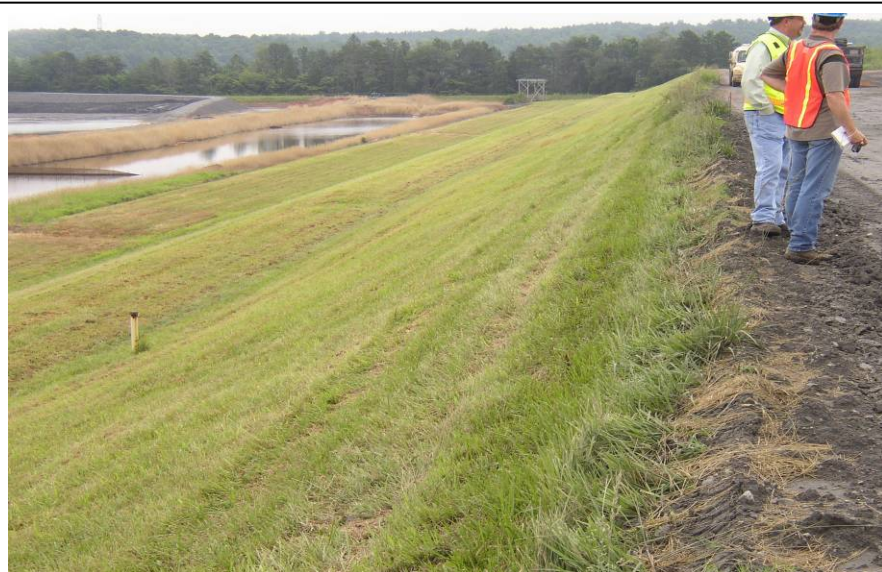
#61 Overview of Central Portion of North Dike

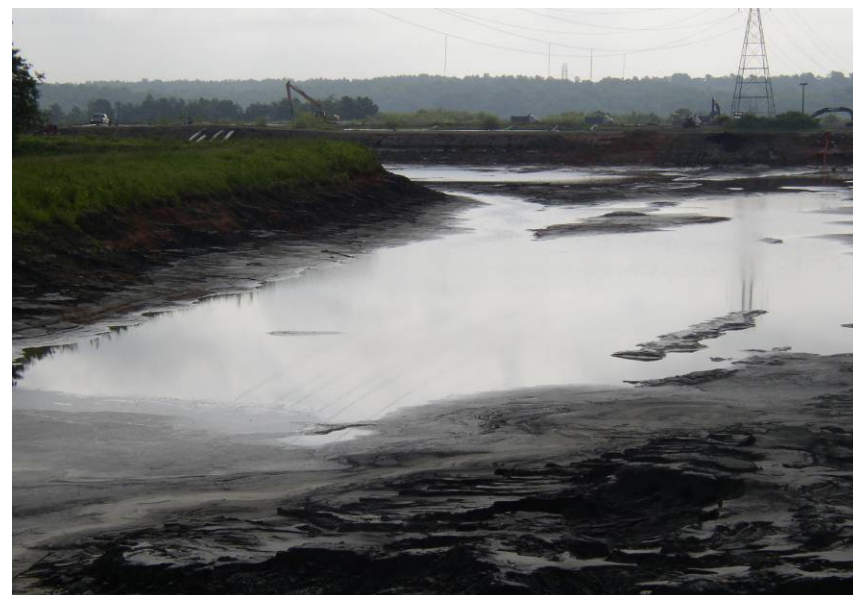
#74 Excavated Ash & Pool Elev. 635 in Cell 1
