# Assessment of Dam Safety

## Coal Combustion Surface Impoundments (Task 3)

Duke Energy  
Buck Steam Station  
Spencer, North Carolina

September 14, 2009

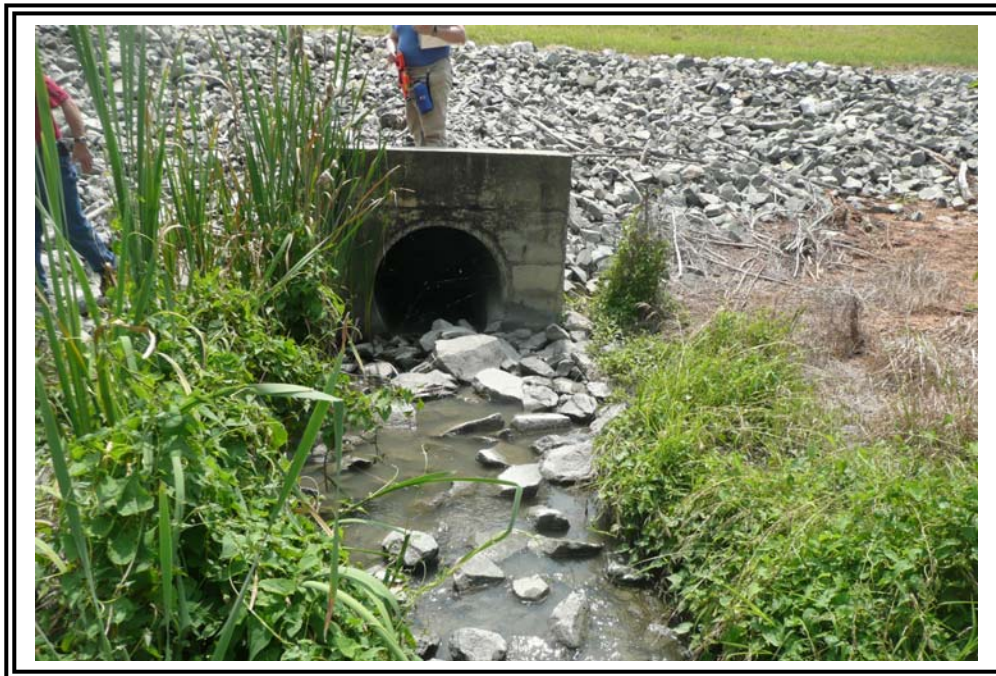
Photos 26 and 27 show the downstream end of the outlet pipe, and the discharge channel between the outlet pipe and Basin 2. Seepage was noted adjacent to the downstream end of the outlet pipe headwall. This seepage flow appeared clear at the time of the site visit.

Downstream end of Basin 1 outlet pipe.

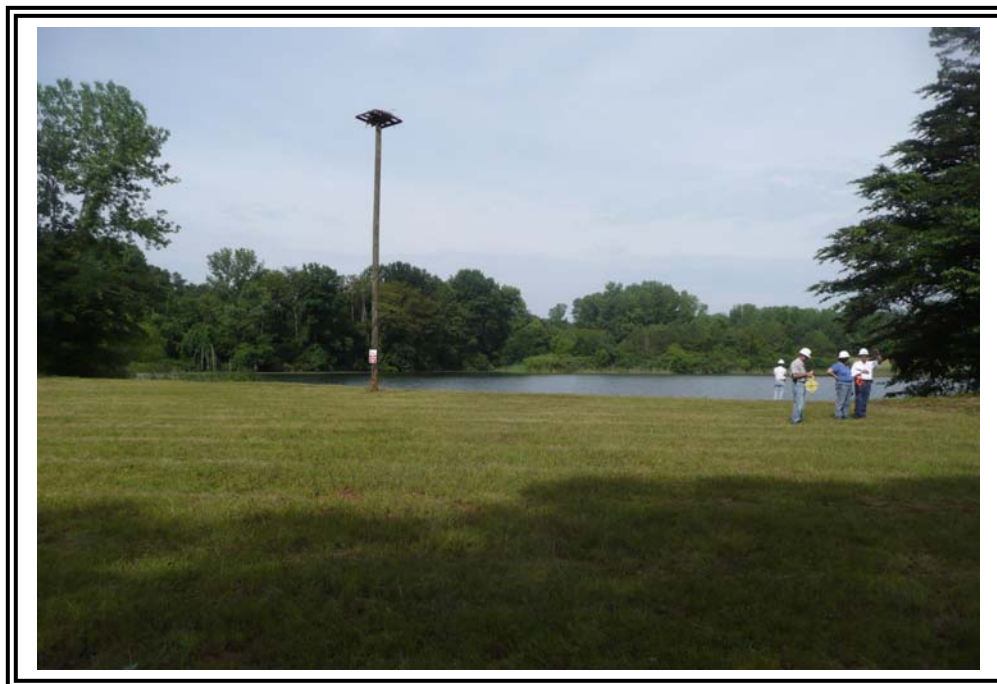
80

Emergency Spillway, looking west at Basin 3.
