**DRAFT REPORT
ROUND 10 DAM ASSESSMENT - MAY 16, 2011
EME HOMER CITY GENERATION L.P.
HOMER CITY GENERATING STATION
ASH DISPOSAL SITE PONDS, COAL REFUSE SITE PONDS
AND ASH RECYCLE PONDS
HOMER CITY, PENNSYLVANIA**

RE: Assessment of Dam Safety of Coal Combustion Surface Impoundments at the
Homer City Generating Station

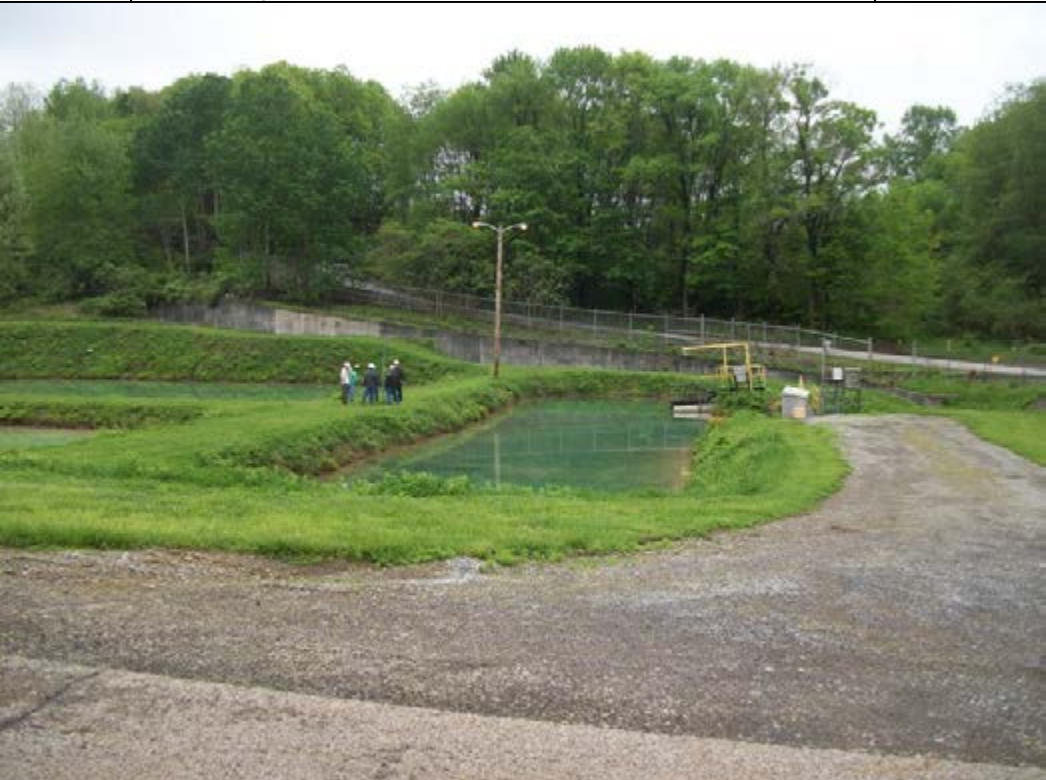
Direction Photo Taken: Easterly			
Description: Overview of Polishing Pond from the right abutment.

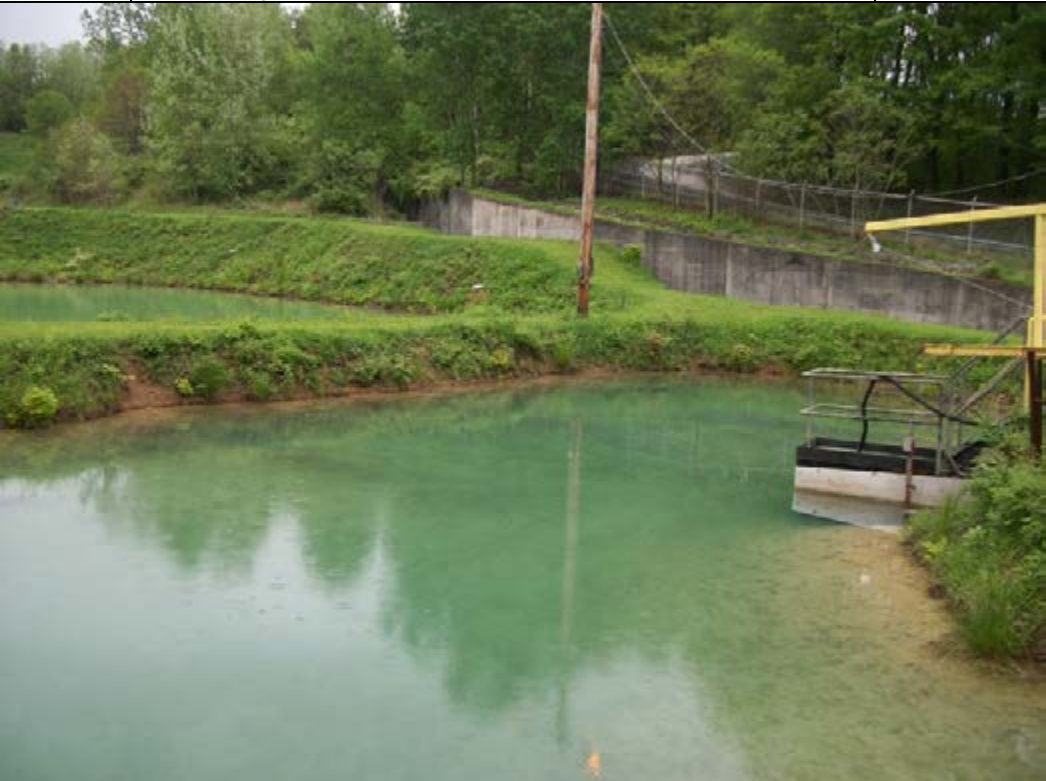
Direction Photo Taken: Northeasterly			
Description: View of erosion, scarps and steep grade at (north) inside slope of Polishing Pond.

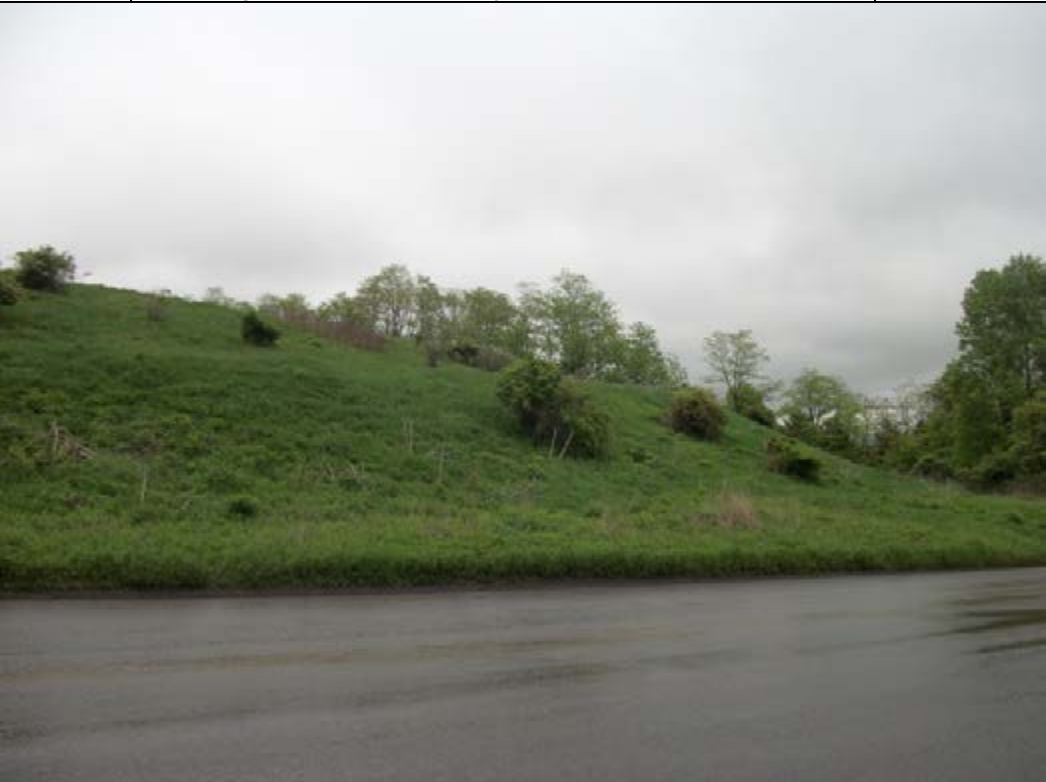
Direction Photo Taken: Northeasterly				
Description: Outside (southern) slope of the Stormwater Surge Pond impoundment. Note shrubs, small trees and high vegetation on slope.				
Photo No. 23	Date: 5/16/2011

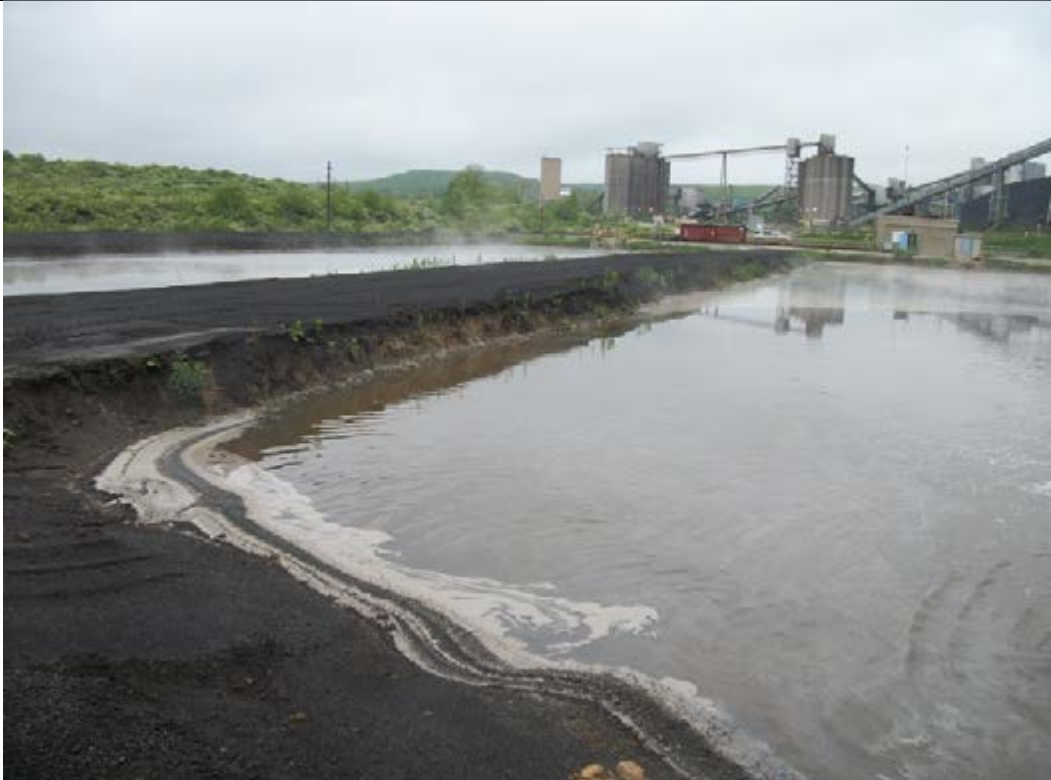
Moderate sloughing and erosion was observed around most of the inside slope above the waterline (Photos 27 and 28). Inside slopes were generally steeper than the two horizontal to one vertical (2H:1V) slopes specified on the original design drawings, and steeper than 1H:1V in localized areas. Light vegetation was observed growing on the inside slopes. The top of the embankment consisted of crushed bottom ash slag and generally appeared to be in satisfactory condition although minor depressions and ruts were also observed.

Direction Photo Taken: Northwesterly			
Description: View of common dike separating Ash Recycle Pond Nos. 1 and 2 from the south side. Note erosion, scarps and over steep slopes (i.e. greater than 2H:1V).

1. Regularly repair sloughs and erosion observed on the embankments. Consideration should be given to providing permanent erosion protection (i.e. revetment matting or similar) as necessary.
2. Clear and grub woody vegetation from outside slope of the western embankments of Ponds 2 and 4 and fill depressions from root balls with compacted sand and gravel. Provide loam as necessary and seed and maintain a healthy grass cover.
3. Re-grade inside and outside slopes of all Ponds as necessary to achieve 2H:1V geometry as specified of the original design drawings. This is best achieved during times when the Ponds are dewatered for cleaning/dredging.
4. Repair railings around wet wells.

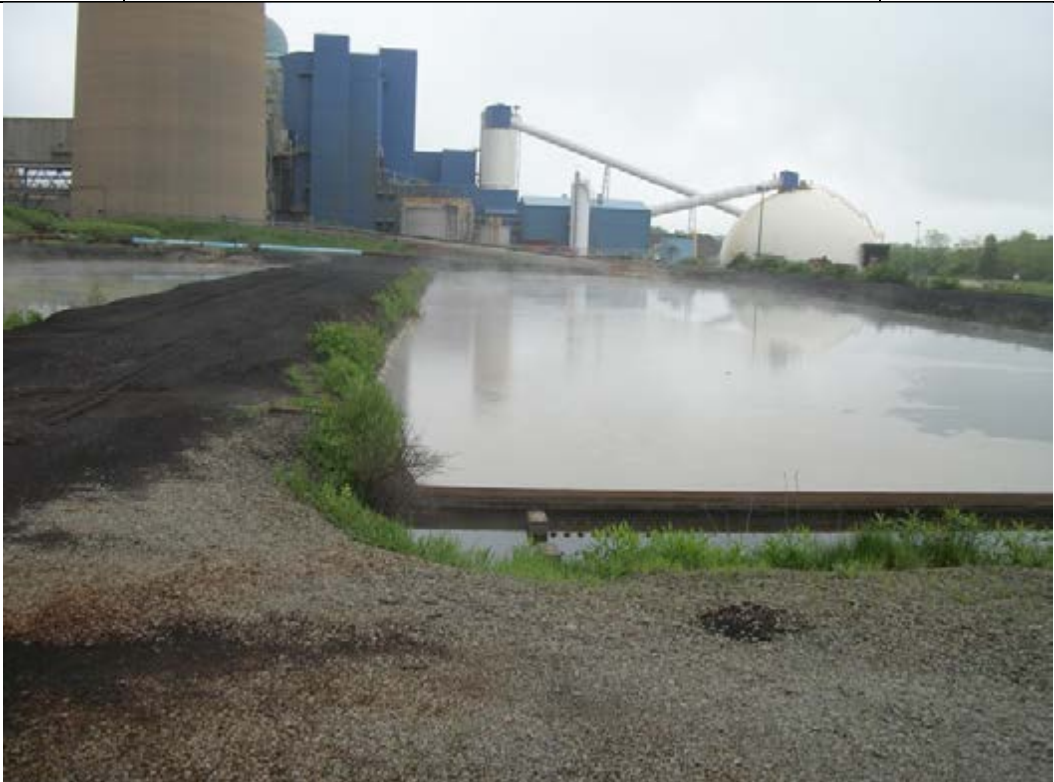
Direction Photo Taken: Southerly			
Description: Overview of Ash Recycle Pond No. 2. Note shared dike separating Ash Recycle Pond Nos. 1 and 2.

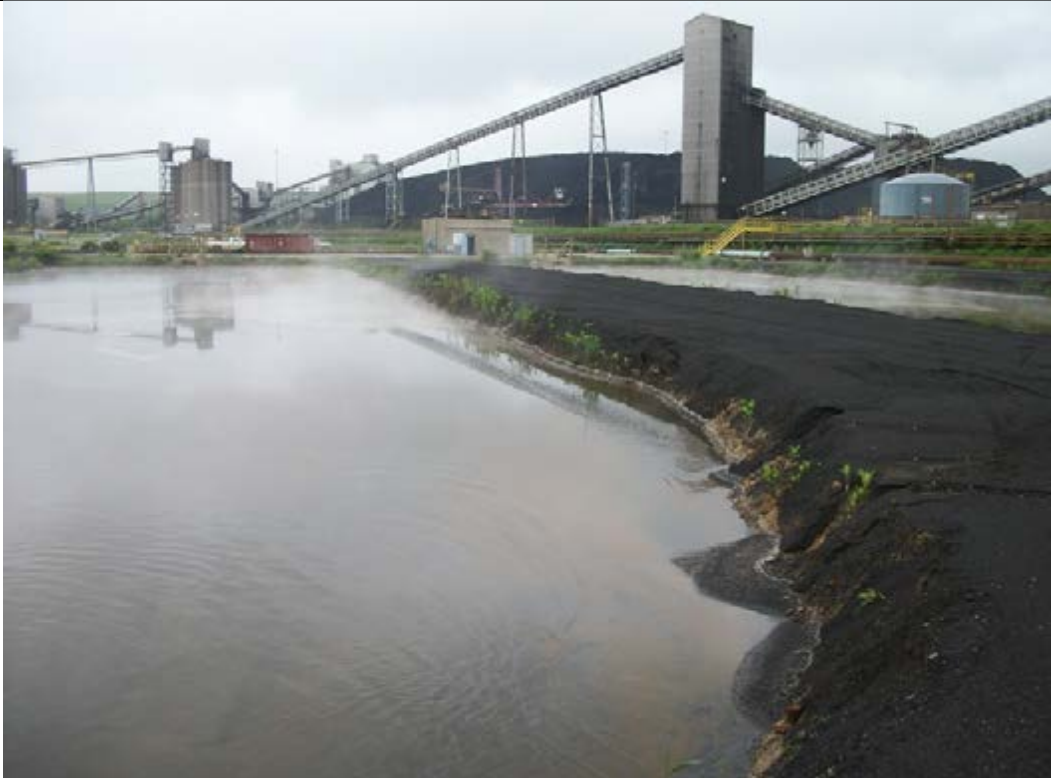
Direction Photo Taken: Northerly			
Description: Overview of Ash Recycle Pond No. 2 from the south end. Note erosion, scarps and steep inside face along the separation common dike separating Ash Recycle Pond Nos. 1 and 2.

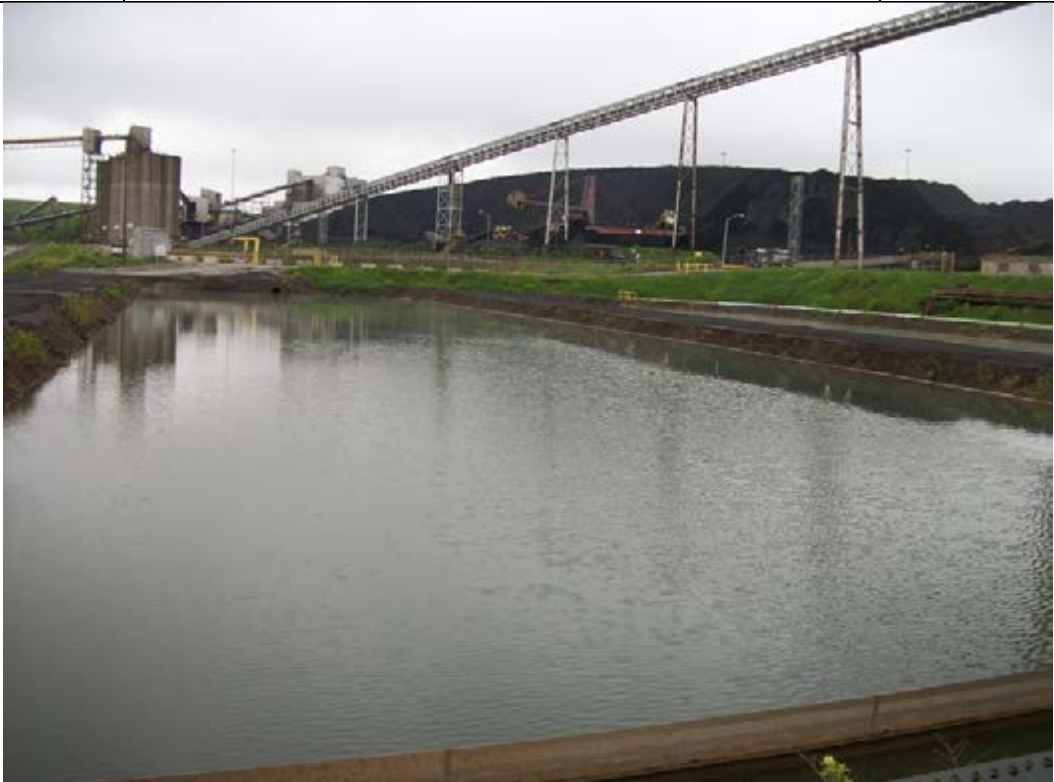
Client Name: U.S. Environmental Protection Agency		Site Location: EME Homer City Station Ash Recycle Ponds, Homer City, PA	Project No. 170142.30
Photo No. 37	Date: 5/16/2011

Direction Photo Taken: Northerly			
Description: Overview of Ash Recycle Pond No. 3 from the south end. Note coal storage pile in background.

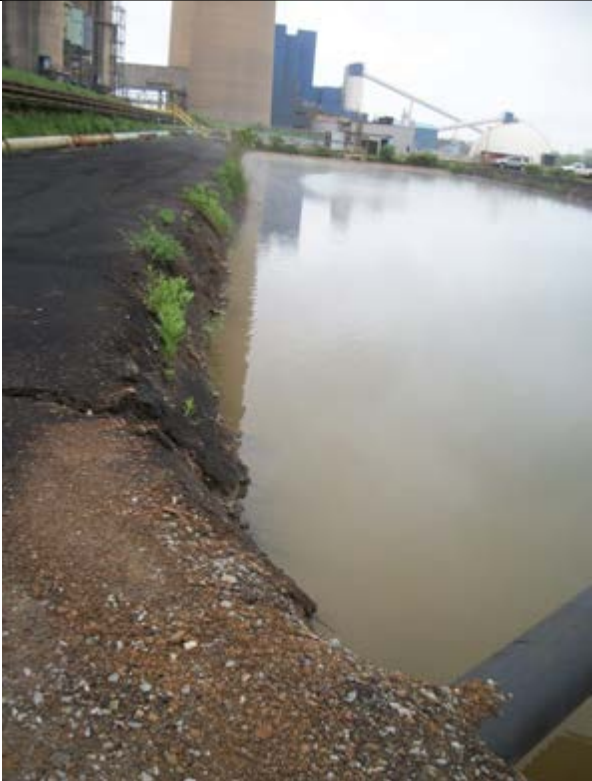
Client Name: U.S. Environmental Protection Agency		Site Location: EME Homer City Station Ash Recycle Ponds, Homer City, PA	Project No. 170142.30
Photo No. 41	Date: 5/16/2011

Ash Recycle Pond No. 3 is located at the northeast quadrant of the four Ponds and generally appeared to be in poor condition. Based on the design drawings, a majority of the Pond, similar to Pond 1, is incised into natural ground. The inside face of the Pond was observed to have moderate erosion, sloughing with slopes locally steeper than 1H:1V (Photos 41 and 42).

Direction Photo Taken: Southerly			
Description: East side of Ash Recycle Pond No. 3 depicting erosion, scarps and near vertical slopes.

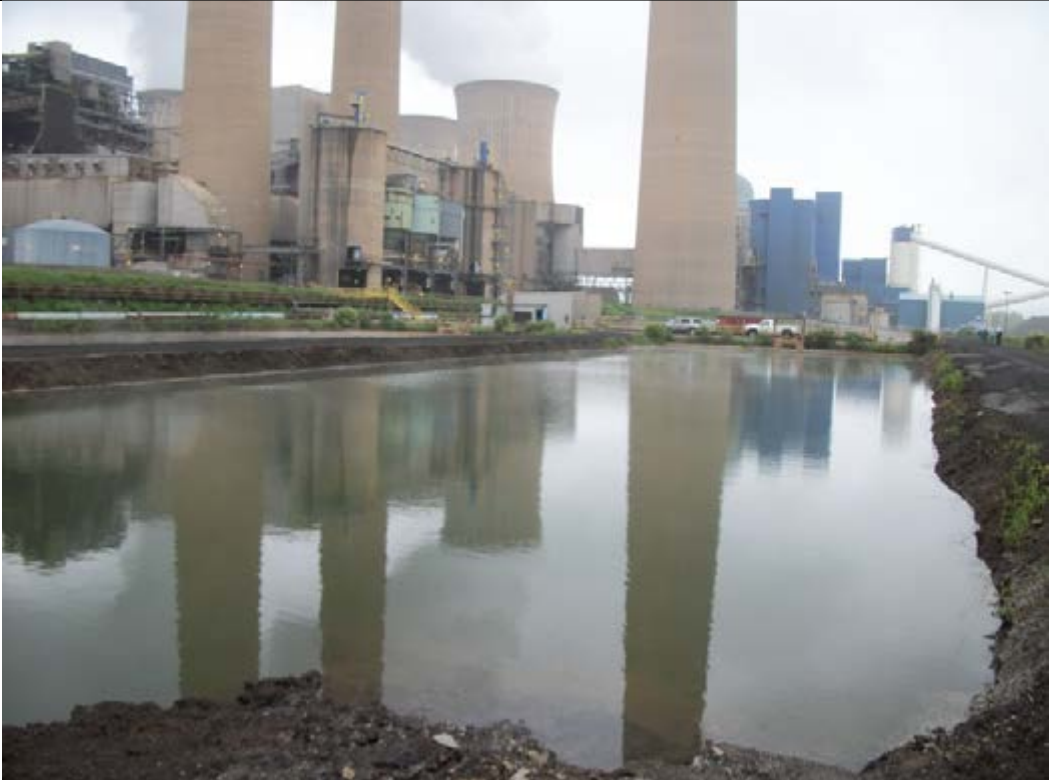
Client Name: U.S. Environmental Protection Agency		Site Location: EME Homer City Station Ash Recycle Ponds, Homer City, PA	Project No. 170142.30
Photo No. 43	Date: 5/16/2011

Direction Photo Taken: Southeasterly			
Description: Overview of Ash Recycle Pond No. 4 from the northwest side.

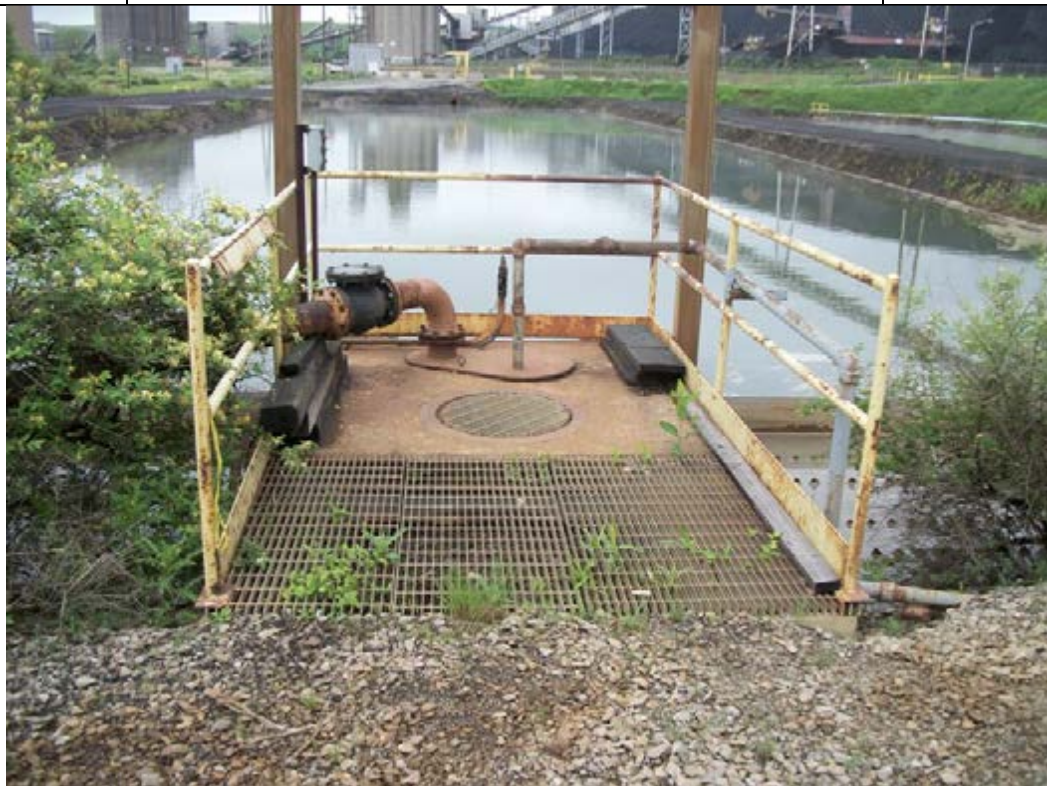
Close-up of intake/weir structure at the south end of Ash Recycle Pond No. 4.

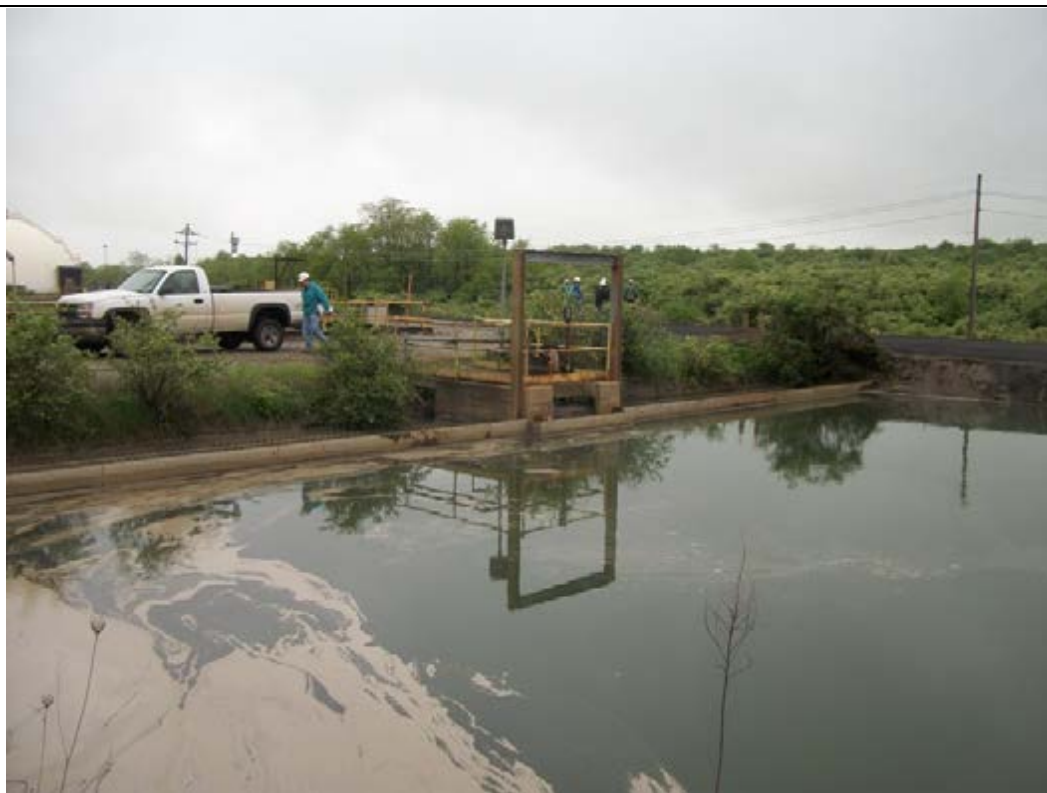
Overview of skimmer and intake/weir structure at the south end of Ash Recycle Pond No. 4.

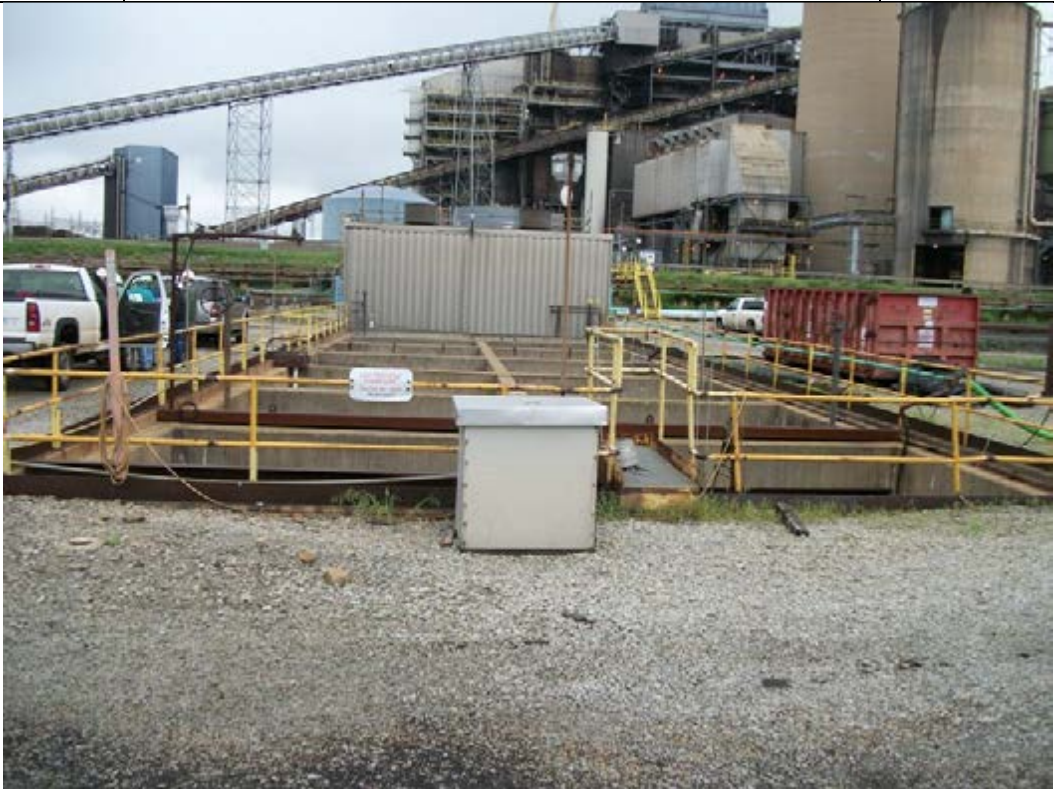
Client Name: U.S. Environmental Protection Agency		Site Location: EME Homer City Station Ash Recycle Ponds, Homer City, PA	Project No. 170142.30
Photo No. 51	Date: 5/16/2011

Direction Photo Taken: Easterly			
Description: Overview of the Pump House overflow treatment basin located in the middle area between the ends of the Ash Recycle Ponds.

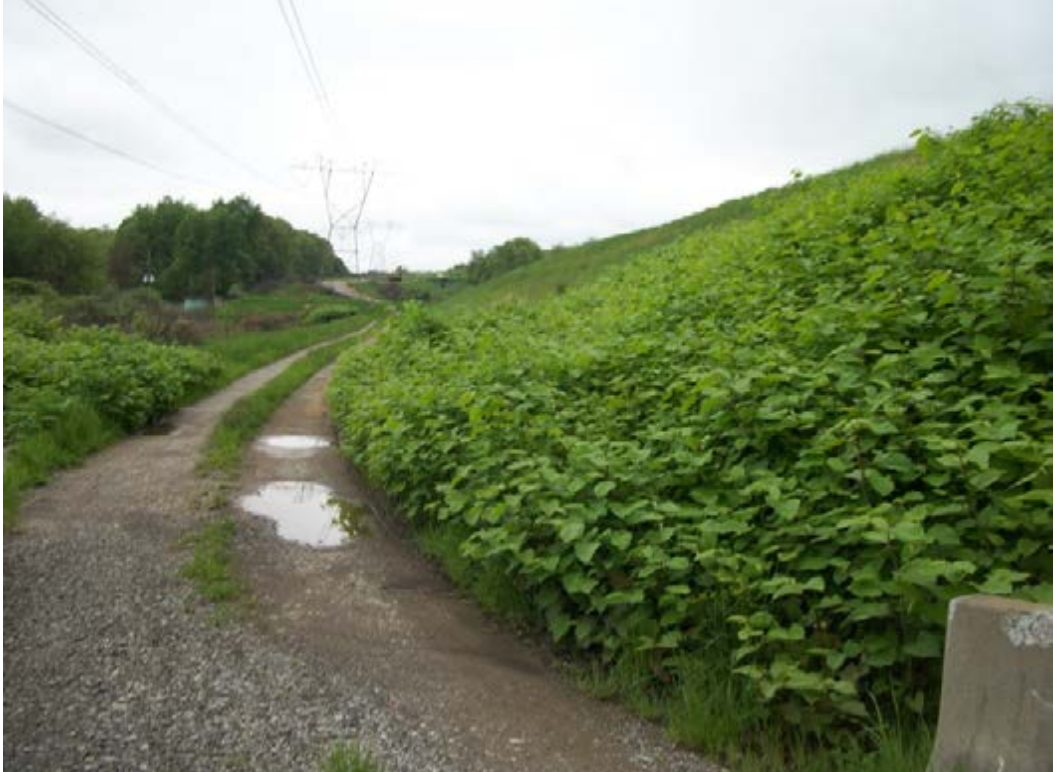
Photo No. 60	Date: 5/16/2011

Direction Photo Taken: Northwesterly		
Description: Western embankment as viewed from the south. Presence of high/overgrown vegetation precluded close visual inspection of slope. Annual mowing normally takes place in June.

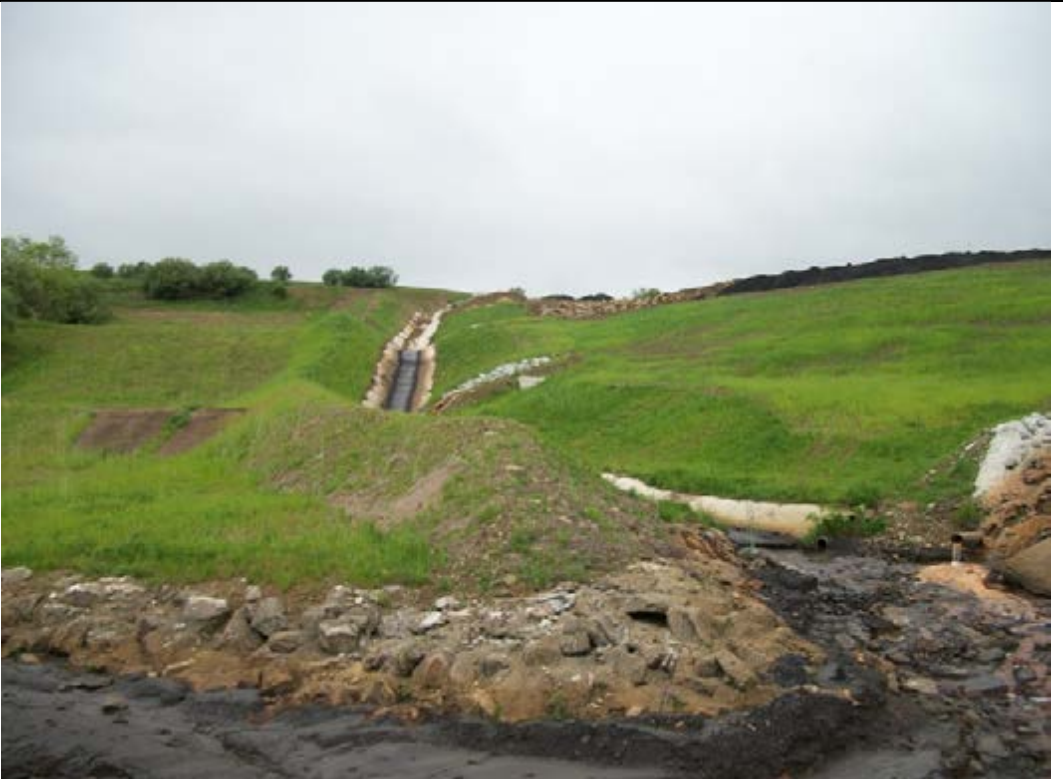
Client Name: U.S. Environmental Protection Agency		Site Location: ENE Homer City Station Stage I/II Sedimentation Pond (Coal Refuse Site), Homer City, PA	Project No. 170142.30
Photo No. 65	Date: 5/16/2011

Direction Photo Taken: Easterly			
Description: Concrete revetment-lined drainage swale which routes surface water runoff and drainage from the Coal Refuse Site to the northeastern corner of the Stage I/II Sedimentation Pond..

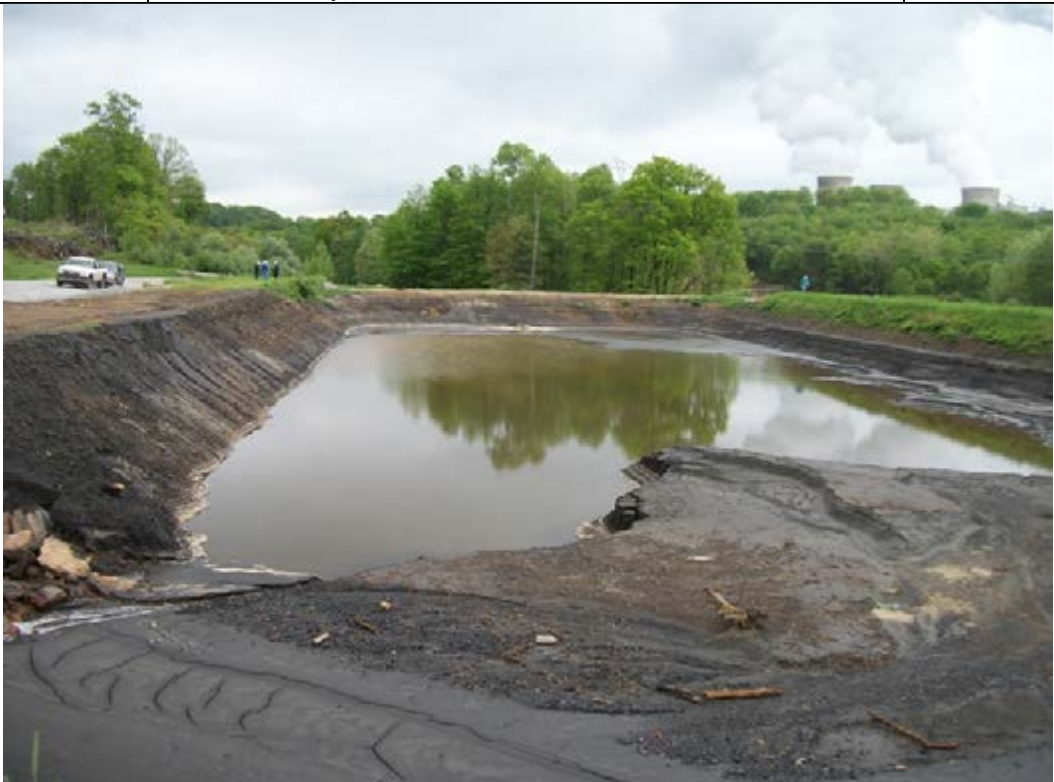
Client Name: U.S. Environmental Protection Agency		Site Location: ENE Homer City Station Stage I/II Sedimentation Pond (Coal Refuse Site), Homer City, PA	Project No. 170142.30
Photo No. 67	Date: 5/16/2011

Direction Photo Taken: Southeasterly			
Description: Overview of impoundment as viewed from near the northeastern corner of the embankment. Note Emergency Spillway at the (far) southern end.

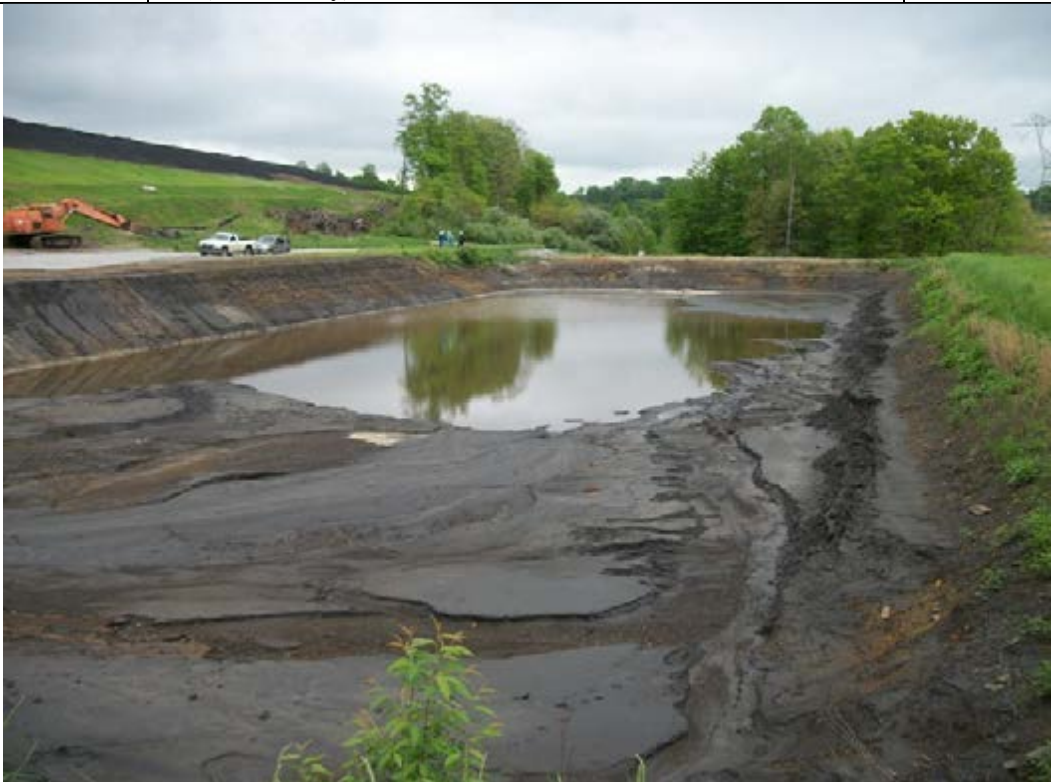
Client Name: U.S. Environmental Protection Agency		Site Location: ENE Homer City Station Stage I/II Sedimentation Pond (Coal Refuse Site), Homer City, PA	Project No. 170142.30
Photo No. 69	Date: 5/16/2011

Direction Photo Taken: Easterly			
Description: Overview of impoundment from the northwestern corner of the impoundment. Note left side of photo depicts the nature of the impoundment's incised/side hill construction.

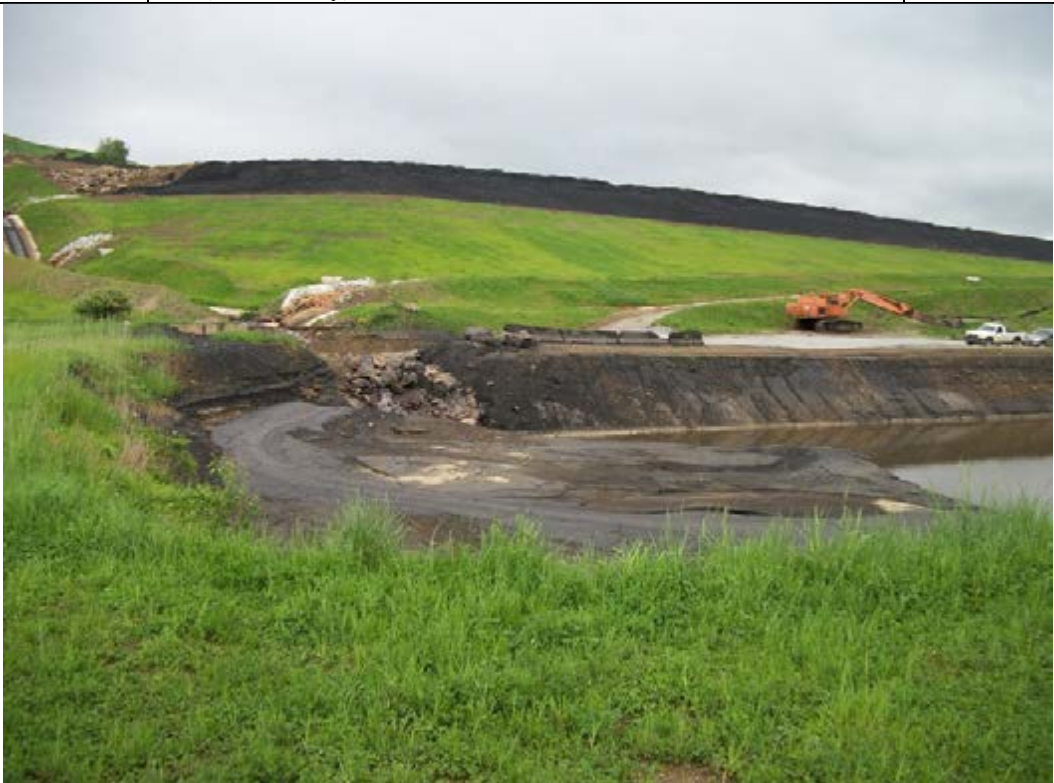
Client Name: U.S. Environmental Protection Agency		Site Location: ENE Homer City Station Stage I/II Sedimentation Pond (Coal Refuse Site), Homer City, PA	Project No. 170142.30
Photo No. 71	Date: 5/16/2011

Direction Photo Taken: Easterly			
Description: Inflow channel into Stage I/II Sedimentation Pond at the northeast corner. Surface/stormwater runoff from the Coal Refuse Site (beyond) flows into the impoundment via the concrete revetment-lined drainage channel (along left).

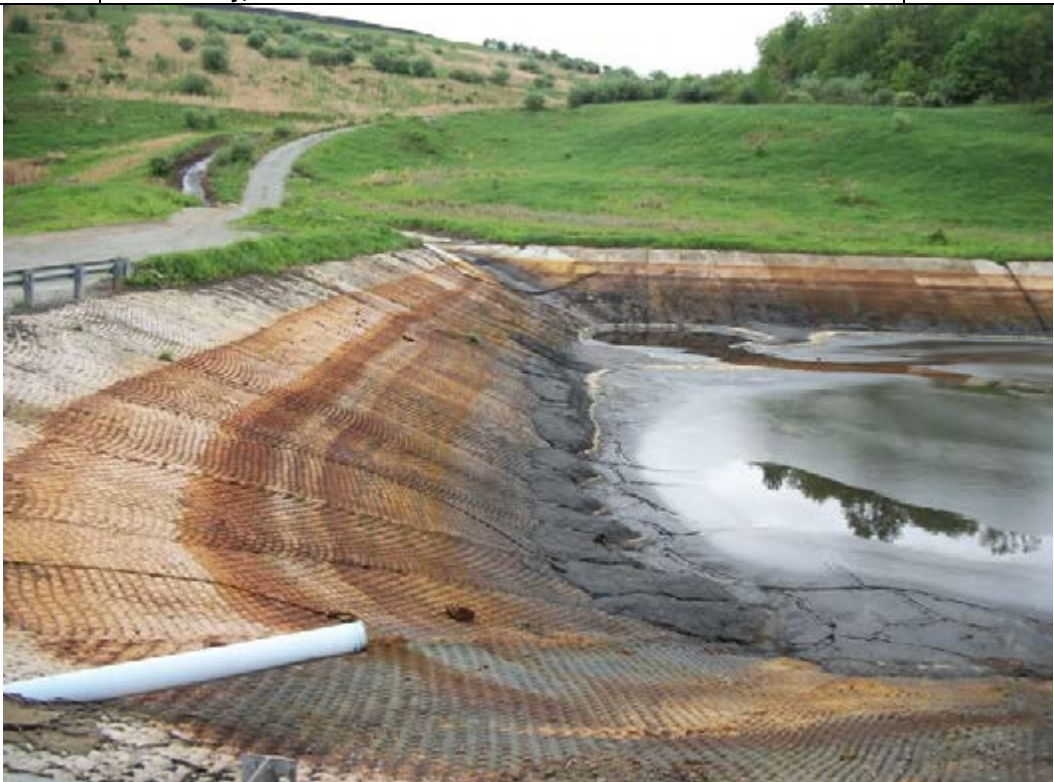
Client Name: U.S. Environmental Protection Agency		Site Location: EME Homer City Station Stage III/IV Surge Pond (Coal Refuse Site), Homer City, PA	Project No. 170142.30
Photo No. 78	Date: 5/16/2011

Direction Photo Taken: Northerly			
Description: Inside face of the western embankment. Note closed portion of the Coal Refuse Site landfill on the hillside above left. Discharge channel from Small Sediment Trap just left of access road. Channel outlets into the northwest corner of the impoundment.

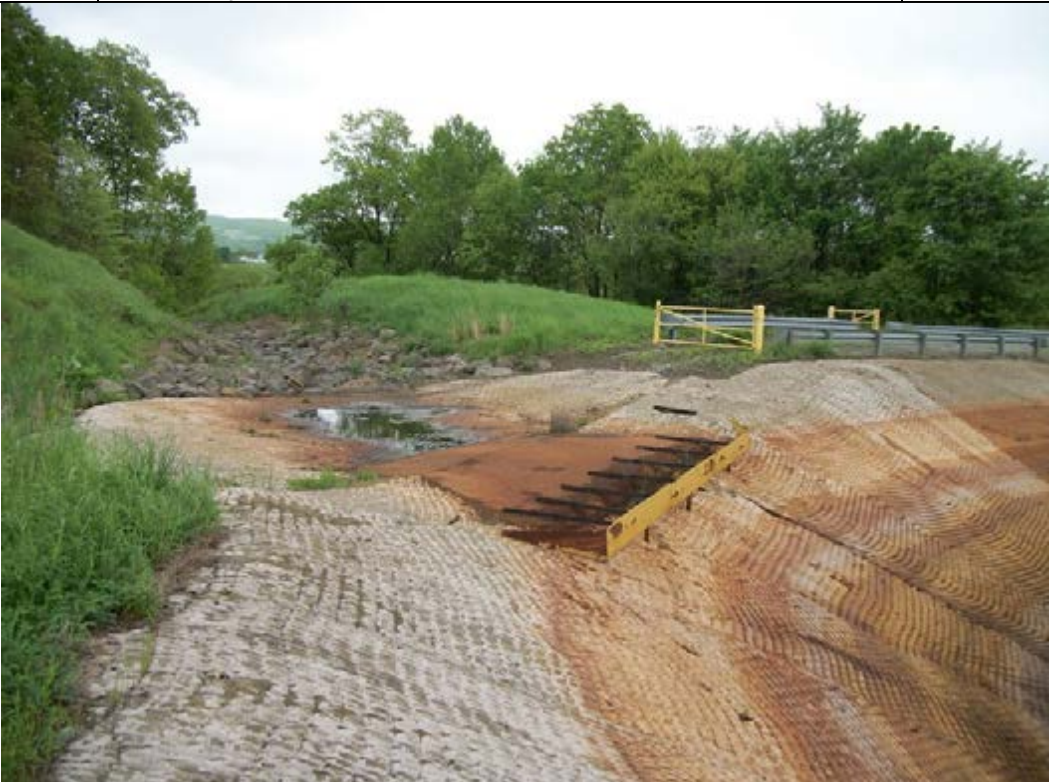
Client Name: U.S. Environmental Protection Agency		Site Location: EME Homer City Station Stage III/IV Surge Pond (Coal Refuse Site), Homer City, PA	Project No. 170142.30
Photo No. 84	Date: 5/16/2011

Direction Photo Taken: Southeasterly			
Description: Emergency Spillway at the northeast corner of the impoundment. Note concrete revetment transitions to stone riprap lined discharge channel beyond.			
Photo No. 85	Date: 5/16/2011

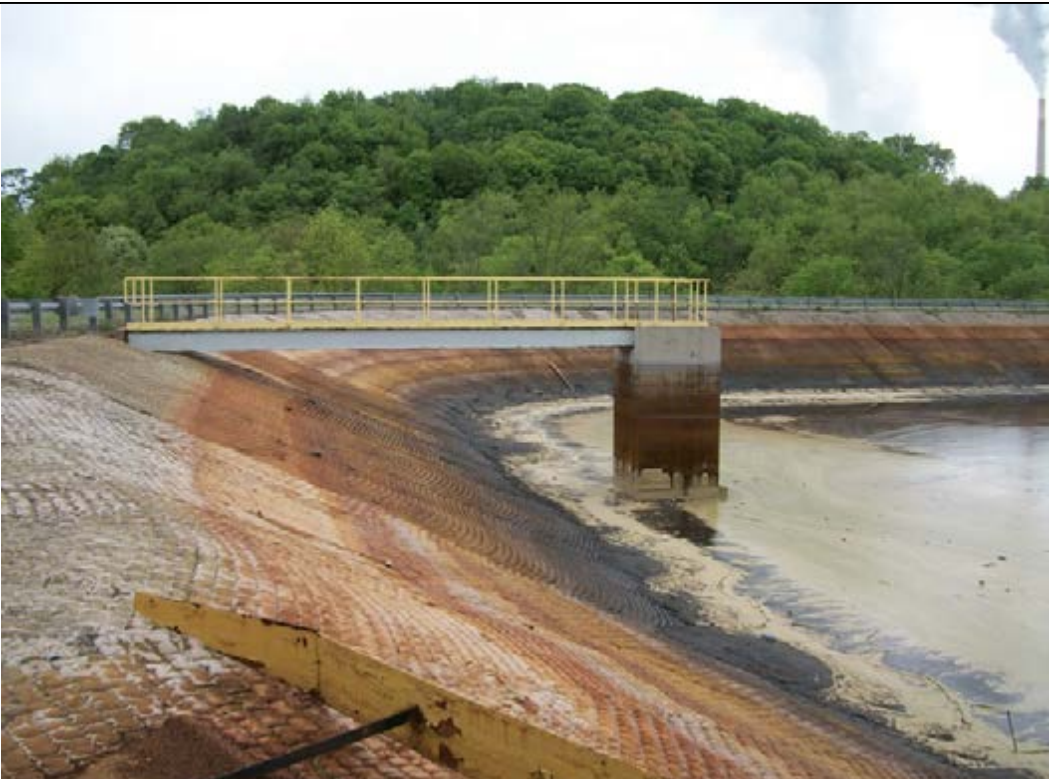
Direction Photo Taken: Southerly			
Description: Catwalk and concrete intake structure as viewed from the Emergency Spillway.

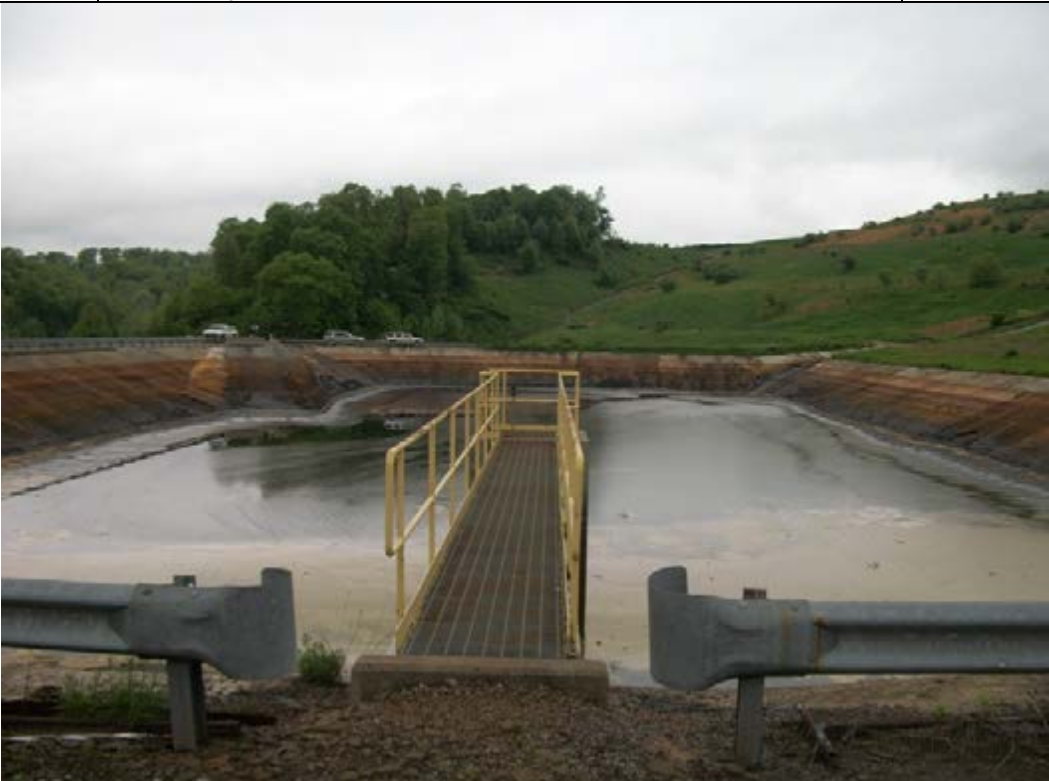
Client Name: U.S. Environmental Protection Agency		Site Location: EME Homer City Station Stage III/IV Surge Pond (Coal Refuse Site), Homer City, PA	Project No. 170142.30
Photo No. 86	Date: 5/16/2011

Direction Photo Taken: Westerly			
Description: Catwalk to top of intake structure at the east end of the Stage III/IV Surge Pond.

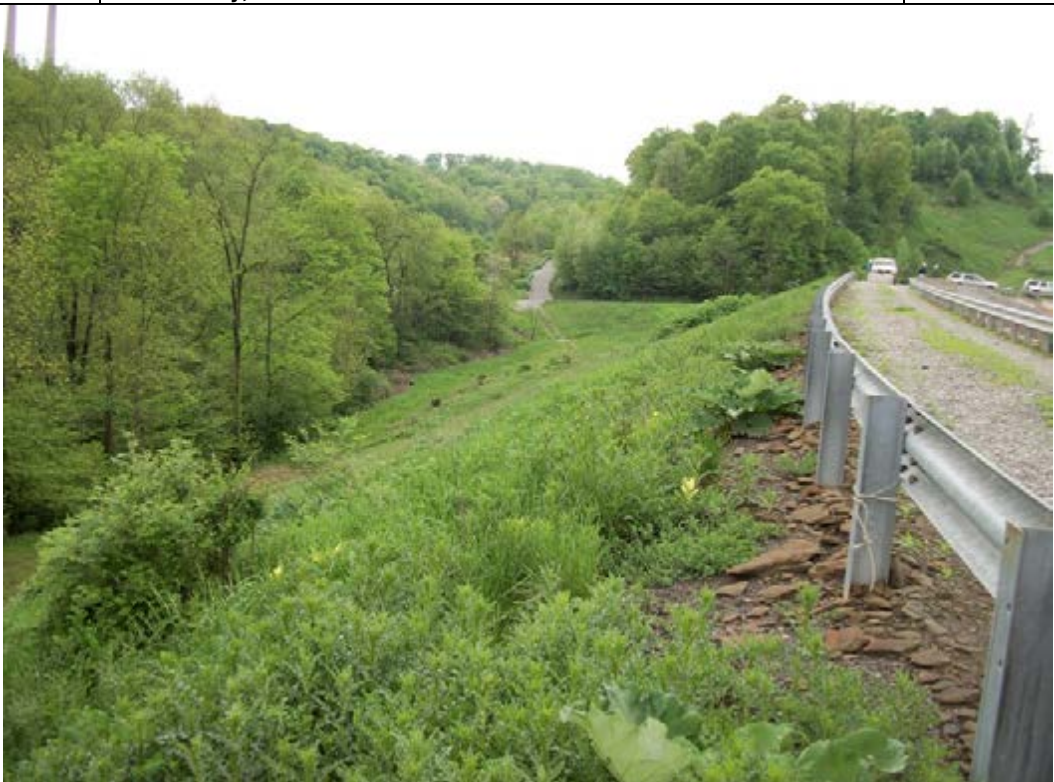
Client Name: U.S. Environmental Protection Agency		Site Location: EME Homer City Station Stage III/IV Surge Pond (Coal Refuse Site), Homer City, PA	Project No. 170142.30
Photo No. 88	Date: 5/16/2011

Direction Photo Taken: Westerly			
Description: Crest and outside slope of the south embankment looking west.

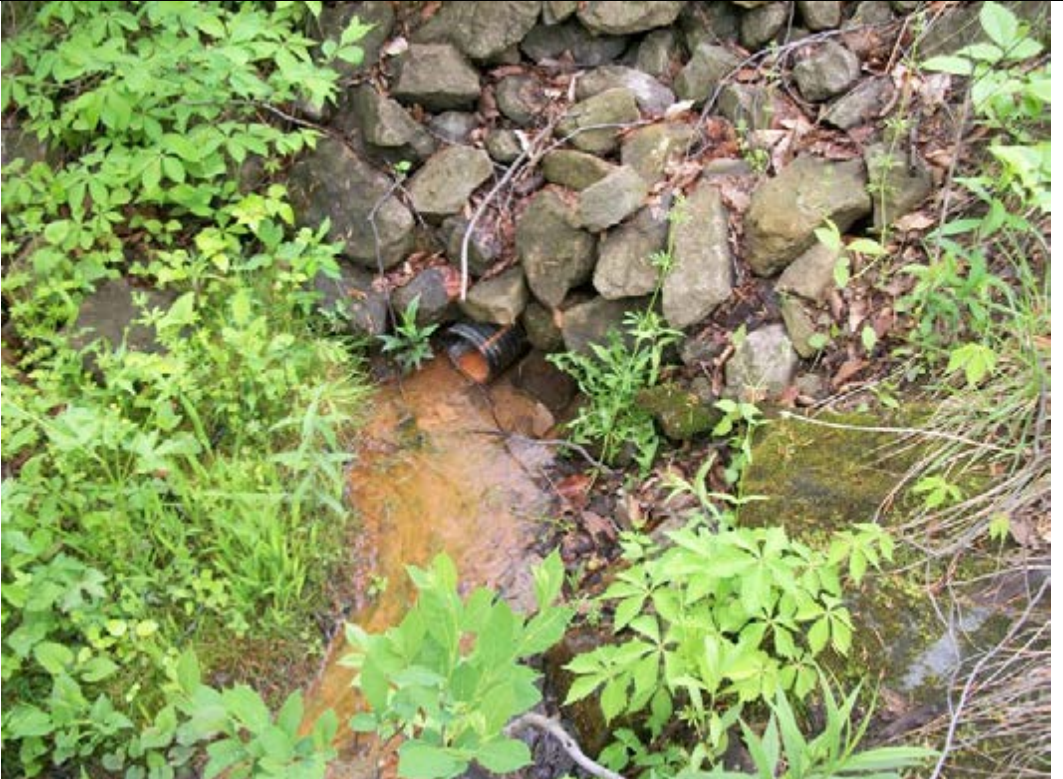
Client Name: U.S. Environmental Protection Agency		Site Location: EME Homer City Station Stage III/IV Surge Pond (Coal Refuse Site), Homer City, PA	Project No. 170142.30
Photo No. 90	Date: 5/16/2011

Direction Photo Taken: Northerly			
Description: Surge Pond underdrain system outlet at base of south embankment.

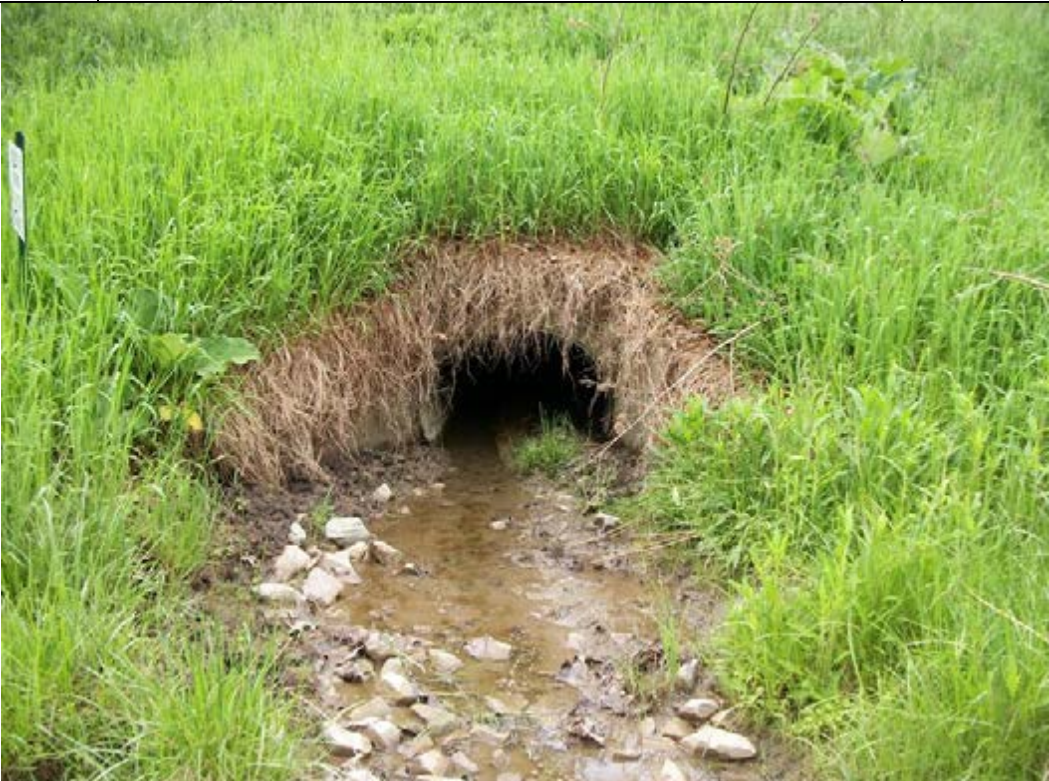
Client Name: U.S. Environmental Protection Agency		Site Location: EME Homer City Station Stage III/IV Surge Pond (Coal Refuse Site), Homer City, PA	Project No. 170142.30
Photo No. 94	Date: 5/16/2011

Direction Photo Taken: Northerly			
Description: Outfall from surface/stormwater runoff collection system associated with closed portion of the Coal Refuse Site landfill. Location of outfall is at the far west end of the Stage III/IV Surge Pond's south embankment..

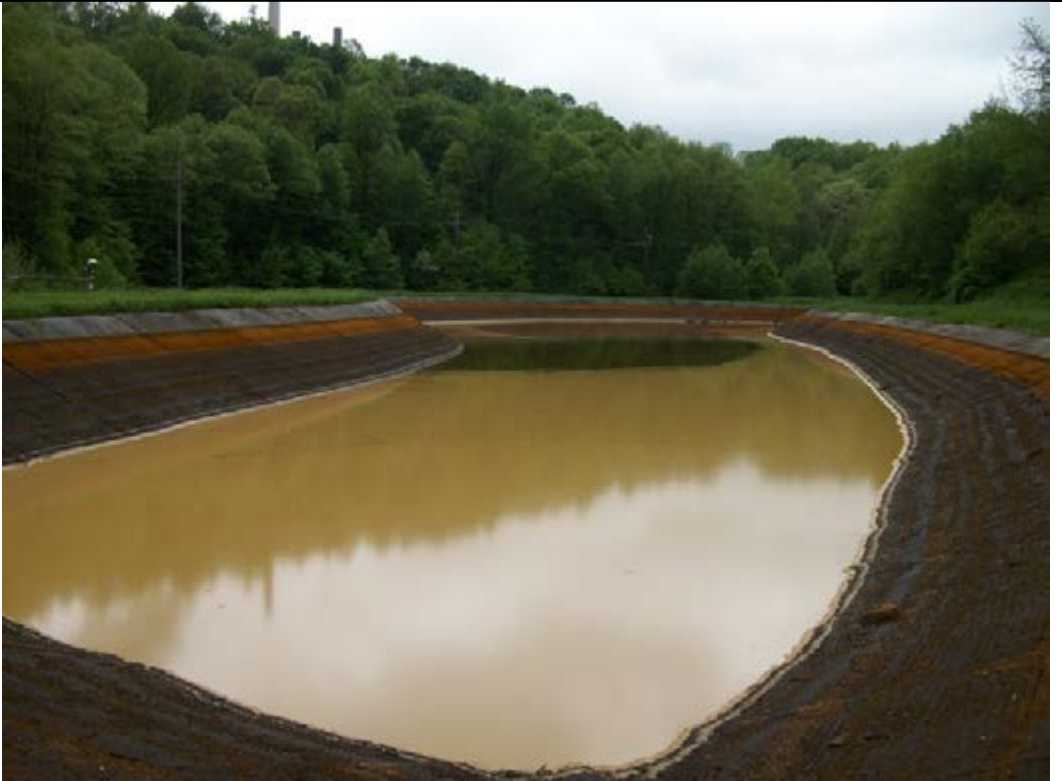
Client Name: U.S. Environmental Protection Agency		Site Location: Homer City Station Storage Pond No. 1, (Coal Refuse Site), Homer City, PA	Project No. 170142.30
Photo No. 95	Date: 5/16/2011

Direction Photo Taken: Westerly			
Description: Overview of the Storage Pond No. 1 from the northeast.
