**DRAFT REPORT
ROUND 10 DAM ASSESSMENT - MAY 16, 2011
EME HOMER CITY GENERATION L.P.
HOMER CITY GENERATING STATION
ASH DISPOSAL SITE PONDS, COAL REFUSE SITE PONDS
AND ASH RECYCLE PONDS
HOMER CITY, PENNSYLVANIA**

RE: Assessment of Dam Safety of Coal Combustion Surface Impoundments at the
Homer City Generating Station

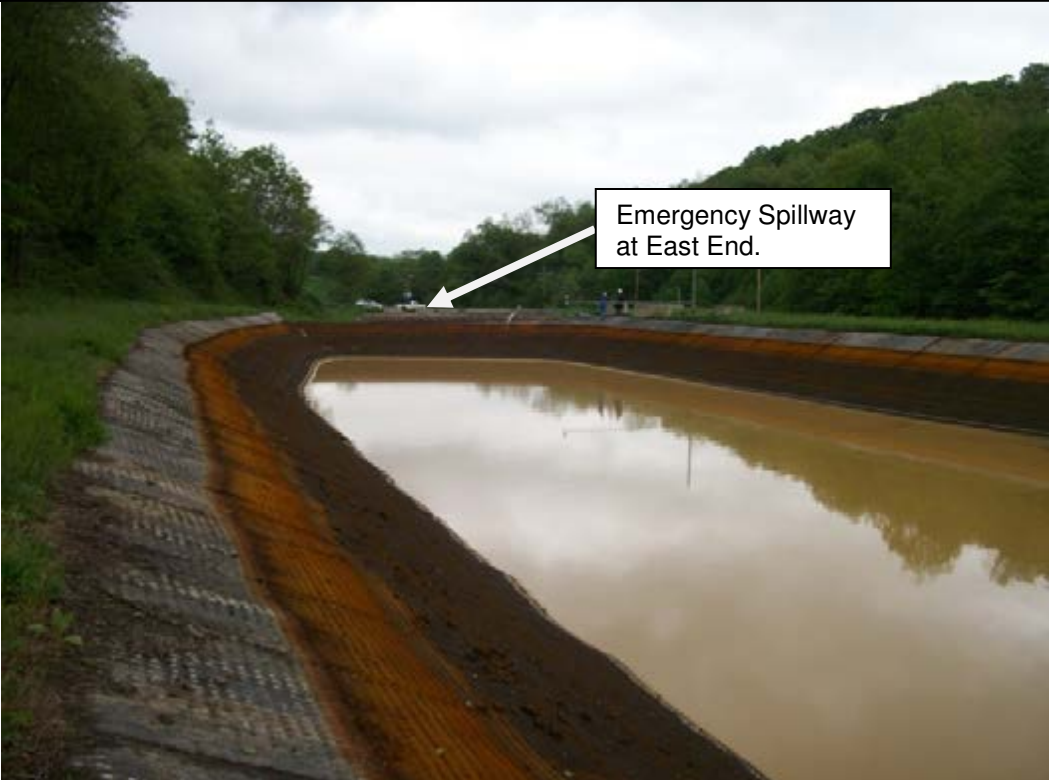
Client Name: U.S. Environmental Protection Agency		Site Location: Homer City Station Storage Pond No. 1, (Coal Refuse Site), Homer City, PA	Project No. 170142.30
Photo No. 97	Date: 5/16/2011

Direction Photo Taken: Easterly			
Description: Overview of Storage Pond No. 1 from the western end. Note the northern portion of the pond is incised. Revetment protection at east end lowered approximately 2 feet and serves as pond's Emergency Spillway which discharges into Storage Pond No. 2.

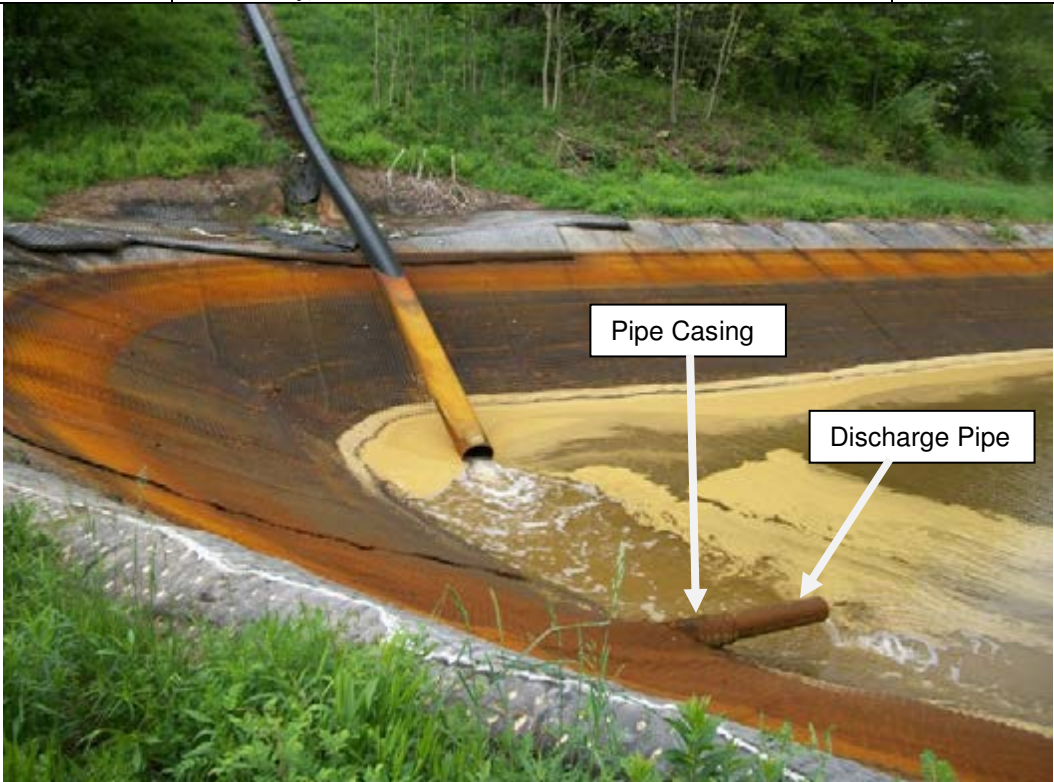
Client Name: U.S. Environmental Protection Agency		Site Location: Homer City Station Storage Pond No. 1, (Coal Refuse Site), Homer City, PA	Project No. 170142.30
Photo No. 99	Date: 5/16/2011

Direction Photo Taken: Northerly			
Description: Inside face of western end of pond. HDPE pipe at left conveys decanted flow from the Stage I/II Sedimentation Pond. Pipe in foreground conveys flows entering nearby stormwater collection system.

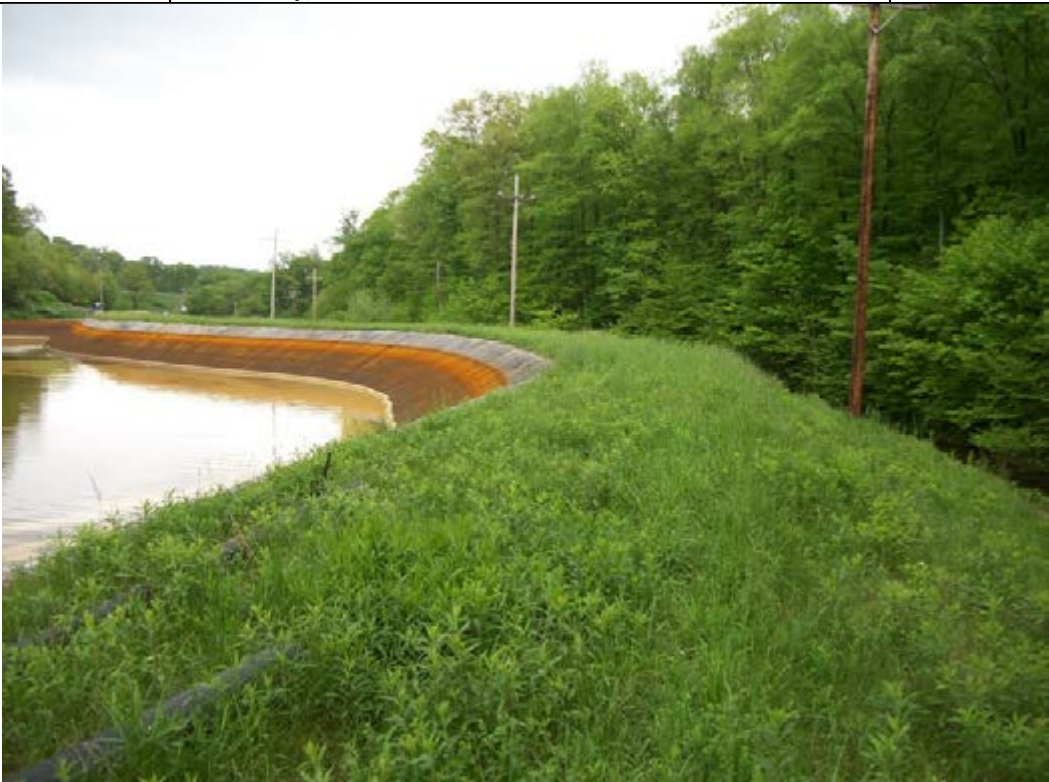
Client Name: U.S. Environmental Protection Agency		Site Location: Homer City Station Storage Pond No. 1, (Coal Refuse Site), Homer City, PA	Project No. 170142.30
Photo No. 101	Date: 5/16/2011

Direction Photo Taken: Easterly			
Description: Crest of southern embankment from the west end. Pipes on top of the crest are not active.

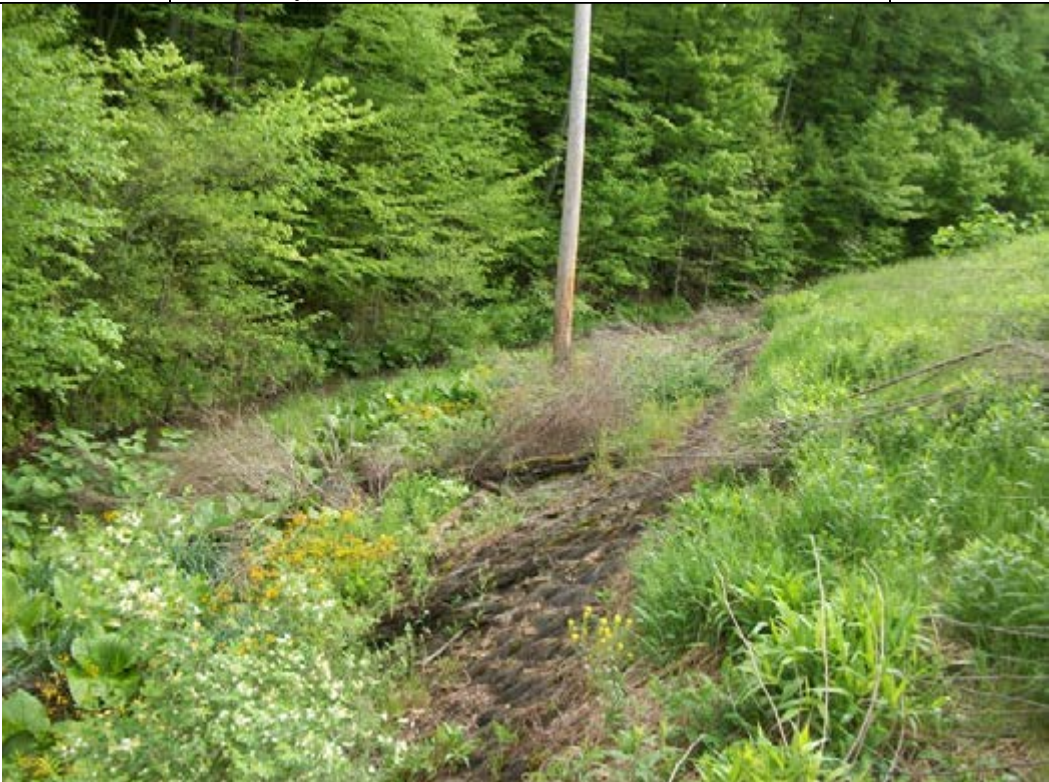
Client Name: U.S. Environmental Protection Agency		Site Location: Homer City Station Storage Pond No. 1, (Coal Refuse Site), Homer City, PA	Project No. 170142.30
Photo No. 103	Date: 5/16/2011

Direction Photo Taken: Southwesterly			
Description: Outside face of southern embankment looking southwest. Note concrete revetment erosion protection along slope and extending to the banks of the un-named stream at left.

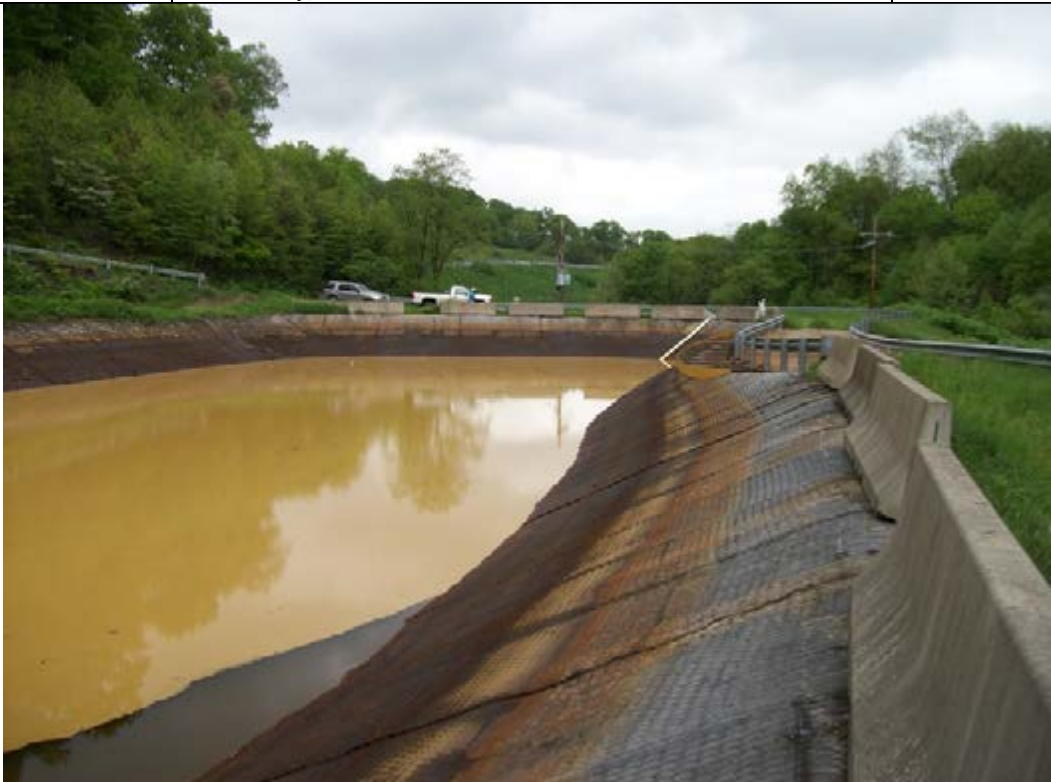
Client Name: U.S. Environmental Protection Agency		Site Location: Homer City Station Storage Pond No. 2 (Coal Refuse Site), Homer City, PA	Project No. 170142.30
Photo No. 111	Date: 5/16/2011

Direction Photo Taken: Easterly			
Description: Inside face of the southern embankment viewed from the west.

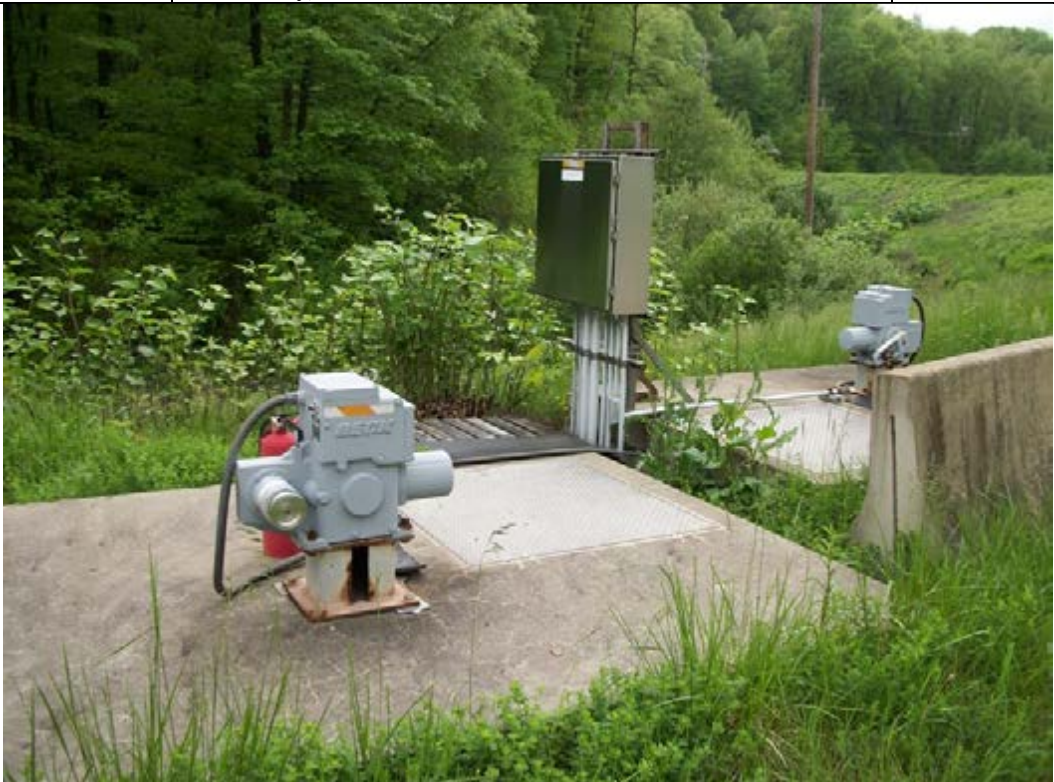
Client Name: U.S. Environmental Protection Agency		Site Location: Homer City Station Storage Pond No. 2 (Coal Refuse Site), Homer City, PA	Project No. 170142.30
Photo No. 113	Date: 5/16/2011

A photograph showing a white valve operator with a red fire extinguisher on a concrete pad. In the background, there is a green electrical box and another valve operator on a concrete wall, surrounded by lush green vegetation.	
Direction Photo Taken: Southerly			
Description: Valve operators at the southwestern end of Storage Pond No. 2 which apparently control flow within the 10-inch-diameter poly-ethylene pipe leading from Storage Pond No. 1 to Storage Pond No. 2.

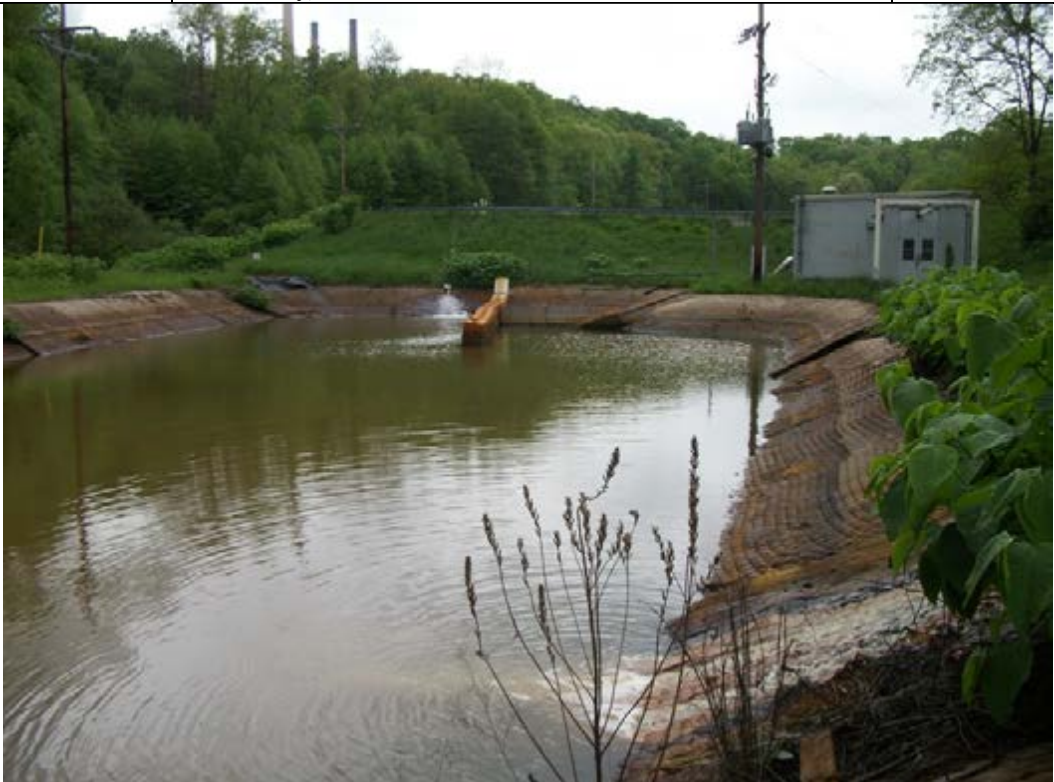
Client Name: U.S. Environmental Protection Agency		Site Location: Homer City Station Leachate Pump Pond (Coal Refuse Site), Homer City, PA	Project No. 170142.30
Photo No. 117	Date: 5/16/2011

Direction Photo Taken: Westerly			
Description: Overview of Leachate Pump Pond from the northeast. Note pump house structure at right side. Decanted flow from the Leachate Pump Pond is pumped to the Site's Wastewater Treatment System.

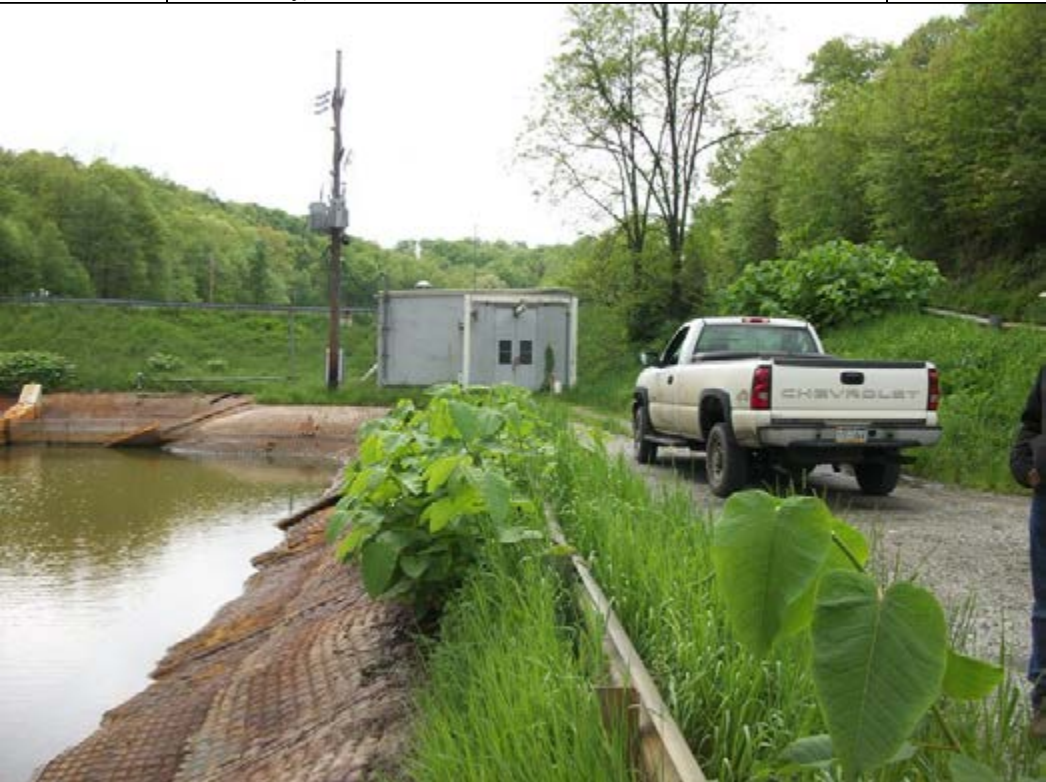
Client Name: U.S. Environmental Protection Agency		Site Location: Homer City Station Leachate Pump Pond (Coal Refuse Site), Homer City, PA	Project No. 170142.30
Photo No. 119	Date: 5/16/2011

Direction Photo Taken: Westerly			
Description: Inside face and crest of northern portion of the pond. Pump house structure and east embankment of Storage Pond No. 2 beyond.

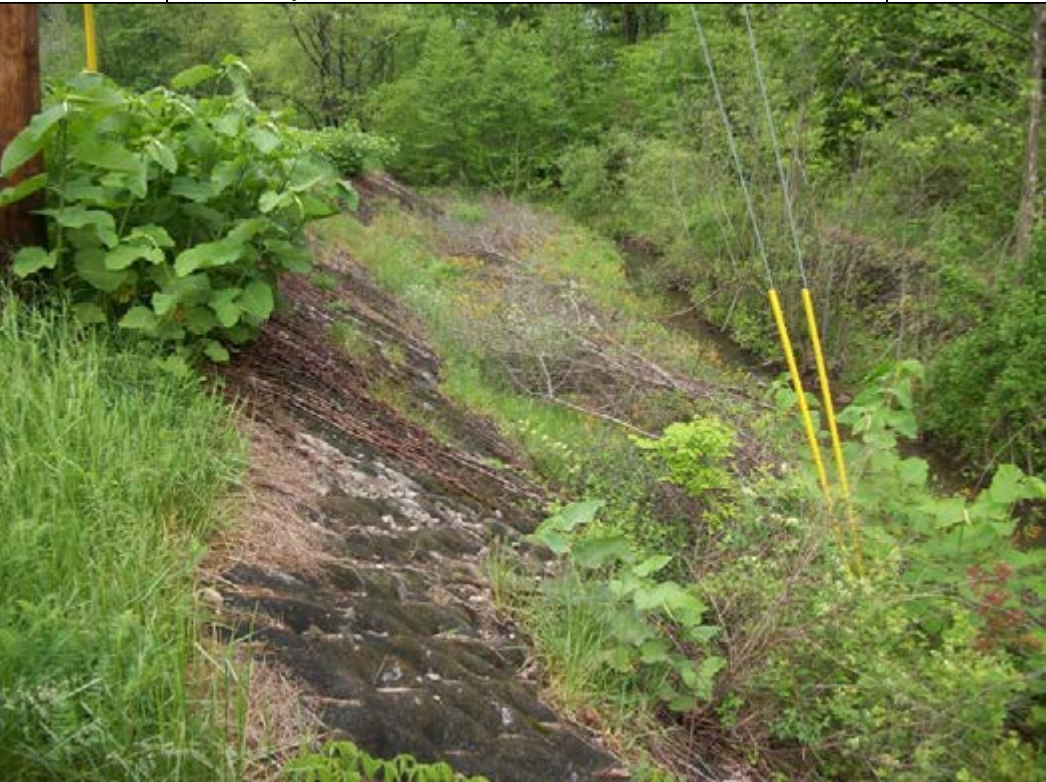
Client Name: U.S. Environmental Protection Agency		Site Location: Homer City Station Leachate Pump Pond (Coal Refuse Site), Homer City, PA	Project No. 170142.30
Photo No. 121	Date: 5/16/2011

Direction Photo Taken: Easterly			
Description: Concrete revetment erosion control matting along outside face of the southern embankment and lining the banks of the un-named stream.

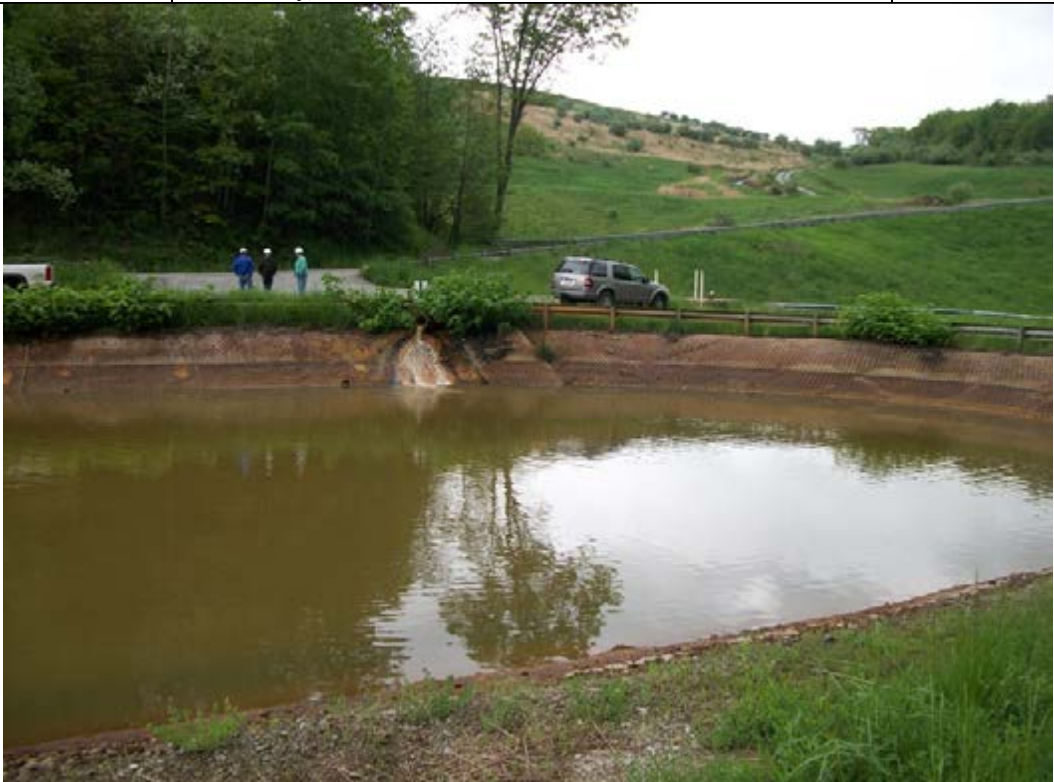
Client Name: U.S. Environmental Protection Agency		Site Location: Homer City Station Leachate Pump Pond (Coal Refuse Site), Homer City, PA	Project No. 170142.30
Photo No. 123	Date: 5/16/2011

Direction Photo Taken: Northerly			
Description: Overview of inside face at northeast corner of the Leachate Pump Pond. Flow into pond is discharge from the Coal Refuse Site landfill leachate collection system.

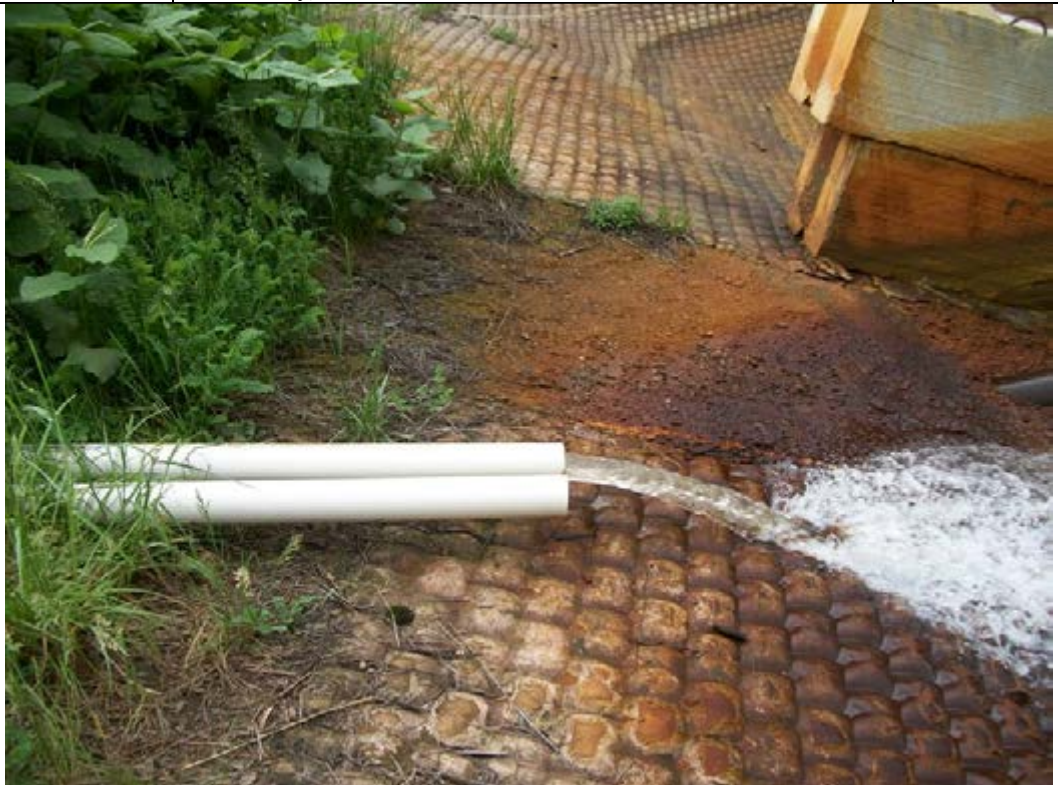
Siphon outfall from Storage Pond No. 2 discharging into the west end of the Leachate Pump Pond.

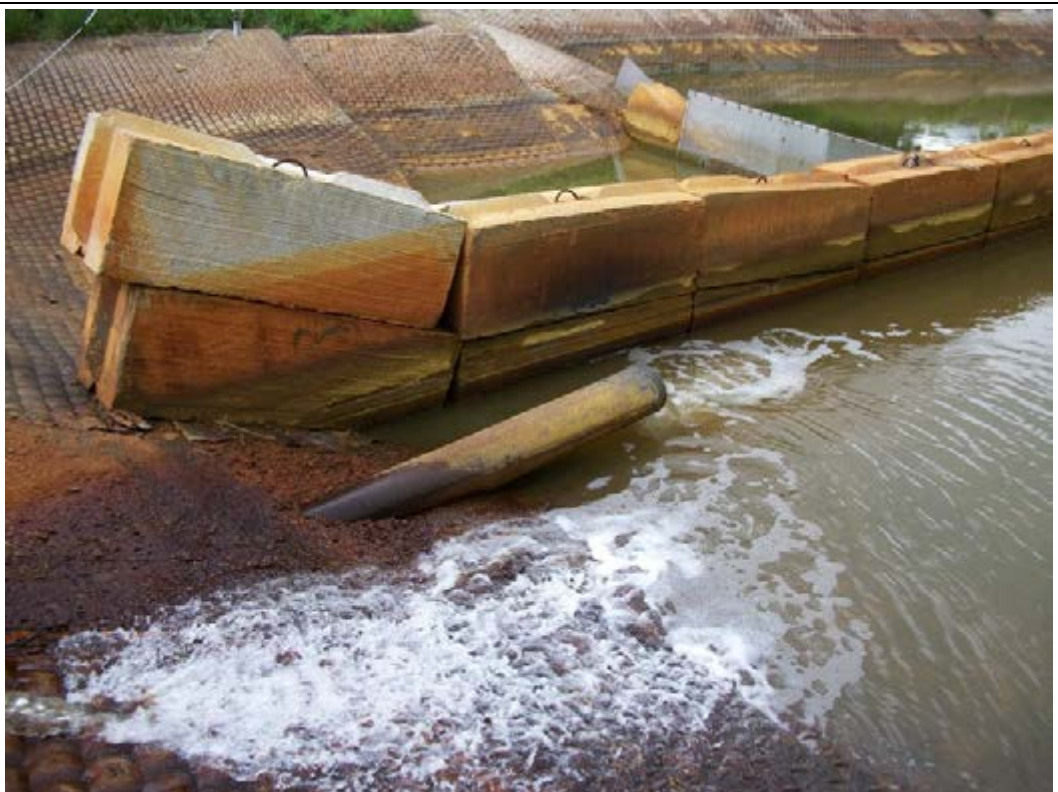
126

Gravity flow outlet pipe from Storage Pond No. 2. Note flow is supplemented by PVC siphon pipes depicted in the previous photo.
