# Assessment of Dam Safety Coal Combustion Surface Impoundments (Task 3) Draft Report

**Kentucky Utilities**

**Ghent Generating Station**

December 8, 2009

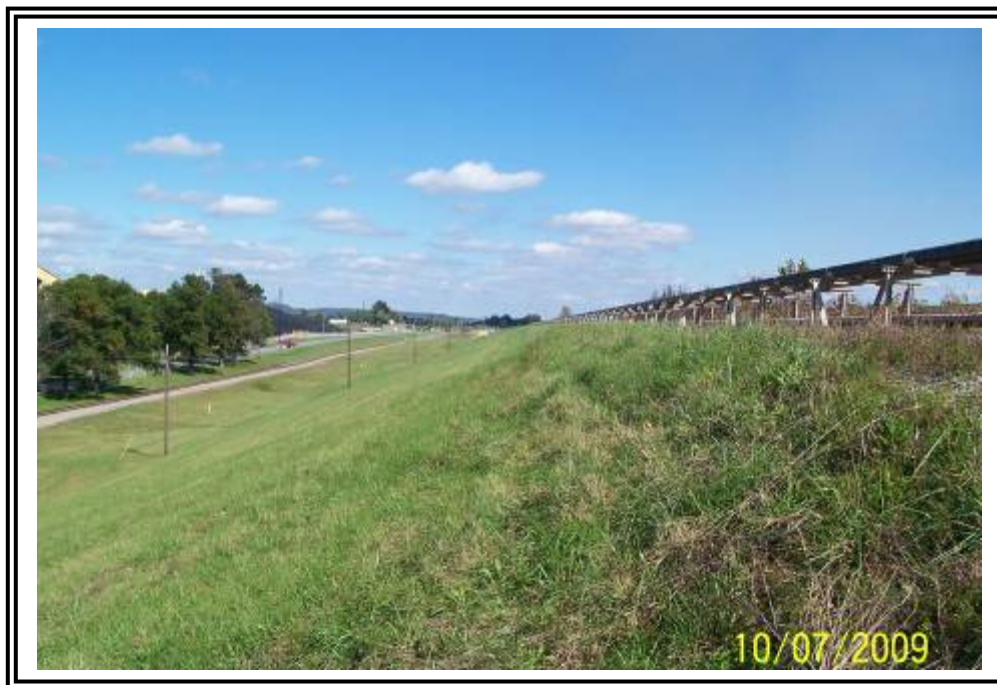
13

In general, the ATB #1 dike does not show signs of changes in horizontal alignment from the proposed alignment. The up and downstream slopes were reasonably uniformly graded and vegetation had been recently mowed at the time of our site visit. Photos 4, 5, 13, 14, 16, and 20 show the general condition of the downstream embankment, which is covered with appropriate grass vegetation. As noted in Photo 13, some areas at the crest are over steepened, which Kentucky Utilities staff indicated may have occurred during regrading of the crest when work was performed to ensure the top elevation was at the design elevation. No signs of movement were observed in these areas. Photo 14 also shows typical tire rutting from mowers. This is common on earthen embankments, and requires observation to ensure that erosion and sloughing does not occur. Kentucky Utilities indicated that they have reduced their maintenance program to mowing twice a year from three times a year to reduce the impact of mower rutting on the embankments. A few areas of different vegetation were noted along the north slope, which can be an indication of softer soil or seepage. These observed areas, while softer at the surface were firm below a depth of about 6 to 8 inches.

Downstream slope of ATB #1 north dike. Note over steepening adjacent to crest, looking east.

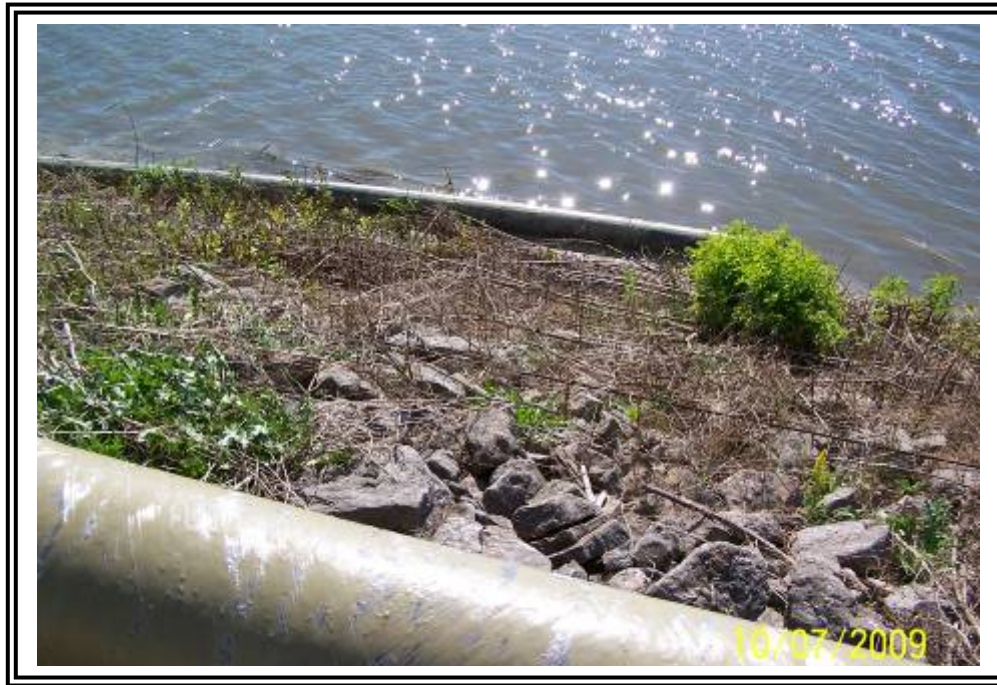
21

The general condition of the ATB #1 upstream slope is shown in Photos 3, 6, 9, 10, 12 and 21. The upstream slope is weed covered, but had been trimmed to near the water line. ATB #1 is not a primary disposal site now and primarily receives outflow from ATB #2 and a comparatively small flow of waste water from the plant. This has resulted in ash deposits that are above the water line. Along the west and majority of the north dikes, the ash is within 3 to 5 feet of the top of the dike. As shown in Photo 12, small trees have begun to grow on the exposed ash within the basin. As can be seen in Photo 21, erosion on the upstream slope of the east dike has been filled with rip rap.

Upstream slope of ATB #1 east dike. Rip rap has been placed to fill areas of erosion.

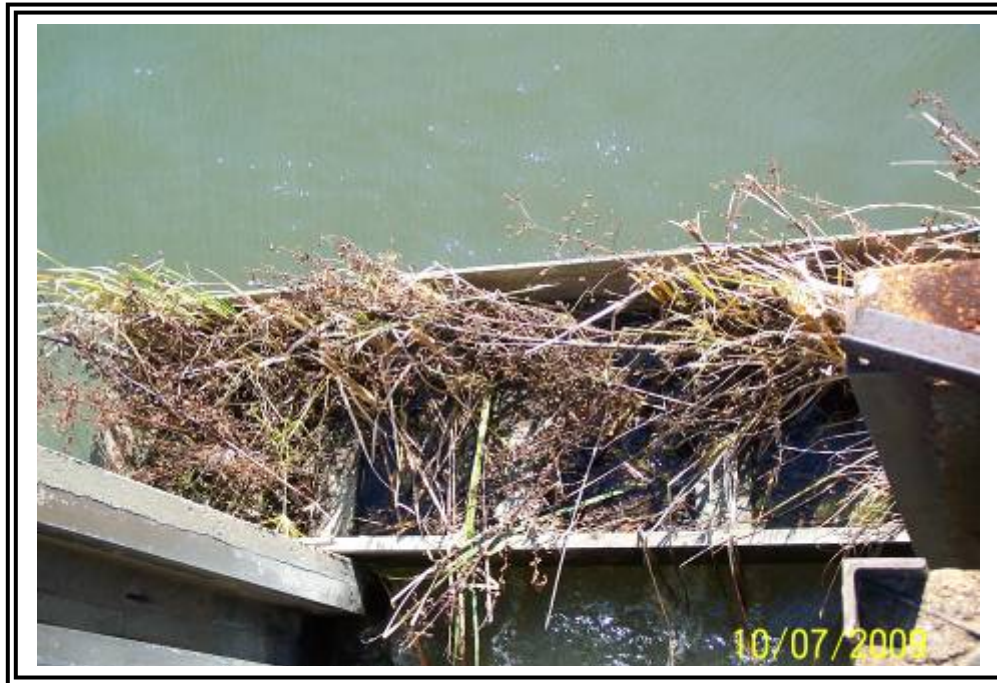
25

Decant structure in ATB #1.

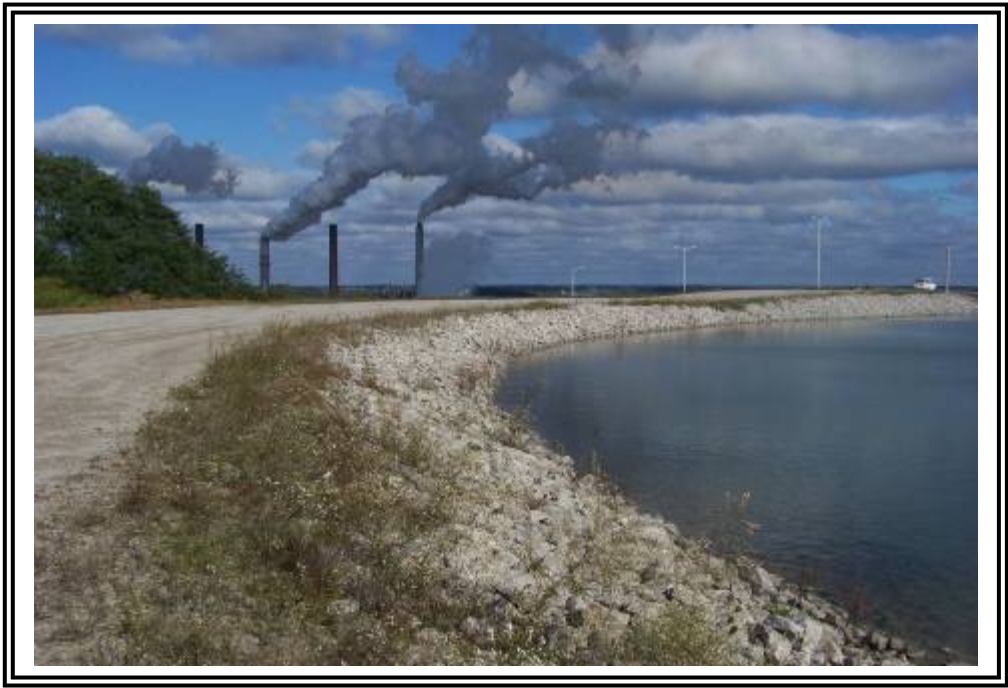
The upstream slope of the ATB #2 was covered with rip rap, which appeared uniformly placed. Photos 27 through 34 show the general conditions of the upstream slope. Occasional erosion rills, such as that noted in Photo 30 were observed.

Upstream slope of ATB #2 looking north.

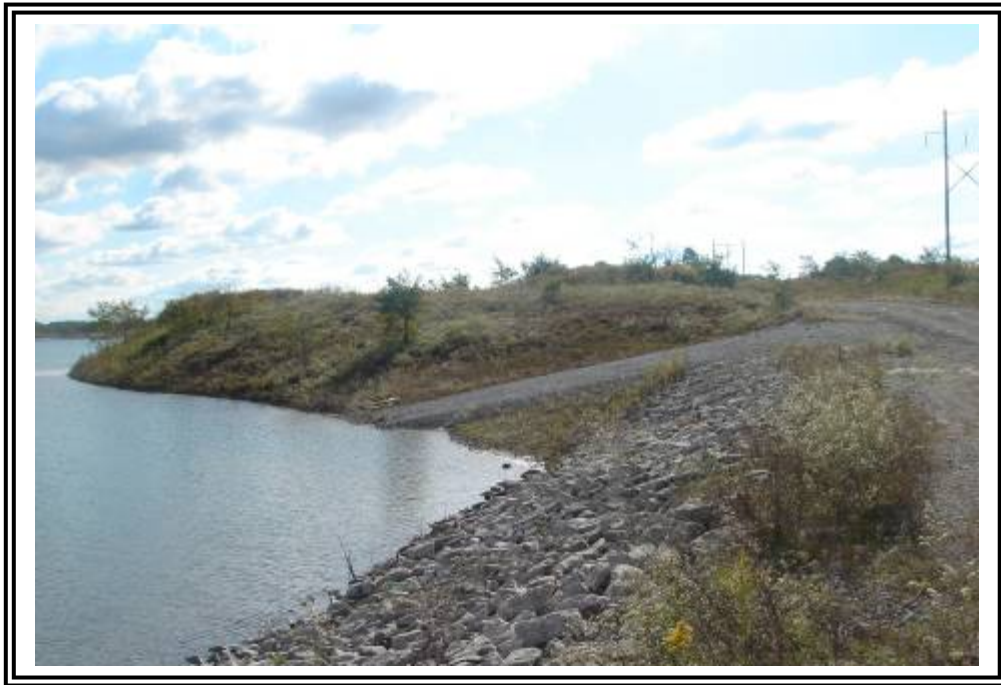
29

Upstream slope of ATB #2 looking south at west abutment and boat ramp.

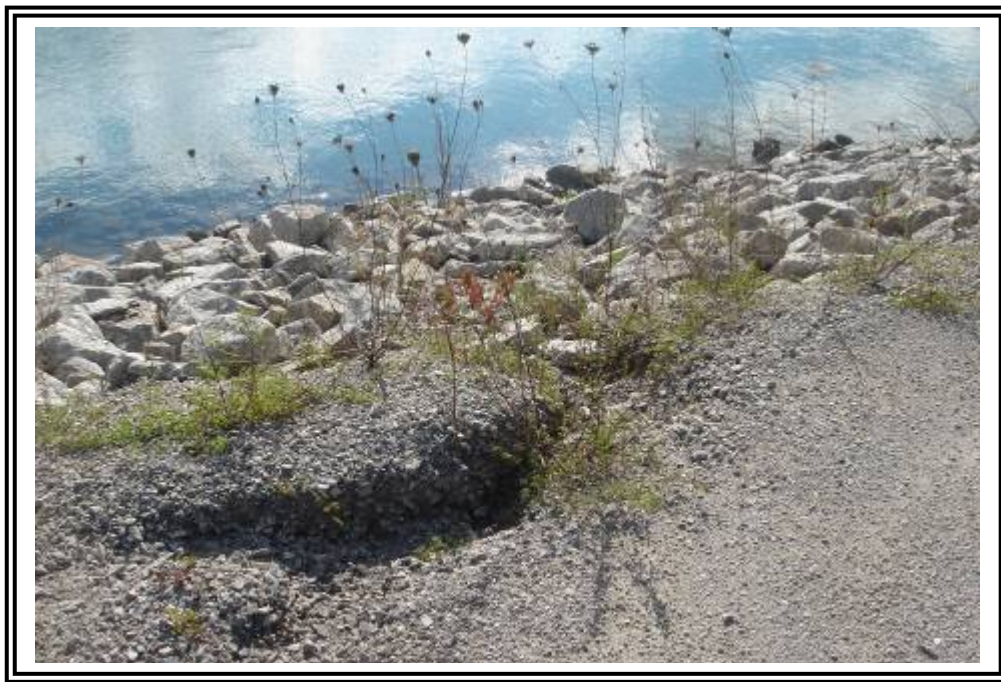
30

Erosion rill on upstream slope.

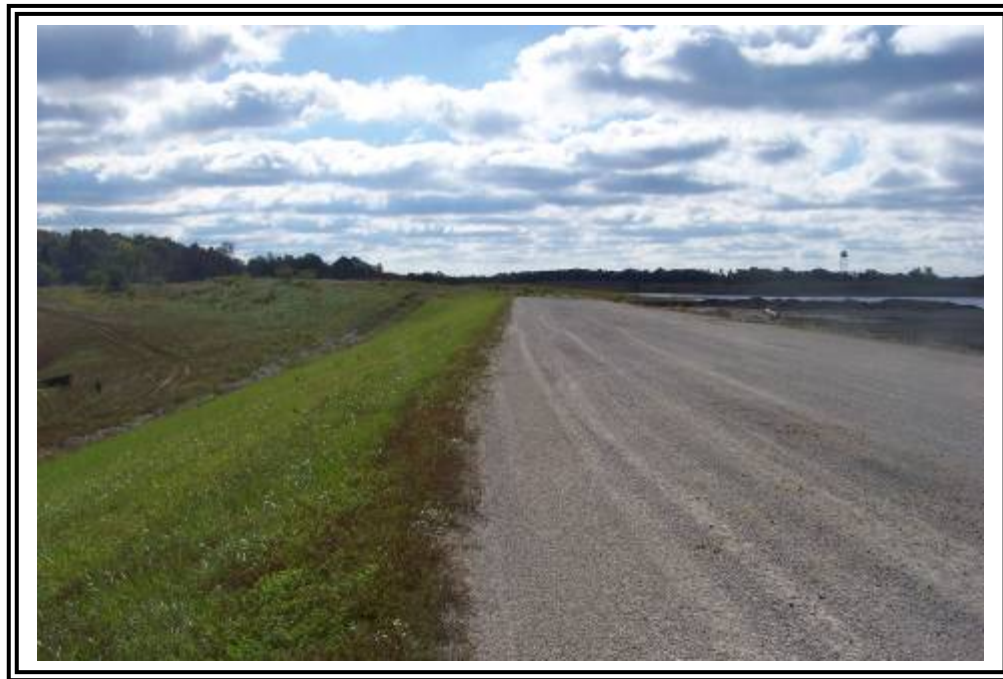
The crest of the ATB #2 dam is uniform and did not show signs of significant settlement or deflection. Photos 35 through 40 show the general condition of the crest.

Crest of ATB #2 looking south toward east abutment.

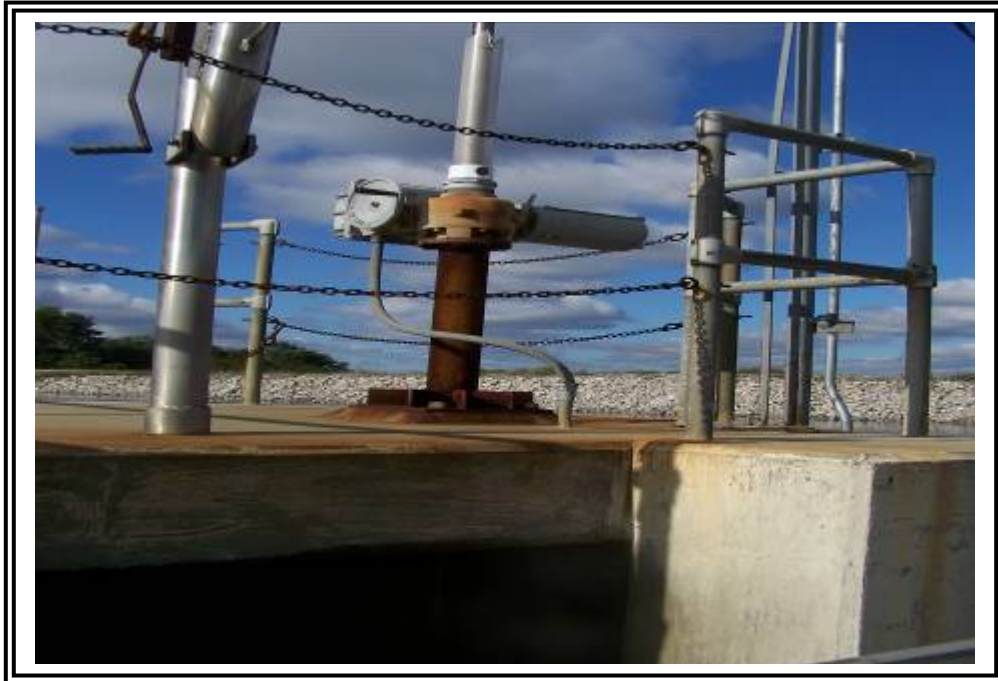
77

Outlet structure equipped with gates to close outlet flow from discharge pipe.

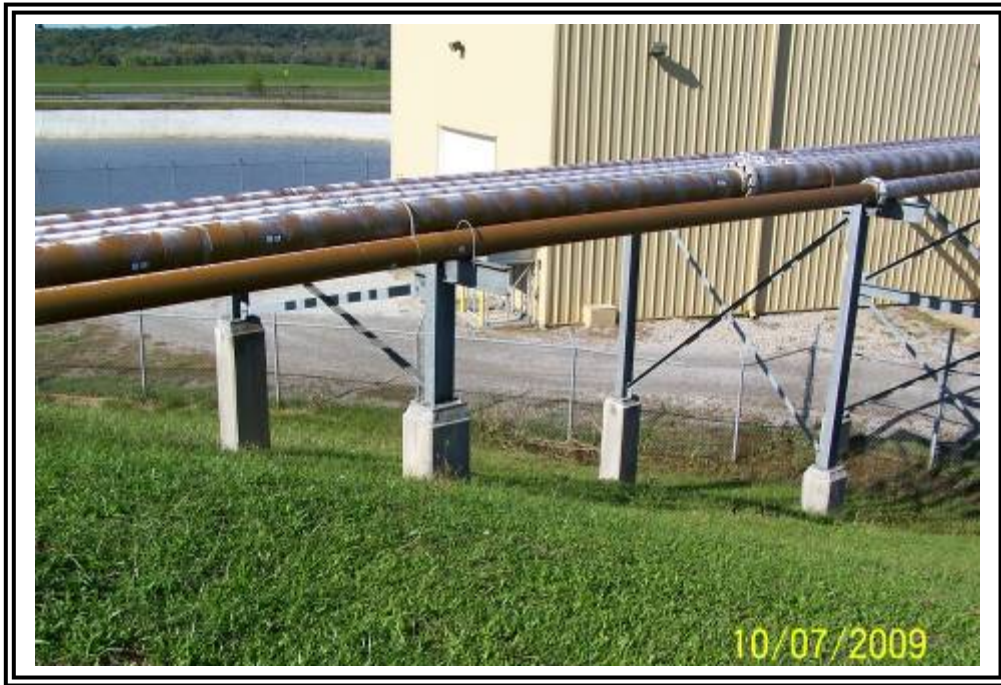
93

Pipe rack diverting gypsum to reuse facility on northeast corner of the gypsum stacking facility starter dike.

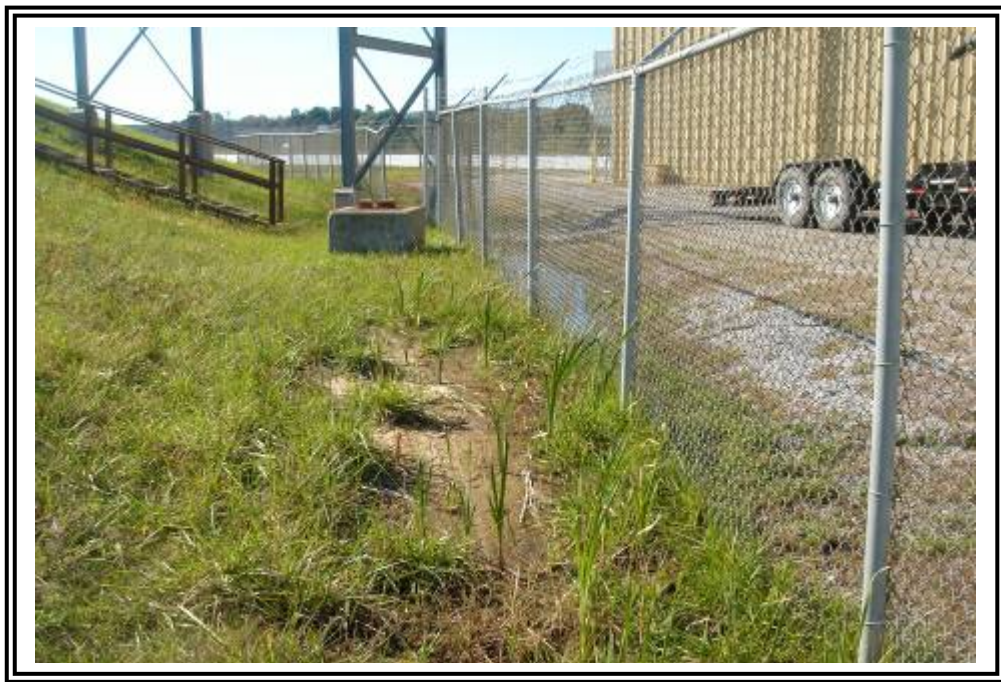
94

Standing water at toe at northeast corner of gypsum stacking facility starter dike. Appears to be surface drainage water.

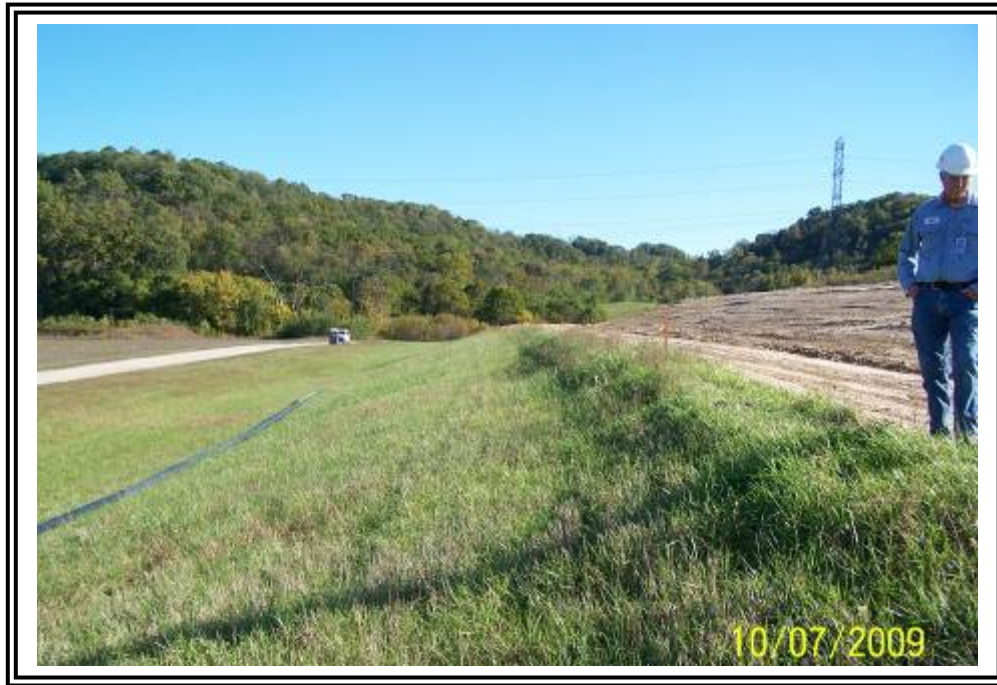
97

Over steepening at crest of east side of gypsum stacking facility starter dike, looking south.

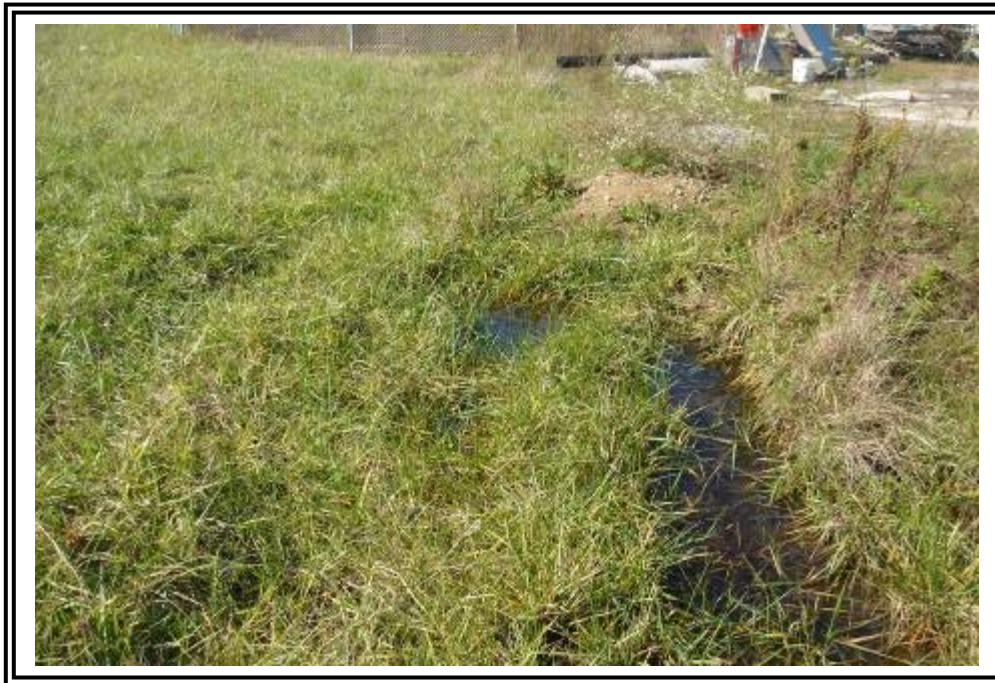
99

Standing water at the toe along the east side of the gypsum stacking facility starter dike.  
Ground is firm, appears to be surface water drainage.

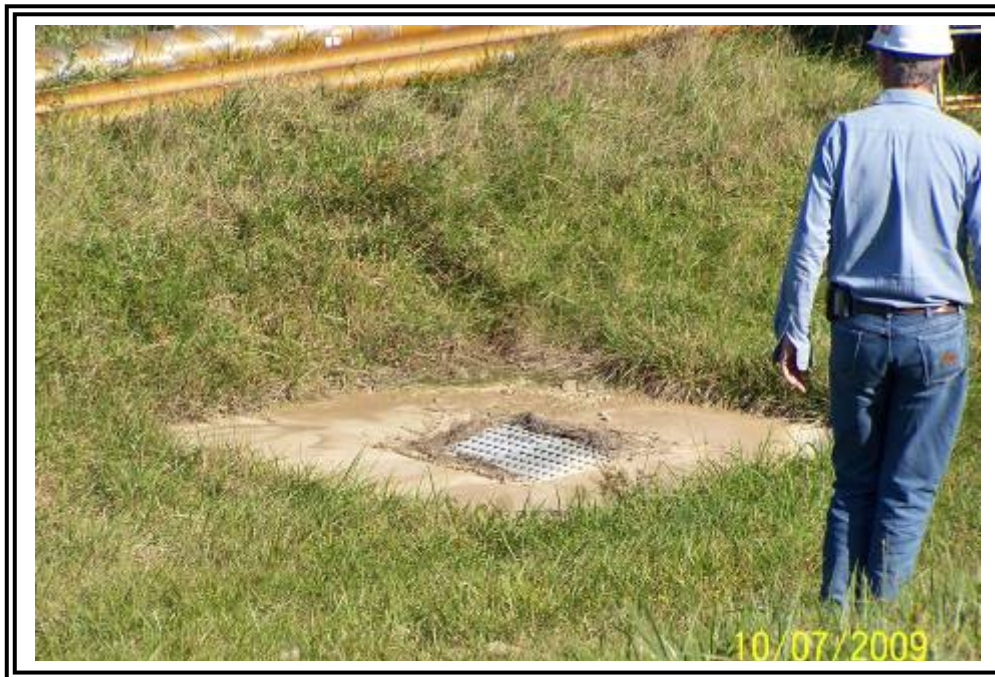
100

Surface drainage system on east side of gypsum stacking facility starter dike.
