Assessment of Dam Safety Coal Combustion Surface Impoundments (Task 3) Draft Report

FirstEnergy Generation
Corporation

Bruce Mansfield
Power Plant
Little Blue Run Dam
Shippingport, Pennsylvania

December 3, 2009

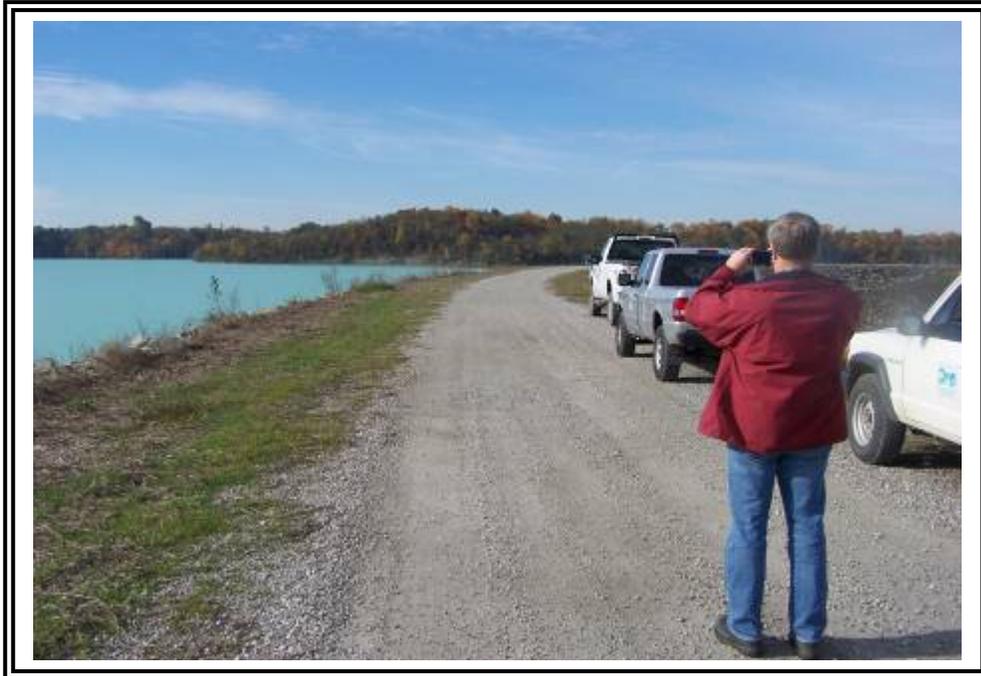
3

A gravel access road runs the entire length of the crest of the Little Blue Run Dam (Photo Nos. 2 through 5). The downstream embankment slope is covered with large rip rap which is reportedly sprayed for vegetation control every two years (Photo Nos. 7 and 8). Near the toe of the downstream slope there is a stilling basin (Photo No. 9). Slope protection above the reservoir pool elevation on the upstream embankment slope was observed to be rip rap (Photo Nos. 14 and 15).

Dam crest, looking southwest.

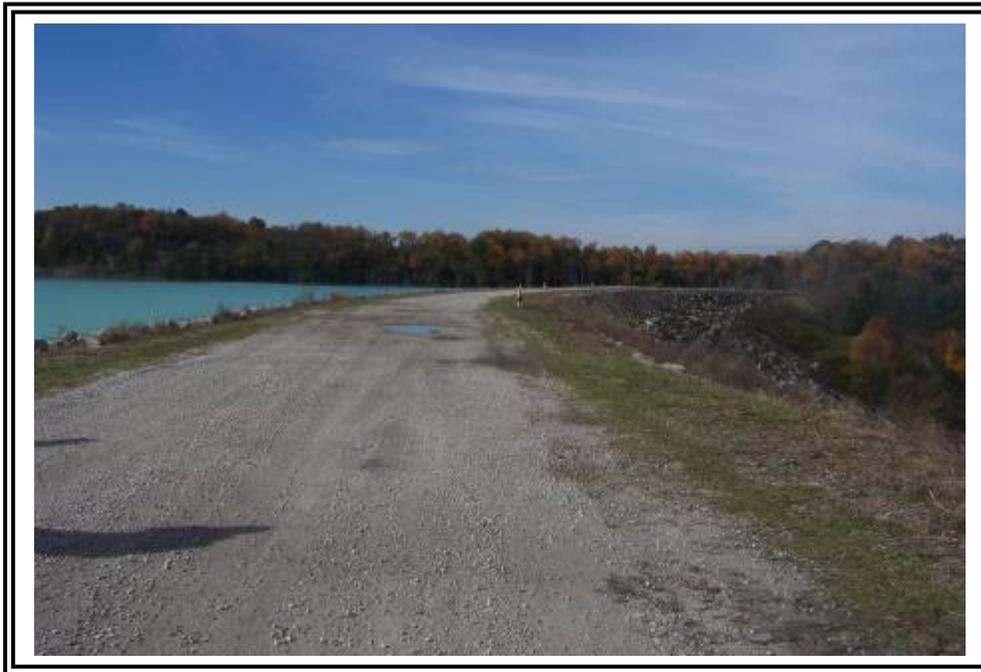
4

Dam crest, looking west.

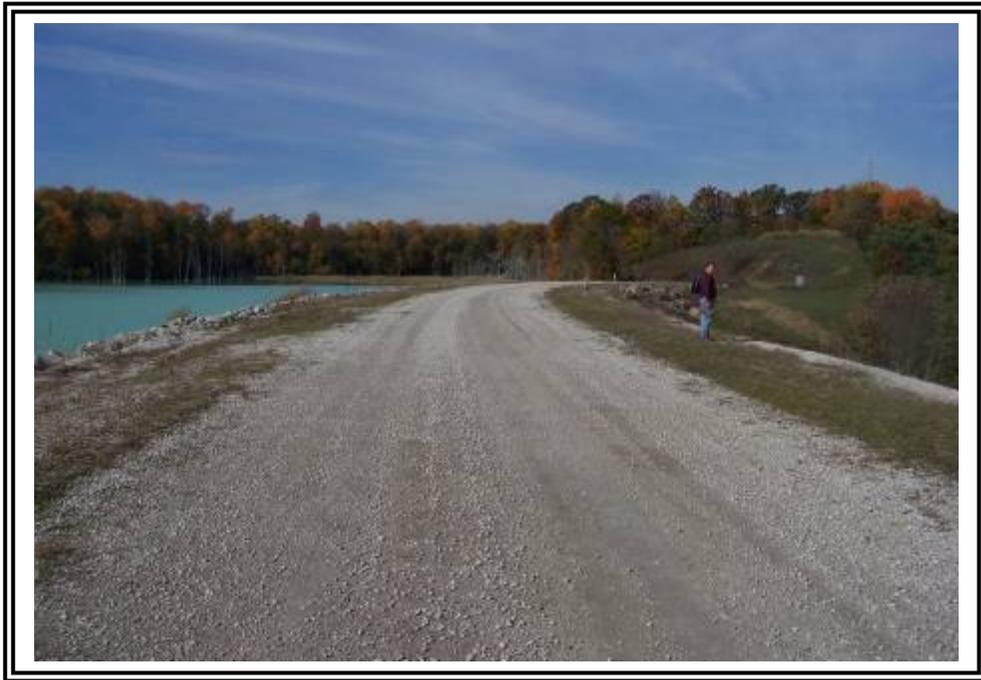
5

Dam crest, looking west.

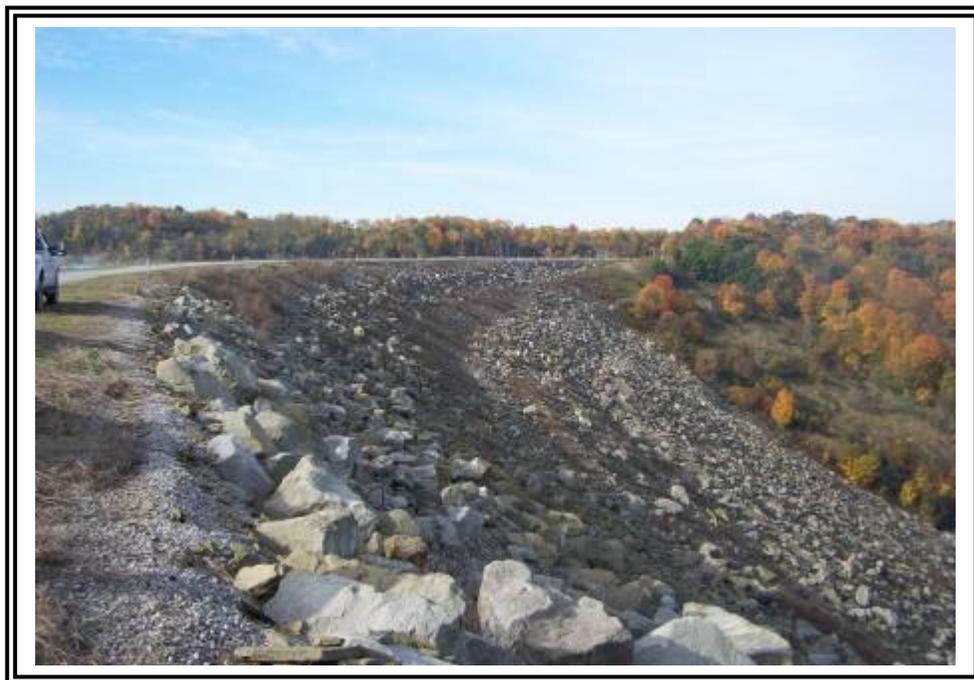
7

Downstream slope, looking west.

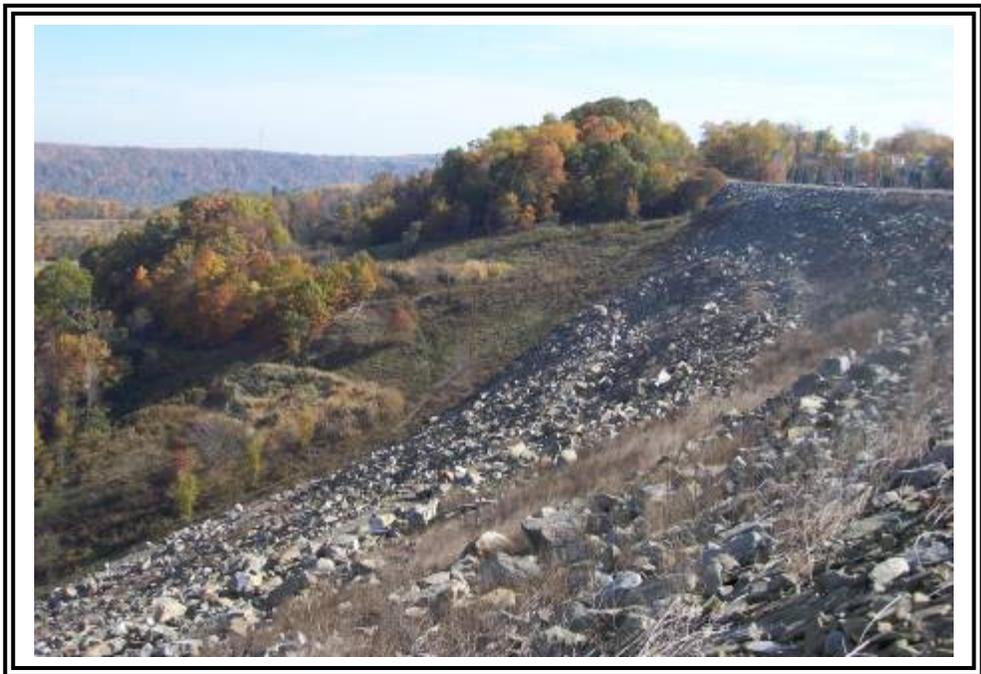
10

During the site visit, First Energy and GAI representatives pointed out areas previously repaired on the west embankment-abutment contact where surface sloughing and sliding of surficial soils had occurred in the location of an access road some years ago (Photos 6, 12 and 13). Seepage that is directed to weirs for monitoring was observed on the west abutment (Photos No. 27 and 33). The east abutment was also observed (Photo Nos. 1, 10, and 11).

East abutment contact with downstream slope, looking east.

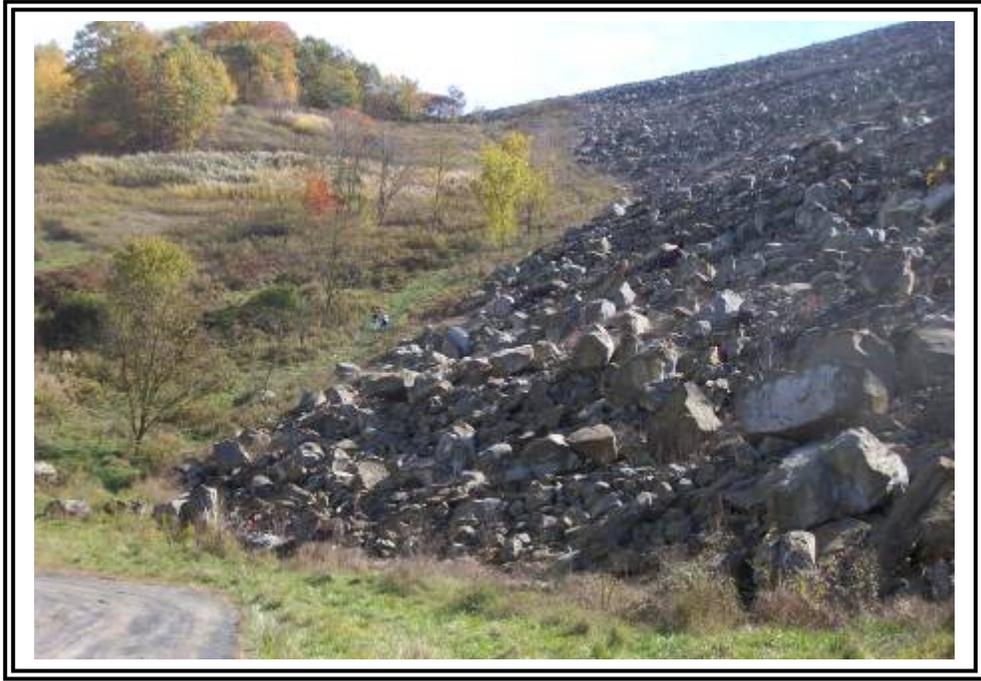
11

East abutment contact with downstream slope, looking up from the toe.

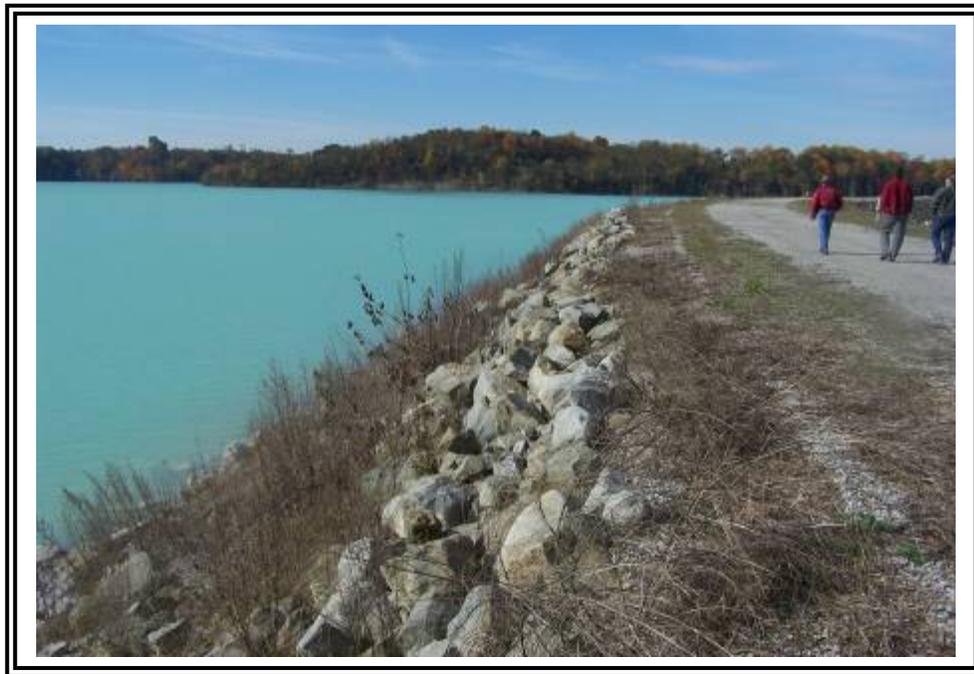
14

Upstream slope, looking southwest.

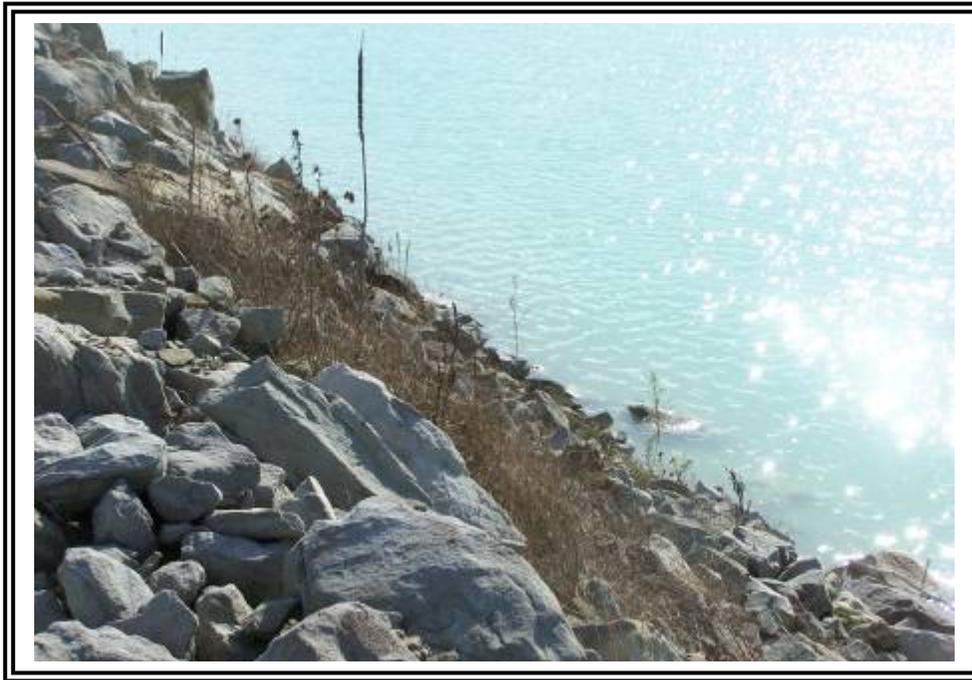
15

Upstream slope, looking southeast.

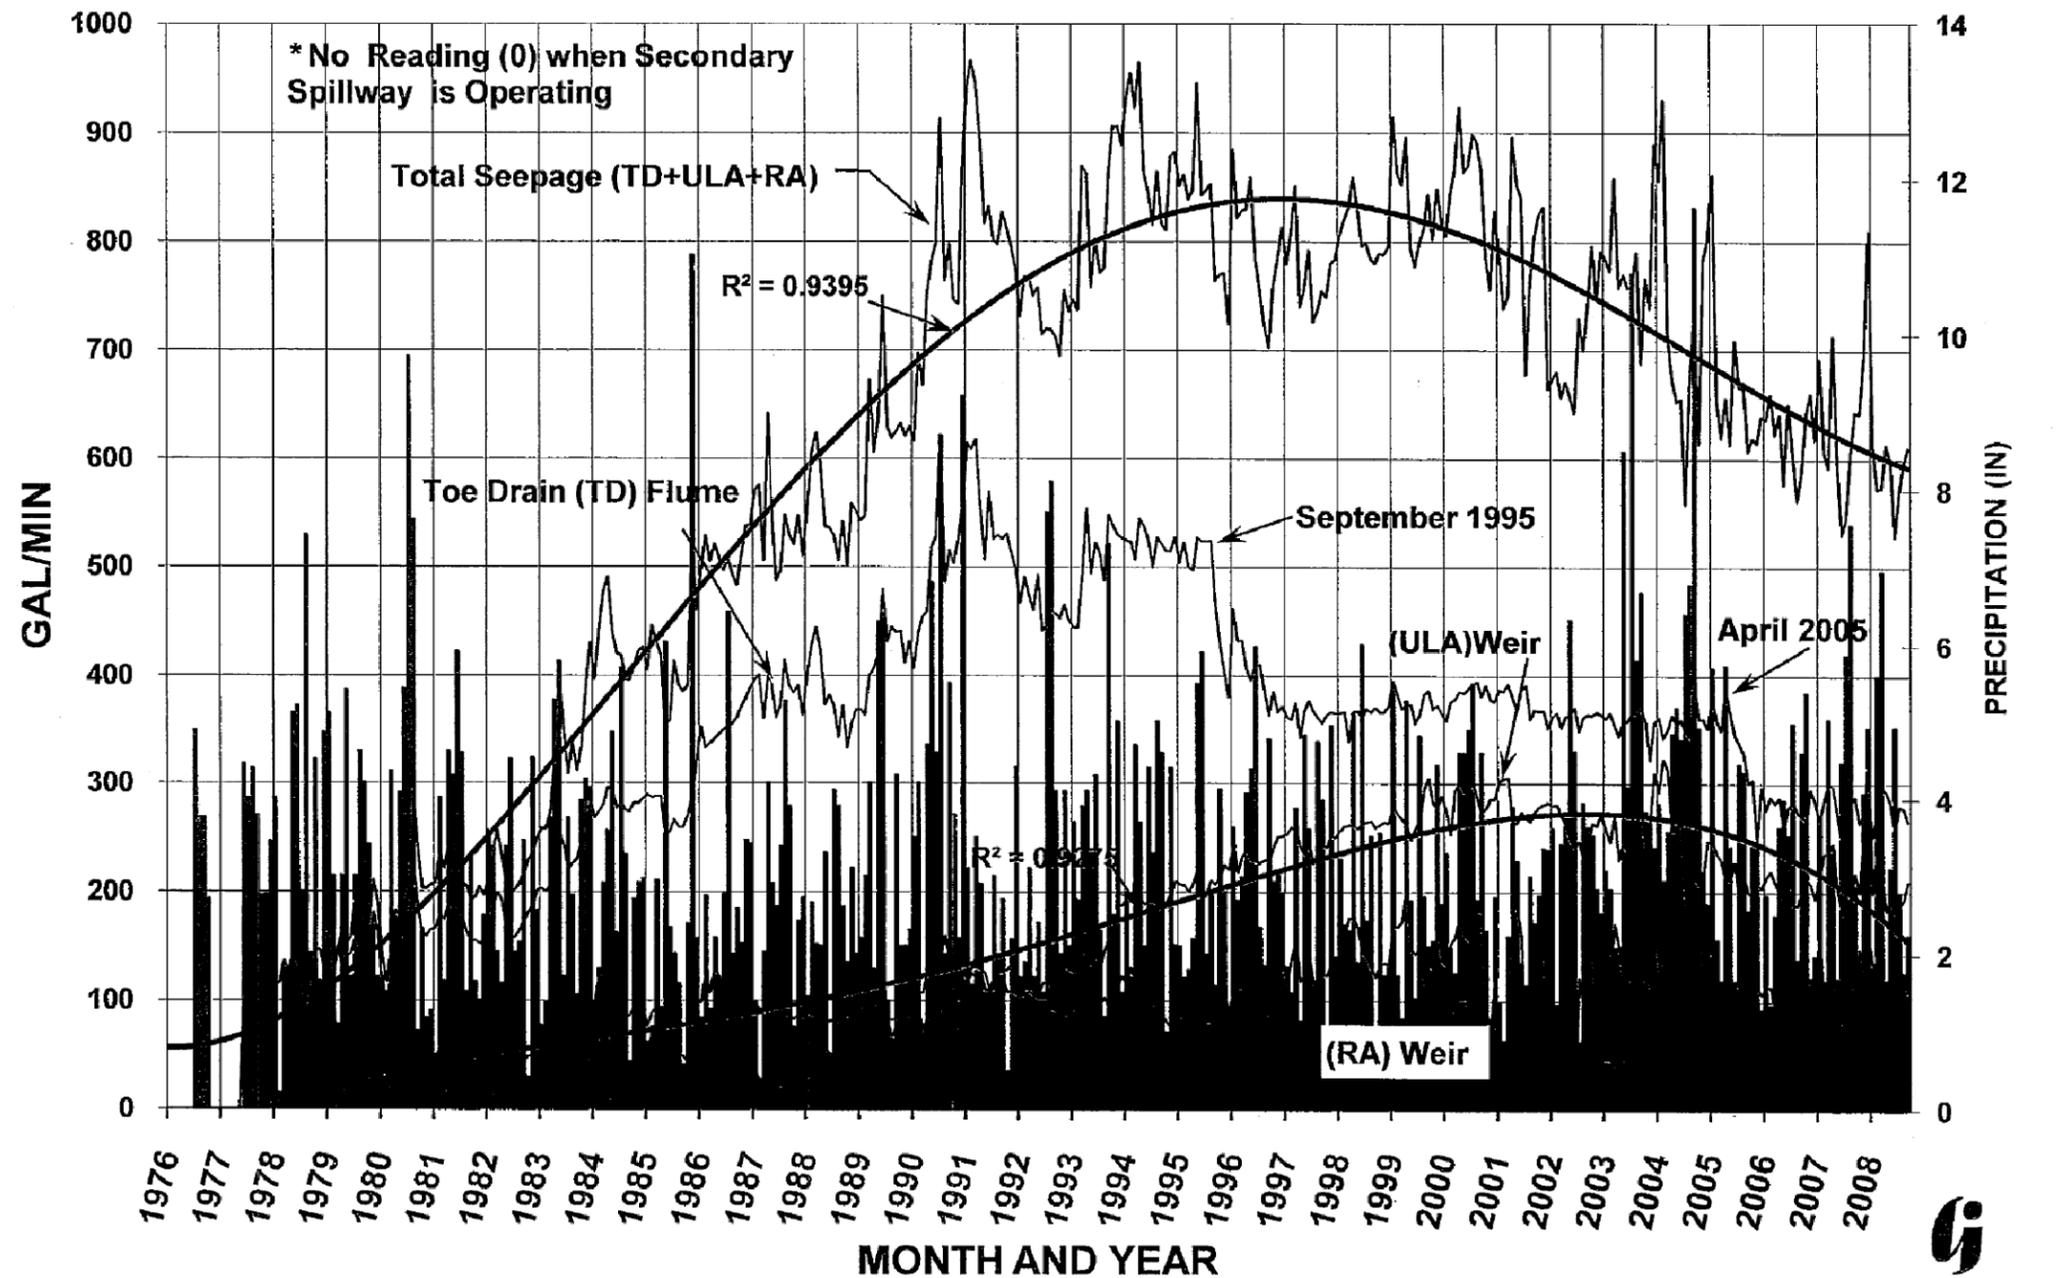
PROJECT NO. 20085.8000
DATE: 12/2009
FIGURE 9A

Discharge through these devices is measured daily. The data is reduced to obtain a monthly average for each device. The monthly average is combined and averaged for the current period to obtain the six-month average. Since weir data includes surface runoff, data collected on days where ½-inch of rainfall has been recorded is not tabulated for the six-month average calculation. The average base flow through the RA Weir is plotted for data collected only when the secondary spillway is not discharging. Plots of seepage from these weirs are shown on Figure 9A and Figure 9B.

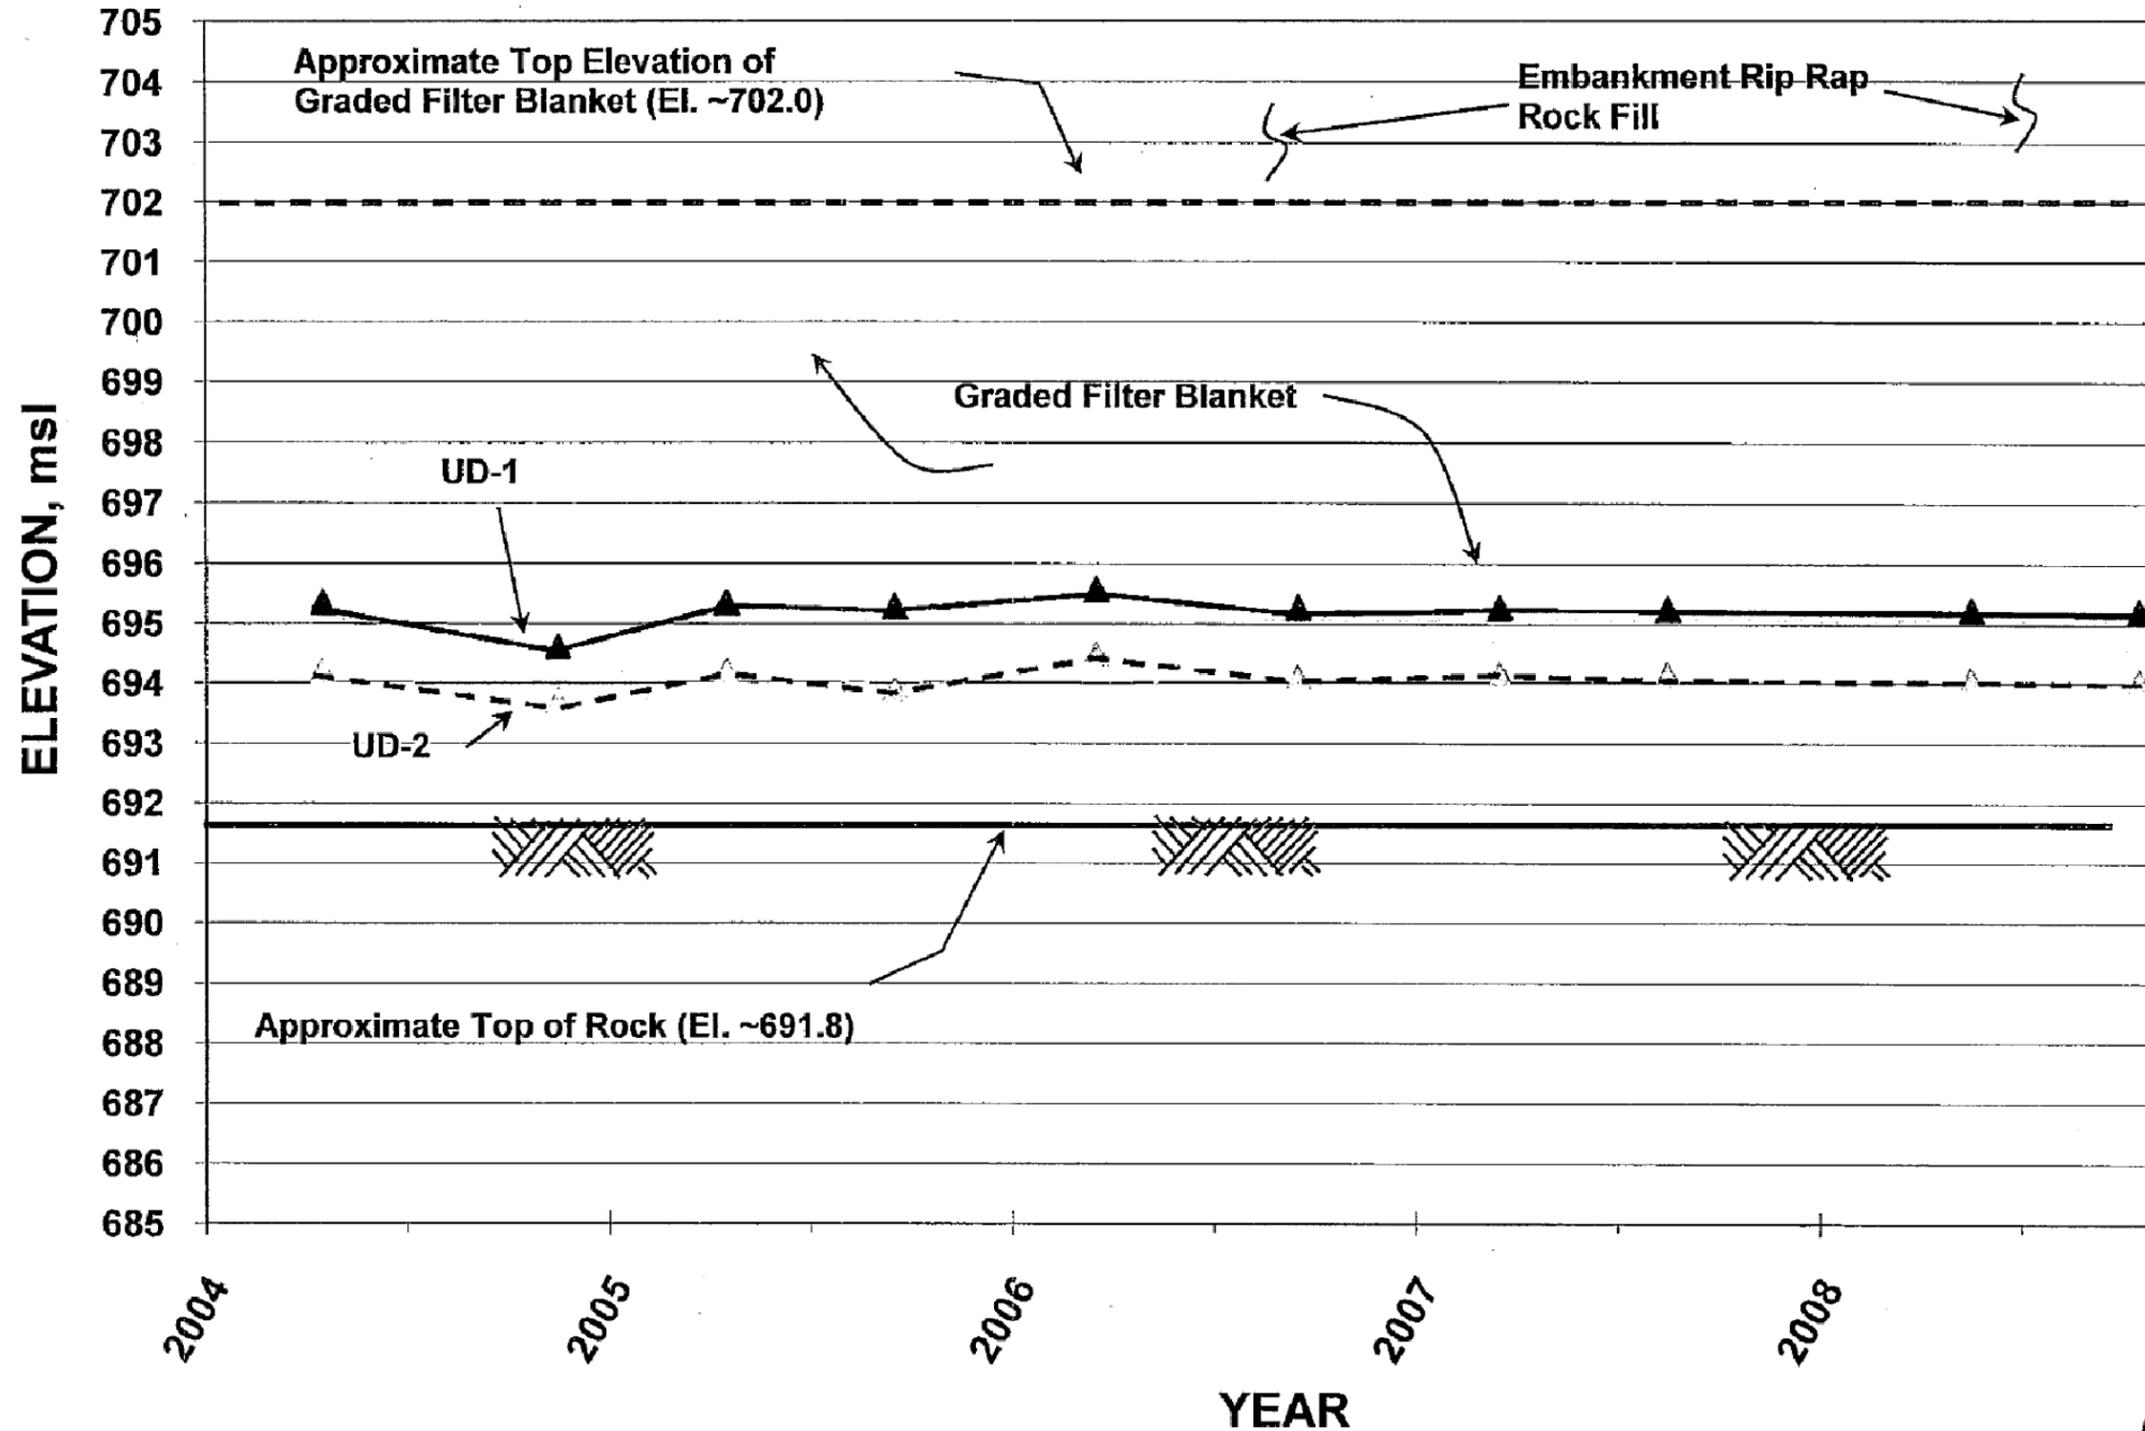
PROJECT NO. 20085.8000
DATE: 12/2009
FIGURE 11C

piezometers and Figures 11A through 11C shows the piezometer data from 2000 to December 2008.

TOE DRAIN PIEZOMETERS UD-1 AND UD-2 LITTLE BLUE RUN DAM

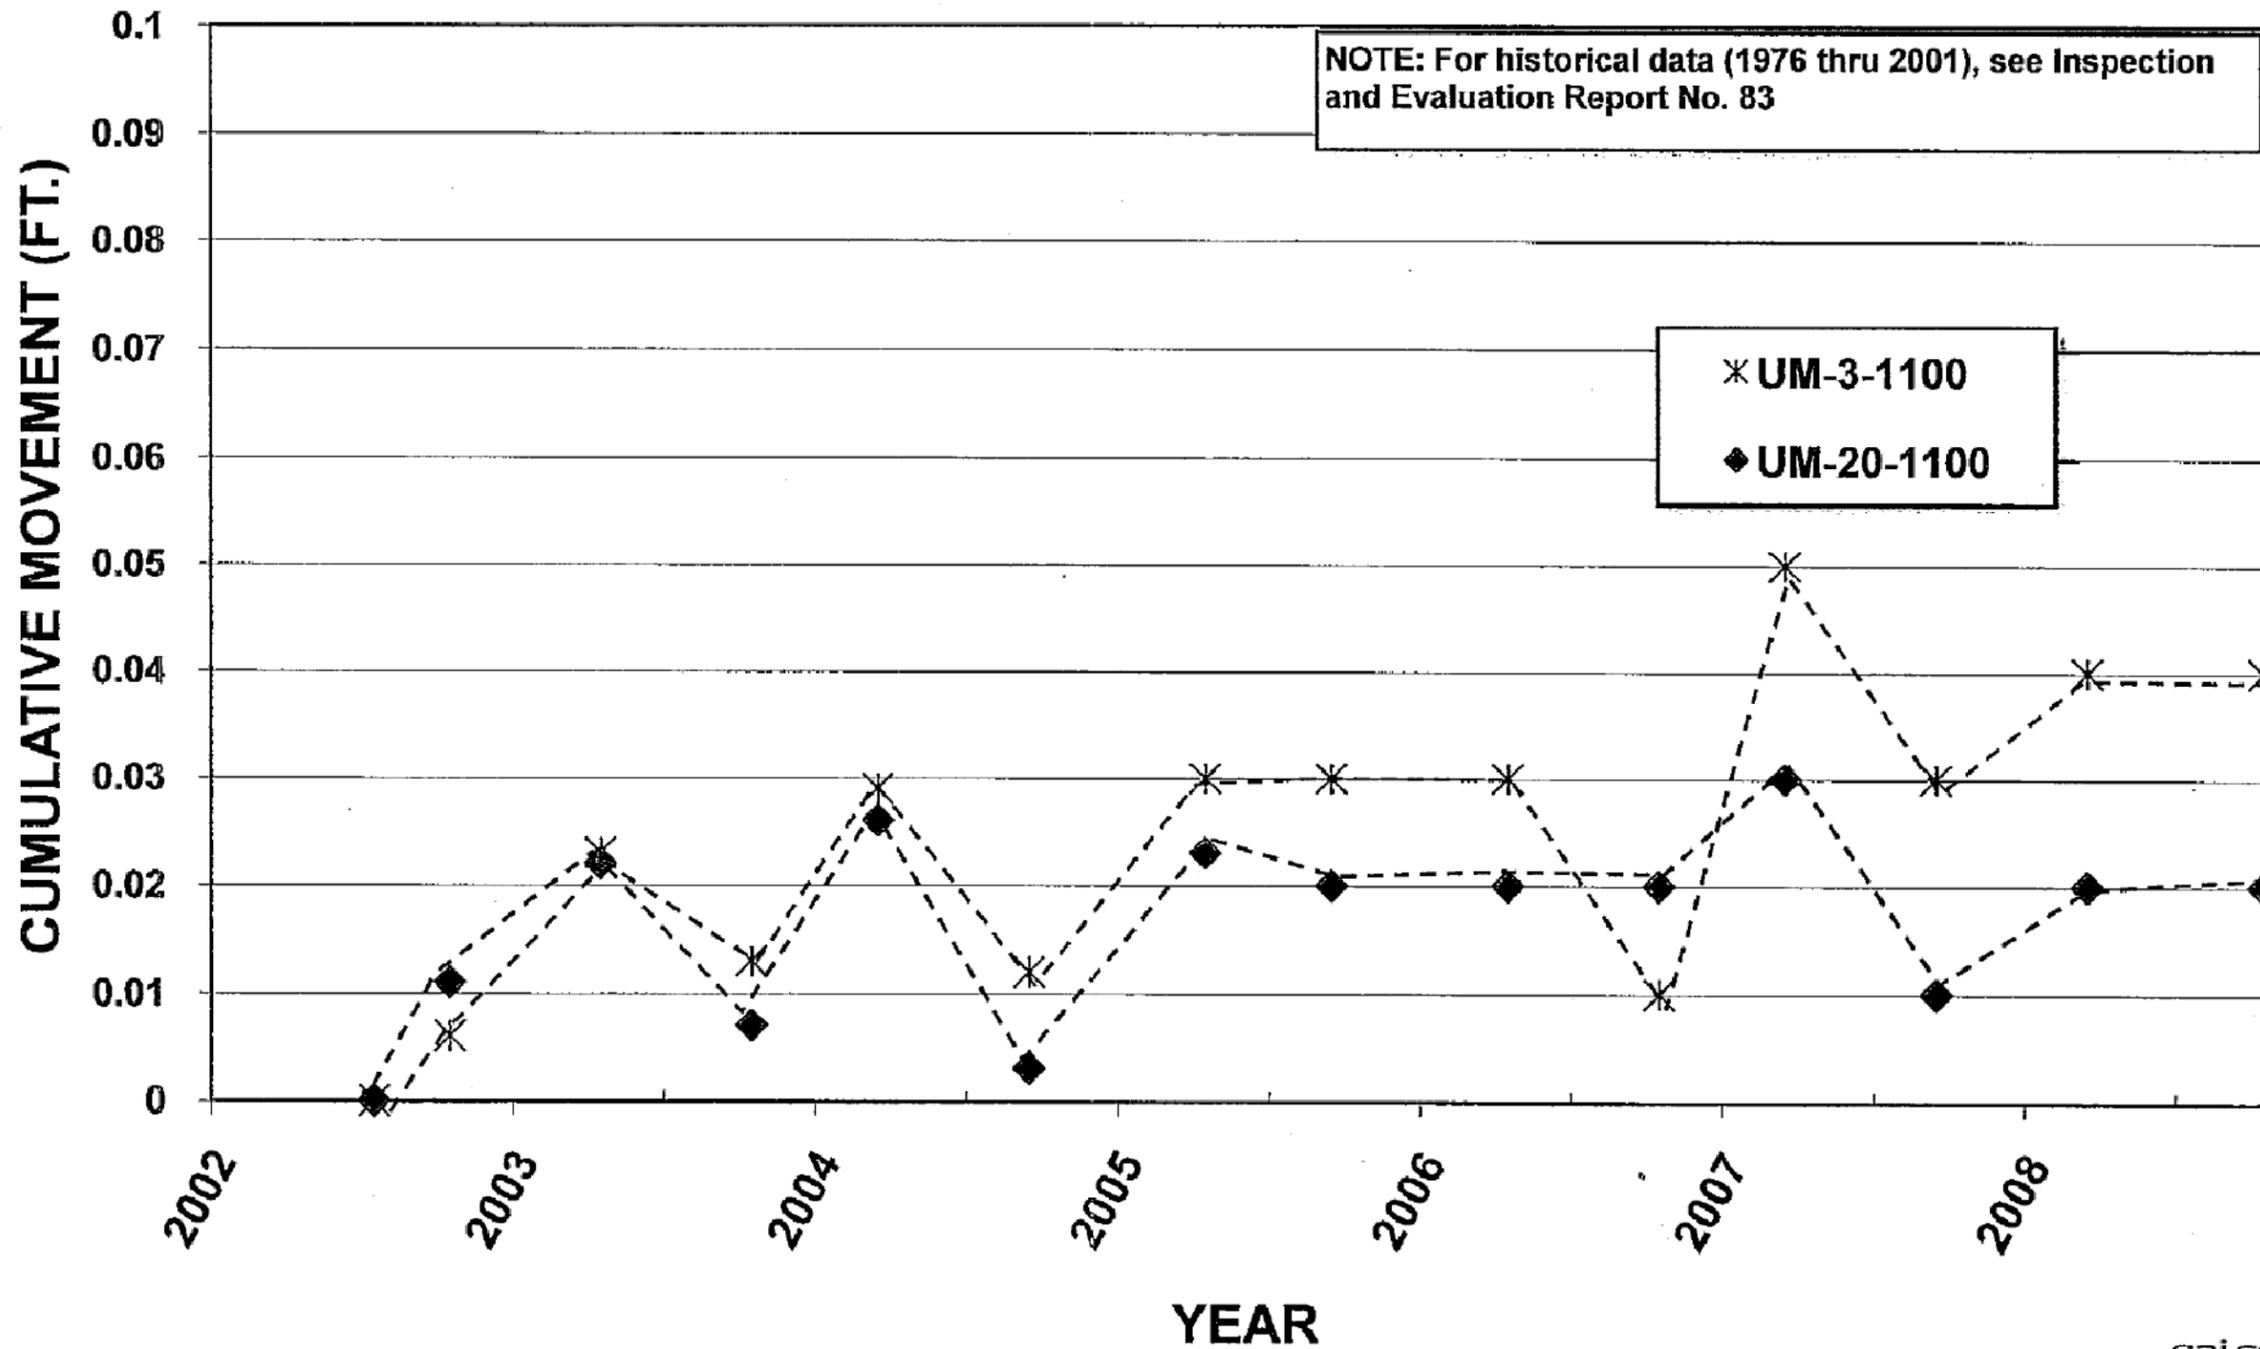
PROJECT NO. 20085.8000
DATE: 12/2009
FIGURE 12A

Twenty-two surface monuments are currently being monitored for vertical and horizontal movement; 13 downstream monuments and 9 upstream monuments. Surface monument data is presented in Figures 12A through 12J from 2002 to March 2008. The surface monuments were surveyed on March 11, 2008. The inspection and evaluation report dated December 10, 2008 prepared by GAI Consultants notes that no evidence of embankment instability has been detected or observed. It should be noted that settlement values reported prior to 2001 for the Elevation 1100 series of monuments have been negated with respect to the dam crest elevation as a result of the dam embankment camber restoration in 2001.

CUMULATIVE VERTICAL MOVEMENT UPSTREAM MONUMENTS - EL. 1100 LITTLE BLUE RUN DAM

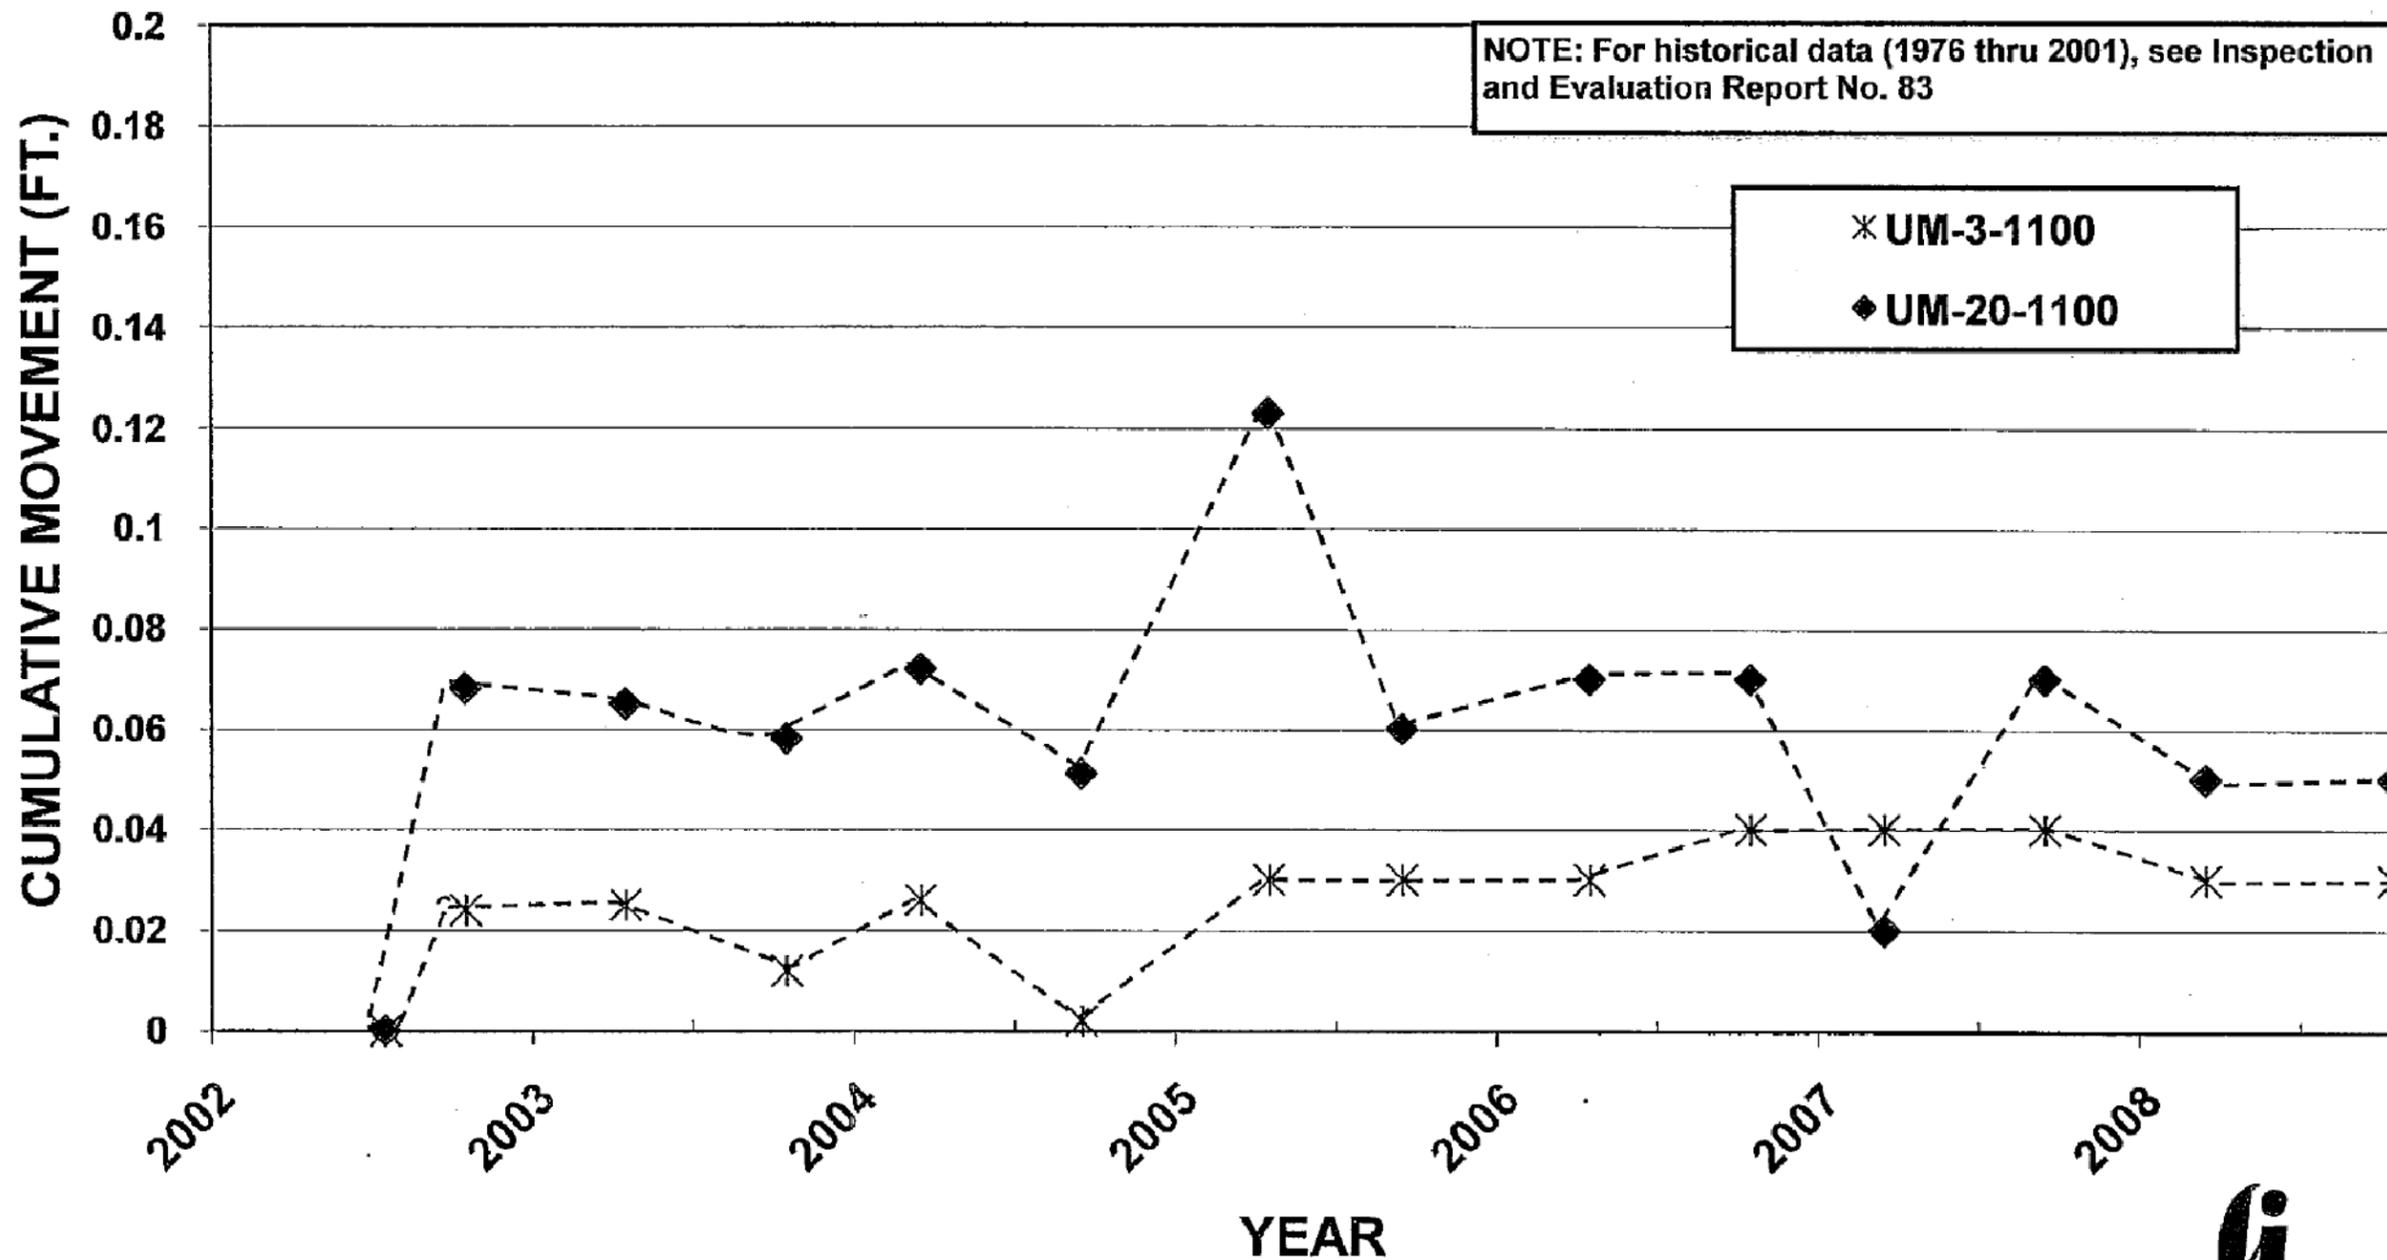
CUMULATIVE HORIZONTAL MOVEMENT UPSTREAM MONUMENTS - EL. 1100 LITTLE BLUE RUN DAM

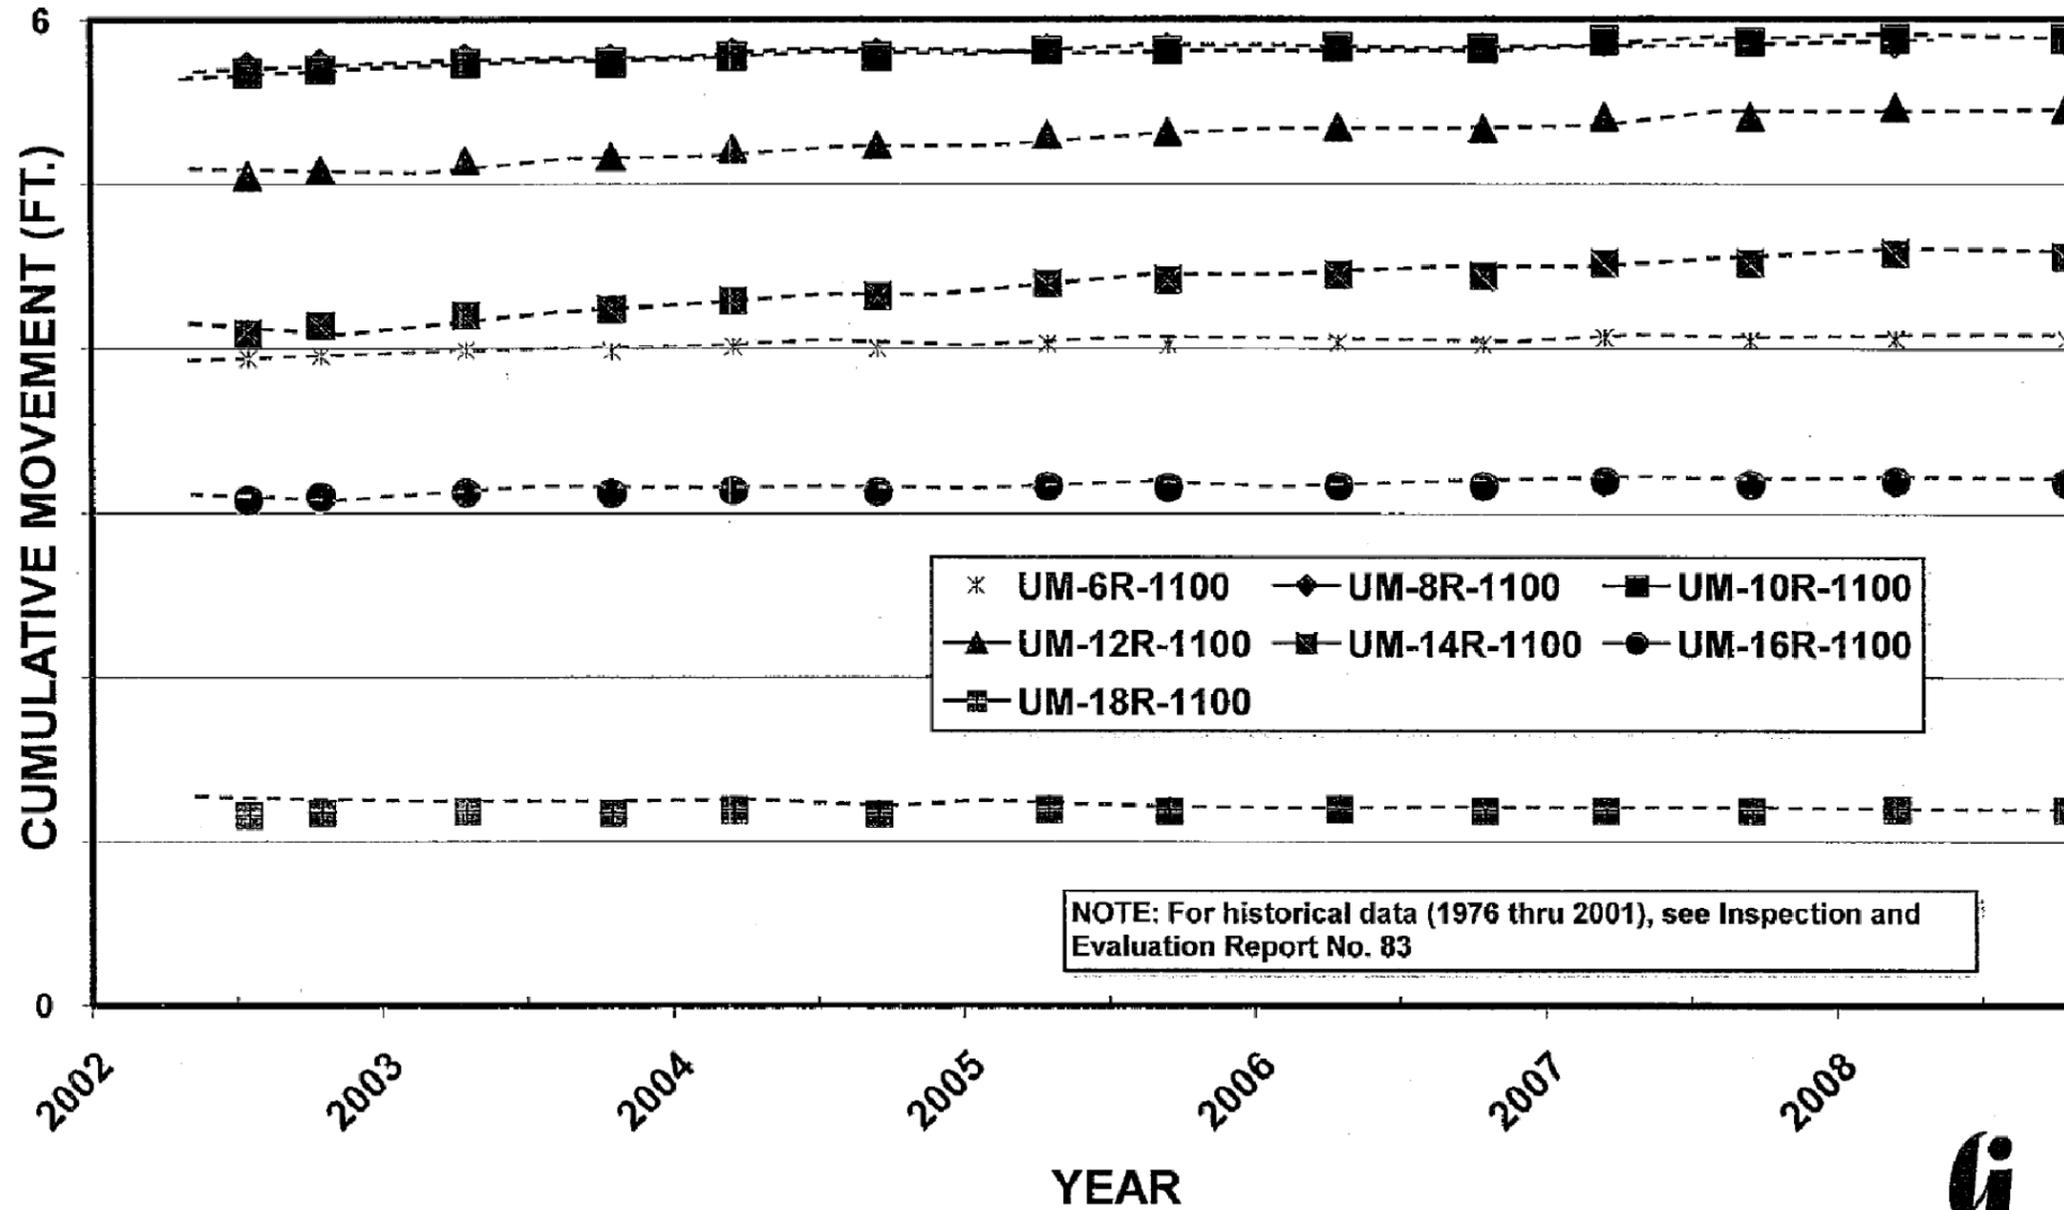
CUMULATIVE VERTICAL MOVEMENT UPSTREAM MONUMENTS - EL. 1100 LITTLE BLUE RUN DAM
