Assessment of Dam Safety Coal Combustion Surface Impoundments (Task 3) Draft Report

FirstEnergy Generation
Corporation

Bruce Mansfield
Power Plant
Little Blue Run Dam
Shippingport, Pennsylvania

December 3, 2009

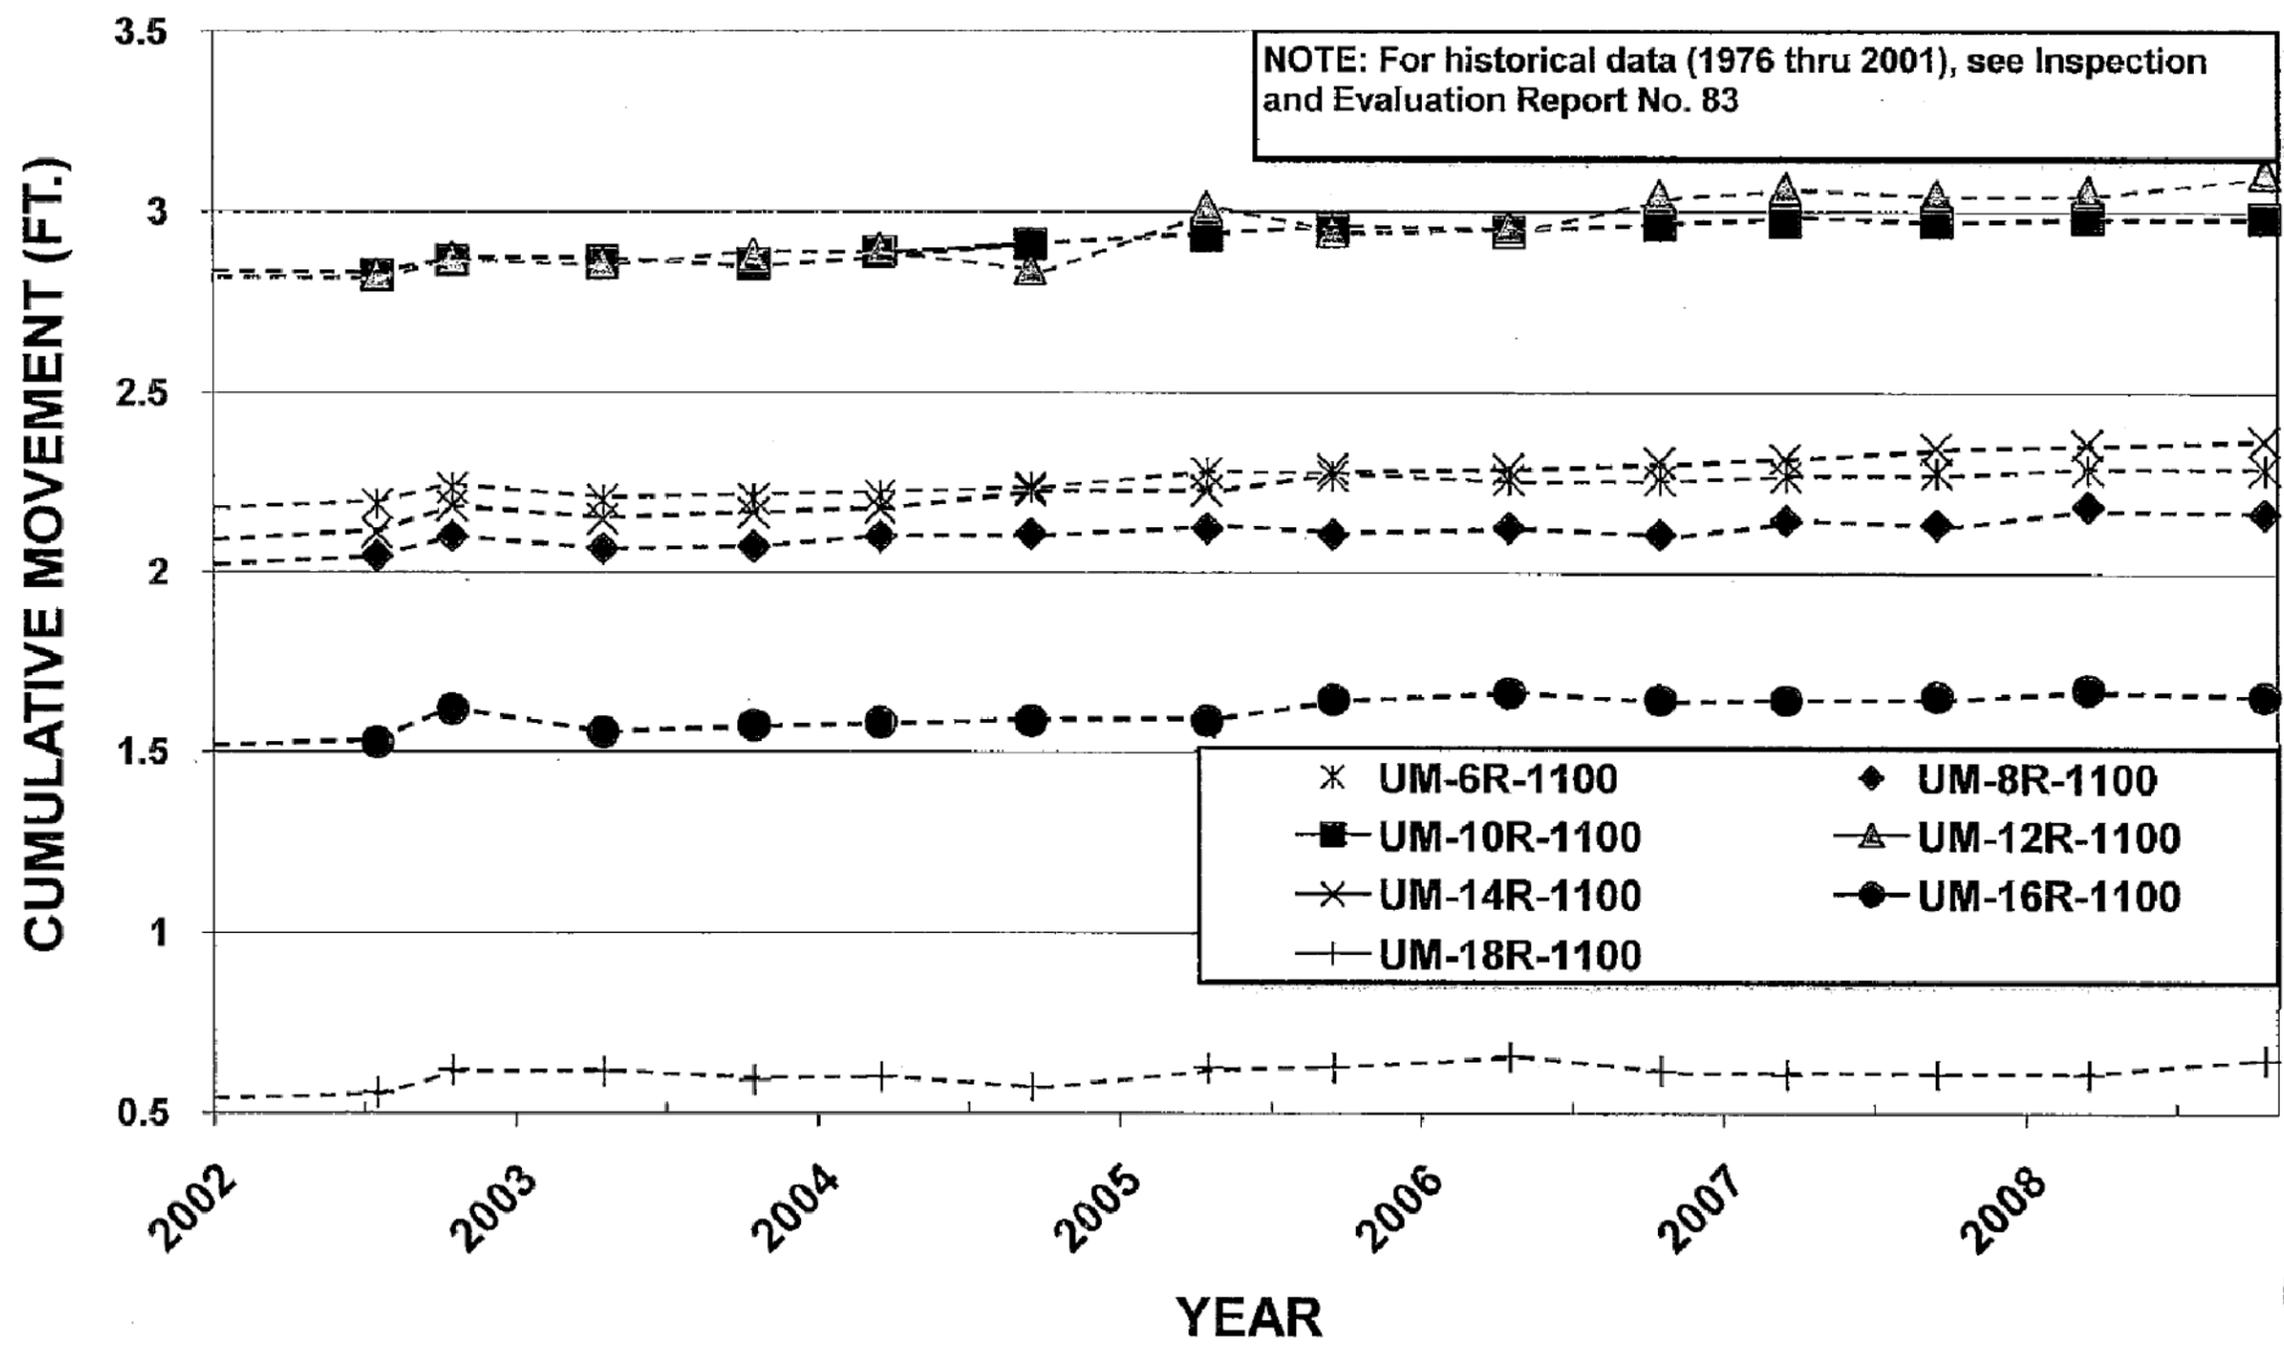
PROJECT NO. 20085.8000
DATE: 12/2009
FIGURE 12D

CUMULATIVE HORIZONTAL MOVEMENT UPSTREAM MONUMENTS - EL. 1100 LITTLE BLUE RUN DAM

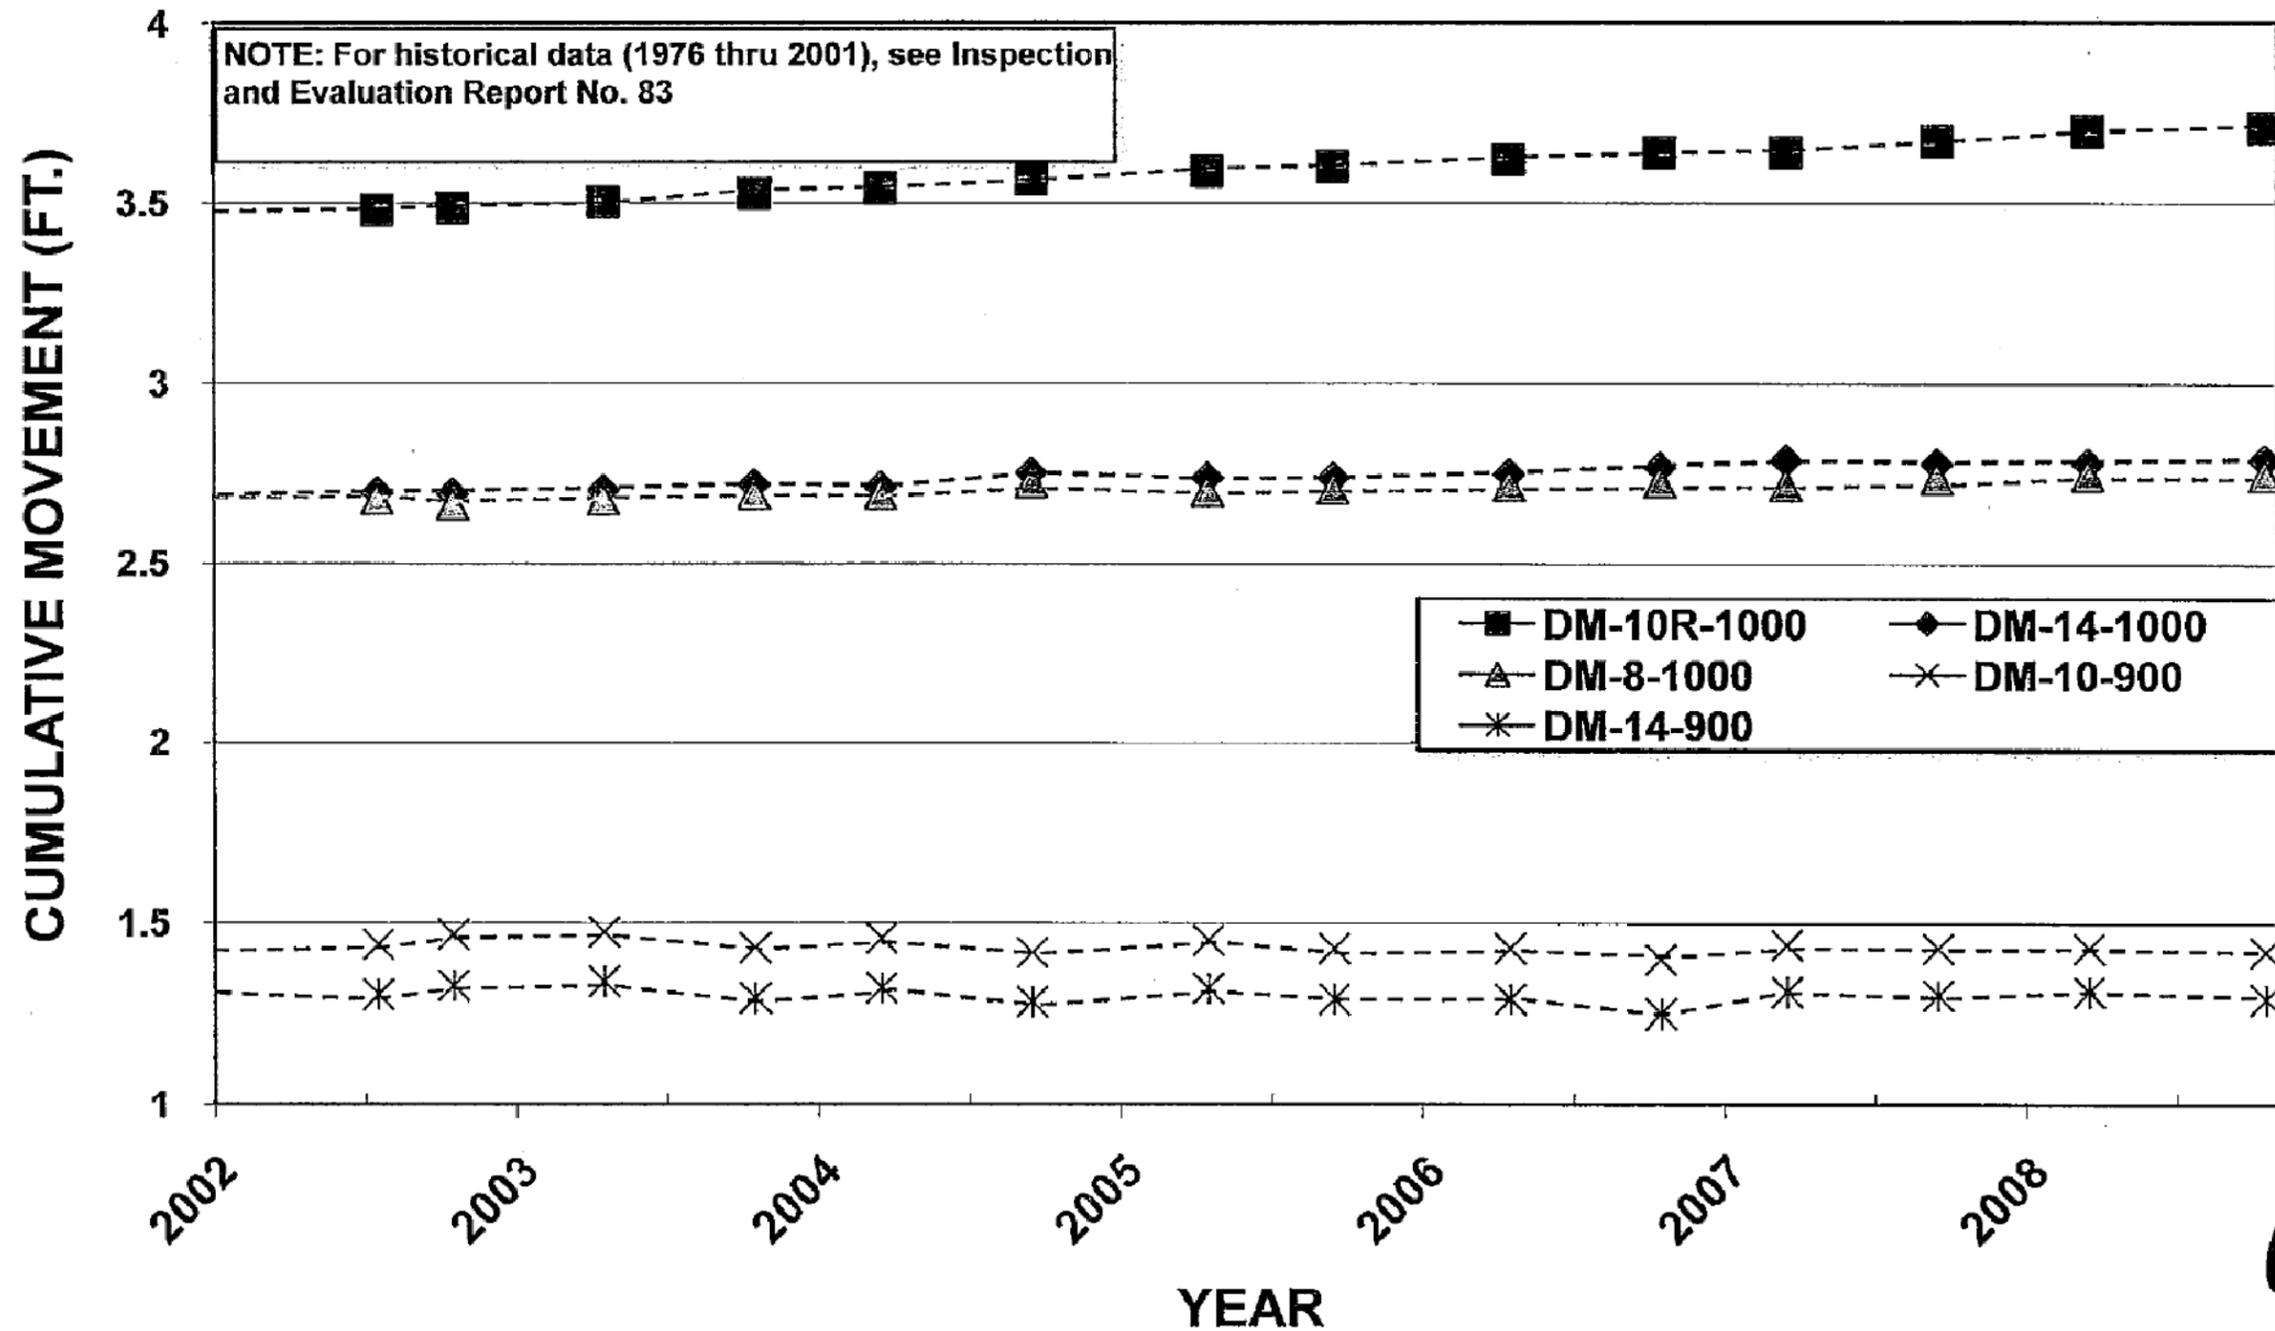
CUMULATIVE VERTICAL MOVEMENT DOWNSTREAM MONUMENTS - EL 1000 & 900 LITTLE BLUE RUN DAM

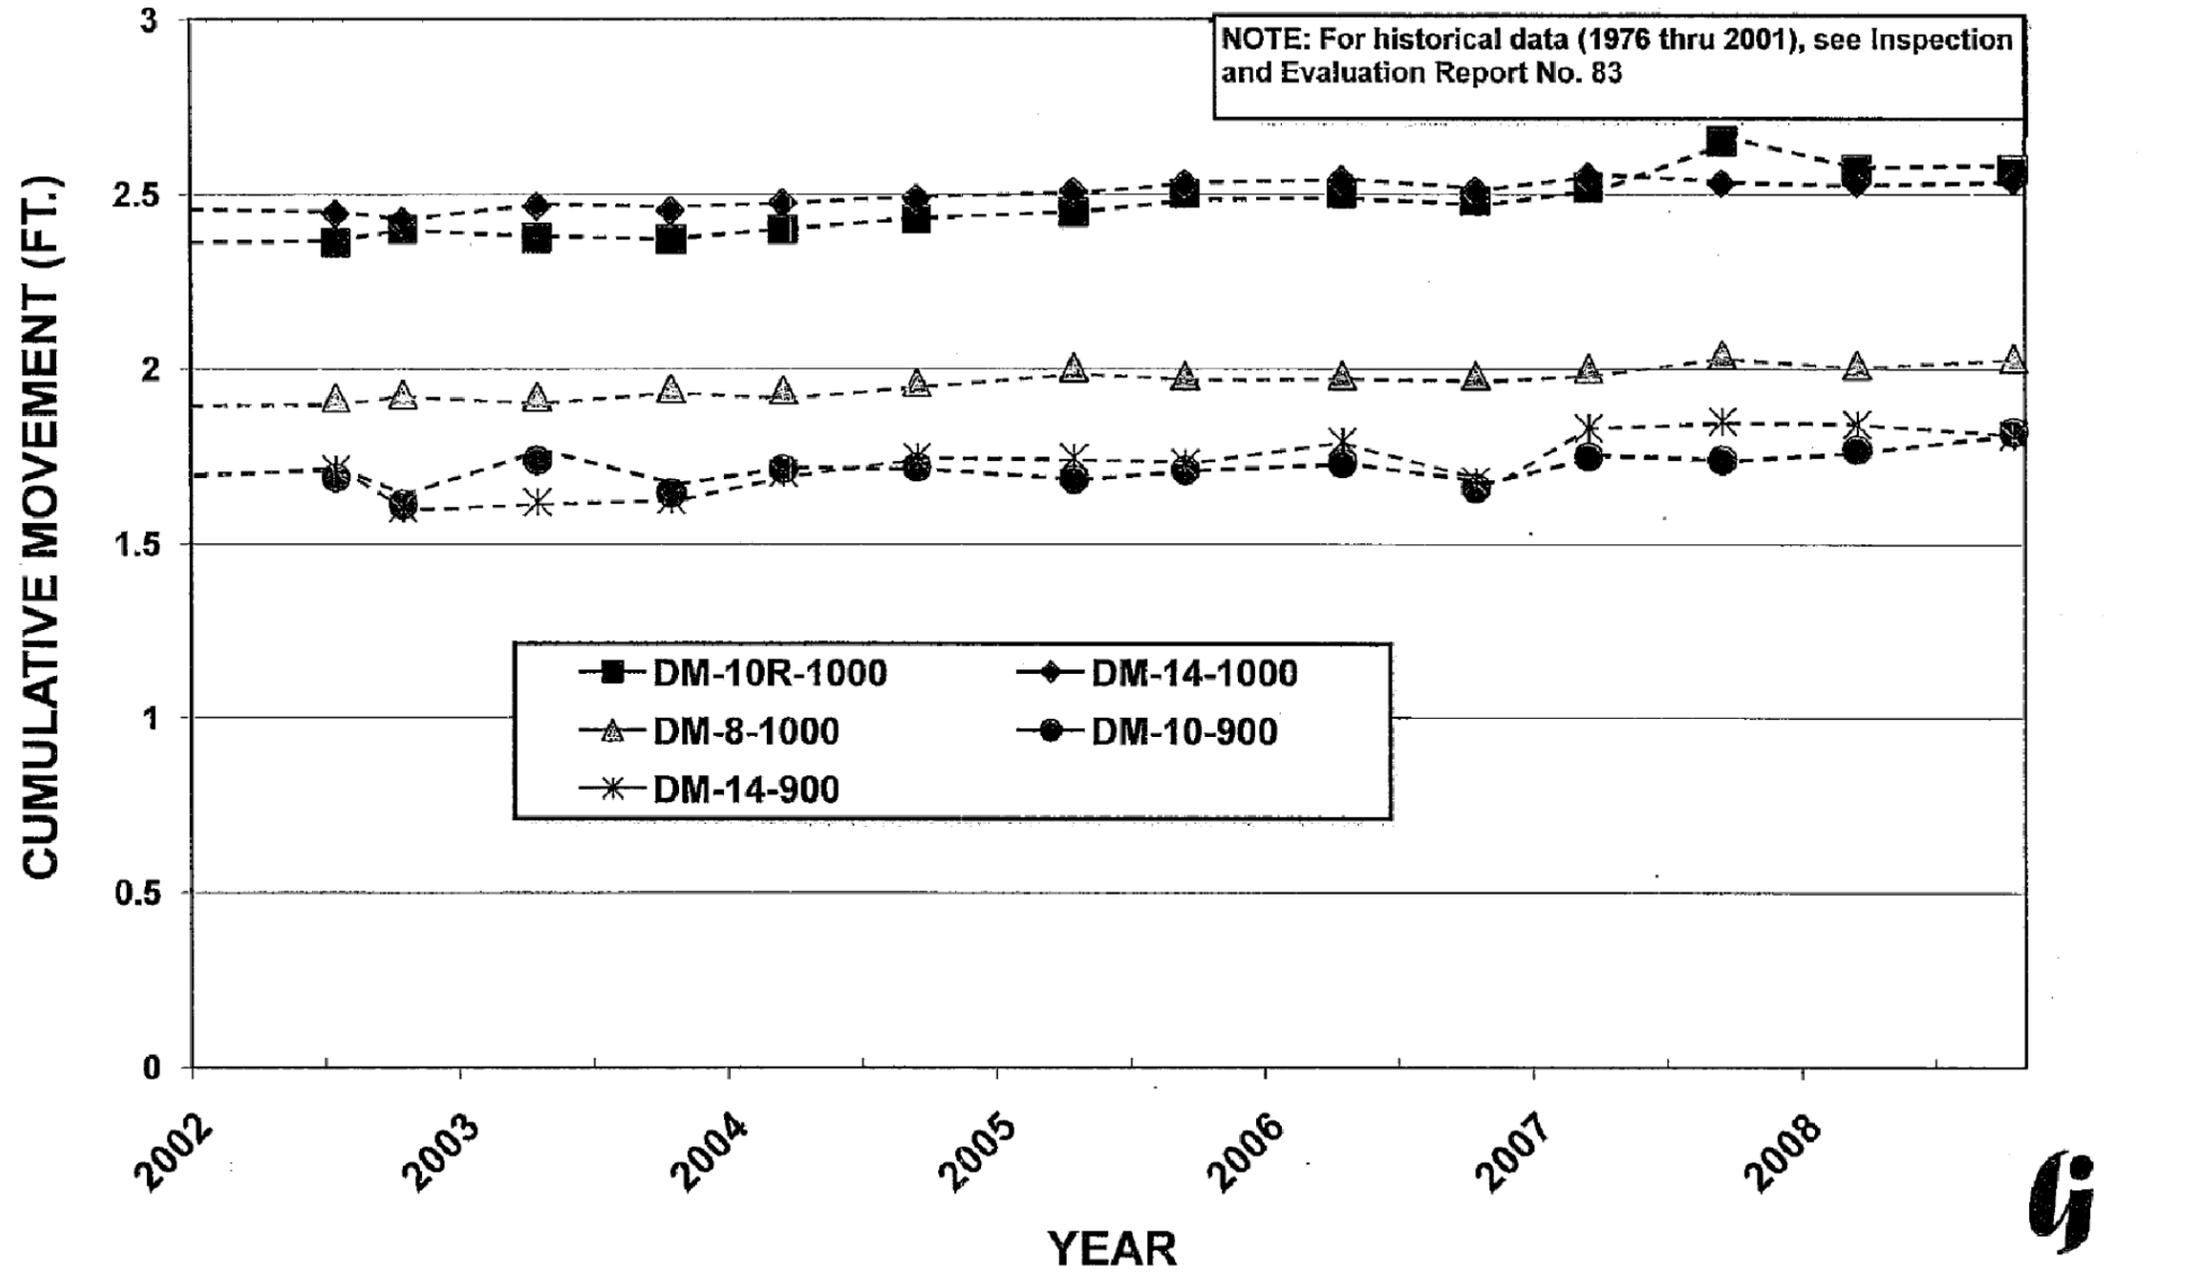
PROJECT NO. 20085.8000
DATE: 12/2009
FIGURE 12F

CUMULATIVE HORIZONTAL MOVEMENT DOWNSTREAM MONUMENTS - EL 1000 & 900 LITTLE BLUE RUN DAM

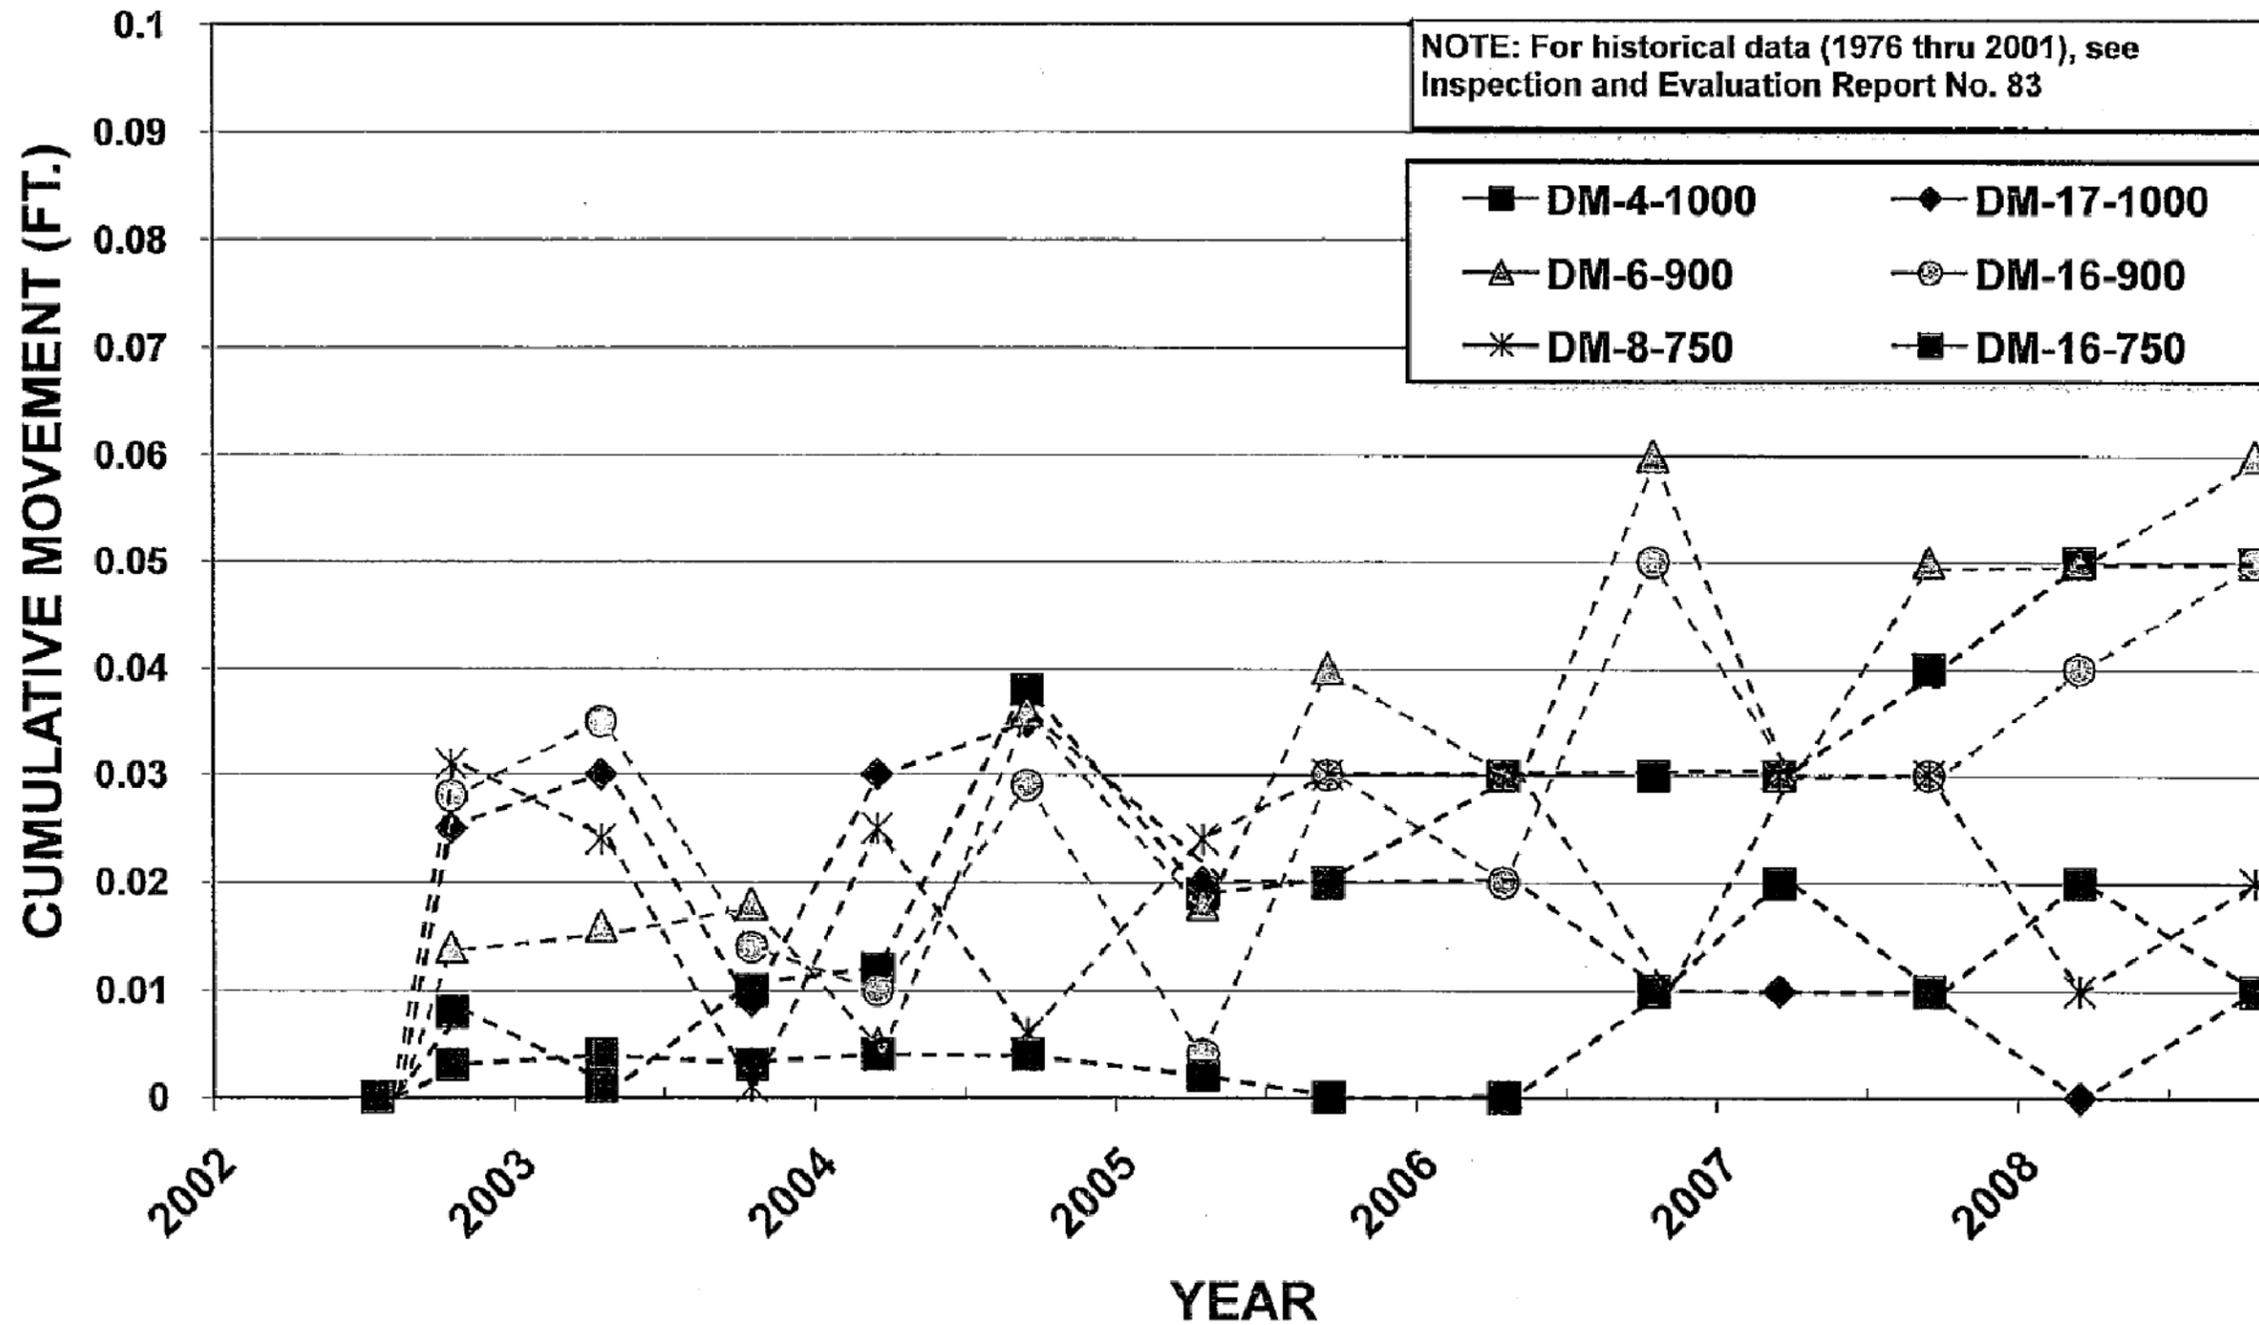
<small>Winners Circle, PO Box 5269 - Albany, NY 12205-0269 Main: (518) 453-4500 - www.chacompanies.com</small>	CUMULATIVE VERTICAL MOVEMENT DOWNSTREAM MONUMENTS - EL. 1000 900 & 750	PROJECT NO. 20085.8000
	LITTLE BLUE RUN DAM SHIPPINGPORT, PENNSYLVANIA	DATE: 12/2009
	FIGURE 12G

CUMULATIVE VERTICAL MOVEMENT DOWNSTREAM MONUMENTS - EL 1000, 900 & 750 LITTLE BLUE RUN DAM

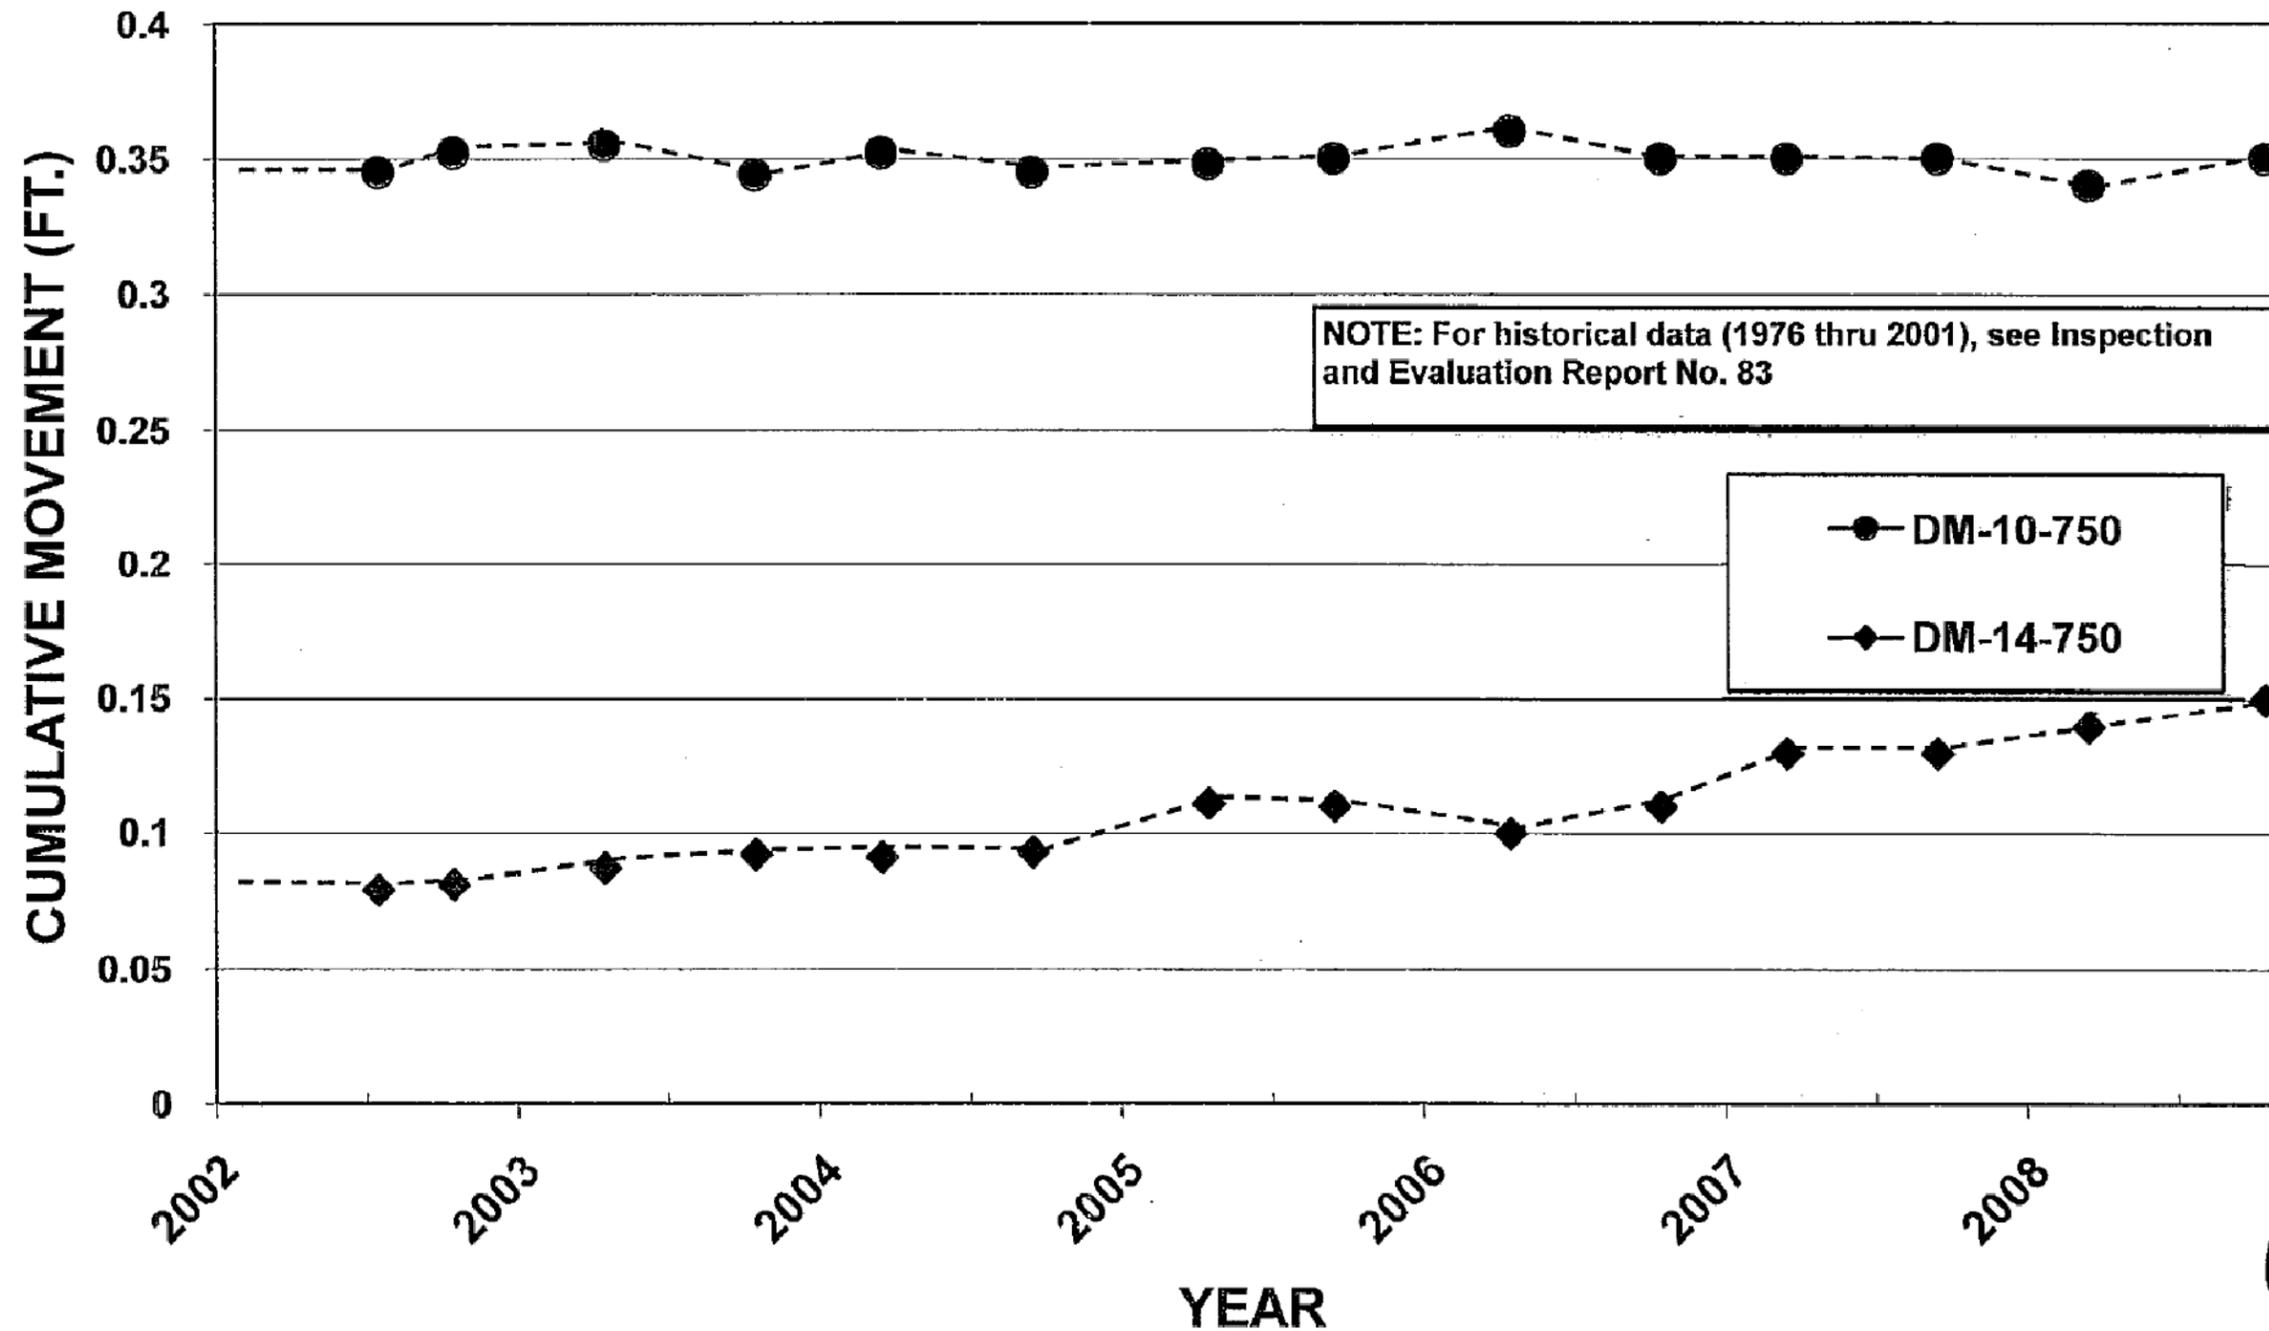
CUMULATIVE VERTICAL MOVEMENT DOWNSTREAM MONUMENTS - EL. 750 LITTLE BLUE RUN DAM

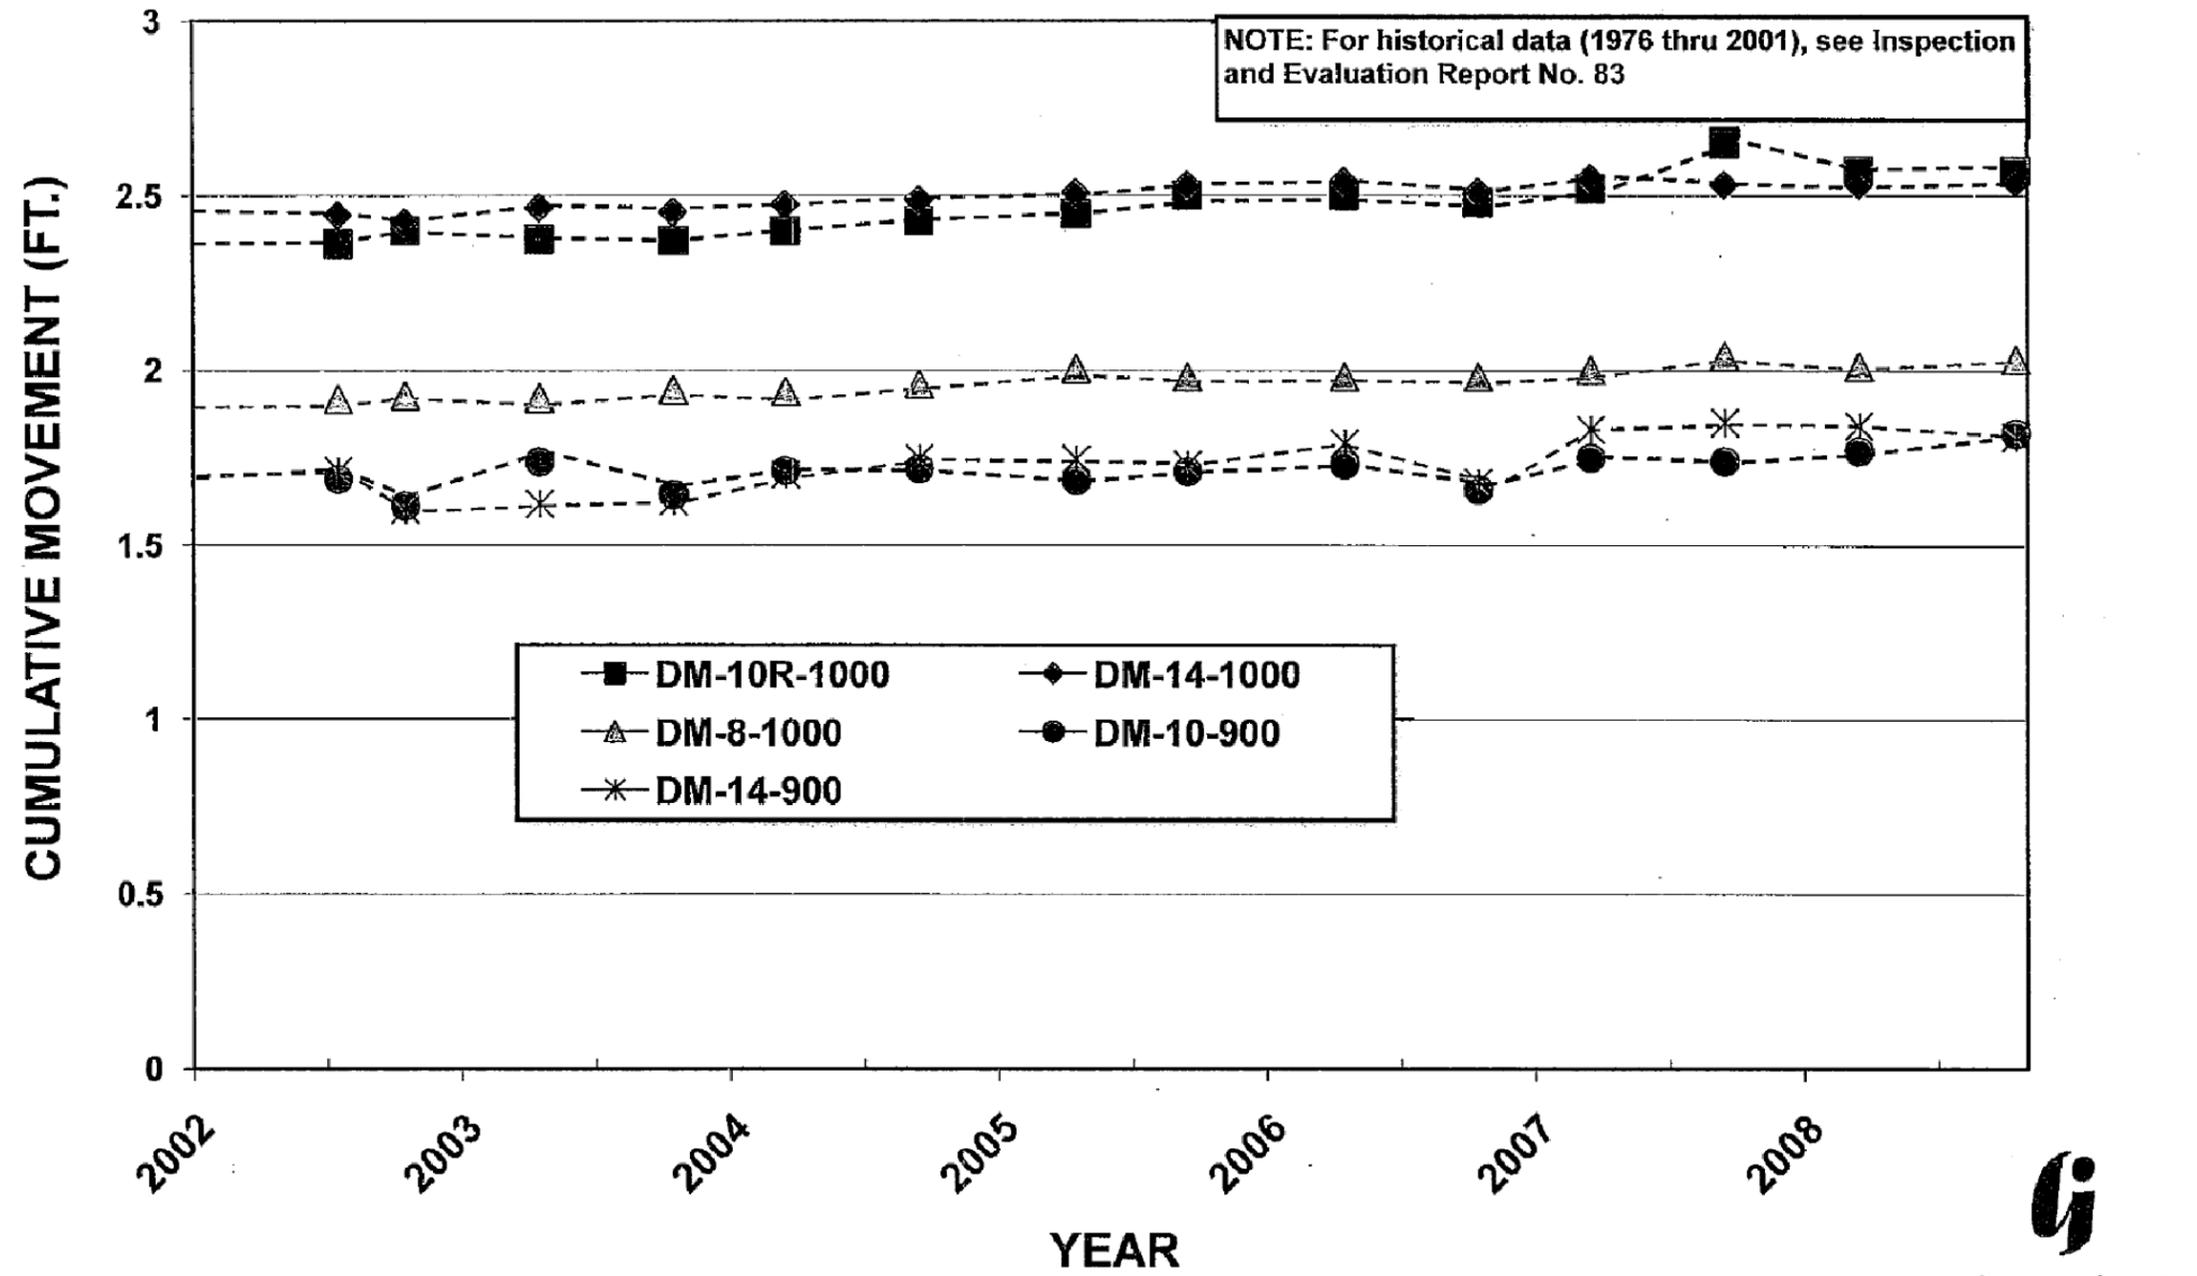
PROJECT NO. 20085.8000
DATE: 12/2009
FIGURE 12J

CUMULATIVE HORIZONTAL MOVEMENT DOWNSTREAM MONUMENTS - EL 1000 & 900 LITTLE BLUE RUN DAM

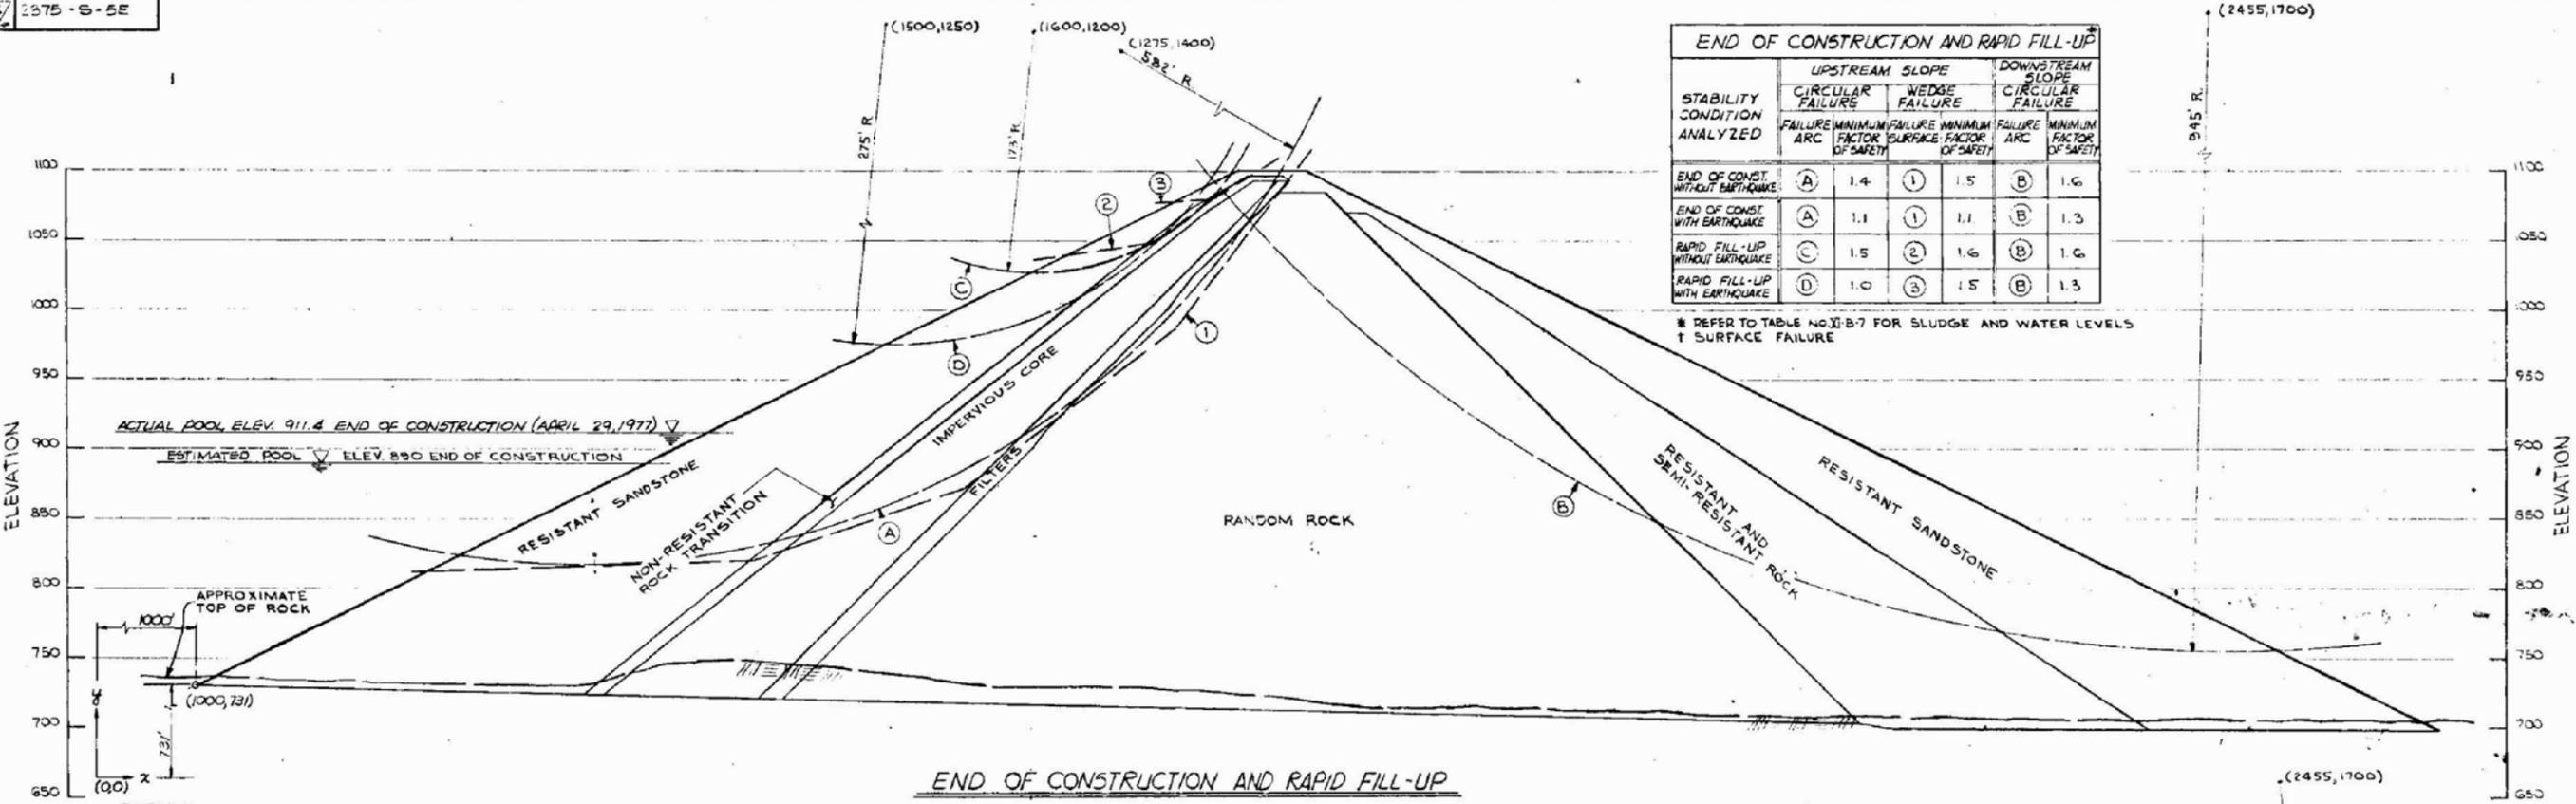
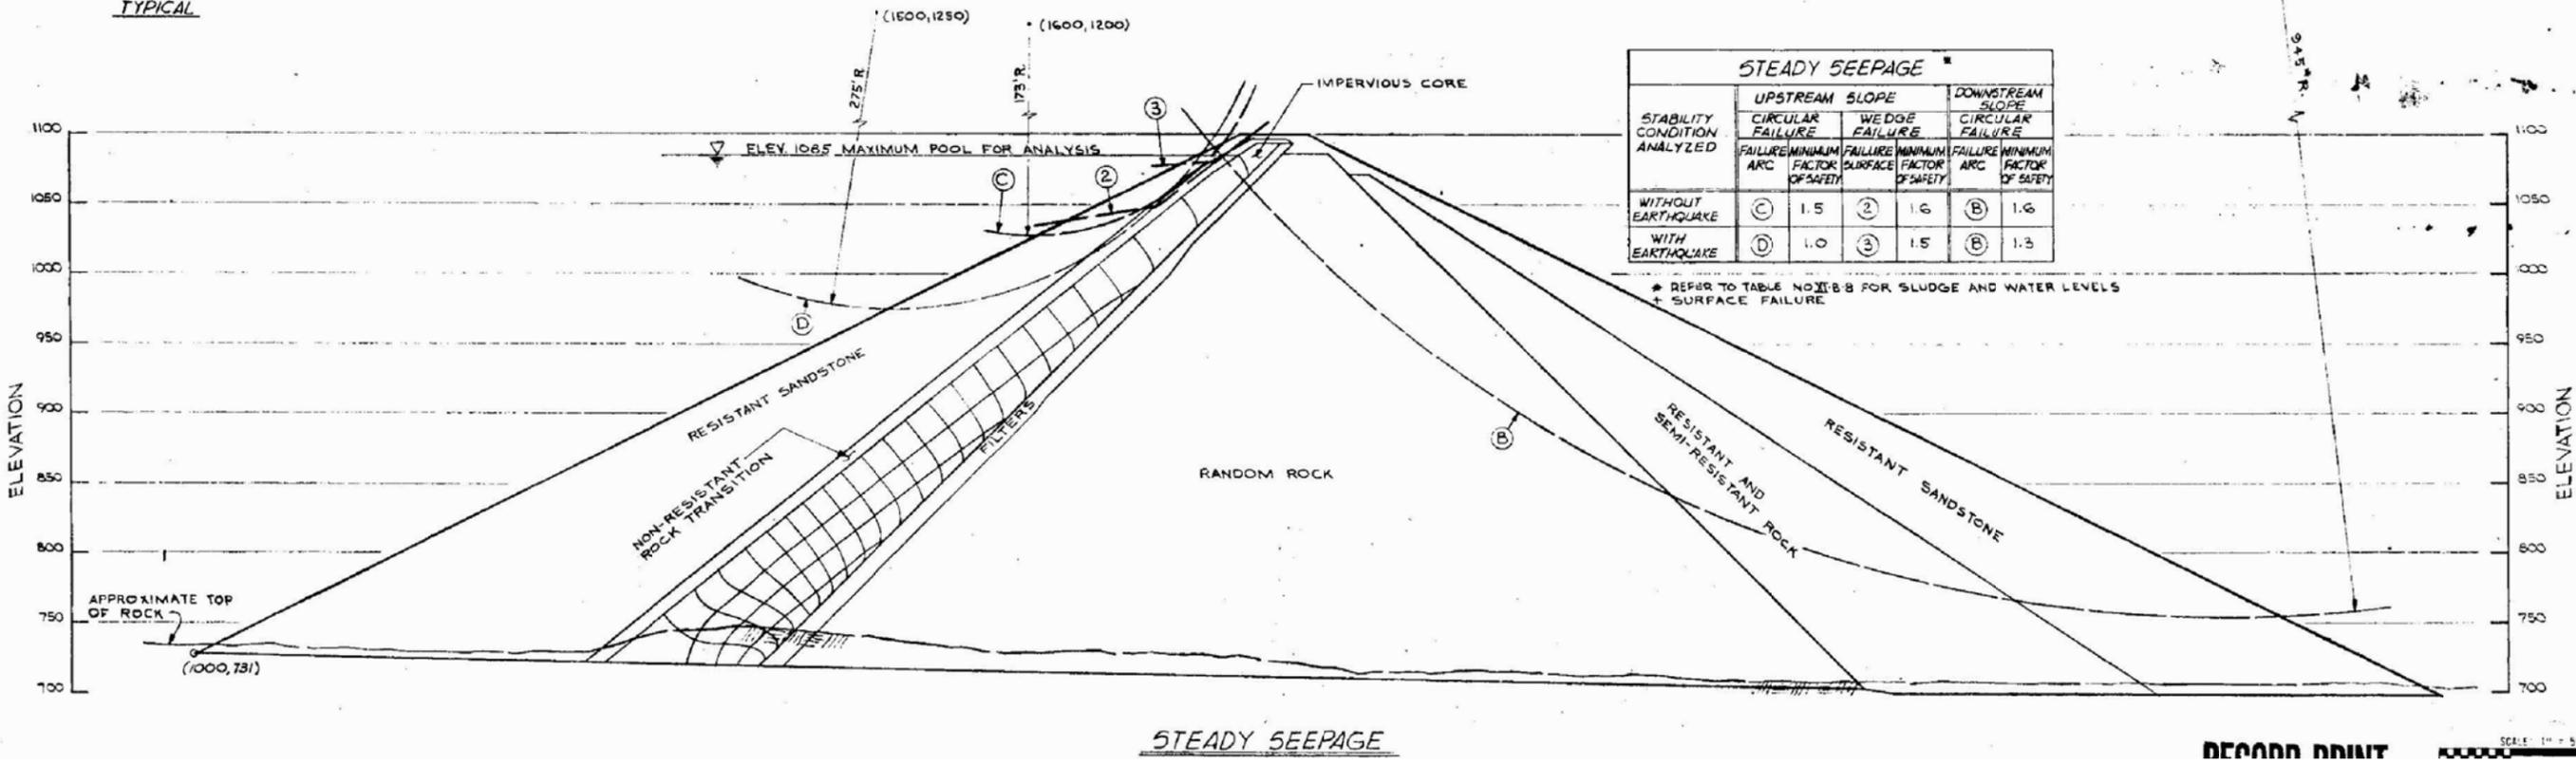
<p>Winners Circle, PO Box 5269 - Albany, NY 12205-0269 Main: (518) 453-4500 • www.chacompanies.com</p>	<p>IMPOUNDMENT DAM STABILITY ANALYSIS</p>	PROJECT NO. 20085.8000
	<p>LITTLE BLUE RUN DAM SHIPPINGPORT, PENNSYLVANIA</p>	DATE: 12/2009
		FIGURE 6

The 1977 As-Built Drawings for the Little Blue Run Dam show engineering analyses results for stability. Figure 6 and Figure 7 show the cross sections modeled and the corresponding results.

Table 4 shows a comparison of the minimum safety factors recommended to the analyses results shown on the 1977 As-Built Drawings.

Minimum Safety Factors Recommended Based on USACOE Guidelines		Engineering Analyses Results Data from 1977 As-Built Drawings
Long-Term – Downstream Slope (Steady state seepage, maximum storage pool elevation)	1.5	1.6
Long-Term – Upstream Slope (Steady state seepage, maximum storage pool elevation)	1.5	1.5
Maximum Surcharge Pool (Flood condition)	1.4	Loading condition not analyzed
Rapid Drawdown (From maximum storage pool elevation)	1.3	1.1
Earthquake Loading – Downstream Slope (Maximum pool elevation)	1.0	1.3
Earthquake Loading – Upstream Slope (Maximum pool elevation)	1.0	1.0
Liquefaction (Analyze potential and safeguard against, if needed)		No conclusion provided to CHA. Subsurface information provided does not appear to suggest liquefaction susceptible soils are found at this site.
