Assessment of Dam Safety

Coal Combustion Surface Impoundments (Task 3)

FirstEnergy Generation
Corporation

Bruce Mansfield
Power Plant
Little Blue Run Dam
Shippingport, Pennsylvania

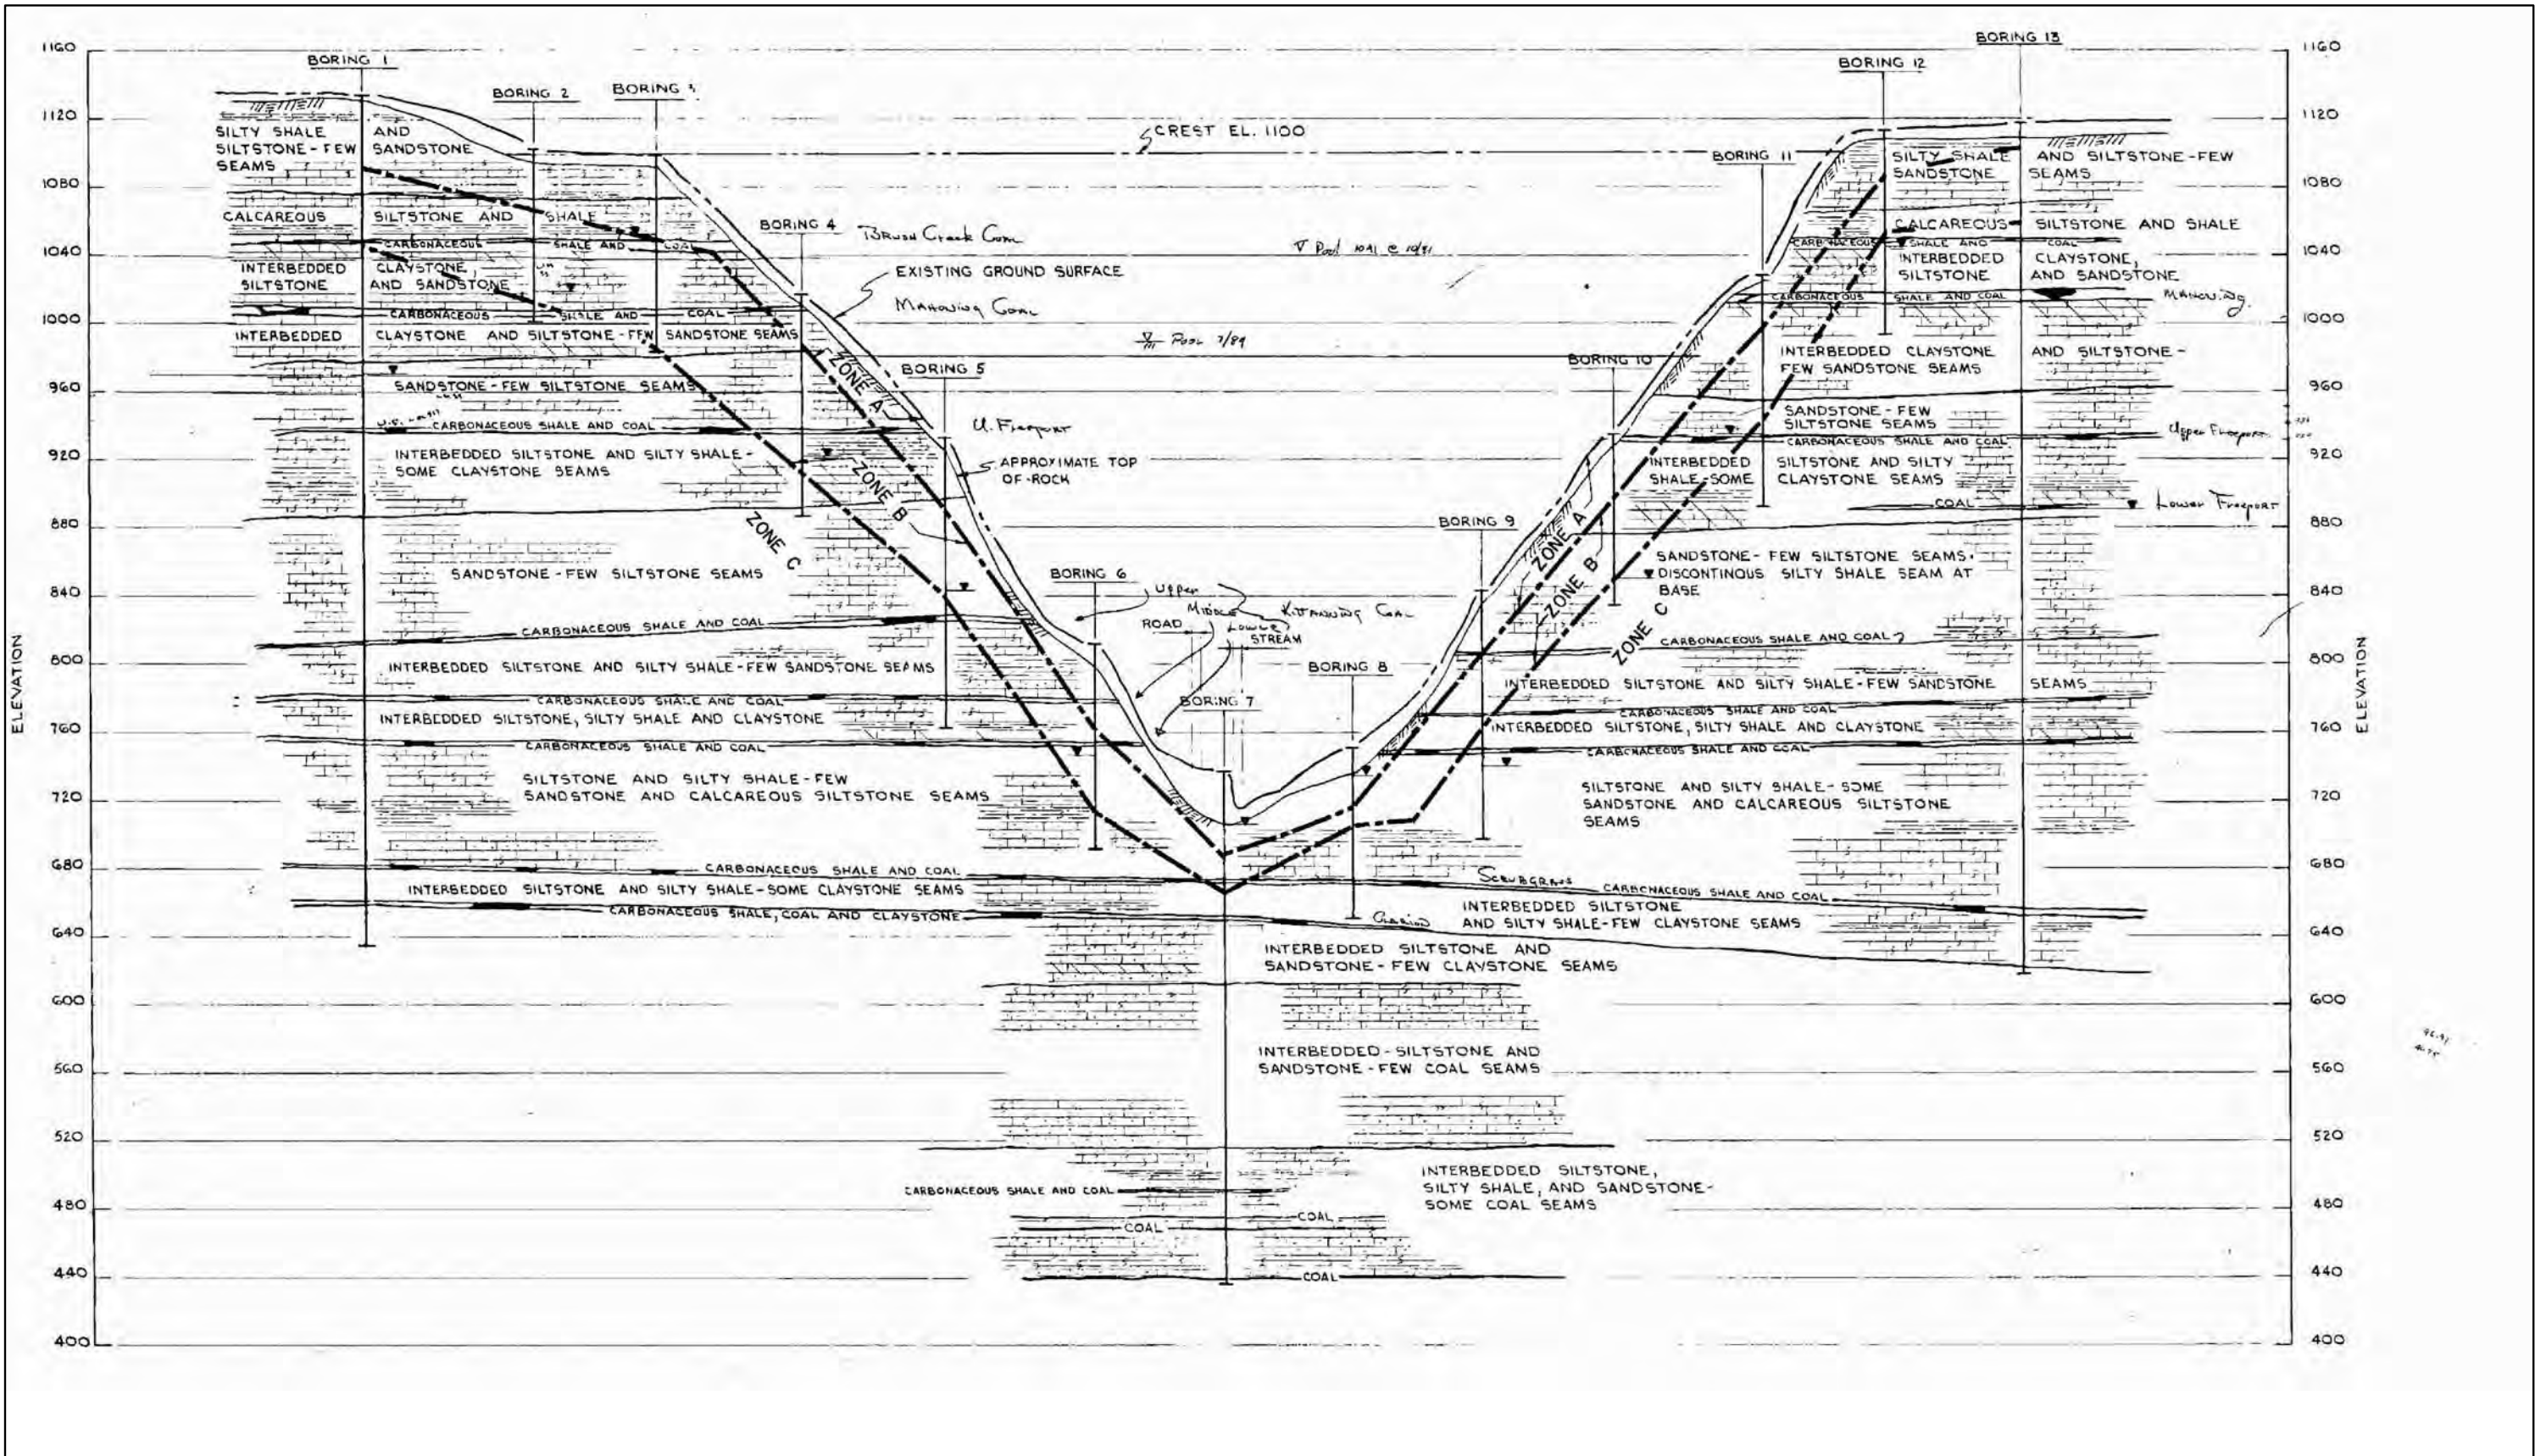
FIGURE 5A

The As-Built drawings note the indication of slickensided surfaces in siltstone core recovery. The drawings also note strata at Elevation 680 feet consists of coal and carbonaceous shale. The *Foundation Treatment for Little Blue Run Dam* notes that there was a series of “county bank” coal mines which penetrated as far as 110 feet into the abutments. Section 3.4 discusses how the coal mines were prepared prior to the construction of the dam. Figures 5A and 5B show generalized geologic sections of the dam in this area.

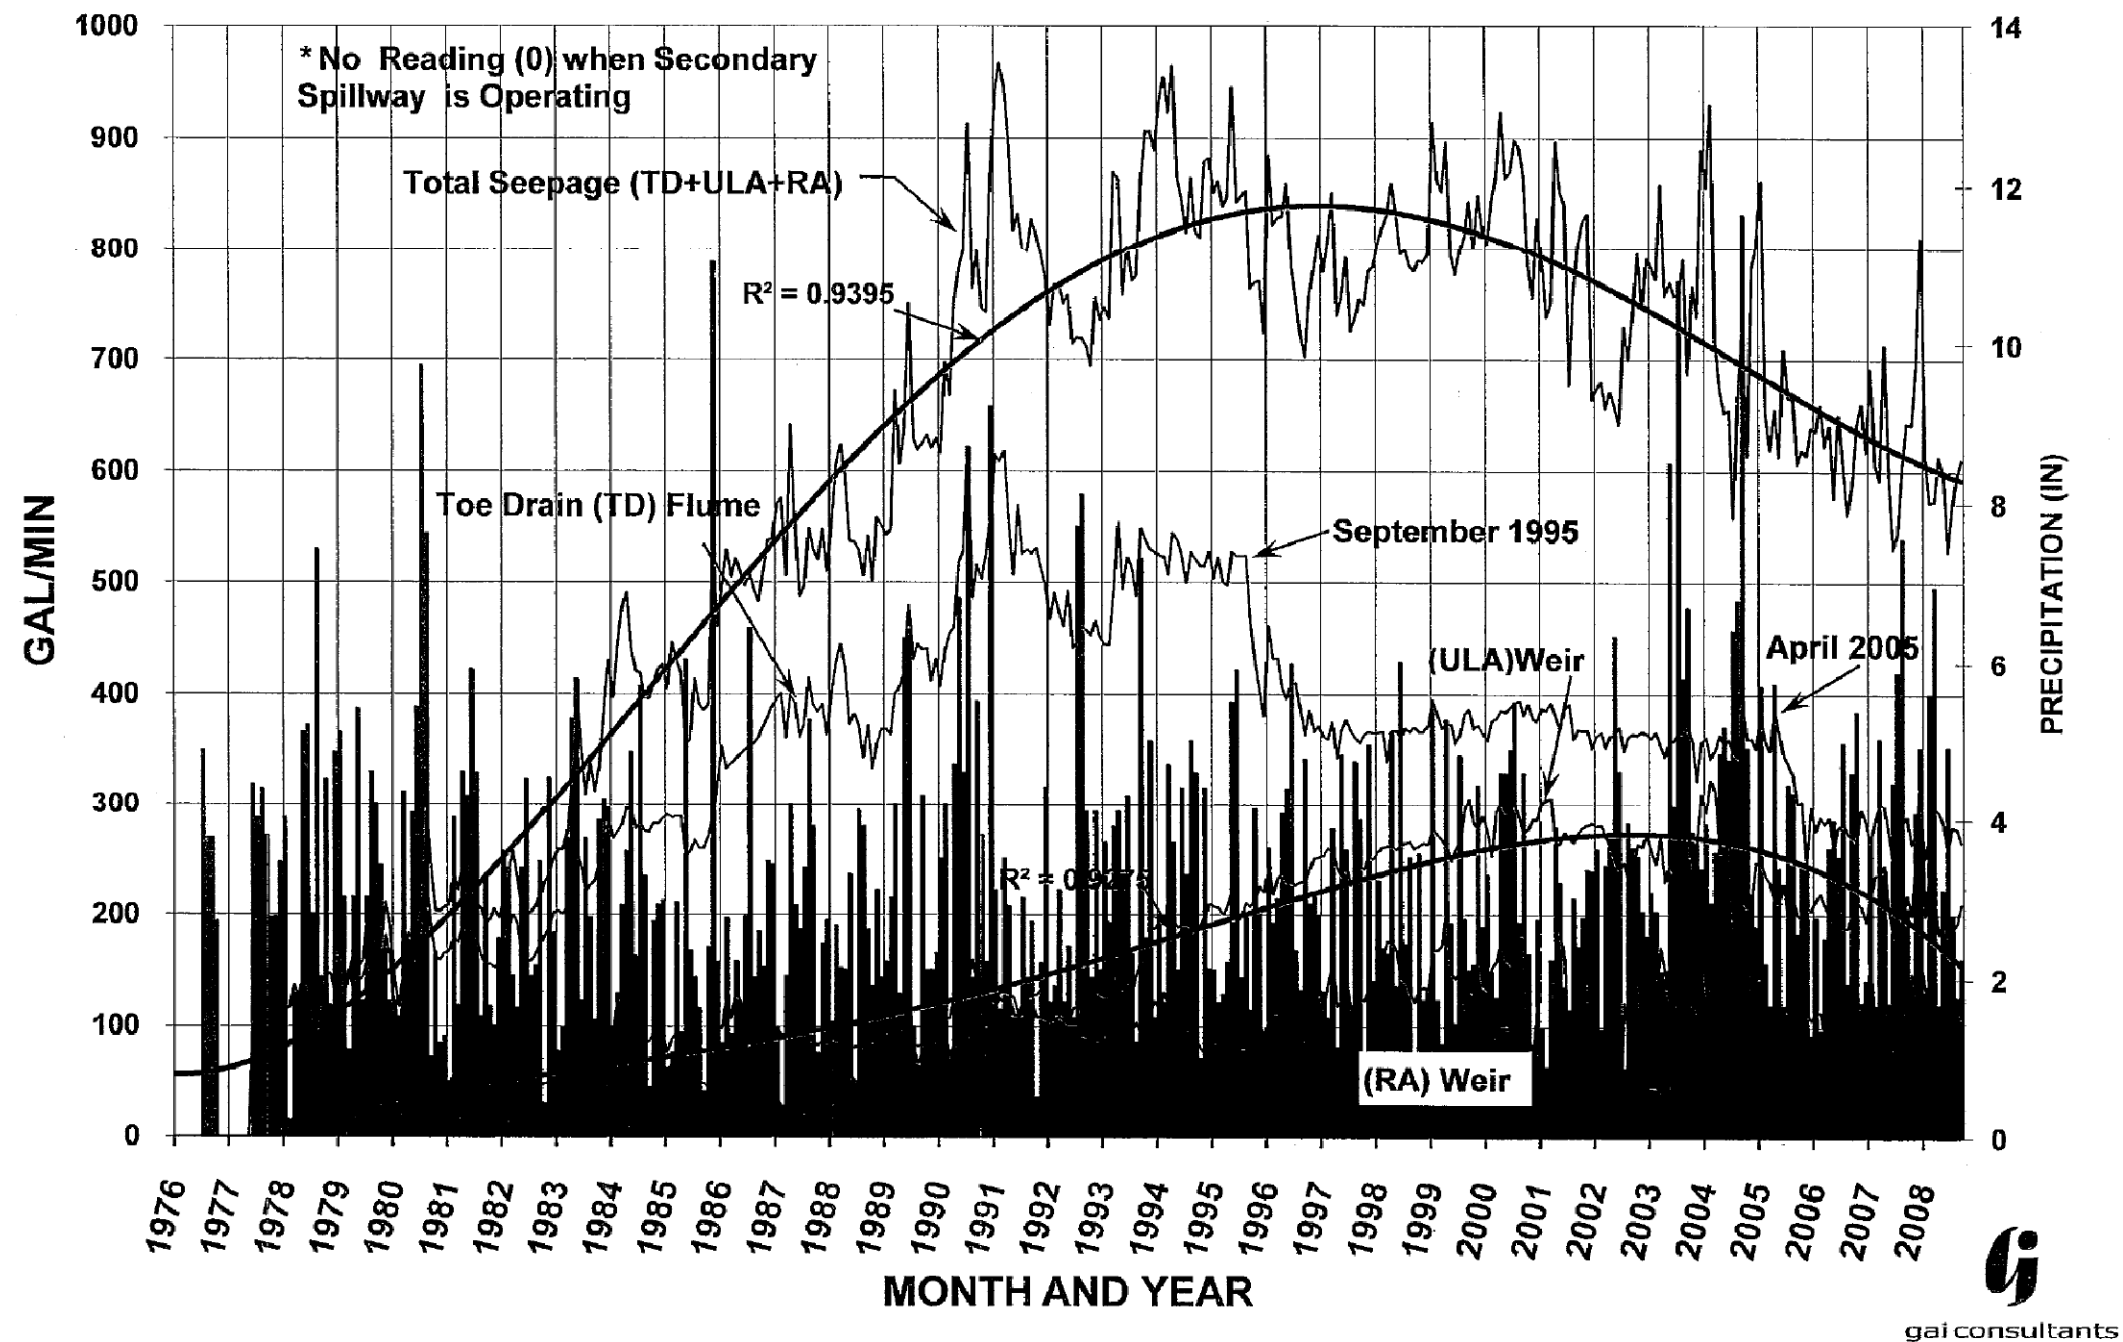
SEEPAGE COLLECTION SYSTEMS (1979 - 2008)	LITTLE BLUE RUN DAM SHIPPINGPORT, PENNSYLVANIA	PROJECT NO. 20085.8000
		DATE: 02/2010
		FIGURE 9A

Discharge through these devices is measured daily. The data is reduced to obtain a monthly average for each device. The monthly average is combined and averaged for the current period to obtain the six-month average. Since weir data includes surface runoff, data collected on days where ½-inch of rainfall has been recorded is not tabulated for the six-month average calculation. The average base flow through the RA Weir is plotted for data collected only when the secondary spillway is not discharging. Plots of seepage from these weirs are shown on Figure 9A and Figure 9B.

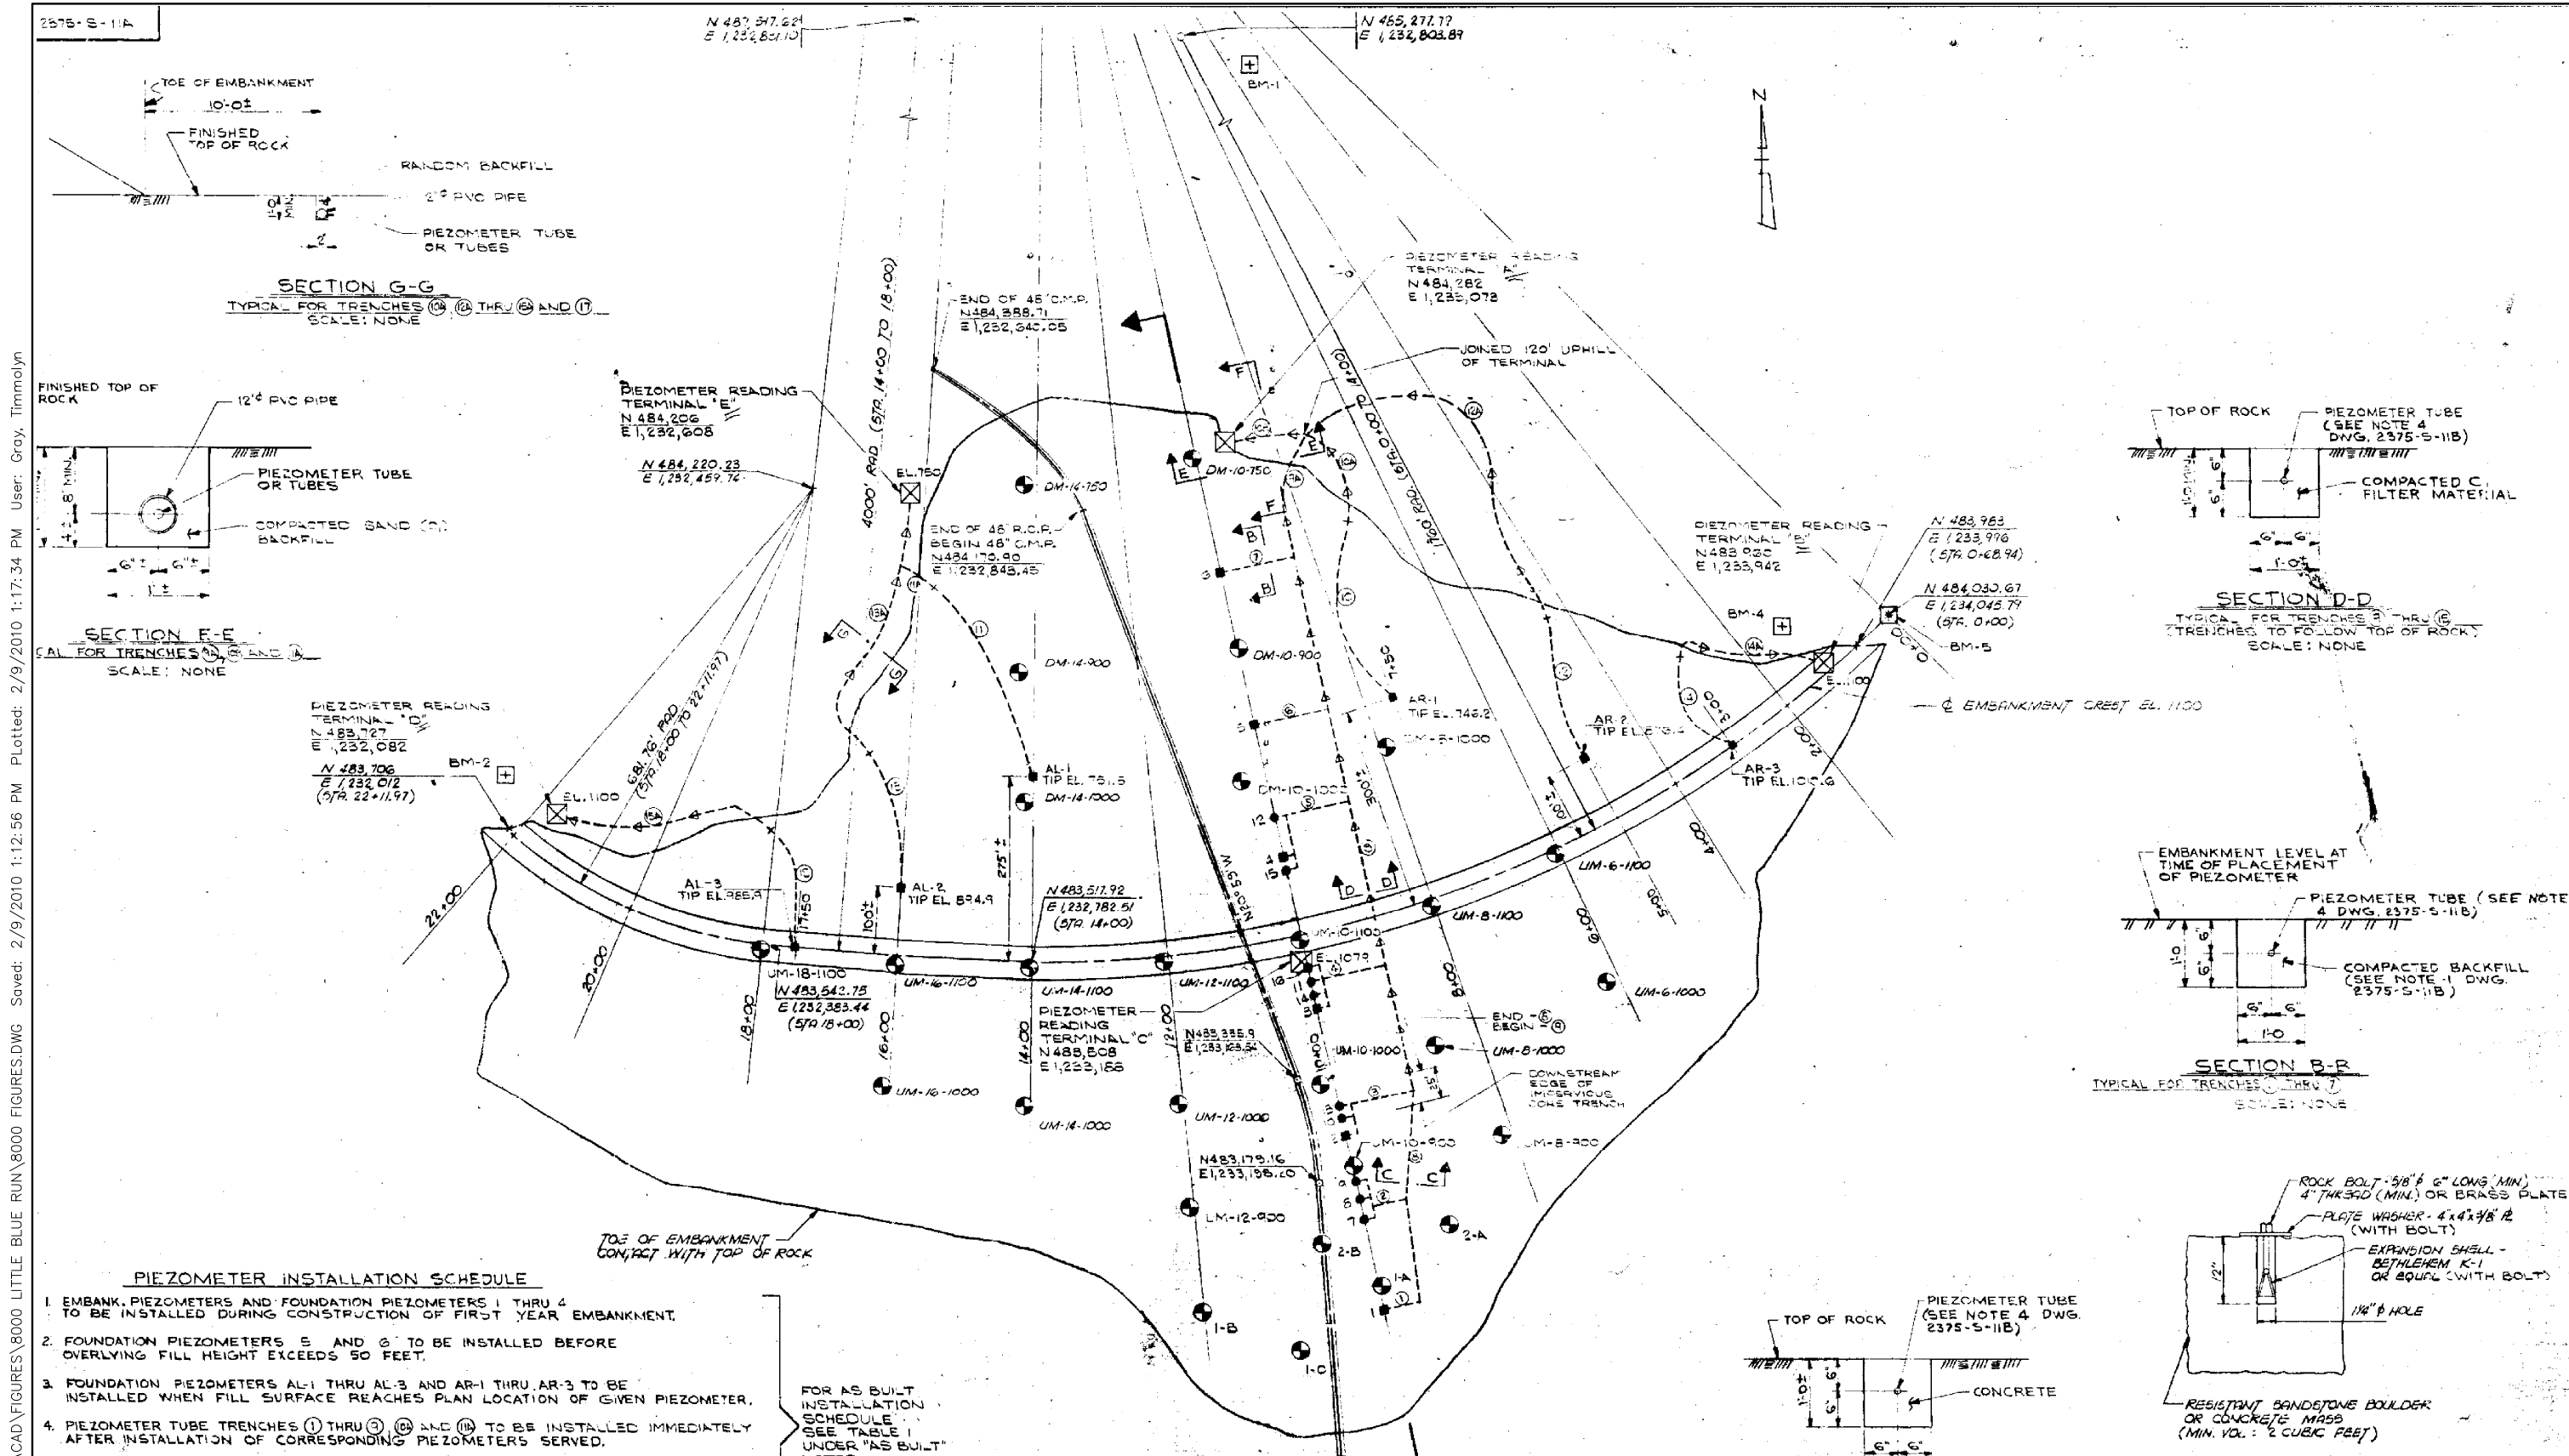
<p>Drawing Copyright © 2010</p> <p>CH2M</p> <p>111 Winners Circle, PO Box 5269 - Albany, NY 12205-0269 Main: (518) 453-4500 - www.ch2m.com</p>	<p>PIEZOMETER LOCATIONS</p>		<p>PROJECT NO. 20085.8000</p>
	<p>LITTLE BLUE RUN DAM SHIPPINGPORT, PENNSYLVANIA</p>		<p>DATE: 02/2010</p>
			<p>FIGURE 10</p>

and 2 well points installed, 16 have reportedly malfunctioned, three yield questionable data according to FirstEnergy's consultant and 5 are performing satisfactorily. Figure 10 shows the location of the piezometers and Figures 11A through 11C shows the piezometer data from 2000 to December 2008.
