**TRANSMITTAL  
ASSESSMENT OF DAM SAFETY OF  
COAL COMBUSTION SURFACE IMPOUNDMENTS  
DRAFT INSPECTION REPORT  
SITE 30 (BRUCE MANSFIELD)**

**DAM SAFETY INSPECTION NOTICE**

DEP Office	SWRO- PITTSBURGH Phone 4124424000	Dam Permit or ID. #	D04-049
Address	400 WATERFRONT DR BH PA 15222	Dam or Project Name	LITTLE BLUE RUN
Owner or Permittee	FIRST ENERGY GENERATION CORPORATION	County	BEAVER
Complete Mailing Address	BRUCE MANFIELD PLANT PO Box 128 SHIPPINGPORT PA 15077-0128	Municipality	GREENE TOWNSHIP
		Take GPS readings at the center of the crest of the dam.	
		Latitude:	40° 37' 40.14" N
		Longitude:	80° 30' 47.79" W

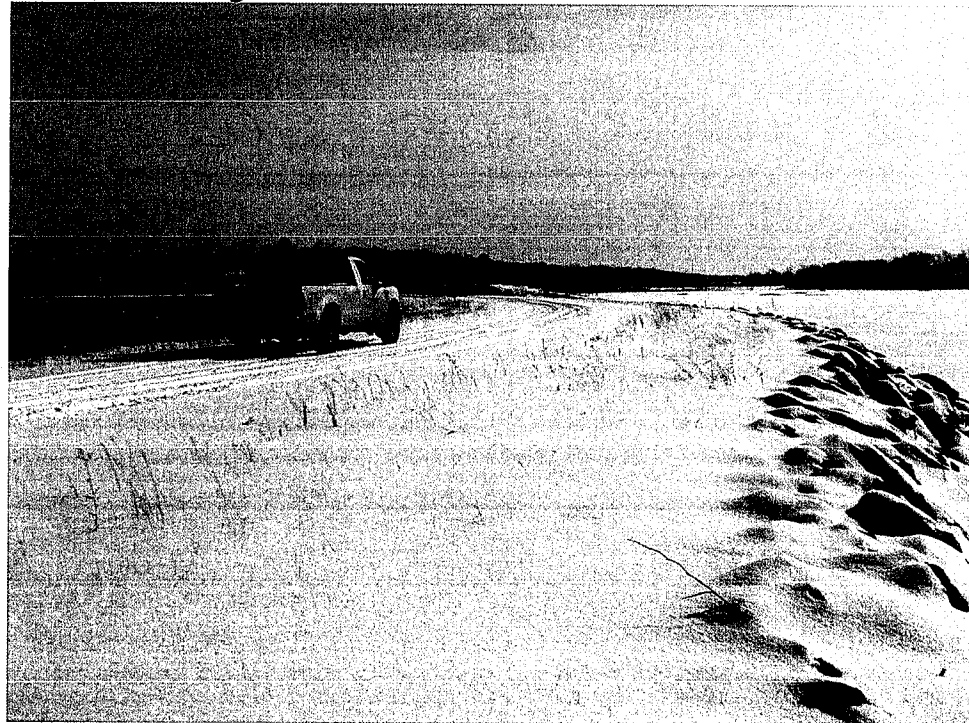
D04-049 01/21/09 Figure 2 View of crest.

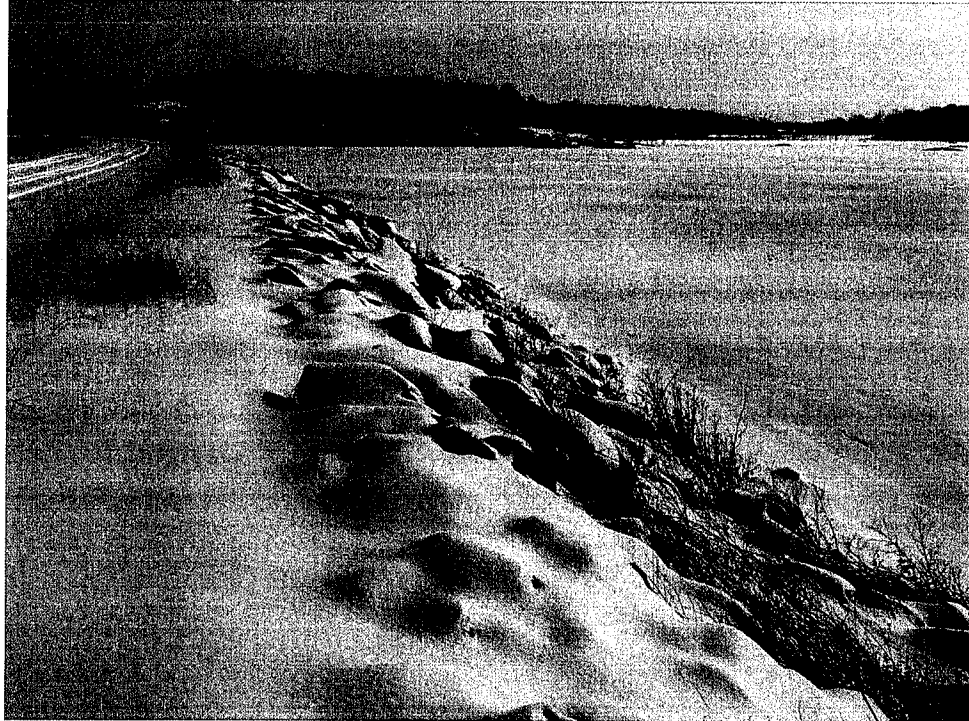
D04-049 01/21/09 Figure 3 View of upstream face.

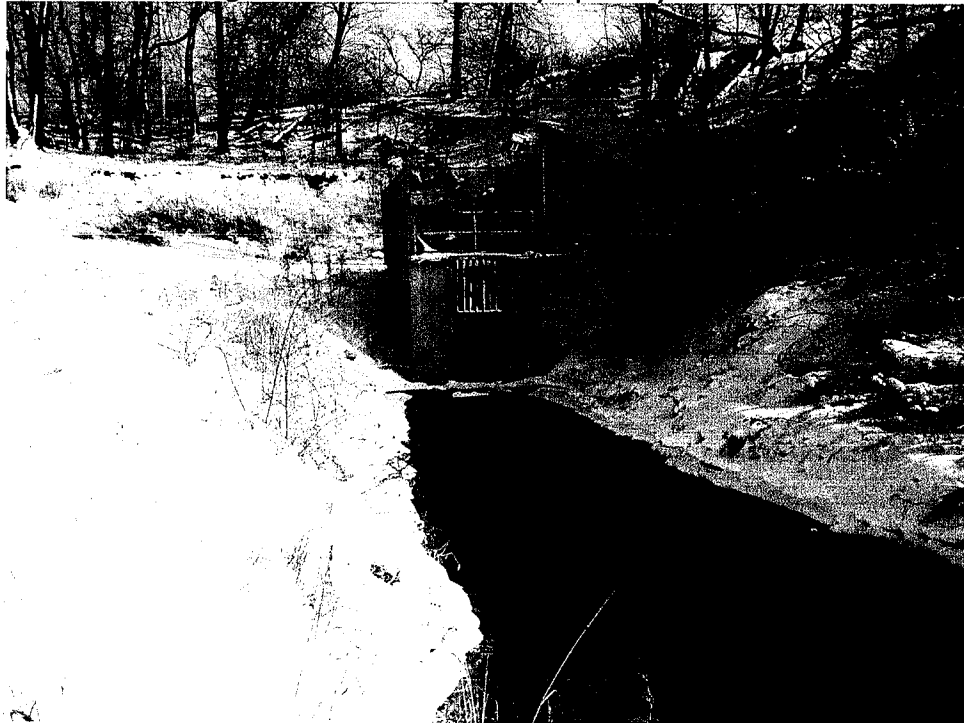
D04-049 01/21/09 Figure 4 View of primary spillway inlet and treatment system.

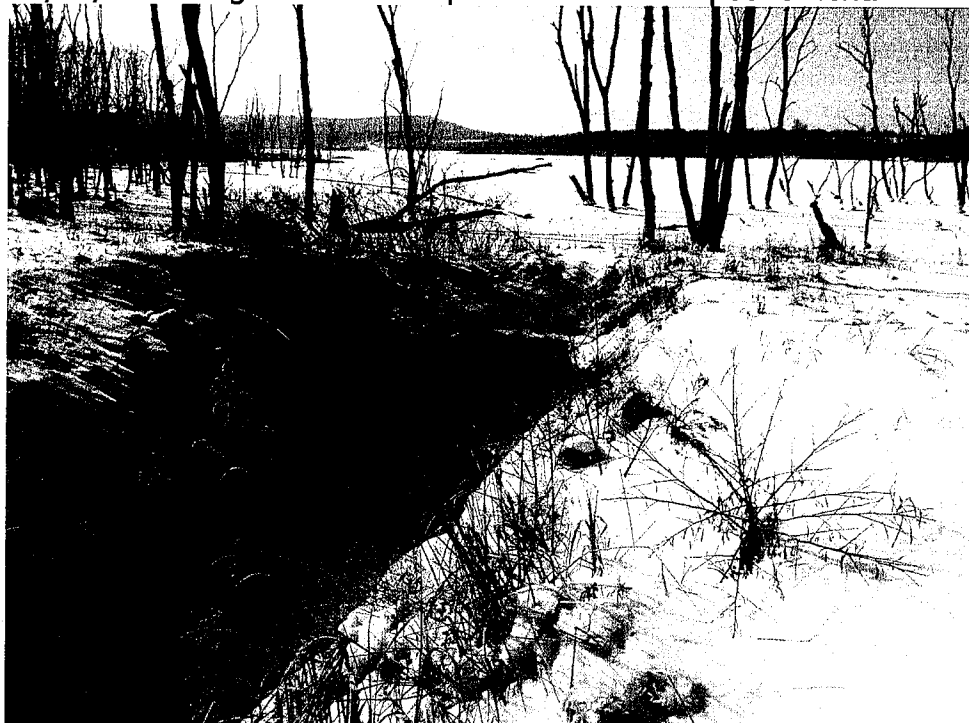
Figure 5 View of pond inlet from impoundment.

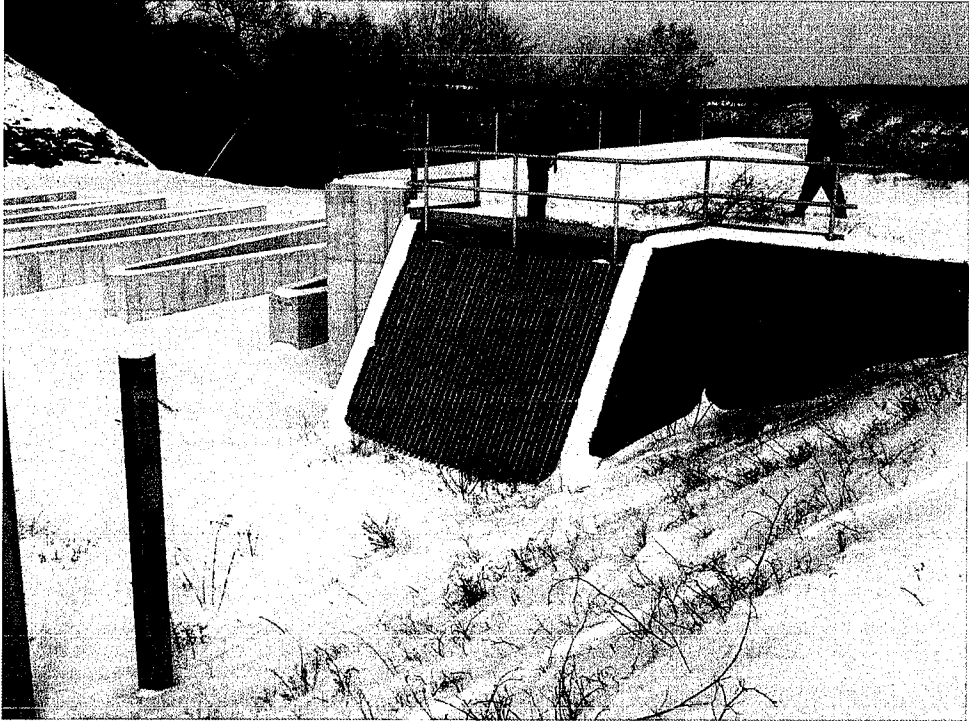
D04-049 01/21/09 Figure 8 View of secondary spillway inlet.

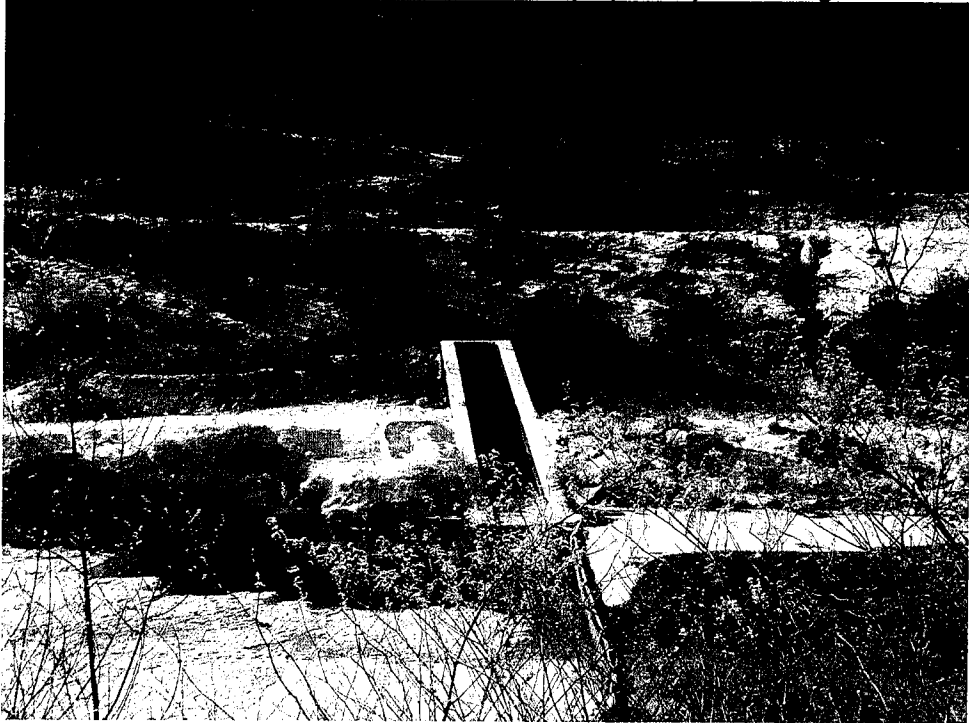
D04-049 01/21/09 Figure 9 View of secondary spillway discharge at stilling basin.

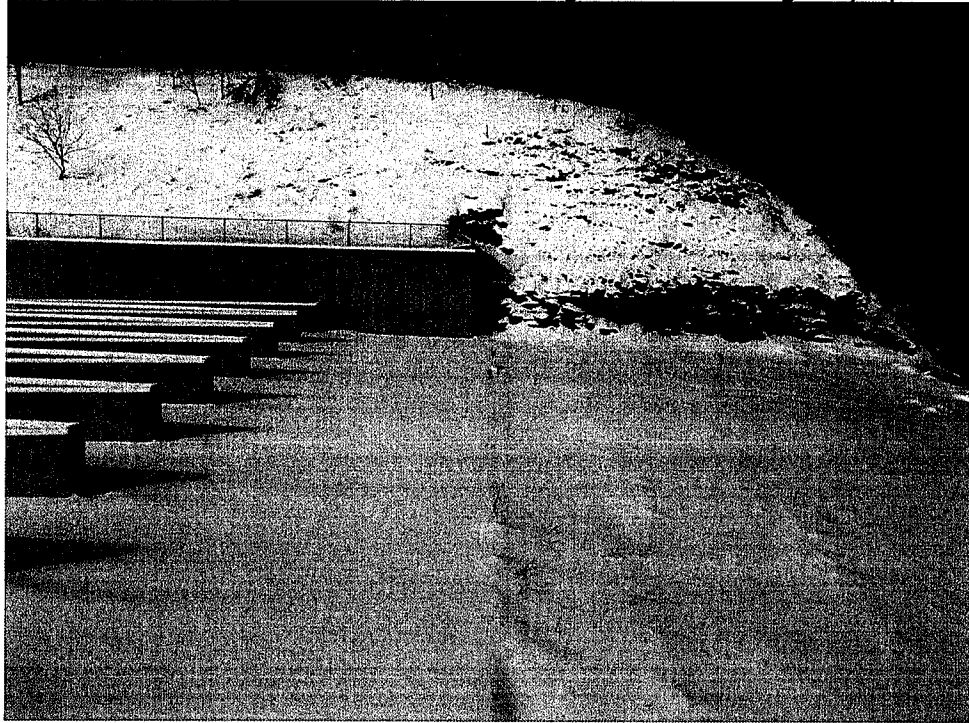
D04-049 01/21/09 Figure 11 View of discharge end of emergency spillway.

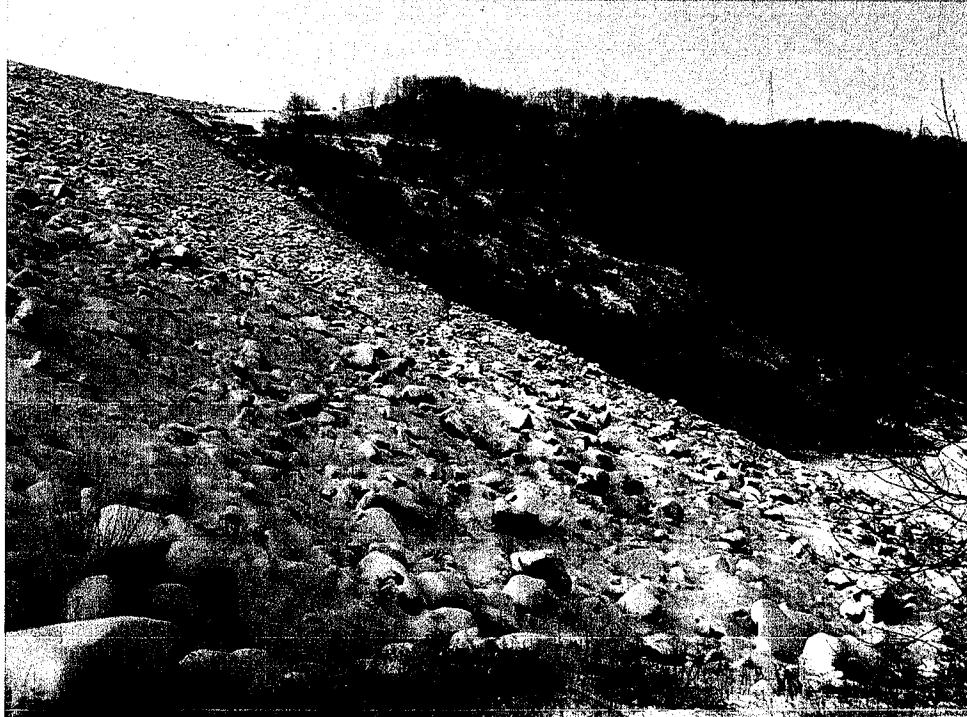
D04-049 01/21/09 Figure 12 View of left abutment and downstream face.

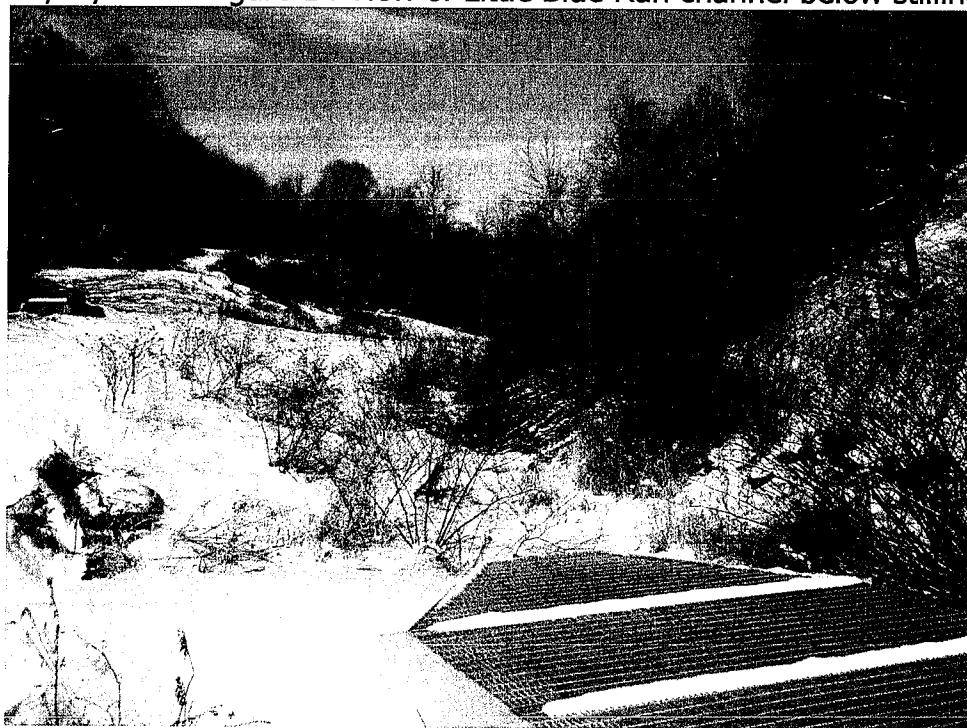
D04-049 01/21/09 Figure 14 View of Little Blue Run channel below stilling basin.

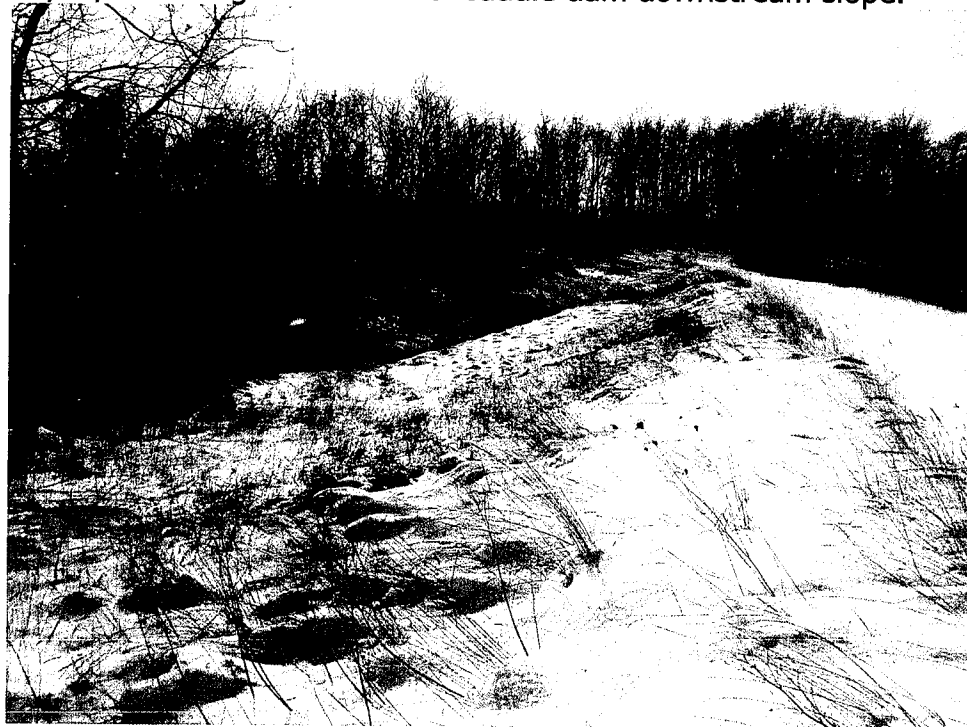
D04-049 01/21/09 Figure 16 View of saddle dam downstream slope.

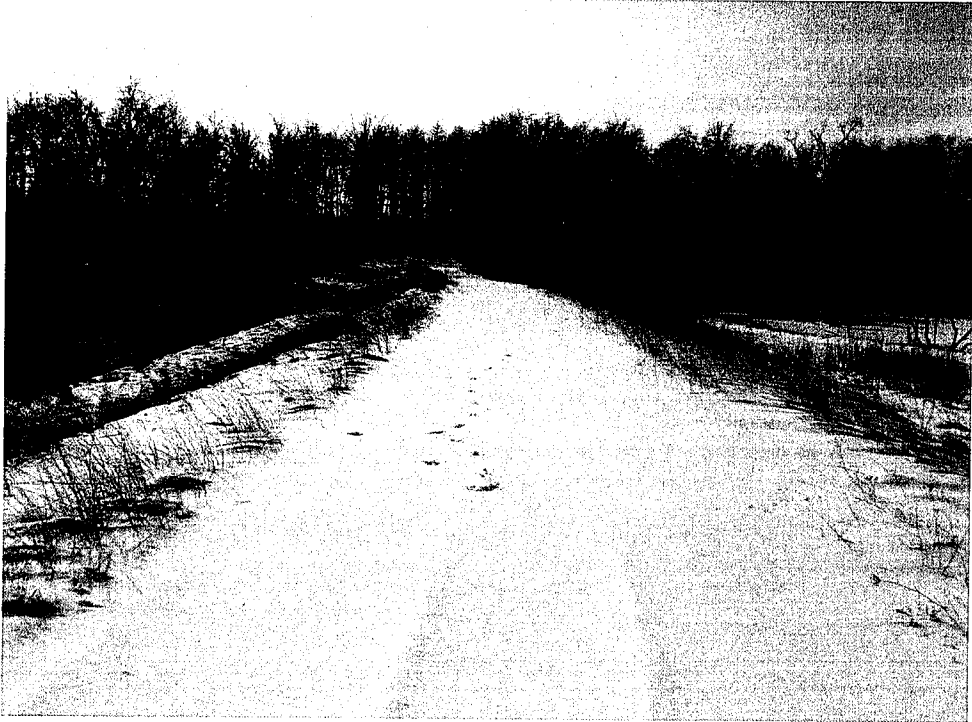
D04-049 01/21/09 Figure 17 View of saddle dam crest.

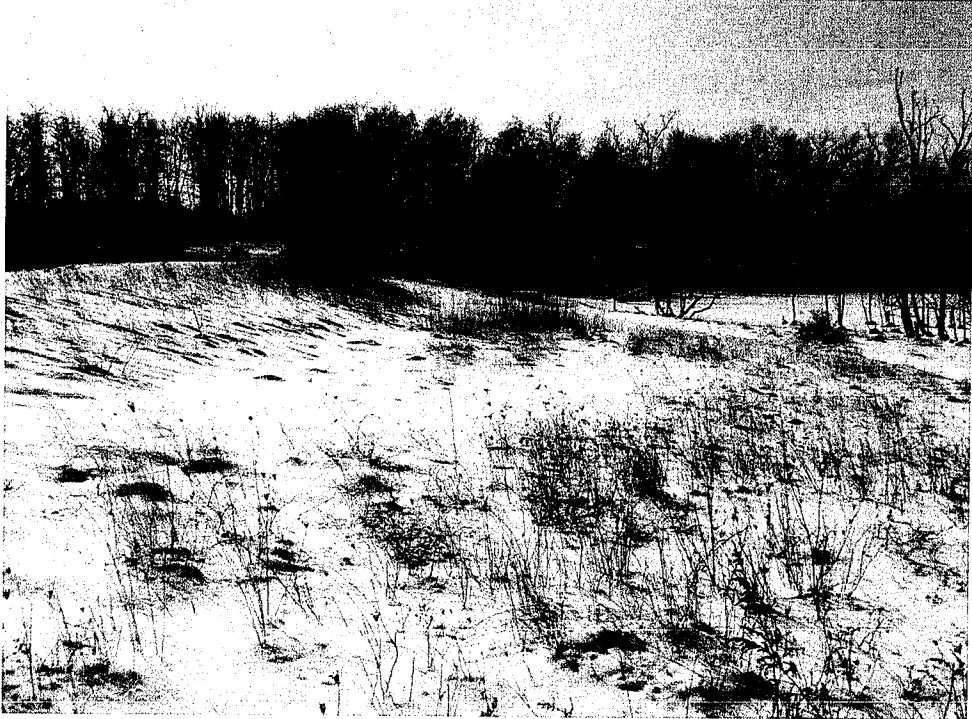
D04-049 01/21/09 Figure 18 View of upstream slope of saddle dam.

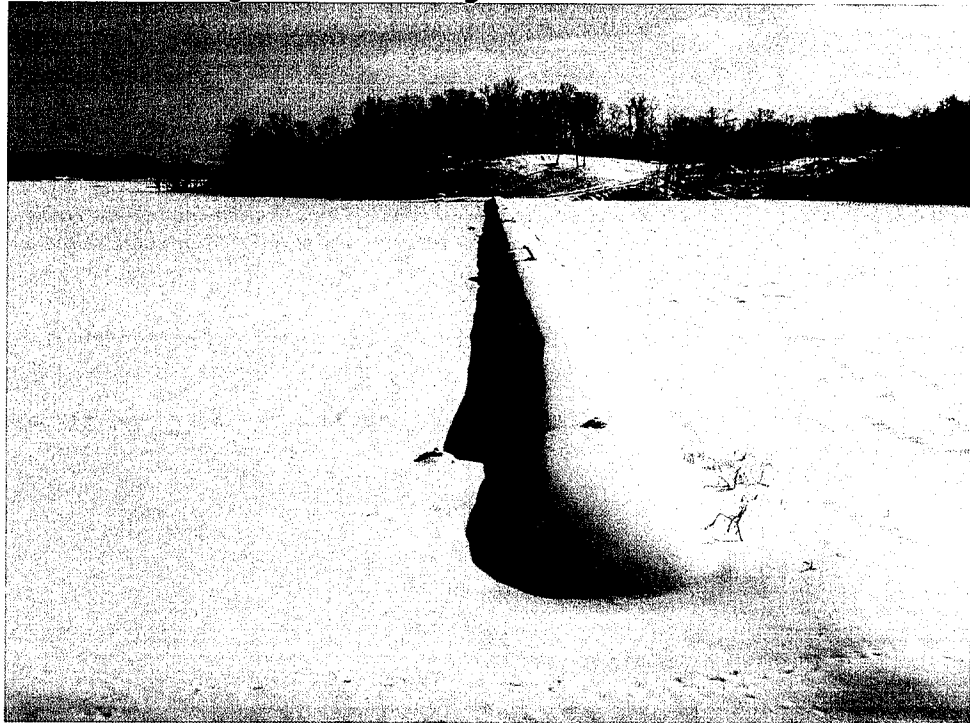
D04-049 01/21/09 Figure 21 View of geotube.

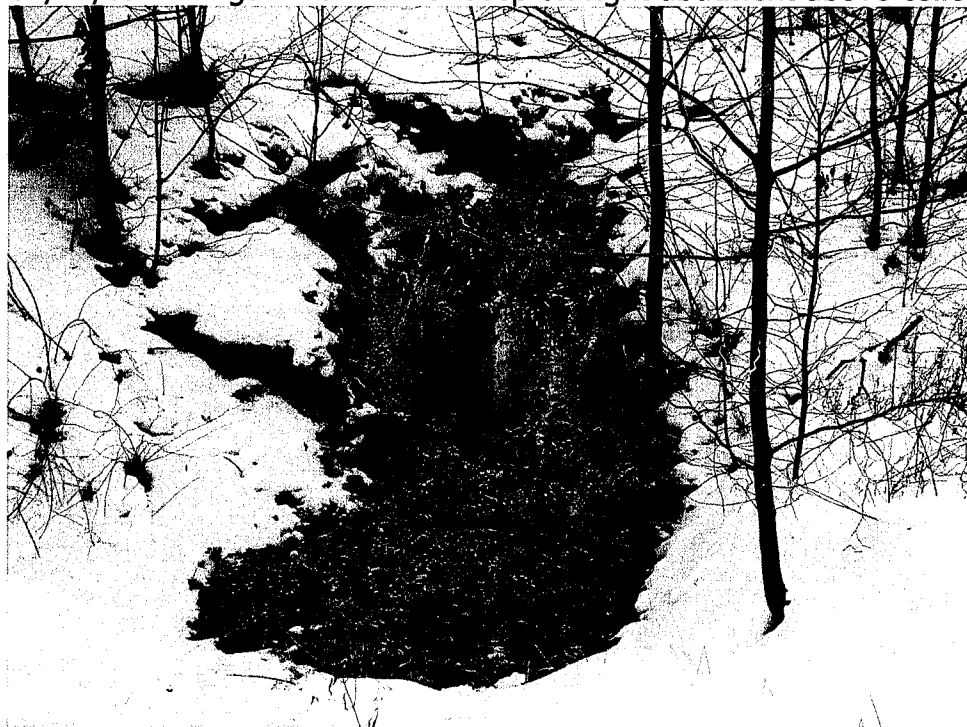
- 01/21/09 Inspected by D. K. Hartner. This dam is in good condition. The seeps on both abutments are monitored on a regular basis. Landsliding on the left downstream abutment has been a historic problem and observations should be made on a regular basis. There seems to be a very small number of working piezometers within this dam. The value of piezometric readings within the various zones should be evaluated and additional piezometers installed as necessary. LiDAR elevations indicate that the saddle dam crest is below 1100. This should be checked at periodic intervals. The valley below the saddle dam has been impacted by leachate and there is a pump return system for this water. The leakage in this valley and in the Mill Creek valley in general should be evaluated. Settlement of the geotubes that are retaining waste in the upper parts of the valleys should be monitored quantitatively.

D04-049 01/21/09 Figure 19 View of seep on right abutment above collection system.

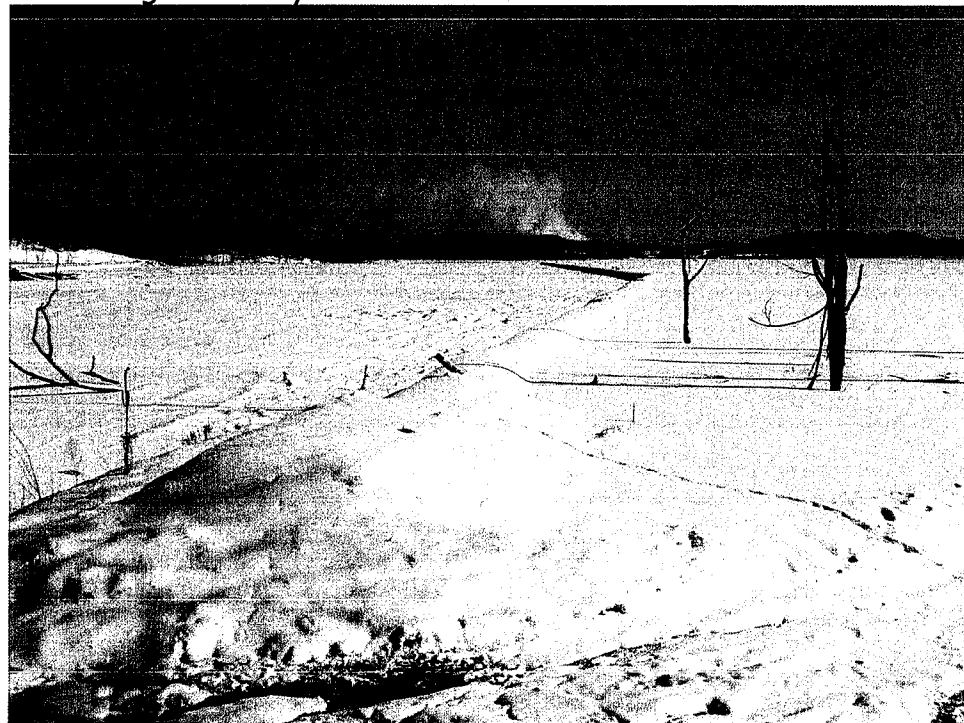
D04-049 01/21/09 Figure 20 View of long geotube starting in West Virginia and continuing to Pennsylvania

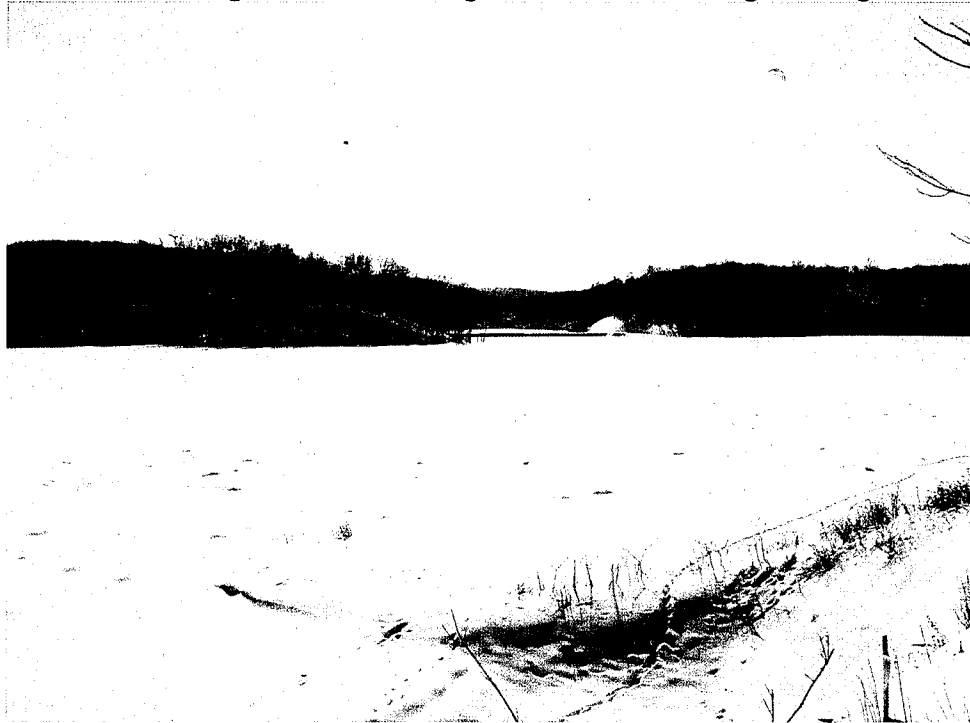
D04-049 01/21/09 Figure 23 View of geotube in West Virginia finger.

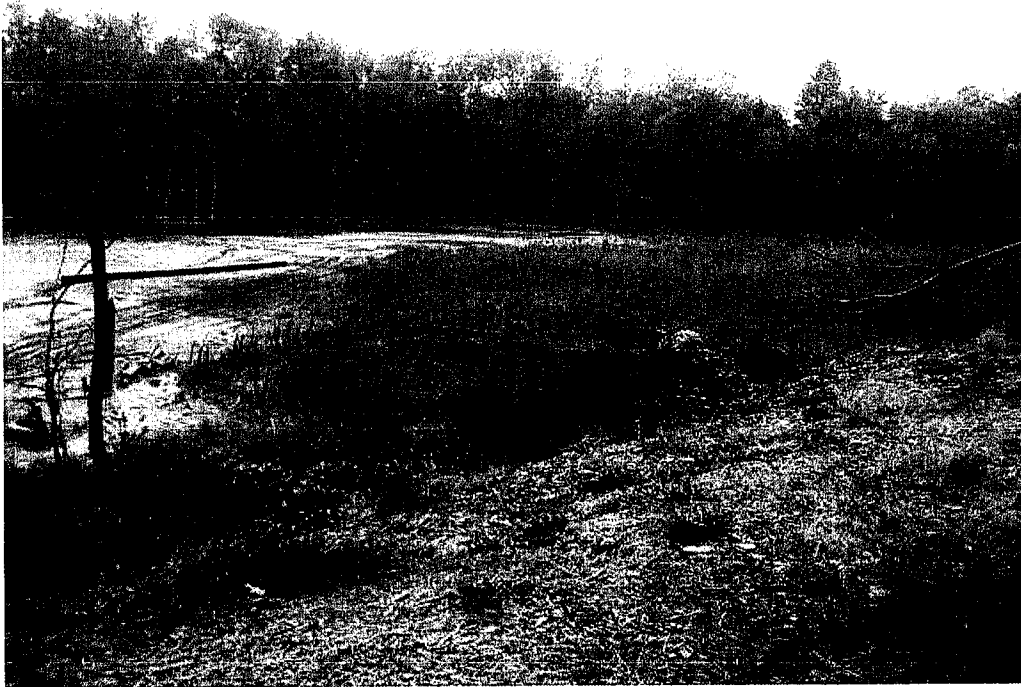
d04-049 10/23/07 discharge from left abutment

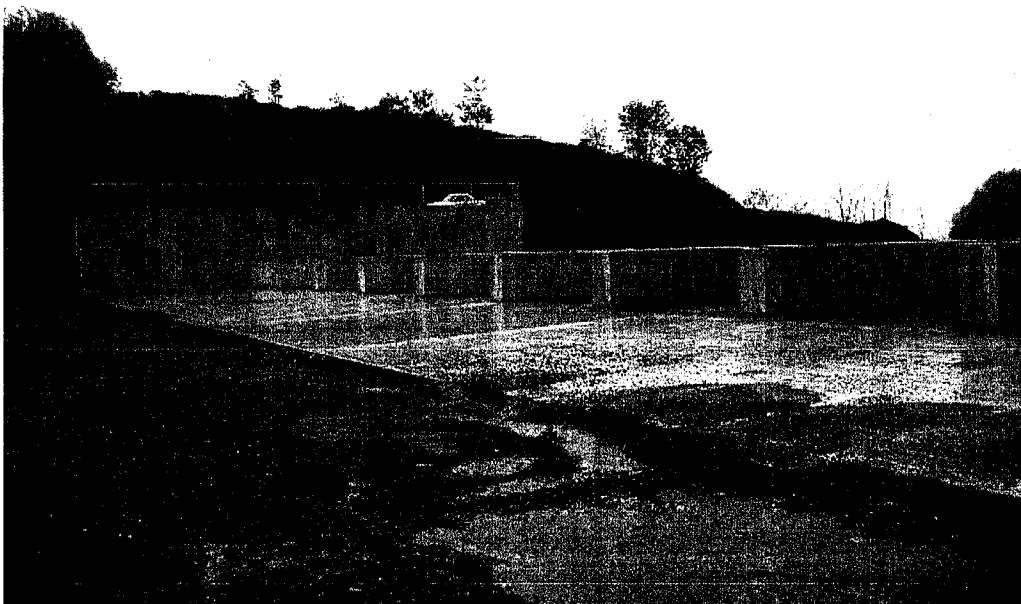
d04-049 10/23/07 DS end of spillway from right

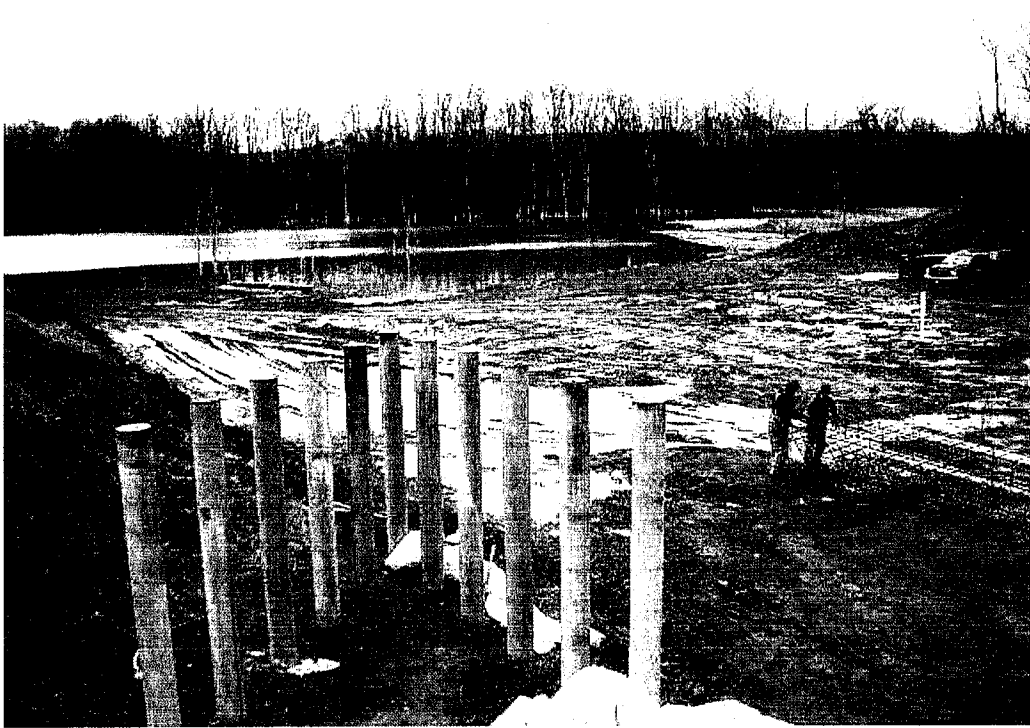
d04-049 11/20/06 spillway approach

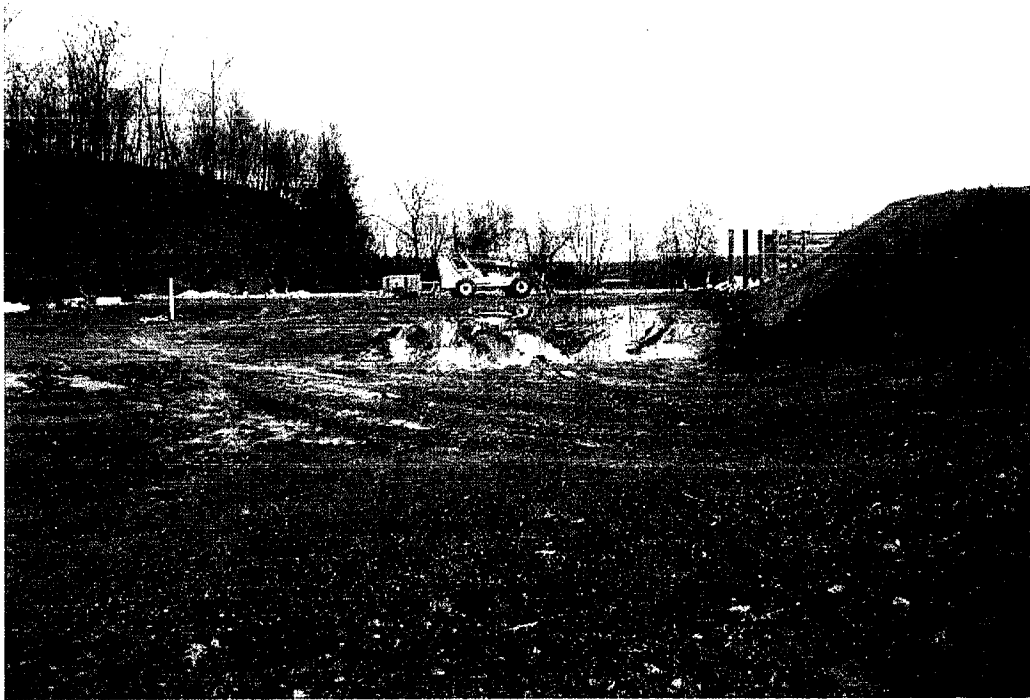
d04-049 11/20/06 spillway from approach

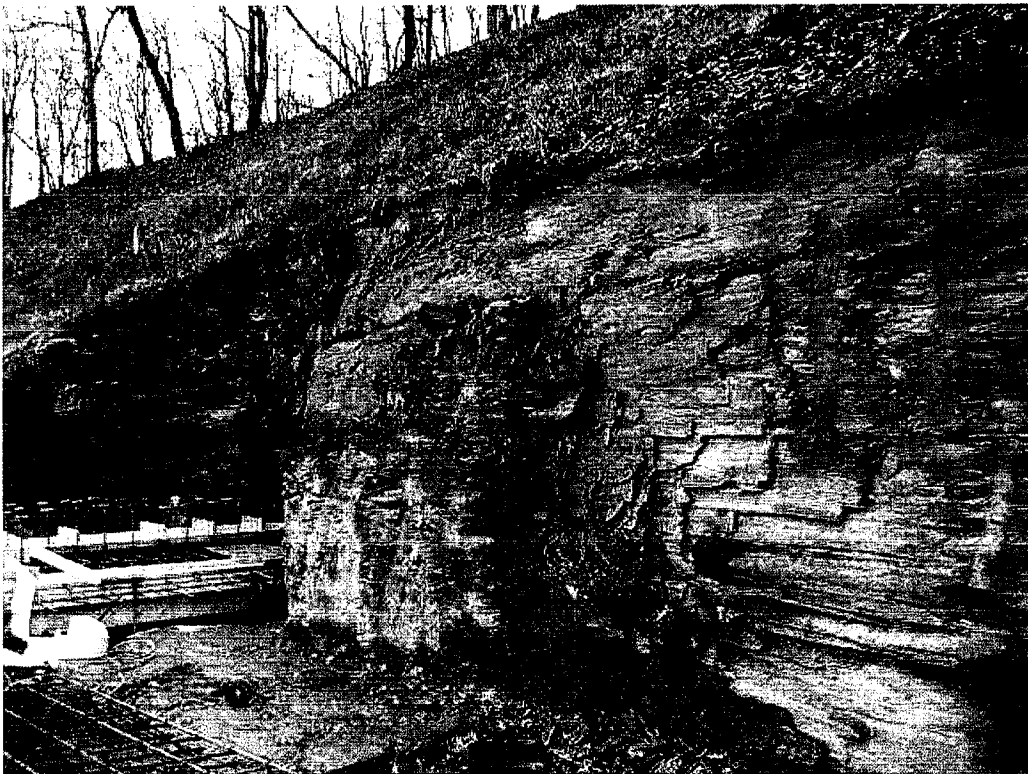
d04-049 11/20/06 left US wall notch

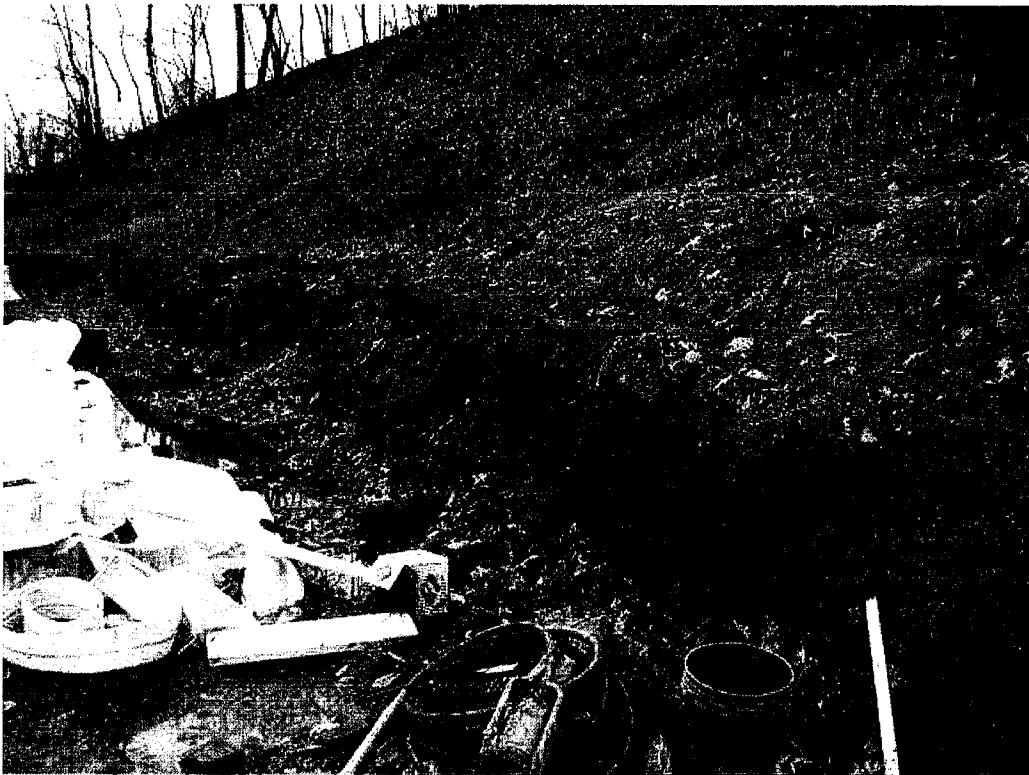
d04-049 11/20/06 left abutment US of weir

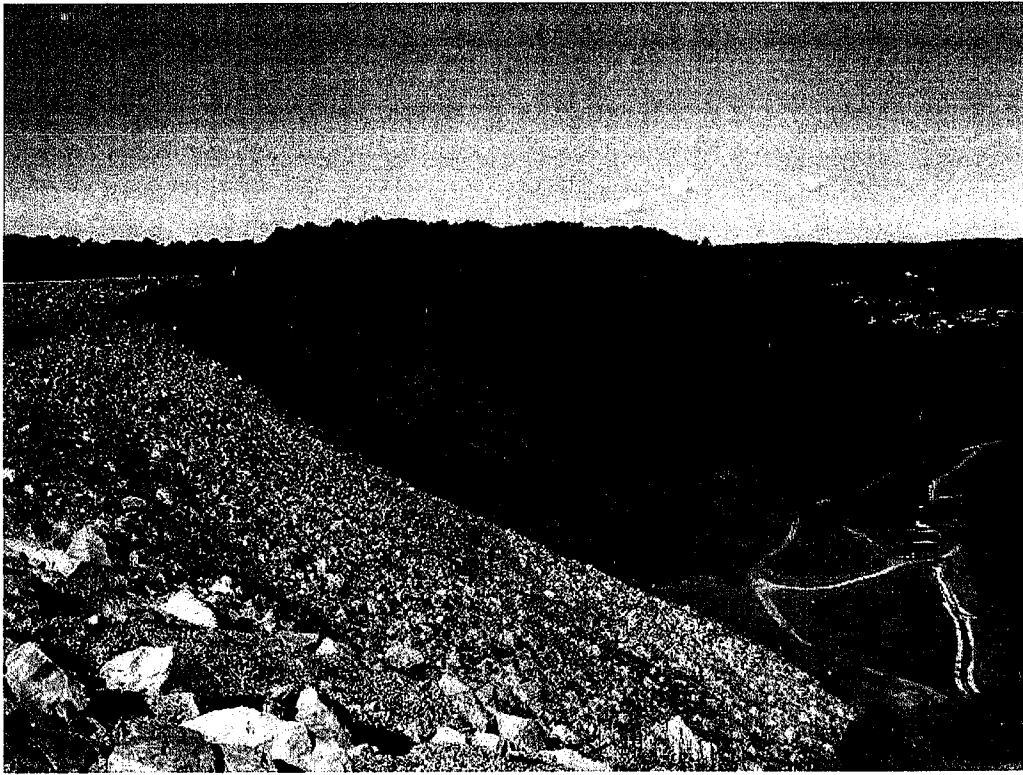
d04-049 9/21/06 DS & left abutment from right crest

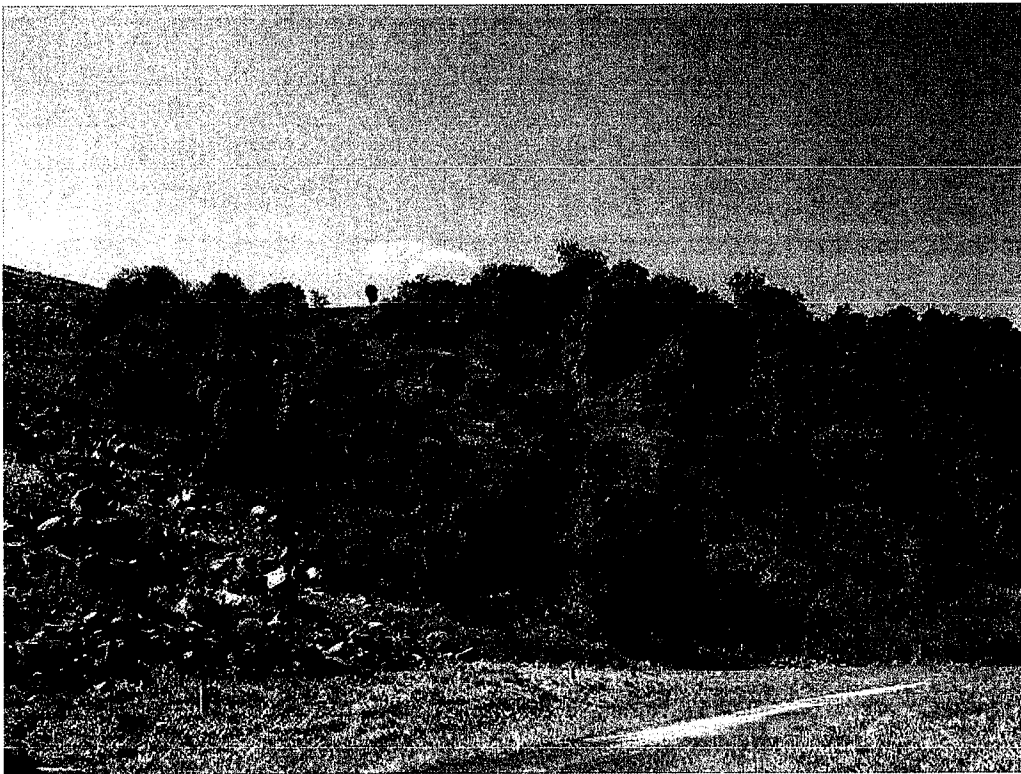
d04-049 9/21/06 left abutment from toe

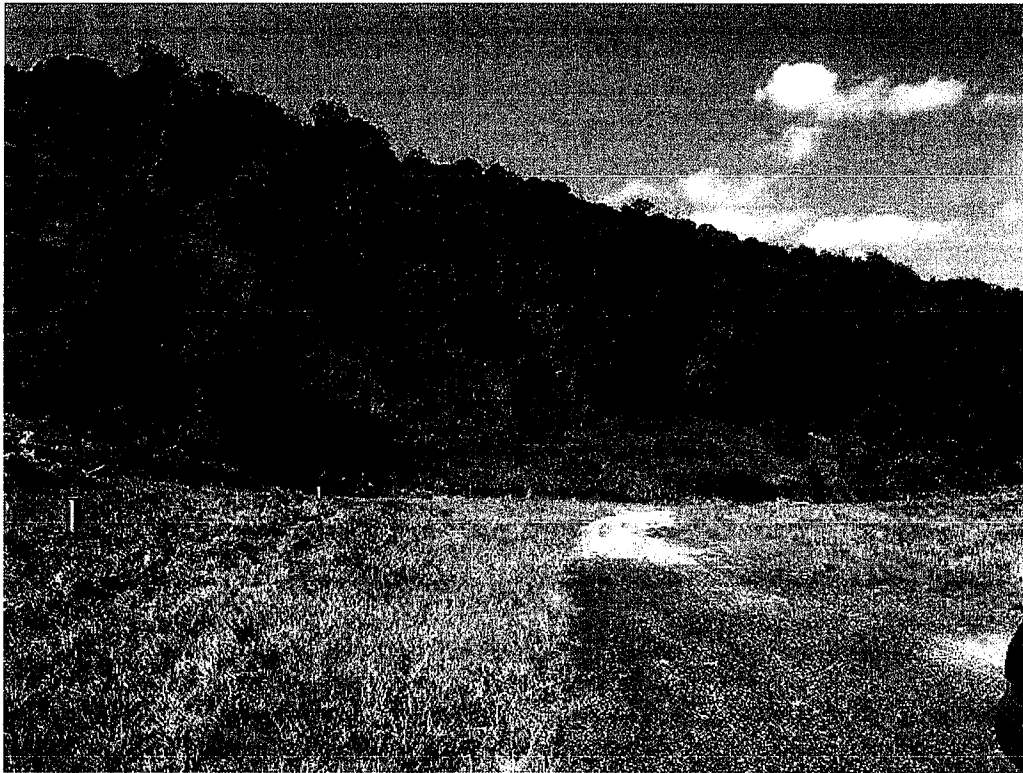
d04-049 9/21/06 left abutment from toe

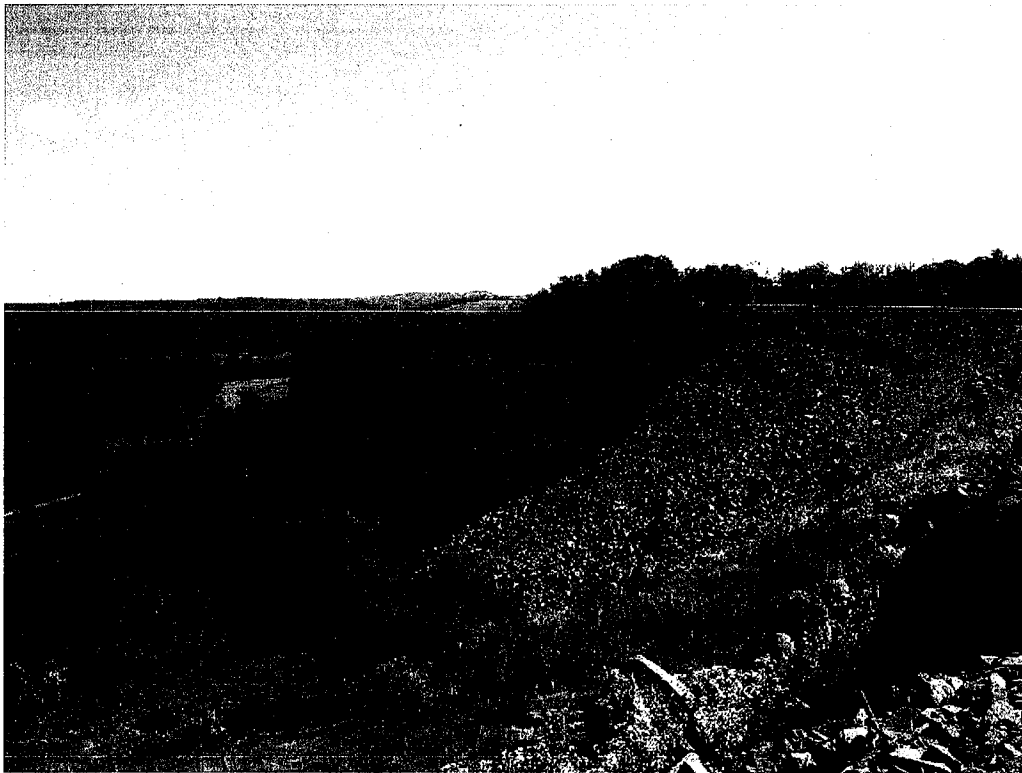
d04-049      9/21/06      DS slope from left

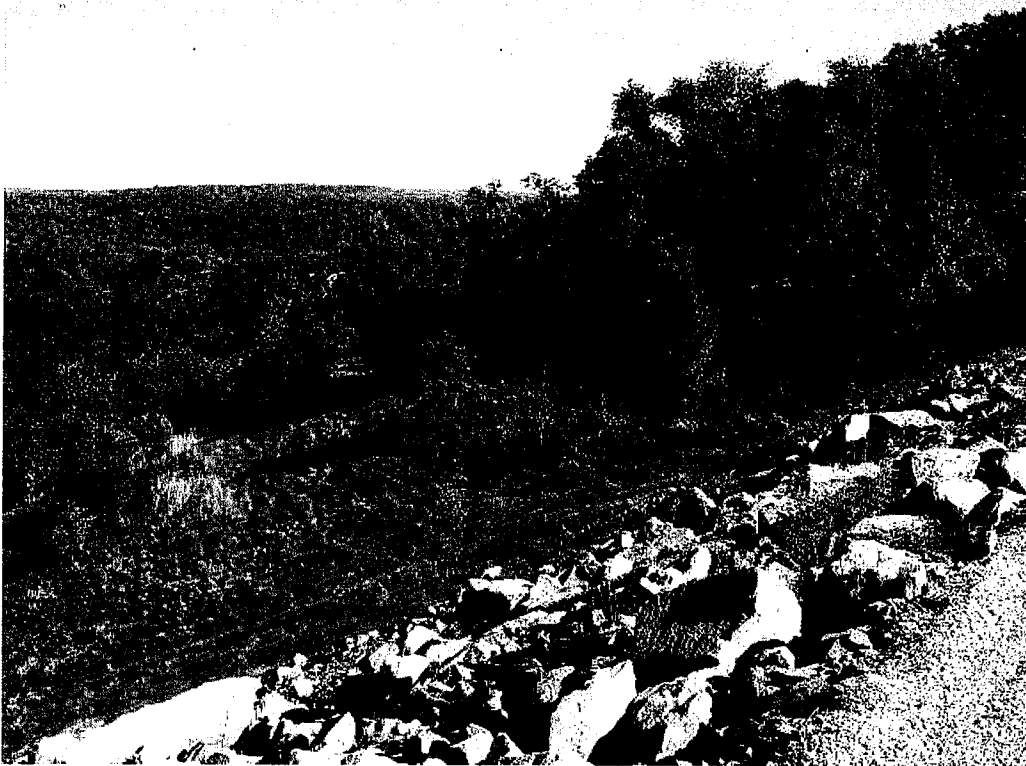
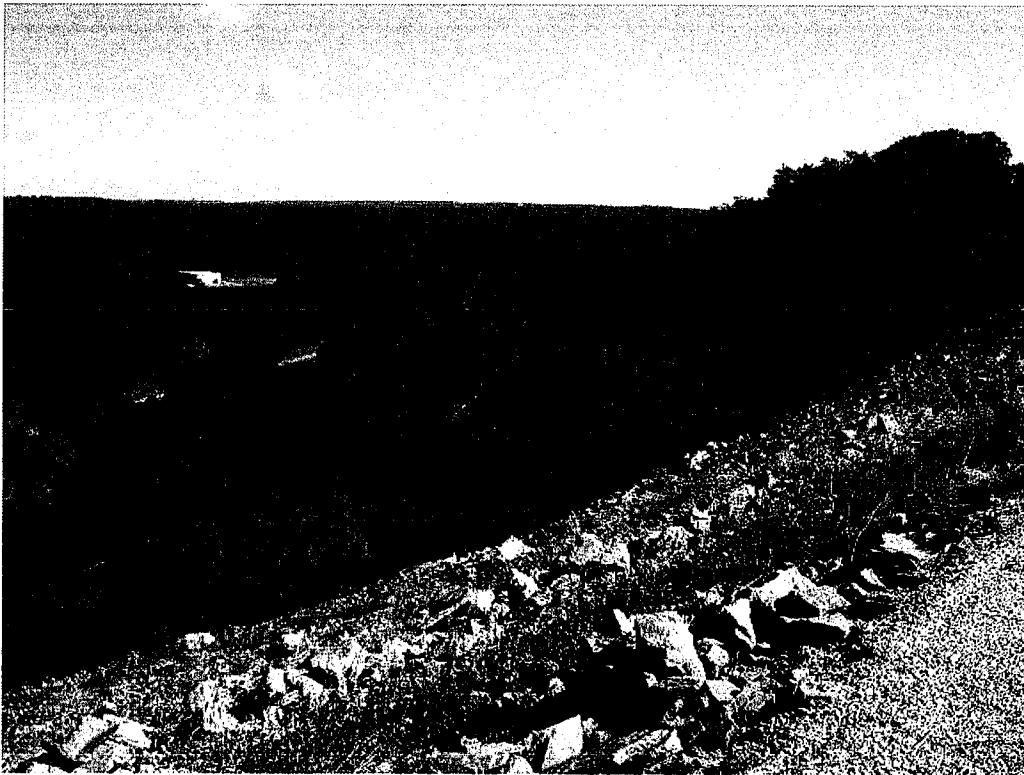
d04-049 9/21/06 right abutment from center

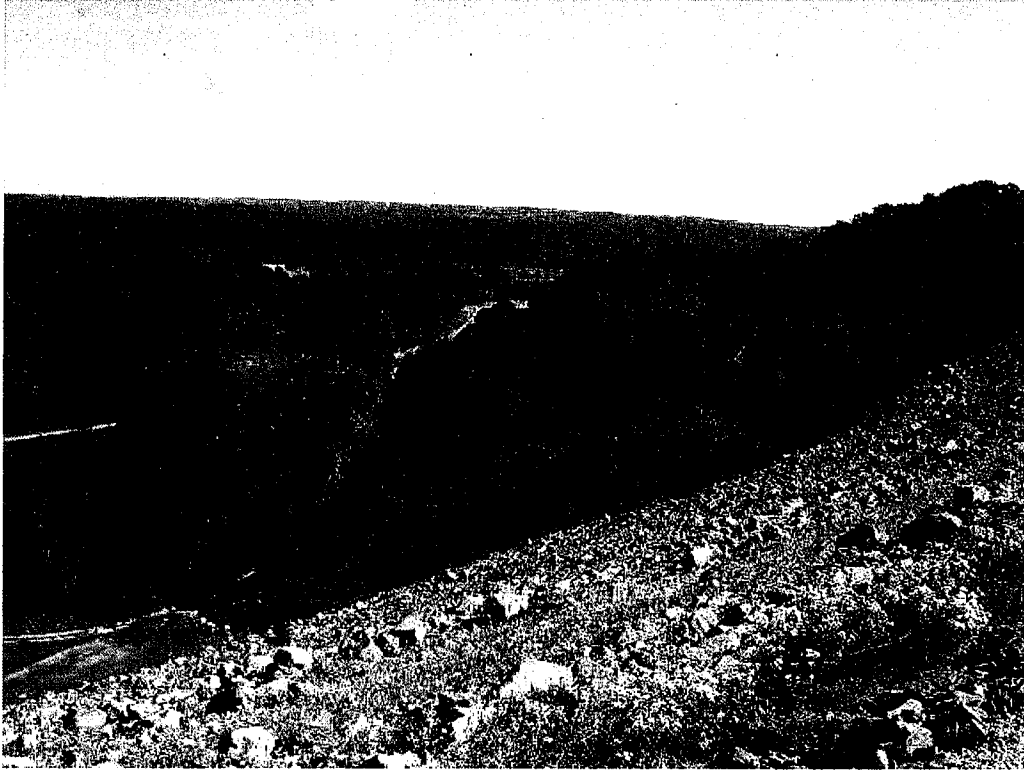
d04-049 9/21/06 right abutment

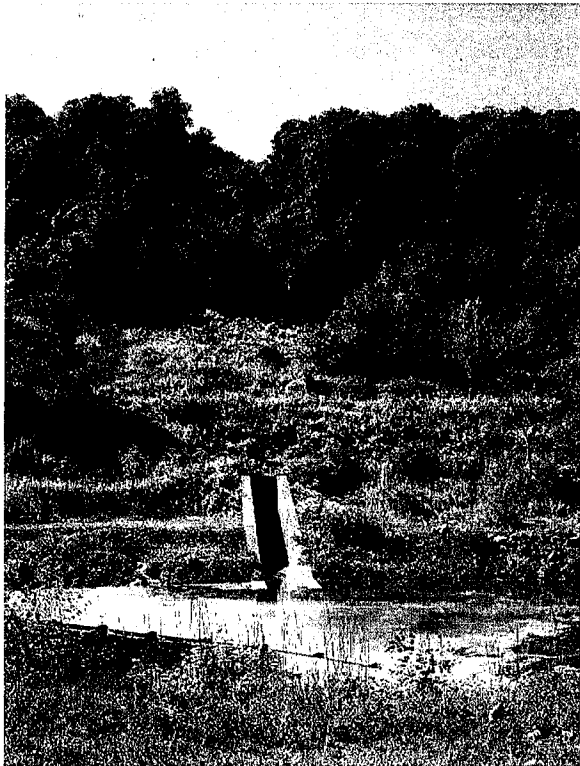
d04-049      9/21/06      outlet of left primary spillway

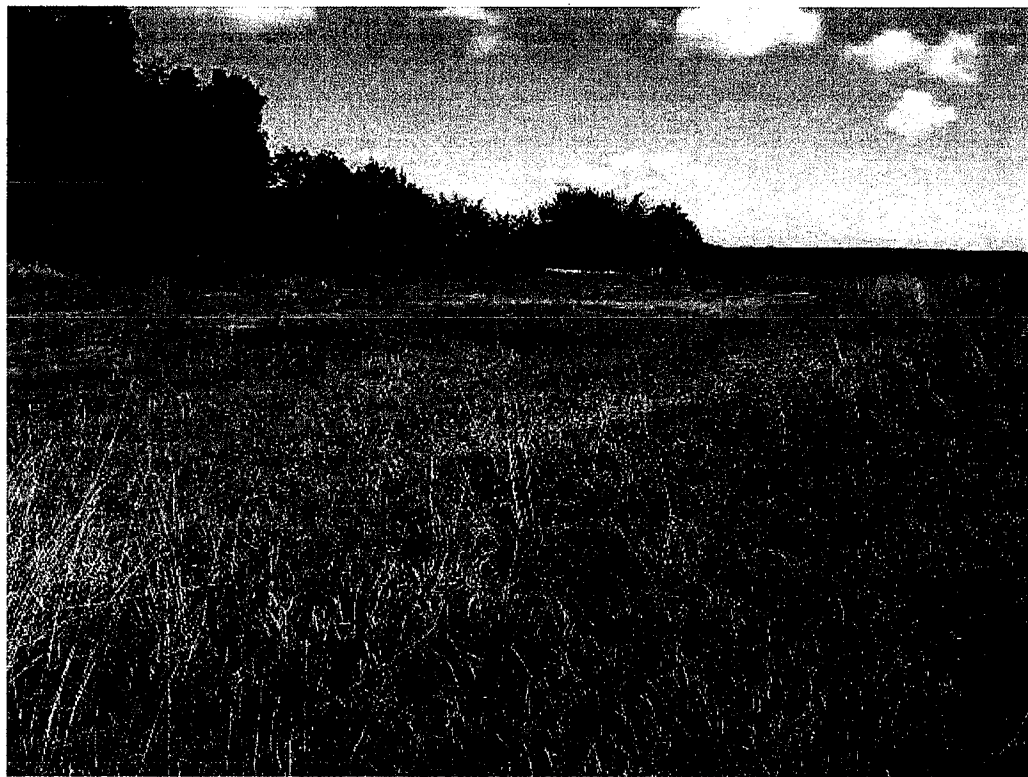
d04-049      9/21/06      area between left primary spillway and emergency spillway
