**TRANSMITTAL  
ASSESSMENT OF DAM SAFETY OF  
COAL COMBUSTION SURFACE IMPOUNDMENTS  
DRAFT INSPECTION REPORT  
SITE 30 (BRUCE MANSFIELD)**

**DAM SAFETY INSPECTION NOTICE**

DEP Office	SWRO- PITTSBURGH Phone 4124424000	Dam Permit or ID. #	D04-049
Address	400 WATERFRONT DR BH PA 15222	Dam or Project Name	LITTLE BLUE RUN
Owner or Permittee	FIRST ENERGY GENERATION CORPORATION	County	BEAVER
Complete Mailing Address	BRUCE MANFIELD PLANT PO Box 128 SHIPPINGPORT PA 15077-0128	Municipality	GREENE TOWNSHIP
		Take GPS readings at the center of the crest of the dam.	
		Latitude:	40° 37' 40.14" N
		Longitude:	80° 30' 47.79" W

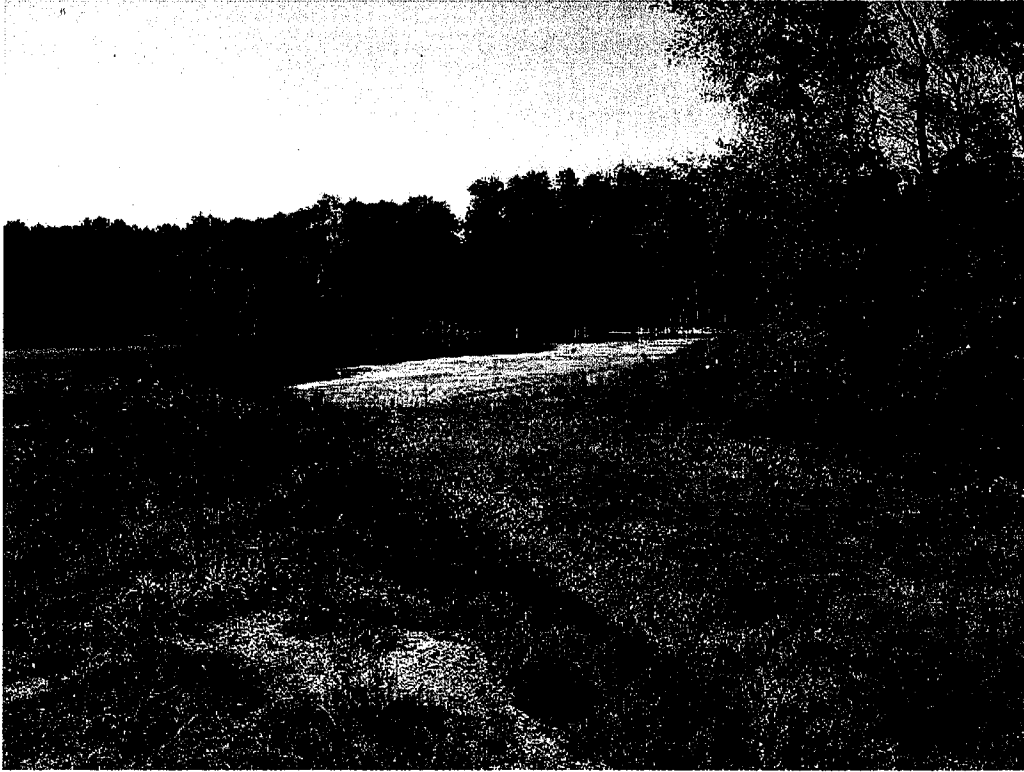
d04-049 9/21/06 approach to emergency spillway

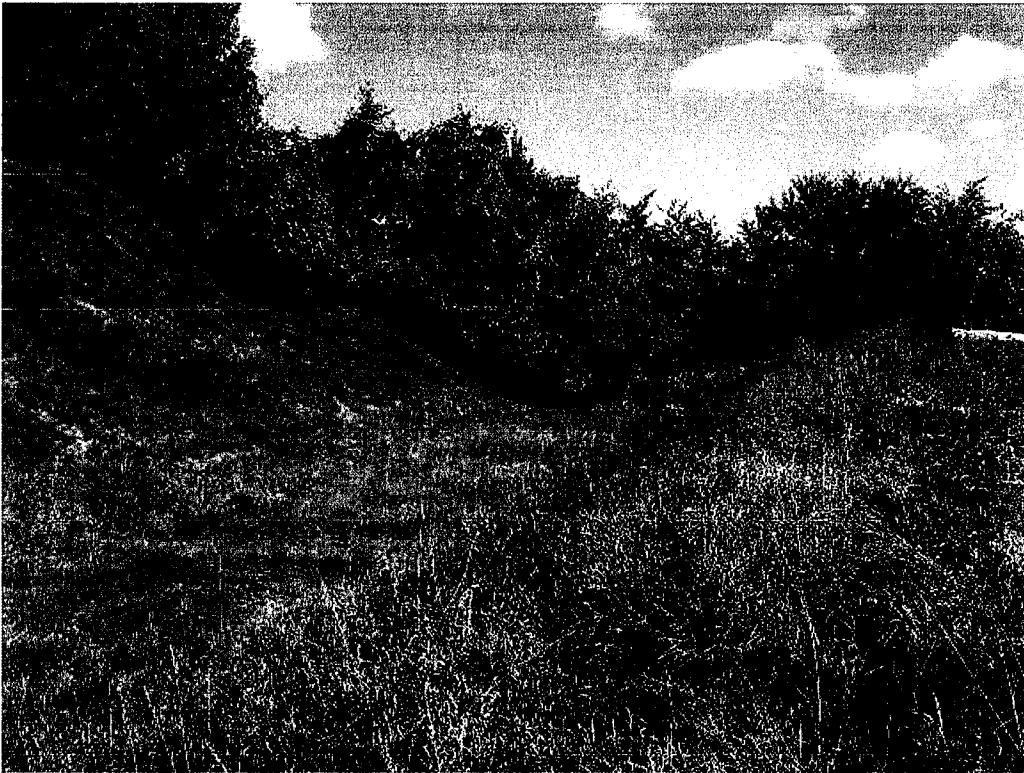
d04-049 9/21/06 emergency spillway looking DS

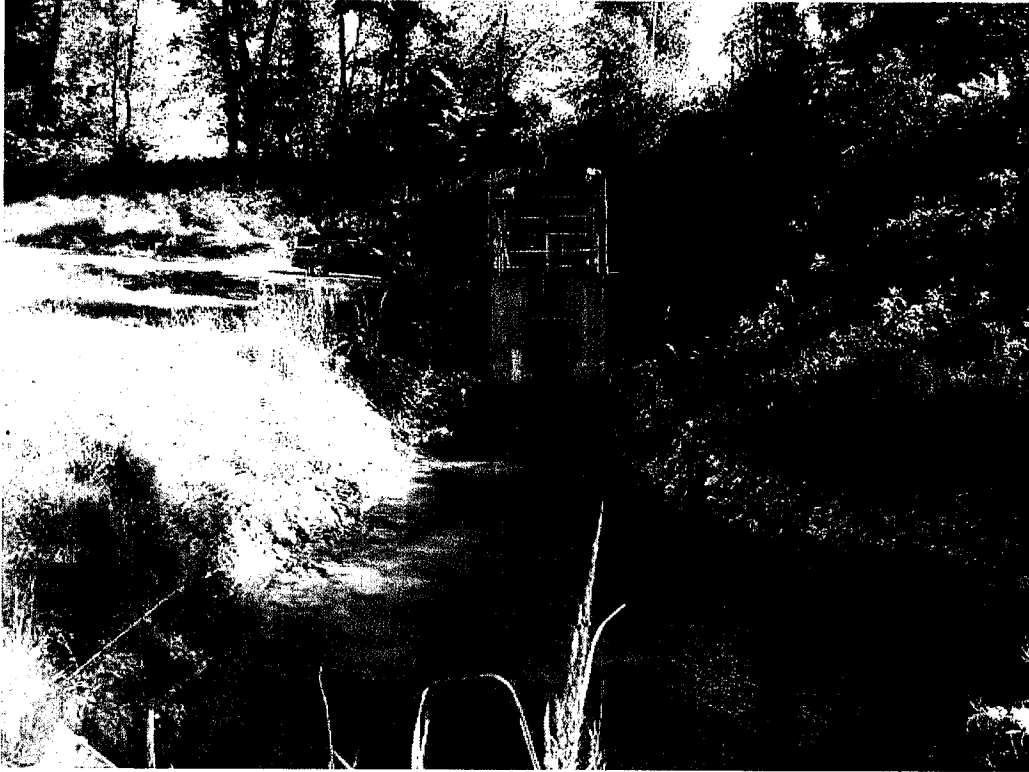
d04-049 9/21/06 right primary spillway intake

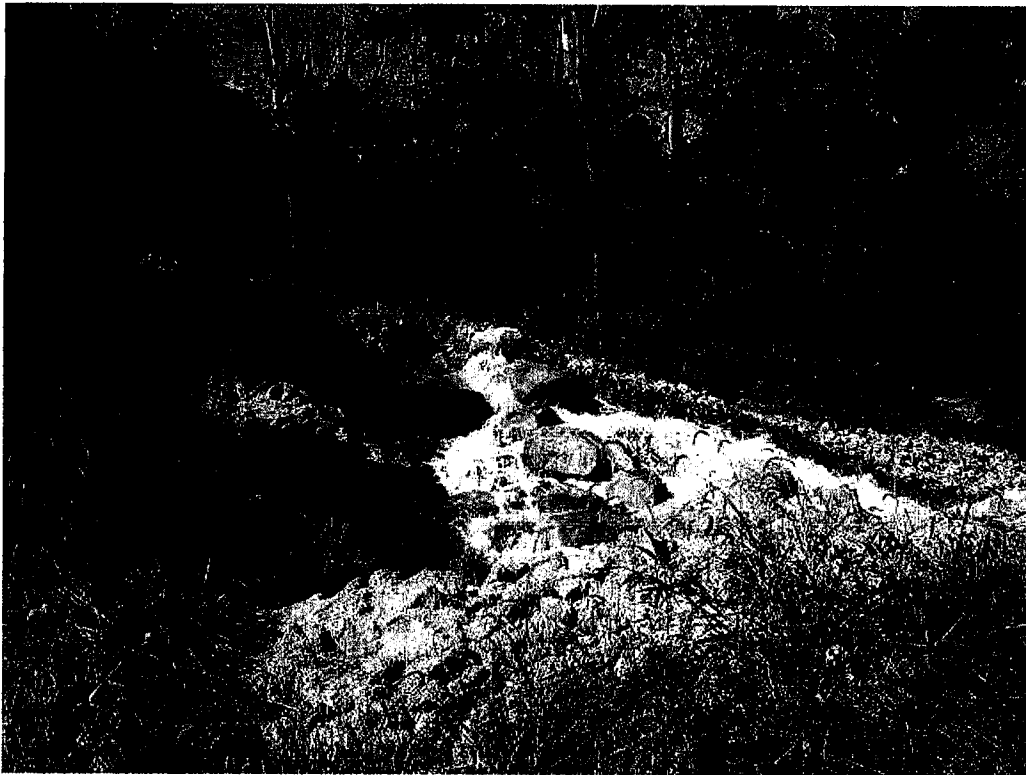
d04-049 9/21/06 right primary spillway outlet

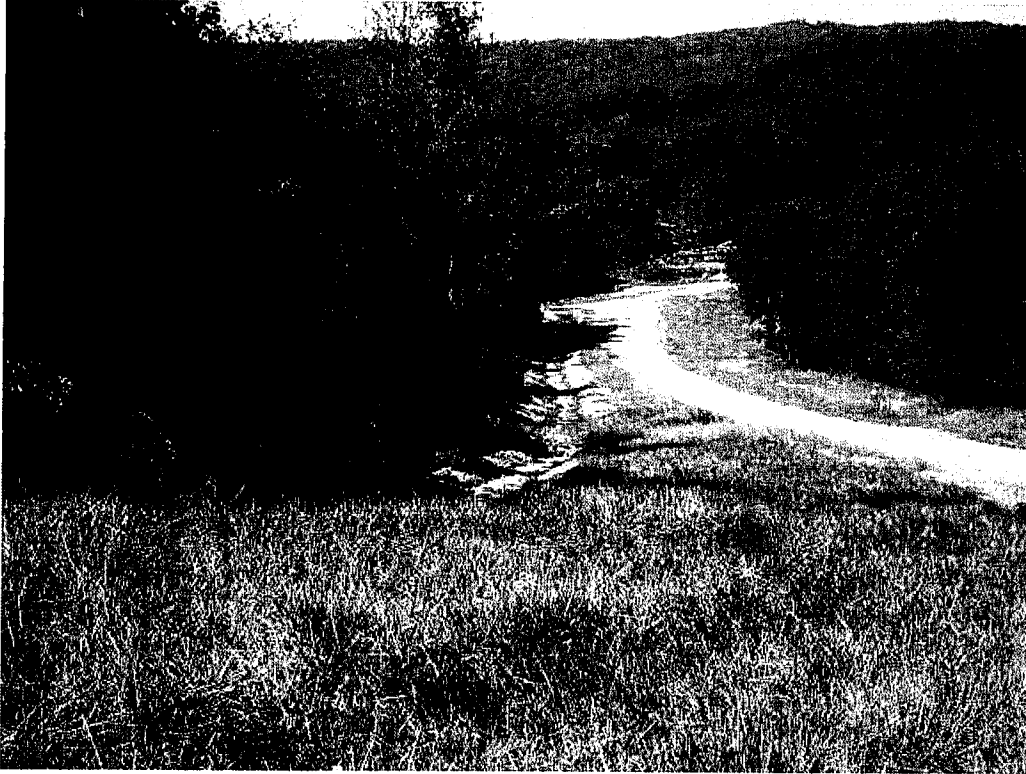
d04-049 9/21/06 right primary spillway wasteway

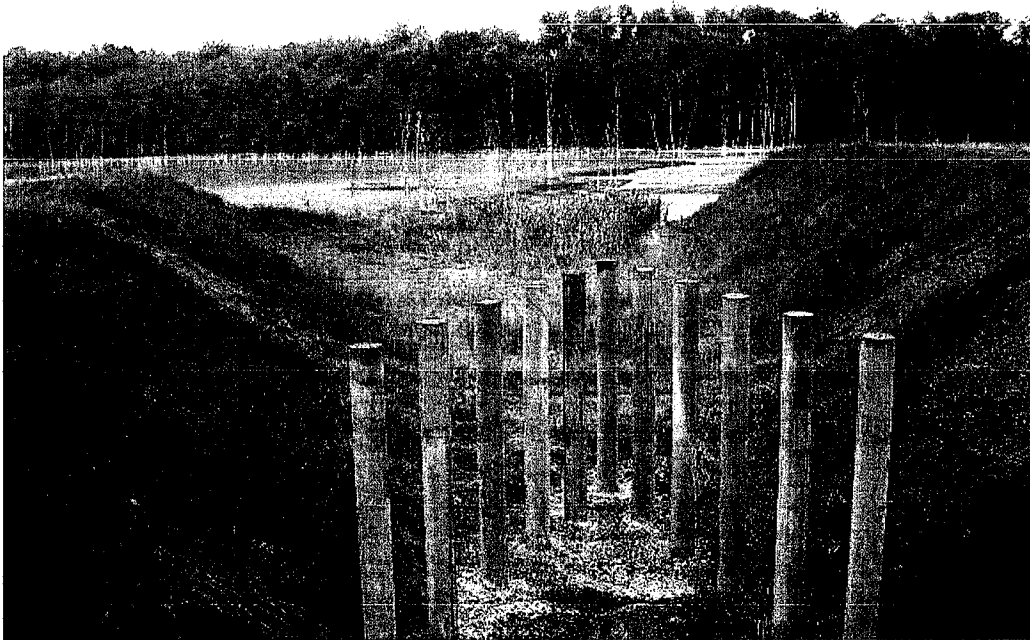
d04-049 8/29/05 looking from left primary spillway toward impoundment

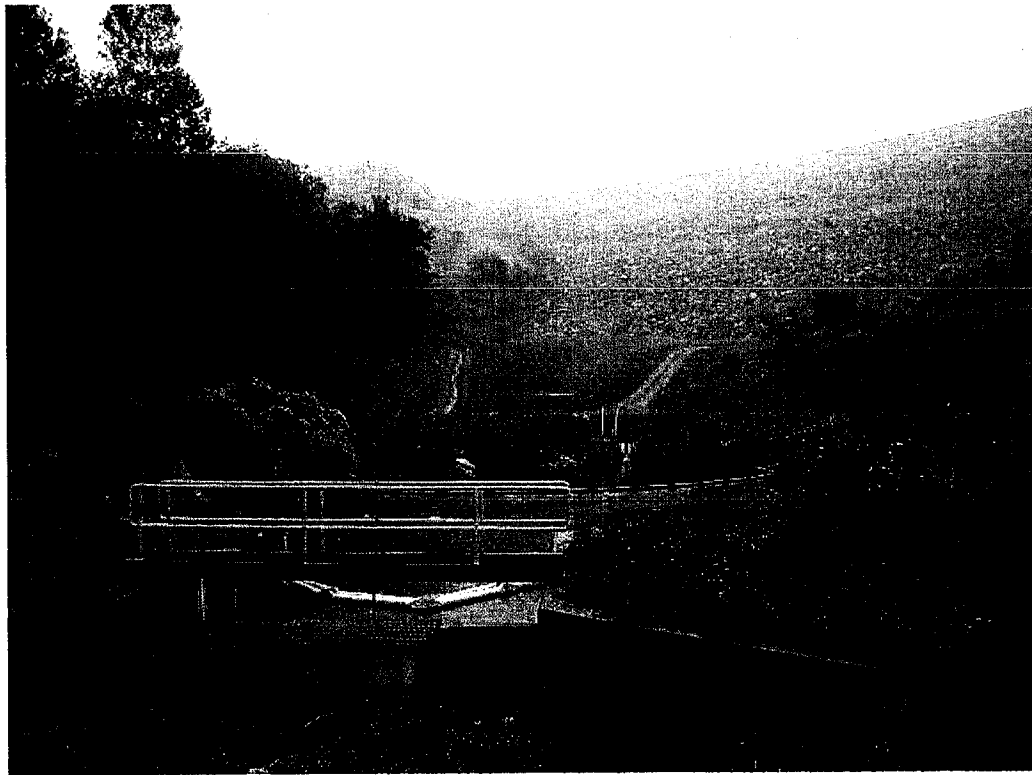
d04-049      8/29/05      stilling basin looking back toward dam
