**DRAFT REPORT  
ROUND 10 DAM ASSESSMENT – MAY 23, 2011  
FIRSTLIGHT POWER RESOURCES, INC.  
MT. TOM GENERATING STATION  
BOTTOM ASH BASIN A, EQUALIZATION TANK, AND SPECIAL BASIN  
HOLYOKE, MASSACHUSETTS**

March 9, 2012  
GZA File No. 170142.30

Re: CCW Impoundment Inspection Report  
Bottom Ash Basin A, Special Basin, and Equalization Tank  
Mt. Tom Generating Station  
Holyoke, Massachusetts

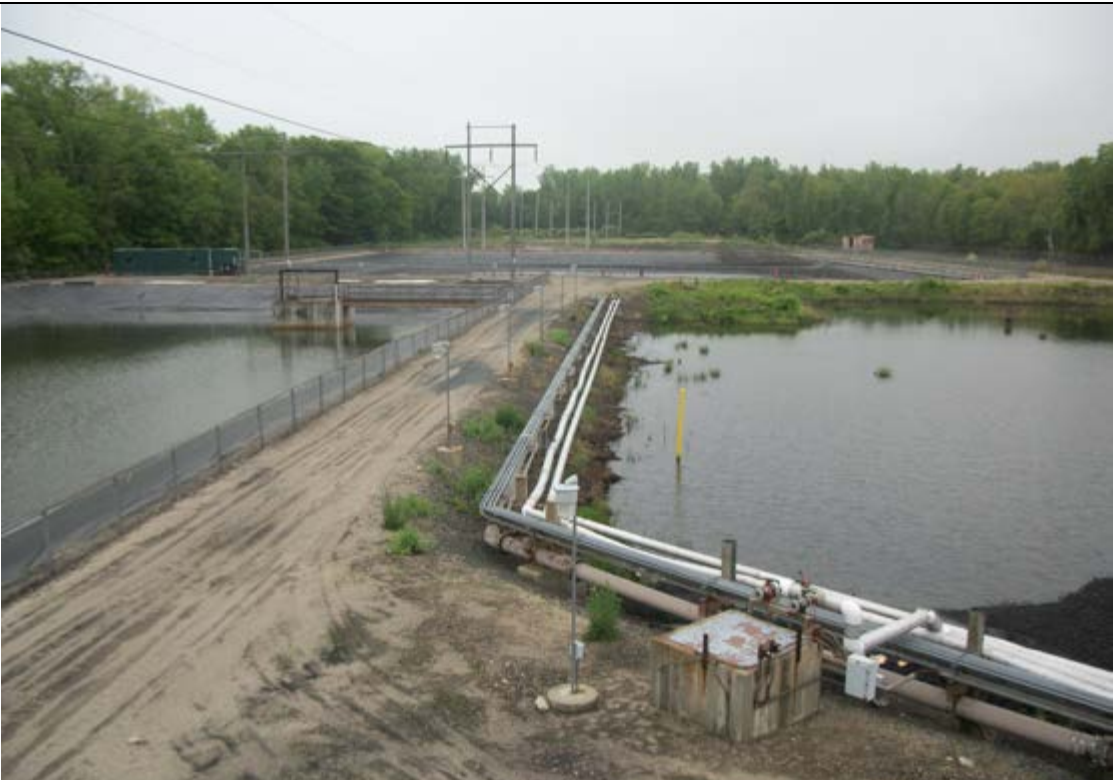
| <b>Description:</b><br>Overview of Special Basin (foreground, left), surface water runoff from Coal Pile (foreground, right), and Bottom Ash Basin (background, center). Note minor embankment between basins and Coal Pile runoff area. | | |

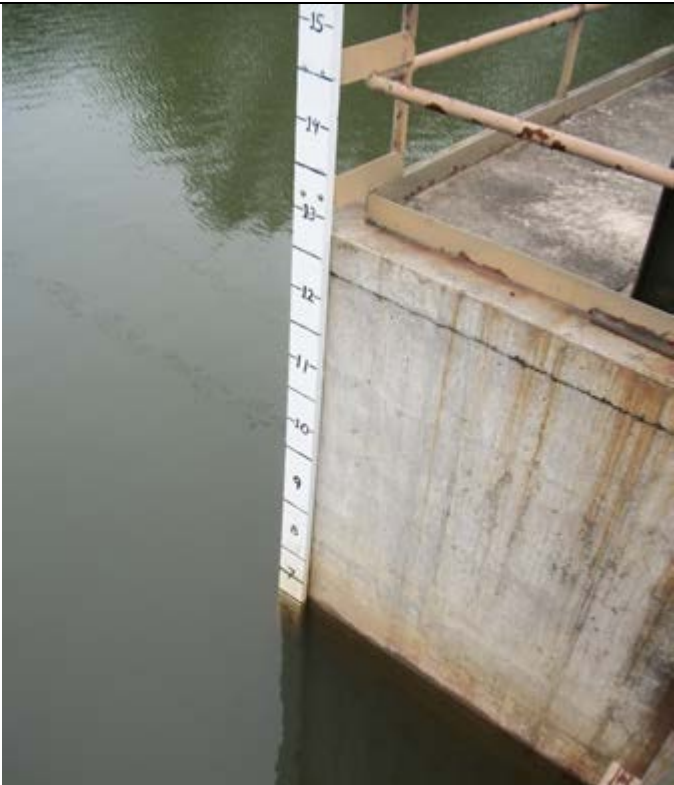
1. Staff gage numbers are worn and difficult to read near the water line.

| <b>Description:</b><br>View of staff gage at Special Basin discharge structure. | | | | |

5. Repair/replace Bottom Ash Basin A and Equalization Tank staff gages, and provide distinct marking for the maximum operating level.

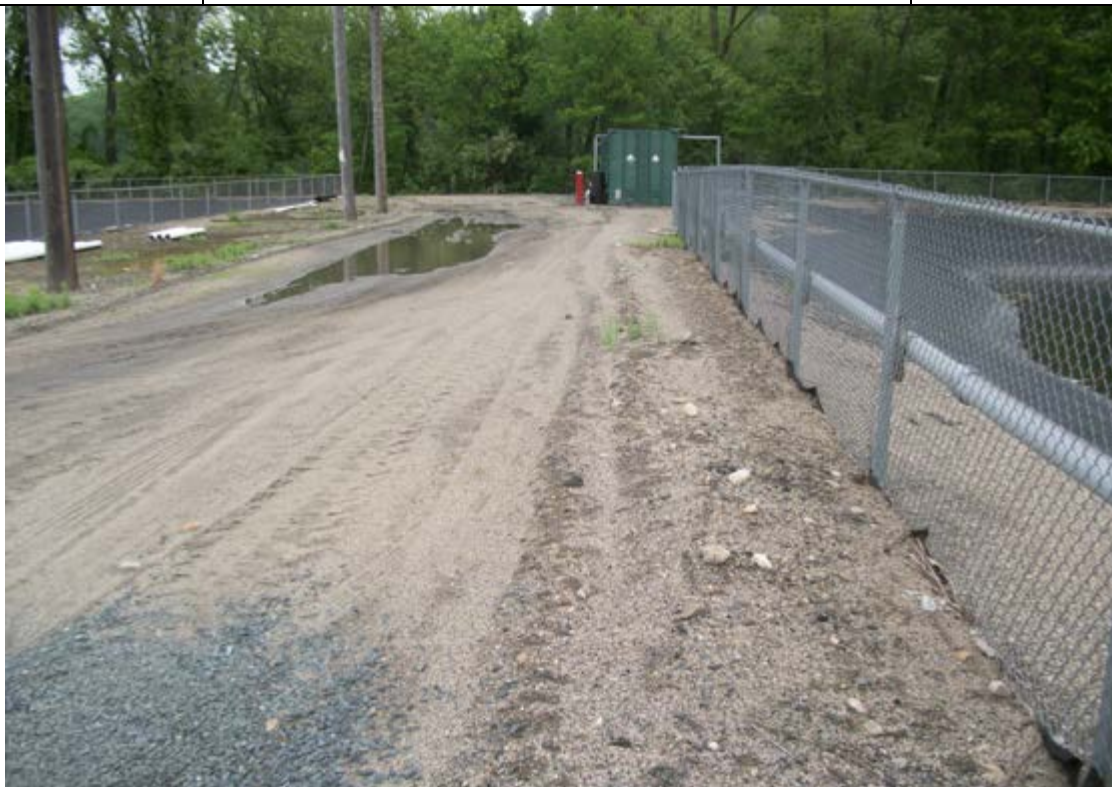
**Photo No.**  
**14**

View of access roadway between Special Basin (left) and Bottom Ash Basin A (right). Note low/rutted areas and standing runoff water. Treatment plant (pH) for Bottom Ash Basin A is located in background.

1. Fill low/rutted areas on access roads around the Bottom Ash Basin A and Special Basin with appropriately sized and compacted stone;
2. Repair/fill areas of erosion on the surface of the berms and embankment slopes. New material should be appropriately sized to prevent erosion from surficial runoff;

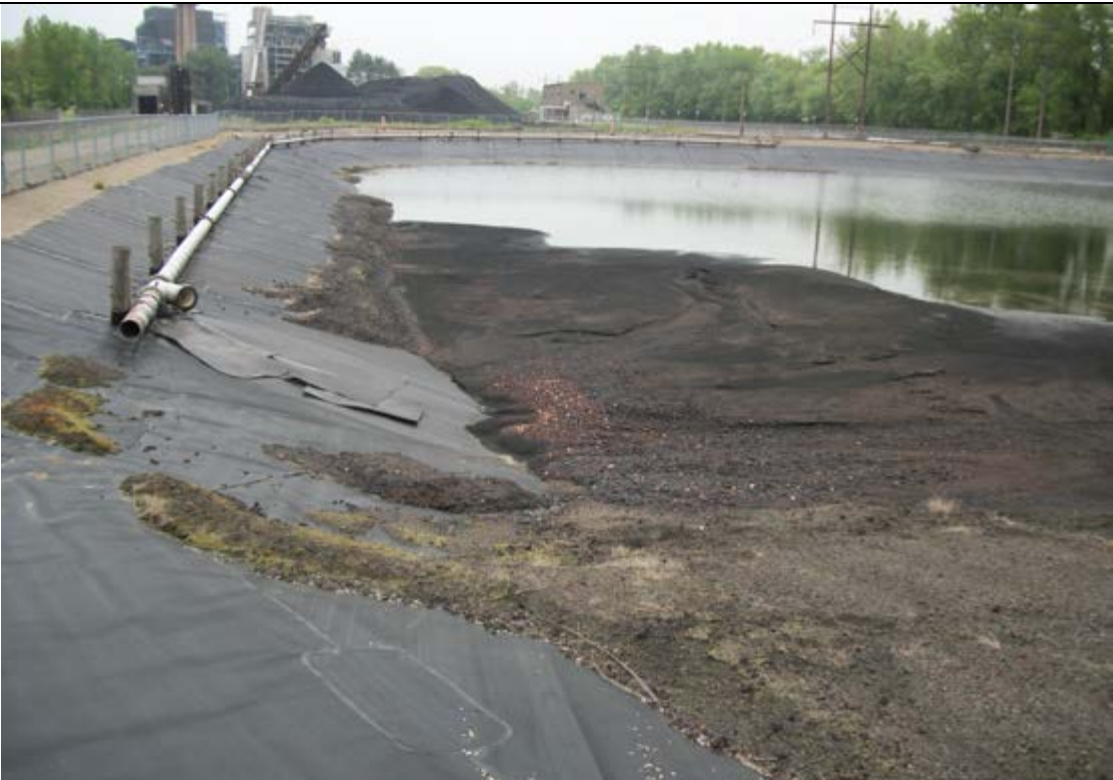
| <b>Description:</b><br>View of bottom ash discharge into Bottom Ash Basin A. Note pads placed at discharge point for protection of liner. | | |

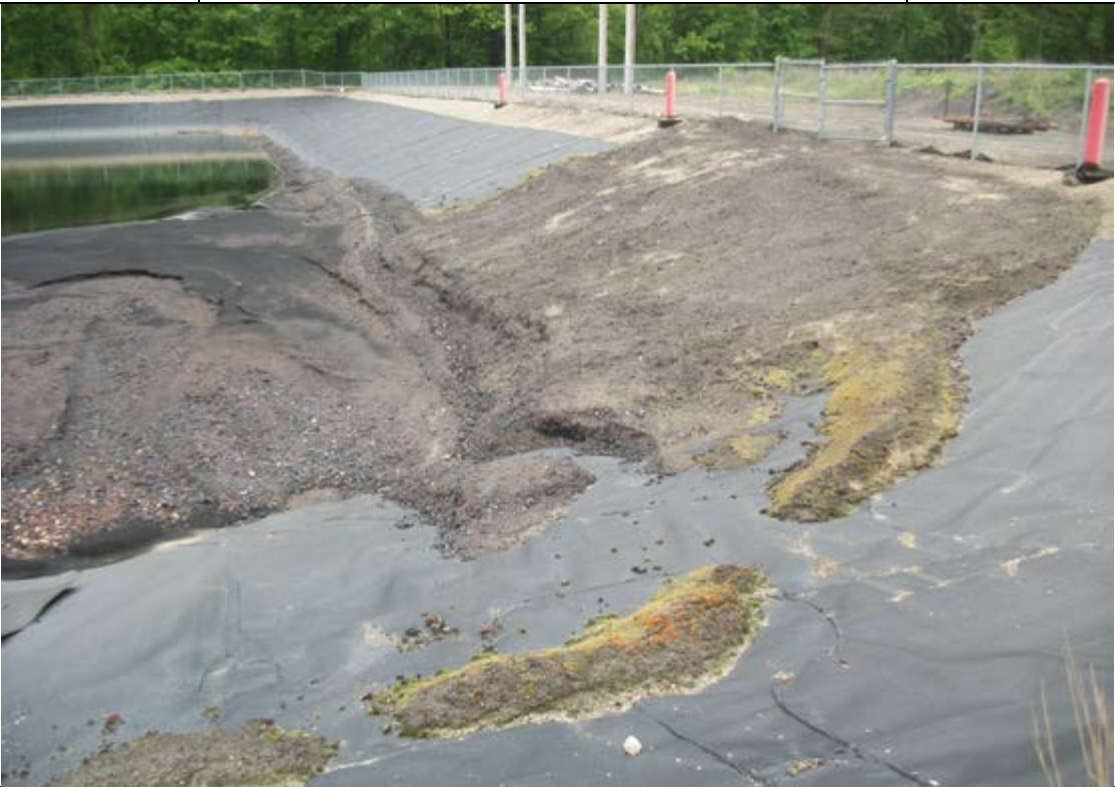
| <b>Description:</b><br>View along south slope of Bottom Ash Basin A. Note bottom ash solids placed on slope to protect liner during sediment removal operations. | | | |

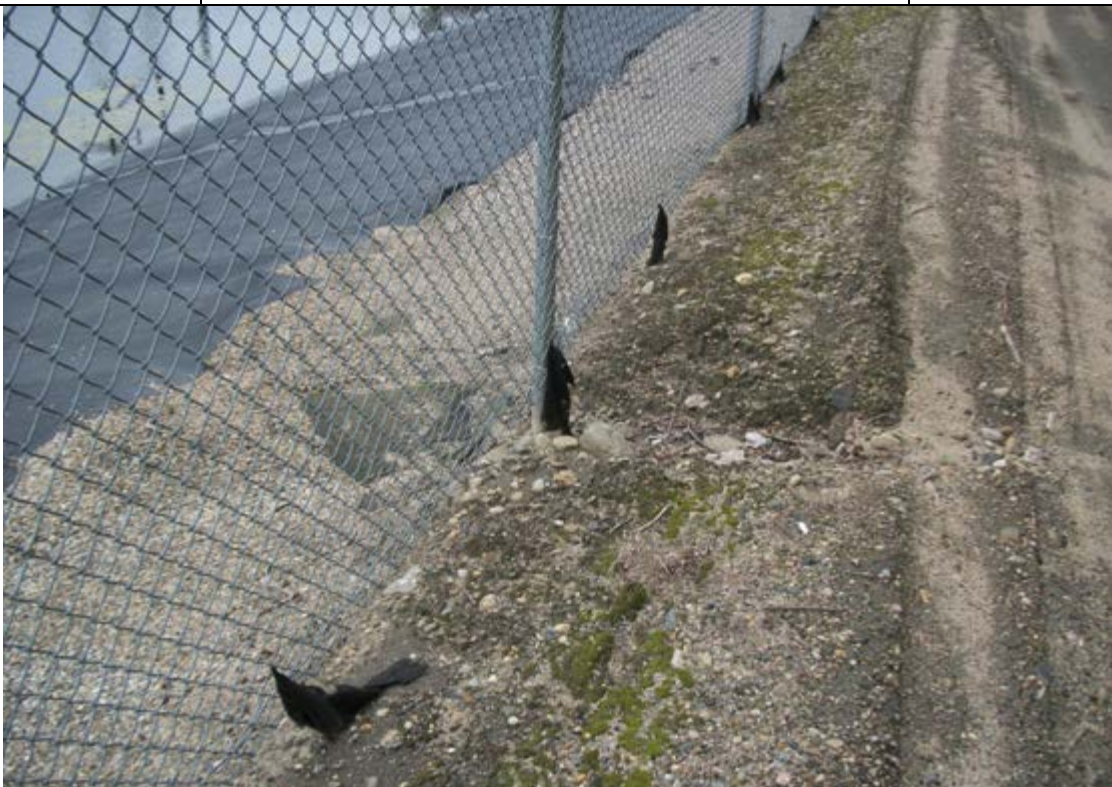
**Photo No.**  
20

View of minor surficial erosion along top of slope at access road along east side of Bottom Ash Basin A.
