Assessment of Dam Safety Coal Combustion Surface Impoundments Draft Report

Georgia Power
Company

Plant Bowen

July 6, 2009

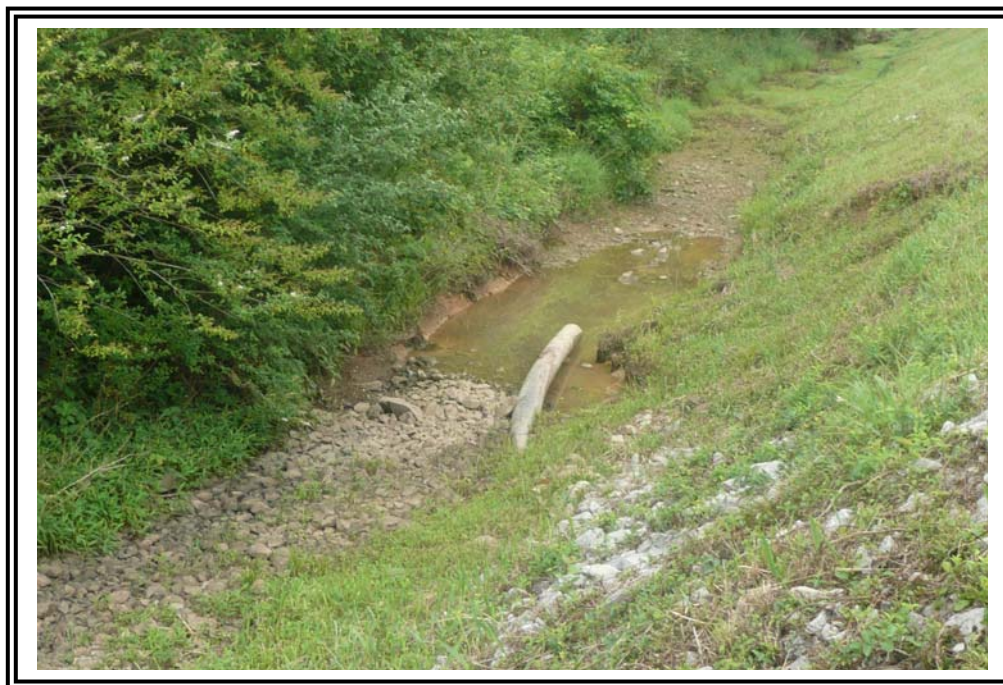
5

flows west until it intersects the Euharlee Creek. This channel is relatively clear, although portions of the channel are being choked by soil previously sloughed from the adjacent natural slope as shown in photos 4 through 7.

Perimeter ditch at south end of main dike looking west, 180 degree view of previous photo.

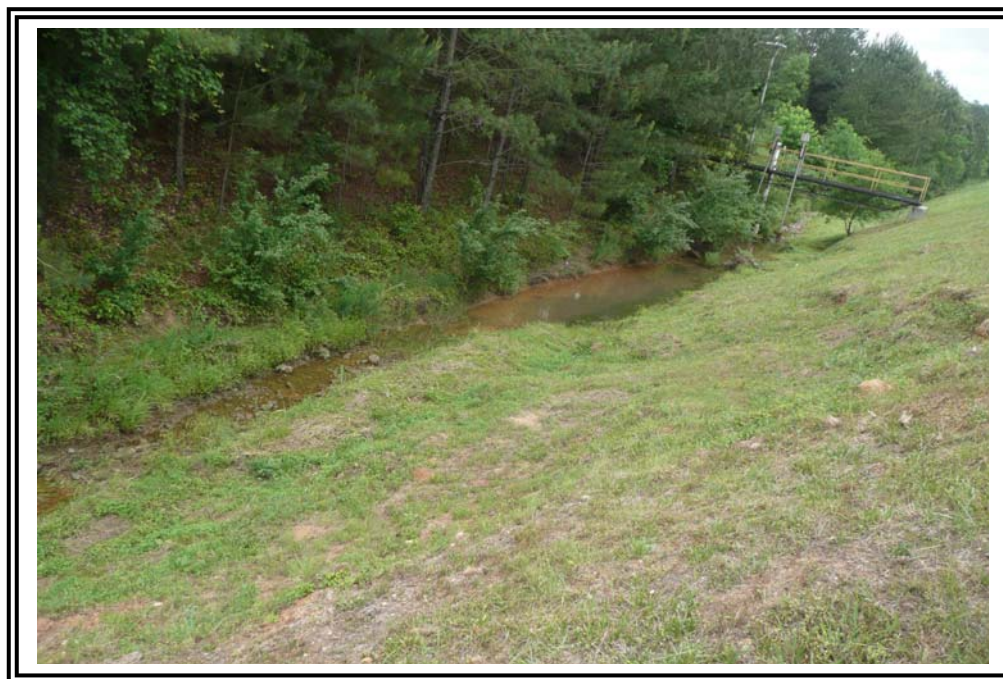
The southern portion of the main dike along the recycle pond consists of a 5- to 10-foot high dike constructed on top of a 15 to 20 foot high natural cut slope. The natural slope throughout this area has several locations where surficial slides have occurred as shown in Photos 1, 2, 5 and 6. Southern Company personnel who perform quarterly inspections at the dam indicated these features have been there for at least 6 to 10 years during which time the current staff responsible for quarterly inspections have been assigned to this project, and during this time the features have remained unchanged. One feature, as shown in Photo 7, appeared more recent because of relatively new erosion control matting. Southern Company personnel indicated this area had

Continuing west on south end of main dike, another slough area in the natural cut slope, reportedly unchanged in 6 to 10 years per Georgia Power engineer responsible for inspections.

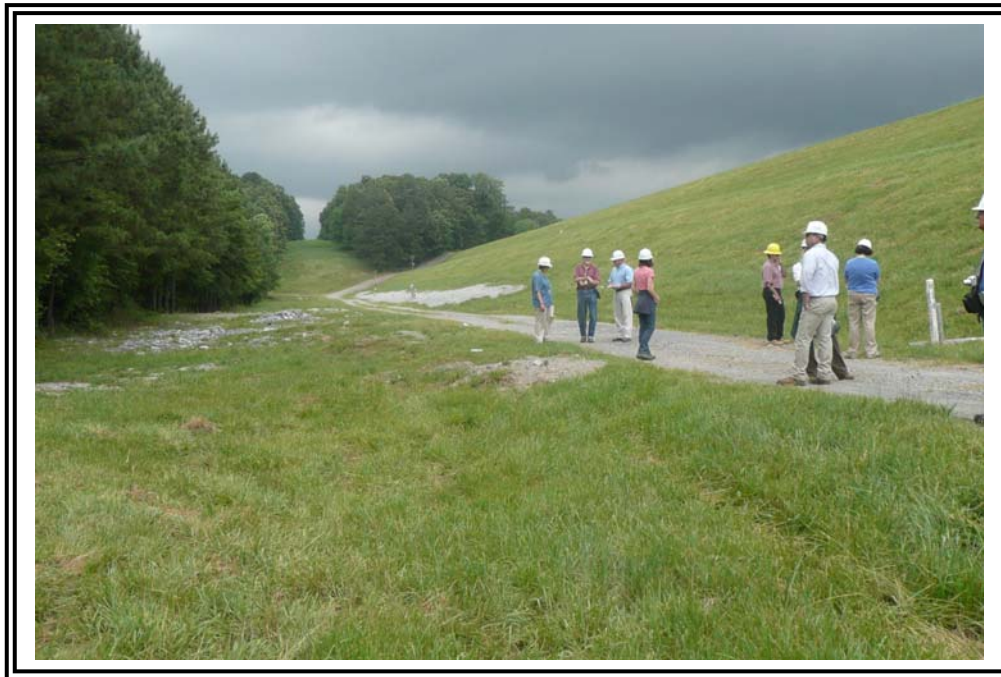
North end of main embankment (looking north). Note the gravel at the toe which was placed during the grouting program to seal karst features below the embankment.

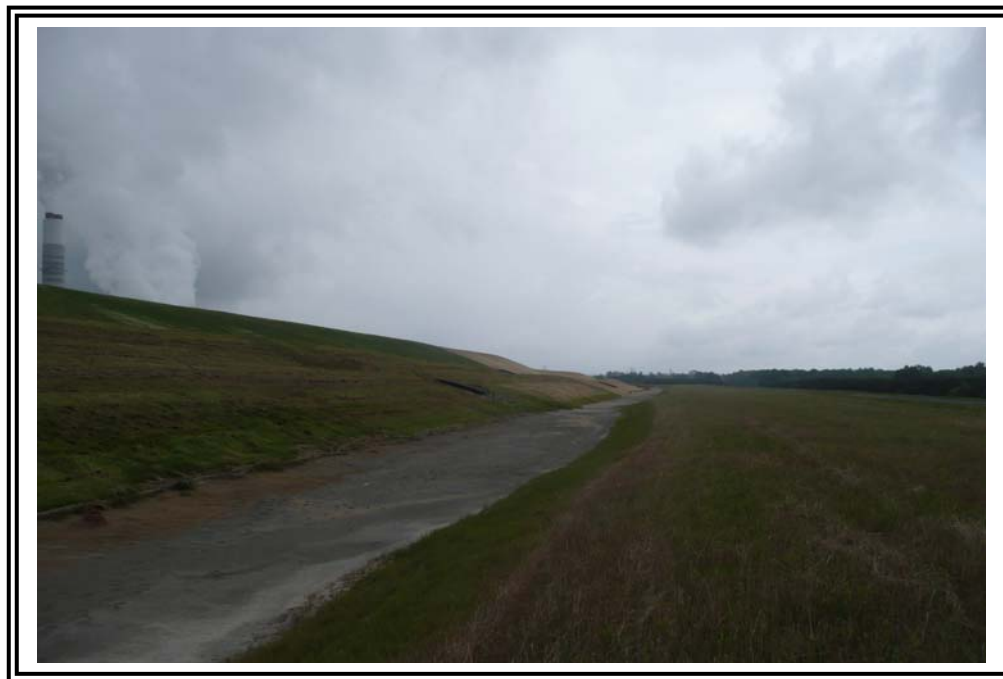
16

In the area where the recycle pond ends and the main dike curves to the north, formerly sluiced or placed ash is level with the crest of the dam as shown in Photos 15, 16, 18, and 20. The design width of the crest was 15 feet. This condition continues along the entire length of the main dike from the southwest curve to the north abutment. Although obscuring the upstream slope of the constructed dike and the upstream edge of the main dike crest, CHA did not observe conditions of concern along the crest of the main dike.

Drainage swale between dam and dry stacked ash piles.

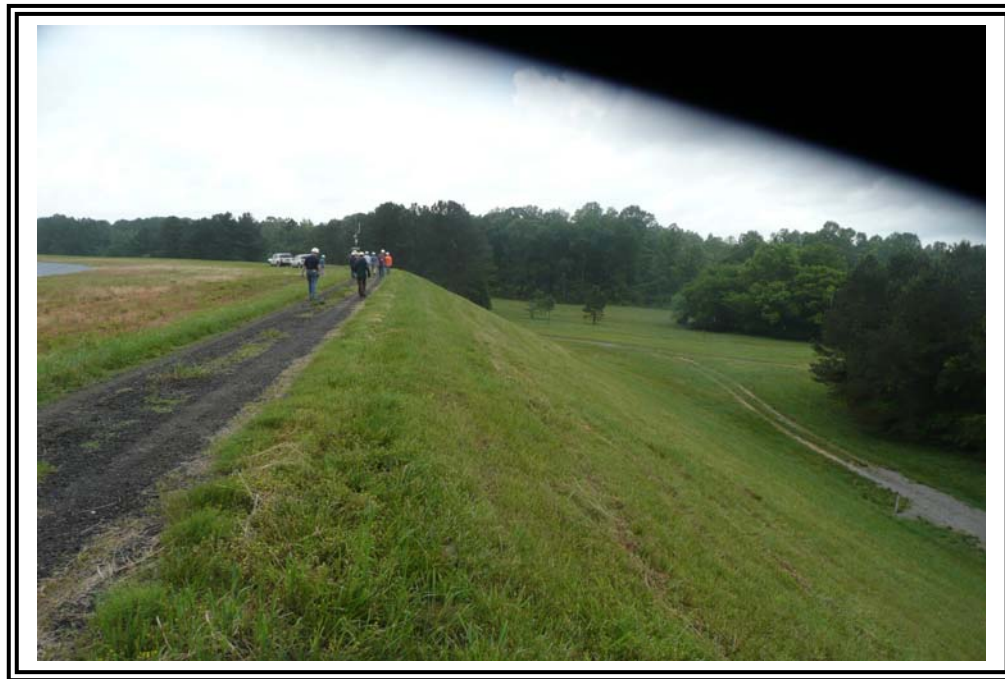
20

Embankment looking from the "Horseshoe" looking south.

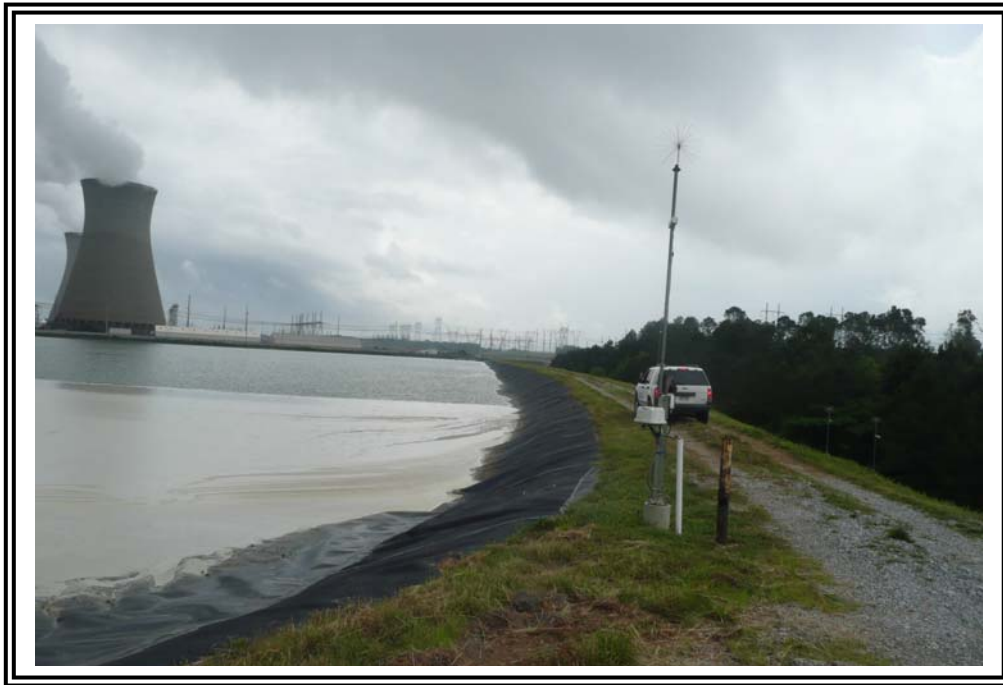
21

Reclaim Pond and south end of the embankment crest looking east. Note the Reclaim Pond is lined with and HDPE liner.

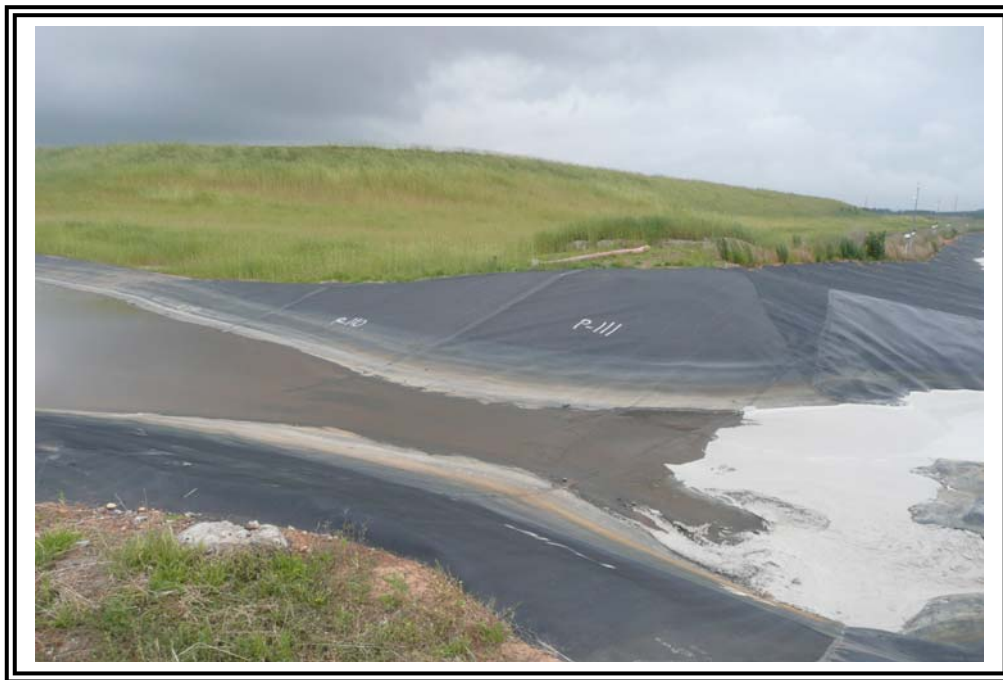
22

Drainage Swale noted in Photos 15, 16, and 17 discharges into the Reclaim Pond. Note the drainage swale is also HDPE lined. Behind the swale in this photo is one of two gypsum ponds.

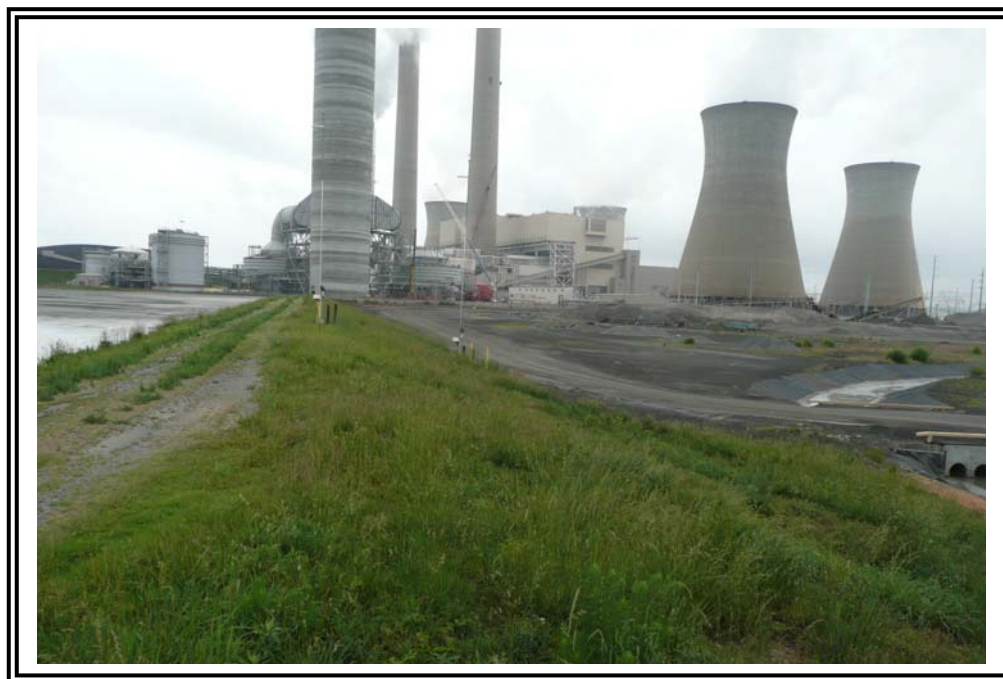
36

South embankment of wet ash ponds, looking East. Note the lined drainage swale in right of photo discharges into the reclaim pond.

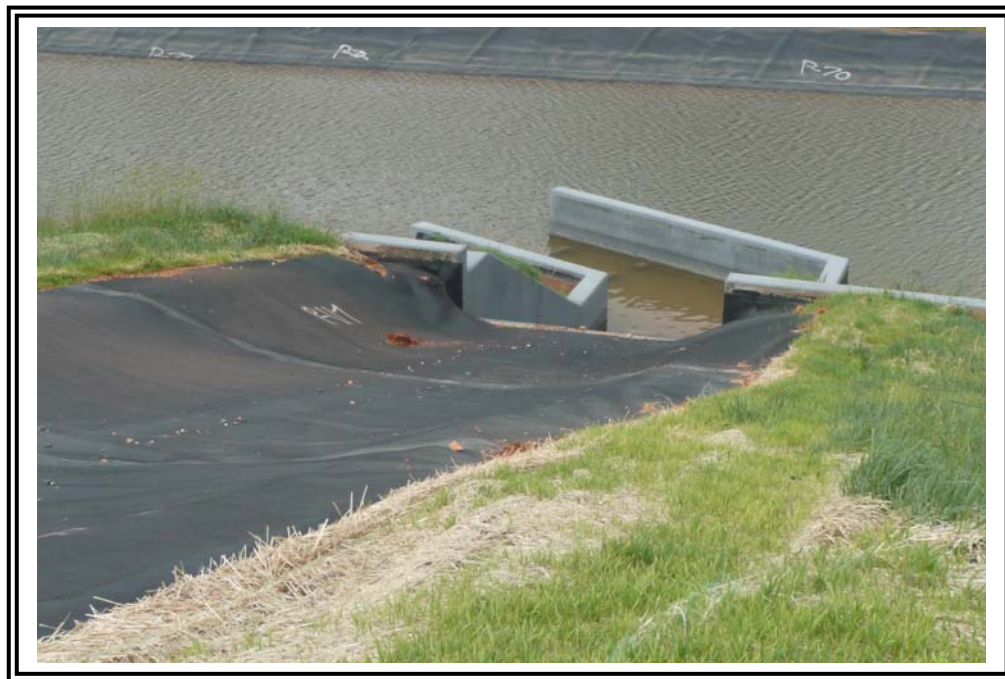
Emergency overflow and outlet sluice (via buried outlet pipe) from the gypsum pond into the drainage swale running to the reclaim pond.

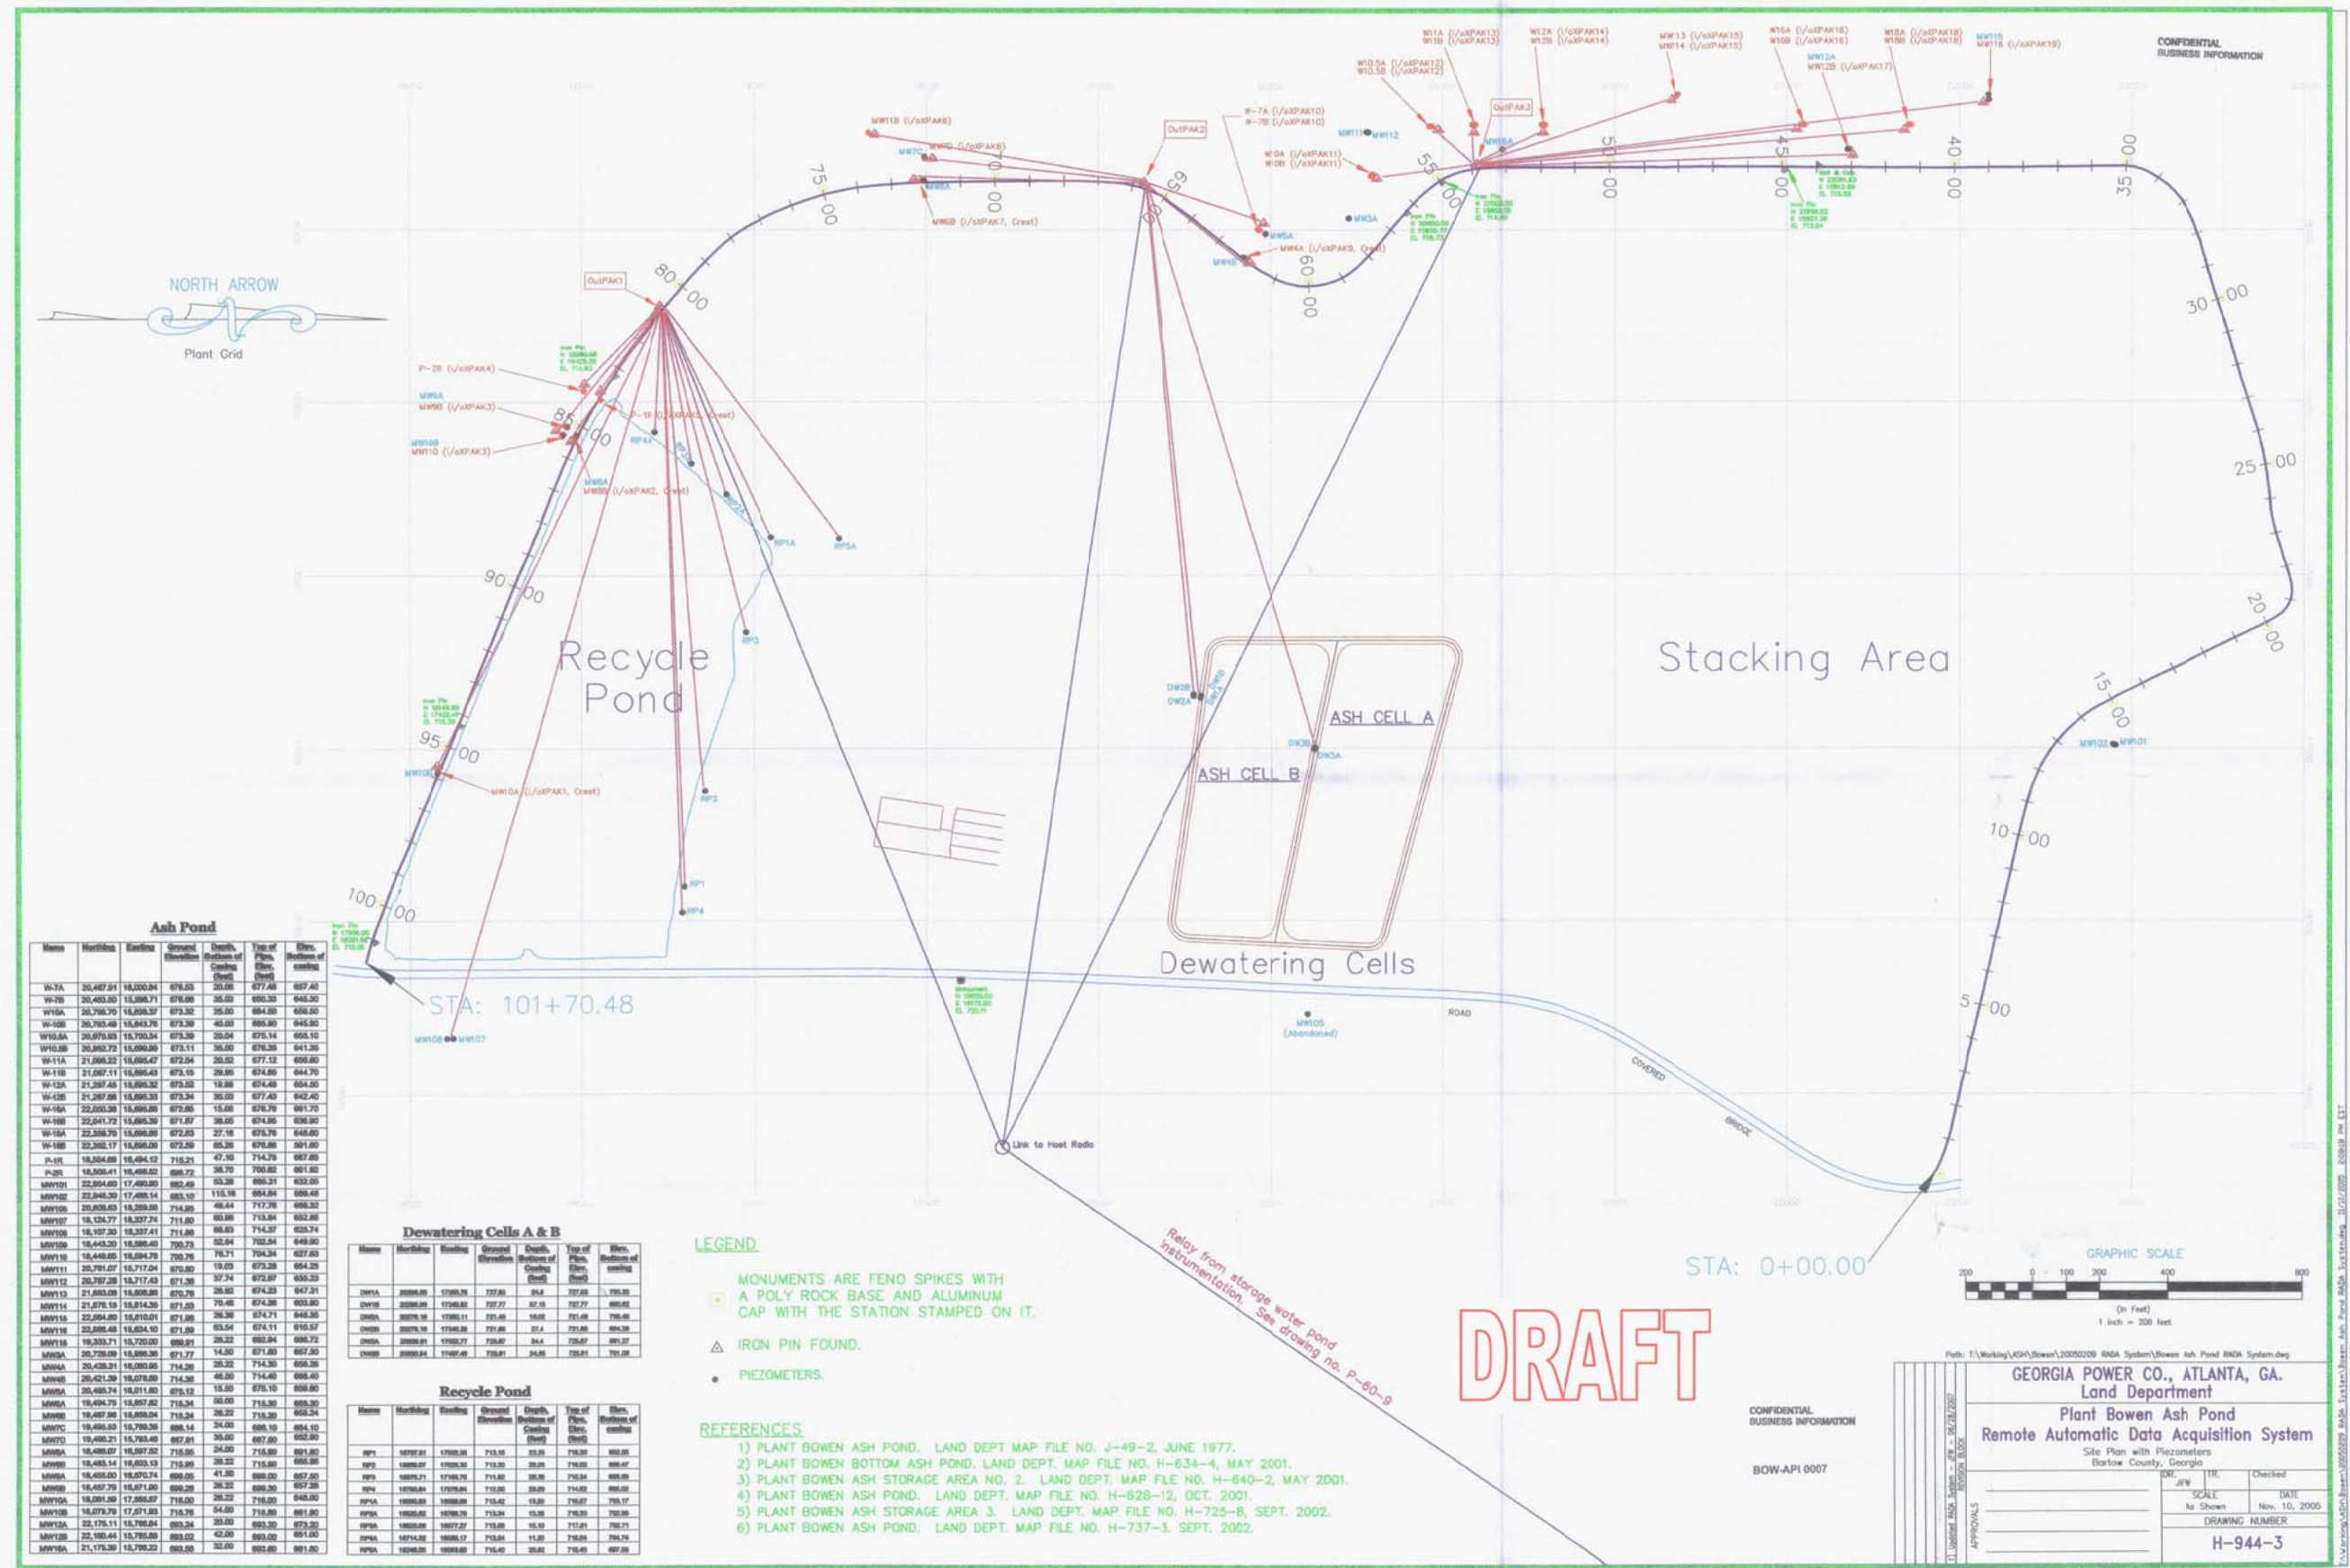
FIGURE 10

Figure 10 shows the piezometer layout at the site. Summaries and a review of this data are included in Section 3.4.1.

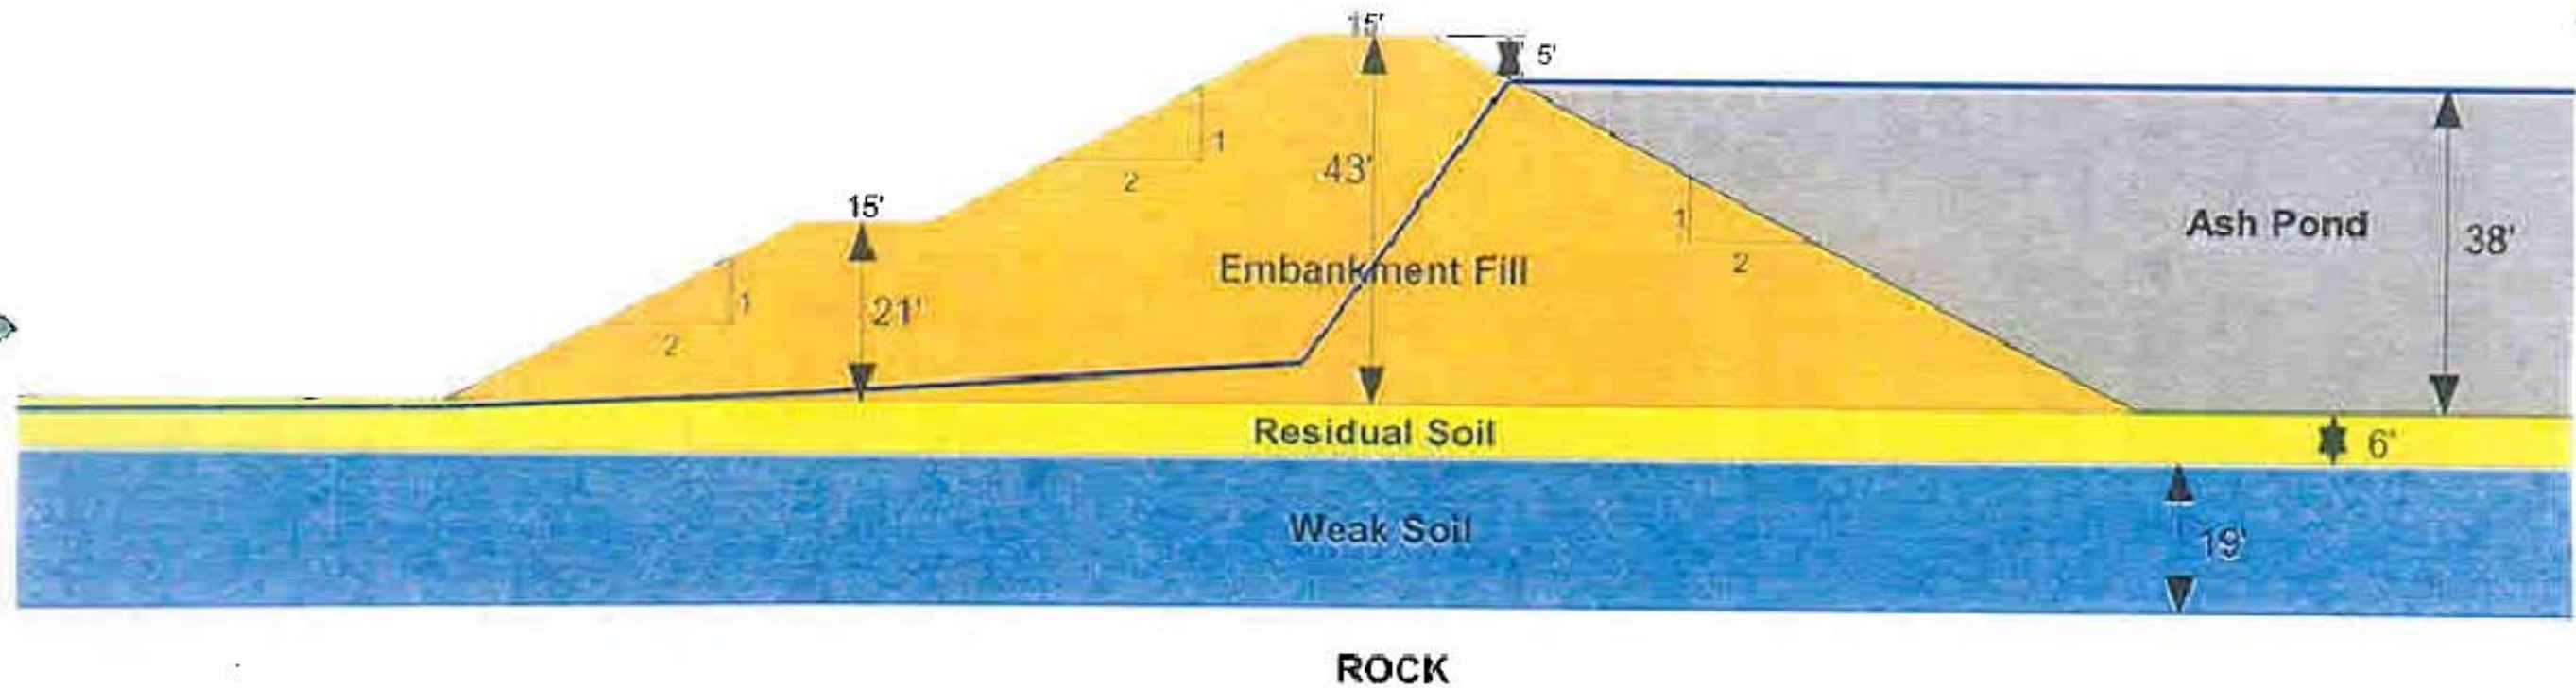
FIGURE 11

Figures 11 and 12 show the typical geometry of the stability models analyzed in the 2003 stability report and Figure 13-1 through 13-3 and Figures 14-1 through 14-3 highlight the results of the analyses. Computed steady state safety factors in these locations ranged from 1.4 to 1.5

Bowen Ash Pond Dike Stability Analysis Section 1-2-3

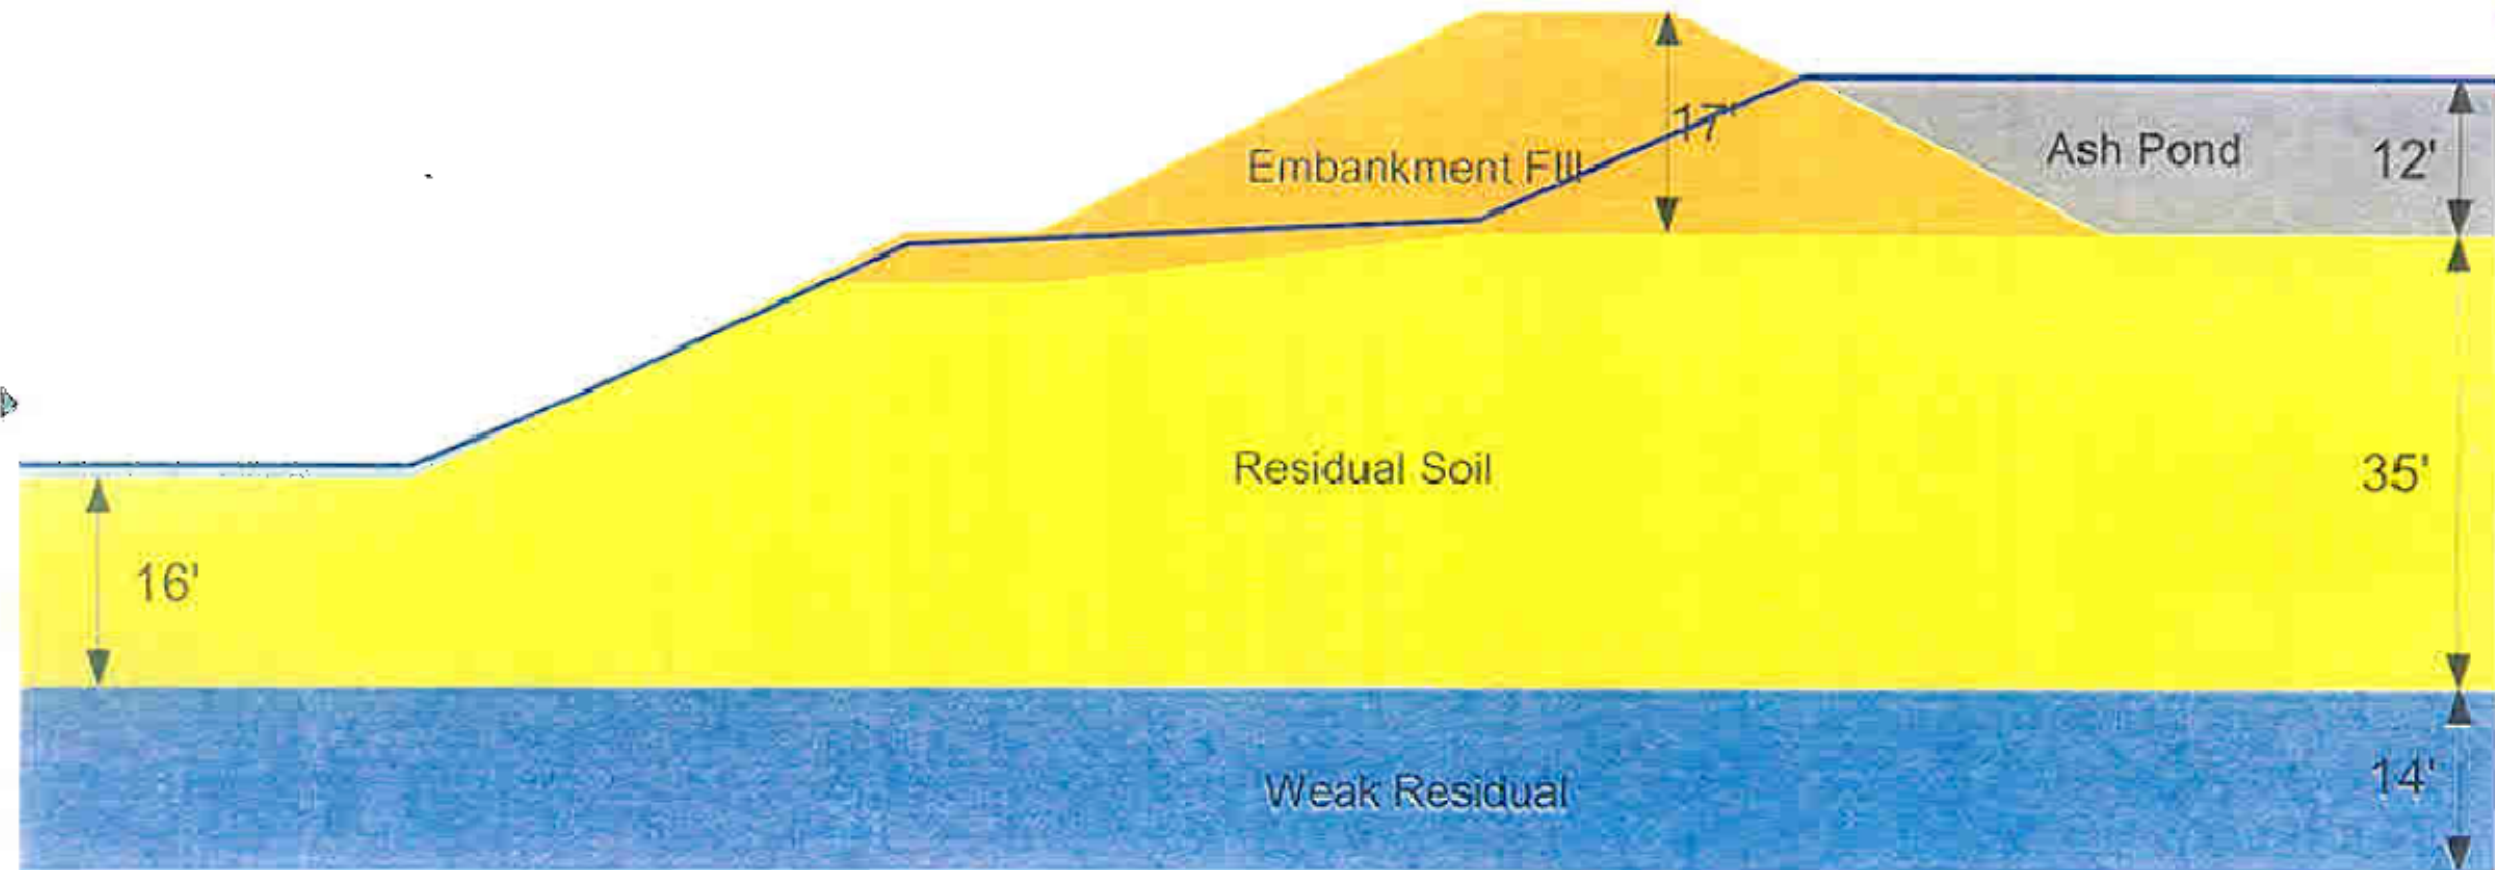
FIGURE 12

Bowen Ash Pond Dike Stability Analysis Section 8-9

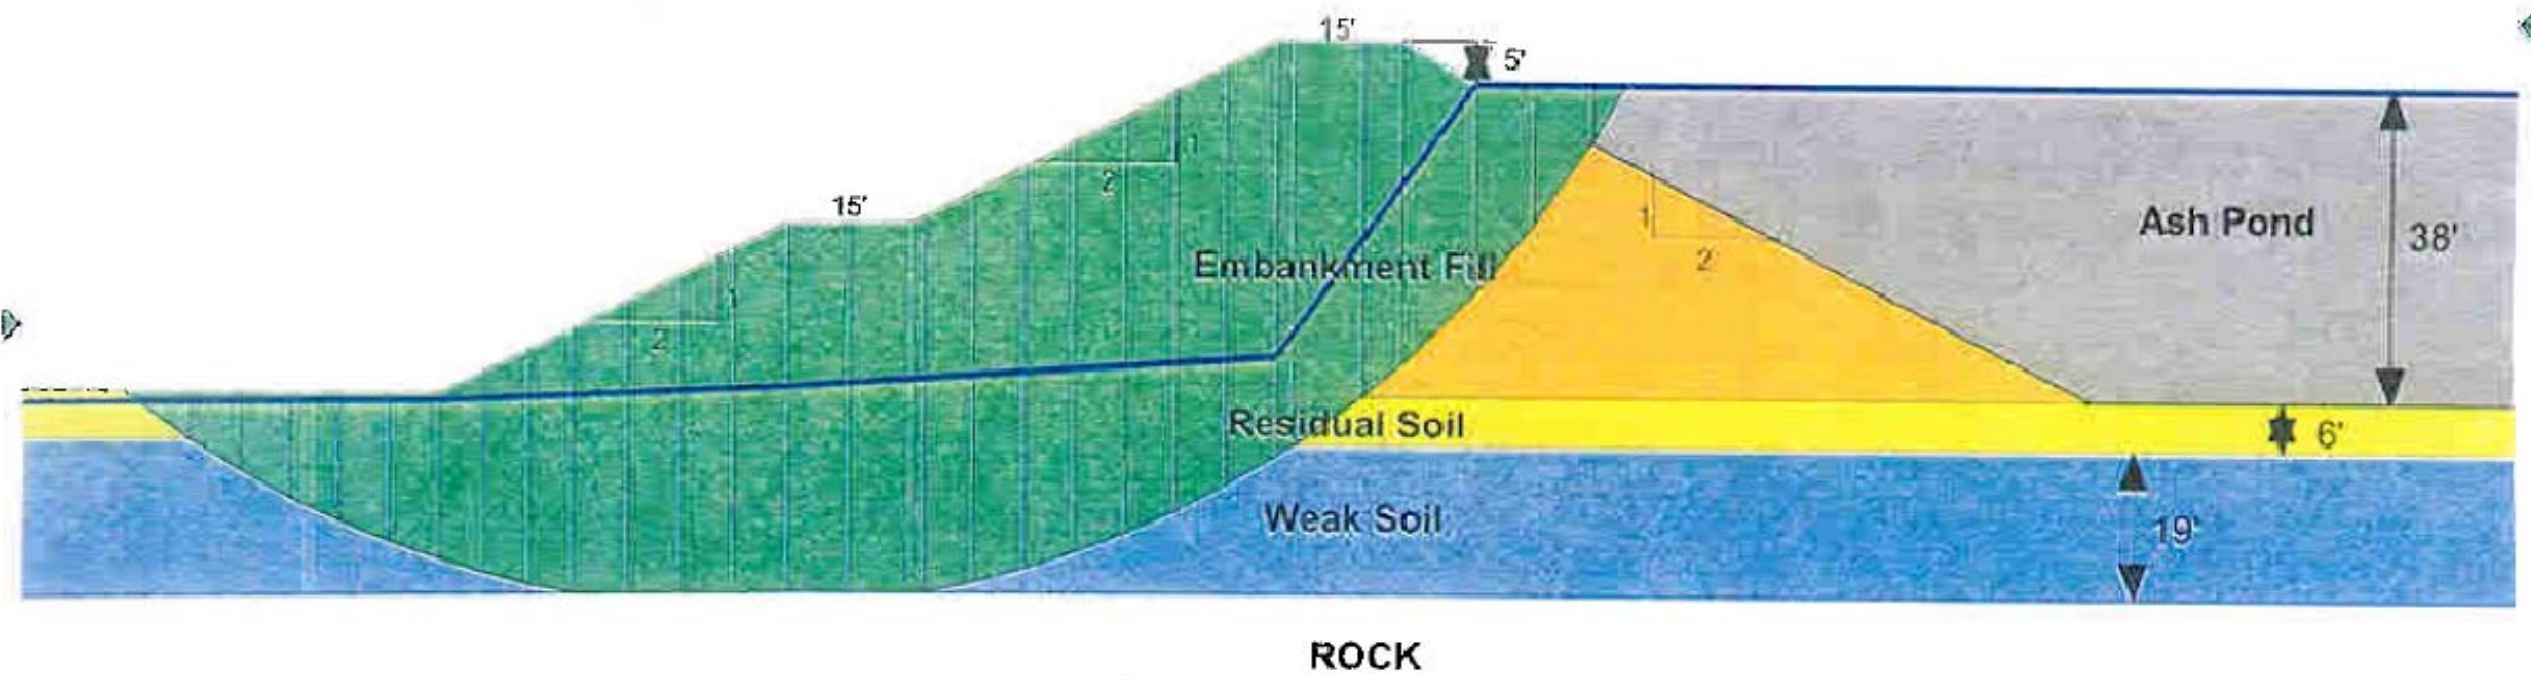
FIGURE 13-1

Bowen Ash Pond Dike Stability Analysis Section 1-2-3 Case A-1

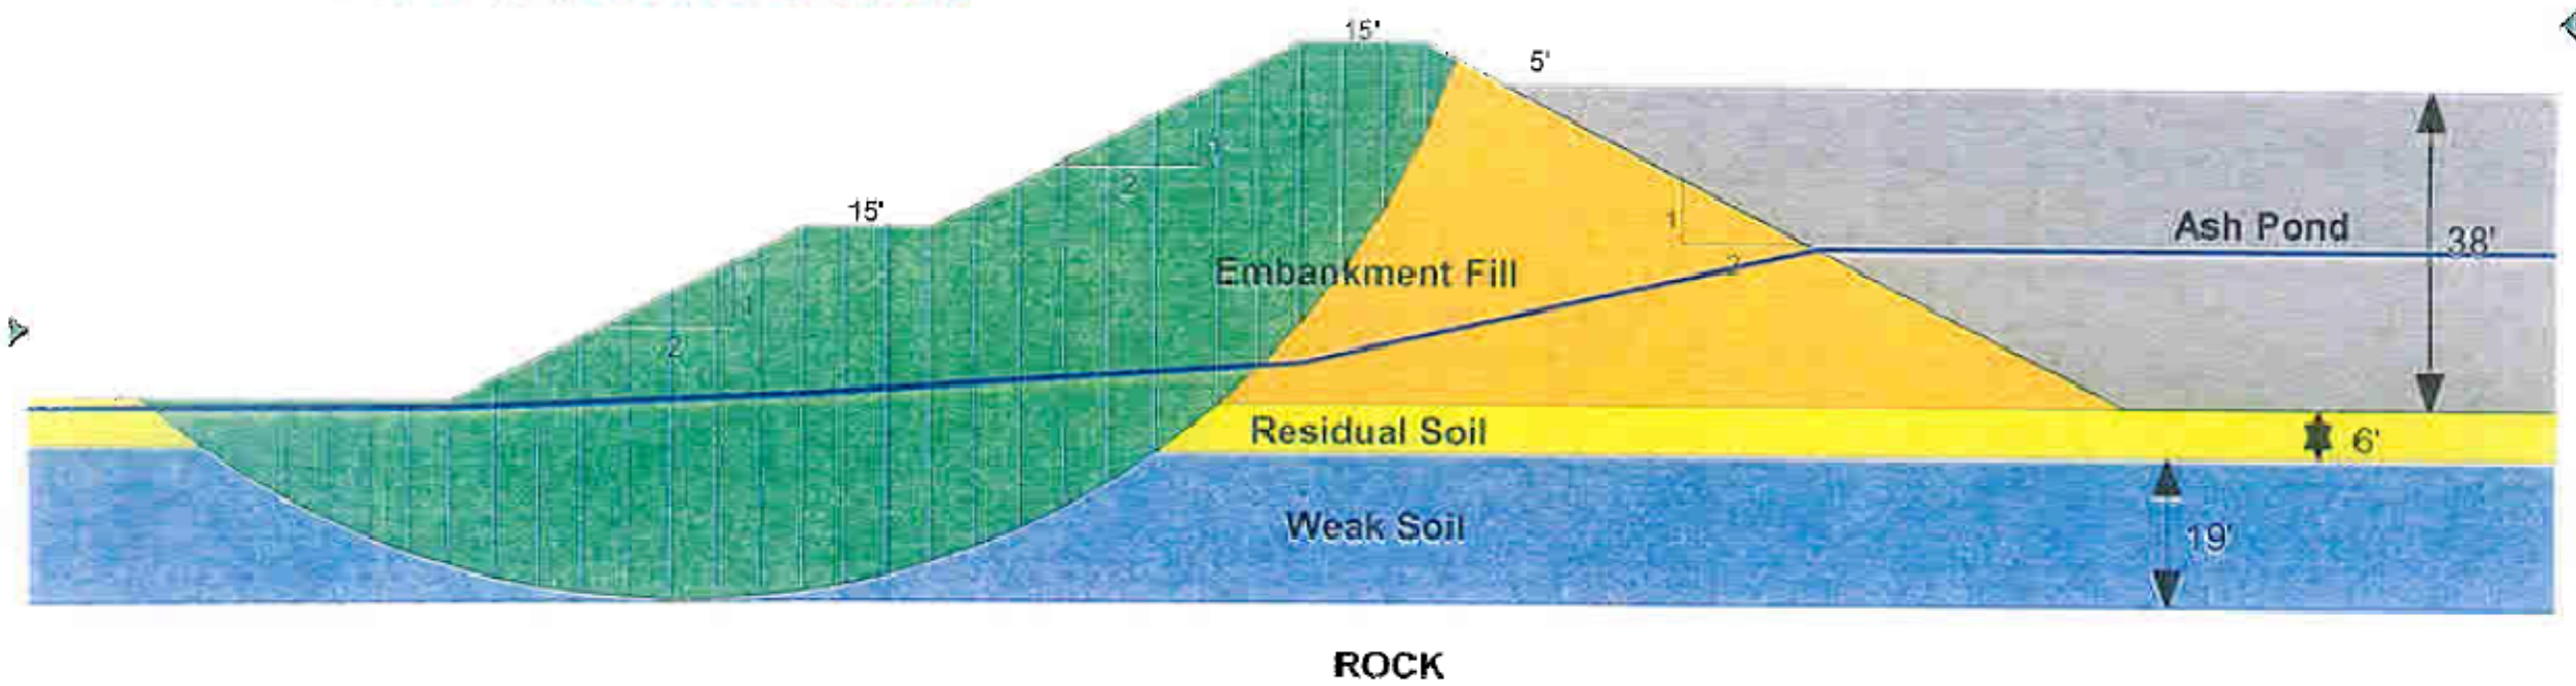
| | FIGURE 13-2 | |

Bowen Ash Pond Dike Stability Analysis Section 1-2-3 Case A-1b

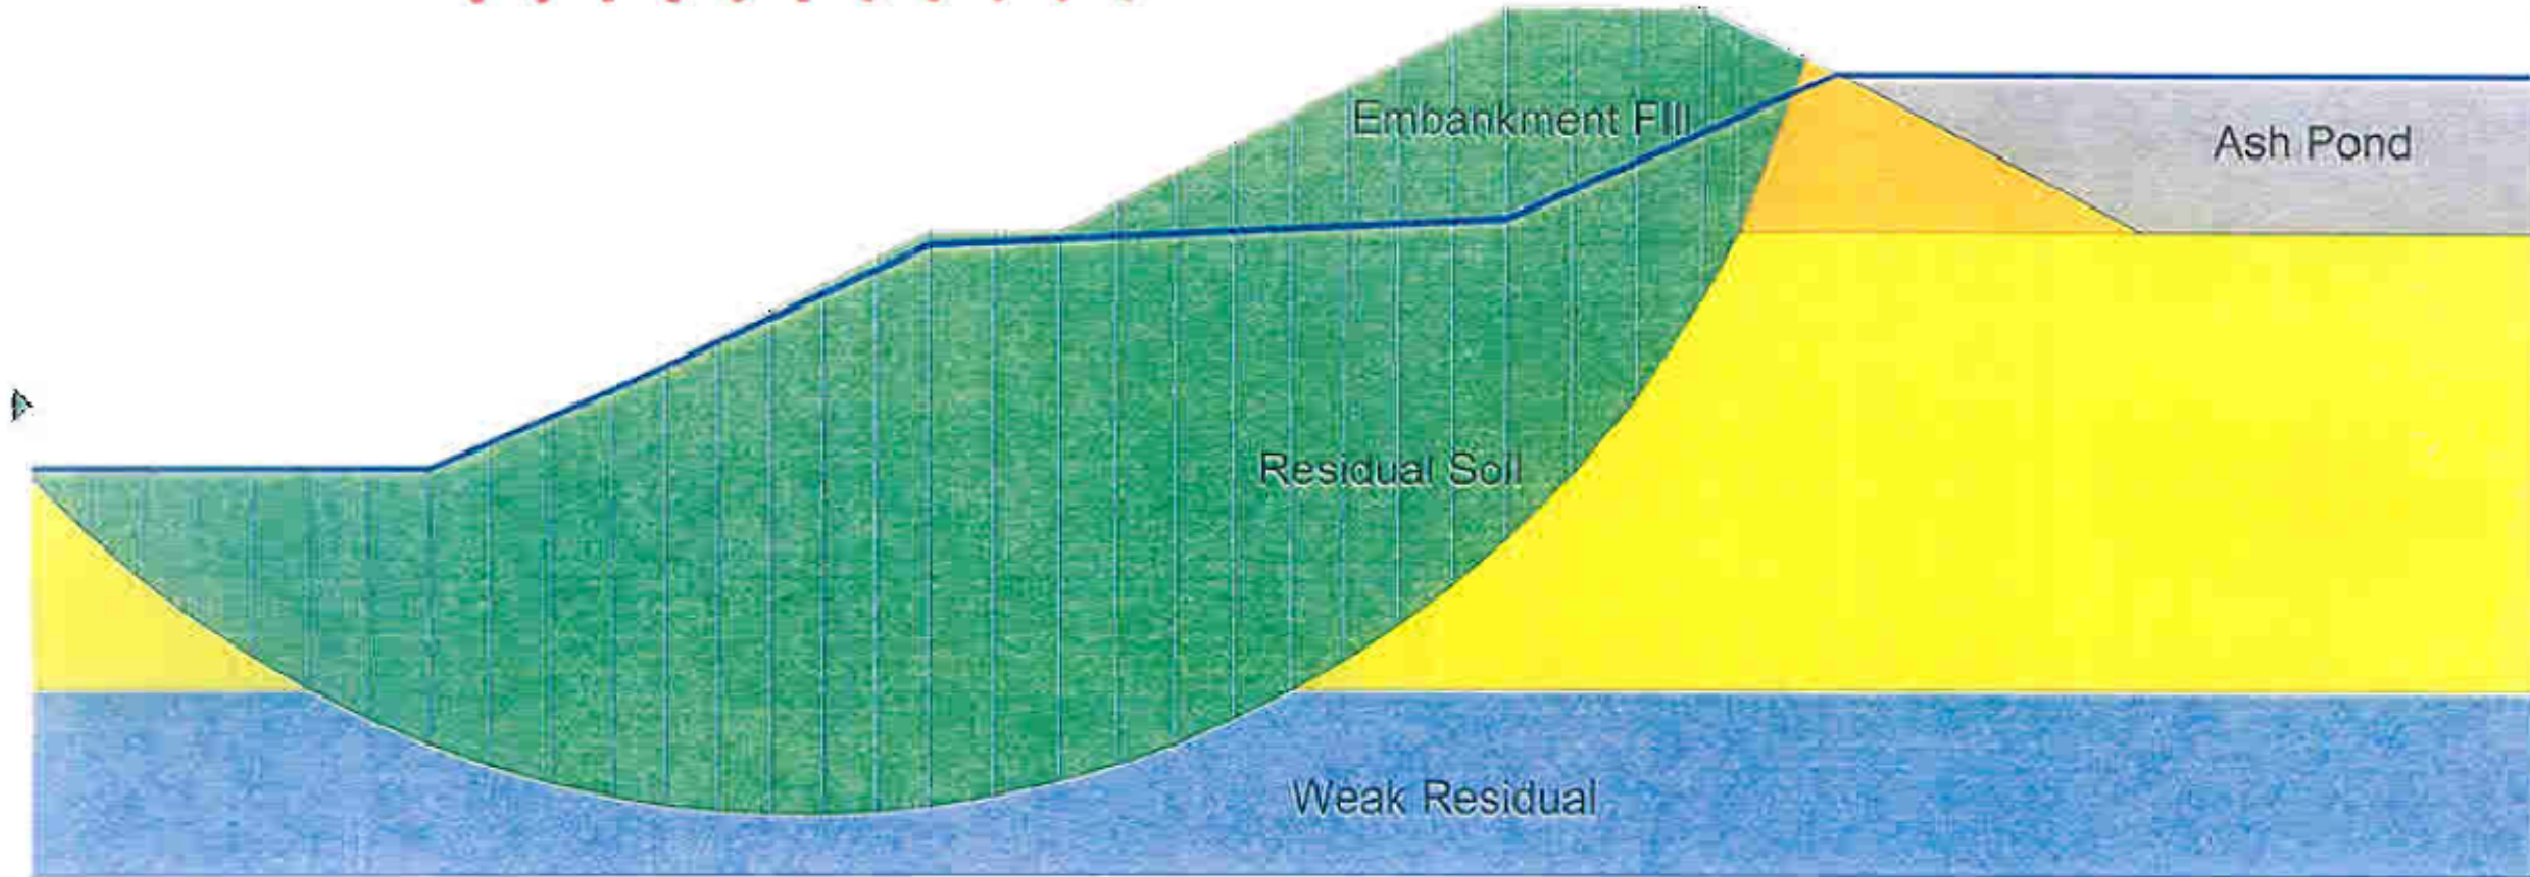
PROJECT NO.
20085.1000
DATE: JULY 2009
FIGURE 14-1

Bowen Ash Pond Dike Stability Analysis Section 8-9 Case A-1
