Assessment of Dam Safety Coal Combustion Surface Impoundments Draft Report

Georgia Power
Company

Plant Bowen

July 6, 2009

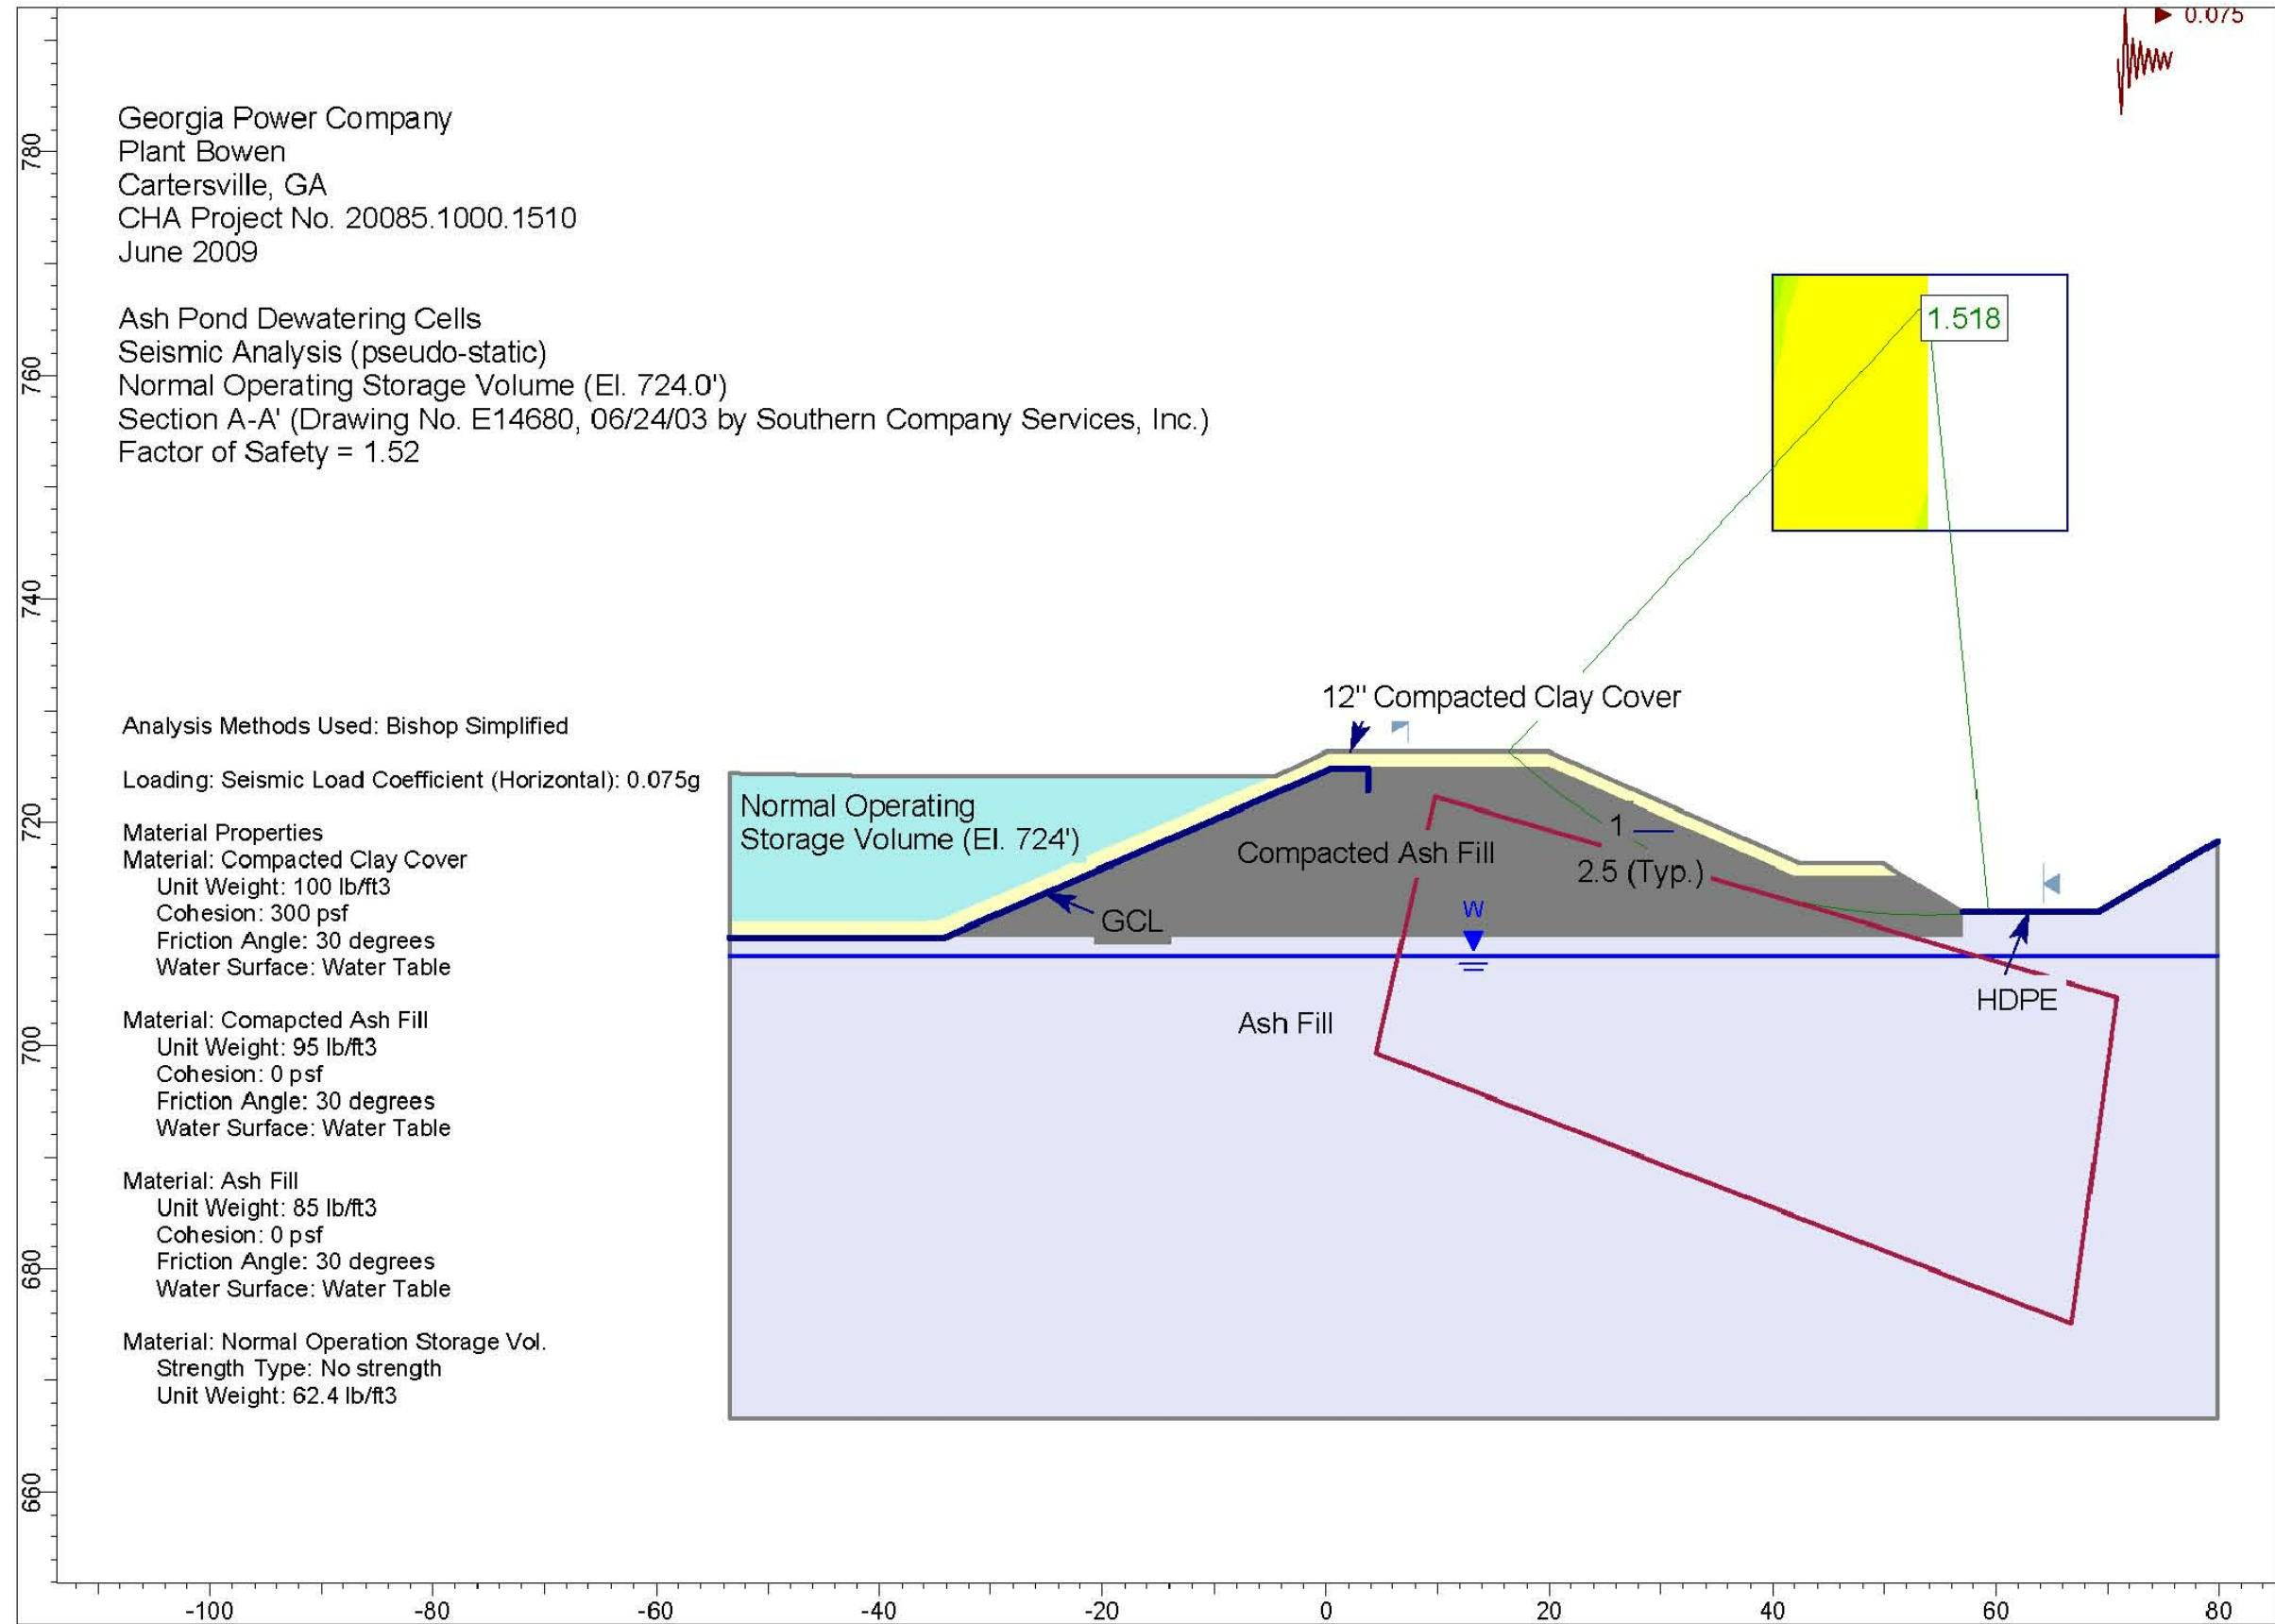
FIGURE 15-1

Figures 15-1 through 15-3 illustrate the construction and stability cross sections for the dewatering cells. Although the gypsum cells are slightly higher (about 23 feet), their side slopes are 3H:1V. Based on CHA analyses, the factors of safety for the gypsum cells is similar to that of the ash dewatering cells.

STABILITY ANALYSIS
ASH POND DEWATERING CELLS
 PLANT BOWEN
 GEORGIA POWER COMPANY
 CARTERSVILLE, GEORGIA

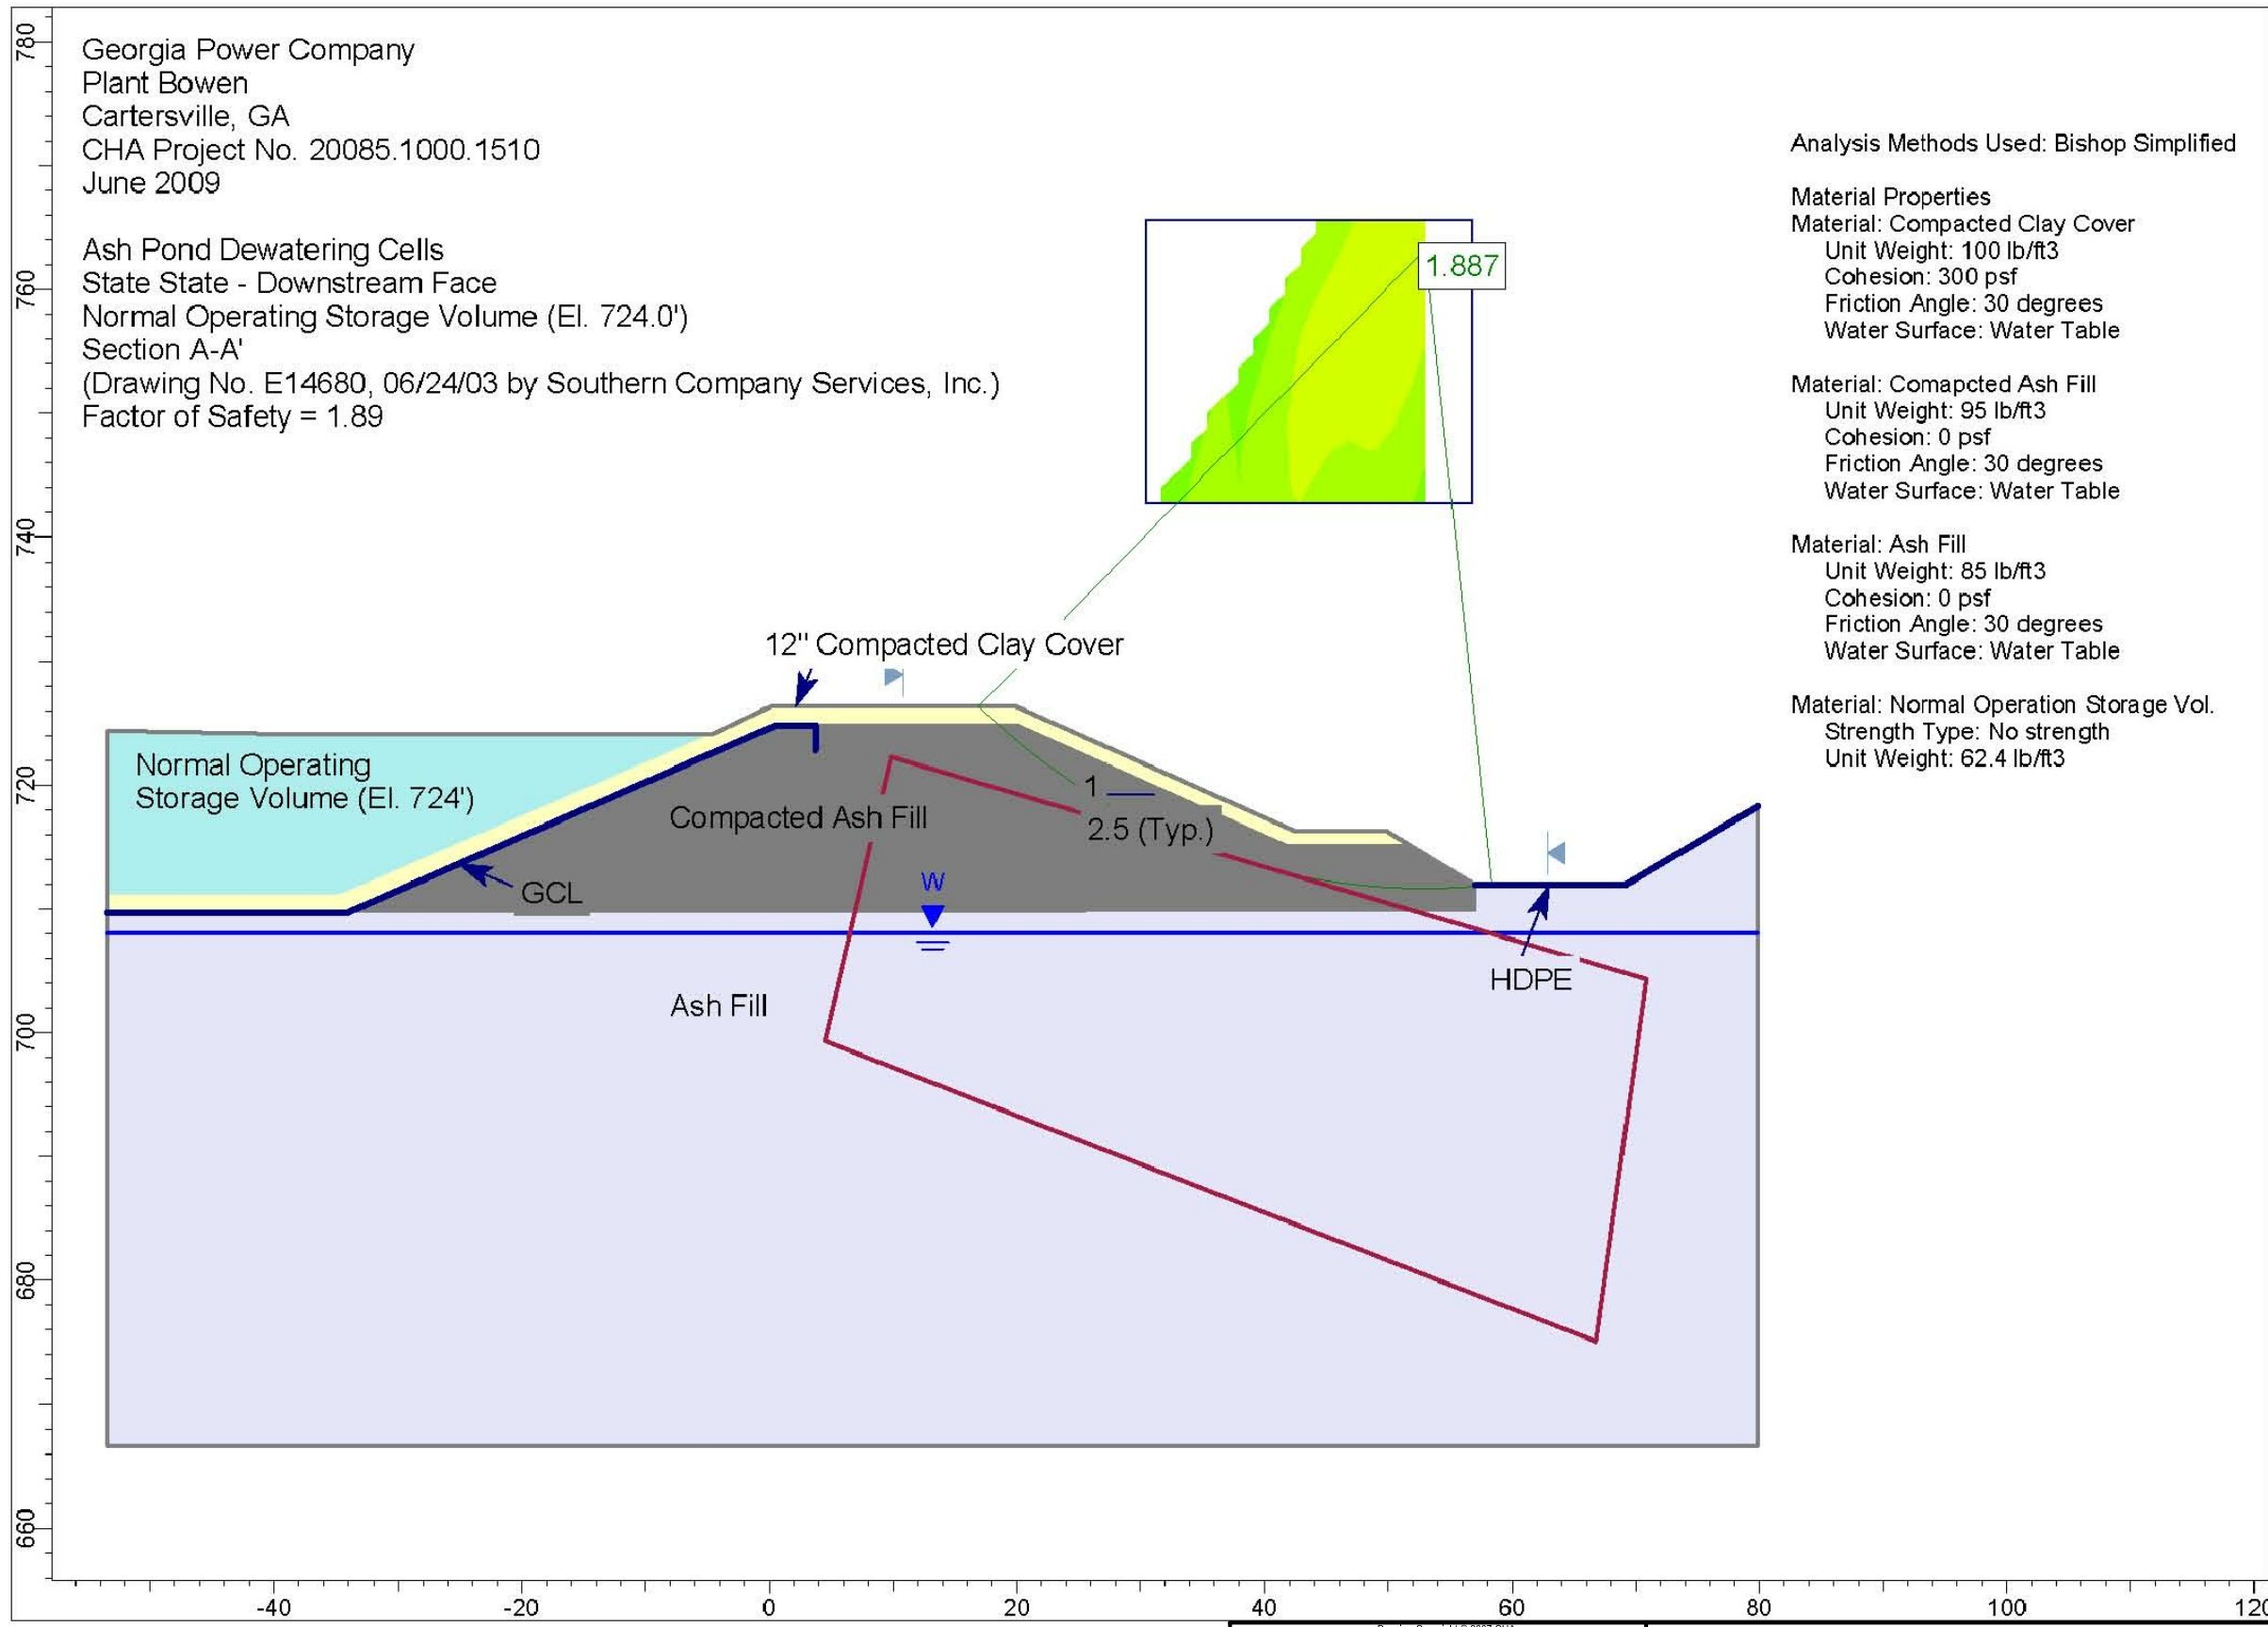
PROJECT NO.
 20085.1000
 DATE: JULY 2009
 FIGURE 15-2

Ash Pond Dewatering Cells
 State State - Downstream Face
 Normal Operating Storage Volume (El. 724.0')
 Section A-A'
 (Drawing No. E14680, 06/24/03 by Southern Company Services, Inc.)
 Factor of Safety = 1.89

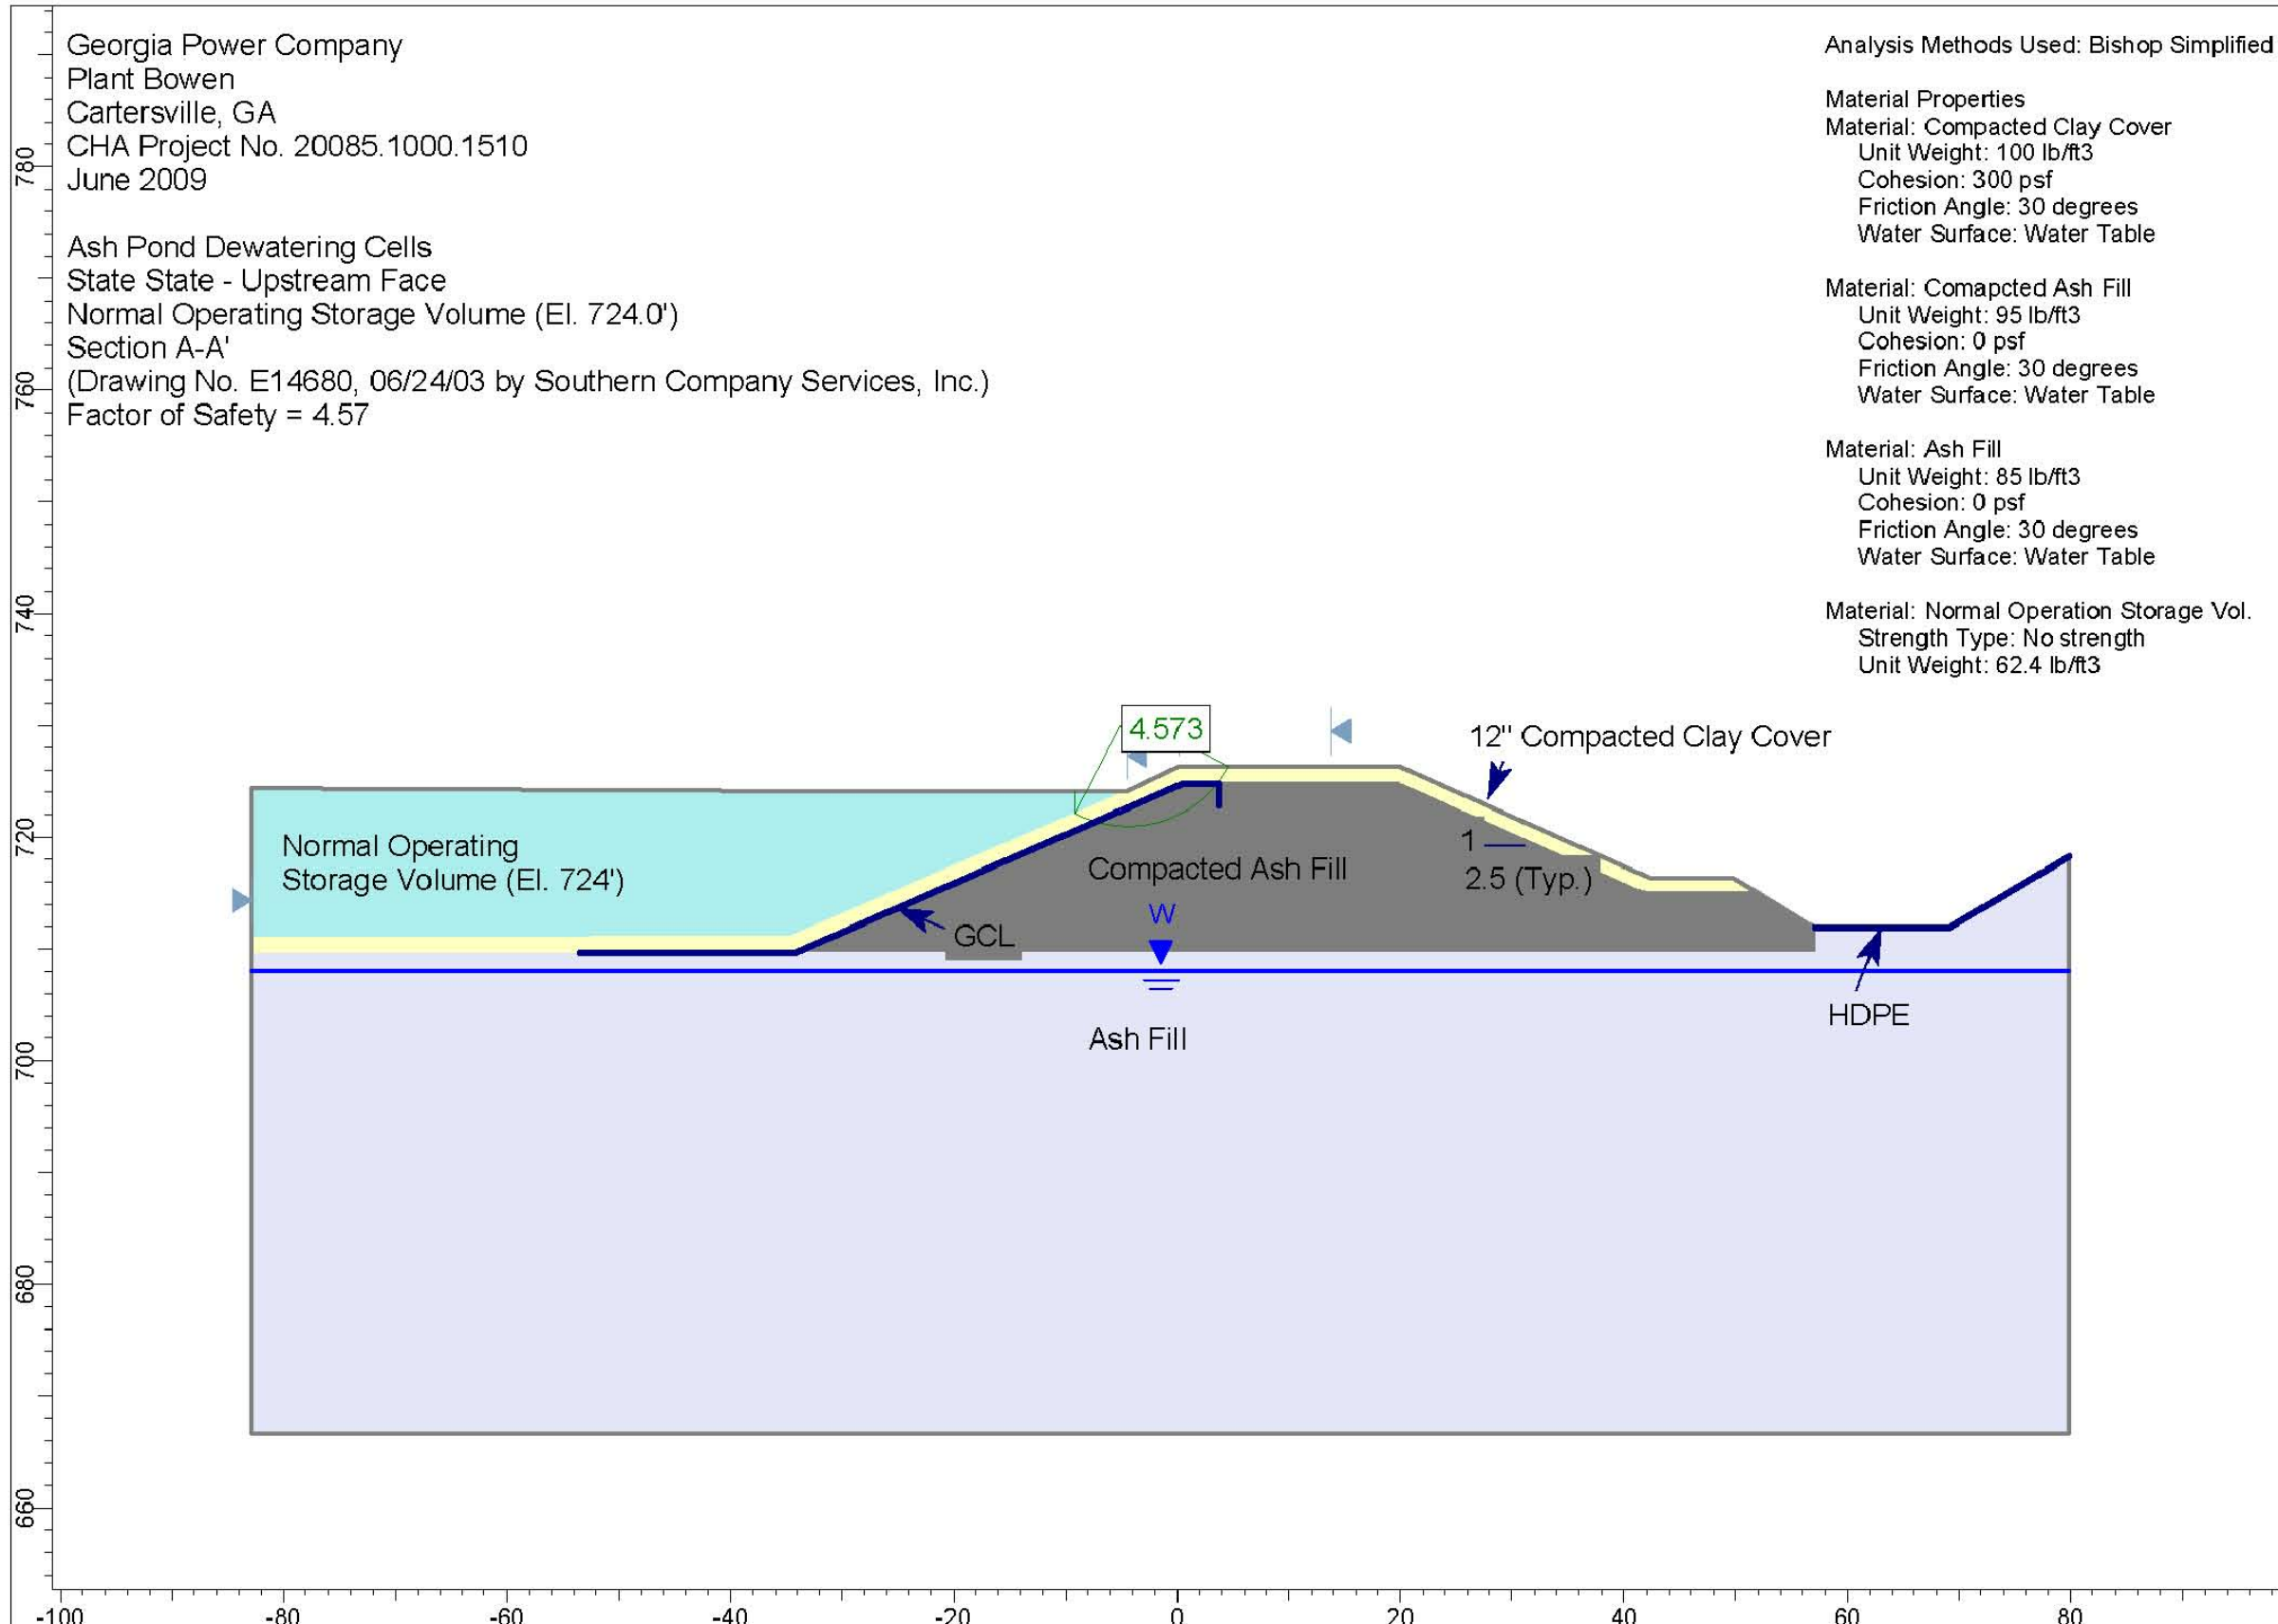
FIGURE 15-3

STABILITY ANALYSIS
ASH POND DEWATERING CELLS
 PLANT BOWEN
 GEORGIA POWER COMPANY
 CARTERSVILLE, GEORGIA
