# Assessment of Dam Safety Coal Combustion Surface Impoundments (Task 3) Final Report

Georgia Power  
Company

Plant Branch

Milledgeville, GA

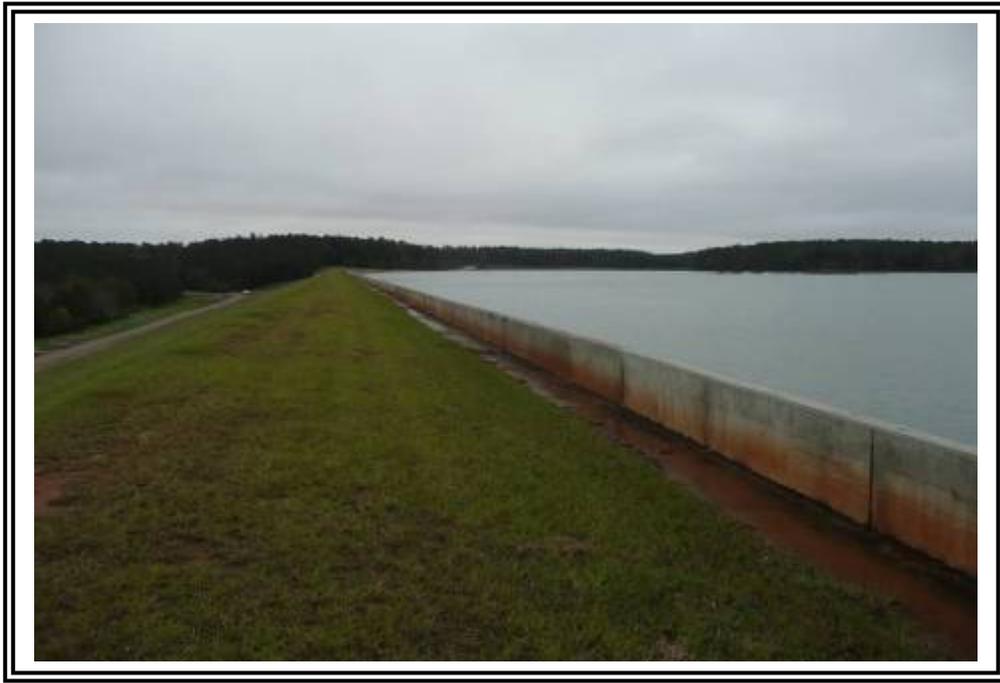
1

Northern end of Ash Pond E dike crest, facing south.

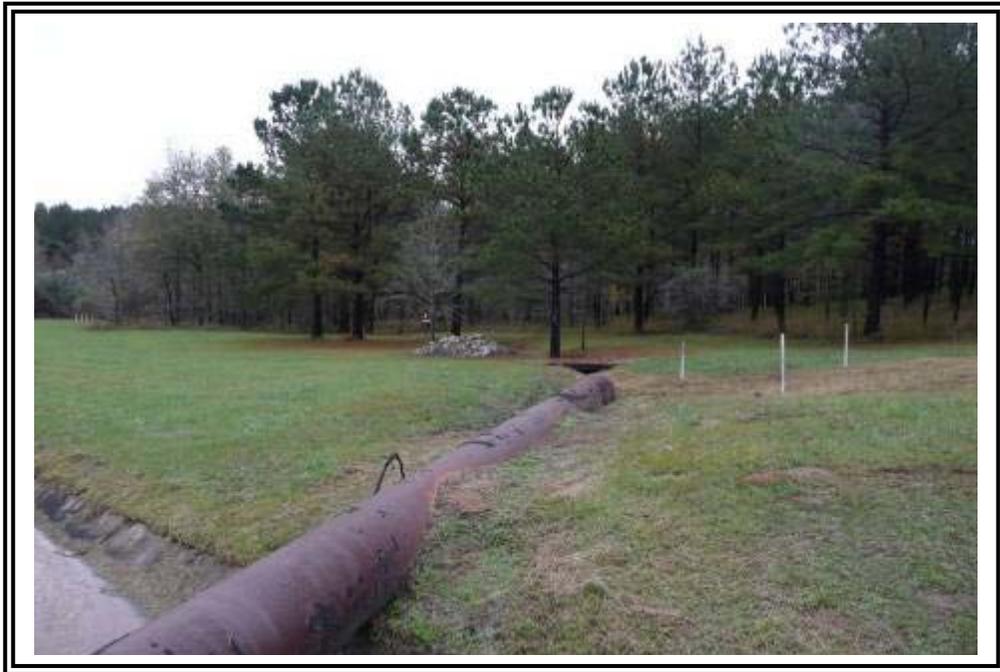
2

Ash Pond E abandoned overflow drain located along southern portion of the dike.  
The drain pipe is constructed of welded steel.

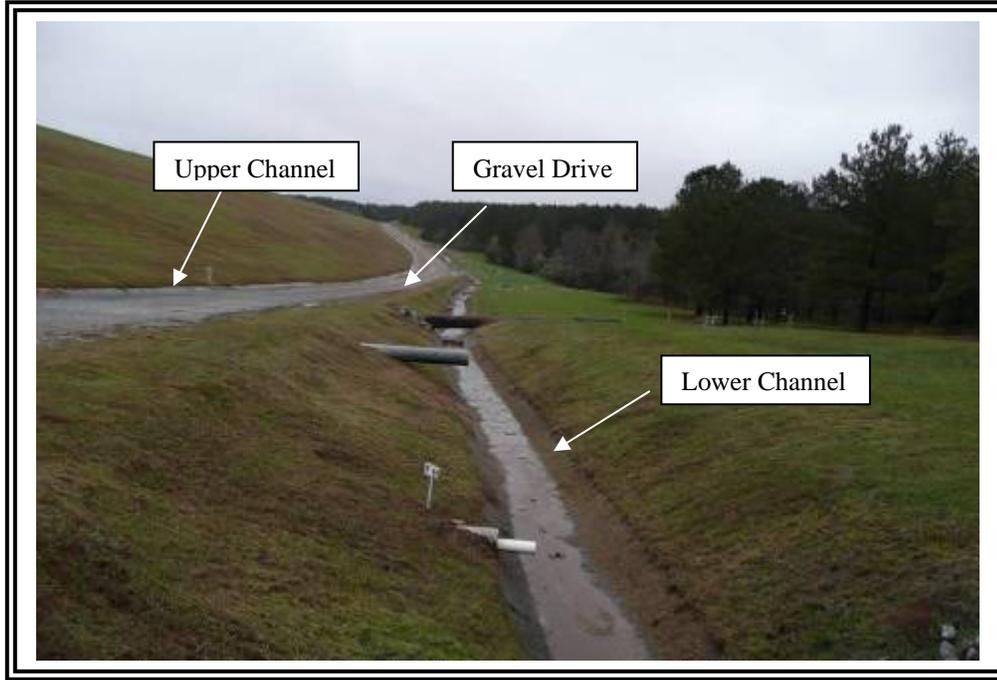
3

Ash Pond E, south dike toe, facing north. Drainage system shown. Upper and lower drainage channels are constructed of a concrete lined channel.

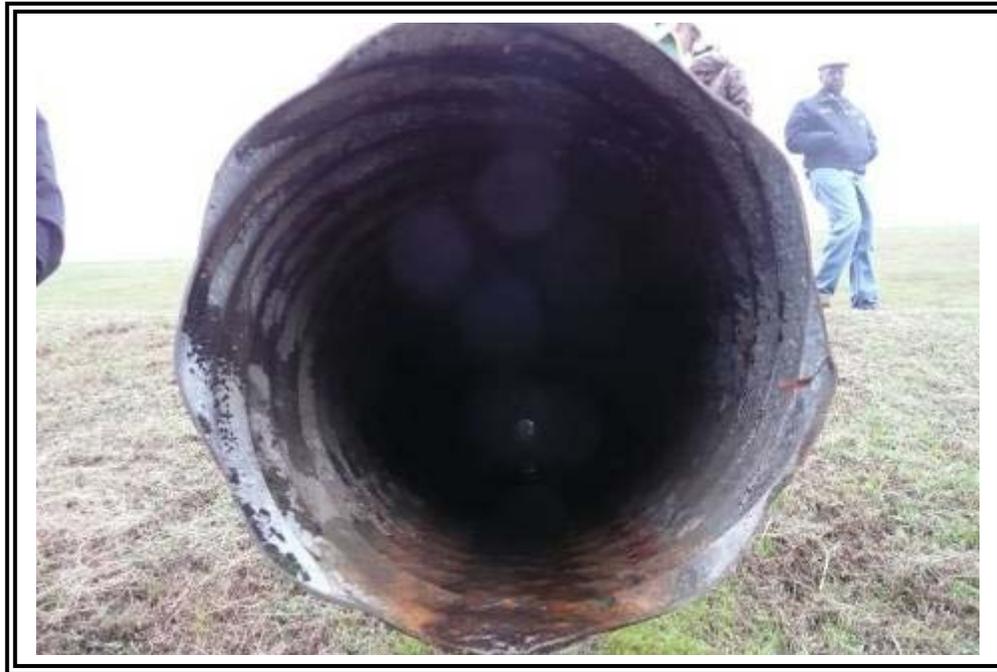
4

Corrugated metal drain pipe located north of Ash Pond E finger drain #11. Light can be seen at the western most end of the drain pipe, indicating a clear drainage channel from upper channel drain to lower channel drain.

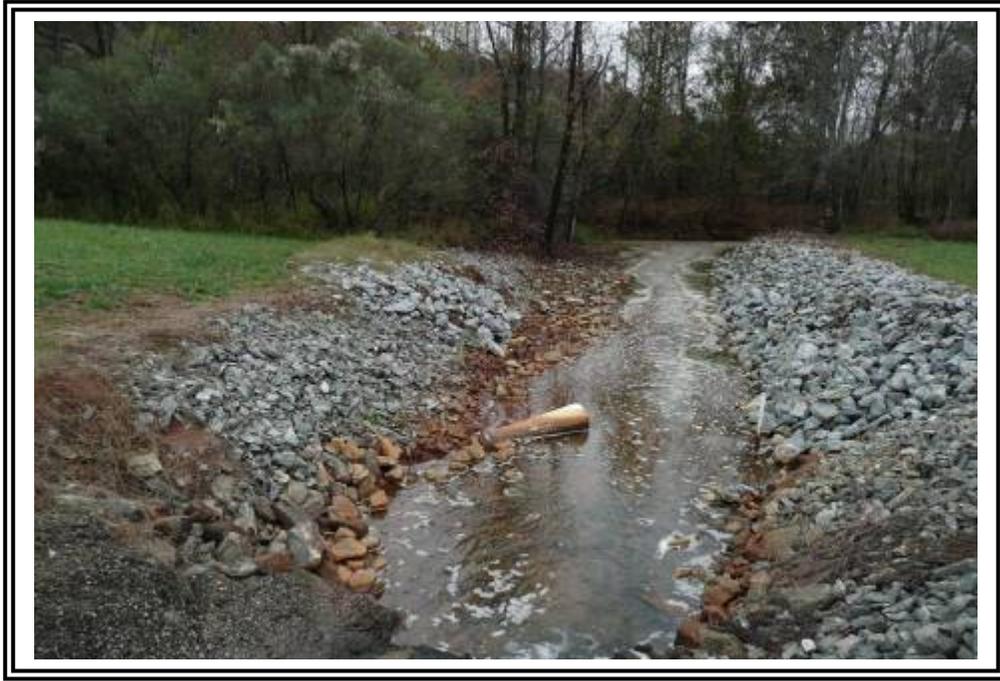
7

Ash Pond E, receiving stream for drainage from the blanket drain system.

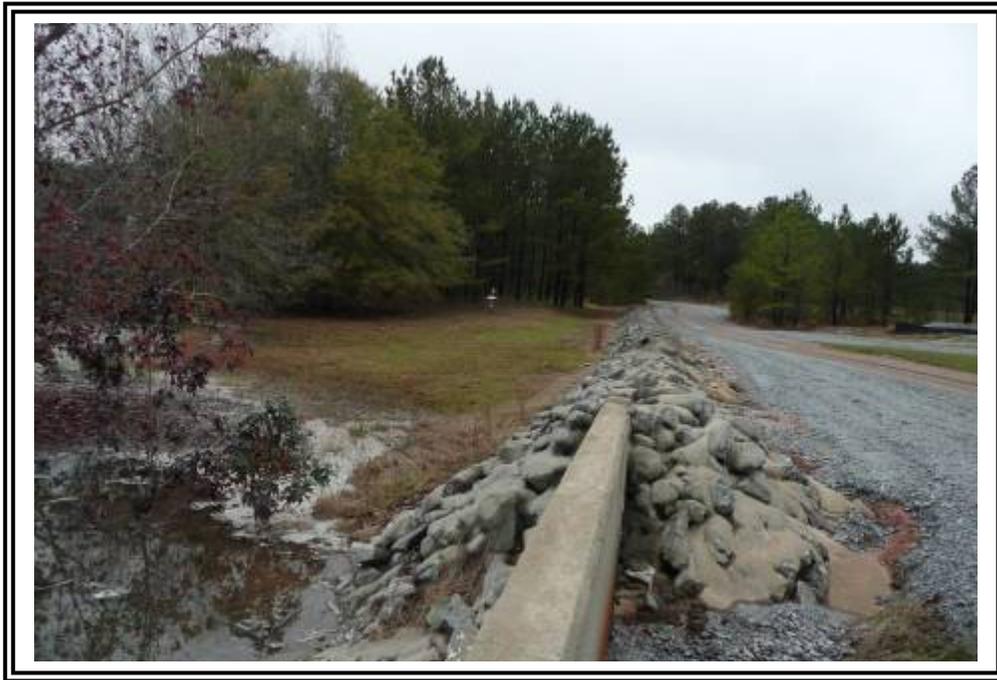
11

Ash Pond E, north end of dike, facing north.

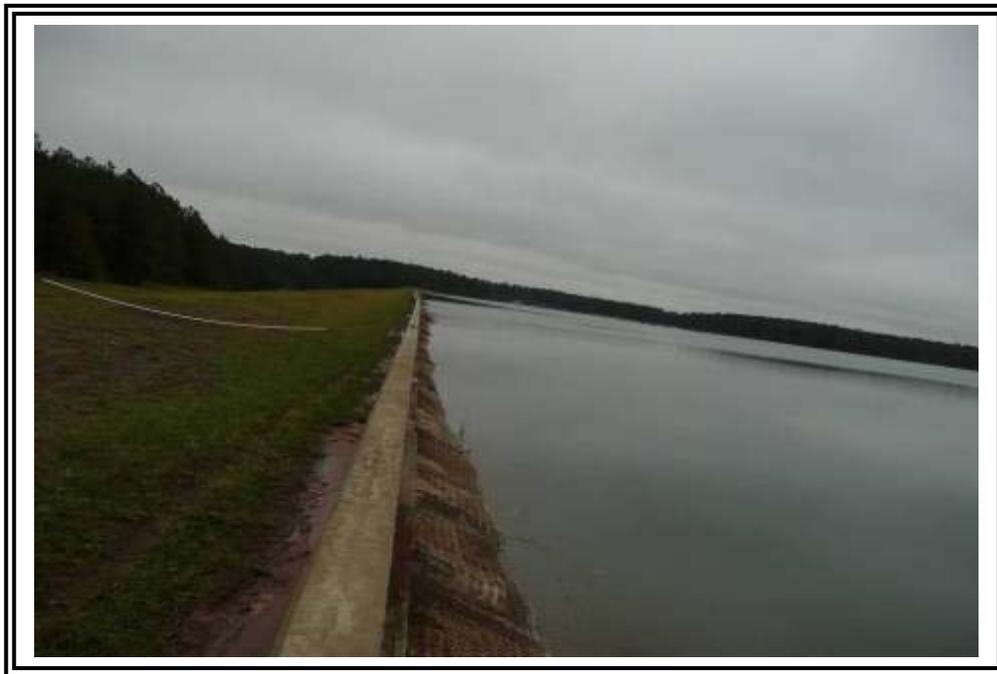
12

Ash Pond E, north end of dike, facing south.  
Shown above, wave wall and rip-rap placement along upstream edge of pond.

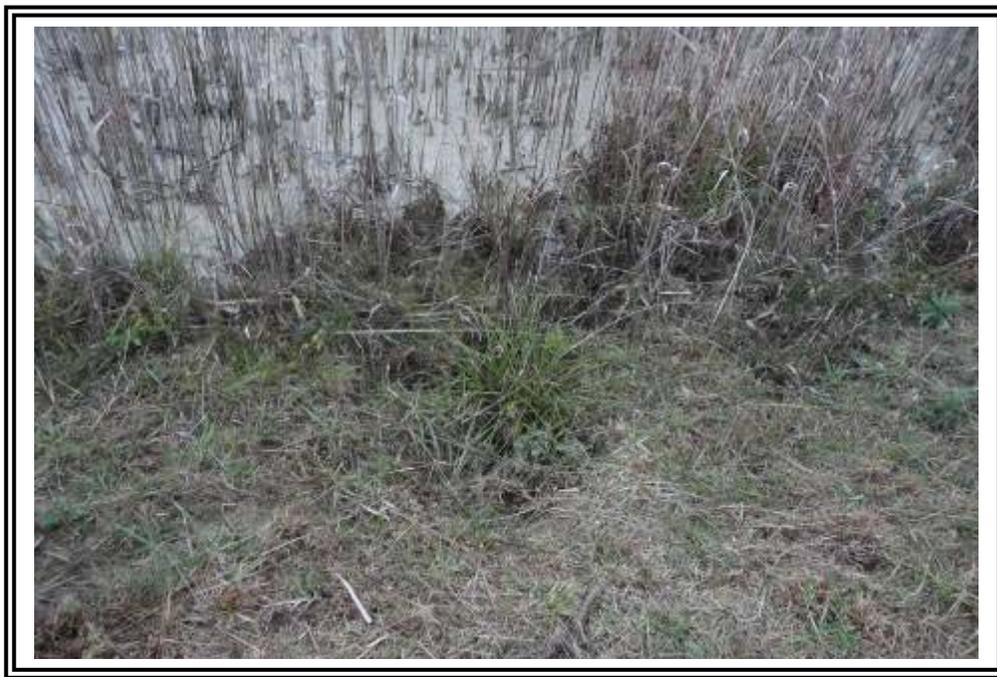
20

Ash Pond D, central portion of the dike facing east. Interior edge of the dike (pond side).

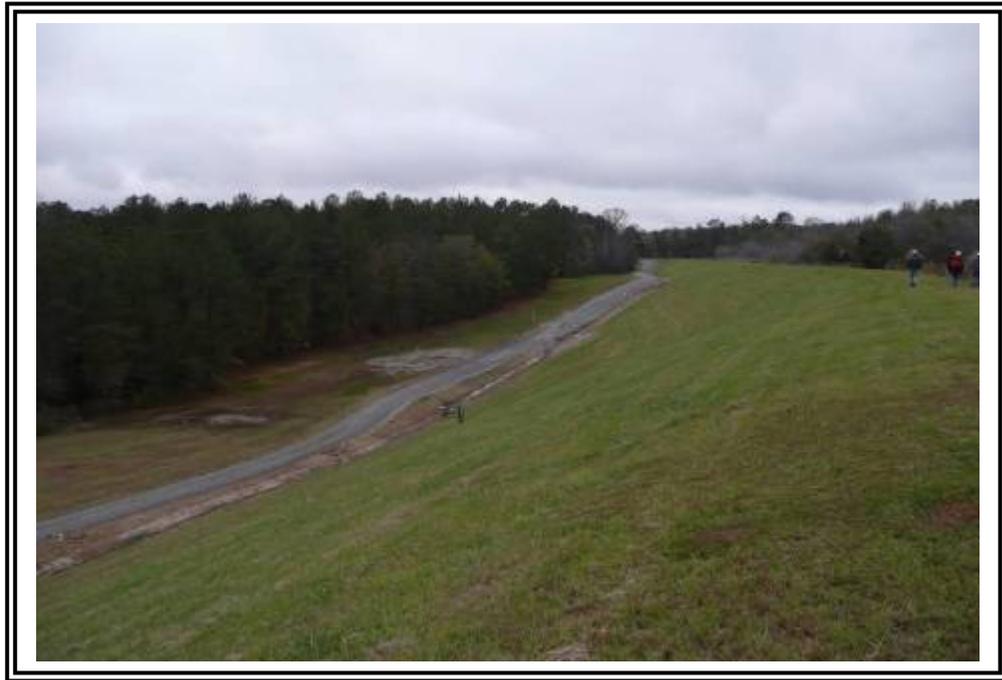
21

Ash Pond D, central portion facing north east.

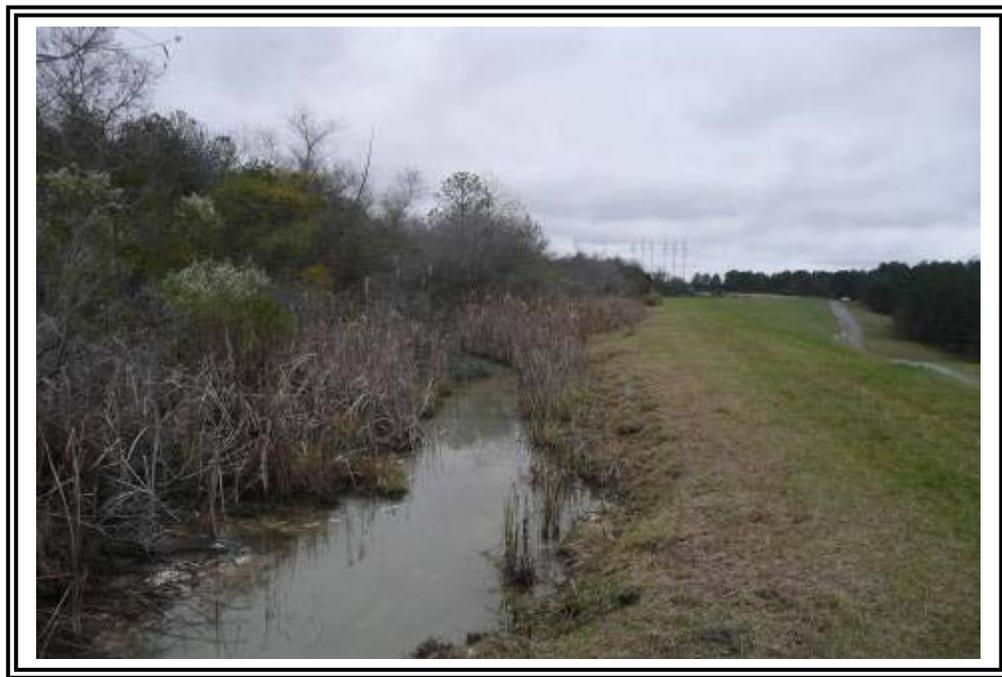
22

Upon inspection of the dike from the crest, a widening of the dike was noted along the northern end as shown in Photo 22. Georgia Power personnel indicated that this is due to the buildup of fly ash along the interior edge of the dike which has slowly filled the pond as shown in Figure 2D. Based upon aerial photo mapping and available site plans, roughly 1,400 feet of the Pond D dike structure has silted in and no longer actively impounds water as measured from the northern end of the dike. Only about 600 feet of the dike now retains open water and this section of the dike has developed a stand of aquatic vegetation at the pond-dike interface over time. Additionally, several rodent borrows (Photo 19) were located along the upstream edge of the dike. These rodent burrows were subsequently filled during the EPA site assessment period.

Ash Pond D, north edge of dike facing south east. Note widened crest of dike.

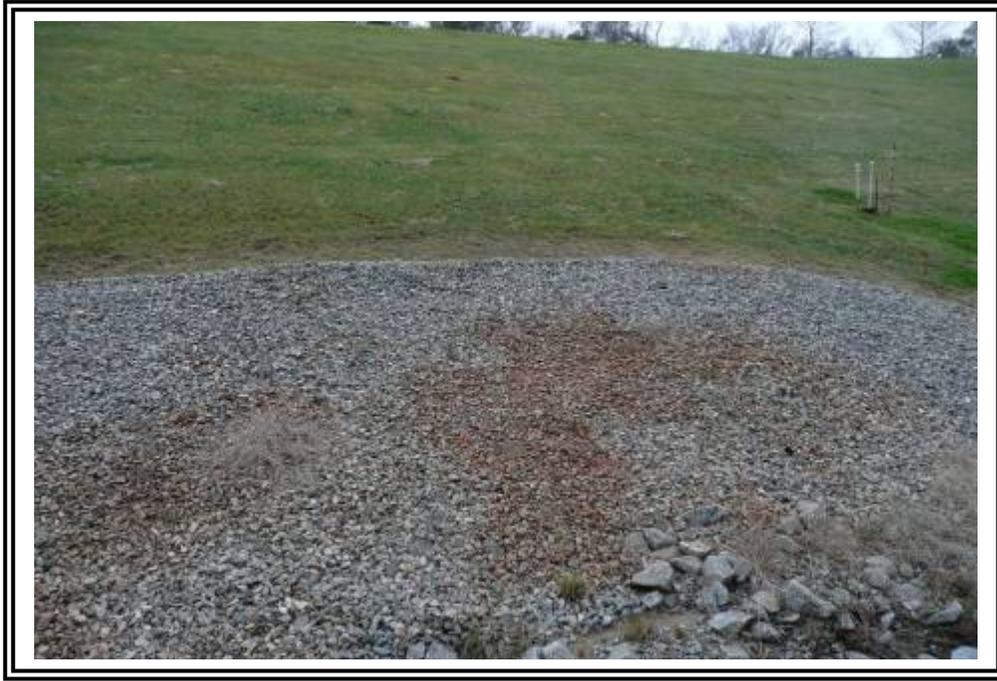
Along the central portion of the downstream face of the dike, an area roughly 10 feet wide by 20 feet long was observed to be covered with rock (Photo 25). Based upon information provided by Georgia Power personnel, it is understood that the existing rock was installed in an effort to remedy seepage at this location. West of this area and across the existing access drive was an area of rock approximately 25 feet in diameter covered with 2 to 4 inch gravel (Photo 27). It was indicated by Georgia Power personnel that this area was known to be a soft area and had been covered with rock as a means of remediation.

Ash Pond D, central portion of dike at edge of toe. Seepage remediation area shown. Georgia Power personnel indicated that this area was previously remediated and the concrete lined channel was inadvertently razed during remediation

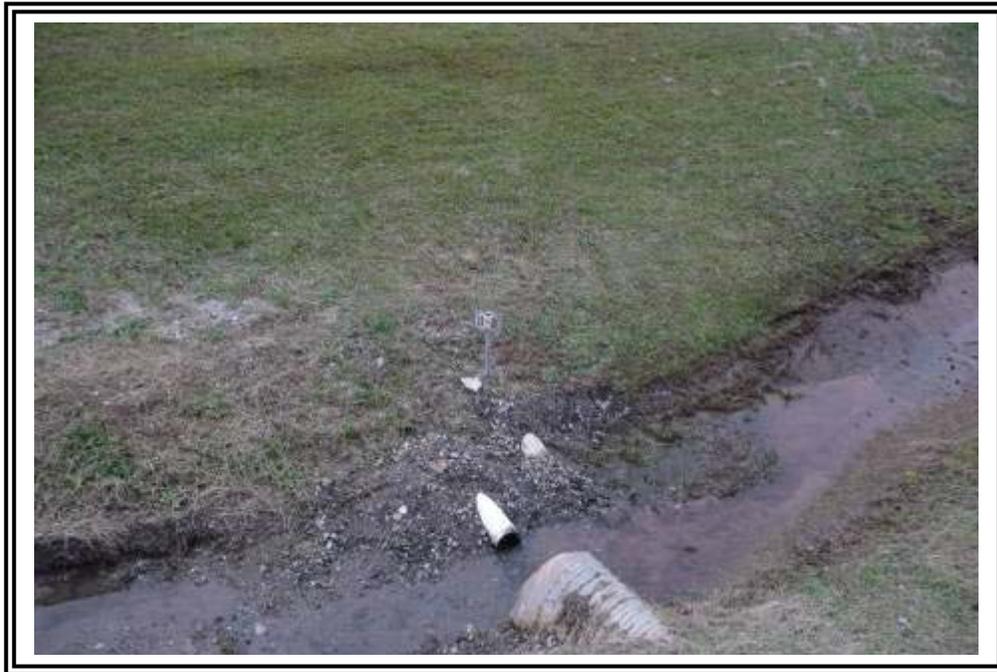
26

Ash Pond D finger drain D-3. .

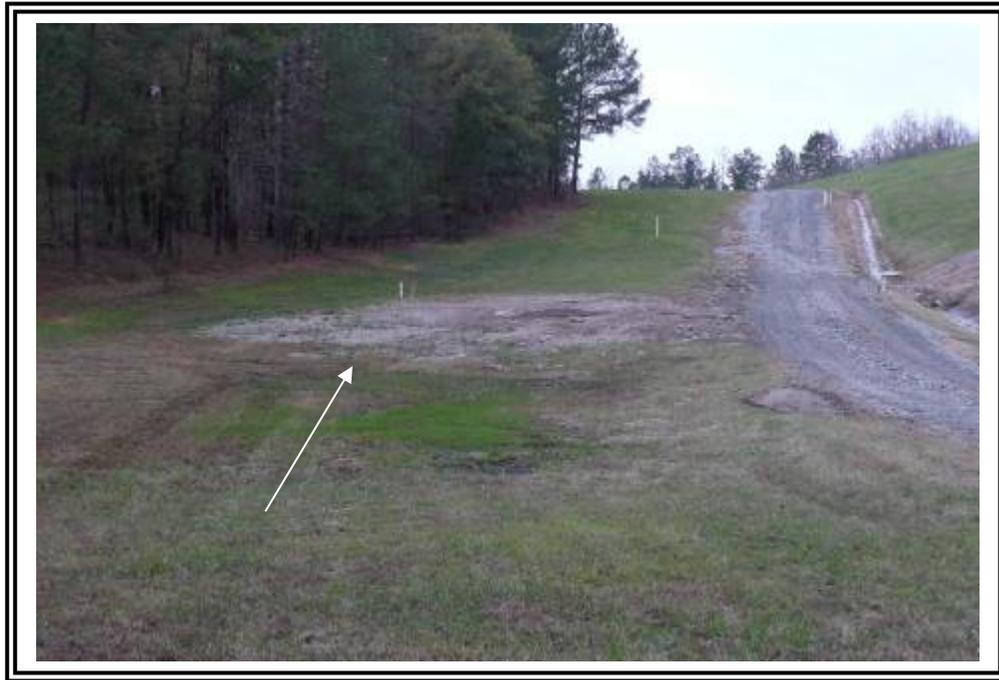
27

Ash Pond D, central portion of dike, west of toe facing north west.  
“Soft area” covered with rock indicated by arrow.

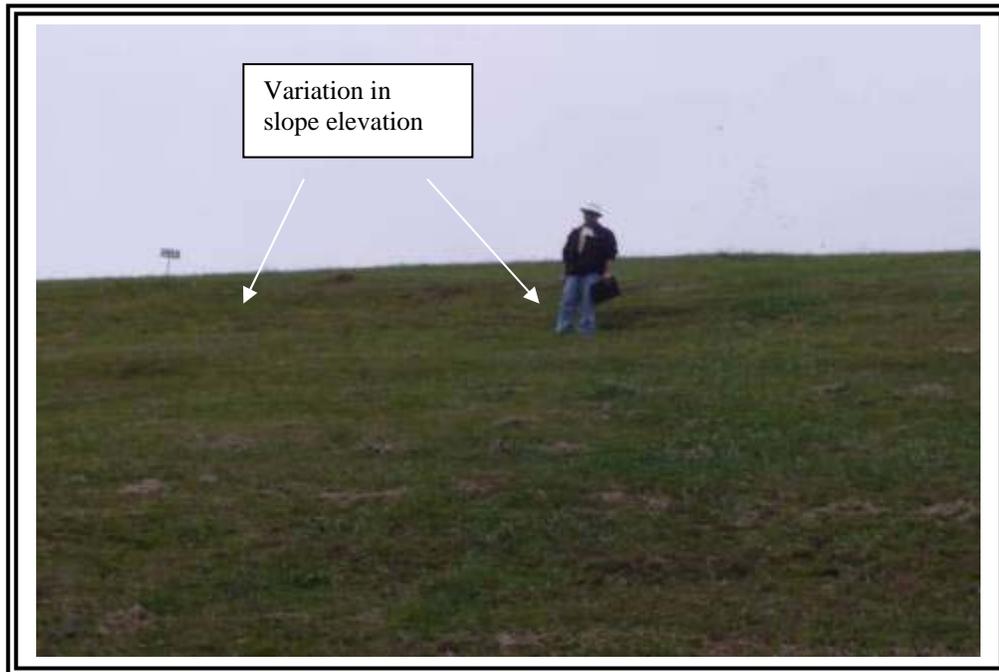
28

Ash Pond D, central portion of dike at edge of toe, facing east into the dike.  
Note dike variation in slope elevation possibly due to scarping or sloughing due to mowing patterns.

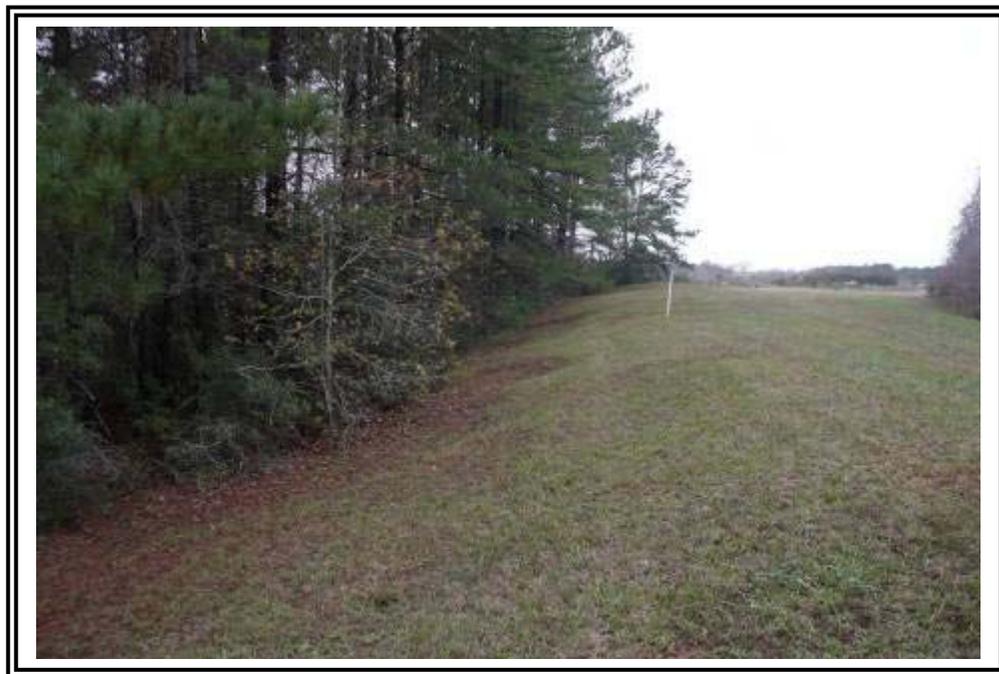
38

Ash Pond C, downstream edge of west dike at north end of dike, facing north.

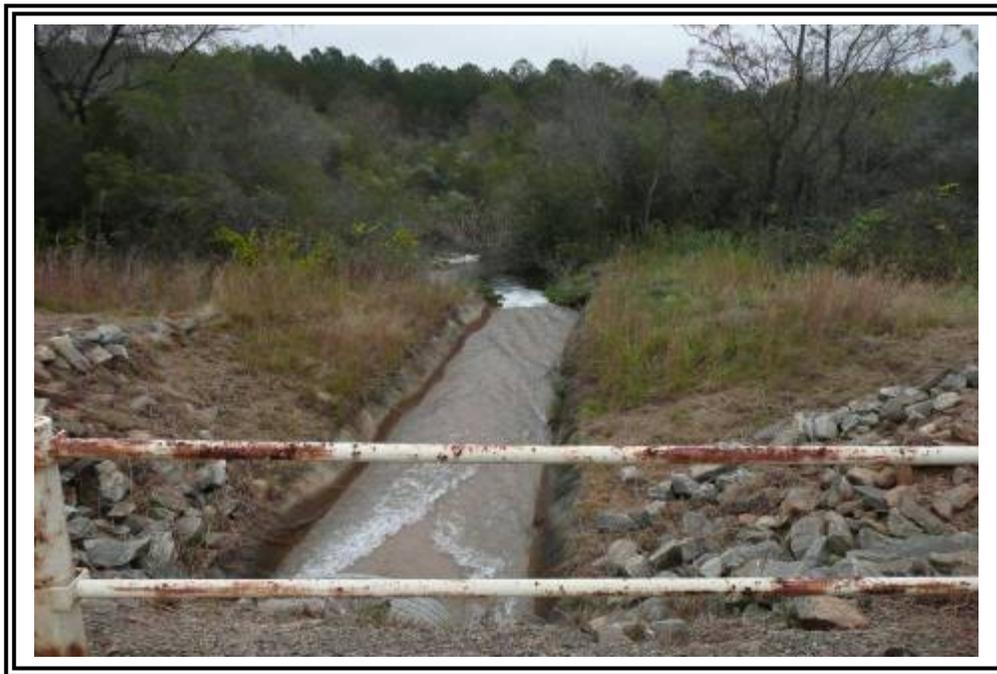
40

Overflow into Ash Pond C from atop the bridge facing southeast.

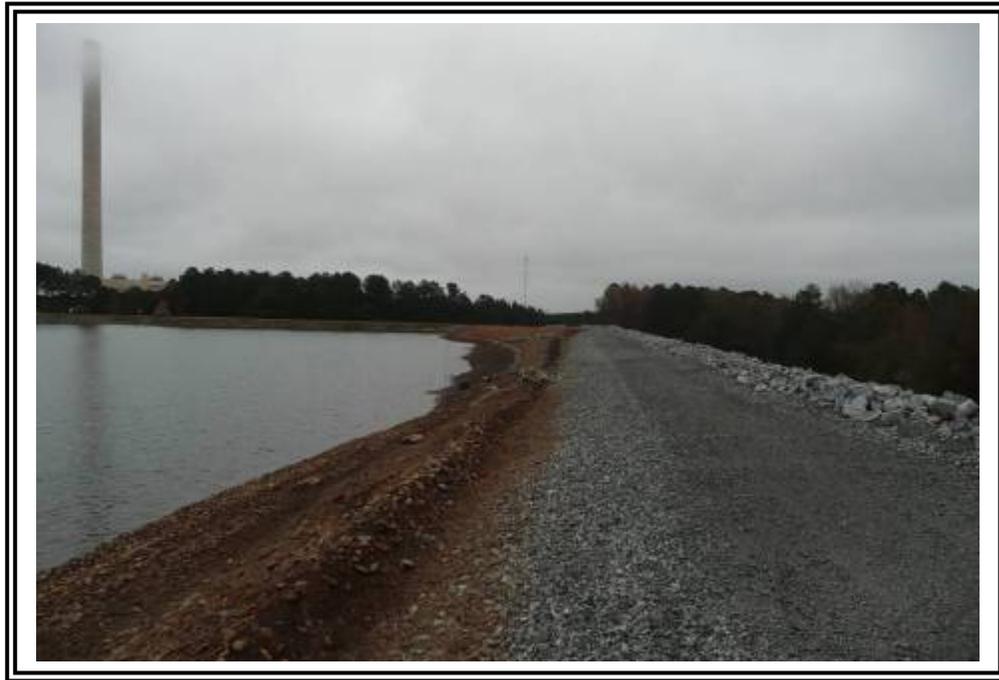
41

Ash Pond C, west end of south dike facing east.

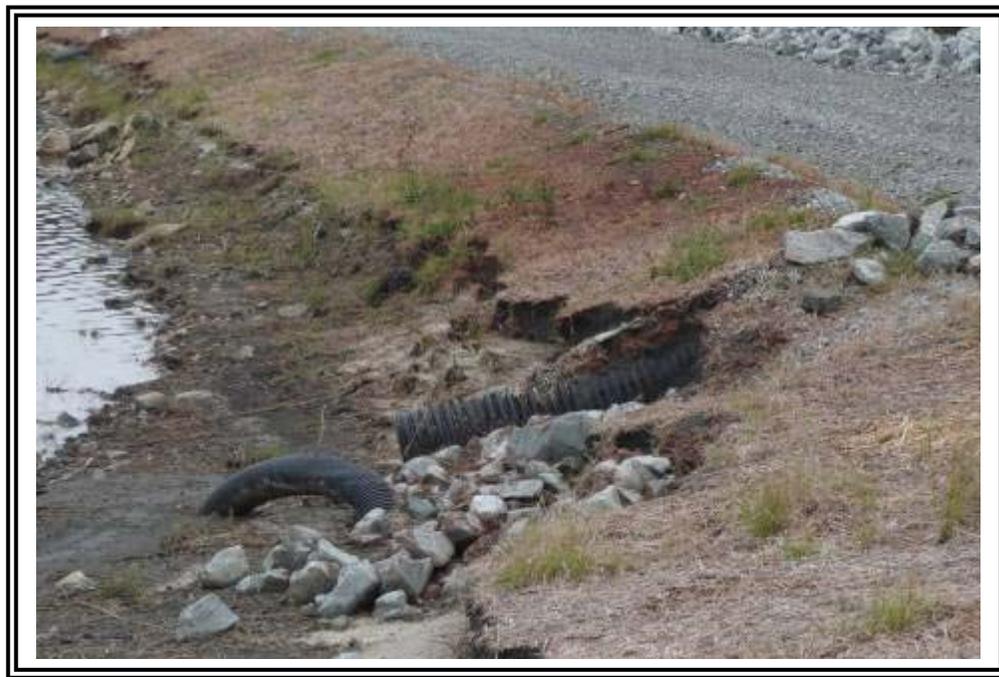
42

Upstream side of Ash Pond C west end of south dike facing east. Crest run-off drain shown.

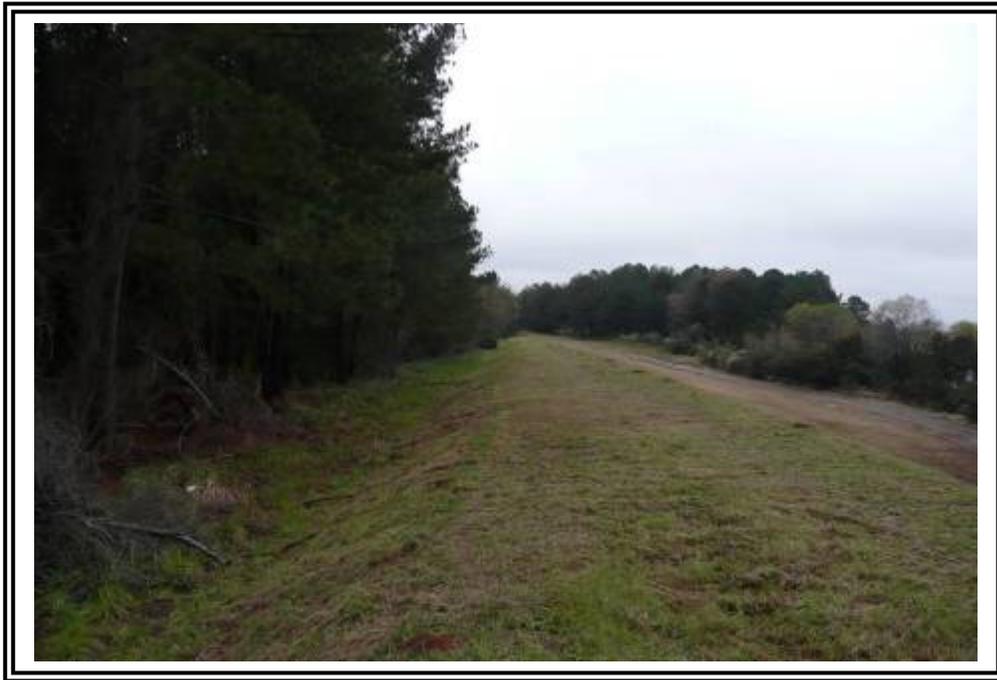
51

Ash Pond C, north portion of east dike facing north.

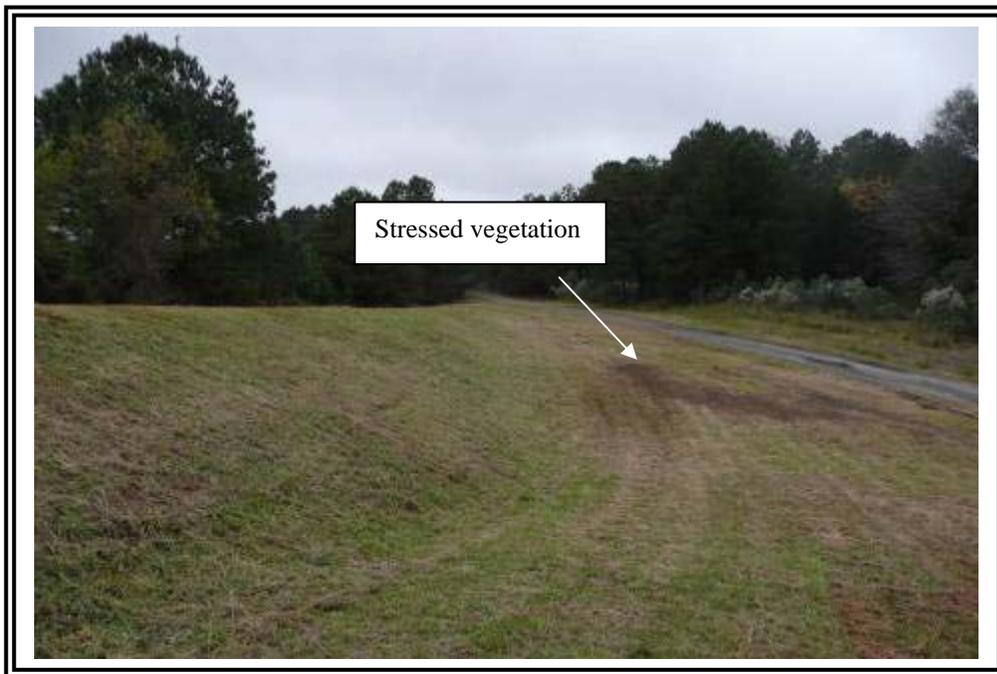
52

Ash Pond C, downstream slope at north end of east dike, facing north.  
Stressed vegetation shown frame right.

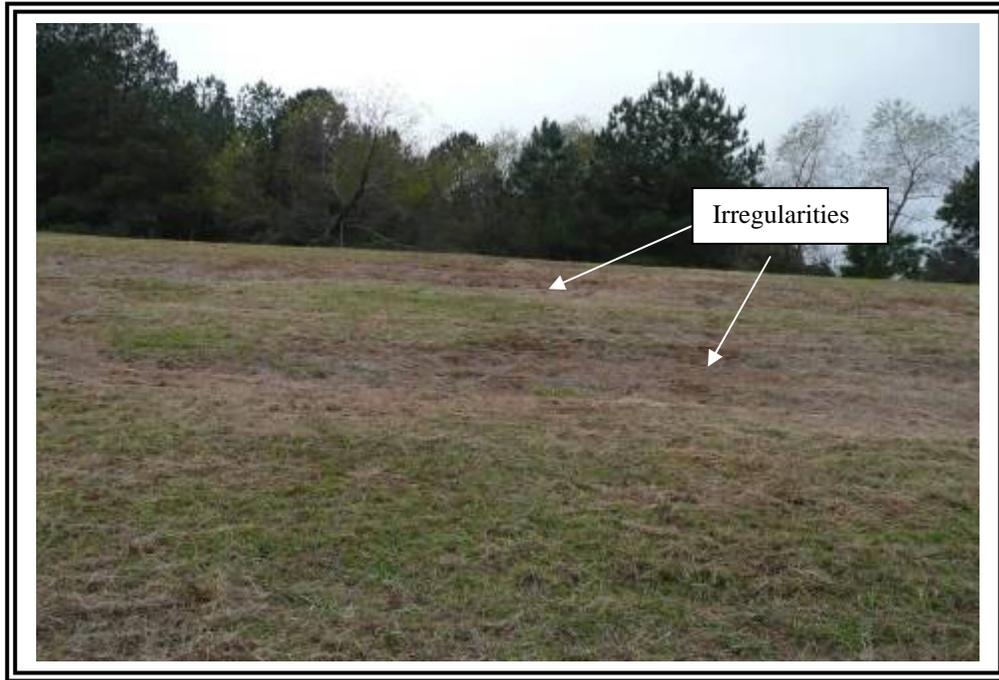
53

Ash Pond C, north end of east dike along dike toe, facing west. Dike irregularity due to mowing indicated.

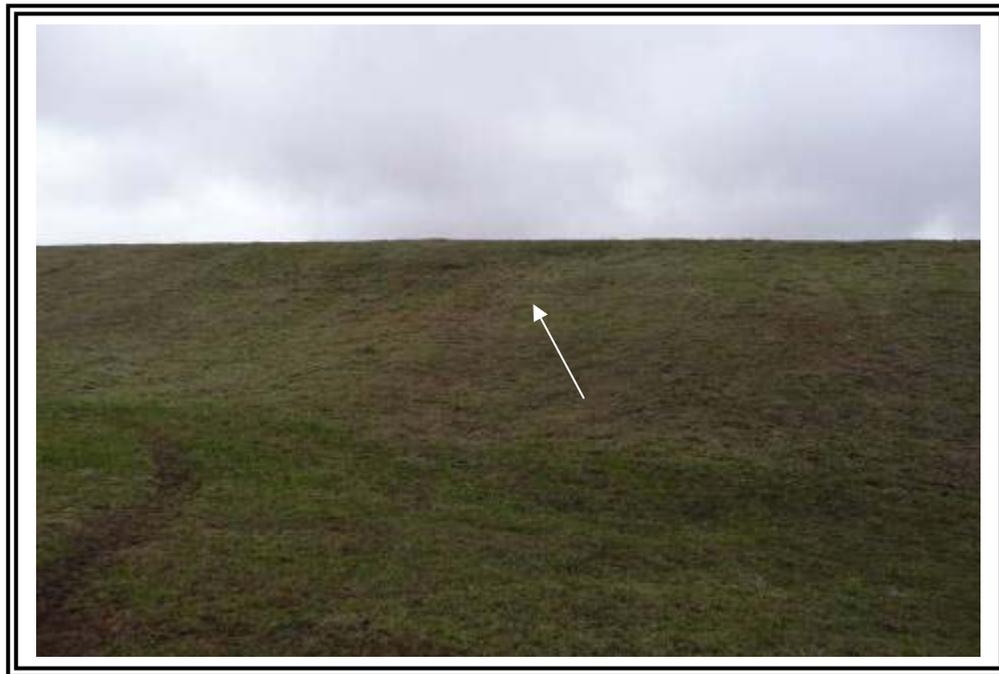
54

Inconsistencies in the dike’s downstream face were also noted along the south end as shown in Photo 54. These variations in the face of the slope appeared to be either the remnants or initial formation of erosion rills beneath the vegetation currently present on the slope.

Downstream slope of Ash Pond C east dike near the south end showing variations in elevation.

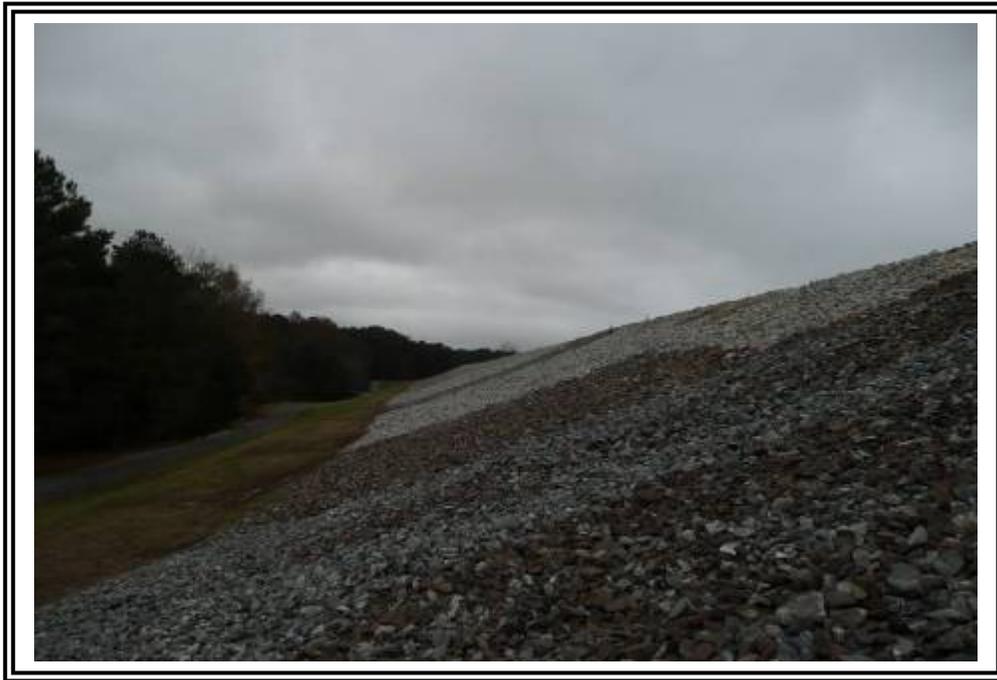
55

Ash Pond C, east end of south dike facing west.  
Downstream slope shown with rip-rap facing.

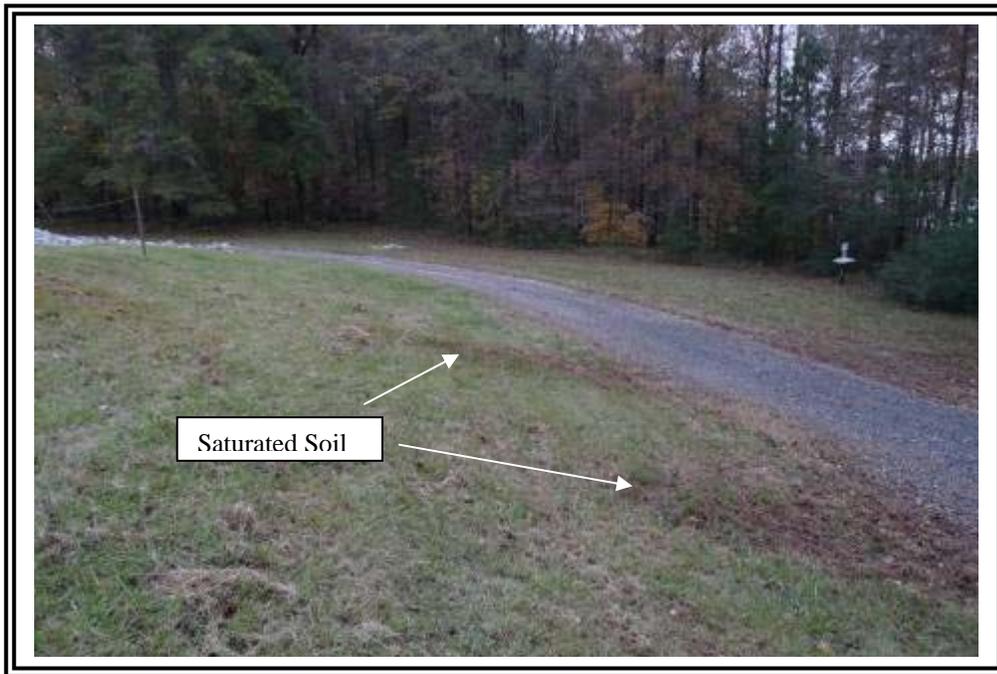
56

Ash Pond C, east end of south dike at the toe, facing east. Two saturated areas shown  
(several located in this area).

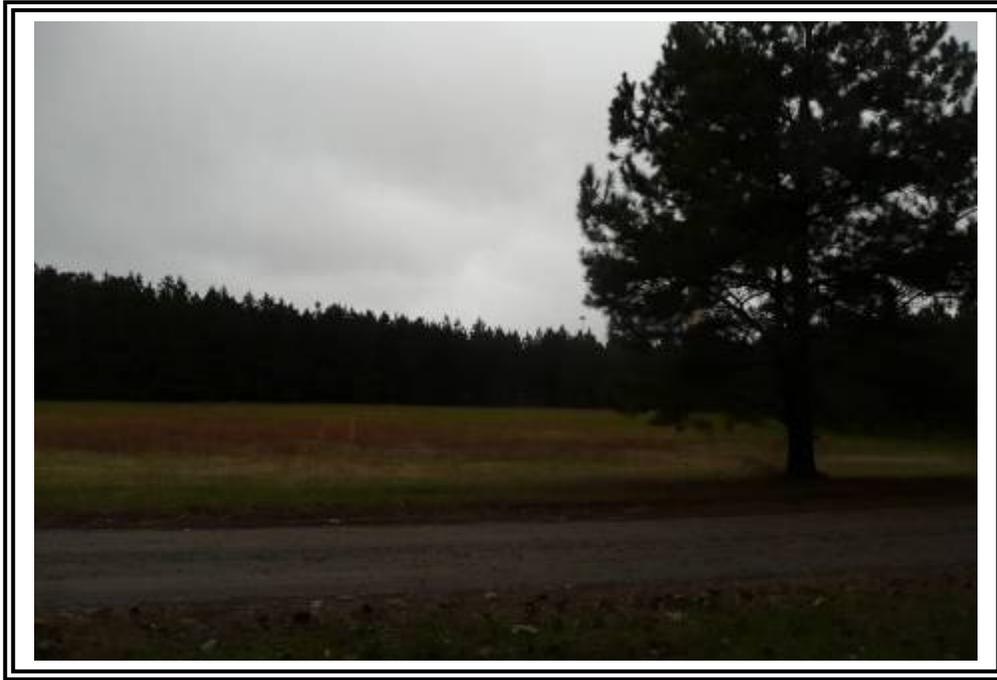
65

Ash Pond B, central portion of dike crest, facing north into area of pond filled with bottom ash and covered with topsoil.

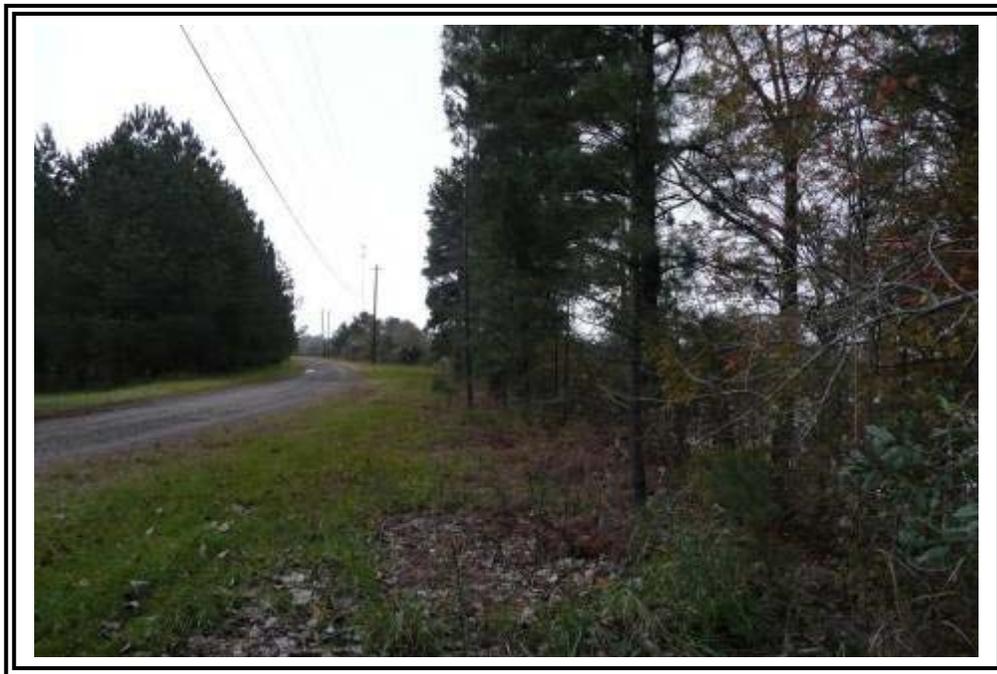
66

Ash Pond B, central portion of dike facing east. Downstream slope of dike shown frame right with vegetation present. Interior edge of dike shown frame left with vegetation (tree cover) present along eastern end of the pond.

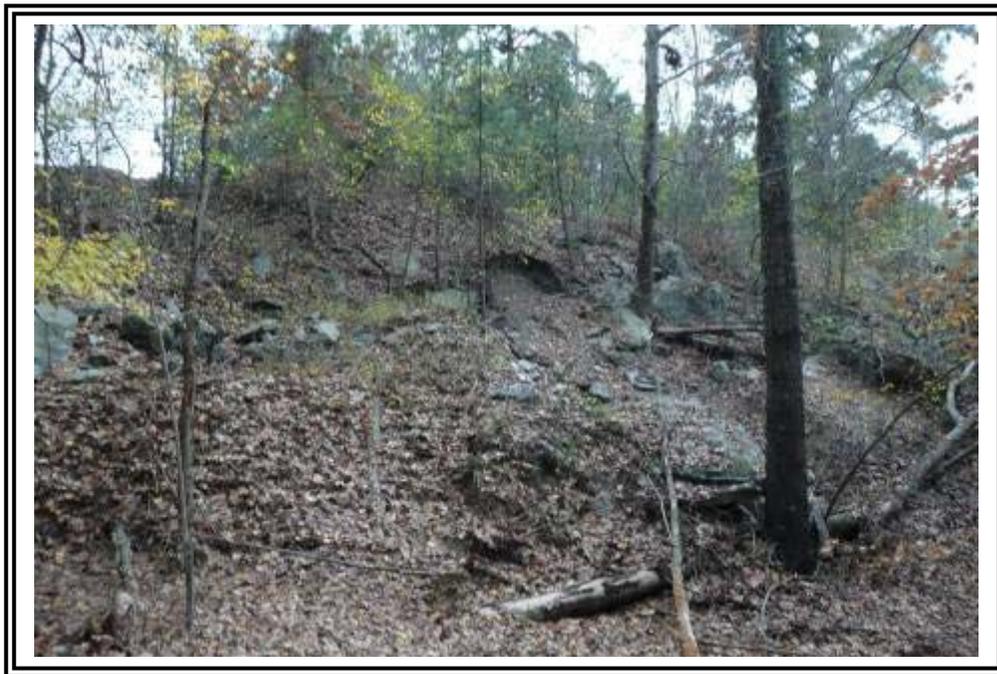
68

Ash Pond B, central portion of dike facing north, along the toe. Exterior of dike shown with large boulders and vegetative growth.

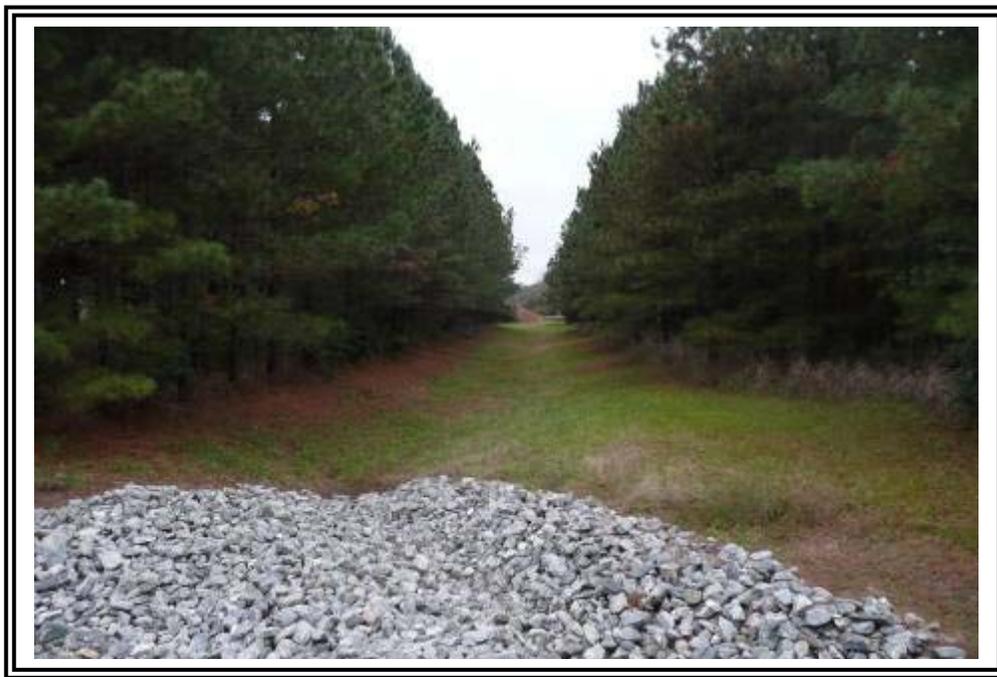
70

Ash Pond B, west end of dike facing north, at emergency spillway and site drainage open channel. Inlet protection for emergency spillway into discharge facility shown.

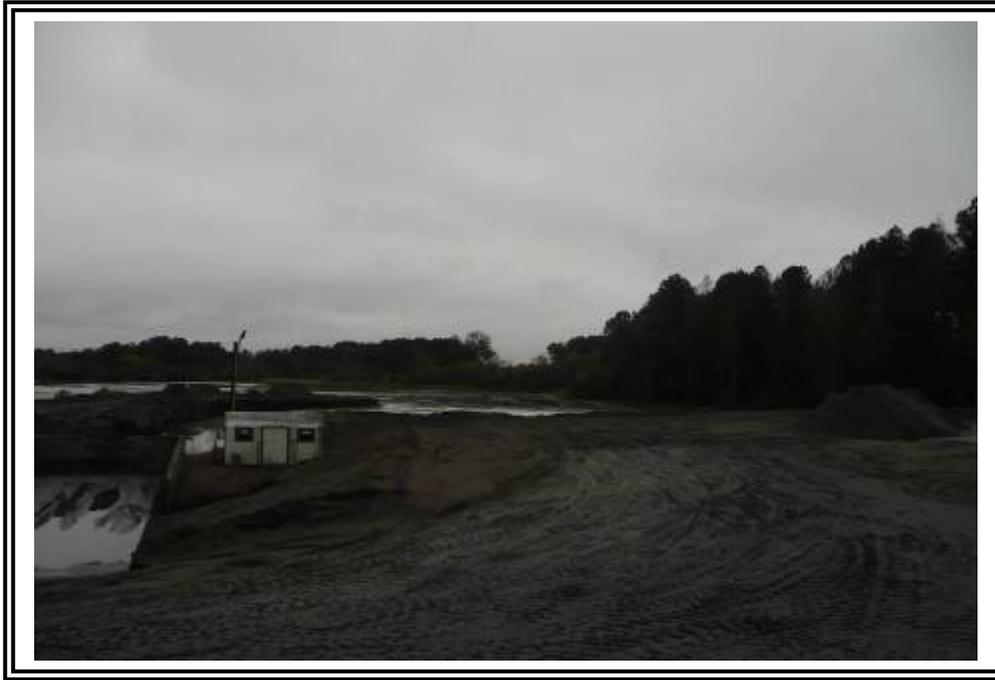
71

Ash Pond B, north end of pond along eastern edge facing west. Shown is the portion of Ash Pond B unfilled with bottom ash. Ash processing facility shown frame left.

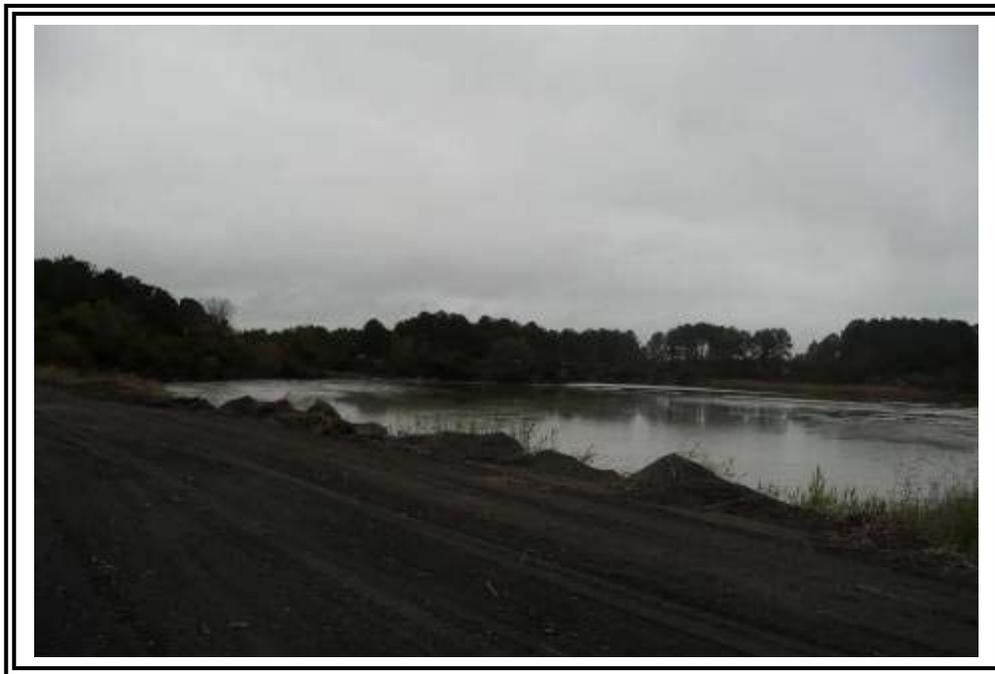
72

Ash Pond B, north end of pond along eastern edge facing south west. Shown is portion of the pond remaining unfilled with bottom ash. Frame left and furthest shows the area of Ash Pond B filled with bottom ash, covered with topsoil, and vegetative cover.
